RAIL CV-5-6

LOCATION AND CROSSING DESCRIPTION

**BAFFINLAND IRON MINES
MARY RIVER PROJECT**

North/South Consultants Inc.
Aquatic Environment Specialists

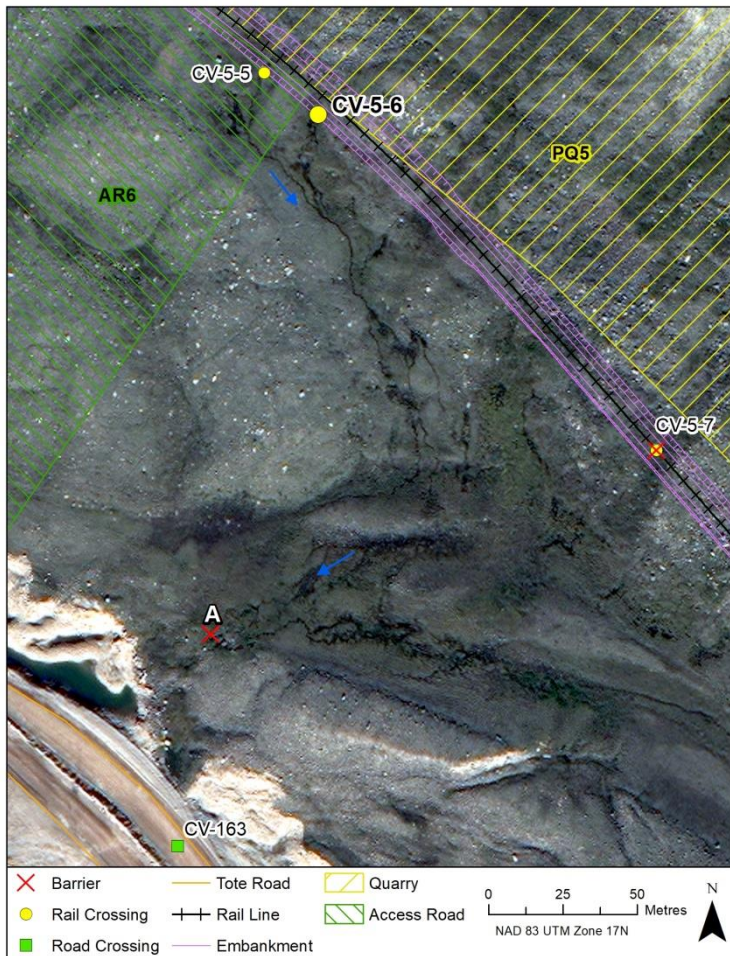
Upstream/ Downstream	UTM		Barrier Type			Height (m)	Gradient (°)	Description	Site Label
	Easting	Northing	1	2	3				
Downstream	506625	7971351	VD	HG	SSF	1.5	15	Permanent Barrier: High gradient with vertical drop, followed (5 m downstream) by subsurface flows	A

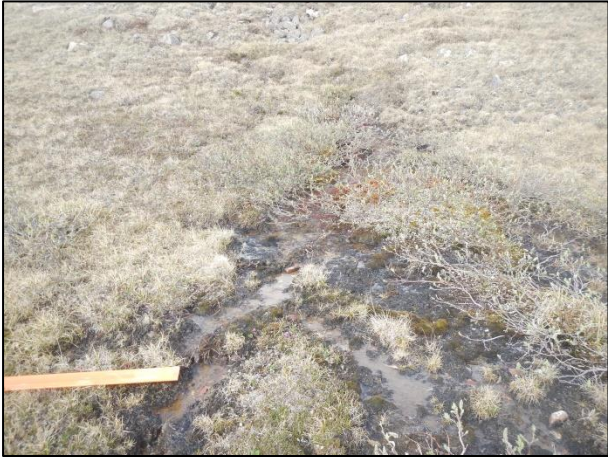
A

There was little water at the crossing, and a permanent downstream barrier of high gradient combined with subsurface flow in spring 2019.

Photos 1. Photos taken at the crossing centreline in spring (A) facing upstream; (B) facing downstream; and (C) across (left bank looking at right bank).
