RAIL CV-6-2

LOCATION AND CROSSING DESCRIPTION

BAFFINLAND IRON MINES
MARY RIVER PROJECT

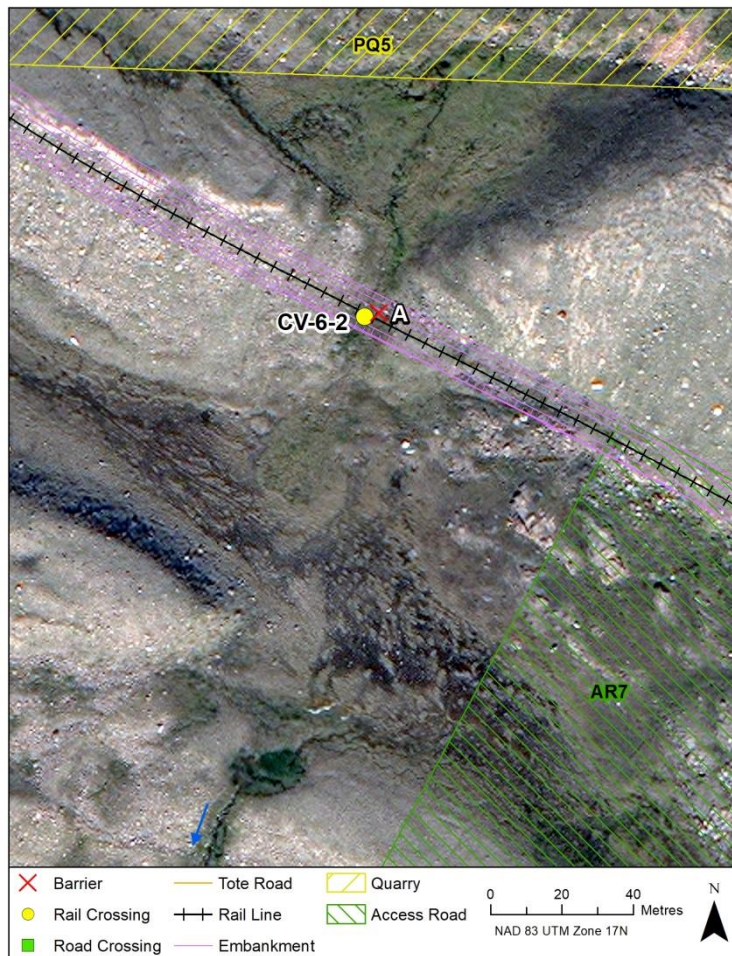
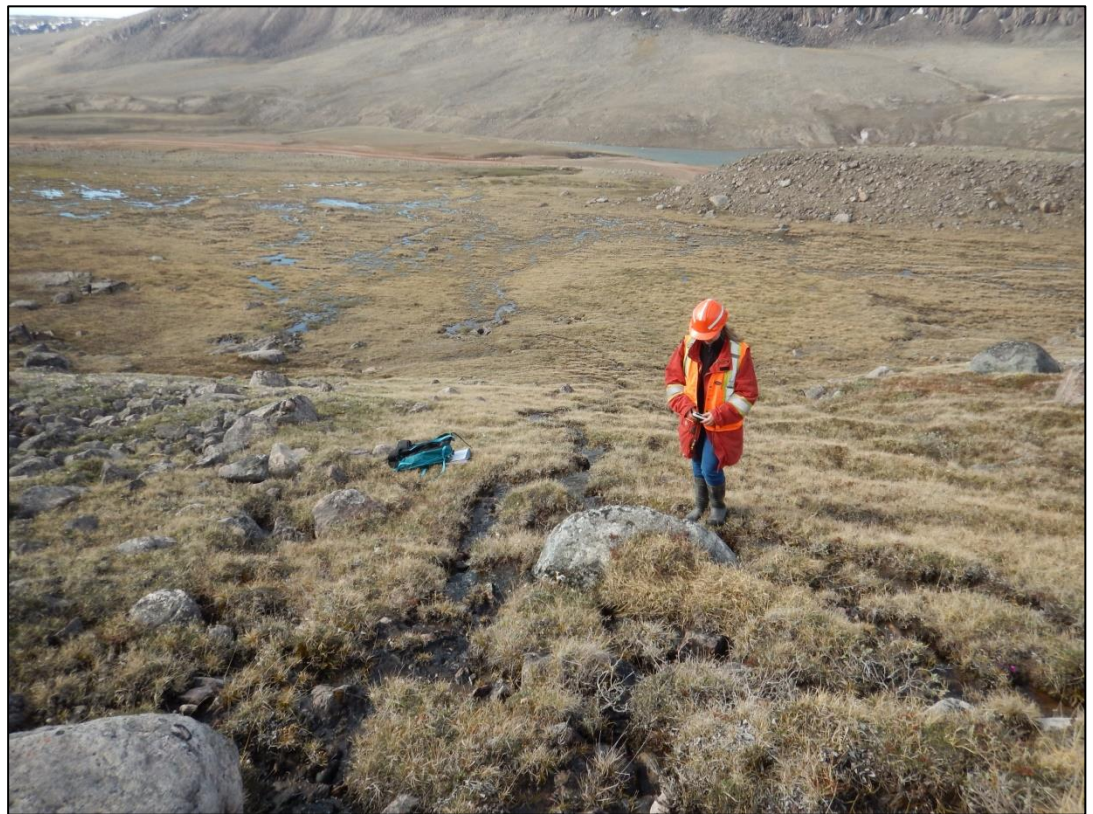
Upstream/ Downstream	UTM		Barrier Type			Height (m)	Gradient (°)	Description	Site Label
	Easting	Northing	1	2	3				
At crossing and downstream	507171	7971067	HG				>10	Permanent Barrier: High gradient along the entire stream length	A

There is no overwintering habitat upstream of crossing CV-6-2, and fish access to the site from downstream habitat is blocked by a permanent barrier (high gradient that extends from the crossing to >100 m downstream). There is no fish habitat at this crossing.

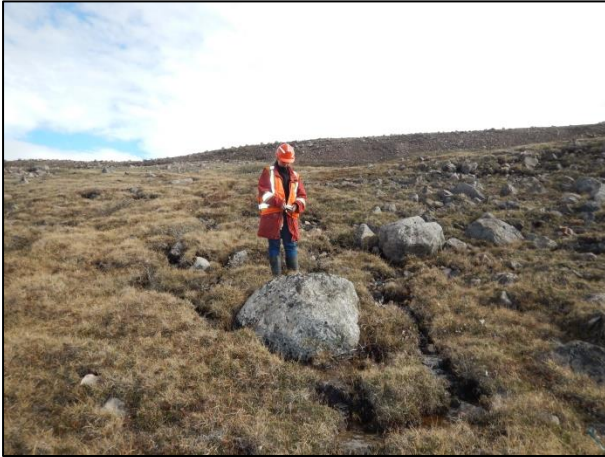
A

The rail crossing is situated on a hillside with a high gradient, which is a permanent barrier to upstream fish passage that extends from the crossing area to more than 100 m downstream. There is no fish habitat at site CV-6-2 due to the permanent barrier and there is no connectivity to any upstream overwintering habitat.

Photos 1. Photos taken at the crossing centreline in spring (A) facing upstream; (B) facing downstream; and (C) across (left bank looking at right bank).
