# RAIL CV-6-4

<b>Site ID:</b>	CV-6-4	<b>Dates Surveyed:</b>	16-Jun-19	<b>Waterbody Type:</b>	Stream
<b>Project Interaction:</b>	Rail Daylight + Culvert	<b>Centreline UTM Coordinates:</b>	17W 507474 E 7970839 N	<b>Culvert Length (m):</b>	12
<b>Number of Barrels:</b>	1	<b>Culvert Diameter/Span (mm):</b>	900	<b>Slope (%):</b>	1

**BAFFINLAND IRON MINES  
MARY RIVER PROJECT**

**North/South Consultants Inc.**  
Aquatic Environment Specialists

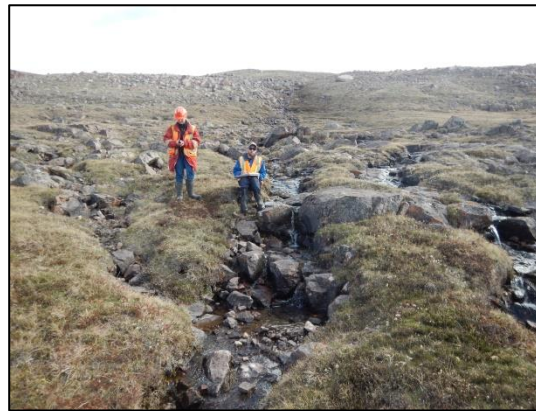
Upstream/ Downstream	UTM		Barrier Type			Height (m)	Gradient (°)	Description	Site Label
	Easting	Northing	1	2	3				
Downstream	507448	7970822	VD			1.0		Permanent Barrier: Vertical drop	A
Downstream	507355	7970778	SSF					Permanent Barrier: Subsurface flow; shared with CV-6-3	B
Downstream	507340	7970775	HG	VD		0.5	15	Permanent Barrier: High gradient with vertical drops and shallow water; shared with CV-6-3	C

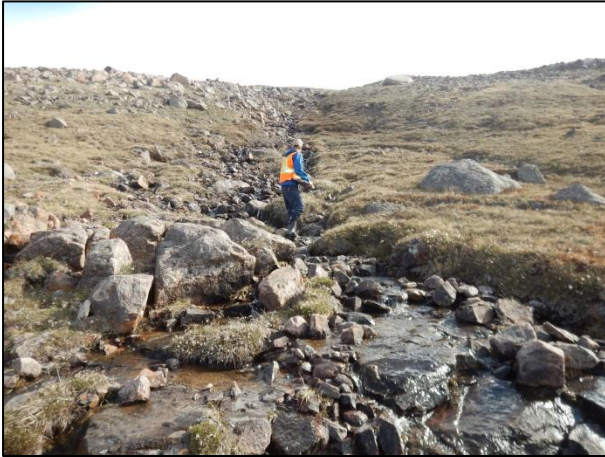
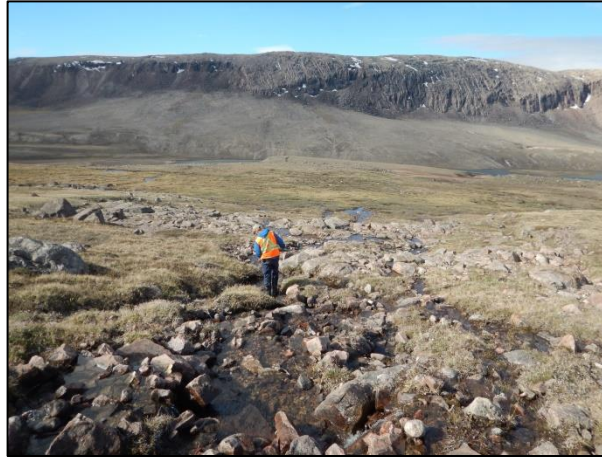
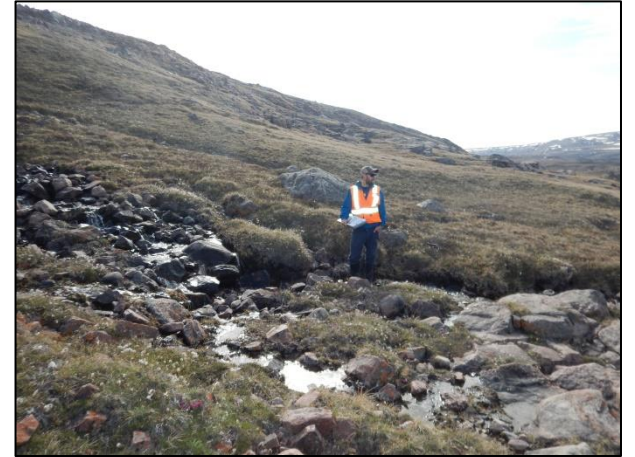
**Photos 1.** Photos taken at the crossing centreline in spring: (A) facing upstream; (B) facing downstream; and (C) across (left bank looking at right bank).
