RAIL CV-9-1

LOCATION AND CROSSING DESCRIPTION

BAFFINLAND IRON MINES
MARY RIVER PROJECT

**North/South Consultants Inc.**
Aquatic Environment Specialists

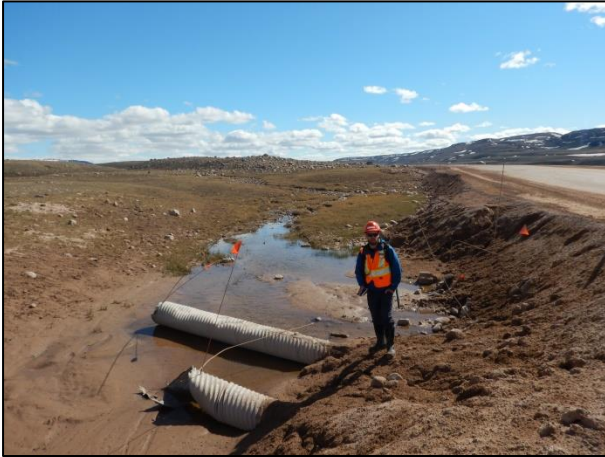
A

Photos 1. Photos taken at the crossing centreline in spring 2019: (A) facing upstream; (B) facing downstream; and (C) across (looking south). Shallow pond located between the crossing and the downstream barrier to fish passage (D).

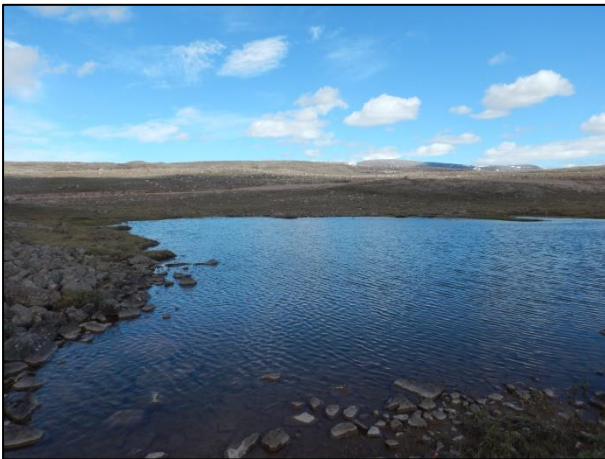
D

The crossing centerline is on the existing Tote Road. A visual fish survey was conducted upstream and downstream of the road in spring 2019. There is a shallow pond downstream of the crossing, but it is of insufficient depth for overwintering. The site does not provide fish habitat due to a high gradient barrier downstream of the road the absence of upstream overwintering habitat.
