RAIL CV-11-3

LOCATION AND CROSSING DESCRIPTION

SUMMARY

BAFFINLAND IRON MINES
MARY RIVER PROJECT

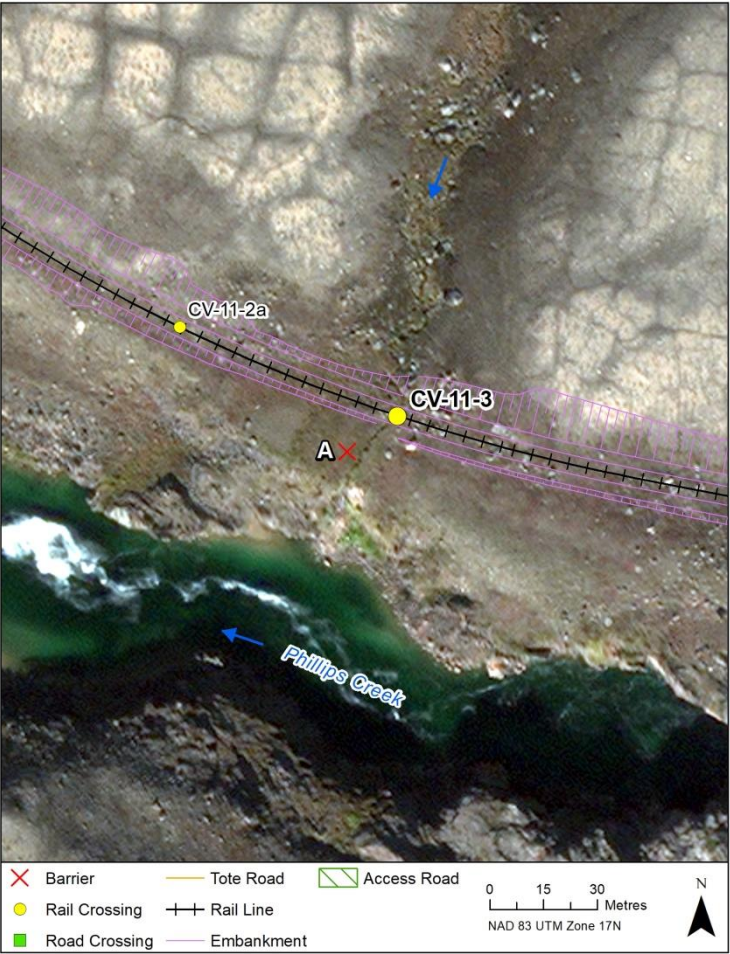
Upstream/ Downstream	UTM		Barrier Type			Height (m)	Gradient (°)	Description	Site Label
	Easting	Northing	1	2	3				
Downstream	510206	7967451	VD			>10.0		Permanent Barrier: Large vertical drop to Phillips Creek with high grade	A

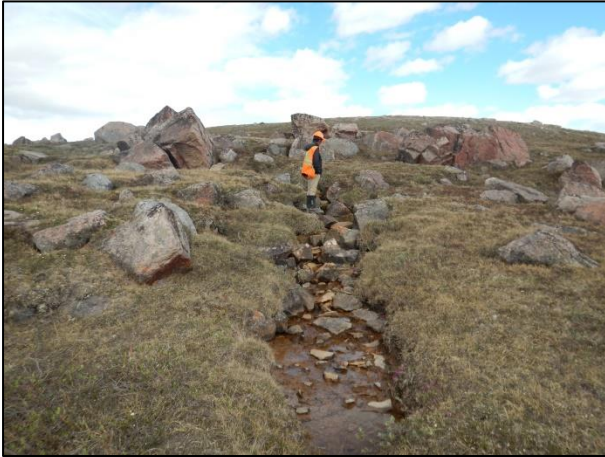
A

The crossing is located on a steep hillside with a large vertical drop prior to discharge to Phillips Creek. The stream had little water in spring 2019 and no fish were observed. This site does not provide fish habitat.

Photos 1. Ground photos taken at the crossing centreline in spring 2019: (A) facing upstream; (B) facing downstream; (C) across (left bank looking at right bank).
