RAIL CV-12-5

LOCATION AND CROSSING DESCRIPTION

BAFFINLAND IRON MINES
MARY RIVER PROJECT

**North/South Consultants Inc.**
Aquatic Environment Specialists

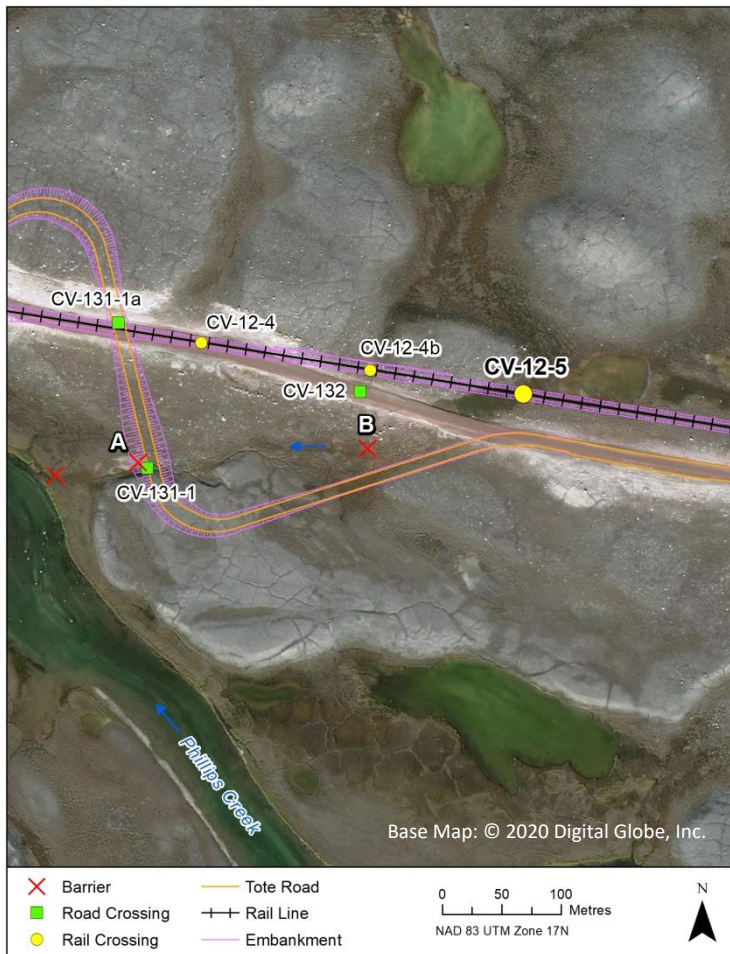
Upstream/ Downstream	UTM		Barrier Type			Height (m)	Gradient (°)	Description	Site Label
	Easting	Northing	1	2	3				
Downstream	511262	7967093	SHALL	HG			8	Permanent Barrier: Depth (<0.02 m) and gradient combine to create a hard barrier throughout the open-water season	A
Downstream	511455	7967105	SHALL					Intermittent Barrier: Water depth consistently shallow and decreasing to <0.02 m by summer	B

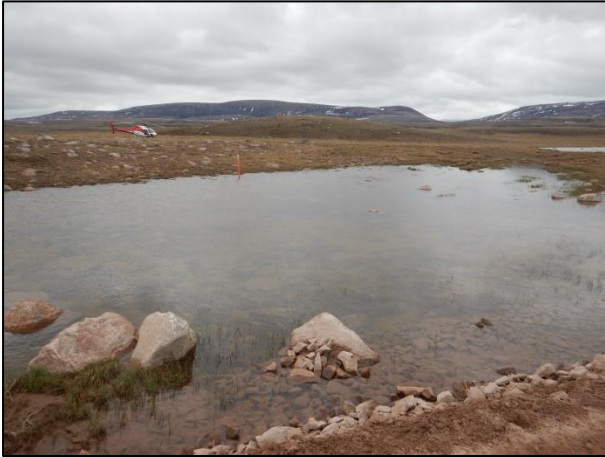
A

Photos 1. Photos of the pond at CV-12-5 in spring 2019: (A) looking north from the existing Tote Road; (B) looking southeast; and (C) looking west. Aerial photo of pond taken in fall 2018 (D).
