RAIL CV-13-4

LOCATION AND CROSSING DESCRIPTION

Site ID:	CV-13-4	Dates Surveyed:	24-Jun-19; 14-Aug-19	Waterbody Type:	Stream
Project Interaction:	Rail Culvert	Centreline UTM Coordinates:	17W 512419 E 7966799 N	Culvert Length (m):	24
Number of Barrels:	5	Culvert Diameter/Span (mm):	1800	Slope (%):	1

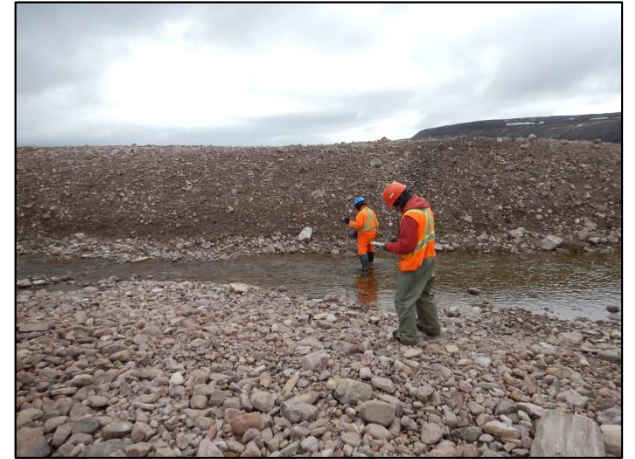
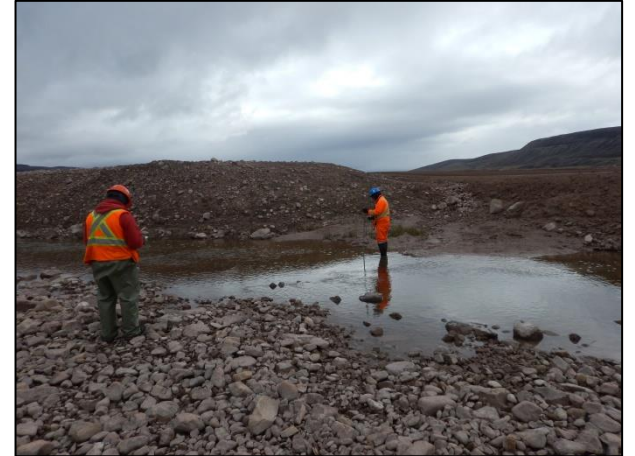
Photos 1. Photos taken at the rail crossing centreline (top) and 20 m downstream (bottom) in spring: (A,D) facing upstream; (B,E) facing downstream; (C,F) across (left bank looking at right bank). Note: in all photos field crew are positioned at the actual transect centreline.

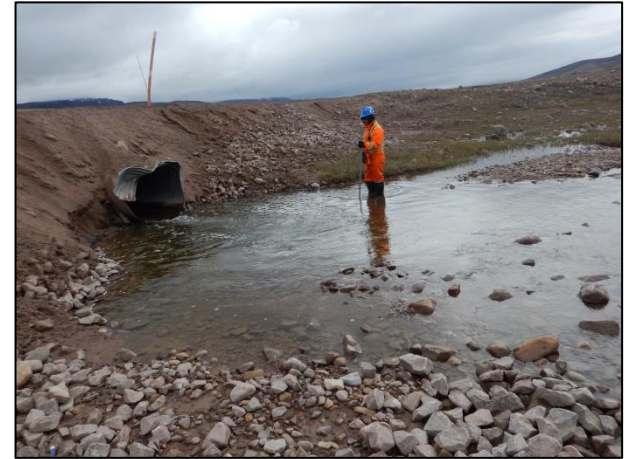
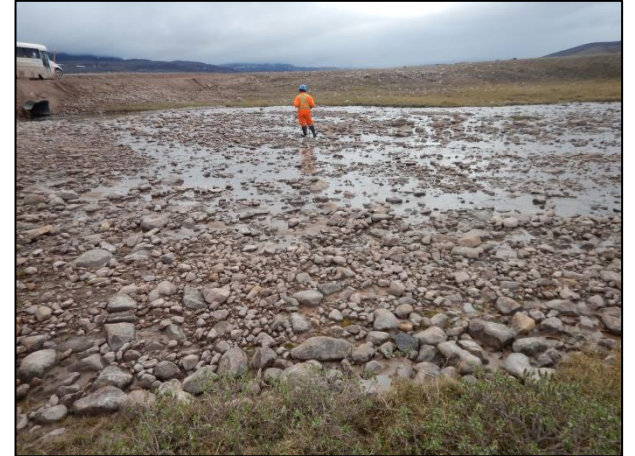
Photos 2. Photos taken 40 m downstream (top) and 60 m downstream (bottom) in spring: (A,D) facing upstream; (B,E) facing downstream; (C,F) across (left bank looking at right bank). Note: in all photos field crew are positioned at the actual transect centreline.

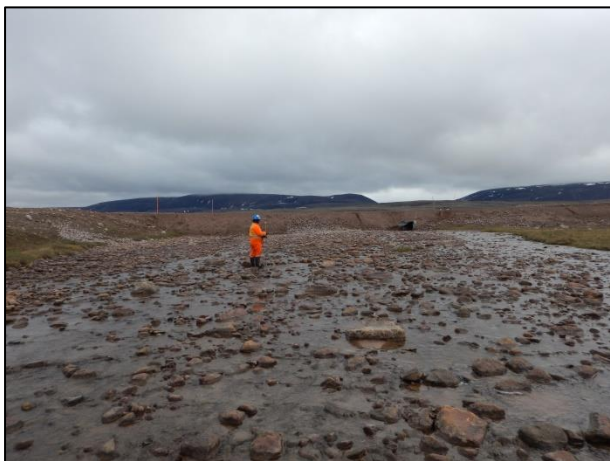
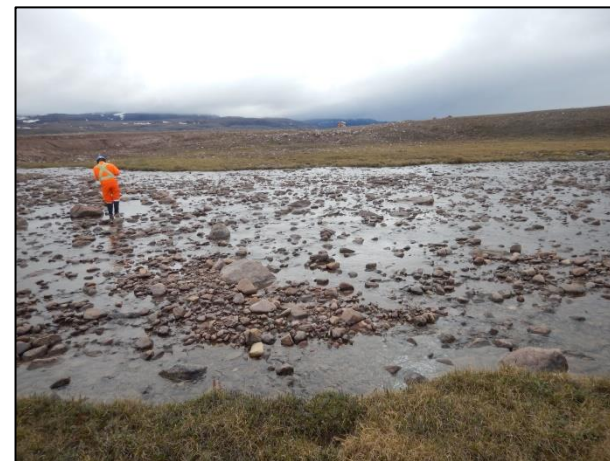
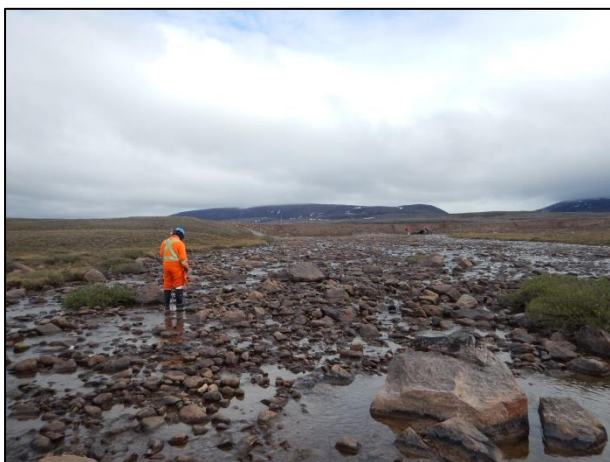
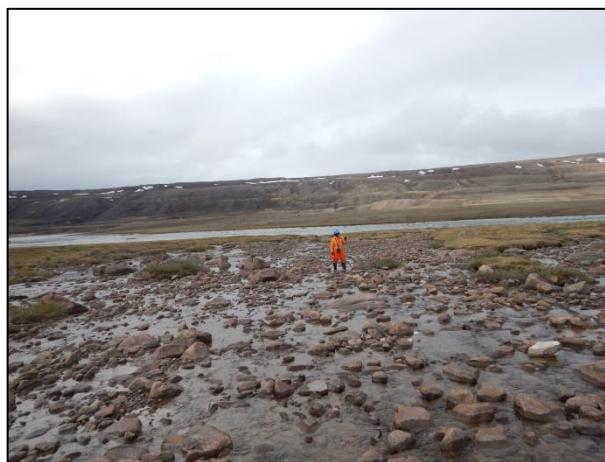
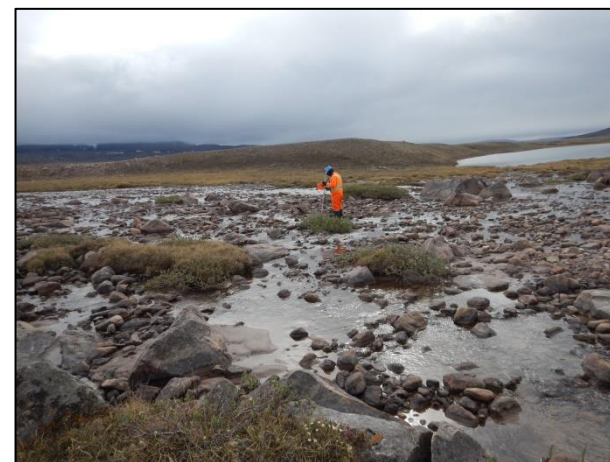
Photos 3. Photos taken 80 m downstream (top) and 100 m downstream (bottom) in spring: (A,D) facing upstream; (B,E) facing downstream; (C,F) across (left bank looking at right bank). Note: in all photos field crew are positioned at the actual transect centreline.

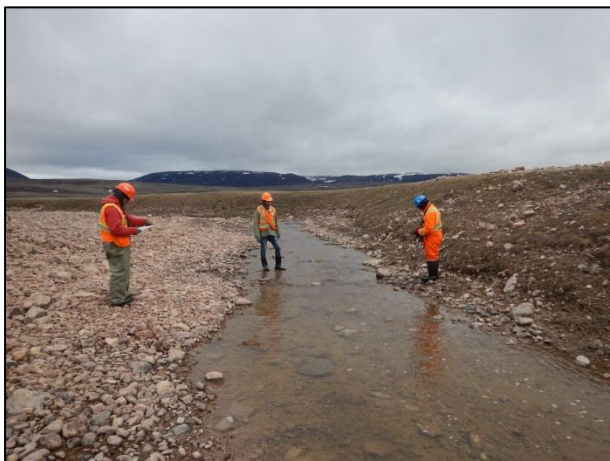
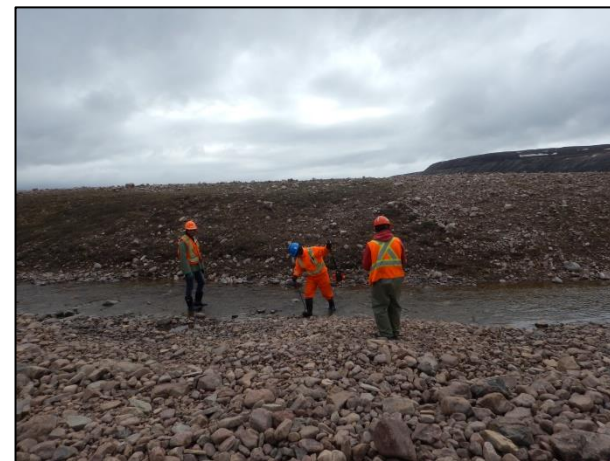
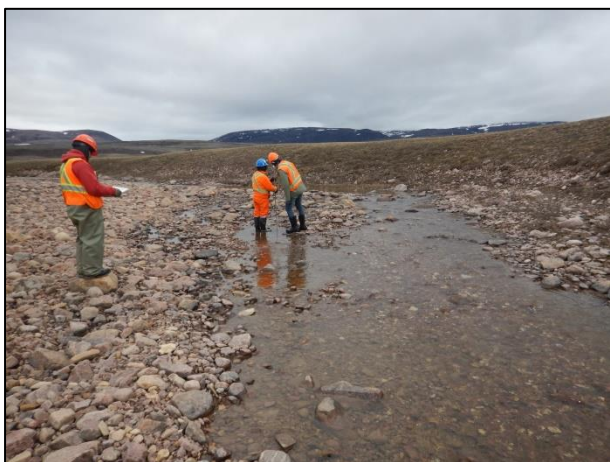
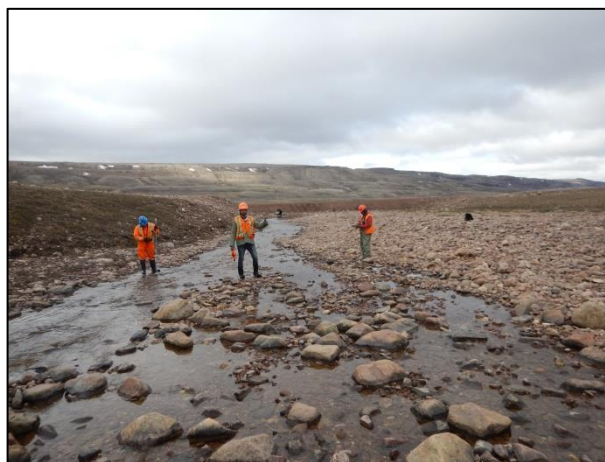
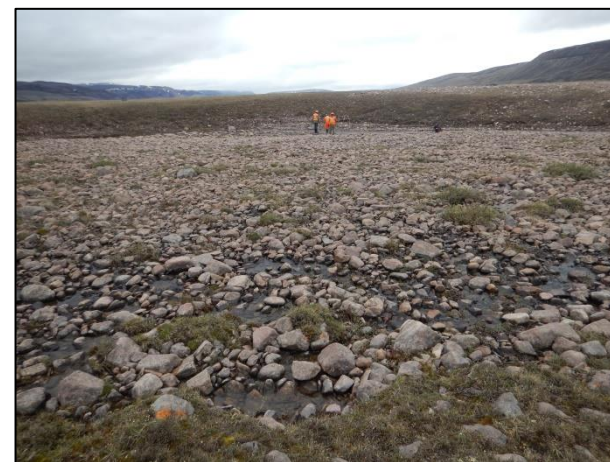
Photos 4. Photos taken 20 m upstream (top) and 40 m upstream (bottom) in spring: (A,D) facing upstream; (B,E) facing downstream; (C,F) across (left bank looking at right bank). Note: in all photos field crew are positioned at the actual transect centreline.

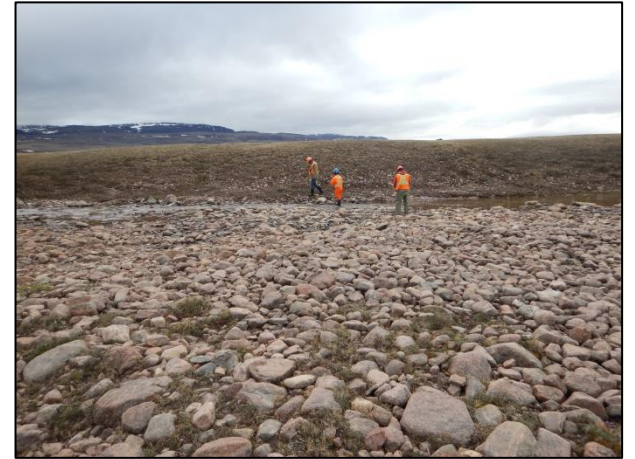
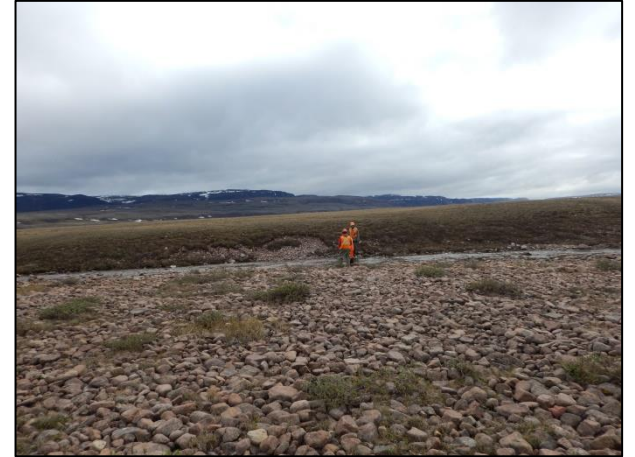
Photos 5. Photos taken 60 m upstream (top) and 80 m upstream (bottom) in spring: (A,D) facing upstream; (B,E) facing downstream; (C,F) across (left bank looking at right bank). Note: in all photos field crew are positioned at the actual transect centreline.

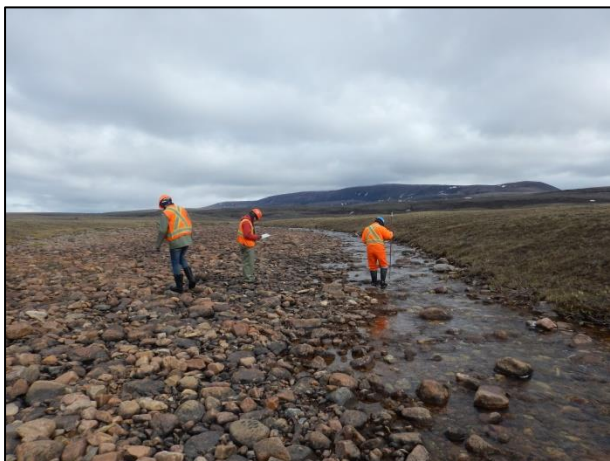
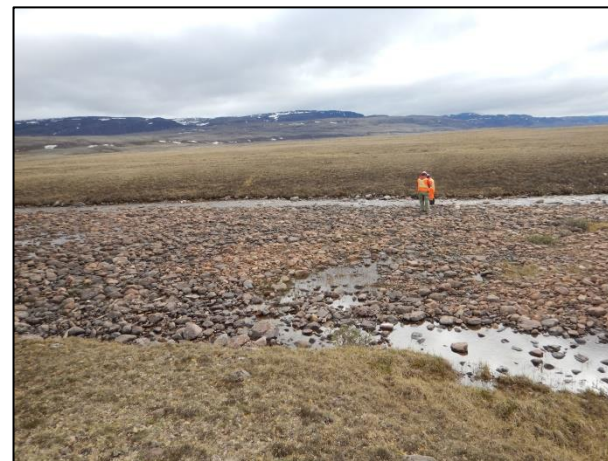
Photos 6. Photos taken 100 m upstream in spring: (A) facing upstream; (B) facing downstream; (C) across (left bank looking at right bank). Note: in all photos field crew are positioned at the actual transect centreline.

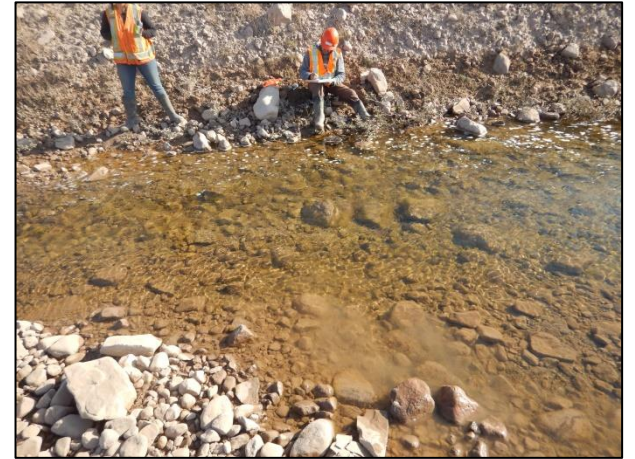
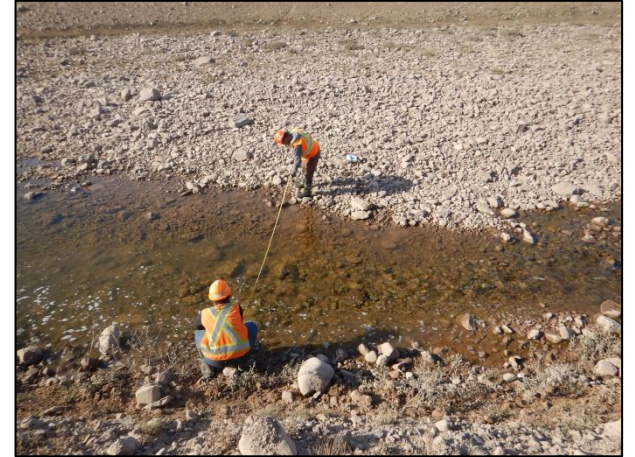
Photos 7. Photos taken at the rail crossing centreline while standing at the centreline (top) and from the right bank offset from the actual centreline (bottom) in summer/fall: (A,D) facing upstream; (B,E) facing downstream; (C,F) across (left bank looking at right bank).

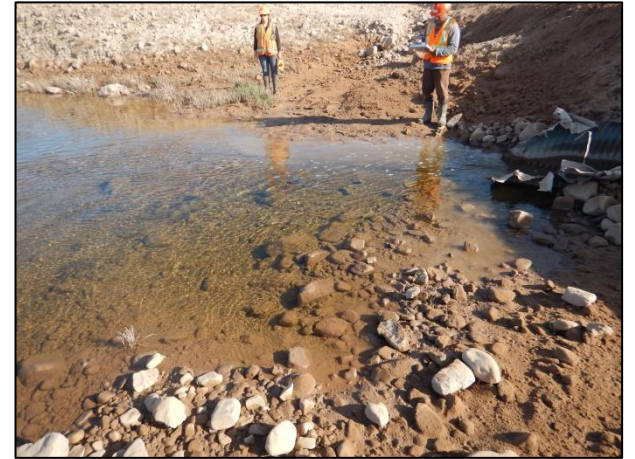
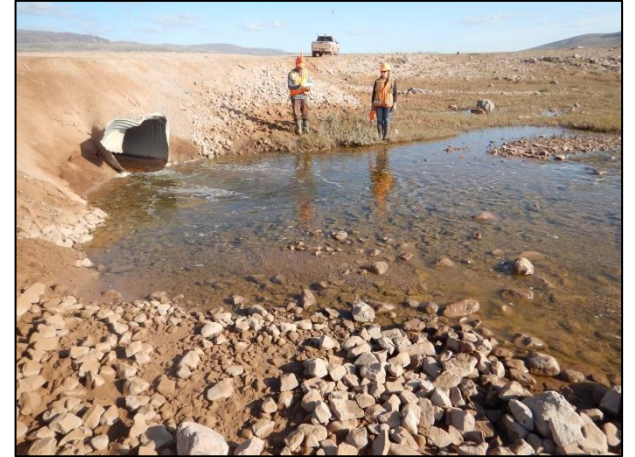
Photos 8. Photos taken 20 m downstream (top) and 40 m downstream (bottom) in summer/fall: (A,D) facing upstream; (B,E) facing downstream; (C,F) across (left bank looking at right bank). Note: all photos taken while standing at the transect centreline.

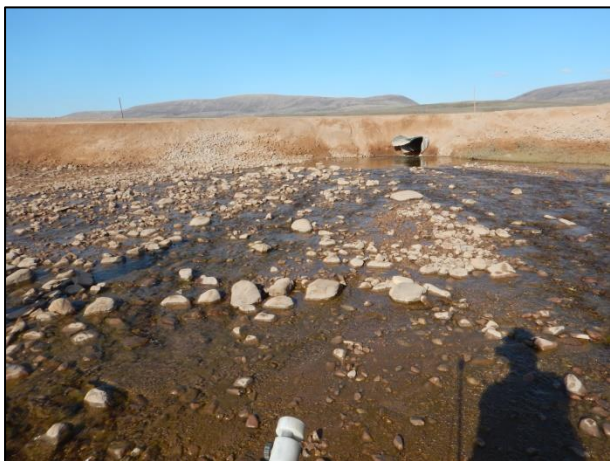
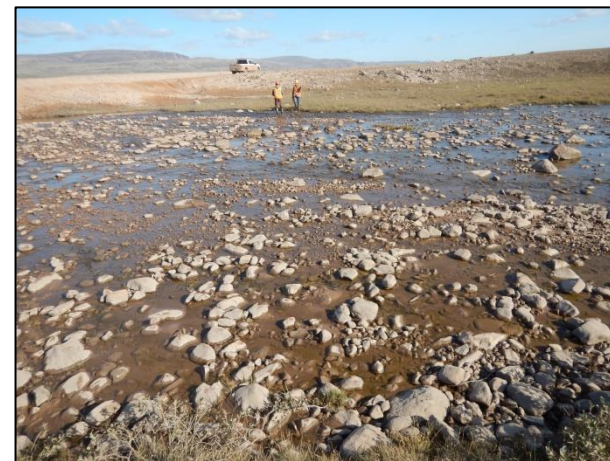
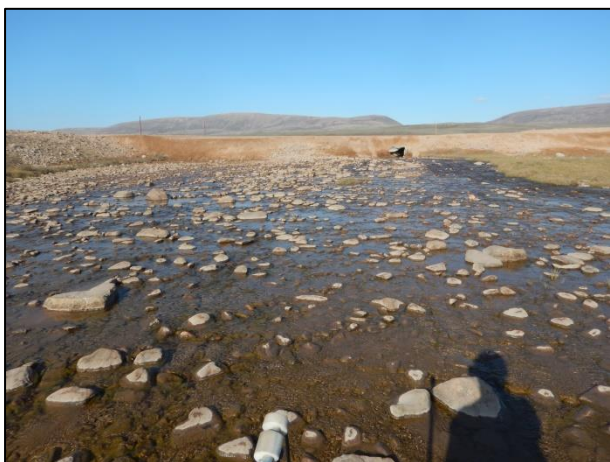
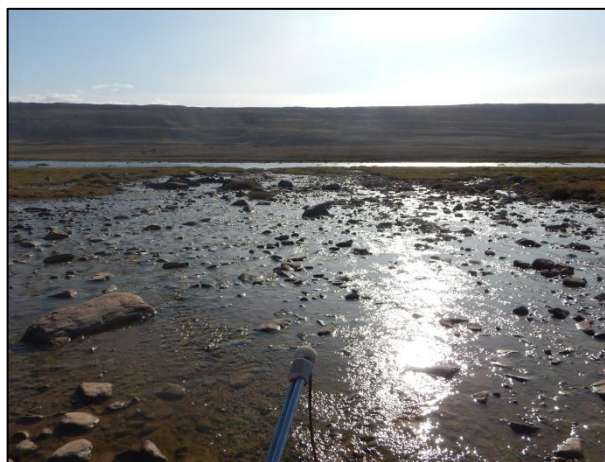
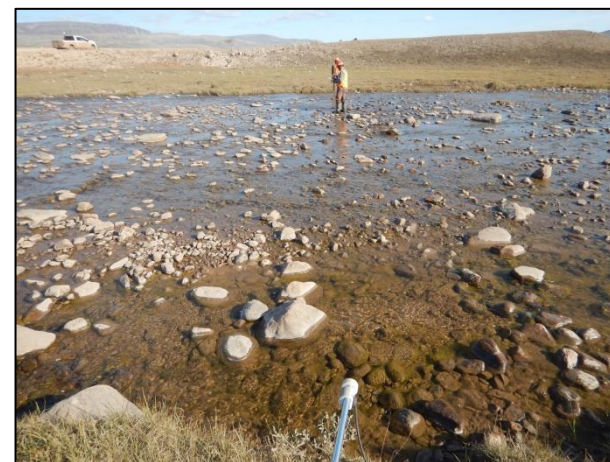
Photos 9. Photos taken 60 m downstream (top) and 80 m downstream (bottom) in summer/fall: (A,D) facing upstream; (B,E) facing downstream; (C,F) across (left bank looking at right bank). Note: all photos taken while standing at the transect centreline.

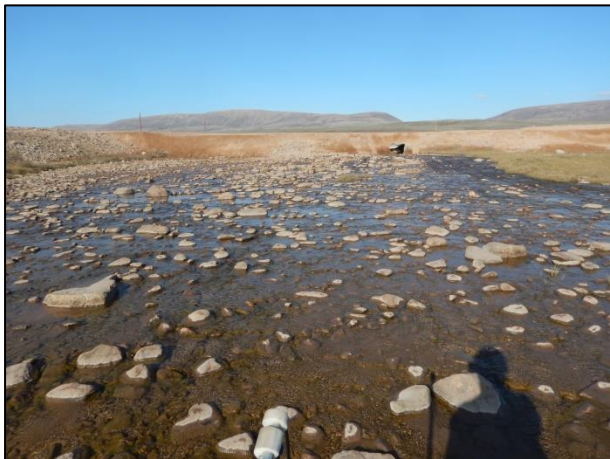
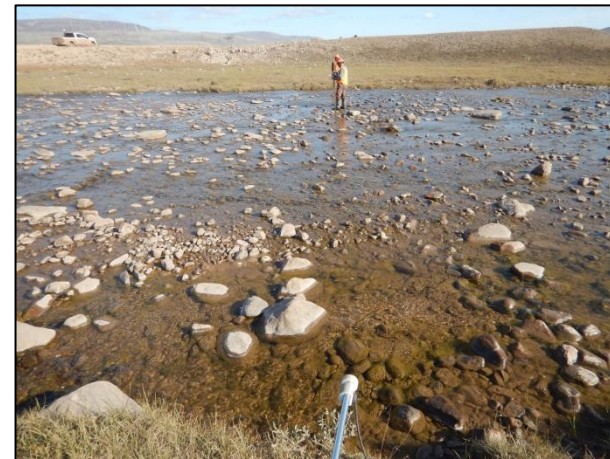
Photos 10. Photos taken 100 m downstream in summer/fall: (A,D) facing upstream; (B,E) facing downstream; (C,F) across (left bank looking at right bank). Note: all photos taken while standing at the transect centreline.

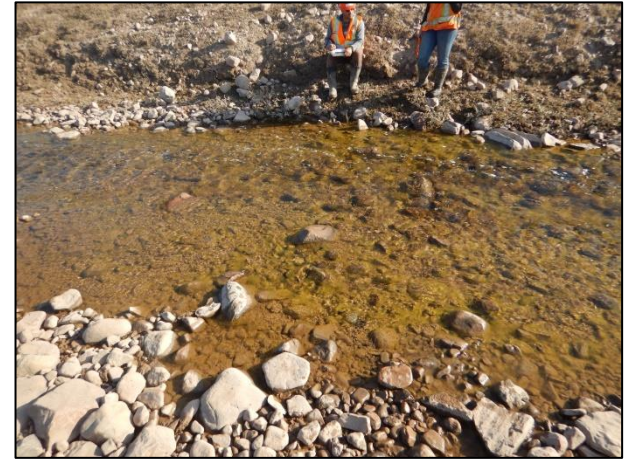
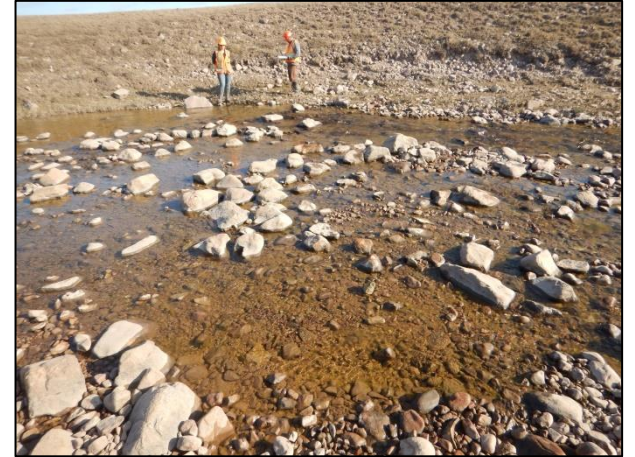
Photos 11. Photos taken 20 m upstream (top) and 40 m upstream (bottom) in summer/fall: (A,D) facing upstream; (B,E) facing downstream; (C,F) across (left bank looking at right bank). Note: all photos taken while standing at the transect centreline.

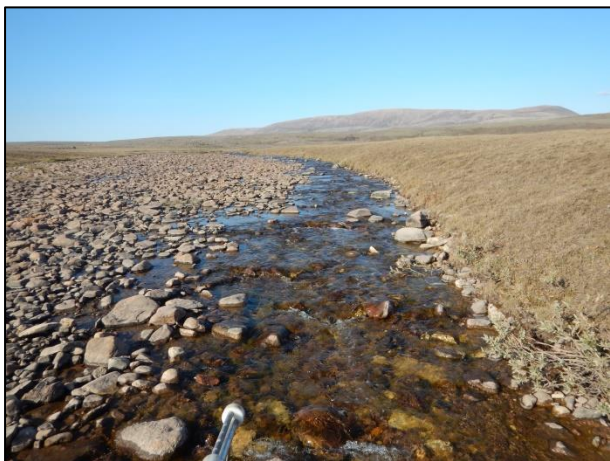
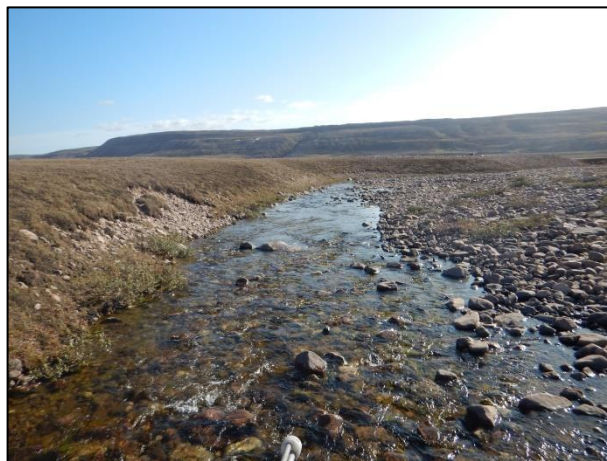
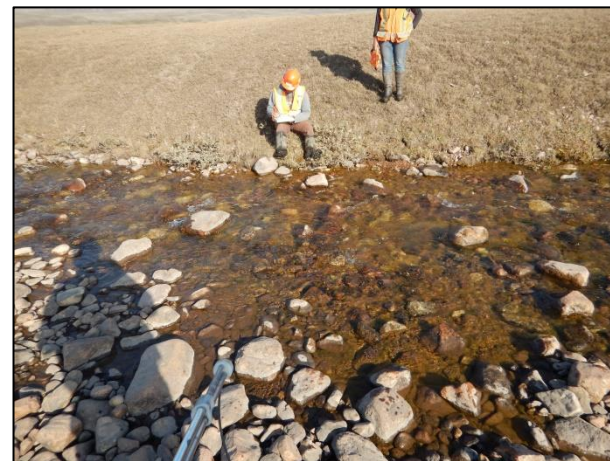
Photos 12. Photos taken 100 m upstream in summer/fall: (A,D) facing upstream; (B,E) facing downstream; (C,F) across (left bank looking at right bank). Note: all photos taken while standing at the transect centreline.

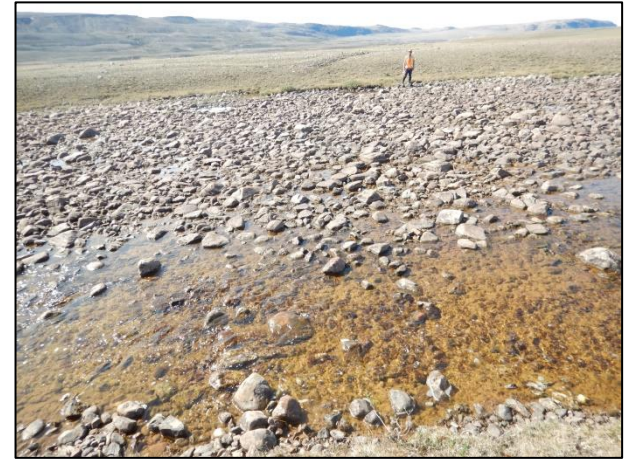
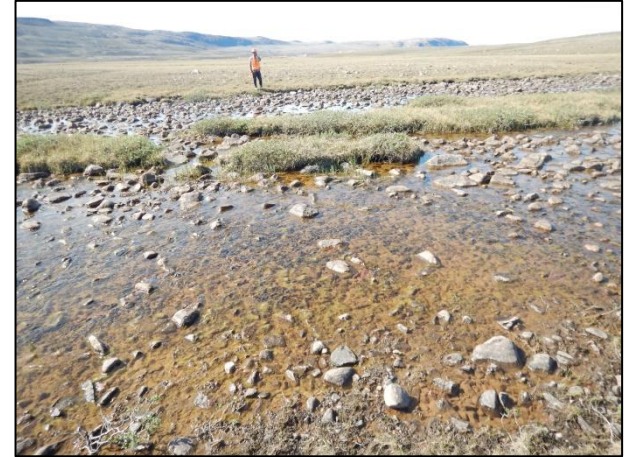
Photos 13. Photos taken 140 m upstream (top) and 180 m upstream (bottom) in spring: (A,D) facing upstream; (B,E) facing downstream; (C,F) across (left bank looking at right bank). Note: all photos taken while standing at the transect centreline.

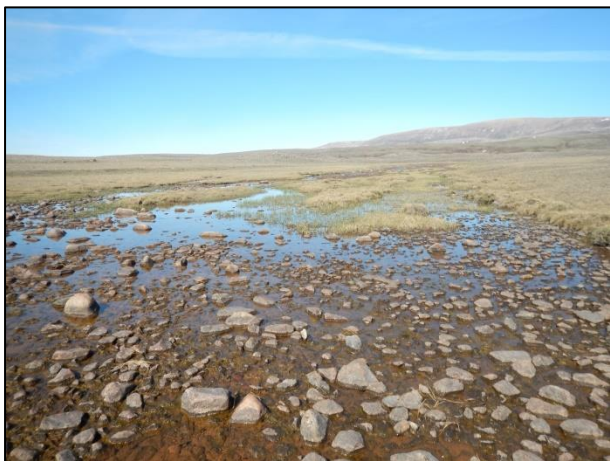
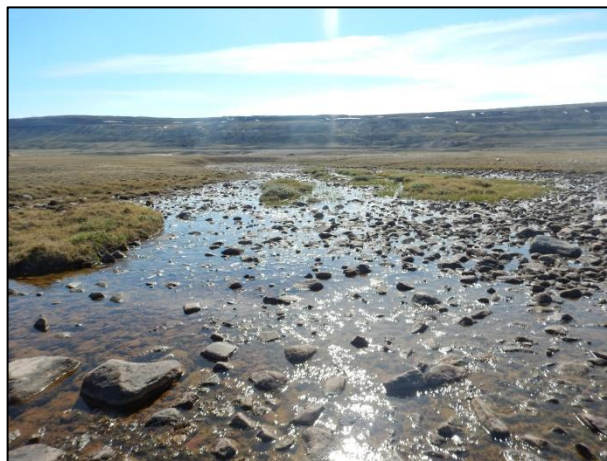
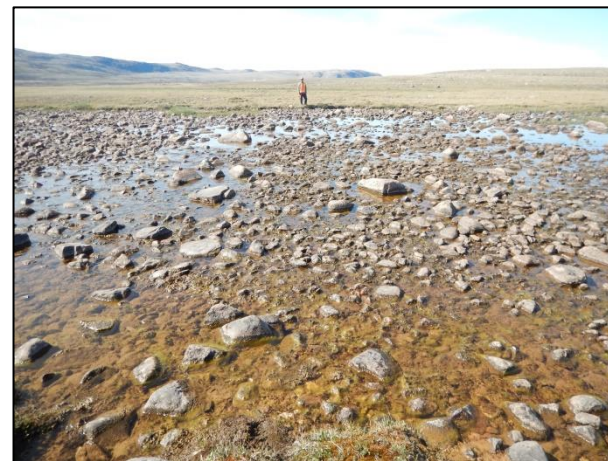
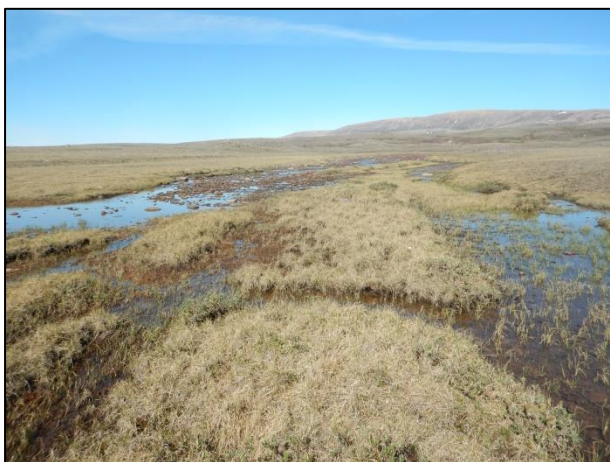
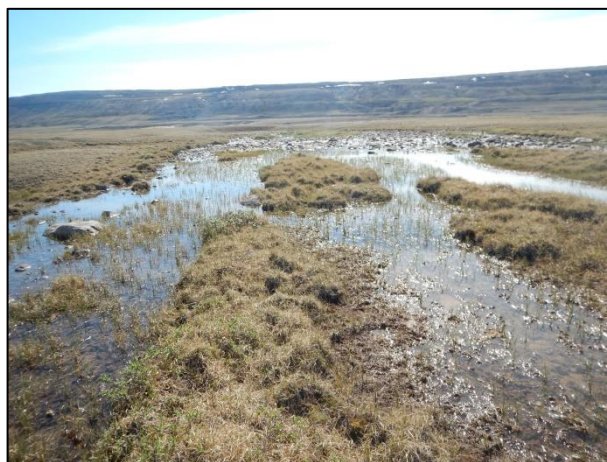
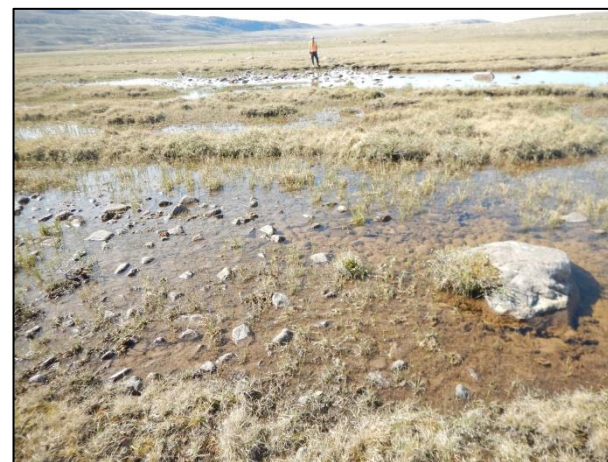
Photos 14. Photos taken 220 m upstream (top) and 260 m upstream (bottom) in spring: (A,D) facing upstream; (B,E) facing downstream; (C,F) across (left bank looking at right bank). Note: all photos taken while standing at the transect centreline.

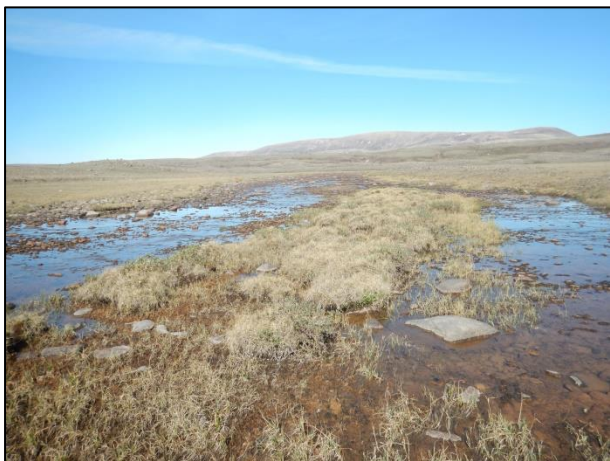
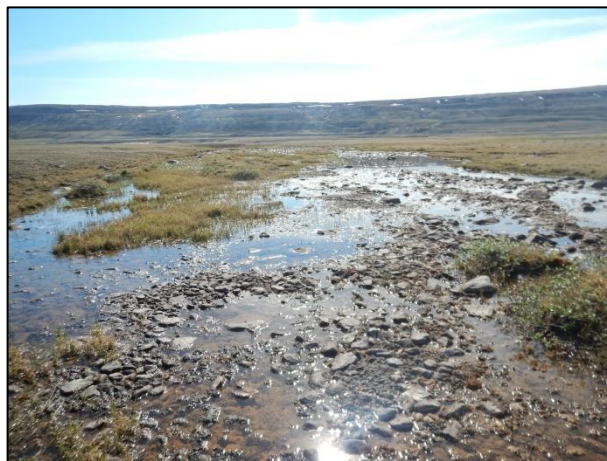
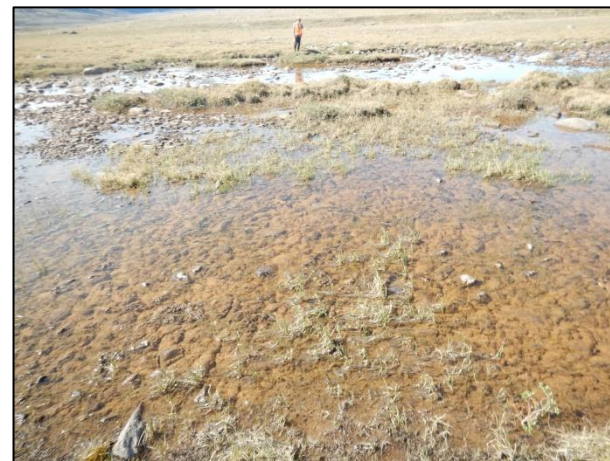
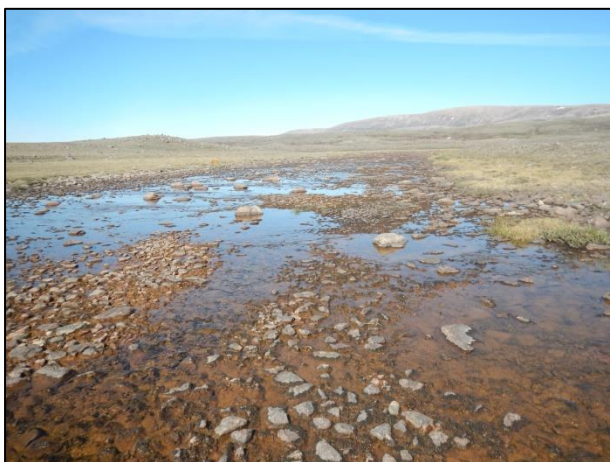
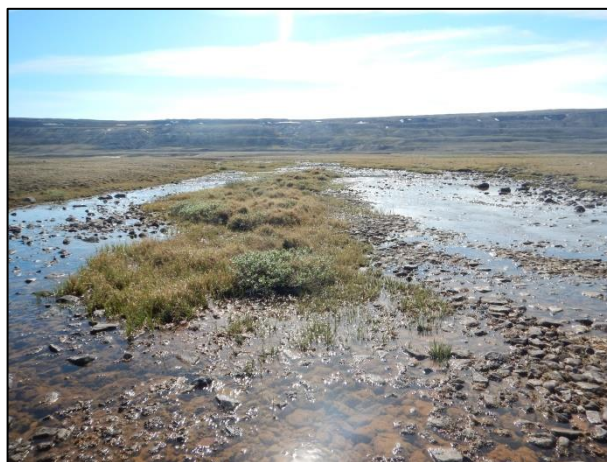
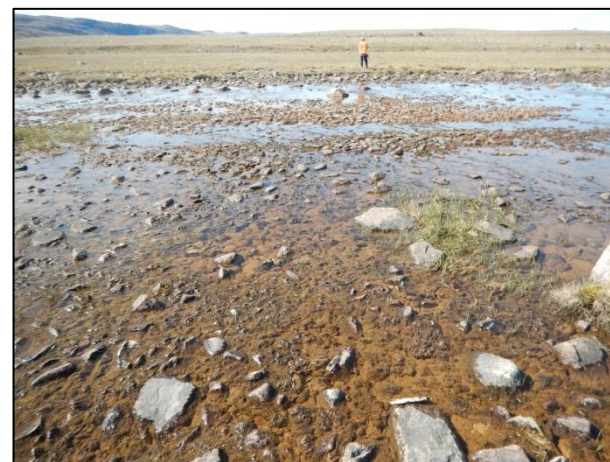
Photos 15. Photos taken 300 m upstream (top) and 340 m upstream (bottom) in spring: (A,D) facing upstream; (B,E) facing downstream; (C,F) across (left bank looking at right bank). Note: all photos taken while standing at the transect centreline.

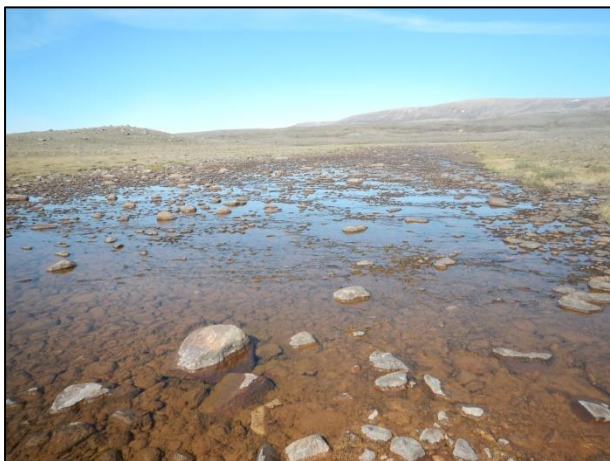
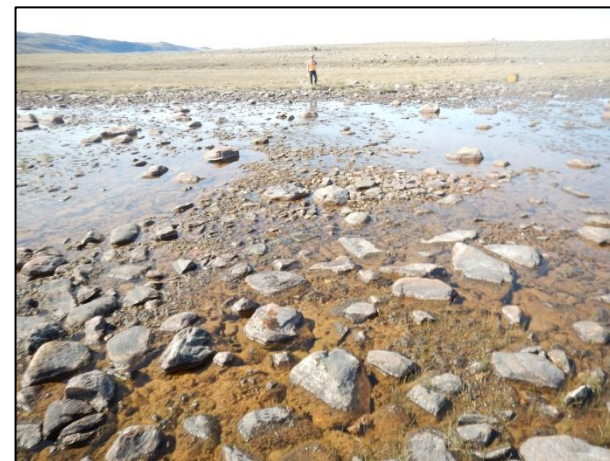
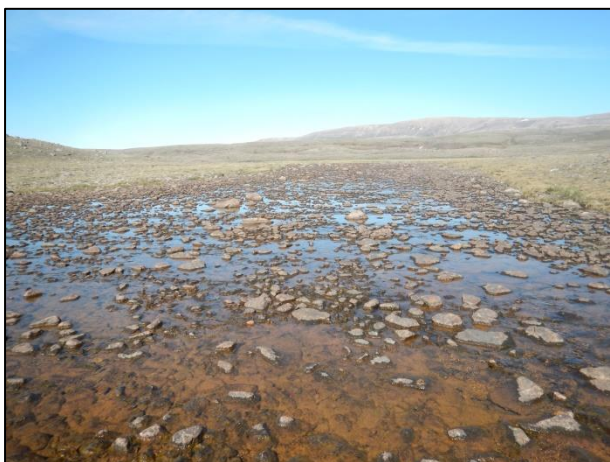
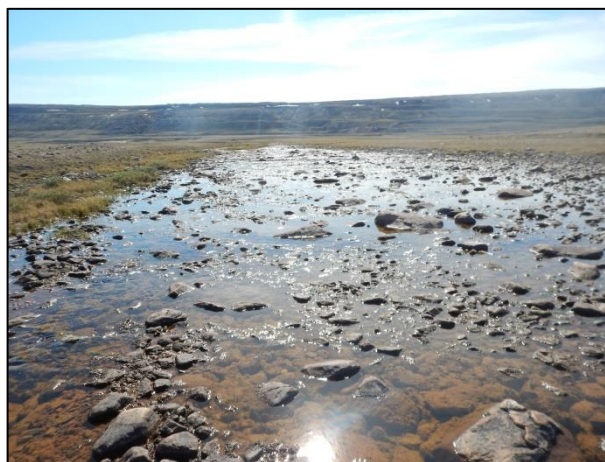
Photos 16. Photos taken 380 m upstream (top) and 420 m upstream (bottom) in spring: (A,D) facing upstream; (B,E) facing downstream; (C,F) across (left bank looking at right bank). Note: all photos taken while standing at the transect centreline.

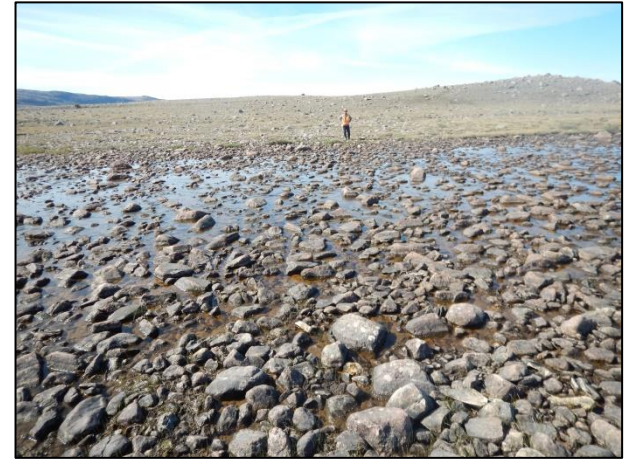
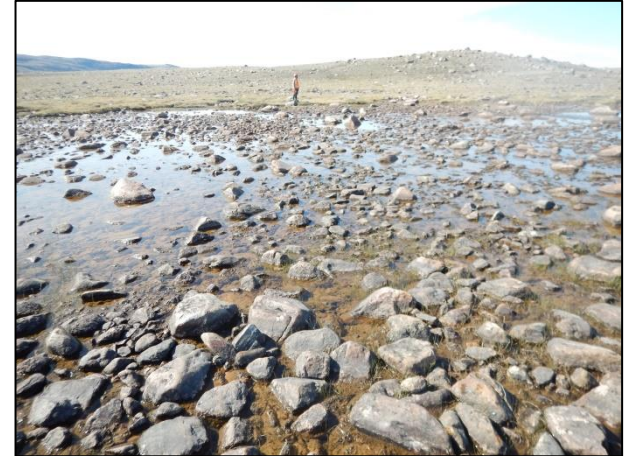
Photos 17. Photos taken 460 m upstream (top) and 500 m upstream (bottom) in spring: (A,D) facing upstream; (B,E) facing downstream; (C,F) across (left bank looking at right bank). Note: all photos taken while standing at the transect centreline.

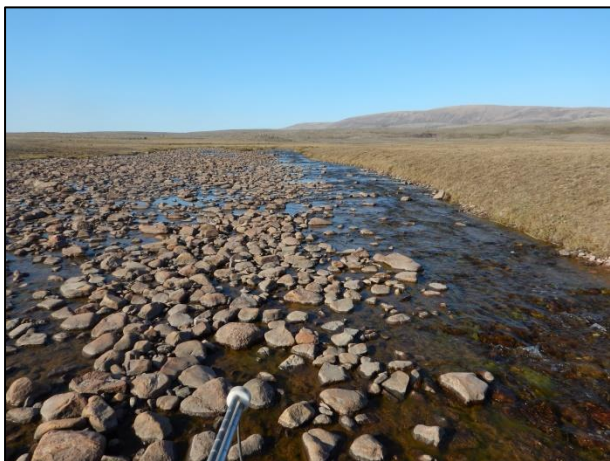
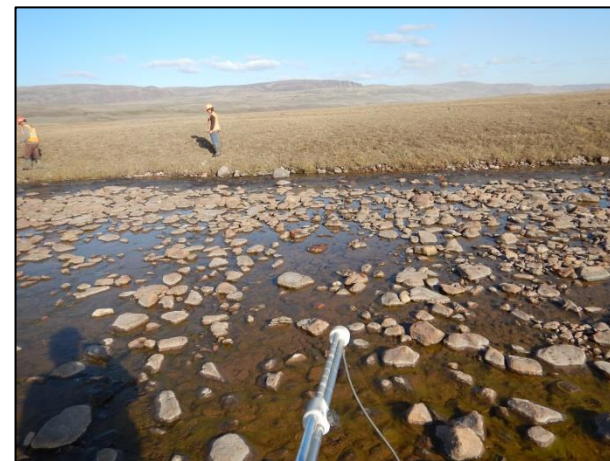
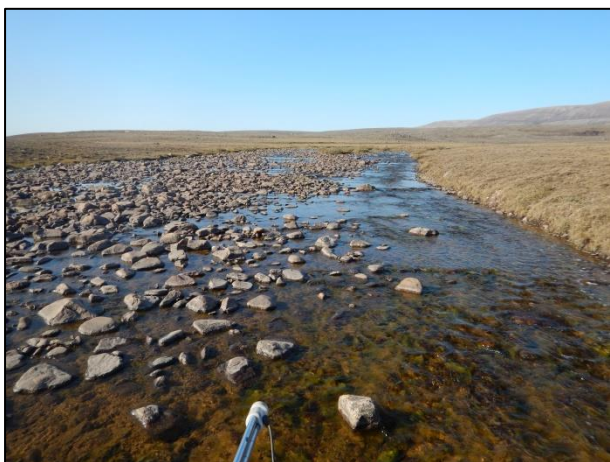
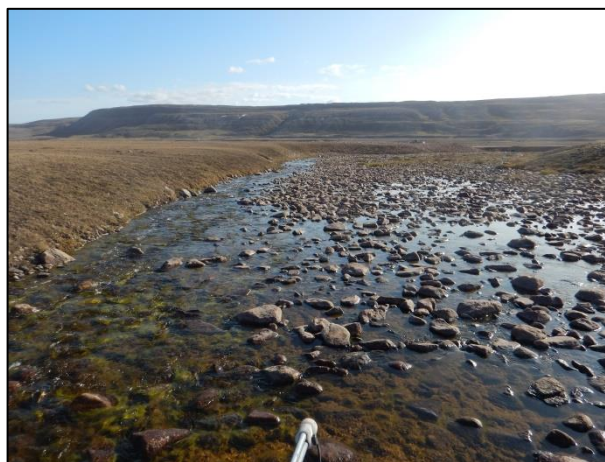
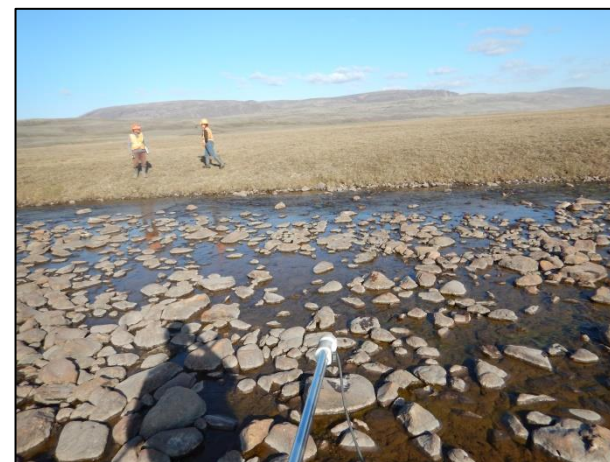
Photos 18. Photos taken 120 m upstream (top) and 140 m upstream (bottom) in summer/fall: (A,D) facing upstream; (B,E) facing downstream; (C,F) across (left bank looking at right bank). Note: all photos taken while standing at the transect centreline.

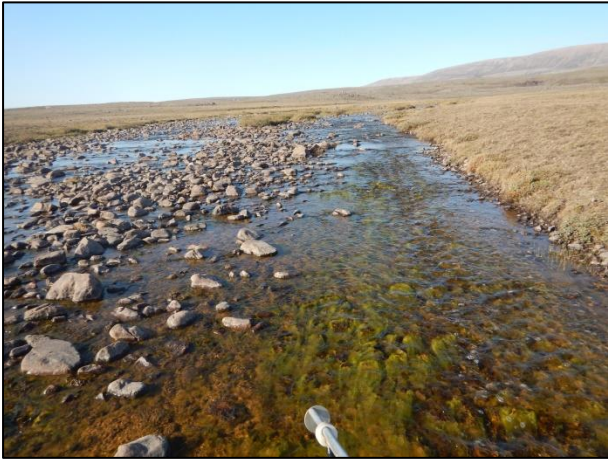
A

Photos 19. Photos taken 160 m upstream (top) and 180 m upstream (bottom) in summer/fall: (A,D) facing upstream; (B,E) facing downstream; (C,F) across (left bank looking at right bank). Note: all photos taken while standing at the transect centreline.

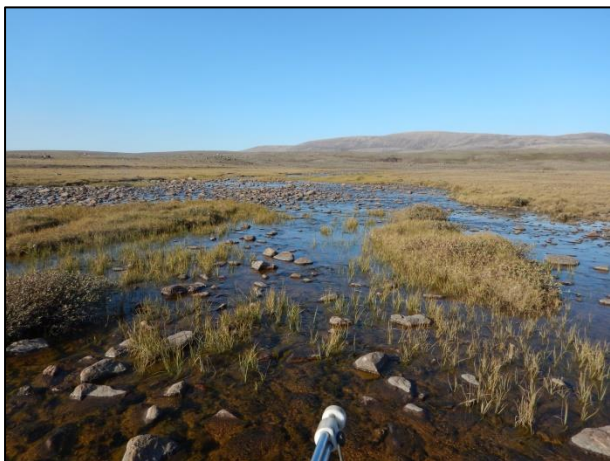
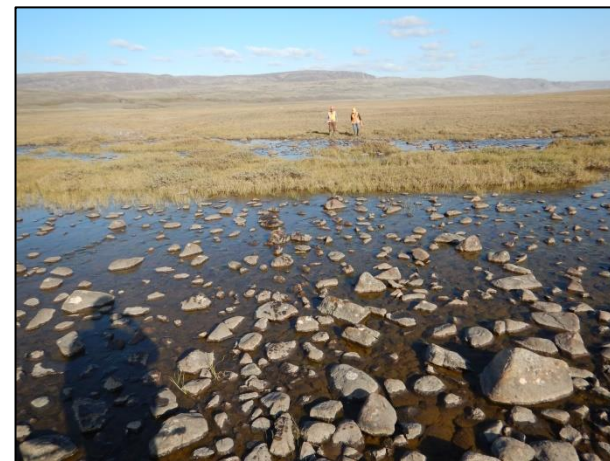
Photos 20. Photos taken 200 m upstream in summer/fall: (A) facing upstream; (B) facing downstream; (C) across (left bank looking at right bank). Note: all photos taken while standing at the transect centreline.

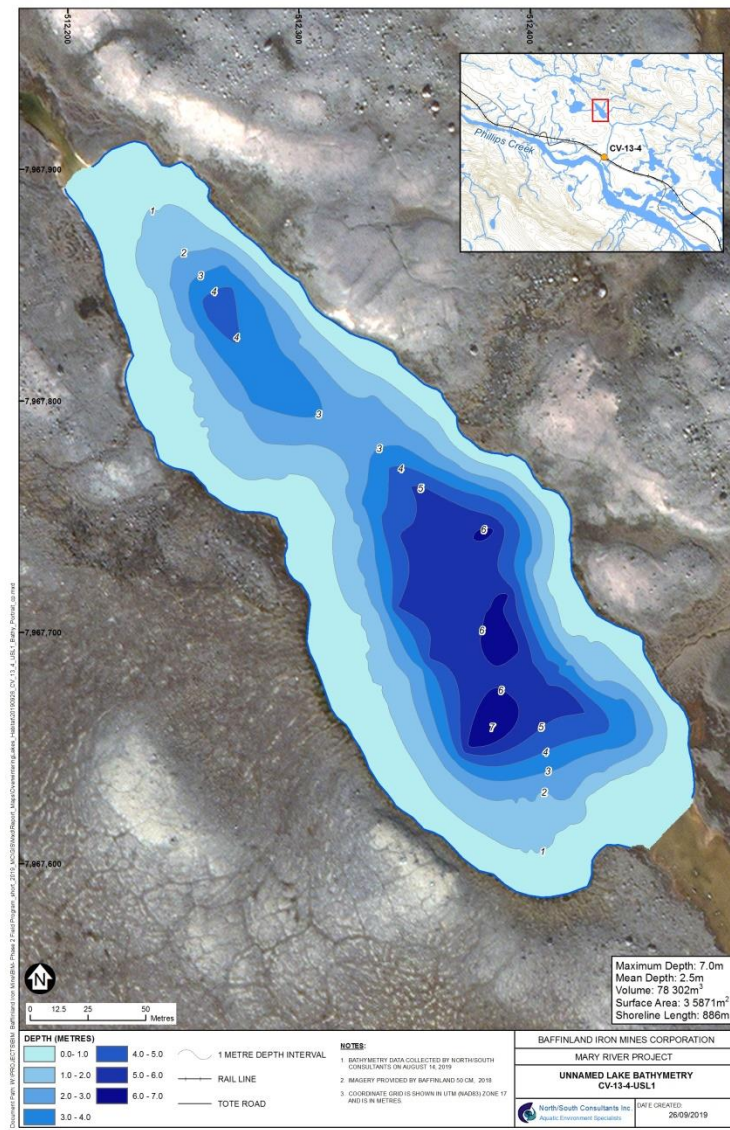
UPSTREAM LAKE BATHYMETRY

There are no barriers to fish movement between this crossing and Phillips Creek downstream or an unnamed potential overwintering lake (CV-13-4-USL1) approximately 700 m upstream from the rail centreline. A bathymetry survey of this upstream lake completed in summer/fall 2019 indicated it had sufficient depth to support overwintering for both species.
