# RAIL CV-14-2

<b>Site ID:</b>	CV-14-2	<b>Dates Surveyed:</b>	24-Jun-19	<b>Waterbody Type:</b>	Pond
<b>Project Interaction:</b>	Rail Pond Infilling + Culvert	<b>Centreline UTM Coordinates:</b>	17W 513435 E 7966375 N	<b>Culvert Length (m):</b>	12
<b>Number of Barrels:</b>	2	<b>Culvert Diameter/Span (mm):</b>	900	<b>Slope (%):</b>	1

BAFFINLAND IRON MINES  
MARY RIVER PROJECT

**North/South Consultants Inc.**  
Aquatic Environment Specialists

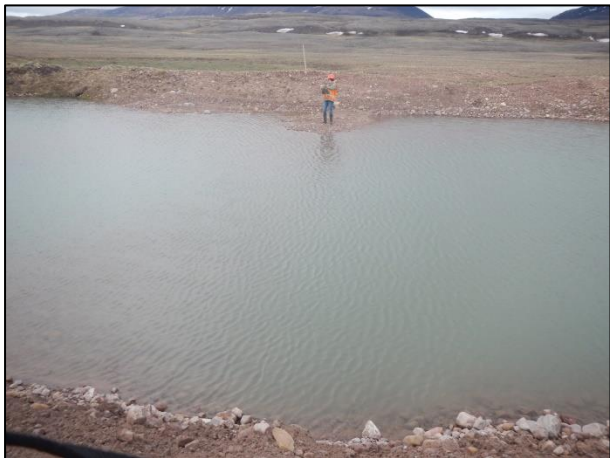
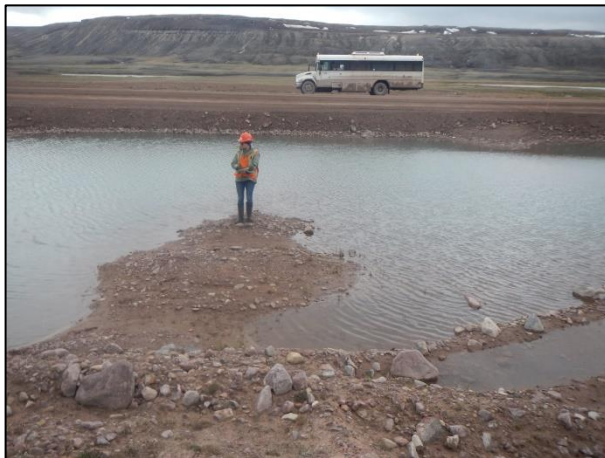
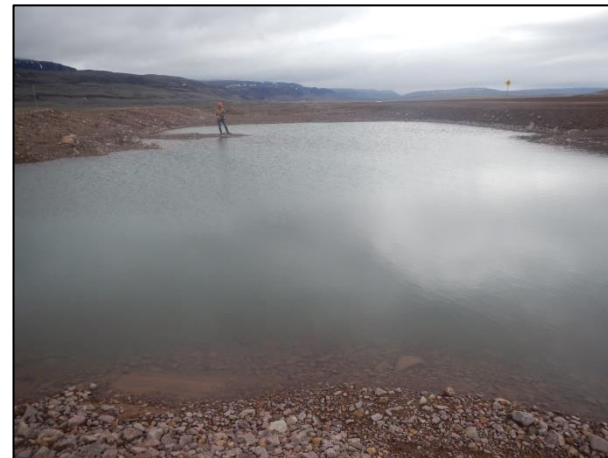
The pond consists of standing water with no defined inflows or outflows. The maximum depth in spring 2019 (1.0 m) was insufficient to support overwintering for either fish species.

**Photos 1.** Photos of the pond at CV-14-2 in spring 2019: (A) looking northeast; (B) looking southwest; and (C) looking southeast.
