RAIL CV-14-3

LOCATION AND CROSSING DESCRIPTION

BAFFINLAND IRON MINES
MARY RIVER PROJECT

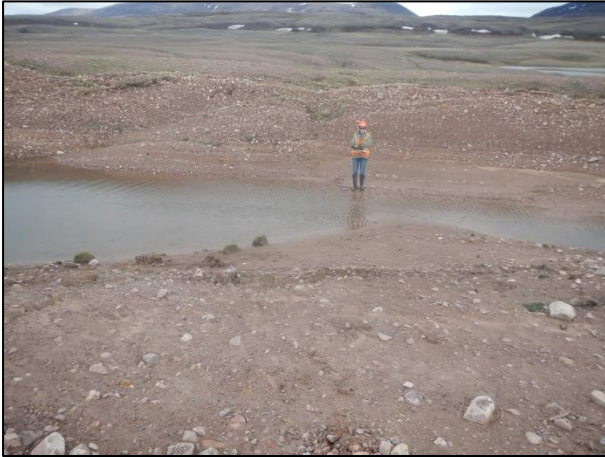
A

The ponds consist of standing water with no defined inflows or outflows. The maximum depth in spring 2019 (0.4 m) was insufficient to support overwintering for either fish species.

Photos 1. Photos of the ponds at CV-14-3 in spring 2019: (A) looking northeast; (B) looking south; and (C) looking southeast. Aerial photo of pond taken in fall 2018 (D).

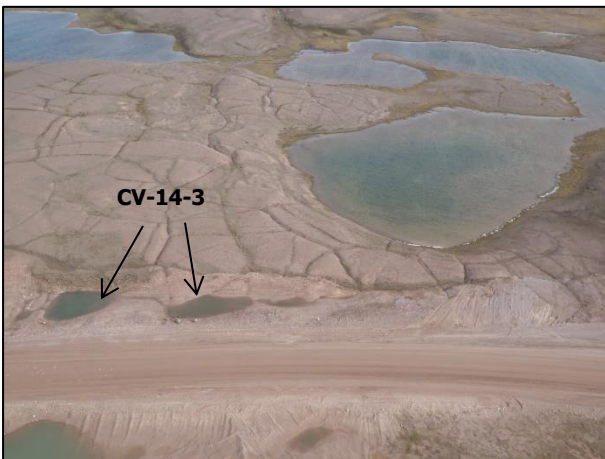
D

The North Rail infills two adjacent shallow roadside ponds (each with approximate maximum depth 0.4 m) northeast of the existing Tote Road at CV-14-3. They are part of a former borrow pit used during Tote Road construction and maintenance and are too shallow to support overwintering of either fish species. The ponds also lack connectivity to overwintering habitat or to another nearby roadside pond at CV-14-2. No fish were observed in either pond in 2018 or 2019.
