# RAIL CV-15-5

## LOCATION AND CROSSING DESCRIPTION

<b>Site ID:</b>	CV-15-5	<b>Dates Surveyed:</b>	27-Aug-19	<b>Waterbody Type:</b>	Stream
<b>Project Interaction:</b>	Rail Bridge	<b>Centreline UTM Coordinates:</b>	17W 514238 E 7965626 N	<b>Culvert Length (m):</b>	N/A
<b>Number of Barrels:</b>	N/A	<b>Culvert Diameter/Span (mm):</b>	N/A	<b>Slope (%):</b>	N/A

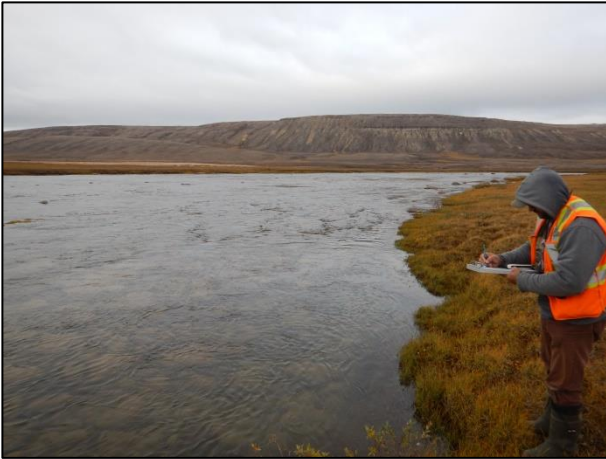
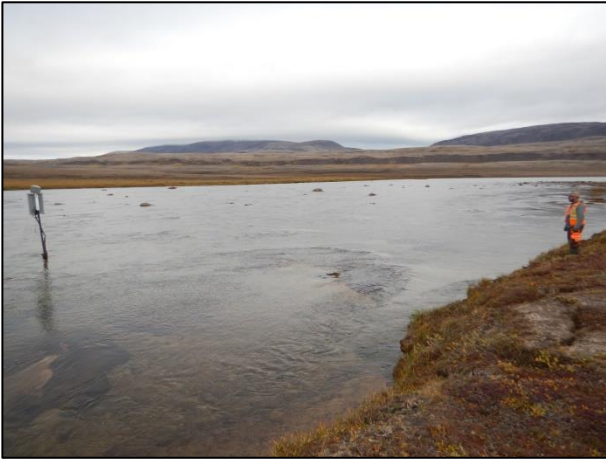
A

**Photos 1.** Photos taken at the rail crossing centreline while standing at the centreline (top) and from the left bank offset from the actual centreline (bottom) in summer/fall: (A,D) facing upstream; (B,E) facing downstream; (C,F) across (left bank looking at right bank).
