# RAIL CV-16-3

## LOCATION AND CROSSING DESCRIPTION

**BAFFINLAND IRON MINES  
MARY RIVER PROJECT**

**North/South Consultants Inc.**  
Aquatic Environment Specialists

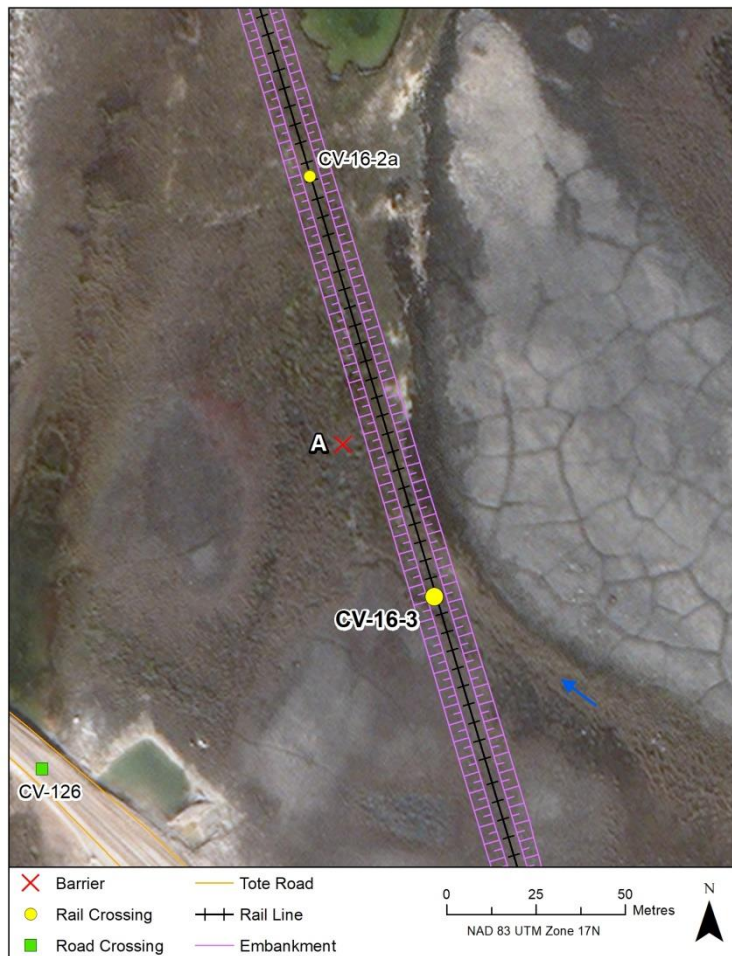
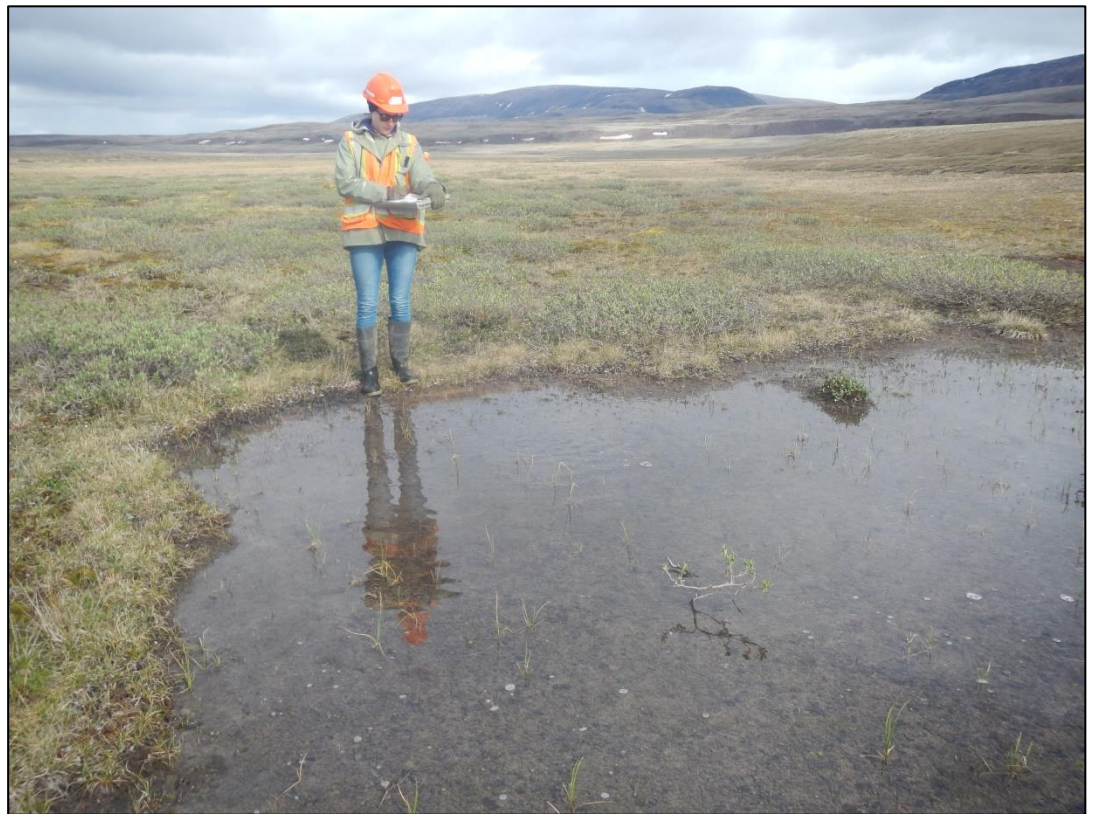
Upstream/ Downstream	UTM		Barrier Type			Height (m)	Gradient (°)	Description	Site Label
	Easting	Northing	1	2	3				
Downstream	514775	7964960	SSF					Permanent Barrier: Stream ends at small ponding approximately 50 m downstream of crossing with no downstream connectivity	A

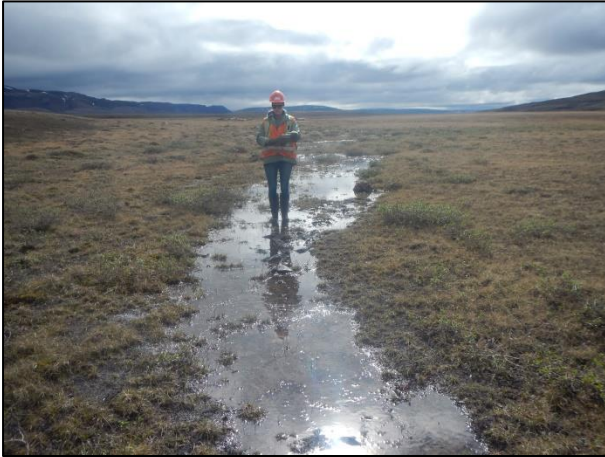
A

**Photos 1.** Ground photos taken at the crossing centreline in spring 2019: (A) facing upstream; (B) facing downstream; (C) across (right bank looking at left bank) and summer 2018: (D) facing downstream. Aerial photo of crossing area during fall 2018 (E).
