RAIL CV-17-1A

LOCATION AND CROSSING DESCRIPTION

BAFFINLAND IRON MINES
MARY RIVER PROJECT

**North/South Consultants Inc.**
Aquatic Environment Specialists

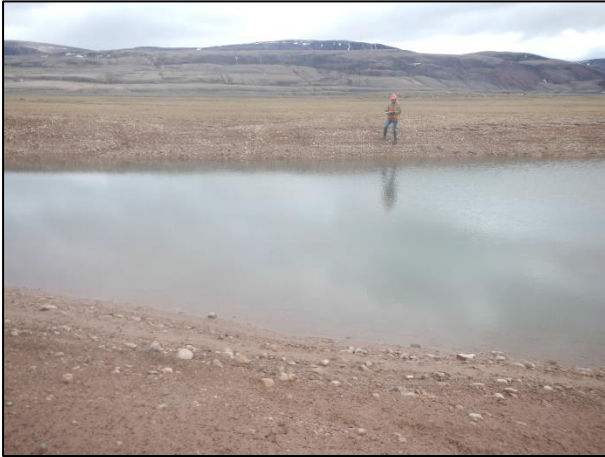
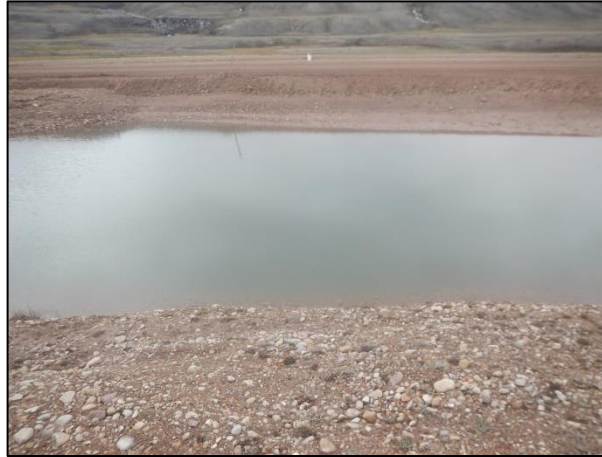
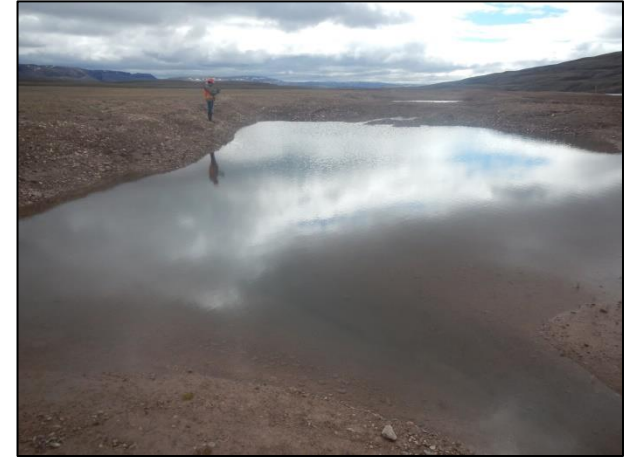
The pond consists of standing water with no inflows or outflows. The maximum depth is approximately 1 m and would not provide overwintering habitat.

Photos 1. Photos of the pond at CV-17-1a in spring 2019: (A) looking northeast; (B) looking southwest; and (C) looking southeast.
