Re: Mary River Project - Notification of Snowmelt and Sedimentation Event Sheardown Lake Tributary

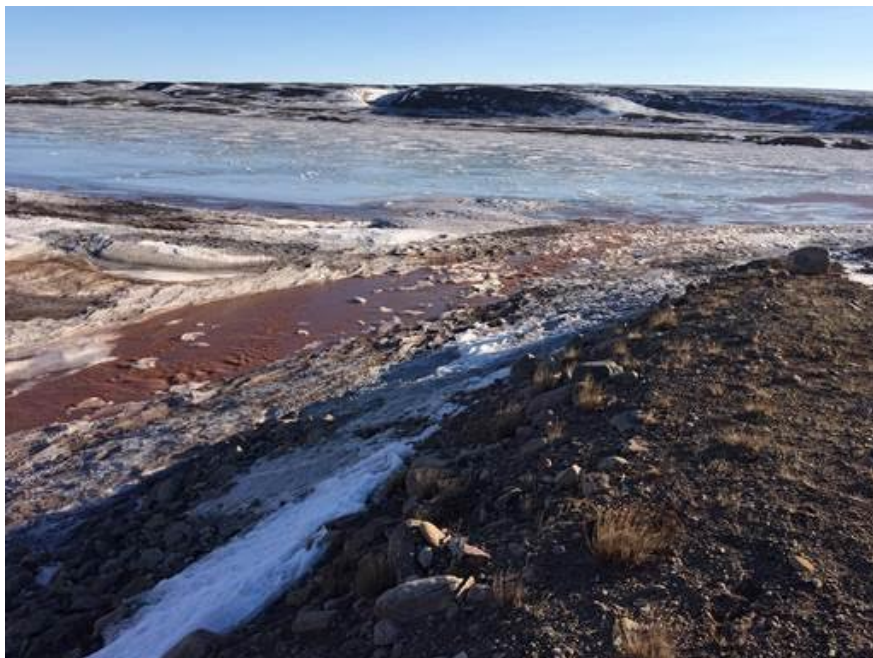
On Saturday evening, May 7, 2016, a snowmelt event occurred at the Mine Site which caused runoff containing some discoloured water / sediment to flow to Sheardown Lake. At this time, Sheardown Lake remains ice covered and there are no fish yet in Sheardown Lake Tributary. Much of the discharge ended up on top of the ice with some discharge to the near shore area of the lake where there is currently land fast ice. The source of the drainage appears to be from an area adjacent to the Crusher Pad area, possibly from snow drifts containing embedded windblown dust. The event resulted in some discoloured water / siltation to two streams flowing from adjacent areas. In accordance with the Surface Water and Aquatic Ecosystems Management Plan, controls were implemented that include installation of silt fences and the deployment of flocculent and treated jute. Once the ice recedes from the shoreline of Sheardown Lake, near-shore silt curtains will be installed in areas of potential discharge. Removal of snow drifts containing entrained dust using mechanical equipment is also currently being considered based on access and ability to operate equipment in those locations. Other possible measures include the construction of check dams and sumps to assist in the settling of sediments from the discharge. Baffinland Site Operations are supporting the Environment Department as required with the necessary resources to quickly and efficiently deal with this situation.

Sheardown Lake Tributary into Sheardown Lake, view downstream.

Samples have been collected of discharge water and daily monitoring is ongoing including water quality for the purpose of tracking improvements to the situation. A more detailed follow-up report will be provided within the next week and include available monitoring results, photos, and map showing the drainage where the incident occurred as well as recommendations to address this situation. In the meantime, please do not hesitate to contact me or Allan Knight, Environmental Superintendent, should you have any questions regarding this incident at the contact numbers below.

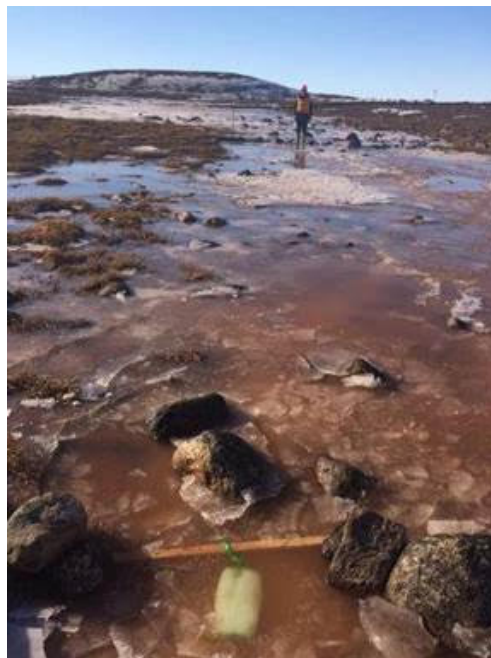
Looking upstream prior to discharge to Sheardown Lake. Flocculent blocks installed in the stream to help settle out sediment.
