## **Appendix D**

### **Sequence of Events and Actions Taken by Spill Report and Other Concerns (With Photos)**

Appendix D.1 - Spill Report 16-158 - Sheardown Lake Tributaries and Sheardown Lake

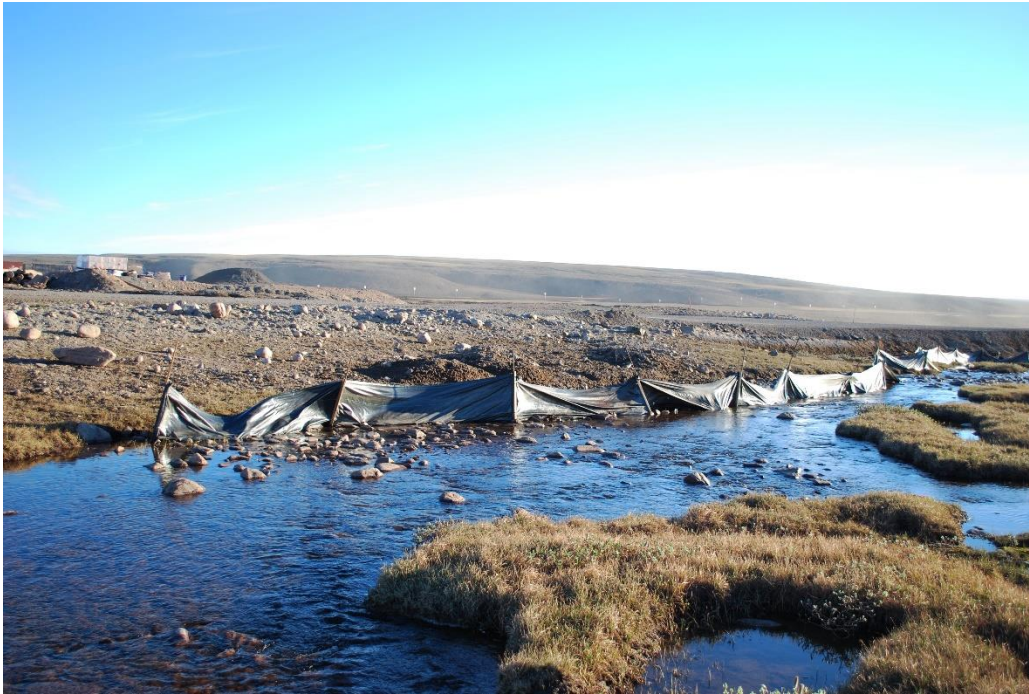
Photo 1 – Silt fence installation along road to prevent road runoff from directly discharging into Sheardown Lake Tributary (SDLT) near CV186.

May 9	Berms built up along road near culverts, CV-186 and CV-187, to prevent road runoff from directly discharging into Sheardown Lake tributary SDLT.
May 10	Sediment release from Sheardown Lake tributaries (LDFG and SDLT) reported to the NT-NU Spill Line and regulators ( <b>NT-NU Spill Report - 16-158</b> ).
	Check Dams #1 and #2 (see Figure 1) installed along Sheardown Lake tributary SDLT downstream of Crusher Pad.
May 12	Feasibility of removing sediments from ice surface on Sheardown Lake investigated. Sediment removal was determined to be not feasible due to weakening ice conditions along the shoreline of Sheardown Lake.
May 13 - 17	Additional flocculent, silt fences and treated jute installed along affected Sheardown Lake tributaries SDLT and LDFG.
May 18	Environment Canada and INDC inspectors arrive onsite and inspect Milne Port and Tote Road.
May 19	Environment Canada and INDC inspectors inspect Mine Site.

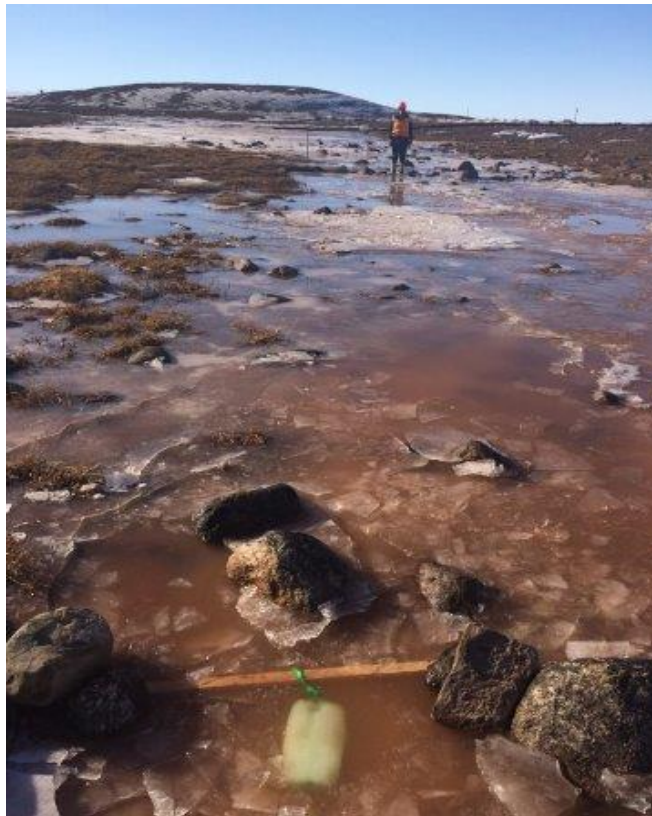
Photo 2 – May 9<sup>th</sup> 2016. Floculant stations installed along Sheardown Lake Tributary SDLT and LDFG.

Flocculent stations installed in upper reaches of SDLT to settle out sediment from Mine Haul Road runoff.
May 23	Constructed check dam directly downstream of the Mine Haul Road "berm punchout" at km 104.5 to collect Mine Haul Road runoff and capture sediment from the Mine Haul Road runoff. (Runoff through this Mine Haul Road berm punchout had resulted in the development of a sediment delta near the upper reaches of tributary SDLT)
May 24	Kemira Chemicals and AMEC-Foster Wheeler contracted to assist Baffinland in developing and optimizing mobile water treatment systems using flocculants.
	Turbid water samples sent to Kemira Chemicals and AMEC-Fost Wheeler for initial flocculant bucket testing.
	Constructed check dam downstream of landfill access road along Sheardown Lake tributary LDFG using sandbags.
May 27 - June 23	Removed lose sediment from sediment delta located downstream of the Mine Haul Road berm punchout at km 104.5. (Sediment delta situated near the bank of tributary SDLT.)

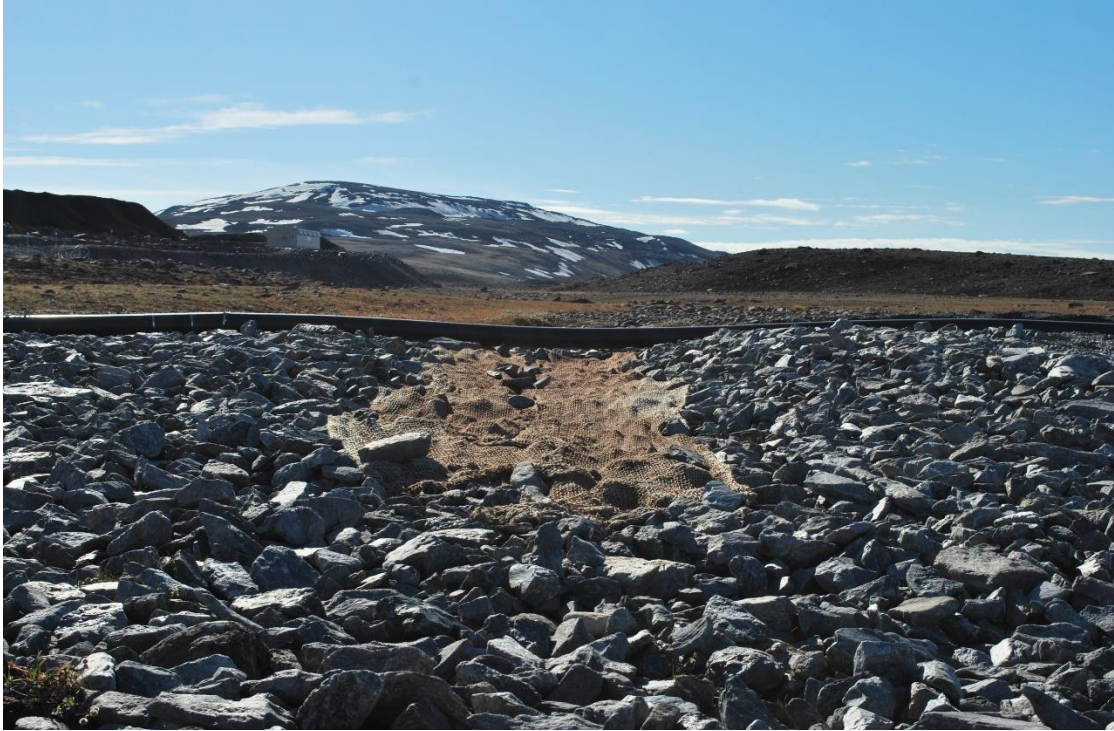
Photo 3 – Treated Jute installed at Check Dam #1 to capture sediments within runoff.

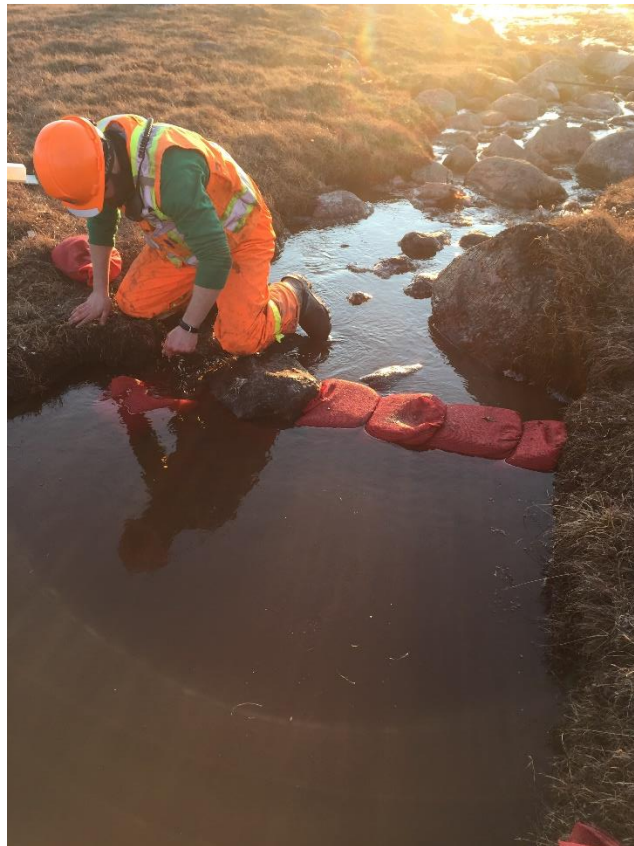
Photo 4 – Sand bag check dams installed along Sheardown Lake Tributary LDFG near landfill access road.

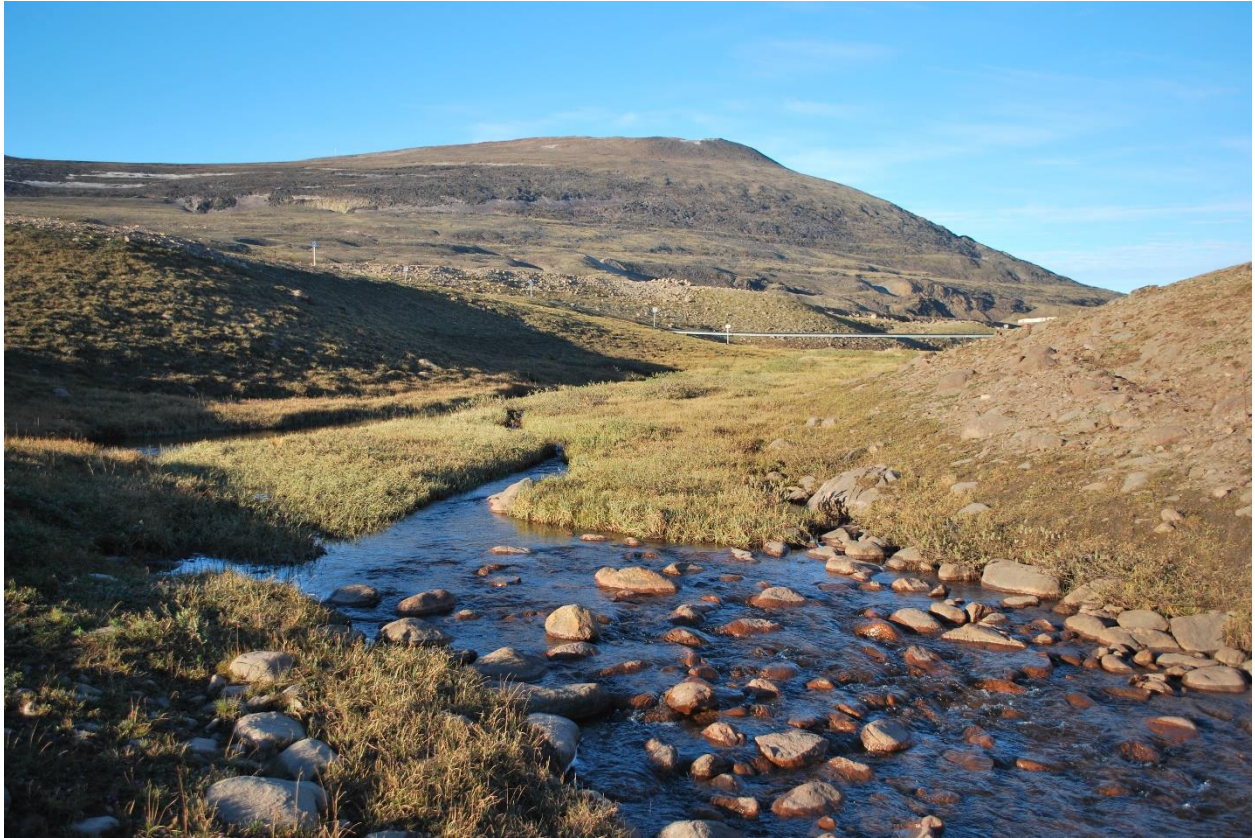
Photo 5 - Improved water clarity and total suspended solid levels at outfall of Sheardown Lake Tributary SDLT following implementation of siltation control measures.

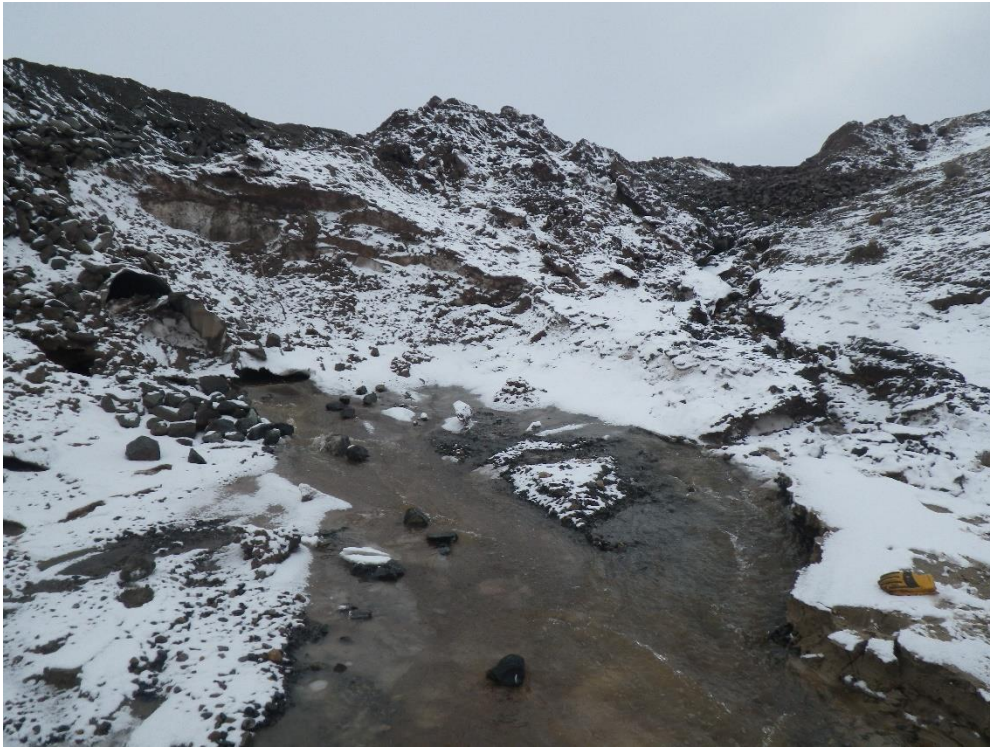
Photo 1 –Airstrip runoff entering Camp Lake Tributary #1.

Table D.2 - Spill Report 16-176 - Sequence of Events and Action Taken	
May 17	Runoff containing sediments observed flowing from the Mine Site airstrip into Camp Lake Tributary # 1 (CLT1) and Camp Lake.
	Siltation control measures (silt fences, flocculent, jute) installed along CLT1 and airstrip drainages to settle out sediments prior to discharge.
	Airstrip swale draining into Camp Lake Tributary #1 lined with 6" aggregate. Culvert installed at North end of airstrip to prevent airstrip runoff from crossing the road into Camp Lake Tributary #1.
	Sediment release to Camp Lake Tributary #1 and Camp Lake reported to the NT-NU Spill Line and regulators ( <b>NT-NU Spill Report- 16-176</b> ).
May 18	Camp Lake Sedimentation Ponds near the Camp Lake water intake jetty repaired to settle out and capture sediment entrained in runoff from the Exploration Camp pad at the Mine Site.
	Monitoring locations established along Camp Lake Tributary #1 and downstream of the Camp Lake Sedimentation Ponds (refer to Figure 1).

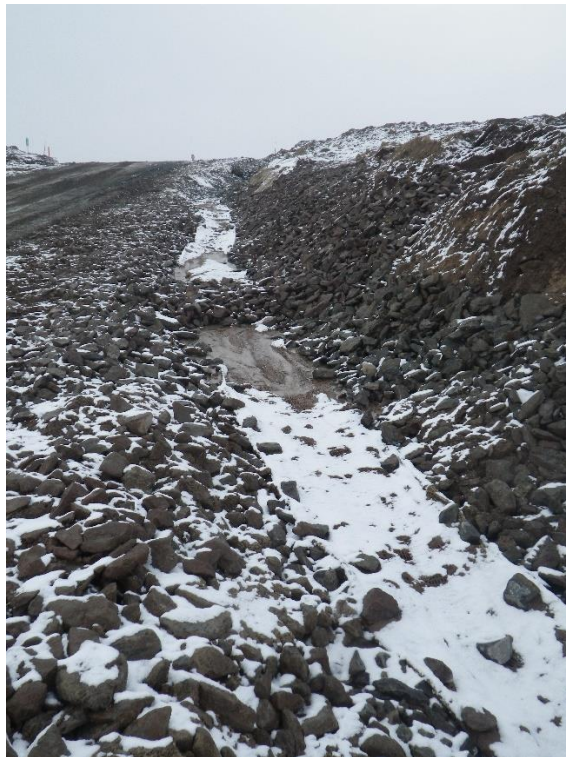
Photo 2 – Swale draining airstrip runoff lined with 6" aggregate and treated jute to capture sediments.

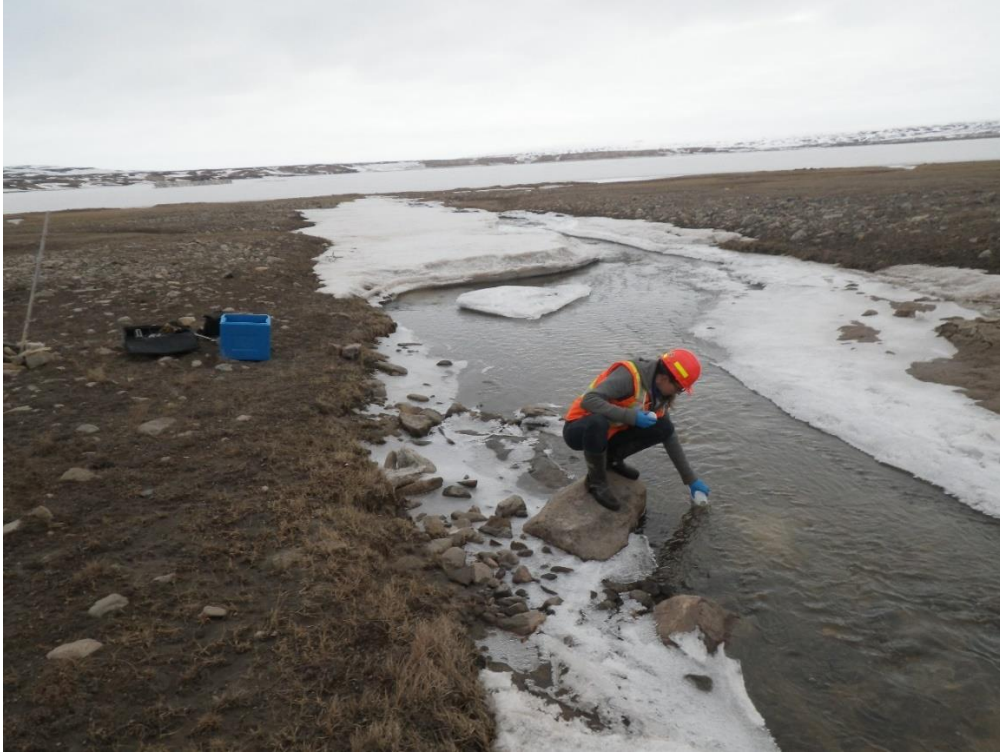
Photo 3 – May 30<sup>th</sup> 2016. Daily sampling and monitoring of Camp Lake Tributary #1 discharge at Camp Lake outfall.

Environment Canada and AANDC inspectors arrive onsite and inspect Milne Port and Tote Road.
May 18 - June 8	Conducted daily sampling until June 8 at established monitoring locations. Daily water samples were primarily analyzed for TSS, TDS, pH and turbidity. Additional sampling was conducted on May 23 for additional parameters, including acute toxicity, metals, nutrients, hydrocarbons and major ions.
May 18	Environment Canada and INAC inspectors arrive onsite and inspect Milne Port and Tote Road.
May 19	Environment Canada and INAC inspectors inspect Mine Site.
	Environment Canada, INAC and Baffinland collect water samples downstream of the Camp Lake Sedimentation Ponds
May 20	Environment Canada and INAC inspectors notify Baffinland that directions under the Fisheries Act will be issued to the Company as a result of surface water runoff conditions observed during their inspection.
May 24	Kemira Chemicals and AMEC-Foster Wheeler contracted to assist Baffinland in developing and optimizing mobile flocculant treatment systems.

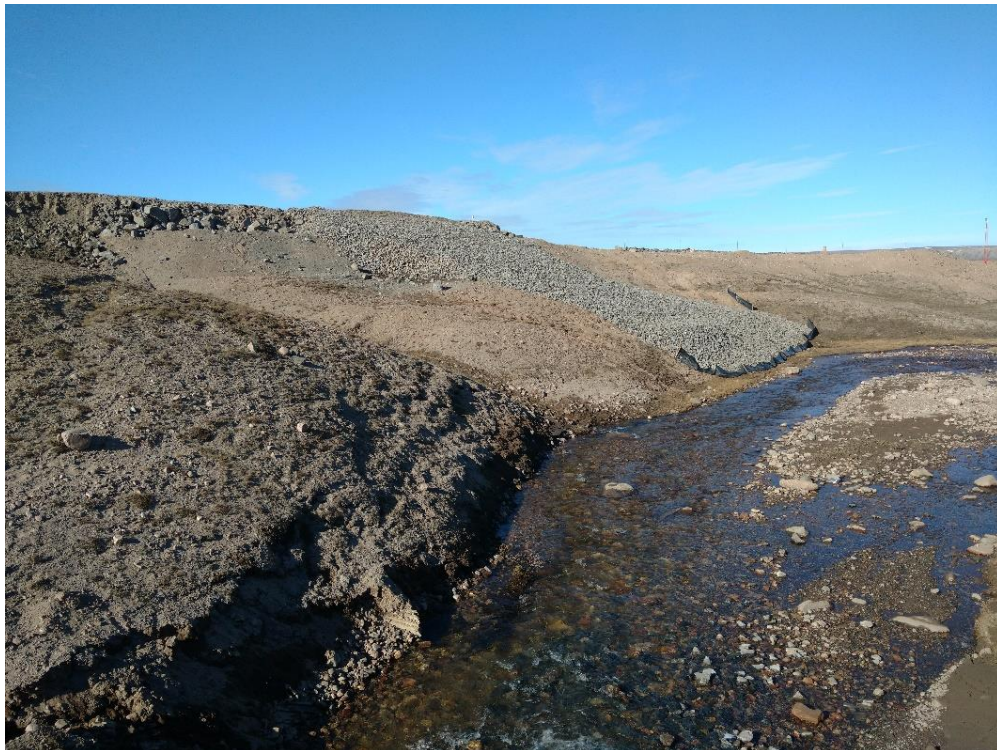
Photo 4 – Improved water clarity and total suspended solid levels at Camp Lake Tributary #1 following implementation of siltation control measures.

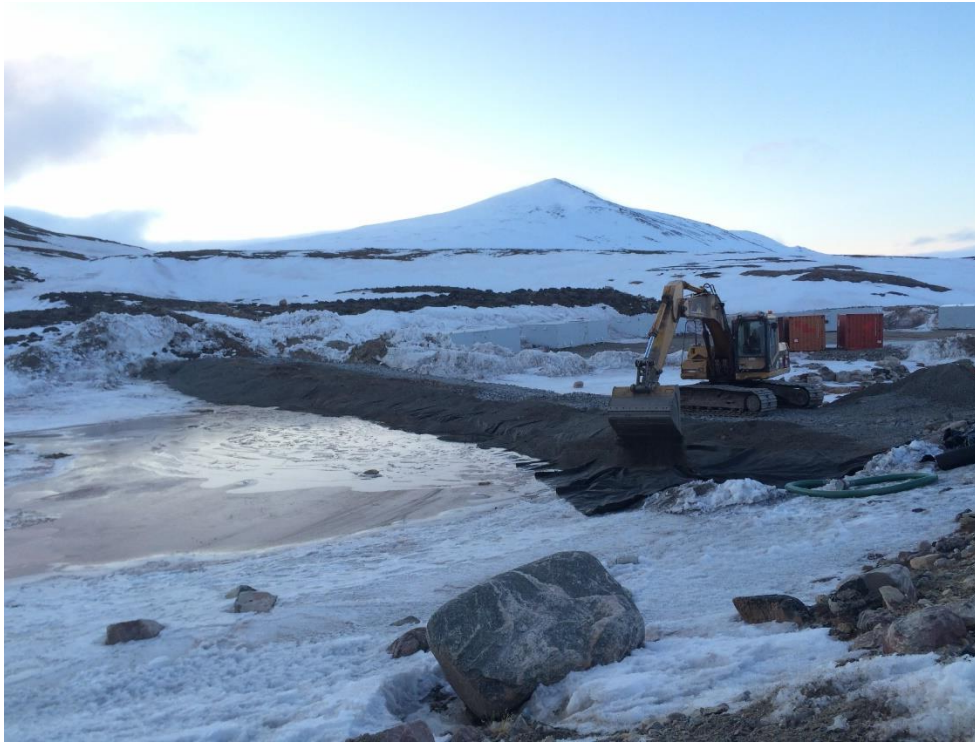
Photo 1– April 28<sup>th</sup> 2016. Construction of Check Dam # 4 near the end of Magazine Access Road.

Sequence of Events and Actions Taken	
May 20	Runoff containing sediments was observed flowing from the surface of the Mine Haul Road through "berm punch outs" on the outer edge of the road and into the Mary River and Sheardown Lake tributary SDLT.
	Sediment deposit discovered near upper reaches of tributary SDLT directly downstream of km 104.5 Mine Haul Road "berm punch out".
May 21	Sediment release to Mary River and Sheardown Lake reported to the NT-NU Spill Line and regulators ( <b>NT-NU Spill Report- 16-181</b> ).
	Mine Haul Road "berm punch outs" are sealed to redirect runoff to check dams and natural sumps to settle out and capture sediment entrained in runoff from the Mine Haul Road.
May 22	Constructed Check Dam #3 near entrance of magazine access road to collect Mine Haul Road runoff and capture sediment.
	Flocculant installed upstream of Check Dam # 3 on Mine Haul Road.
May 23	Constructed Check Dam #4 at the end of magazine access road to collect Mine Haul Road runoff.

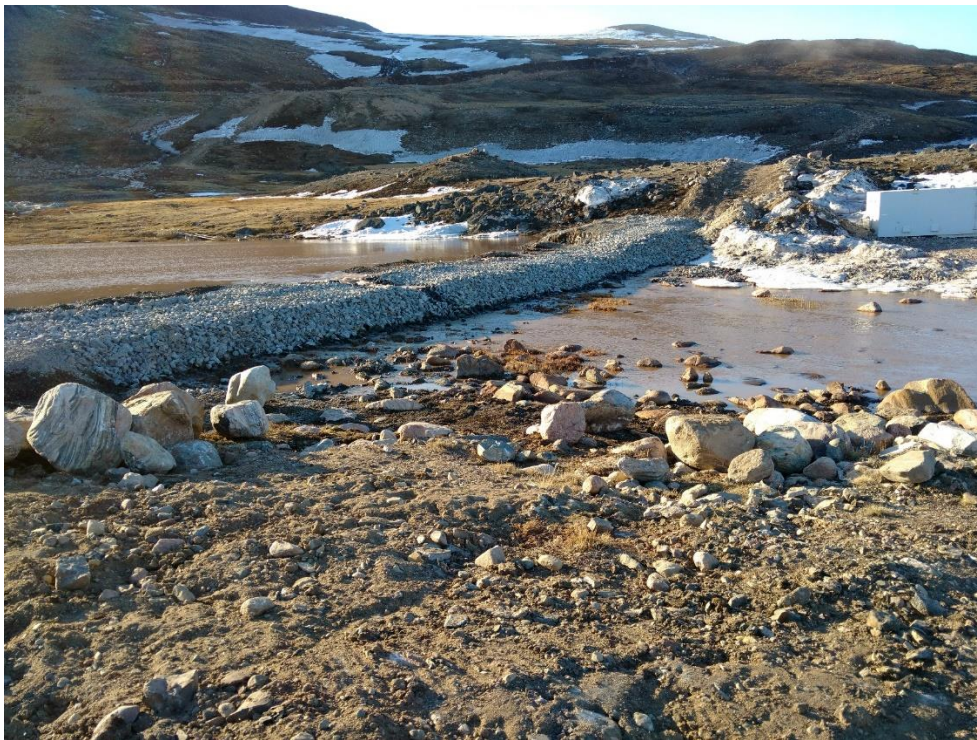
Photo 2 – Mine Haul Road runoff pooling upstream of Check Dam # 4

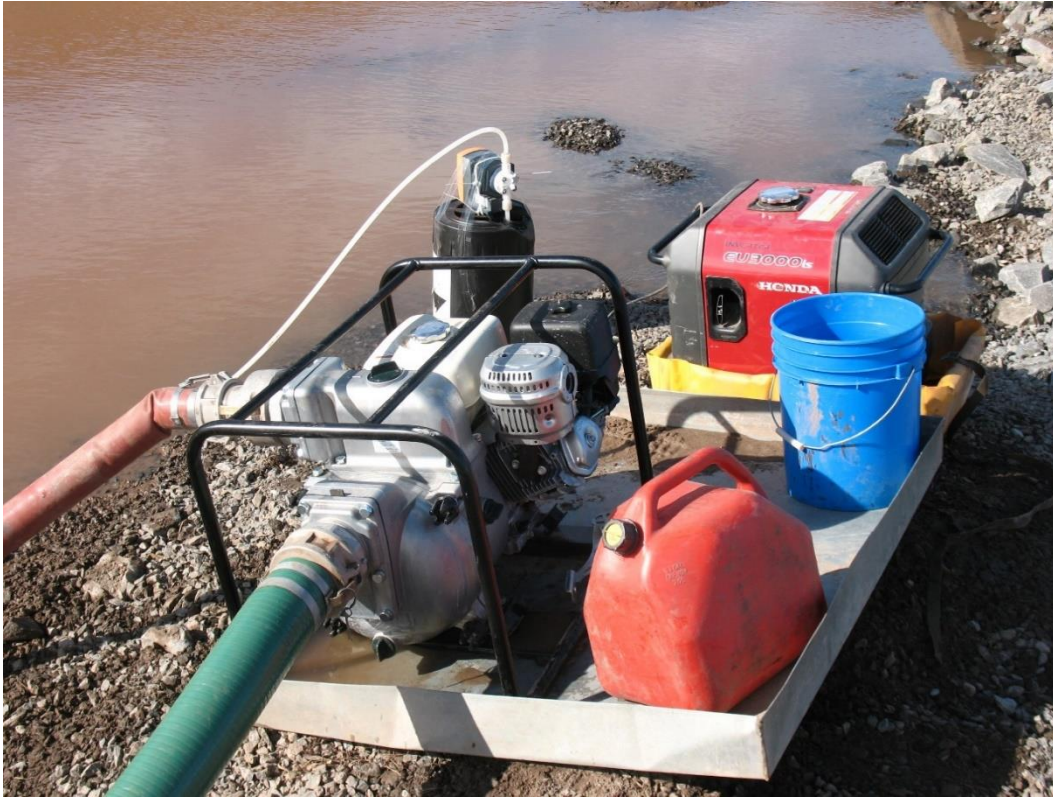
Photo 3 – Flocculant dosing system treating water upstream of Check Dam #4.

June 16	Installed silt fences downstream of the Mine Haul Road culverts discharging to Mary River.
June 17 - 21	Kemira Chemicals Chemist arrives onsite to assist Baffinland in developing and optimizing mobile water treatment systems using flocculants.
June 20 - June 21	Pilot testing of coagulant/flocculant dosing system at Check Dam #4 (assisted by Kemira Chemicals).
June 21	Installed additional siltation controls, including geotextile, silt fences and flocculant, at km 108.5 of the Mine Haul Road.

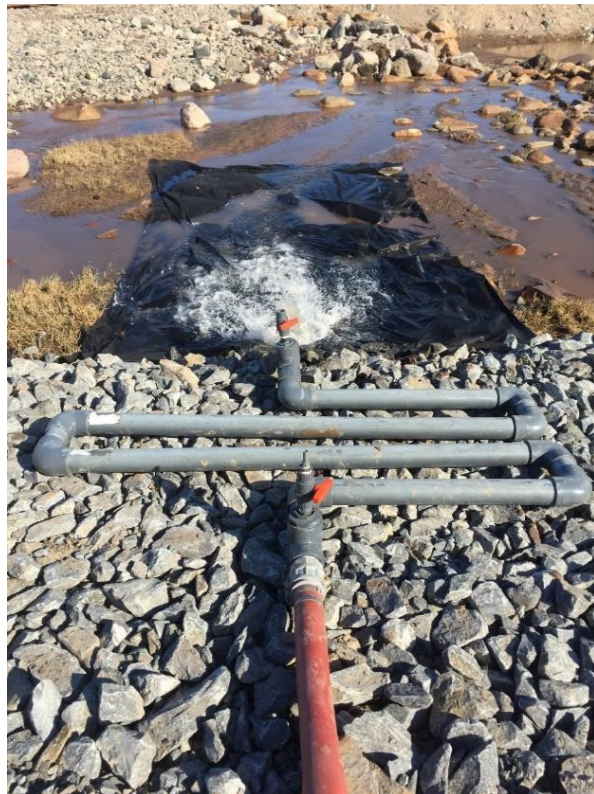
Photo 4 – Discharge of flocculant dosing system at Check Dam #4.

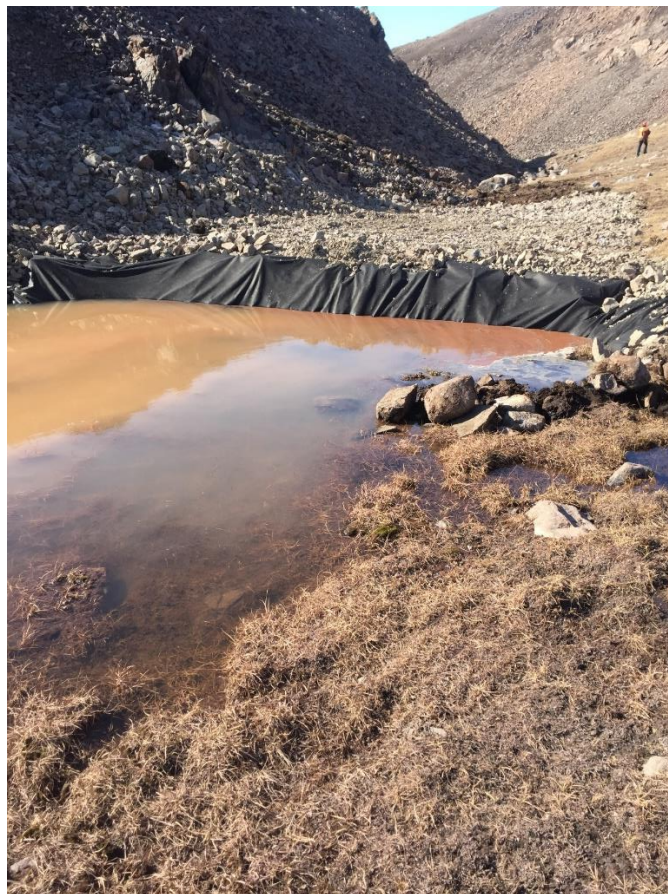
Photo 6 – Check dam constructed at outlet of Sheardown Valley along Mine Haul Road.

June 1 - June 15	AMEC-Foster Wheeler Engineer arrives onsite to develop flocculant treatment systems and pilot test additional siltation controls including geotubes.
June 12	Constructed three (3) check dams upstream of SDLT along Mine Haul Road (Sheardown Valley) to allow for water treatment (flocculants) of Mine Haul Road runoff before entering SDLT.
	Installed silt fences and flocculant stations upstream and throughout Sheardown Valley.
	Water samples taken upstream and downstream of Check Dam #4.

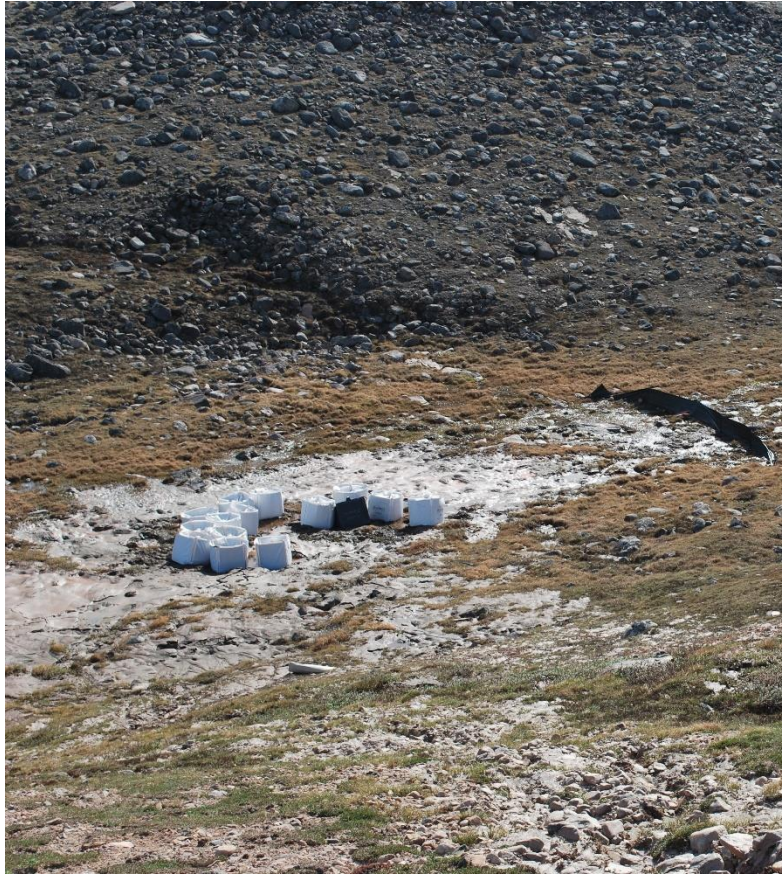
Photo 7 – Sediment deposit removal along upper reaches of Sheardown Lake Tributary SDLT (downstream of km 104.5 of the Mine Haul Road).

Constructed check dam directly downstream of the Mine Haul Road "berm punchout" at km 104.5 to collect Mine Haul Road runoff and capture any additional sediment releases from the Mine Haul Road. (Runoff through this Mine Haul Road berm punchout had resulted in the development of a sediment delta near the upper reaches of tributary SDLT)
May 24	Flocculant installed upstream of Check Dam #4 on Mine Haul Road.
May 26	Installed geotextile over the upstream face of Check Dam #4.
	Water samples taken upstream and downstream of Check Dam #4
May 27 - 31	Golder Associates geotechnical engineer arrives at site to provide guidance, assess risk, and develop a list of priority drainage works along the Mine Haul Road
May 27 - June 23	Removed loose sediment from sediment deposit located downstream of the Mine Haul Road "berm punch out" at km 104.5. (Sediment deposit situated near the bank of tributary SDLT.)

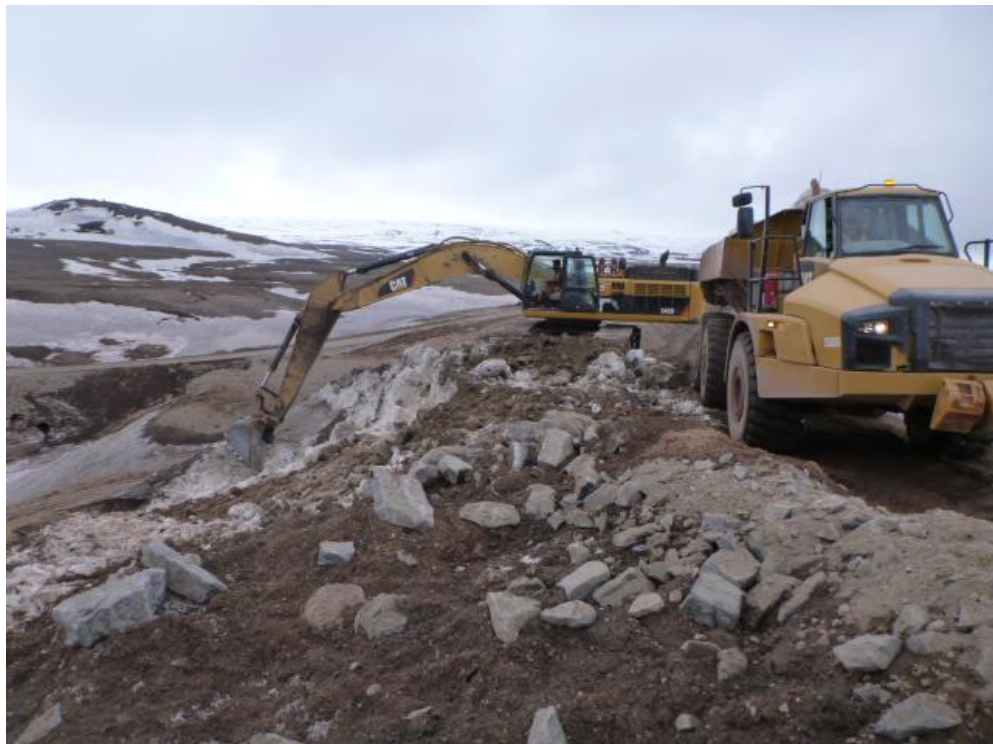
Photo 2 – June 3<sup>rd</sup> 2016. Snow along slumping slope face and sediment deposit removed.

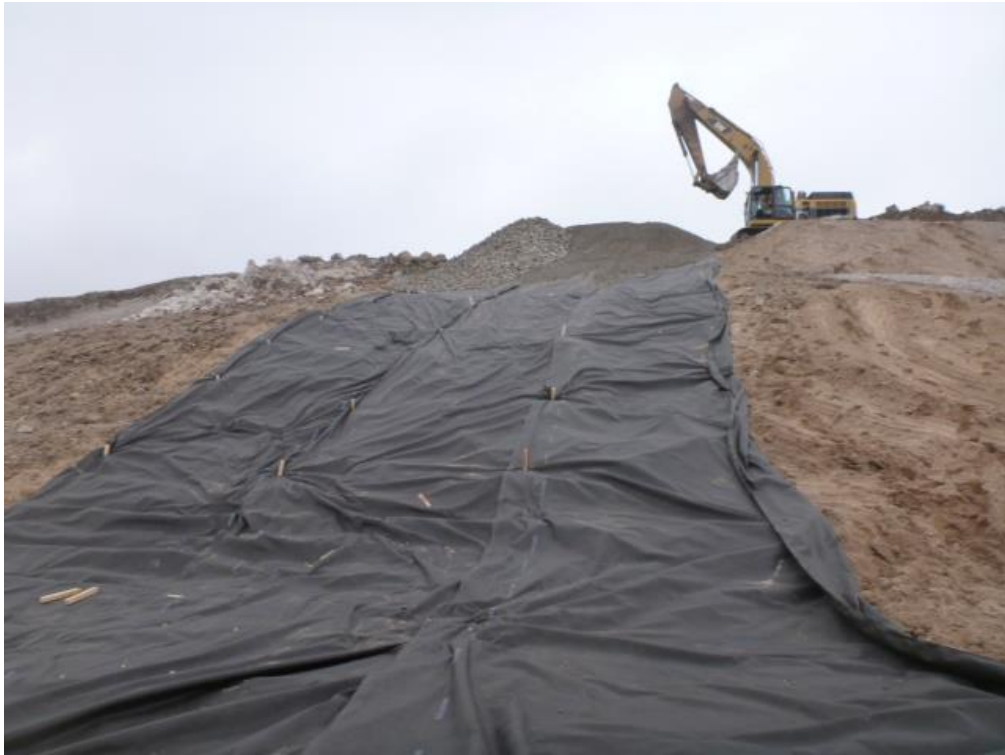
Photo 3 – June 3<sup>rd</sup> 2016. Slumping stream bank lined with geotextile to protect underlying soil from erosion.

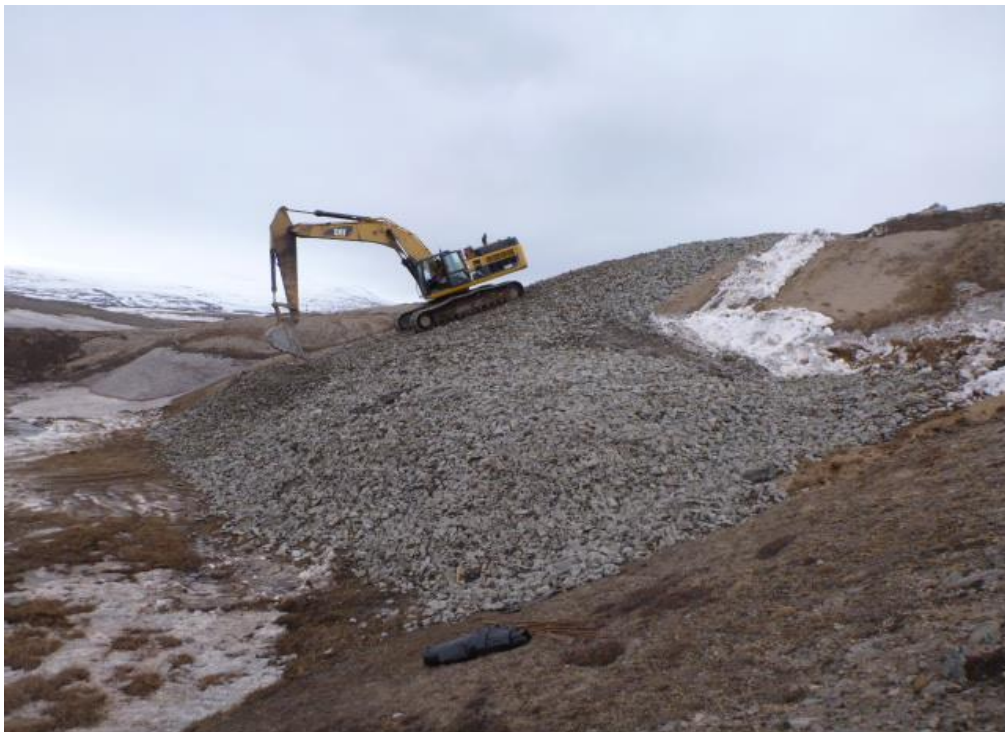
Photo 4 – June 4<sup>th</sup> 2016. Slumping stream bank reinforced with 6" aggregate.
