**APPENDIX D.1**  
**CONSTRUCTION SUMMARY REPORT- MILNE PORT OFF-SPEC PWSP**

**Baffinland Iron Mines Corporation  
Mary River Project**

**Construction Summary Report: Construction Summary Report: Milne  
Port Off-Spec Sewage Effluent Pond (PWSP)**

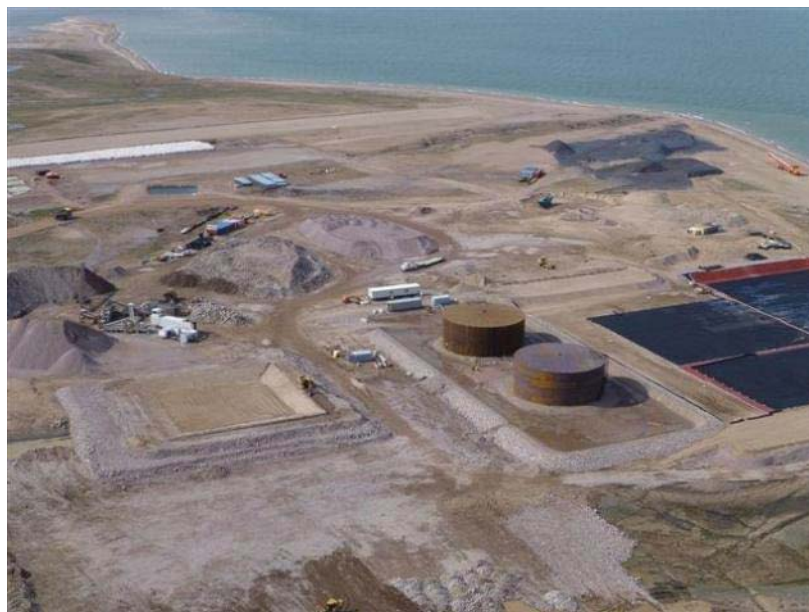
**Figure 4: During – Grading of Final Layer**

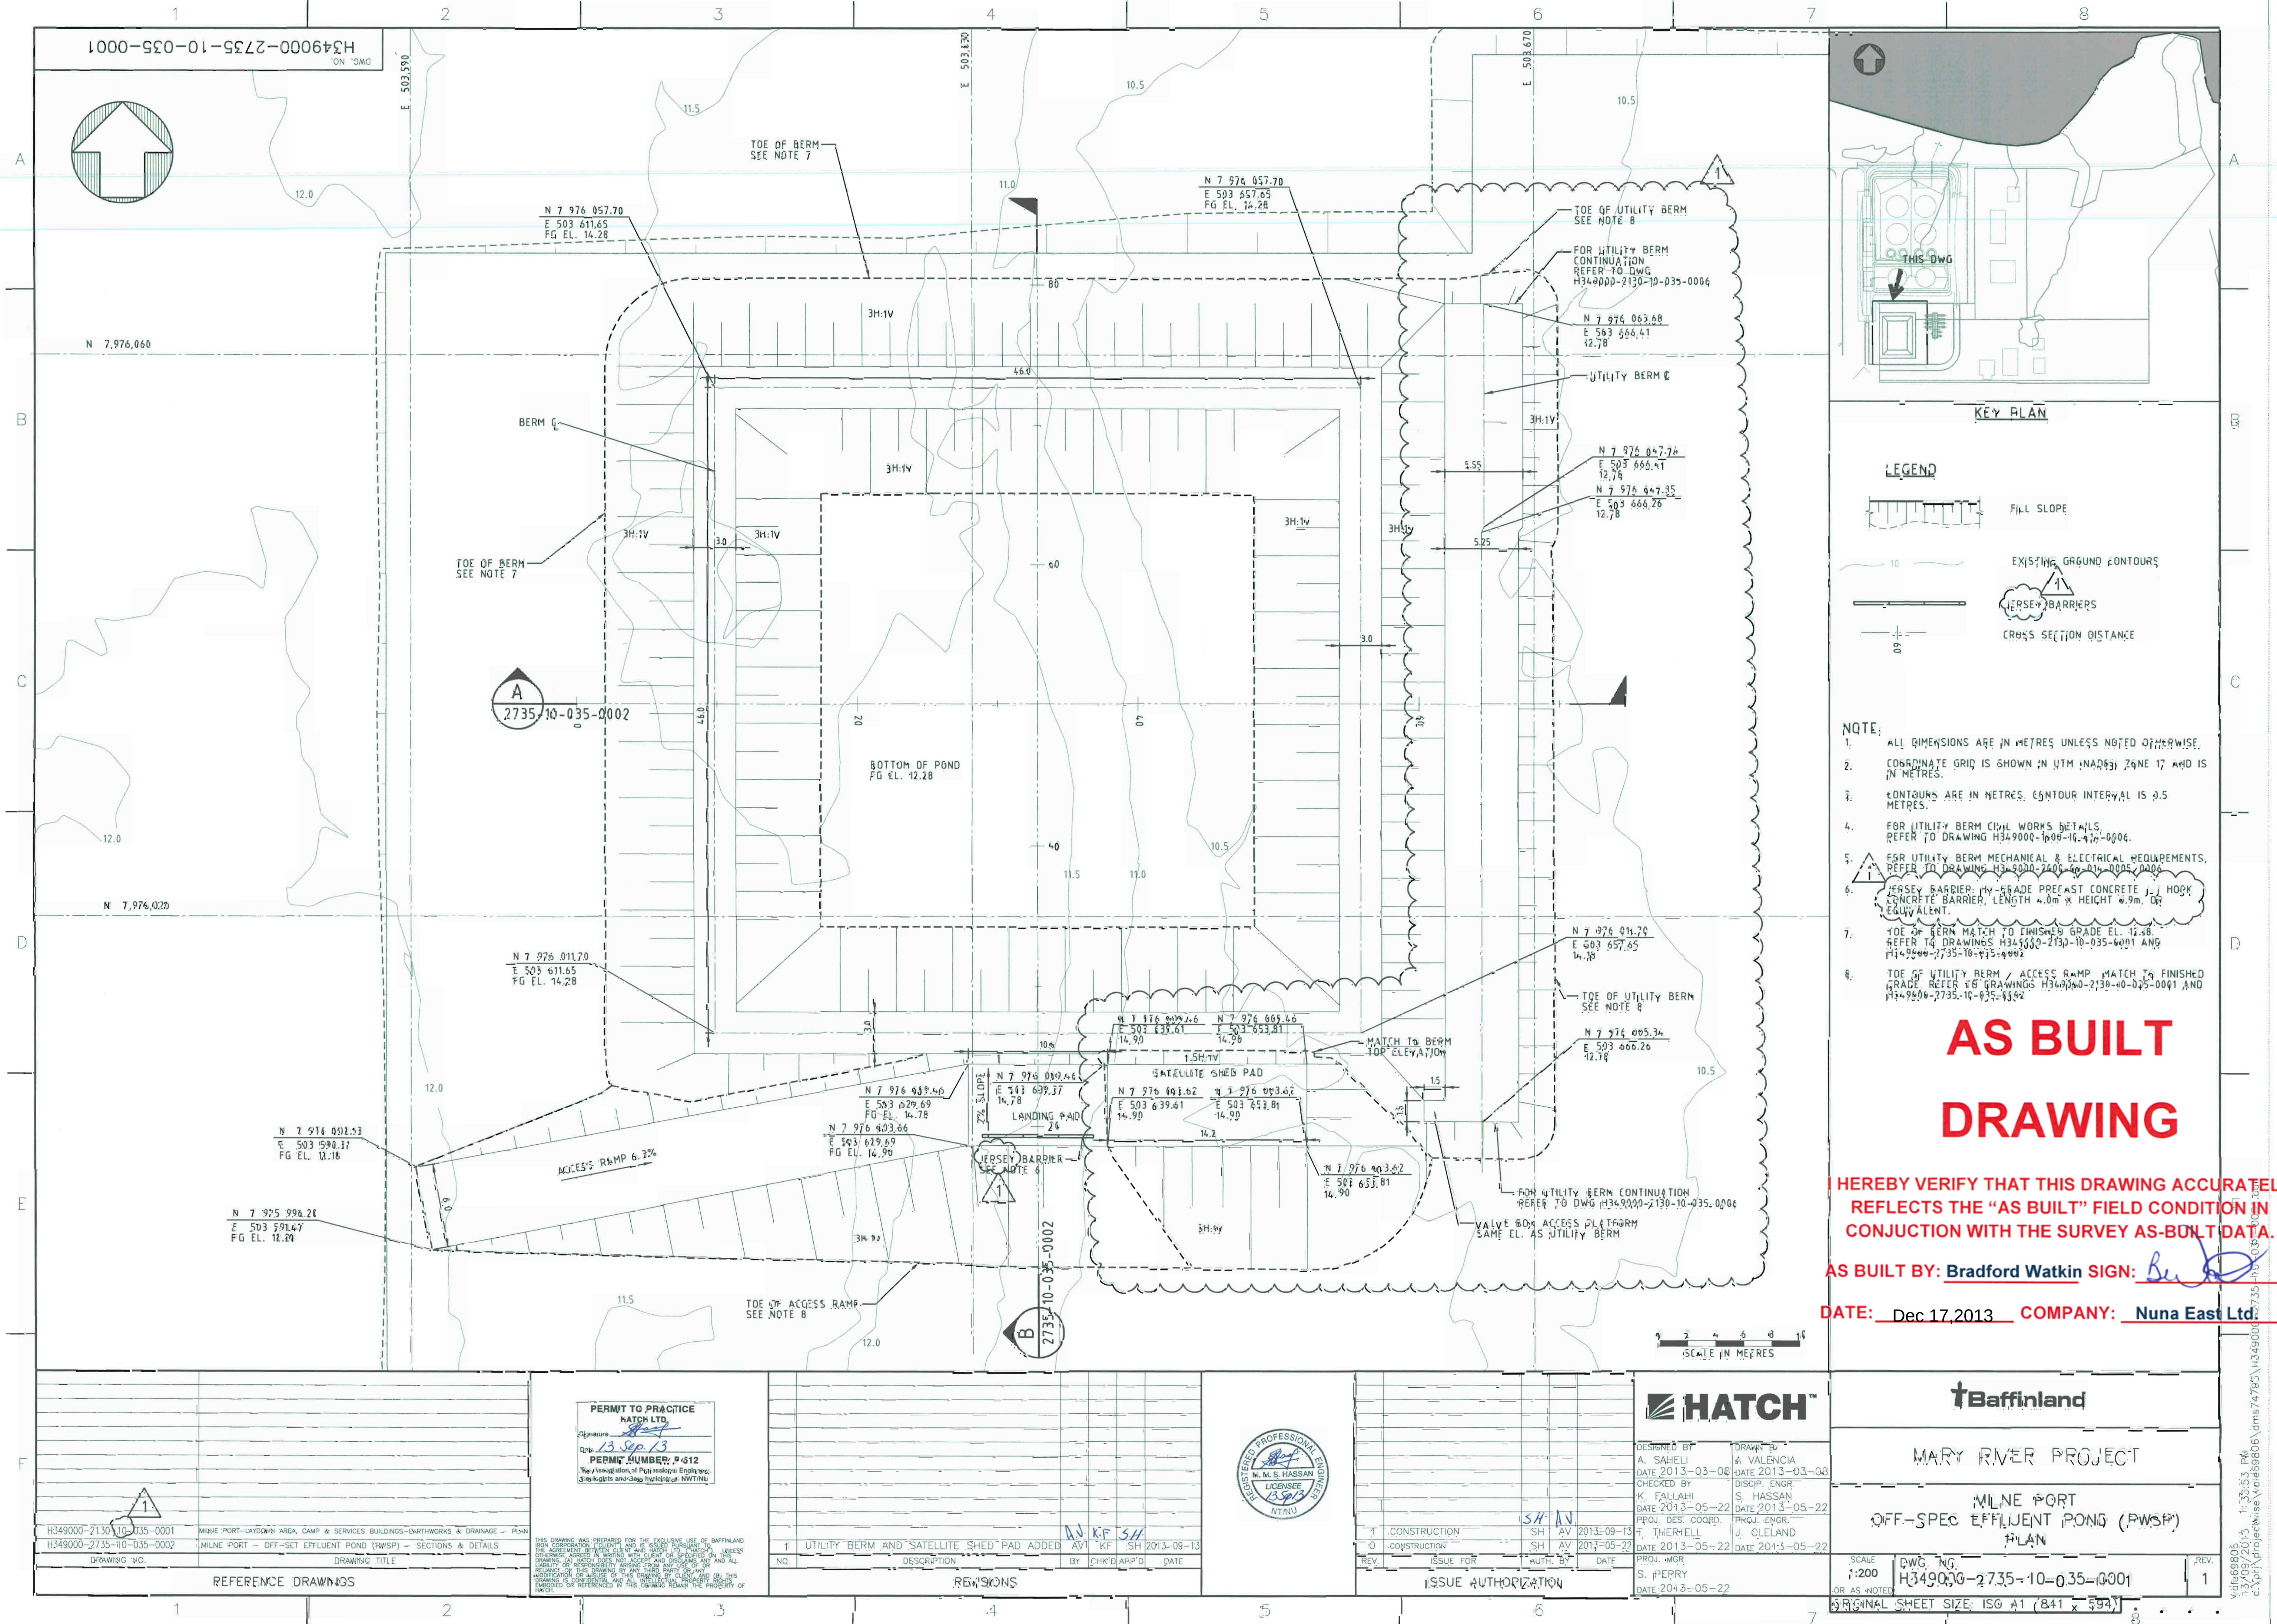
H349000-2735-10-035-0002

I HEREBY VERIFY THAT THIS DRAWING ACCURATELY REFLECTS THE "AS BUILT" FIELD CONDITION IN CONJUNCTION WITH THE SURVEY AS-BUILT DATA.

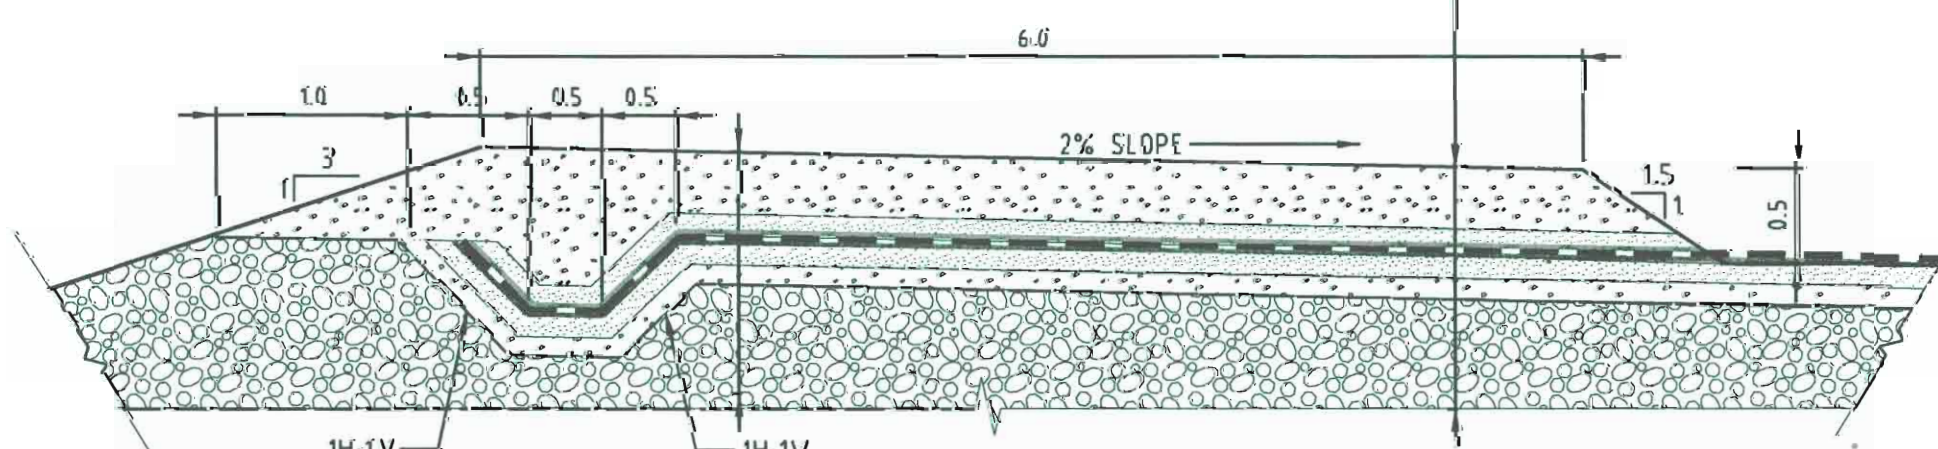
DETAIL 1 - BERM AT LANDING PAD

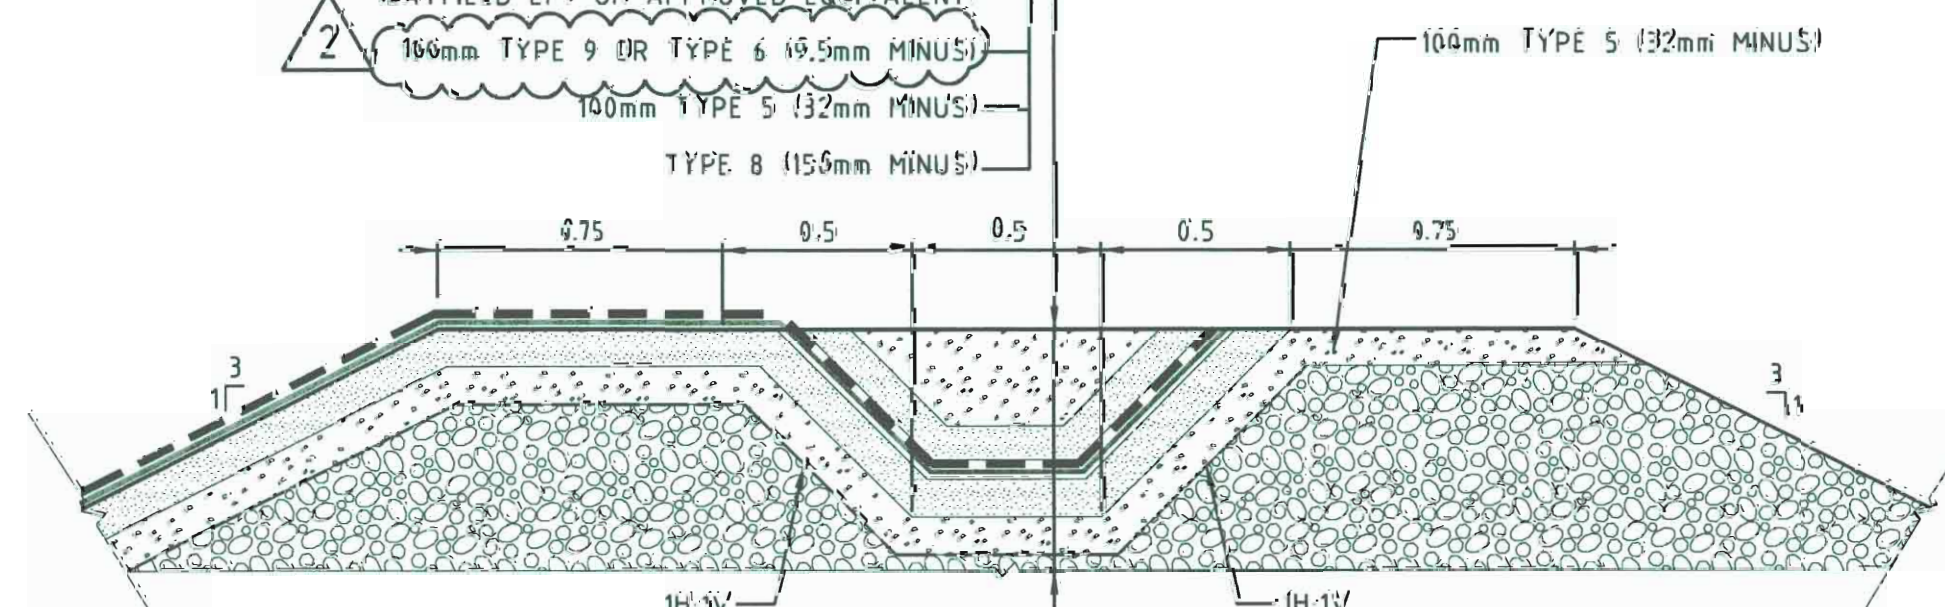
DETAIL 2 - NORMAL BERM

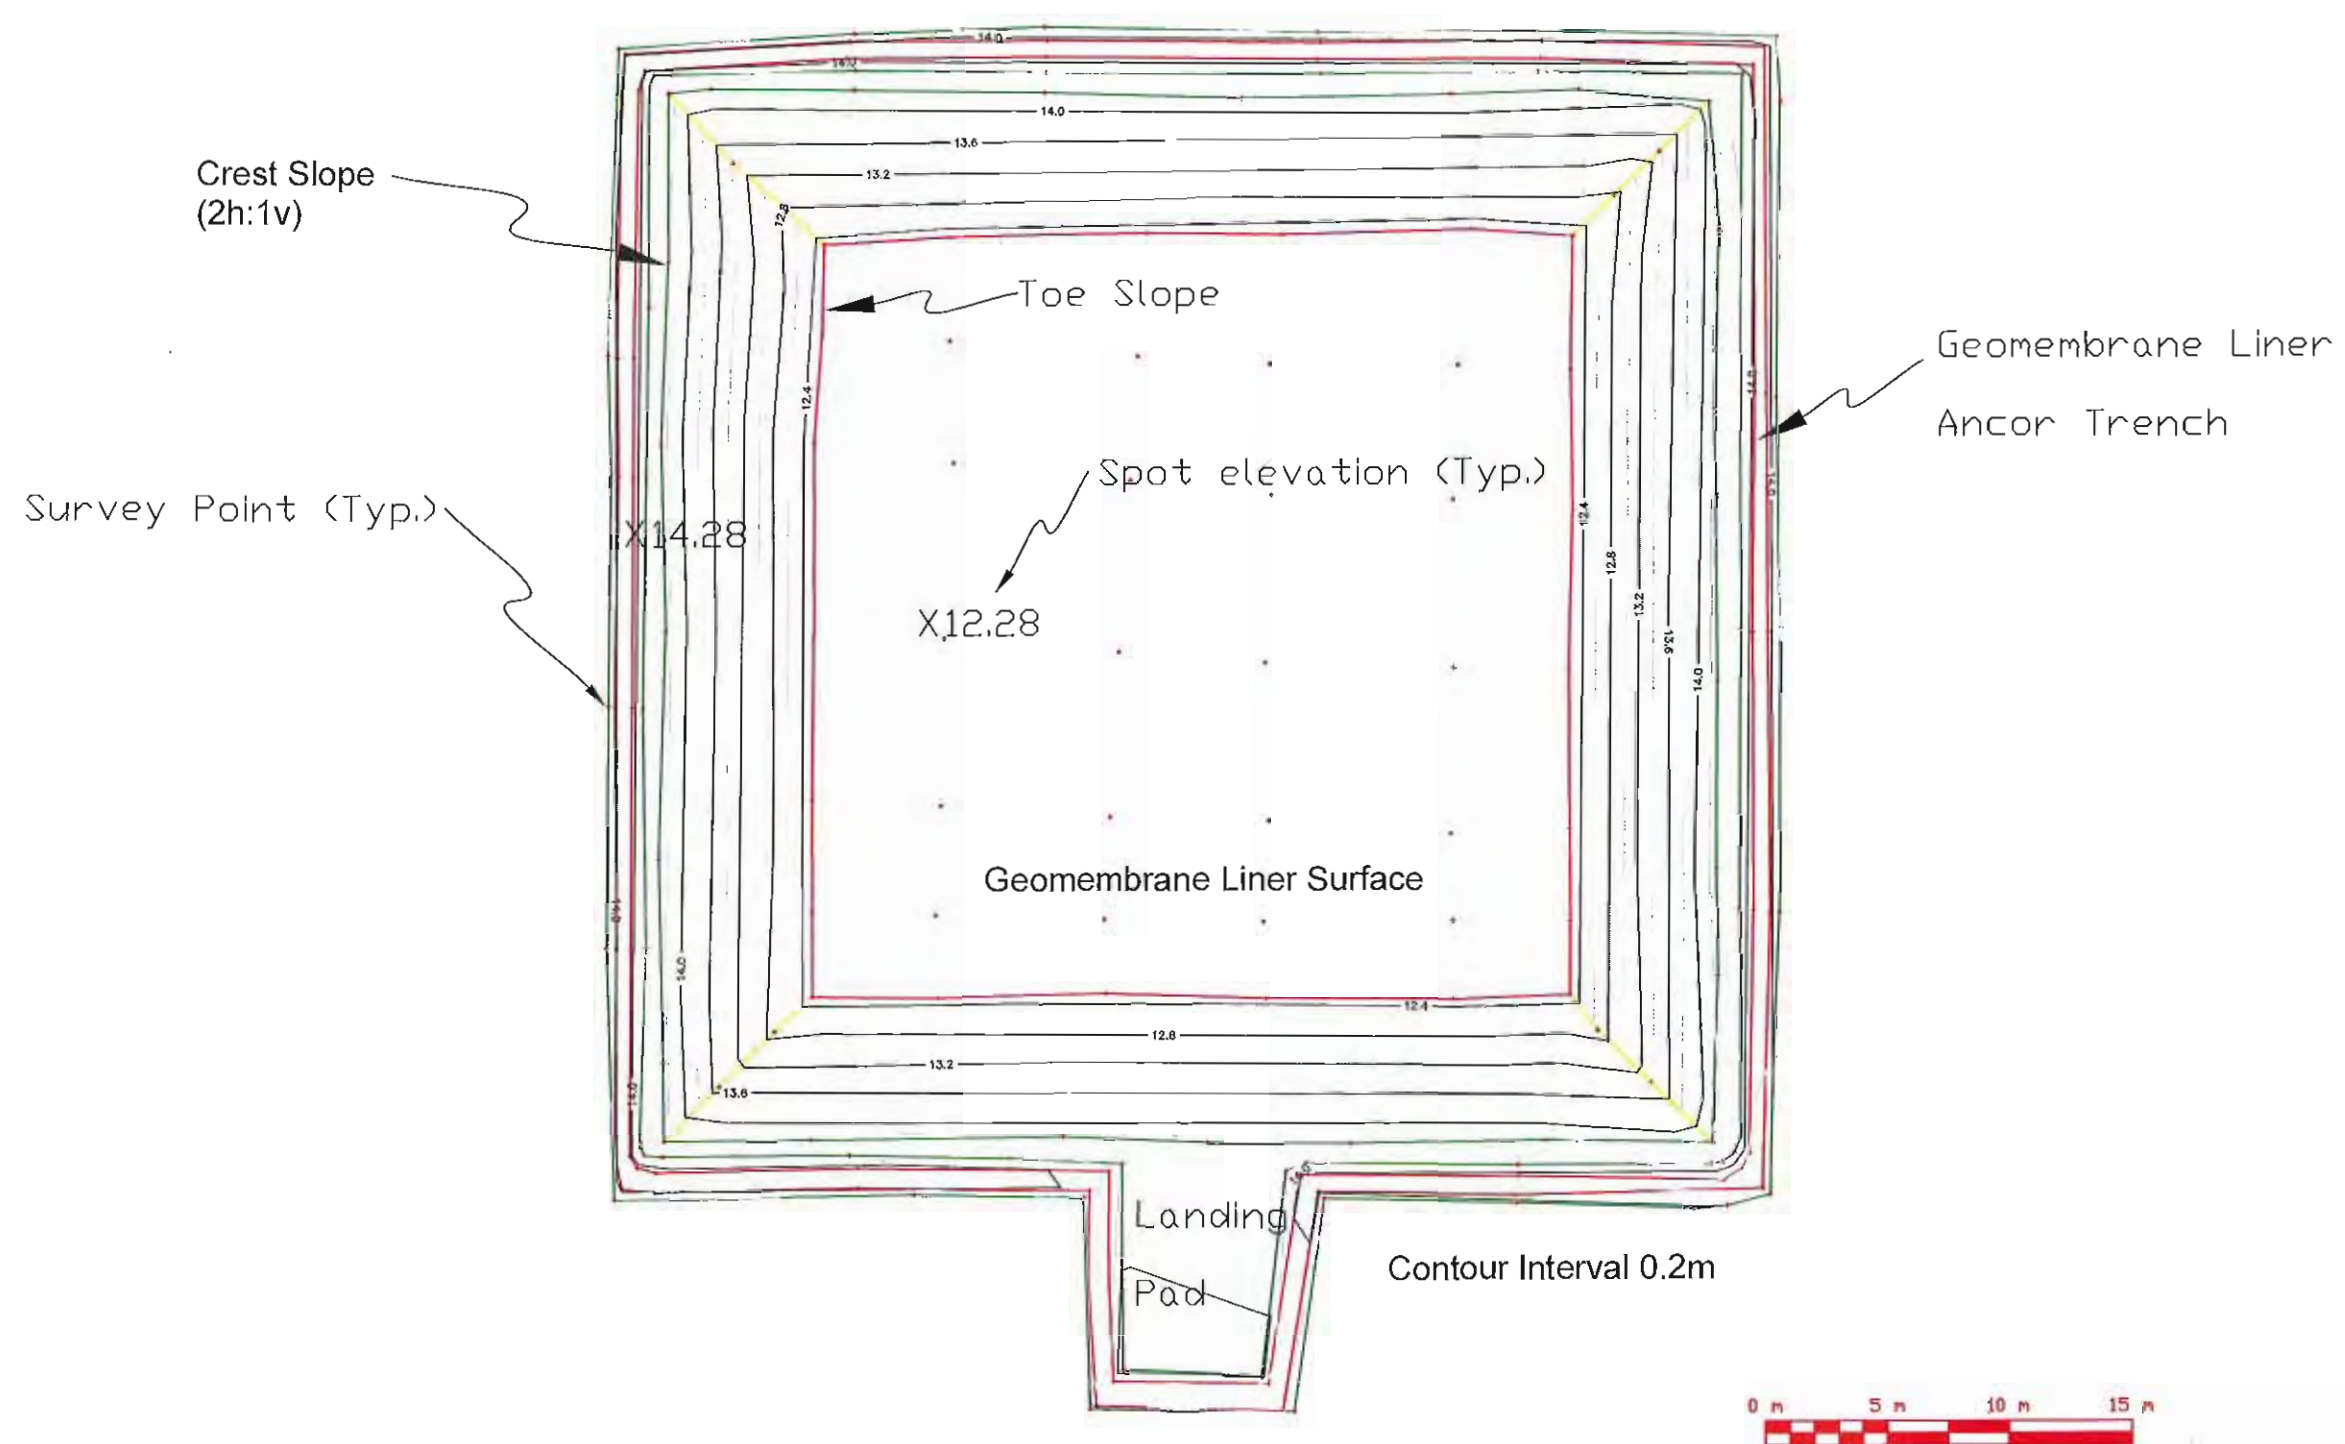
| <p>NOTES:</p> <p>Job No:2999 Bim Ref # 2.3.1.12<br/>Pond floor &amp; berms-Type 9: Activity #10</p> | <p>CLIENT:</p> <p>Baffinland Iron Mines Corporation</p> <p>PROJECT:</p> <p>Mary River Project, Baffin Island, Nunavut</p> | <p>PREPARED BY:</p> <p>Nuna East Ltd.<br/>9839 - 31 Avenue<br/>Edmonton, AB<br/>T6N 1C5</p> <p>DRAWN BY:</p> <p>mc</p> | <p>SCALE:</p> <p>1:300</p> <p>DATE:</p> <p>Sept. 30, 2013</p> | <p>DRAWING TITLE:</p> <p><b>Milne Port-Effluent Pond<br/>Under Liner Surface</b></p> <p>DRAWING NAME (YYMMDD):<br/>2999-10 EP Sand UL 130719.dwg</p> |

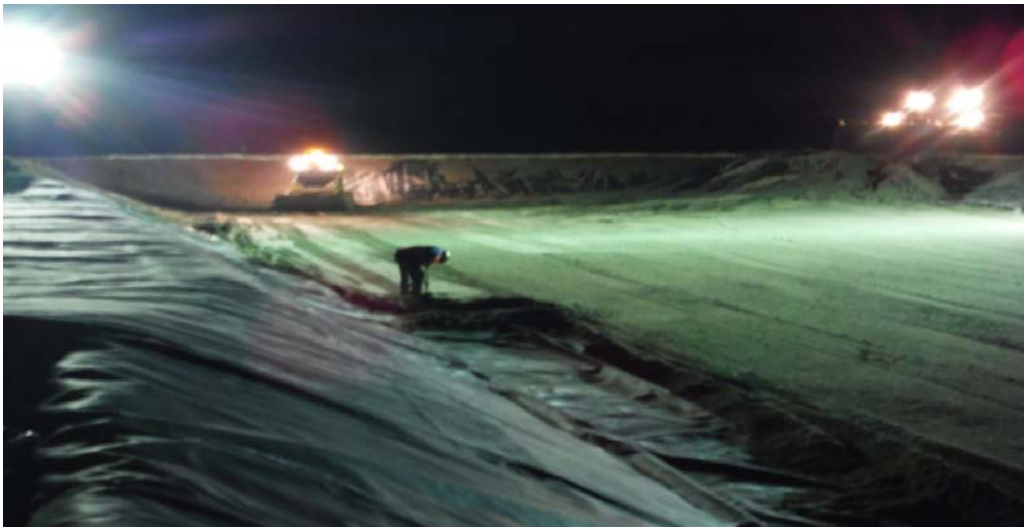
**PHOTO 22** Installing arctic liner at Steel Tank Bulk Fuel Storage Facility engineering containment structure August 2013
