Appendix C.2 – Photos

**June 7th 2016, Fisheries Act Direction (File number: 4408-2016-05-10-001) and
Response to June 16, 2016, INAC Letter of Non-Compliance
Bi-Weekly Report No. 2 for Period July 9 to July 22, 2016**

**June 7th 2016, Fisheries Act Direction (File number: 4408-2016-05-10-001) and
Response to June 16, 2016, INAC Letter of Non-Compliance
Bi-Weekly Report No. 3 for Period July 23 to August 5, 2016**

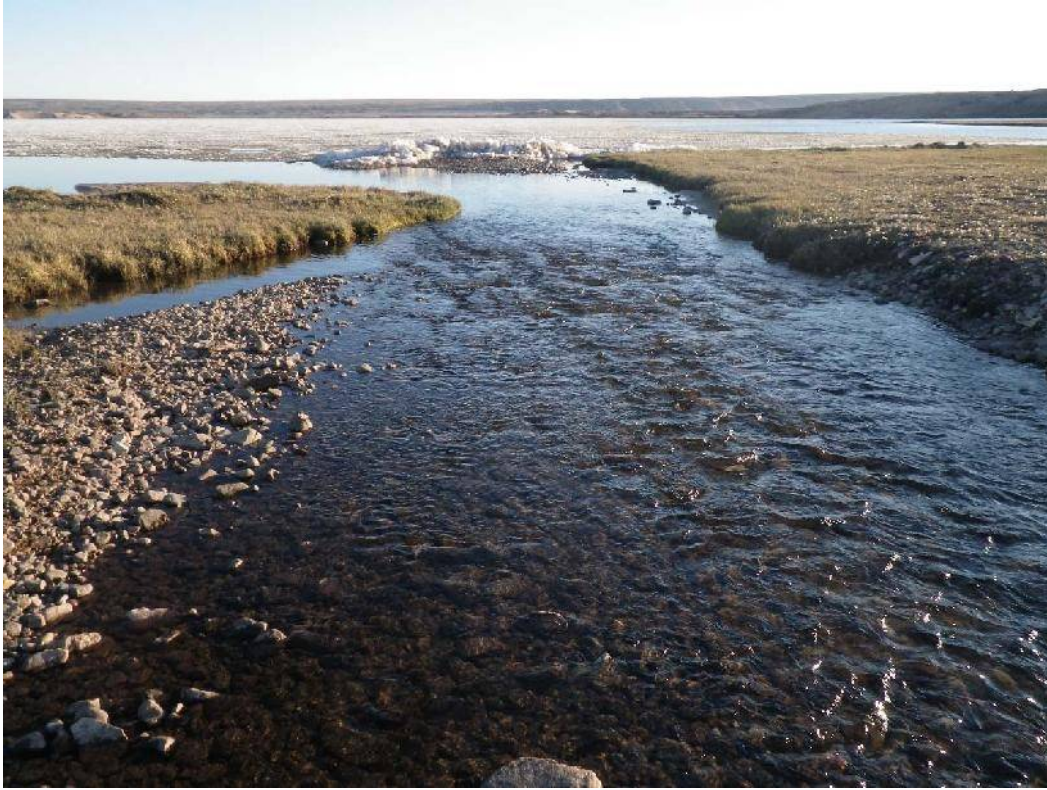
Photo 1 –Outfall to Camp Lake Tributary #1 on July 4, 2016

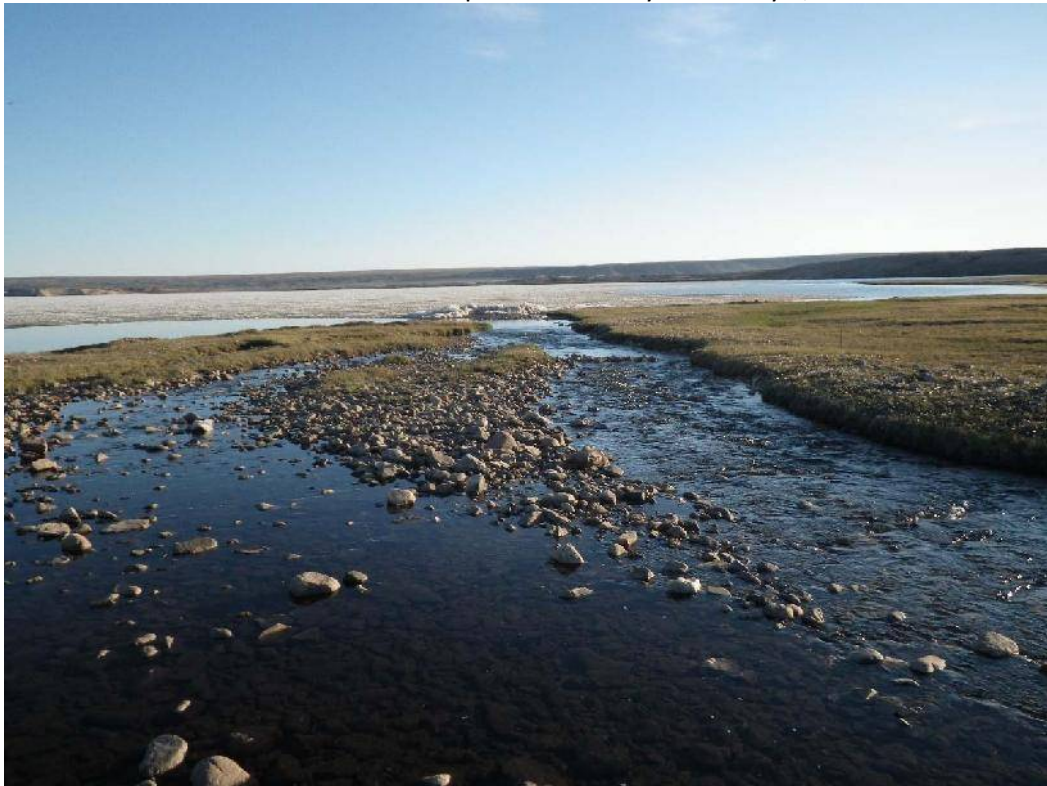
Photo 2 – Camp Lake Tributary #1 on July 4, 2016

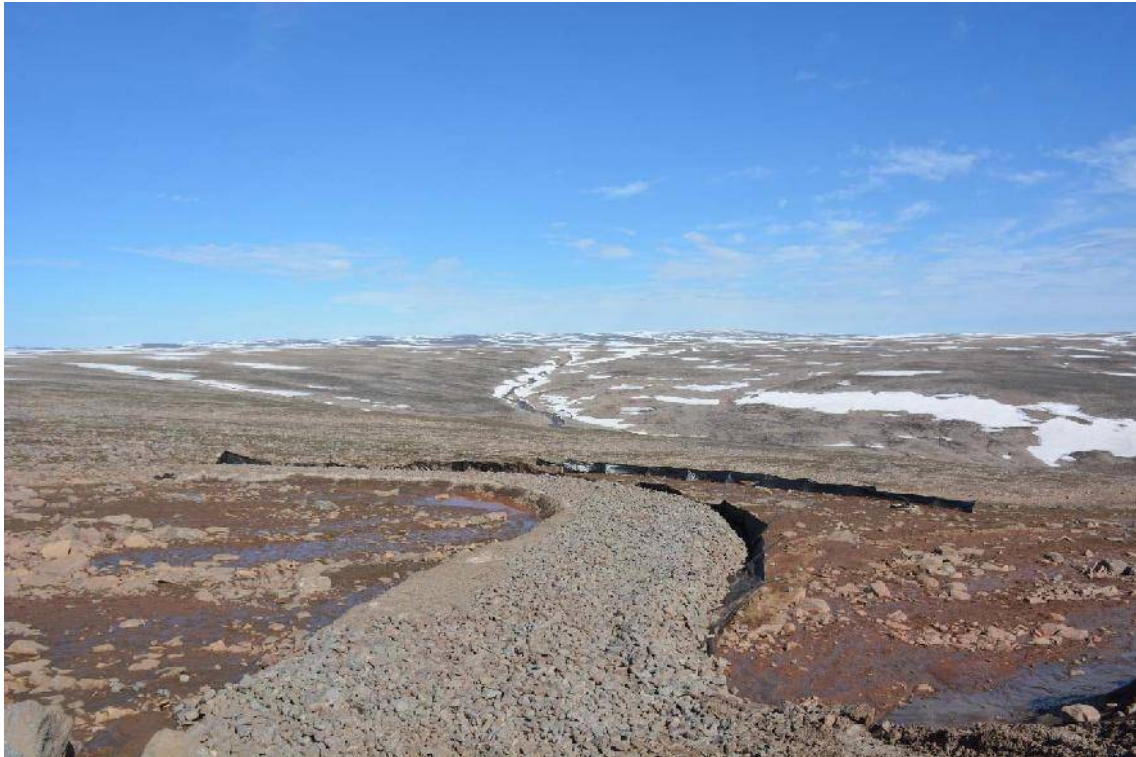
Photo 1– Checkdam #5 constructed at Km 108.5. Picture taken on July 5, 2016.

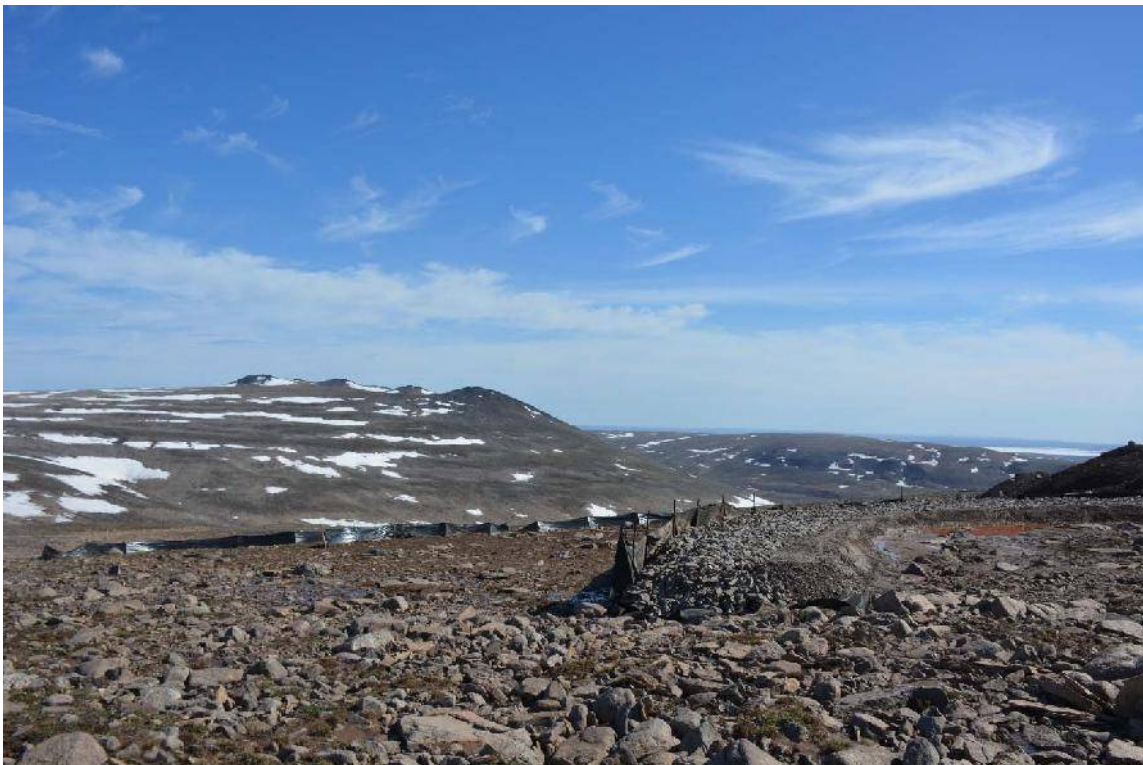
Photo 2 – Silt Fences and Checkdam #5 at Km 108.5. Picture taken on July 5, 2016.

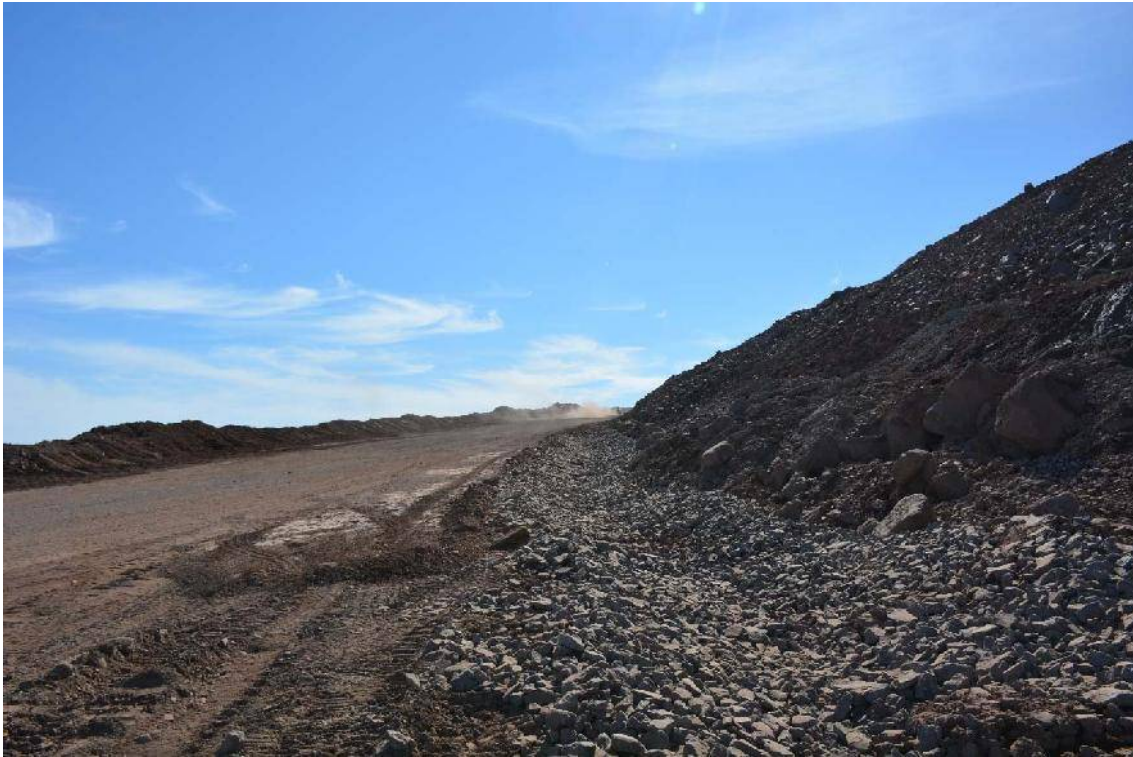
Photo 4 - New ditch with geotextile and rip rap up from Km 108.5. Picture taken on July 5, 2016

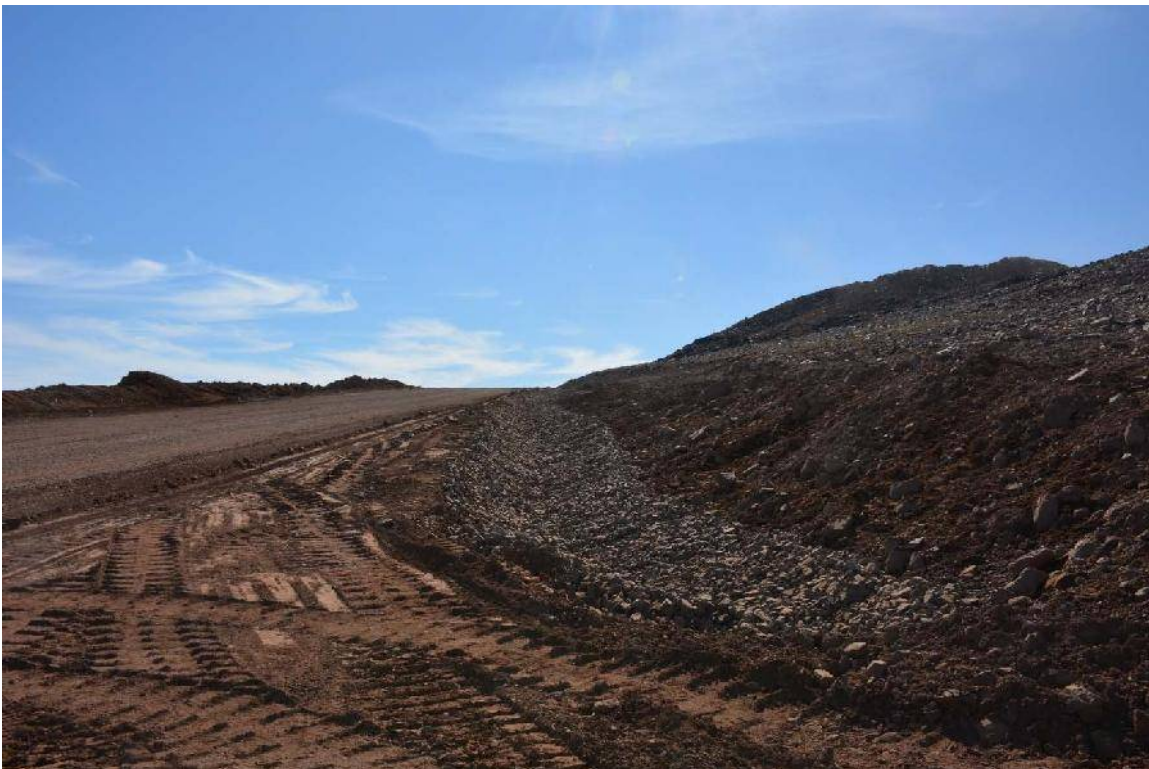
Photo 4 - New ditch with geotextile and rip rap at downhill from Km 108.5. Picture taken on July 5, 2016

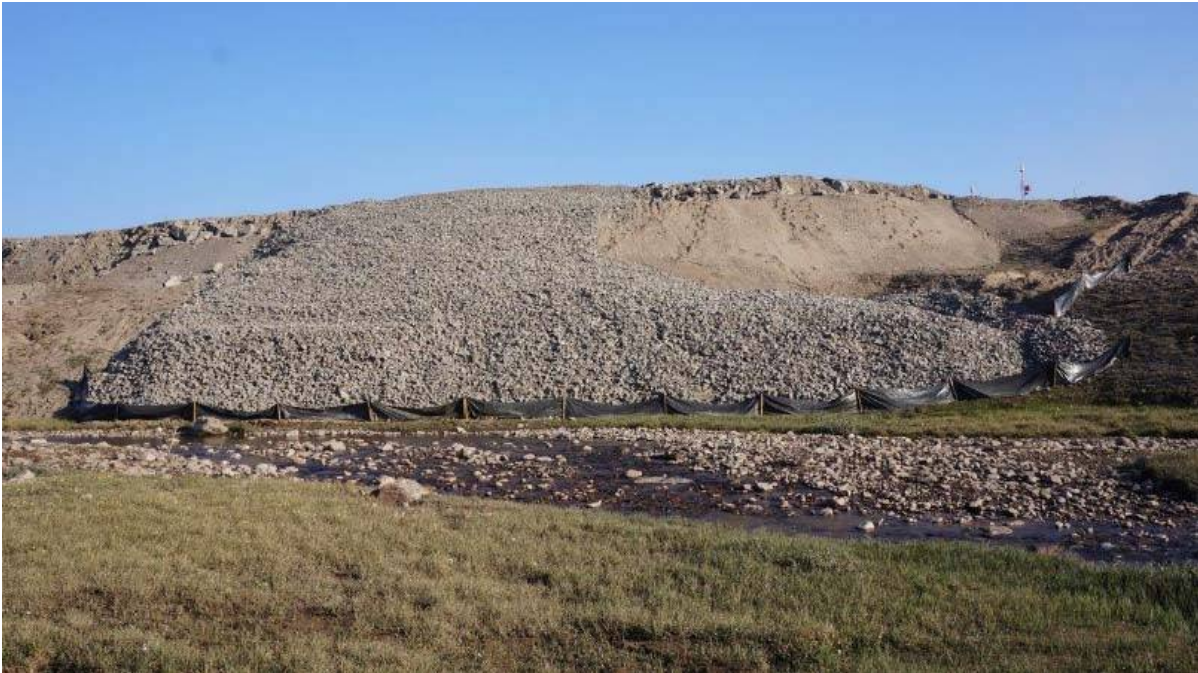
Photo 1 – Update on stable slope face by Camp Lake Tributary #1. Picture taken on July 7, 2016

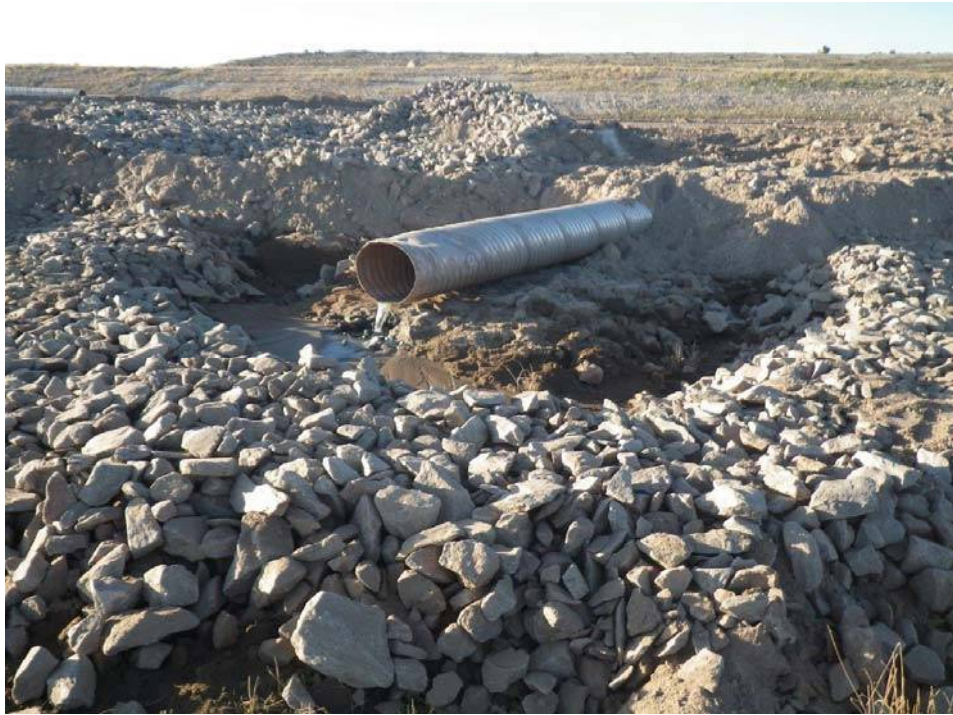
Photo 1 – BG-31. New culvert installation at Km 82 reduces siltation downstream

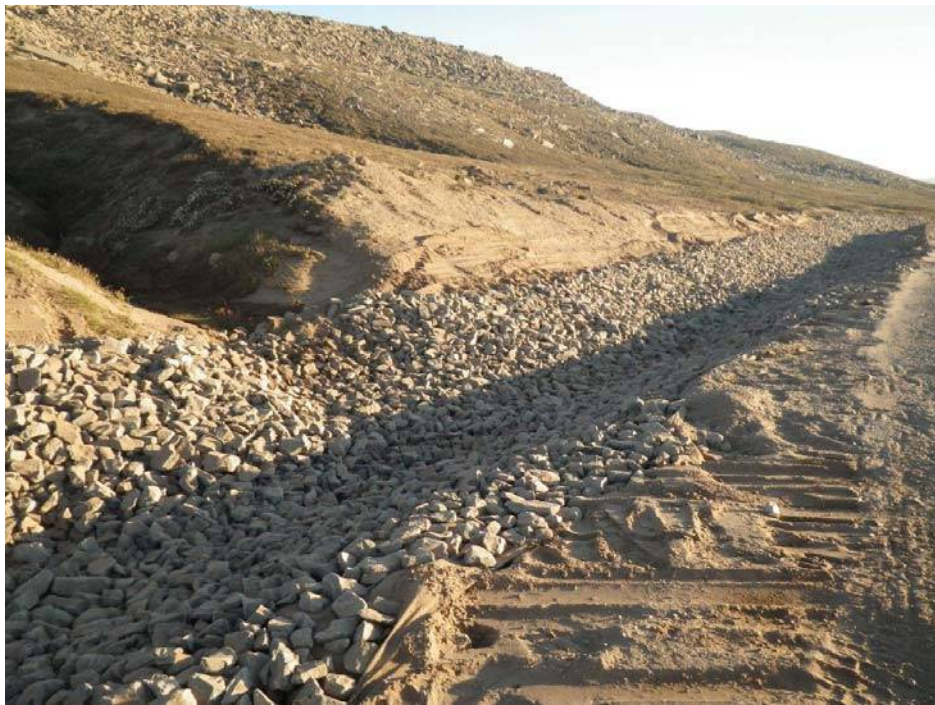
Photo 4- Rip rap in ditch at Km 85

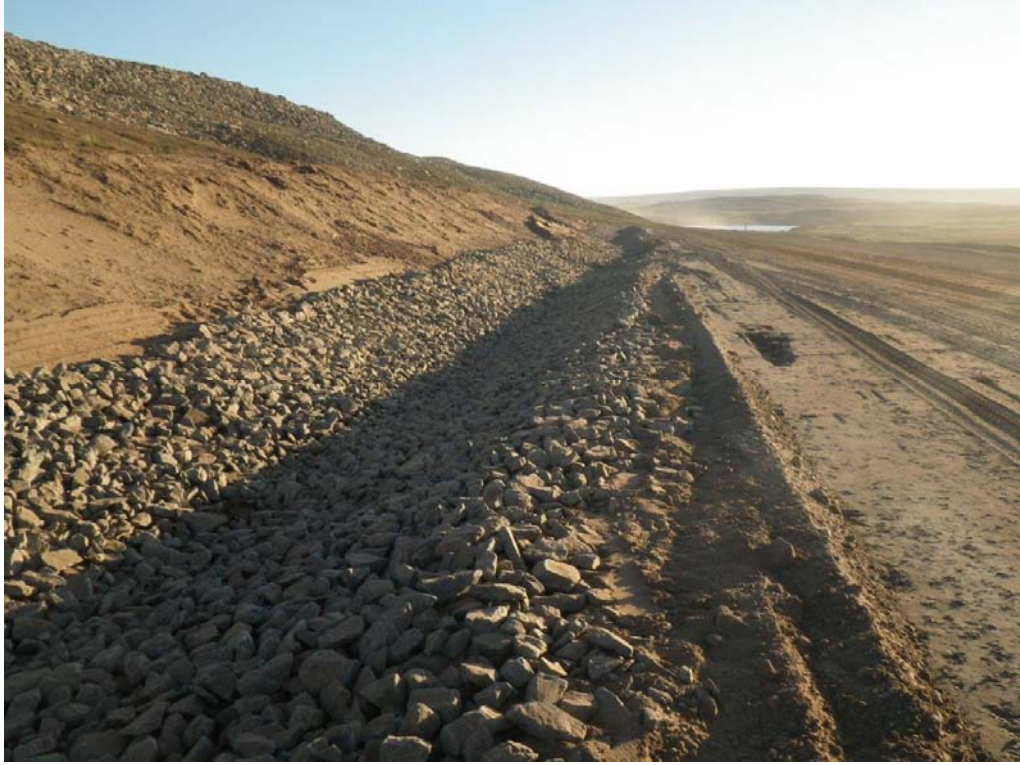
Photo 5: Rip rap in ditch at Km 85

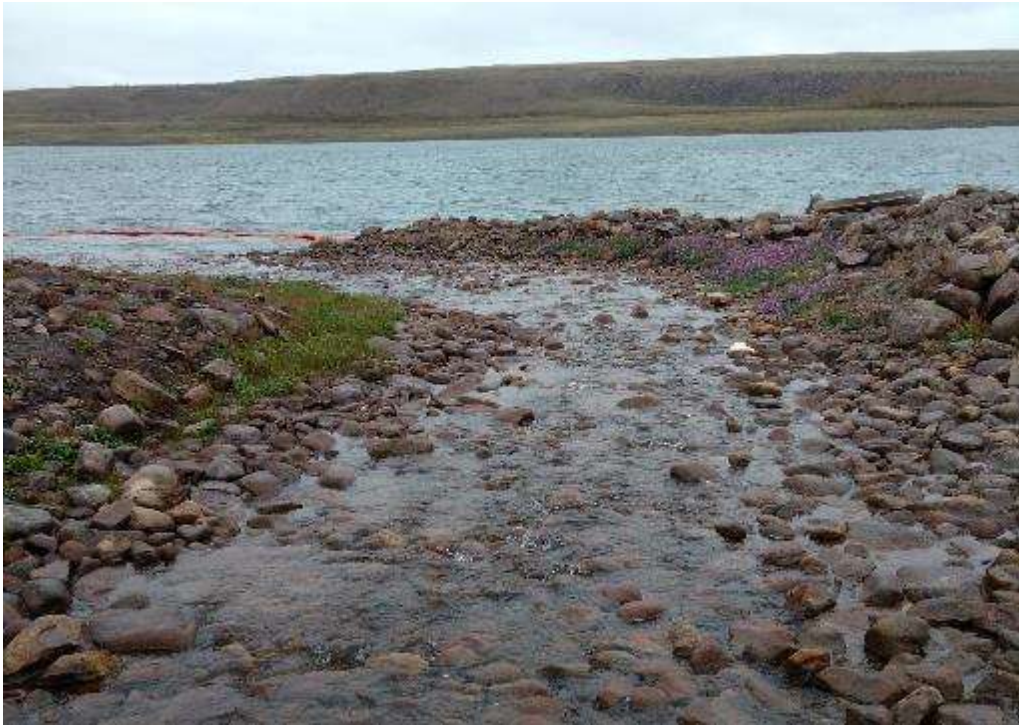
Photo 1 – Outlet at Sheardown Lake Tributary on July 19, 2016

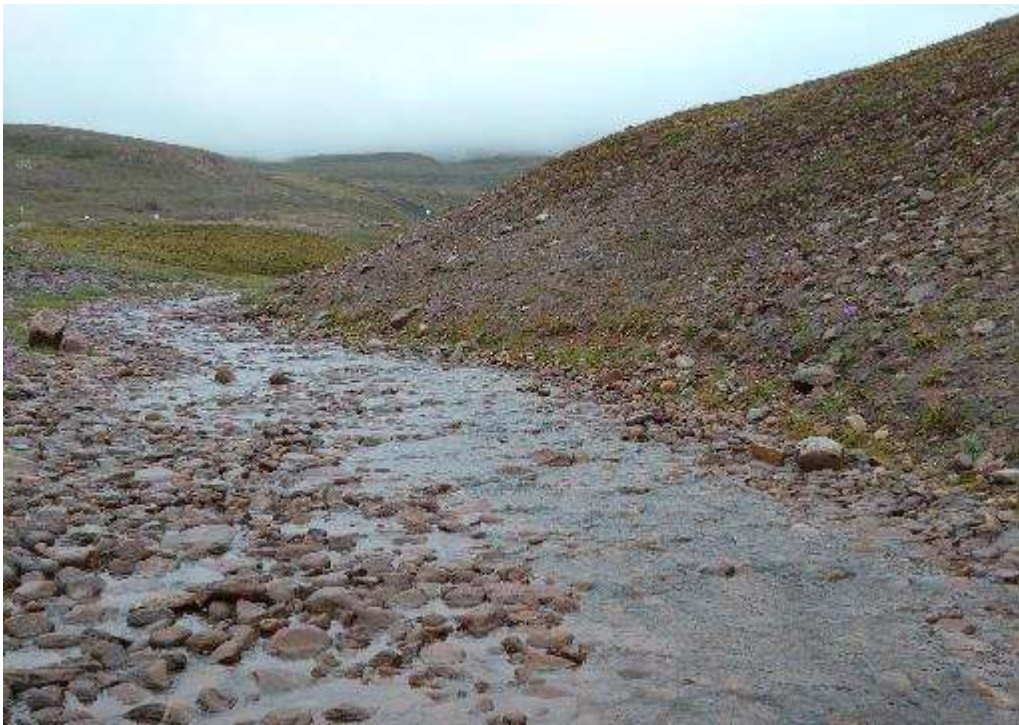
Photo 2 – Upstream at Sheardown Lake Tributary on July 19, 2016

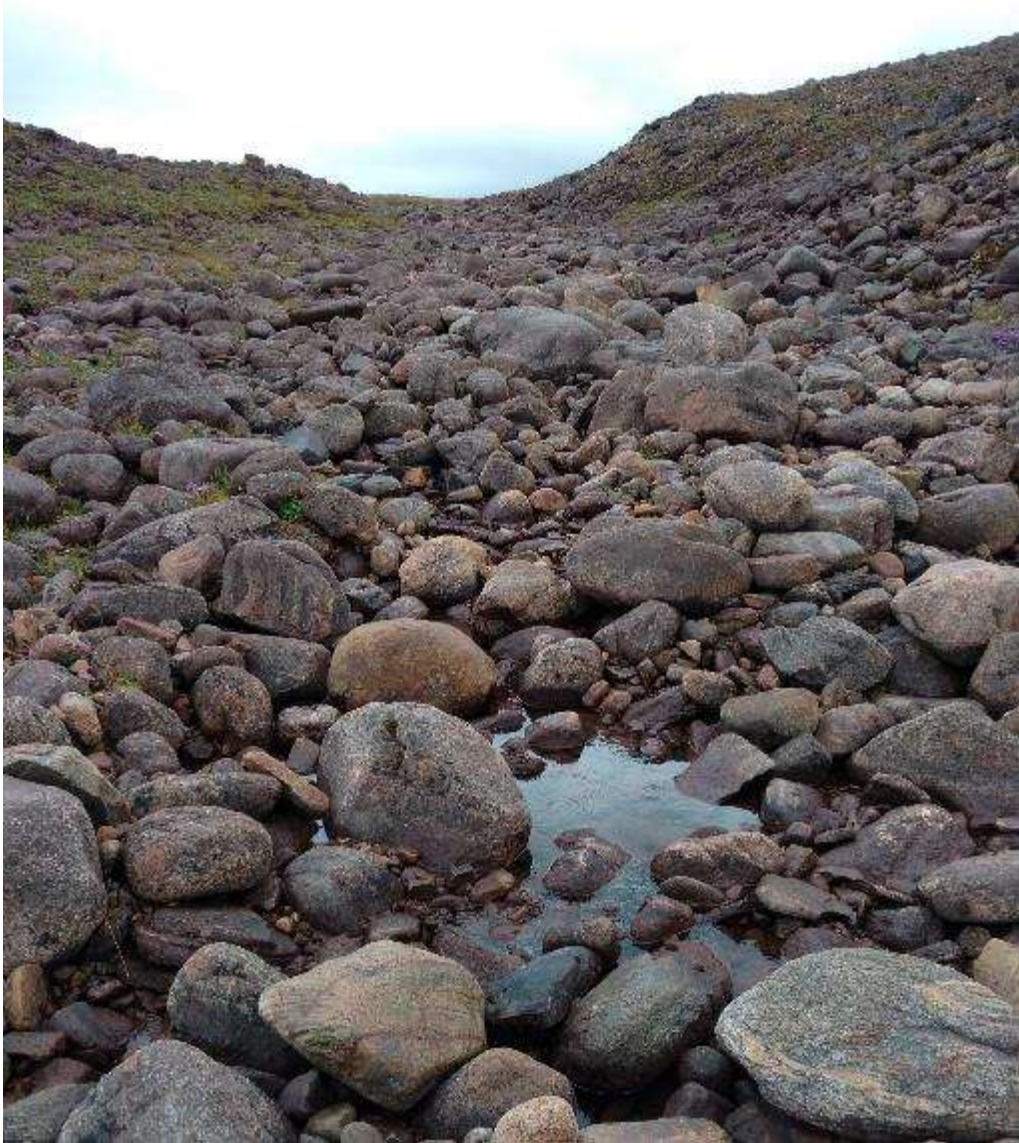
Photo 3 – Flow conditions at Landfill Gate Tributary on July 19, 2016

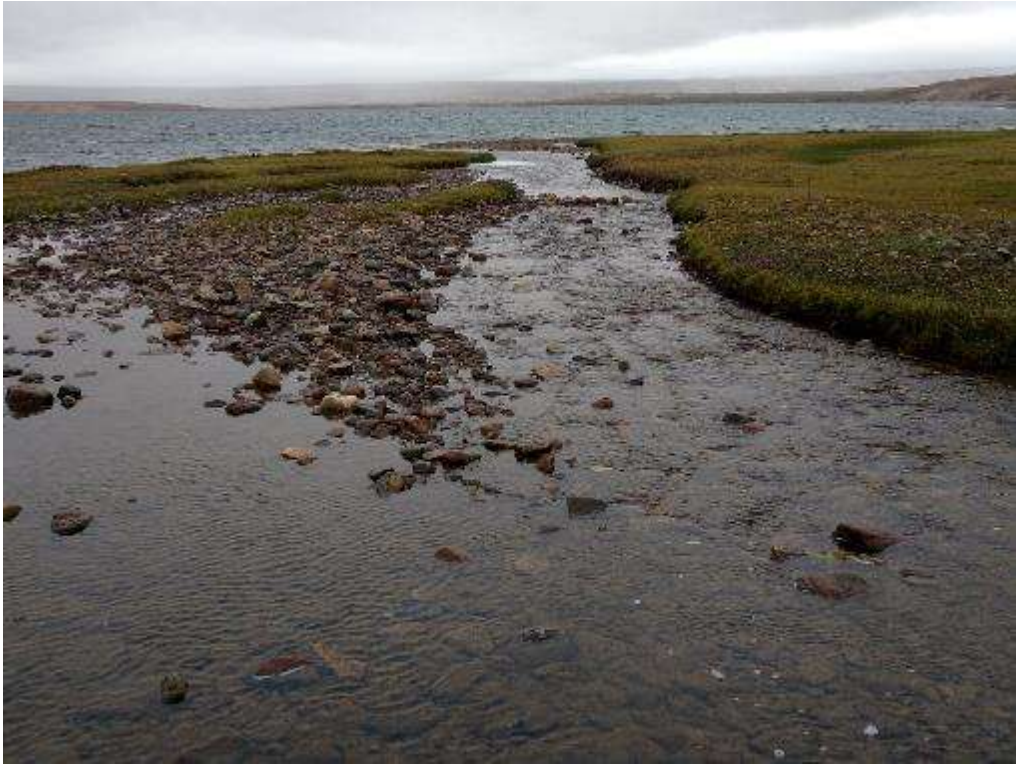
Photo 1 – Camp Lake Tributary #1 on July 19, 2016

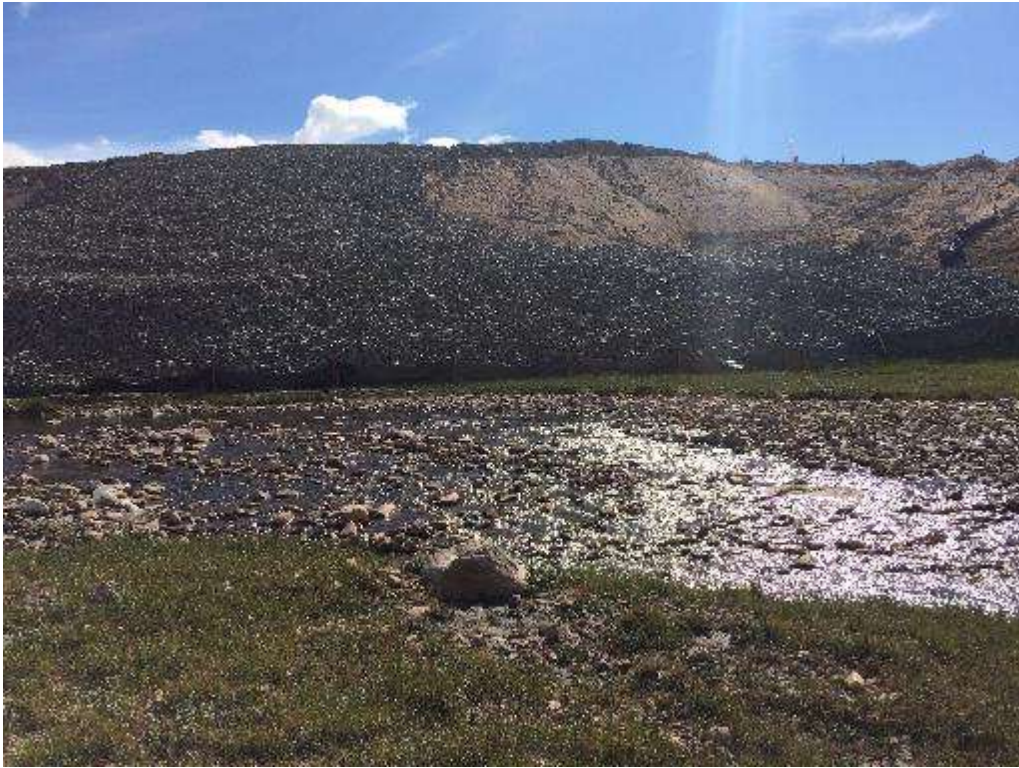
Photo 1 – Update on stable slope face by Camp Lake Tributary #1 on July 22, 2016.

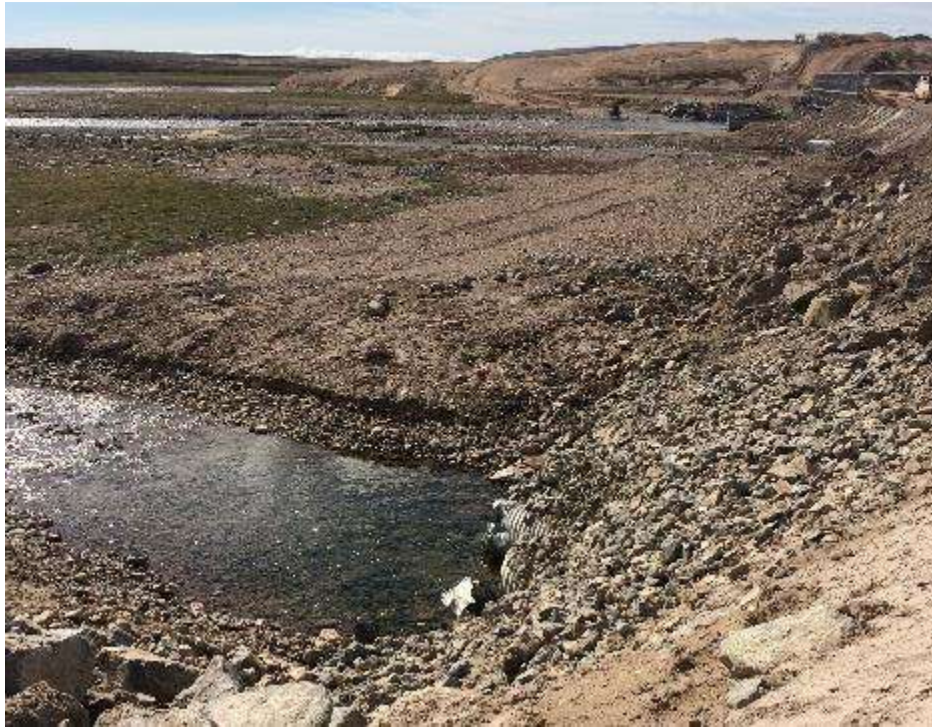
Photo 1 – Water flowing downstream of CV223 on July 22, 2016

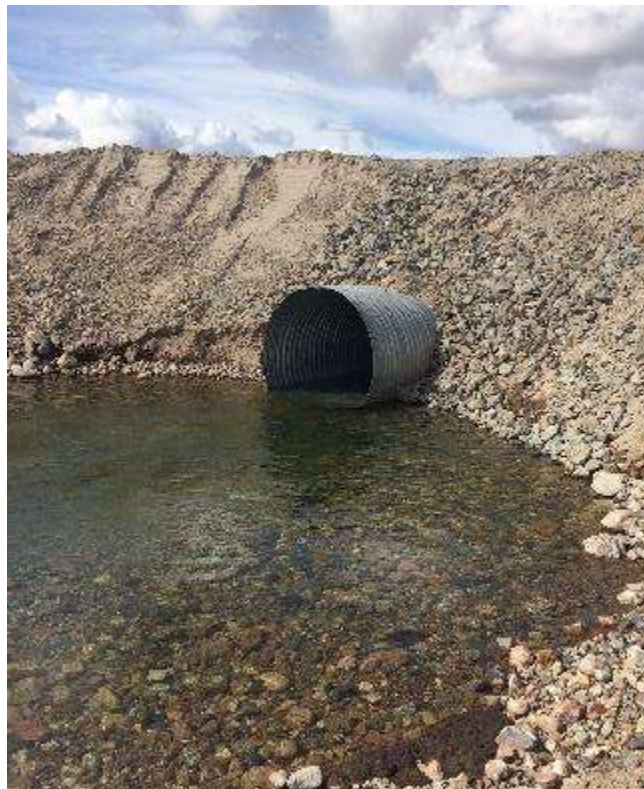
Photo 2 – Outlet of CV223 with armoured slope on July 22, 2016

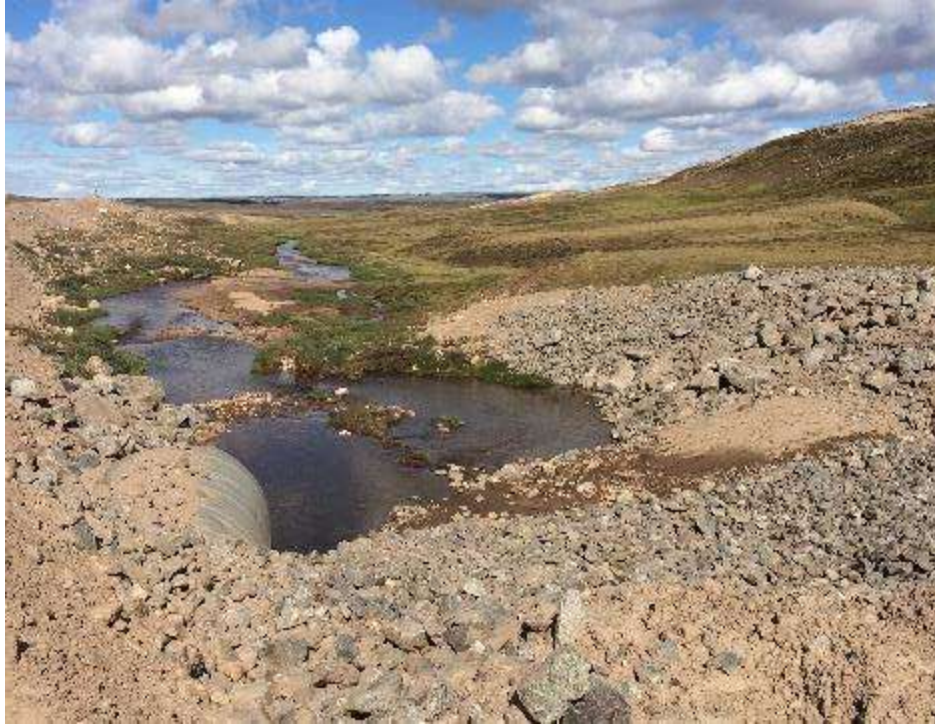
Photo 3 – Clear flow at outlet of BG-17 with armoured banks on July 22, 2016

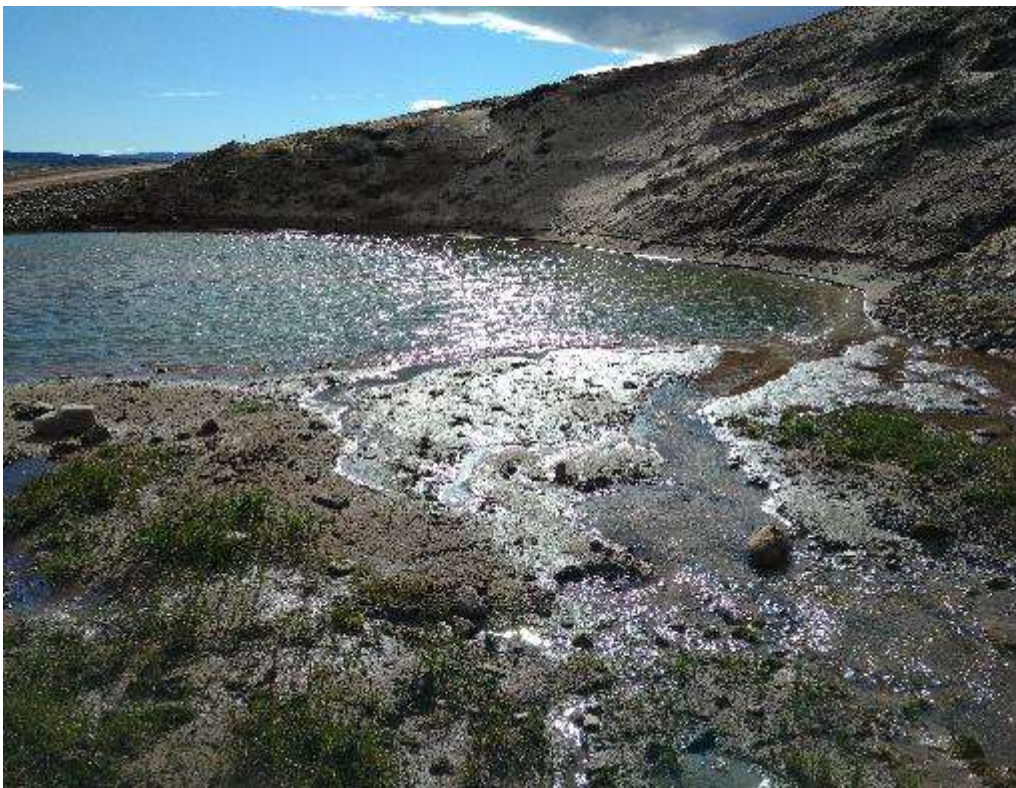
Photo 4 – Outlet of BG-28 flowing clear on July 17, 2016

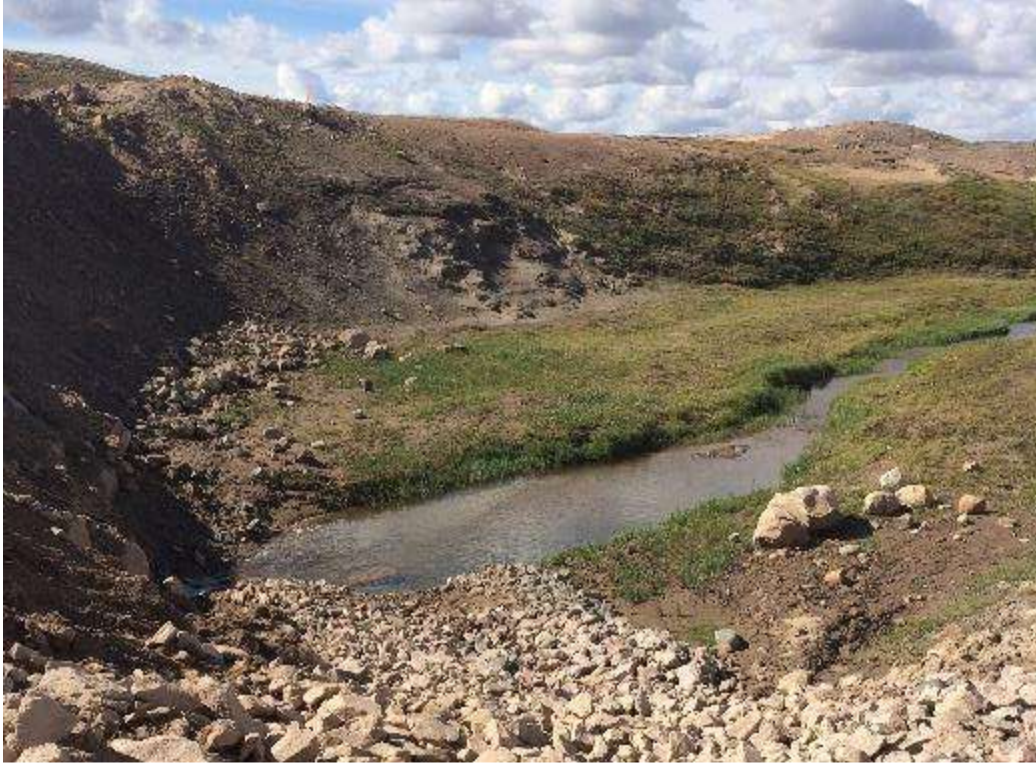
Photo 5 – BG-29 flowing clear at outlet on July 22, 2016

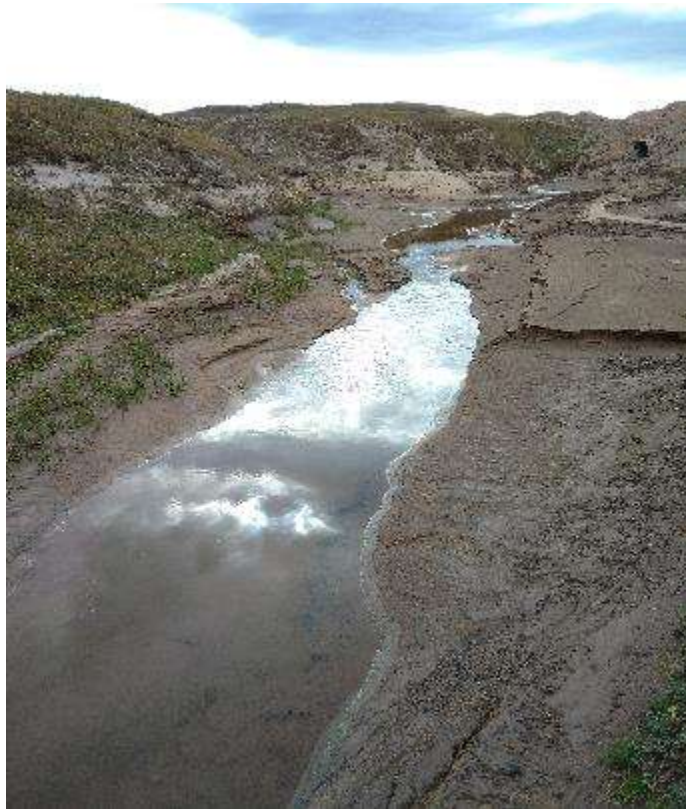
Photo 6 – BG -31 flowing clear downstream of culvert on July 17, 2016

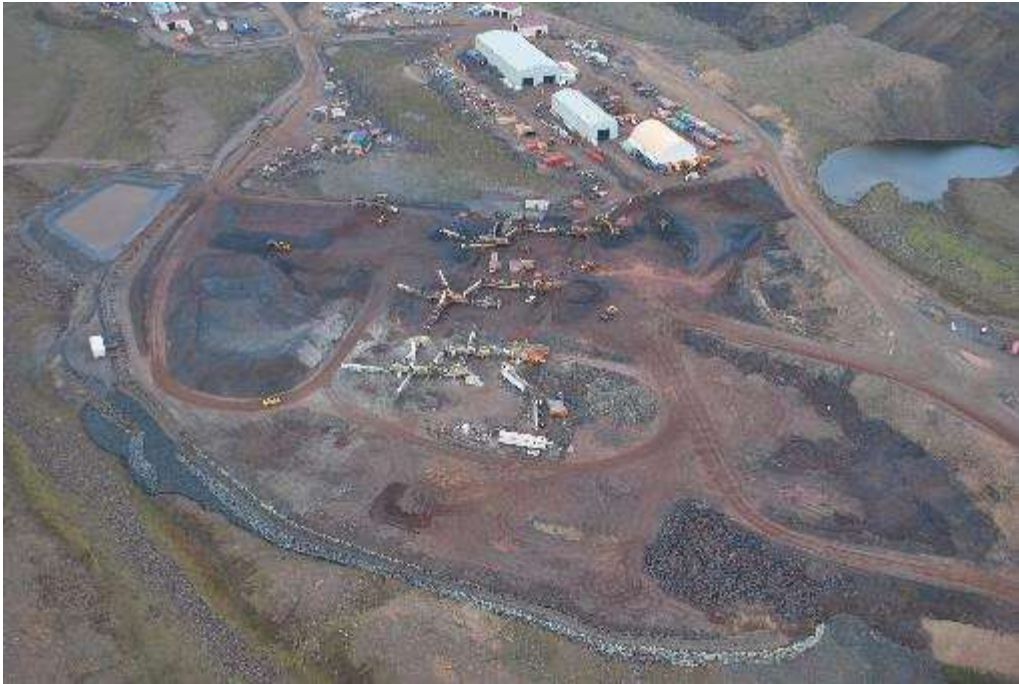
Photo 1 – Aerial view of completed ditch work at the Mine Site Crusher Pad on July 18, 2016

In the case of the Milne Ore Pad and the Mine Site Ore Pad drainage and collection systems, construction of ditch systems were completed by June 15 and July 15, respectively. As of those dates, the ditching systems were functional and currently performance is under observation and evaluation. Construction Summary Reports (CSRs) for the facilities are currently in preparation and will be submitted to the Nunavut Water Board within three months after the substantial completion of construction.

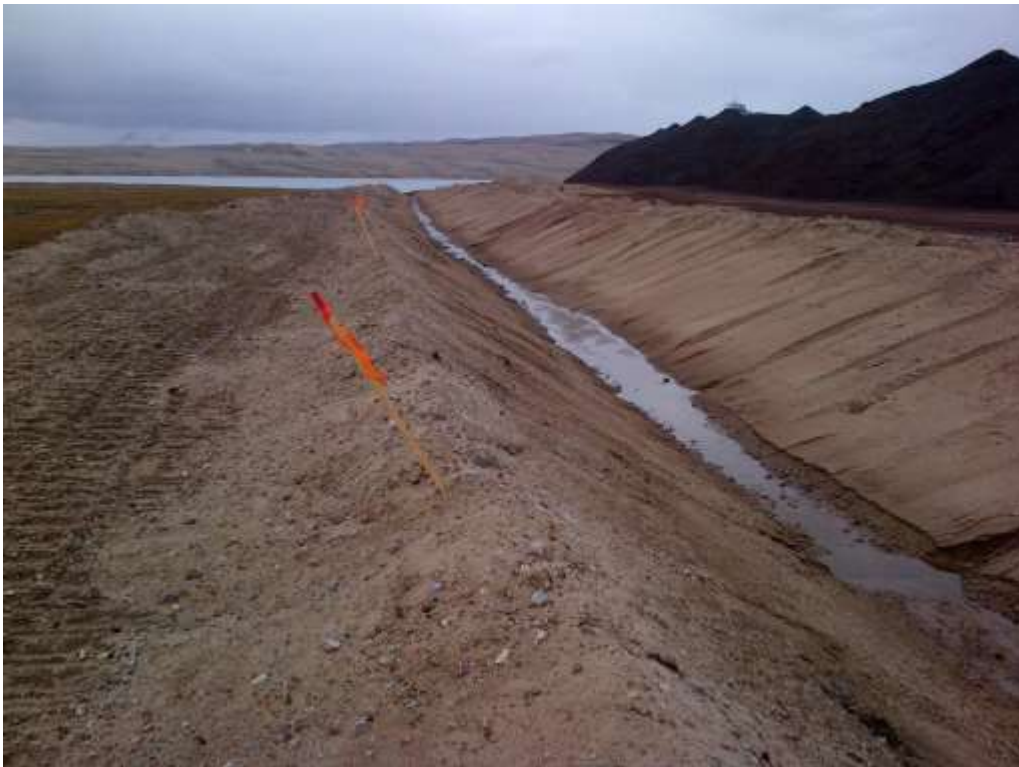
Photo 2 – Completed ditch work at the Milne Port Ore Pad on July 18, 2016

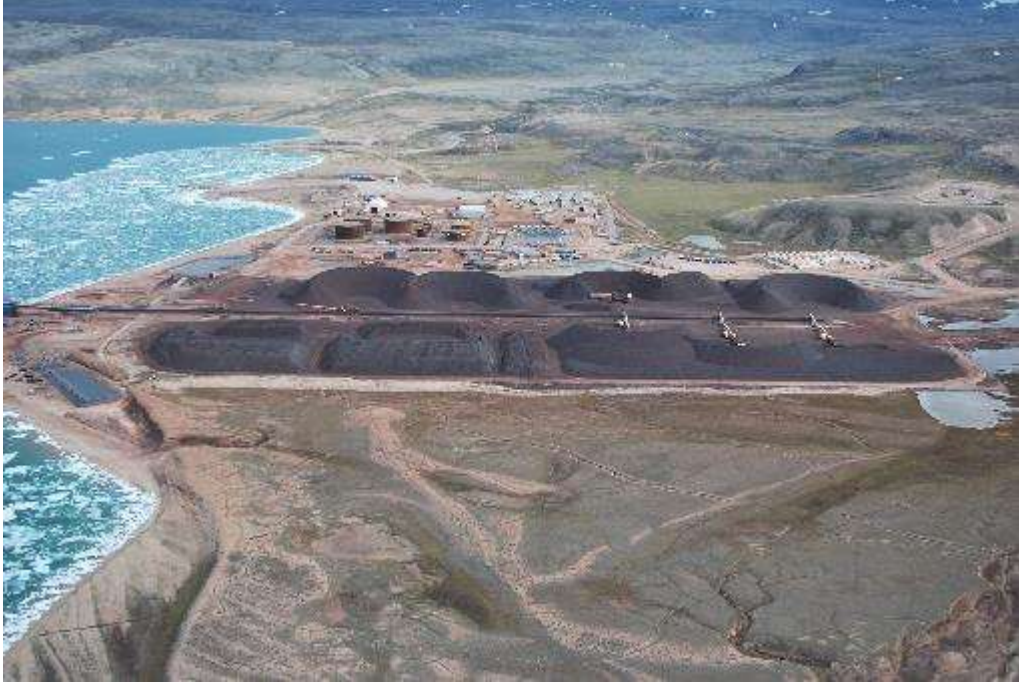
Photo 3 – Aerial view of completed ditch work at the Milne Port Ore Pad on July 18, 2016

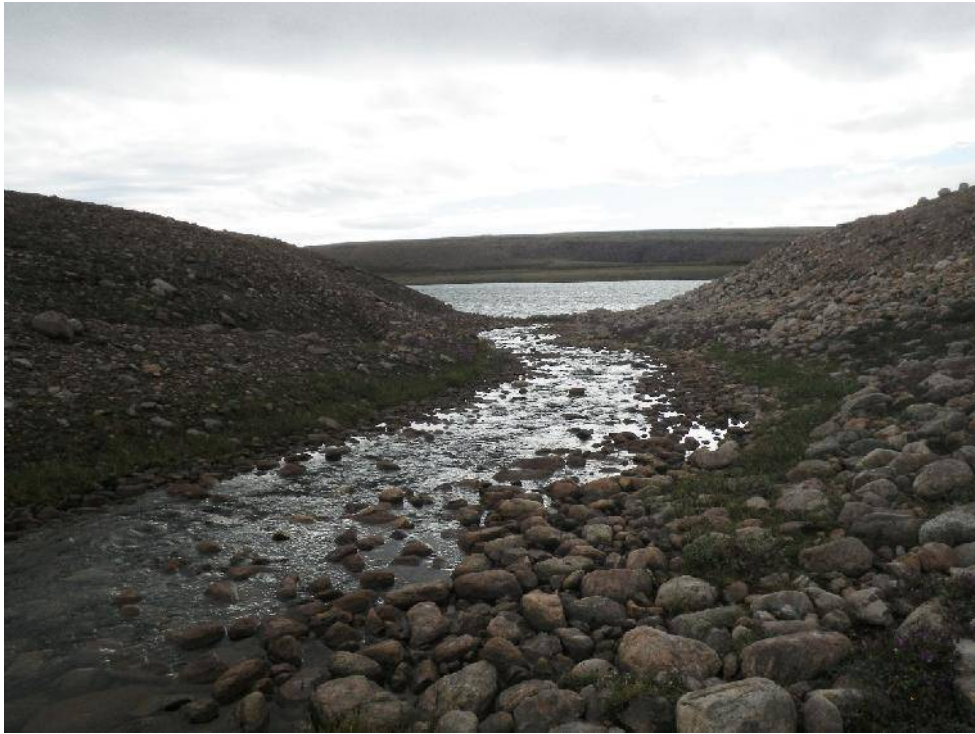
Photo 1 – Outlet at Sheardown Lake Tributary on July 25, 2016

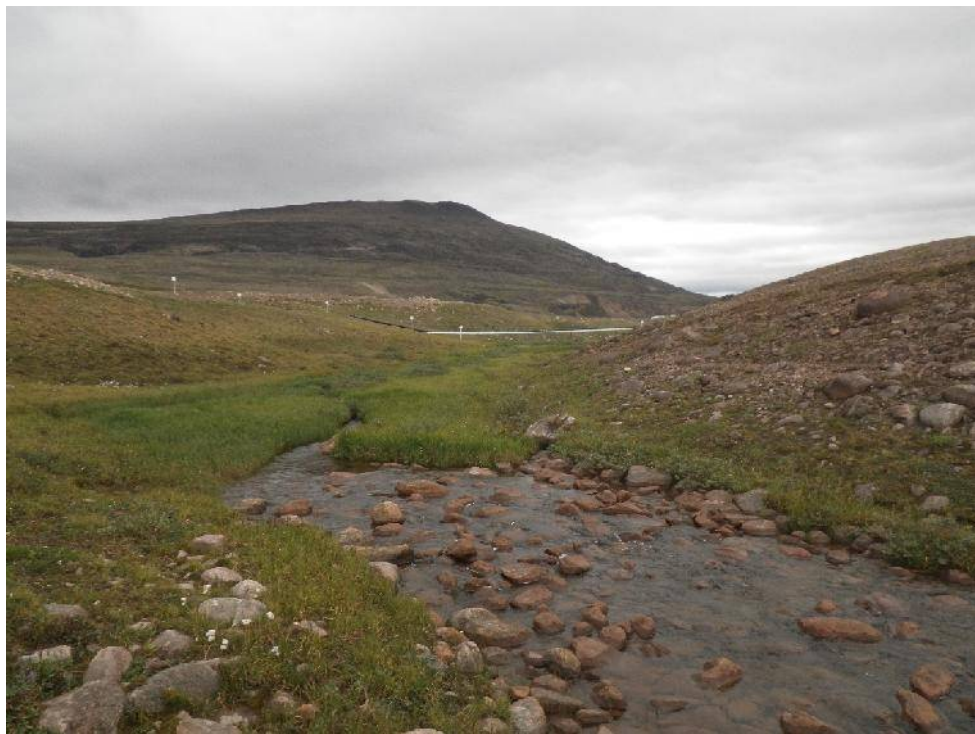
Photo 2 – Upstream at Sheardown Lake Tributary on July 25, 2016

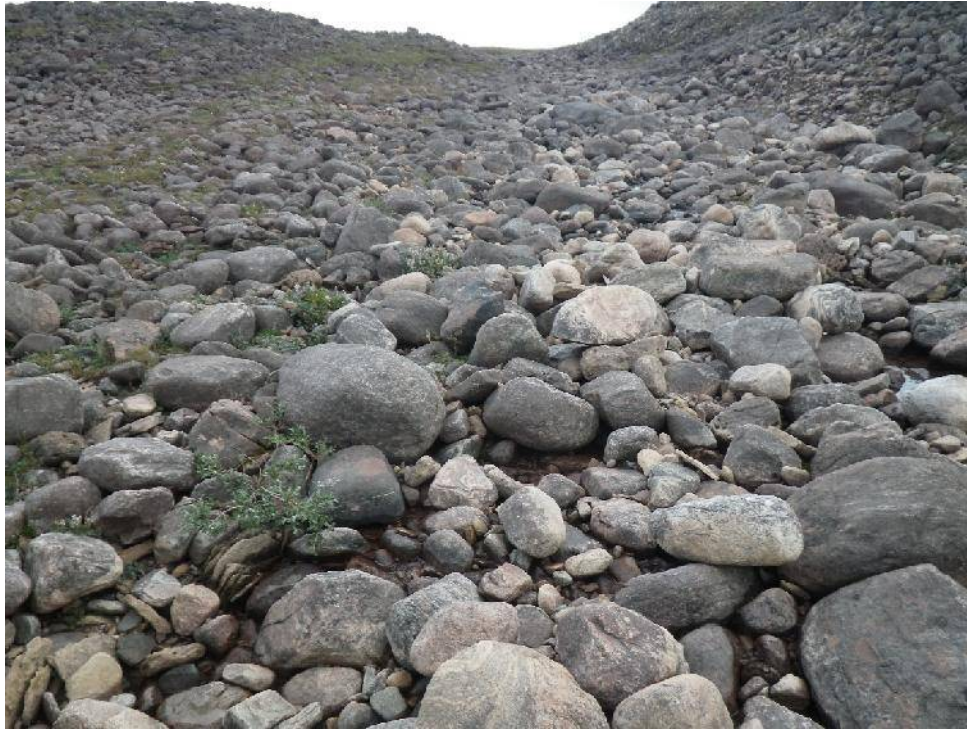
Photo 3 – Flow conditions at Landfill Gate Tributary on July 25, 2016

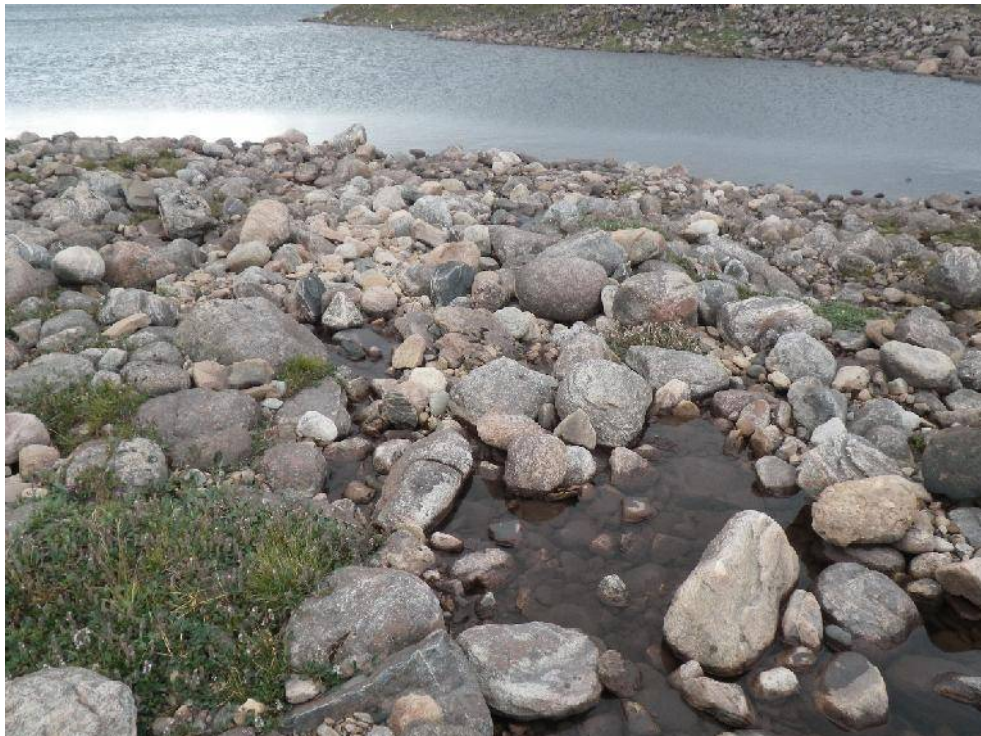
Photo 4 – Outlet at Landfill Gate Tributary on July 25, 2016

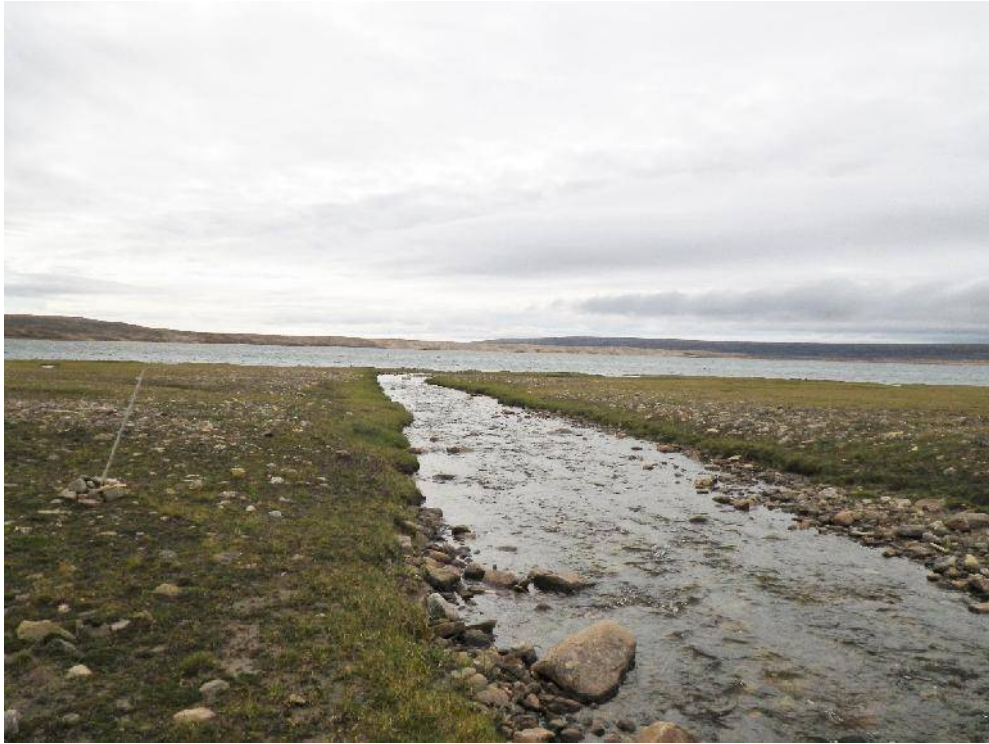
Photo 1 – Camp Lake Tributary #1 on July 25, 2016
