Appendix C.2 – Photos

**June 7th 2016, Fisheries Act Direction (File number: 4408-2016-05-10-001) and
Response to June 16, 2016, INAC Letter of Non-Compliance
Bi-Weekly Report No. 2 for Period July 9 to July 22, 2016**

**June 7th 2016, Fisheries Act Direction (File number: 4408-2016-05-10-001) and
Response to June 16, 2016, INAC Letter of Non-Compliance
Bi-Weekly Report No. 3 for Period July 23 to August 5, 2016**

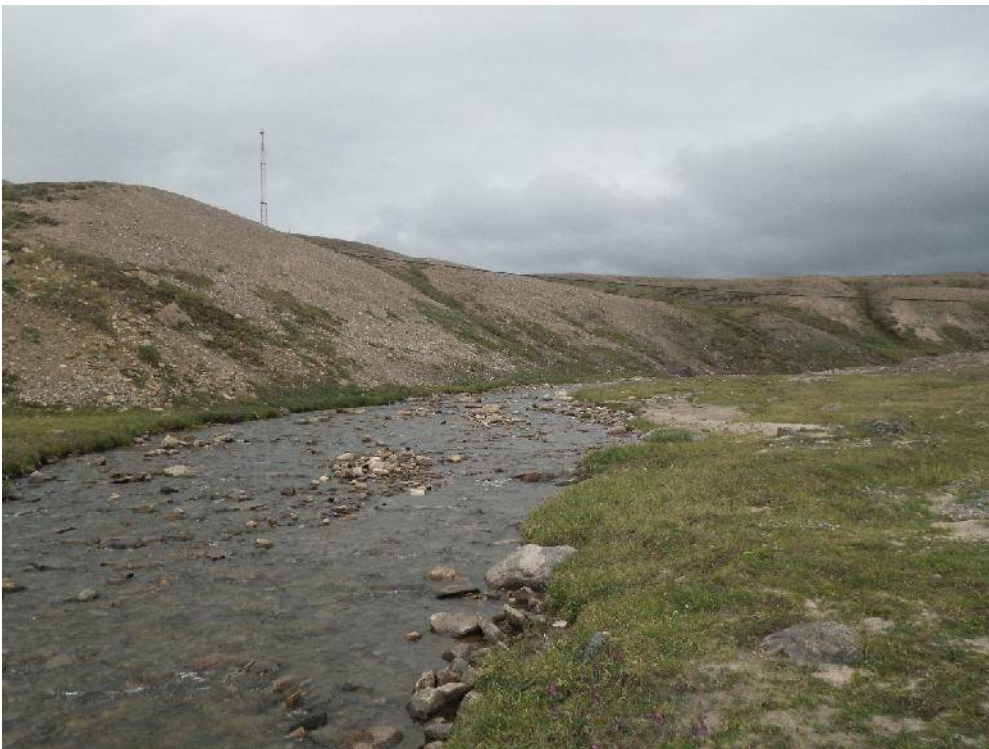
Photo 2 – Upstream Camp Lake Tributary #1 on July 25, 2016

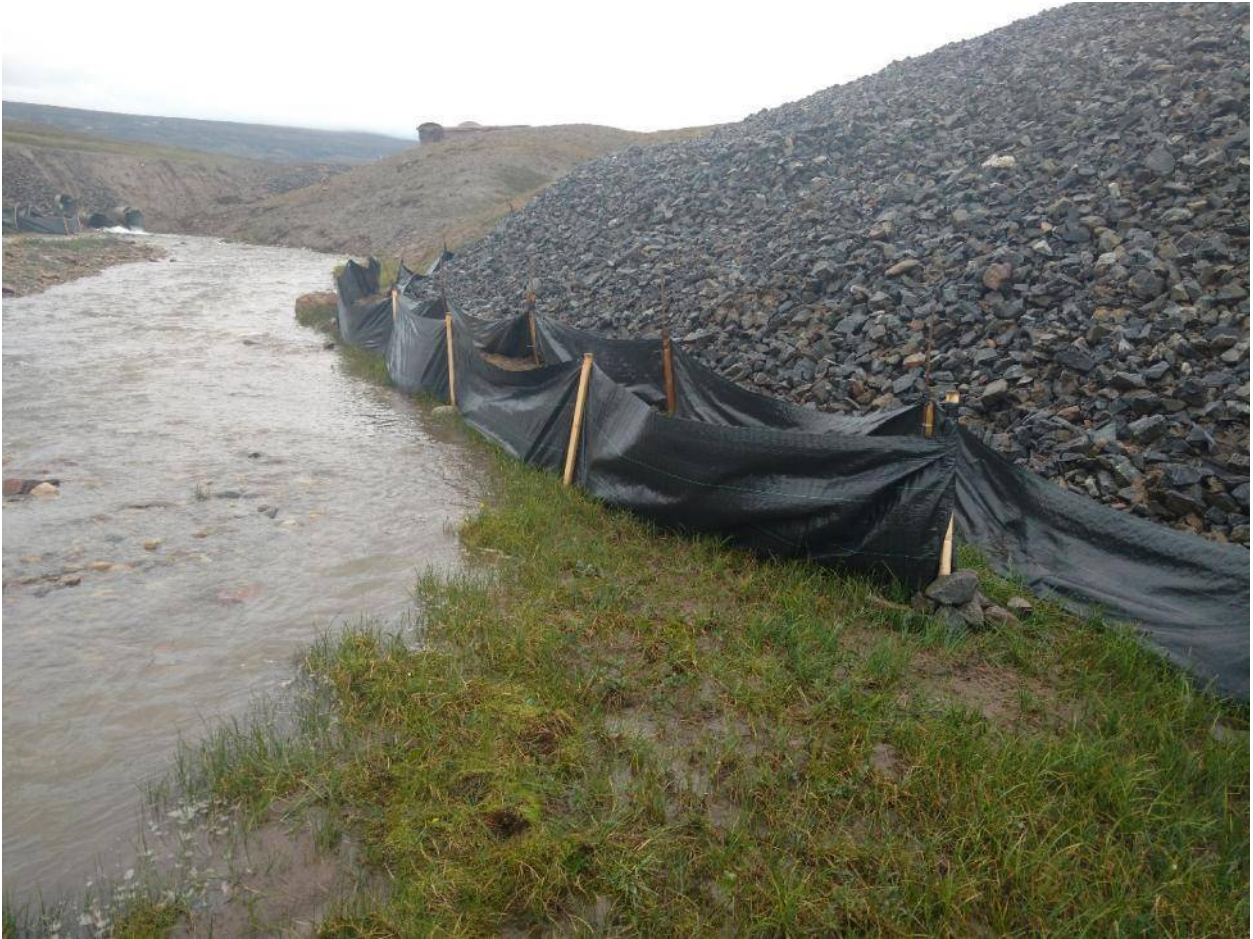
Photo 1 – Update on stable slope face by Camp Lake Tributary #1 on August 1, 2016.
