**APPENDIX E.8.7.2**  
**INITIAL AND FOLLOW UP SPILL REPORTS**  
**OTHER**  
**(Part 3)**

**Re: Follow-up to Spill #17-253- Reported on July 13<sup>th</sup>, 2017**  
**Mary River Project - Water Licence No. 2AM-MRY1325**

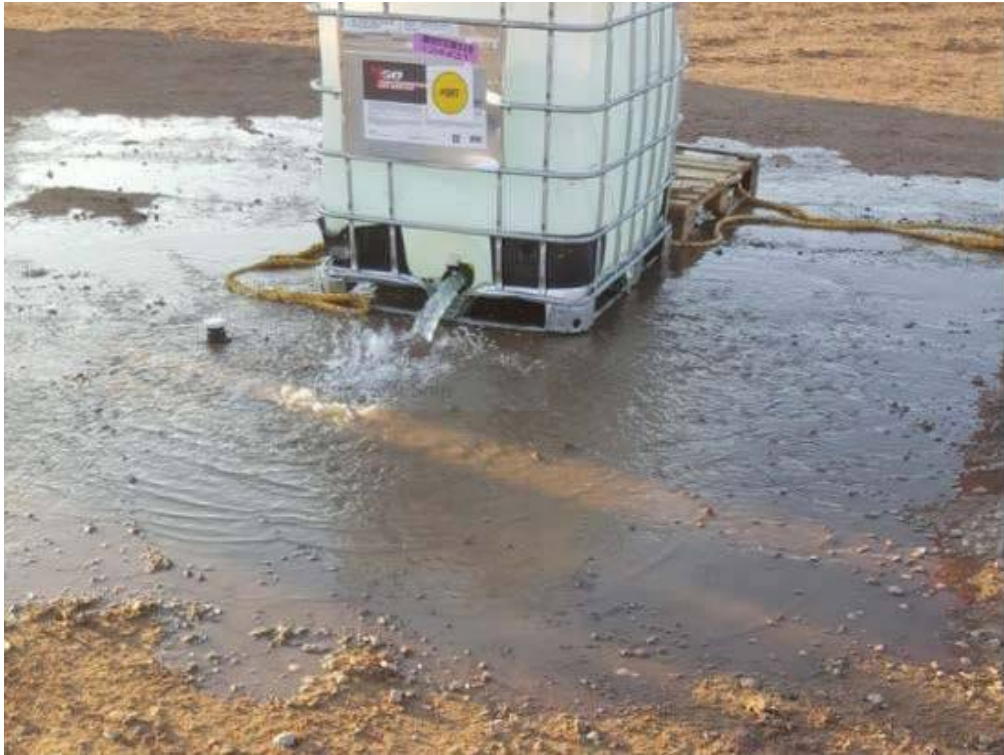
On September 3, 2017 at 07:30, a loader operator was handling DEF totes to load on a trailer. One of the Totes had come off the ship on its side on top of a skid. The tote was leaking from the top lid. When the tote was turned upright, the bottom valve burst and DEF started to leak rapidly until it was flipped back onto its side. Approximately half the contents leaked on the ground surface (~500 L). Absorbent pads, booms and rags were immediately placed around the spill and spill trays were placed under the tote. The location of the spill was more than 150 metres from any water body.

Figure -1 Material Leaving Tote

Spill booms and spill pads were placed on to the grounds surface and contained the spill. The tote was immediately moved upside down to stop the leak. Coordination with other departments assisted with the removal of the contaminated soil and deposited within our land farm. Clean material/ aggregate was brought in to fill the excavated area.

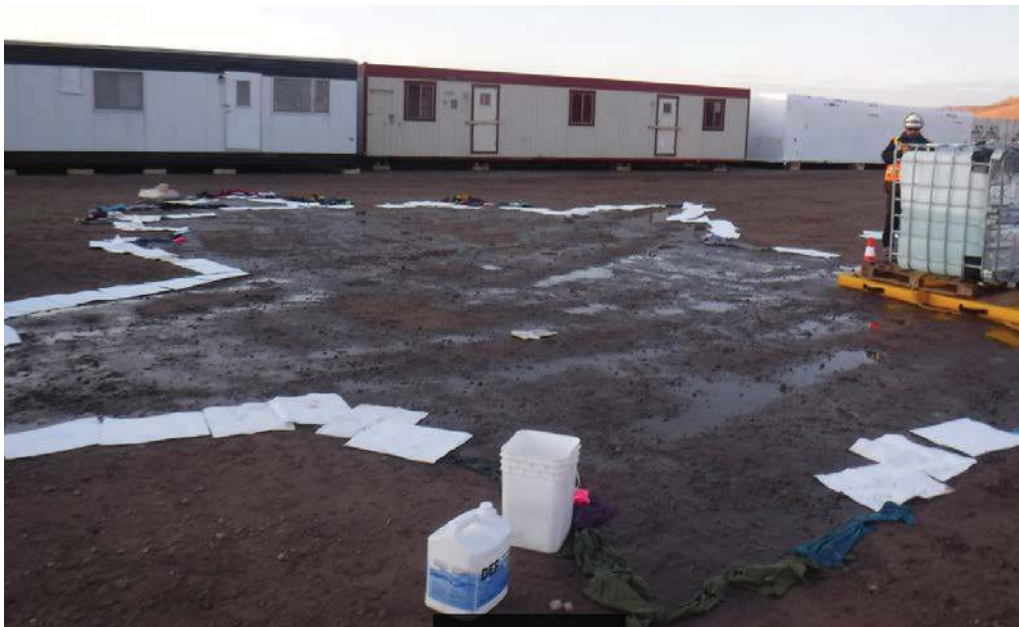
Figure 2 – Stop / Prevent further Plume

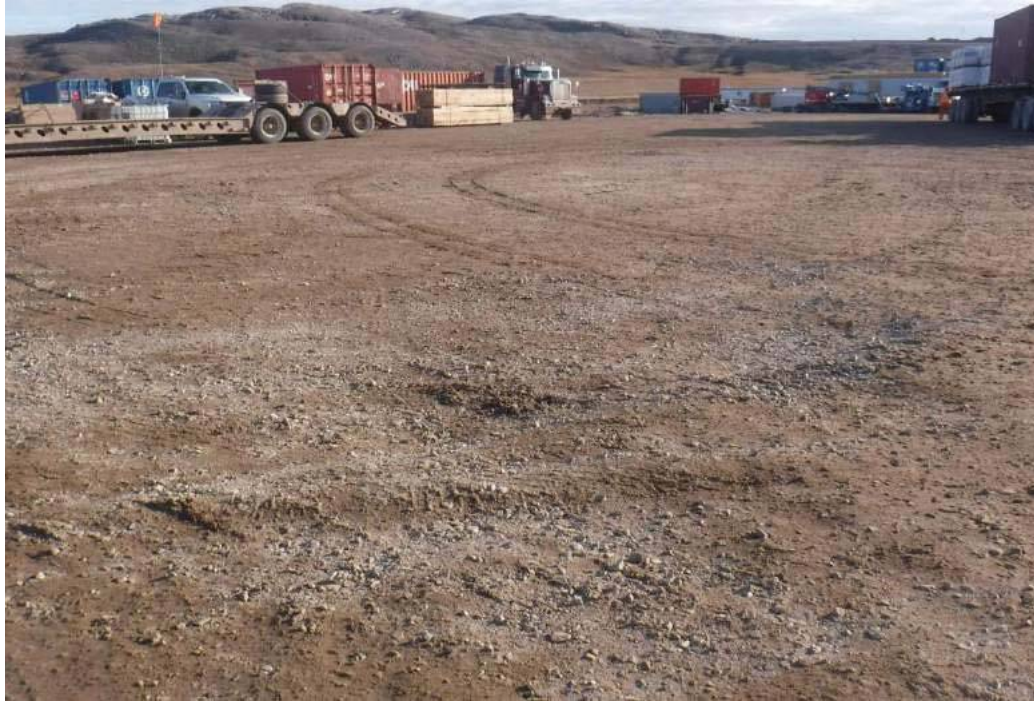
Figure 3: Soil Excavated and clean fill replaced and leveled.

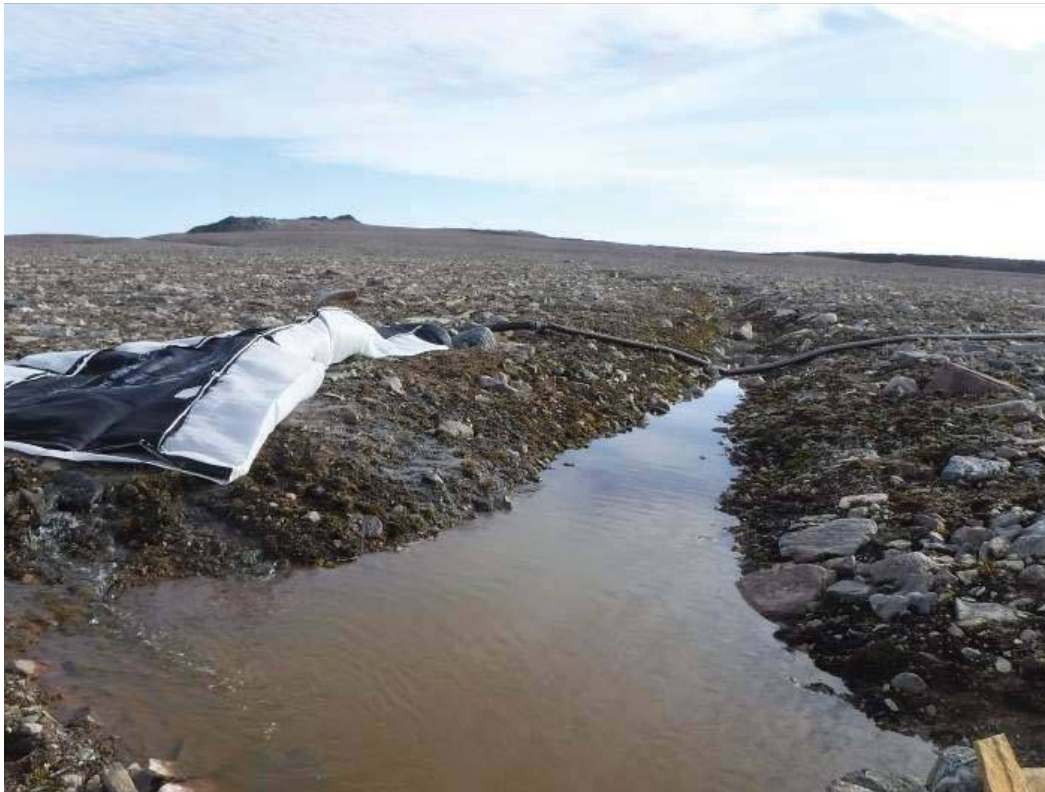
**Photo 1: Geotube filtration system downstream of the FDP on the discharge line installed to mitigate TSS exceedances**

- Conduct a detailed hydrologic review to determine the appropriate capacity or required increase in dimensions for the WRSP. Golder Associates Inc is currently conducting the a review.
- Initiate a geochemical review of the waste rock dump layout and materials to develop a better understanding of low pH conditions observed on site and, if necessary, develop supplemental mitigation measures to reduce or eliminate production of acidic water from entering the WRSP.
- Review and amend the Waste Rock Management Plan to provide contingency plans for the treatment of non-compliant water.

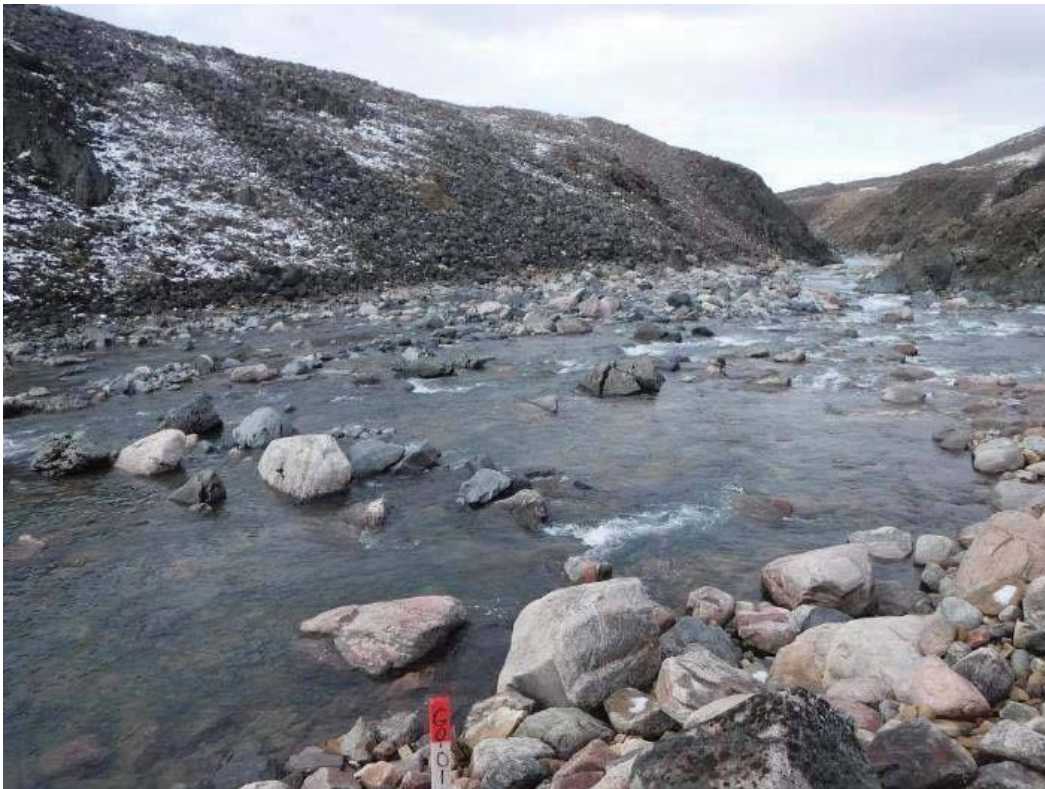
**Photo 2: Confluence of Tributary F, which receives MS-08 effluent, at Mary River**

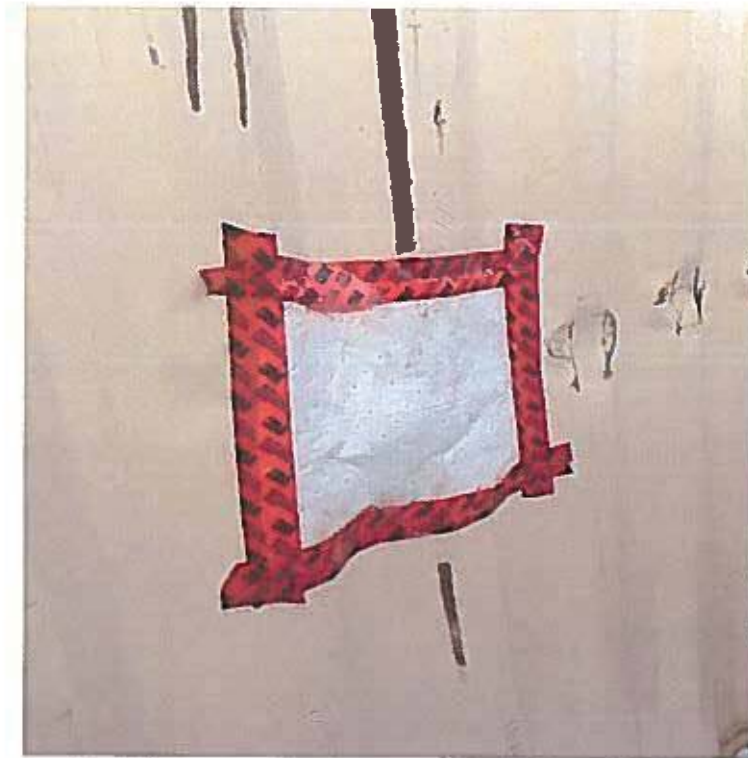
Photo 1: Sea-can puncture sealed with Absorbent Pad

The use of a spotter when moving materials in an environment where collisions are possible. Routine walk-around inspection of the work area for hazards.

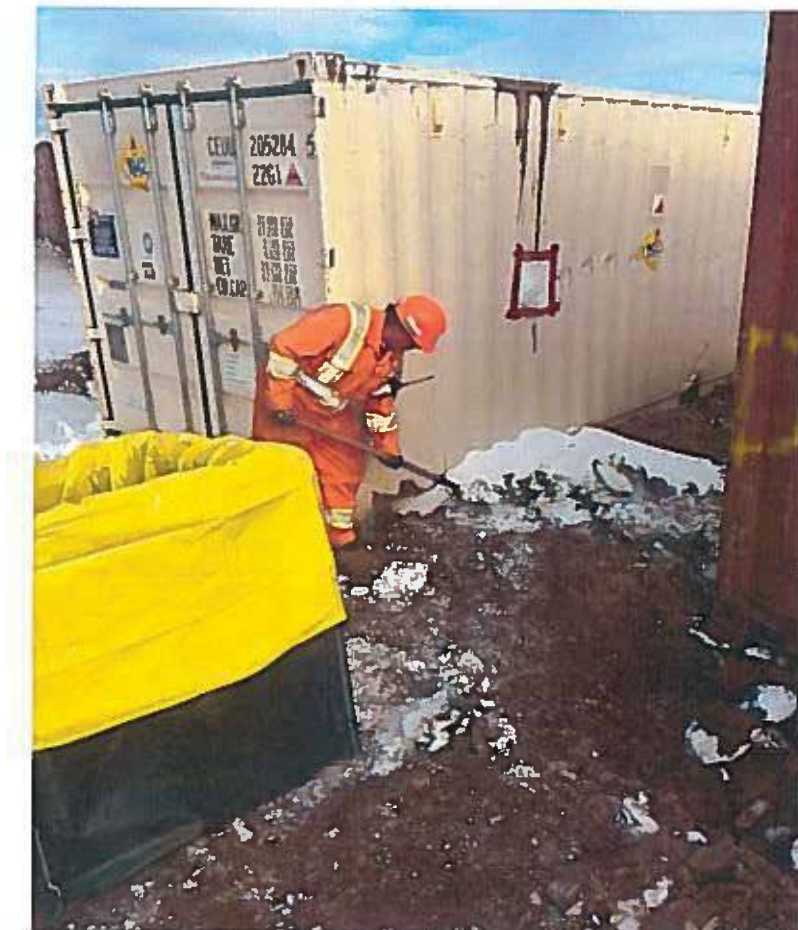
Photo 2: Ammonium Nitrate and contaminated soil being removed and placed into Quatrex bags

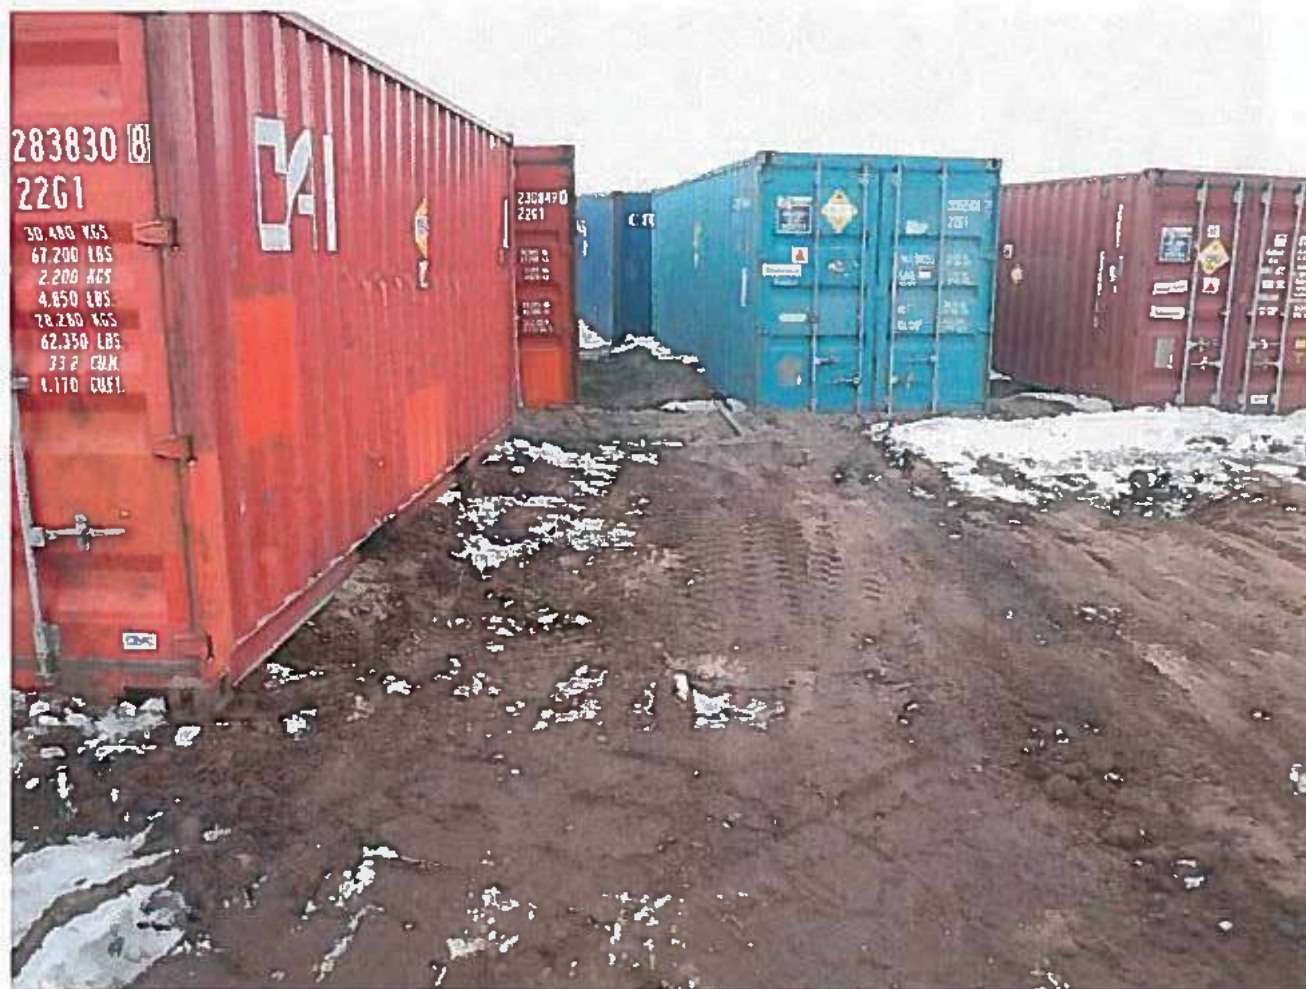
Photo 3: Ground after contaminated soil and sea-can removal

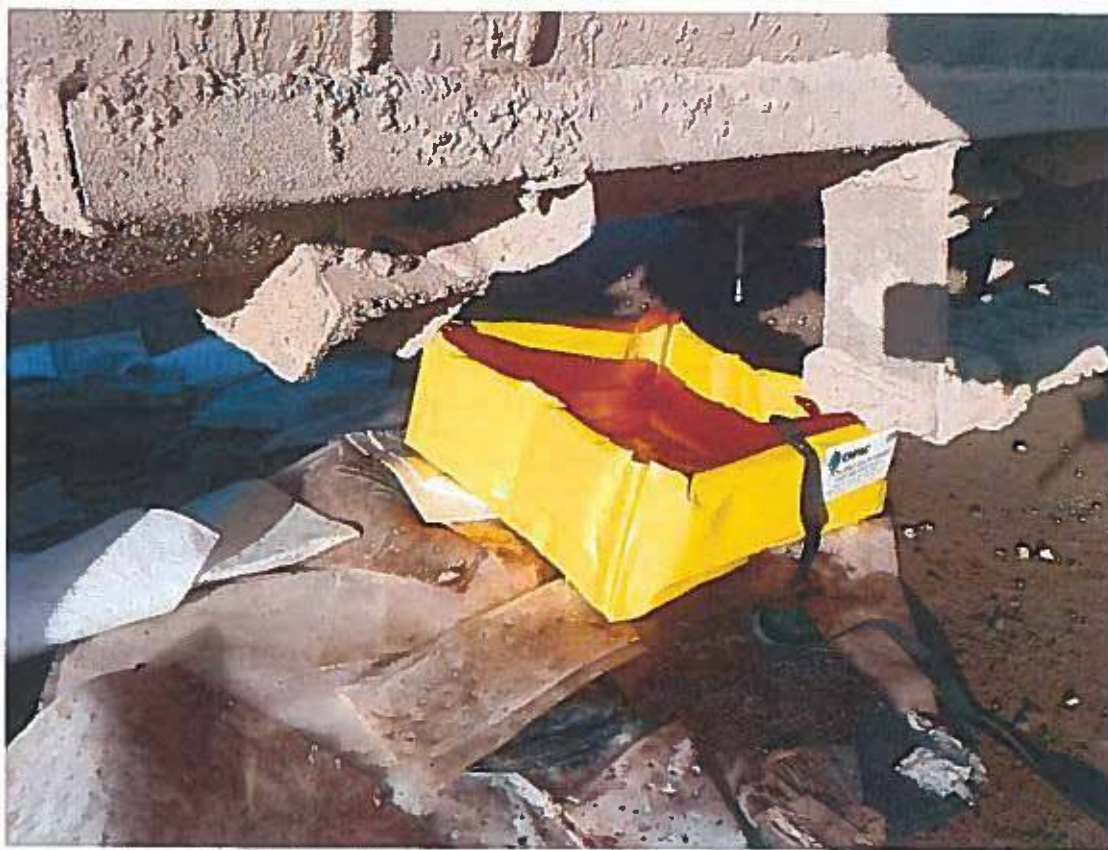
On September 12<sup>th</sup> 2017, an OHT was climbing the hill north bound at KM 62 on the tote road and a drive shaft failed, severing the fuel lines on the passenger side fuel tank causing the fuel to release onto the road. Approximately 100 Liters of Diesel fuel was released onto the Tote Rd. The flow of fuel was stopped, contained and cleaned up immediately. The spill occurred >10 m from the nearest water body and occurred on Crown Land. The spill was contained and did not enter nearby waterways.

**Photo 1: Plugged fuel leak and berm to contain fuel.**

The severed fuel lines were immediately plugged to slow the flow of fuel and a spill berm was placed under the leaking tank. The released fuel was cleaned up with absorbent spill pads and a mechanic was brought to the site to repair the severed fuel lines. The contaminated soil was then scraped off the road with a loader and transported to a lined containment facility.

Preventative maintenance inspection programs on Ore Haul Trucks to prevent and reduce mechanical failures and resultant spills. Ore Haul Trucks carry spill response supplies to mitigate spills on the Tote Road.

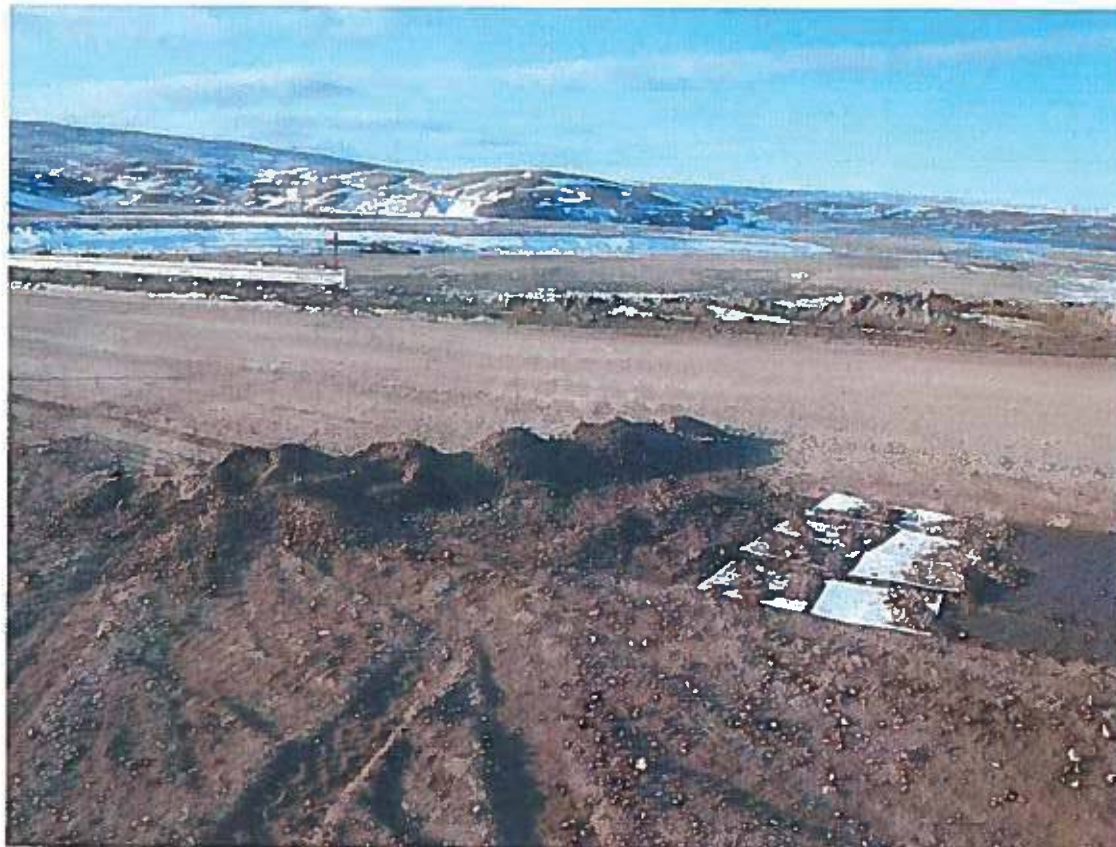
**Photo 2: Contained Fuel Spill with Absorbent Pads**

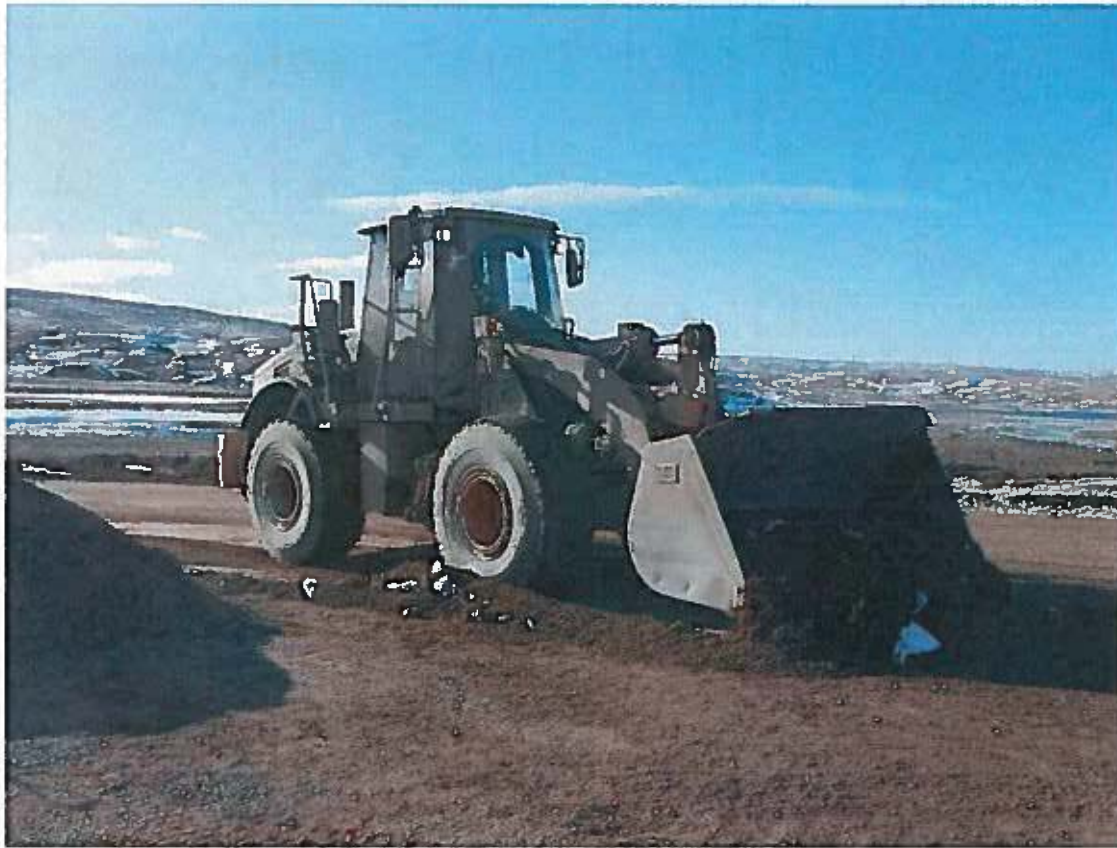
Photo 3: Removal of Contaminated Soil

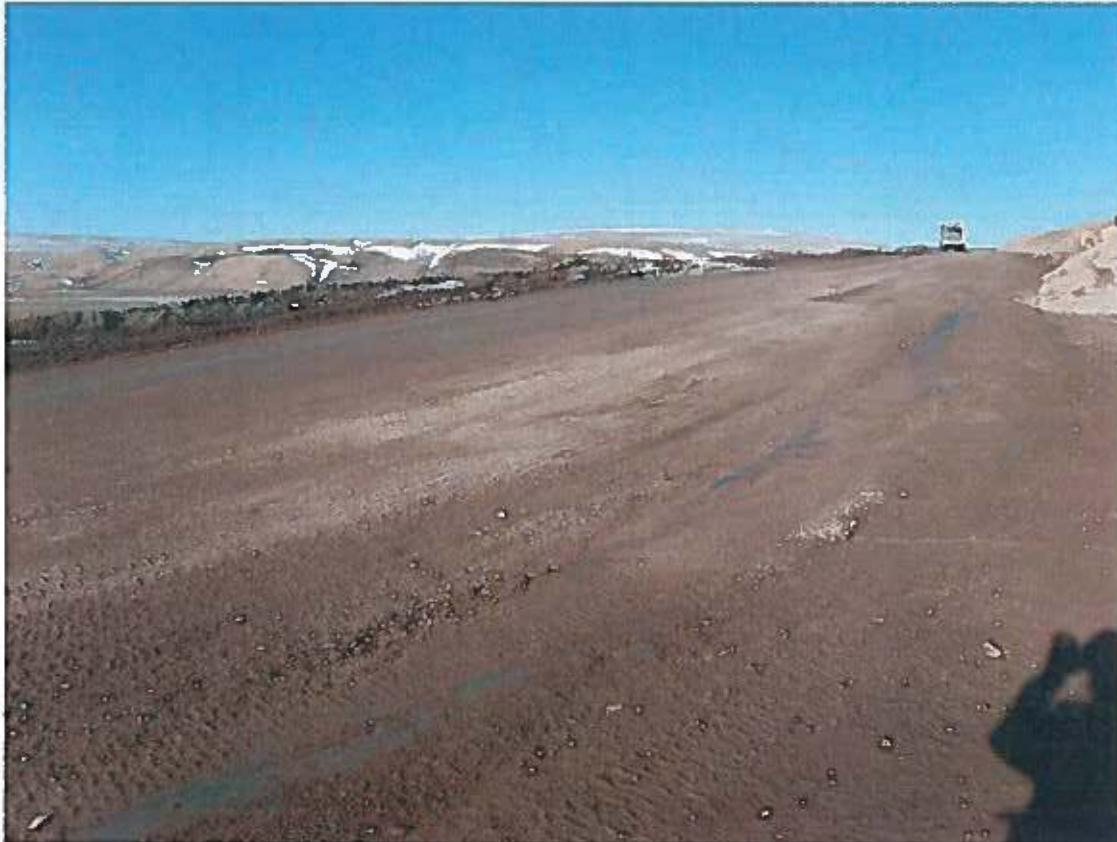
Photo 4: Road after contaminated soil removal

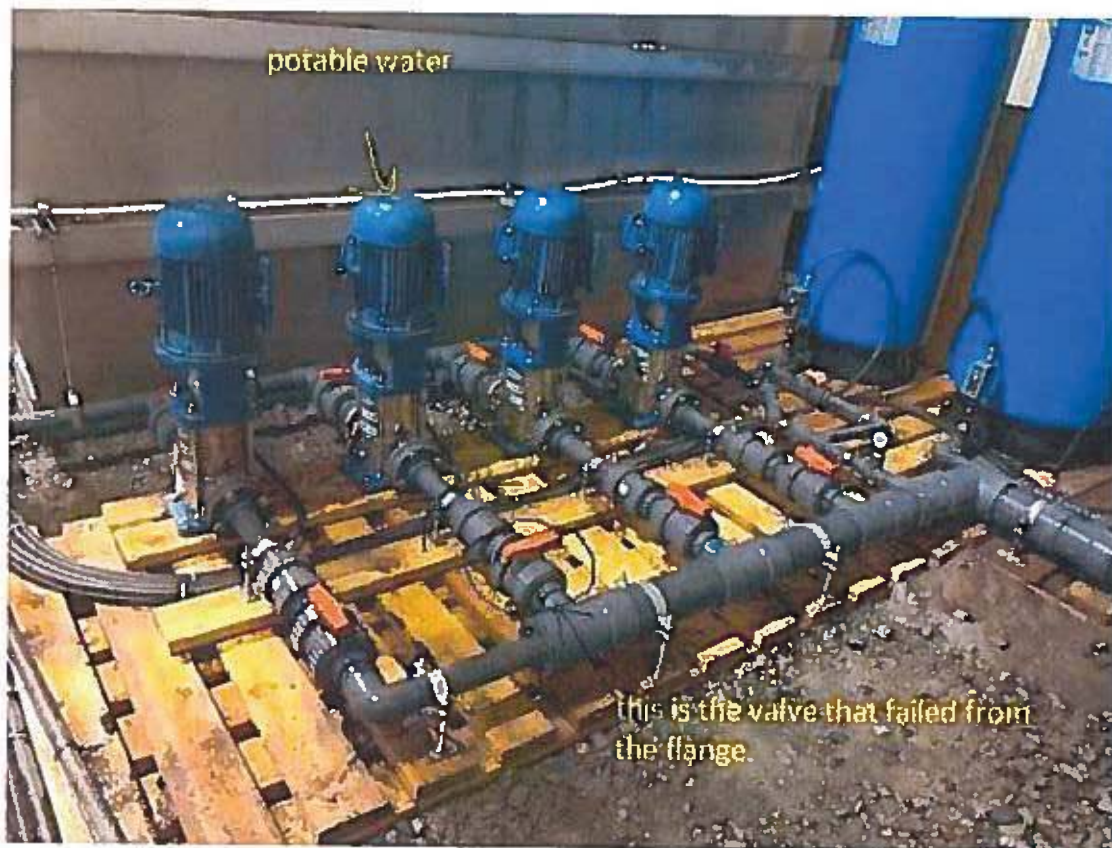
On the morning of September 13<sup>th</sup> 2017, the water treatment plant operator was called out to a report of a water leak at the Mine Site Potable Water Treatment Plant (WTP). Upon initial investigation, it was identified that a ball valve on distribution pump #2 had split open, releasing treated potable water to the building pad and migrating to the surrounding area. The pumps were turned off and the breakage isolated. Approximately 40% of water tank was drained down before the leak could be stopped, releasing an estimated 25 cubic metres of treated water, which percolated into the pad and surrounding area. The facility is located >100 m from the nearest water body and occurred on Inuit owned land.

Photo 1: Distribution pumps with broken valve on #2 that released the water.

The breakage was immediately isolated and the pump switched off. The pipe and valve was replaced on distribution pipe #2 from the pump to the manifold, including a new ball-check valve and manual ball valve. A follow-up inspection of the breakage area occurred, revealing ground settlement below the distribution piping that placed stress on the piping. Clamping on all distribution pumps was loosened to allow the piping the ability to move as base elevations change.

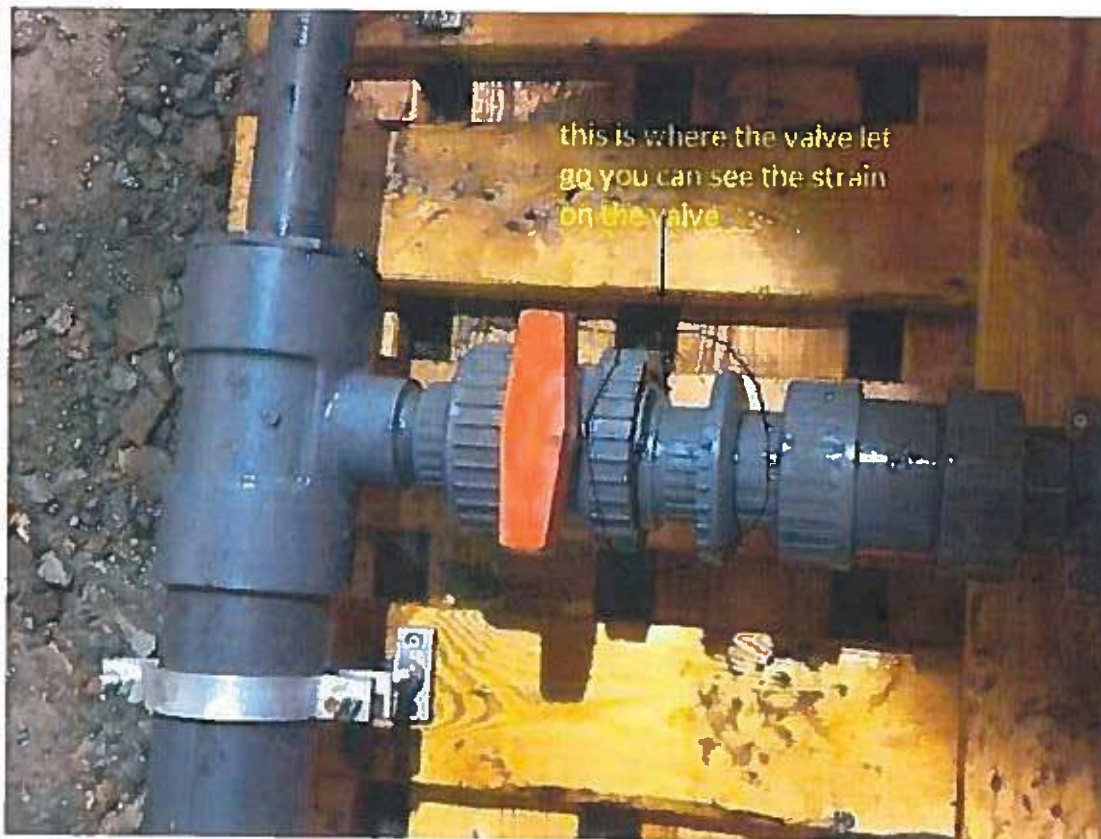
Photo 2: Broken valve from stress strain.

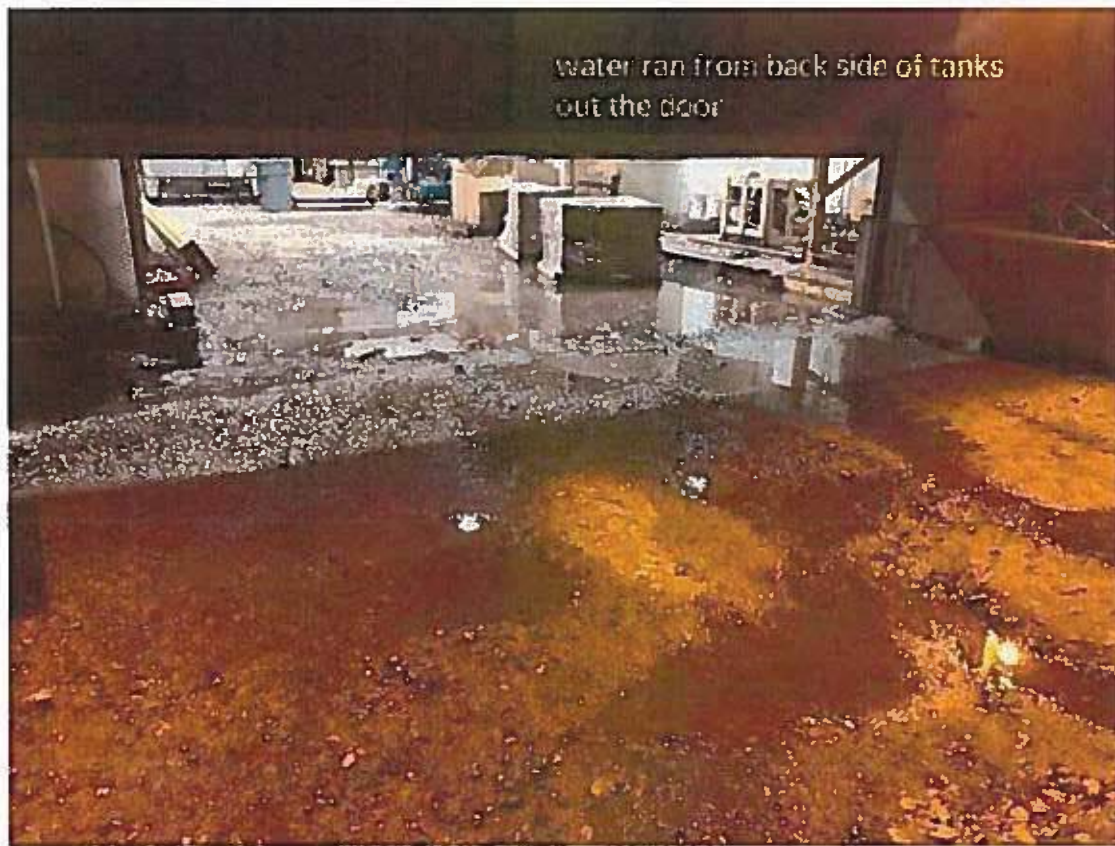
water ran from back side of tanks  
out the door

Photo 3: Extent of released water in the water treatment plant.

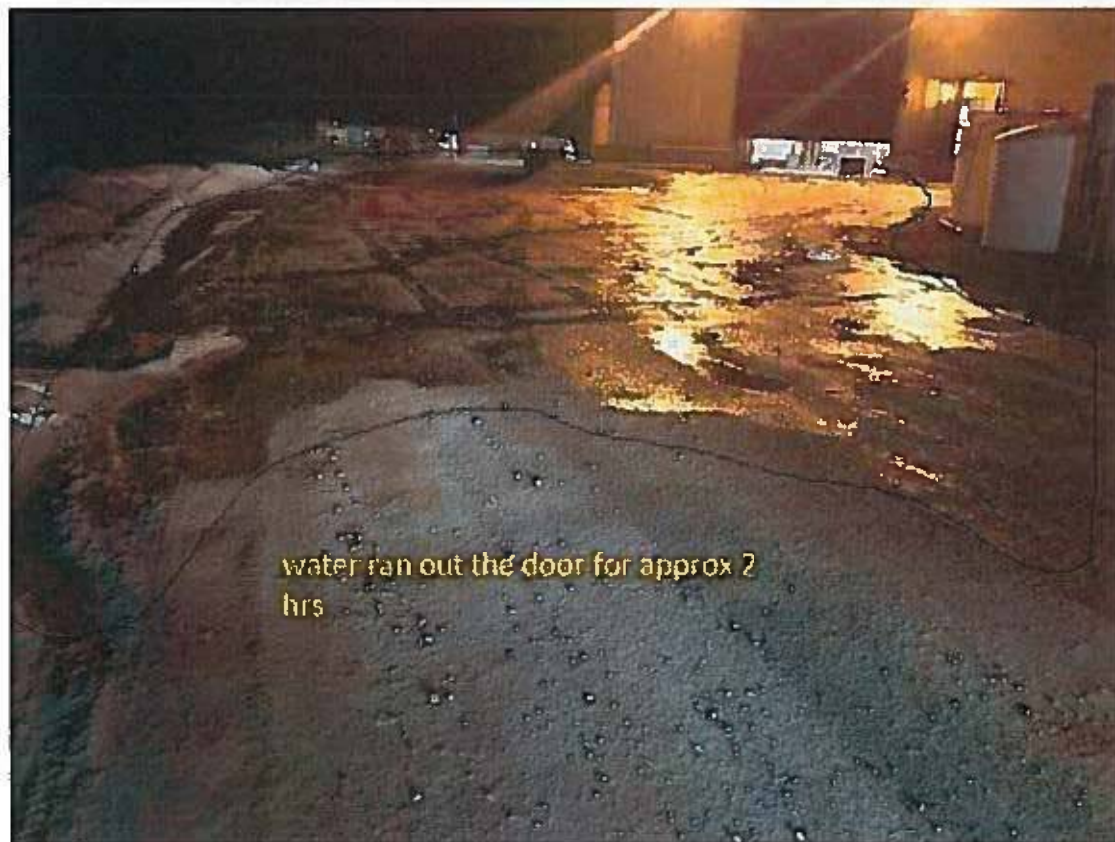
water ran out the door for approx 2  
hrs

Photo 4: Extent of released water outside of the water treatment plant

All non-treated water percolated into the ground, with no pooling and did not cause erosion to the area. The distribution pumps are all adjusted for potential settlement, repaired and back in service.
