### DFO Tote Road Annual Report

**BAFFINLAND IRON MINES CORPORATION  
MARY RIVER PROJECT**

**FISH HABITAT MONITORING  
2019 ANNUAL REPORT  
EARLY REVENUE PHASE - TOTE ROAD UPGRADES**

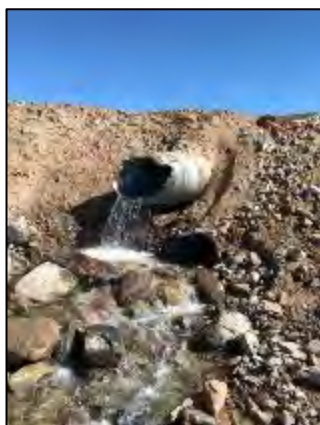
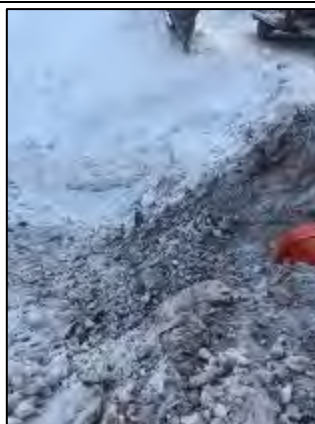
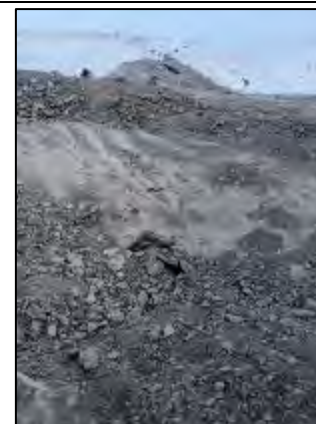
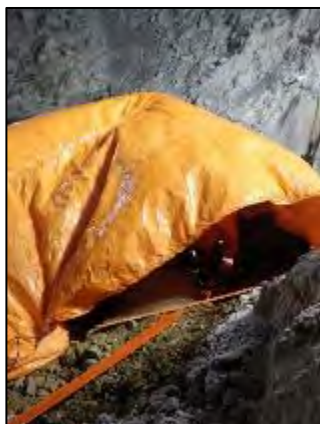
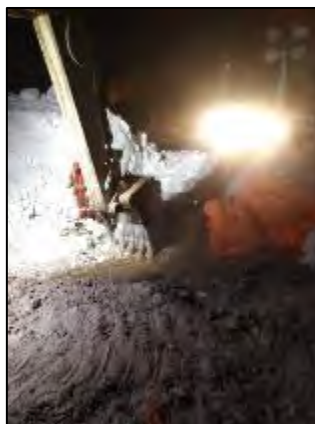
**Photos 1:** Photographs of the culvert crossing at CV-111 (KM 32) (A-C) before, (D-H) during, and (I-L) after construction works to replace existing culverts with a single new culvert. Work was completed on 19 February 2019.

Remediation could not be completed at two sites (CV-111 and CV-225) in 2019 (Table 6; Appendix D). The culvert at CV-111 was reinstalled during winter 2018/2019 to replace two culverts with a single culvert and reduce erosion of the embankment. However, the new culvert had a 0.25 m perch, preventing upstream access for fish. A rocky ramp was constructed to improve fish access to the culvert and upstream habitat in fall 2019. Unfortunately, though access has likely been improved, due to the height of the original perch, such a drop could not be completely eliminated by this method. Additional/alternative works may be required for all of the size classes of juvenile Arctic Char found downstream of this crossing to have full access to upstream habitat.

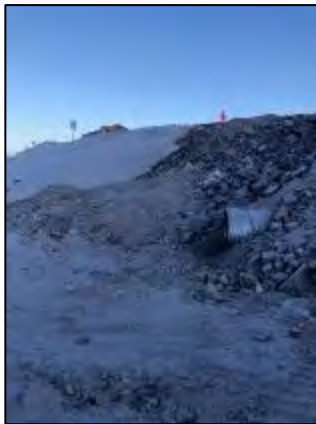
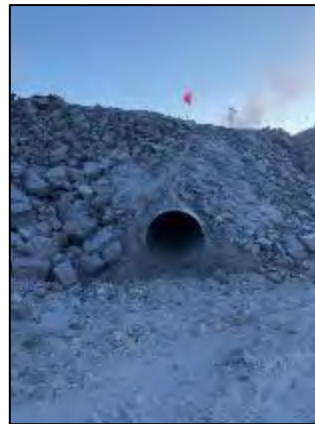
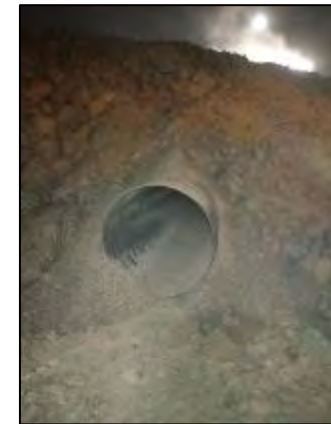
**Photos 1:** Continued.

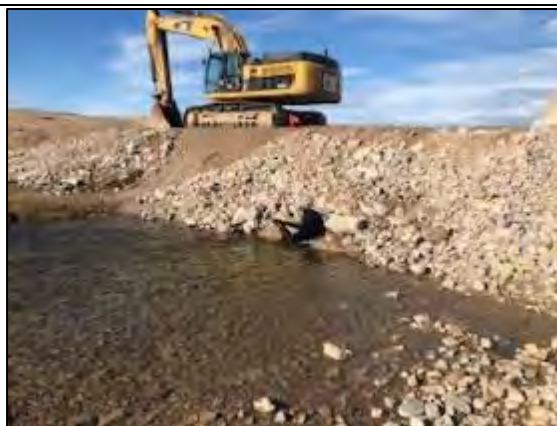
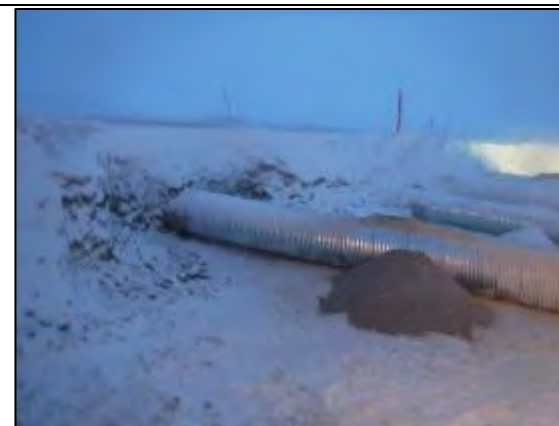
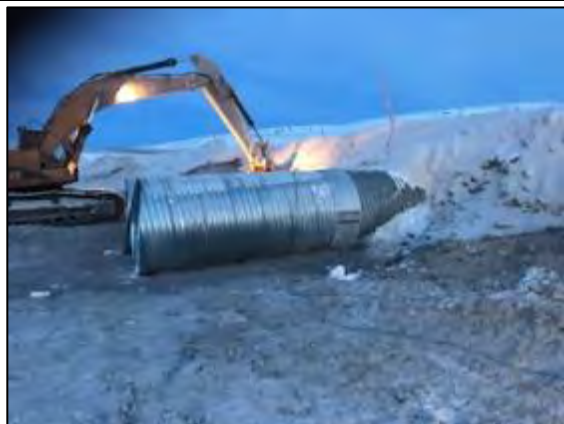
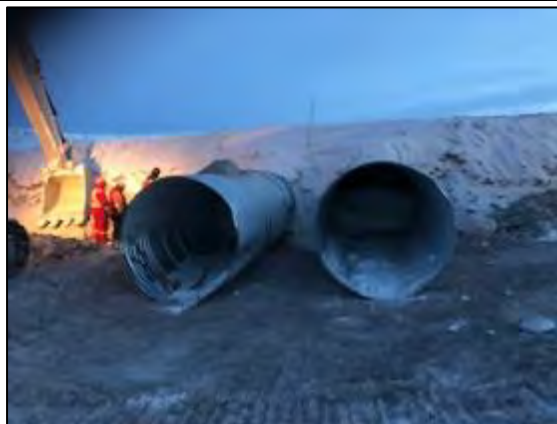
**Photos 2:** Photographs of the culvert crossing at CV-078 (KM 51) (A-E) during and (F) after construction works to add extensions to existing culverts. Work was completed on 7 January 2019.

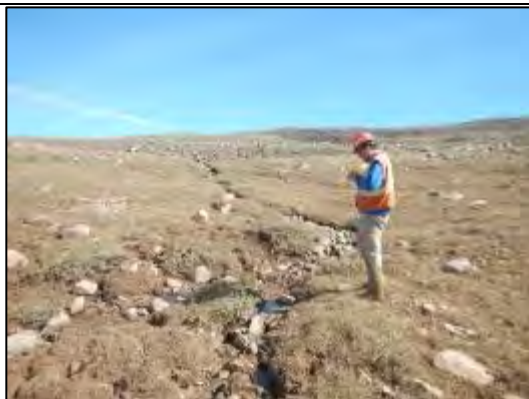
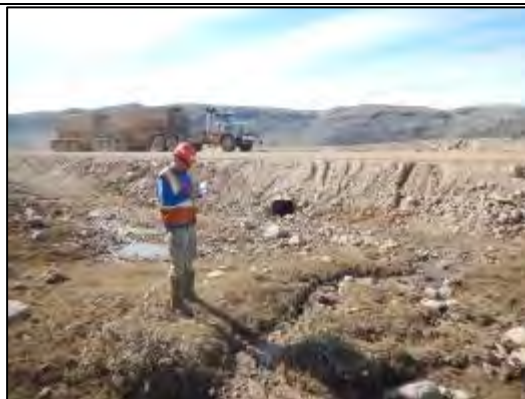
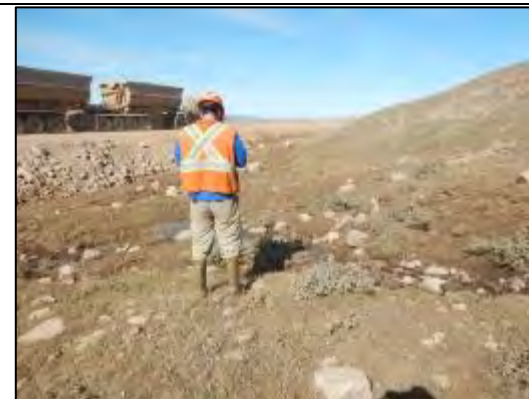
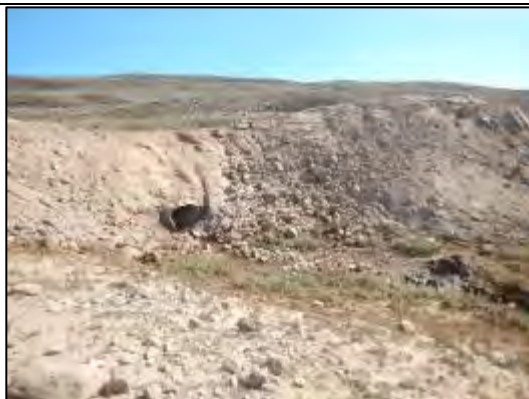
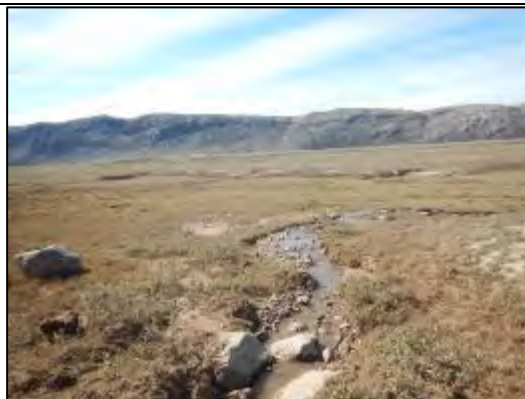
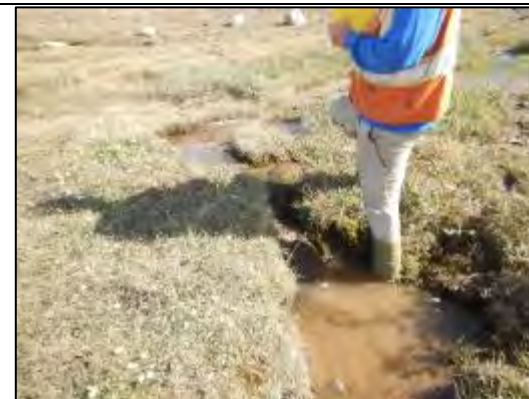
**Summary:** This small stream has several natural steep gradient and vertical drop barriers downstream that prevent fish access to the crossing area from Phillips Creek. There is no upstream overwintering habitat.

**Photos 1.** Photographs upstream of the Tote Road crossing CV-170: (A) looking upstream; (B) looking downstream; (C) looking across; and photographs downstream of the Tote Road: (D) looking upstream; (E) looking downstream; and (F) a vertical barrier preventing fish access.

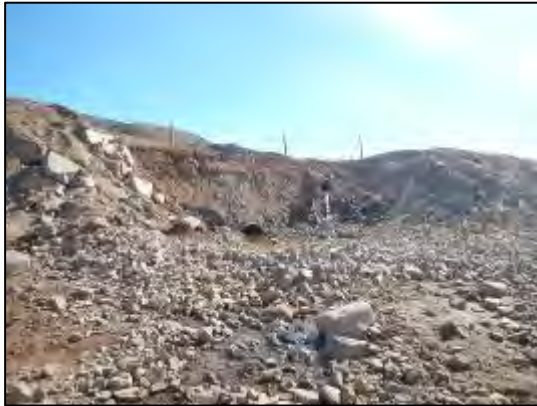
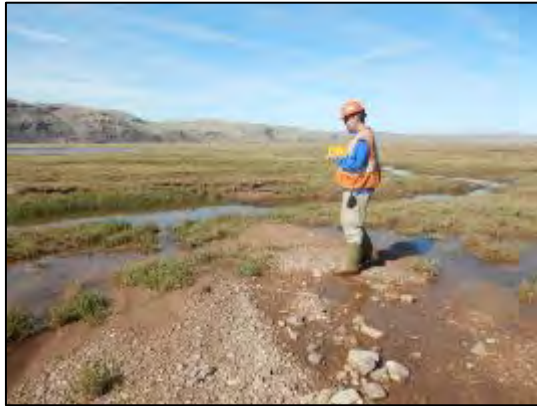
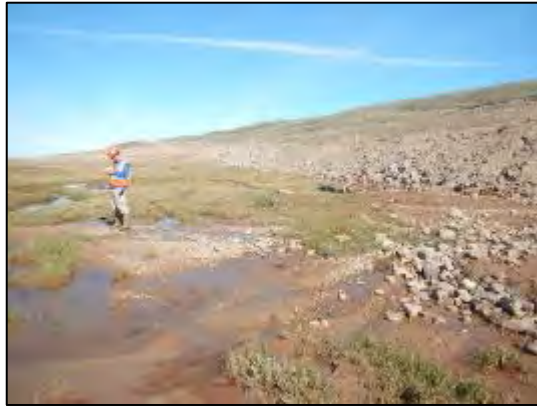
| Tote Road Site CV-166 | | | |
|---|---|---|---|
| <b>Summary:</b> Anadromous juvenile Arctic Char occasionally use habitat downstream of the Tote Road, but a steep gradient at the crossing and a rocky barrier immediately downstream prevent access to the crossing and upstream habitat. | | | |
| <b>Photos 1.</b> Photographs downstream of the Tote Road crossing CV-166: (A) looking upstream; (B) looking downstream; and (C) looking across. | | | |

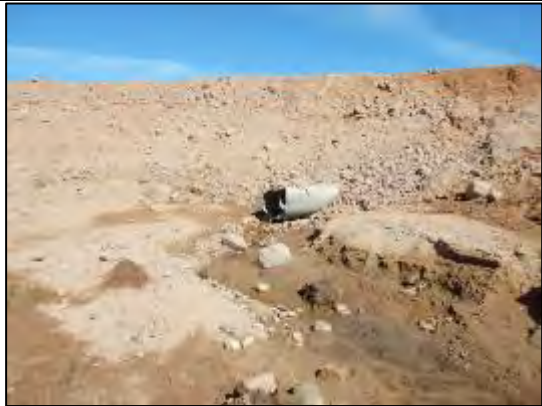
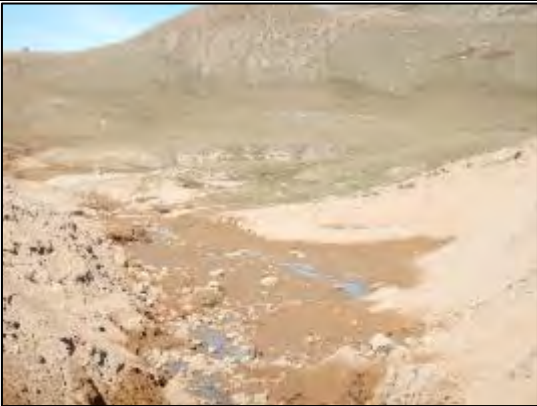
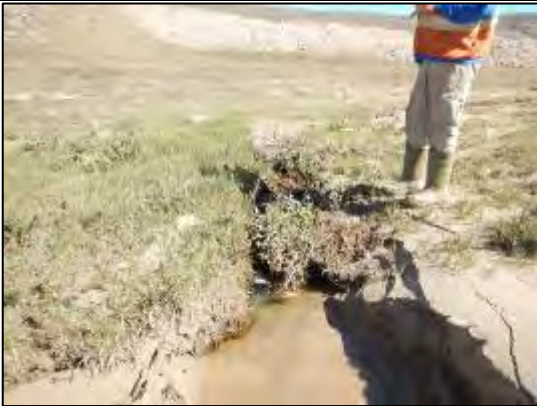
| Tote Road Site CV-159 | | | |
|---|--|---|---|
| <b>Summary:</b> This small stream has several natural steep gradient and vertical drop barriers downstream that prevent fish access to the crossing area from Phillips Creek. There is no upstream overwintering habitat. | | | |
| <b>Photos 1.</b> Photographs downstream of the Tote Road crossing CV-159: (A) looking upstream; (B) looking downstream; and (C) a vertical barrier preventing fish access to the crossing. | | | |

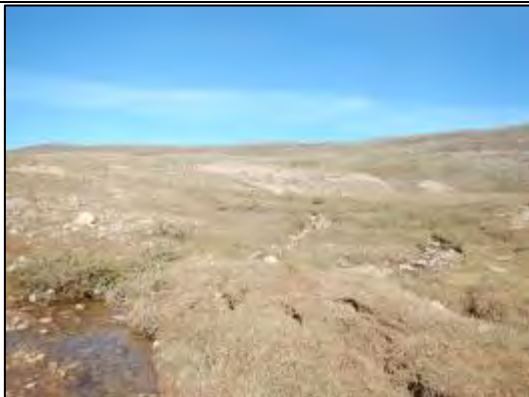
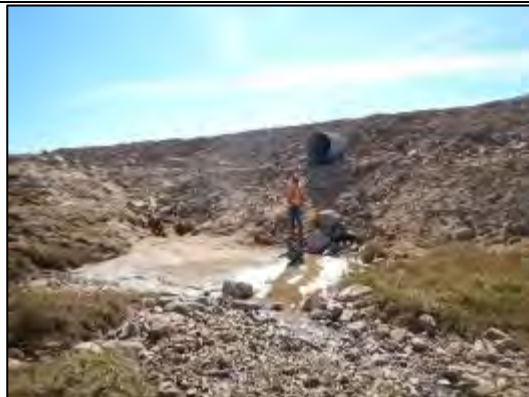
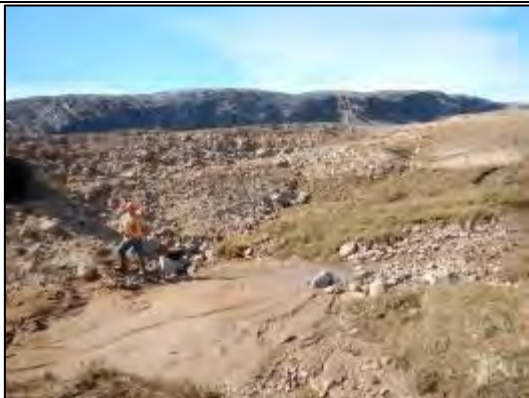
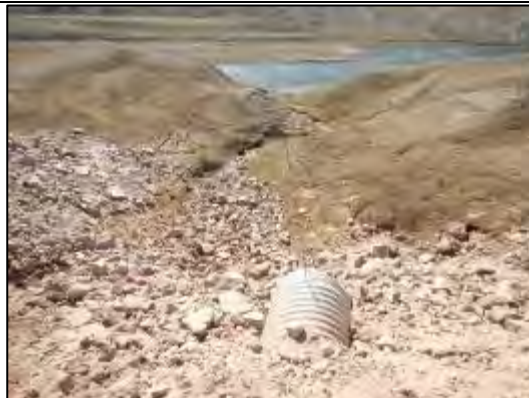
| | | | |
| C | | D | | | | |
| <b>Photos 1.</b> Photographs upstream of the Tote Road crossing CV-157: (A) looking upstream; (B) looking downstream; (C) looking across; and (D) photograph downstream of the Tote Road looking downstream. | | | | | | |
| Baffinland Iron Mines<br>Mary River Project | |

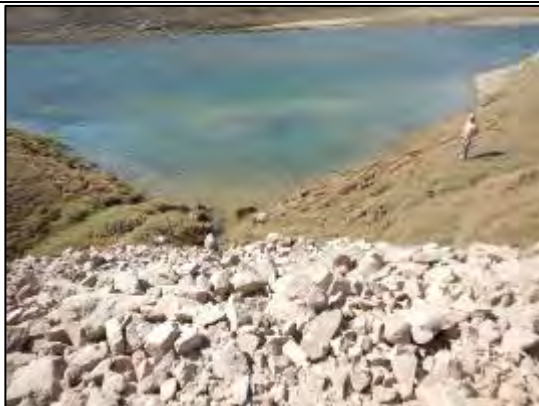
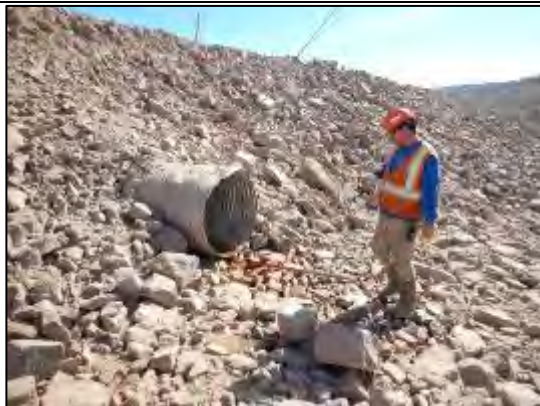
| | | | |
| A | | B | | | | |
| <b>Photos 1.</b> Photographs downstream of the Tote Road crossing CV-156: (A) looking downstream; and (B) looking across. | | | | | | |
| Baffinland Iron Mines<br>Mary River Project | |

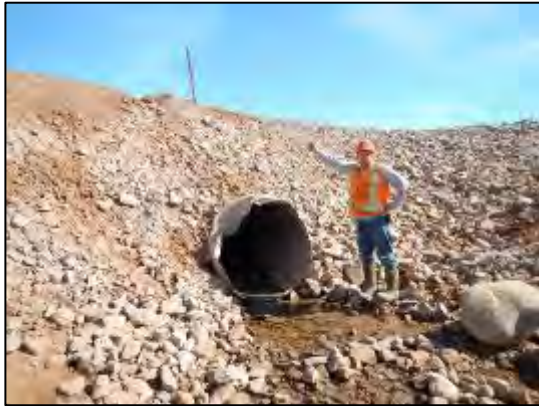
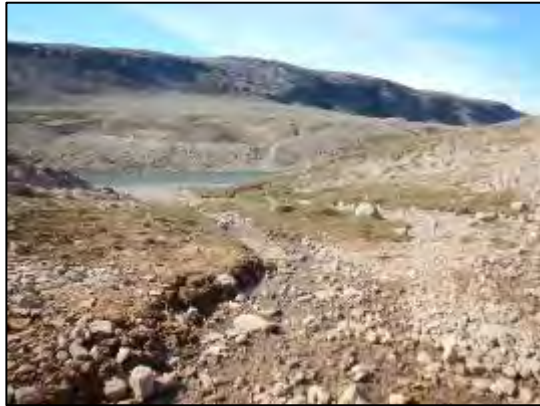
| Tote Road Site CV-154 | | | |
|---|--|---|---|
| <b>Summary:</b> This small stream typically has low natural water levels and lacks connectivity at the confluence with Phillips Creek, preventing fish access to the crossing. There is no upstream overwintering habitat. | | | |
| <b>Photos 1.</b> Photographs downstream of the Tote Road crossing CV-154: (A) looking upstream; and (B) looking downstream. | | | |

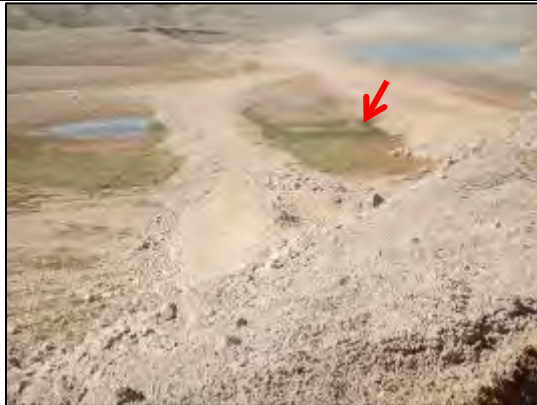
| Tote Road Site CV-153 | | | |
|---|---|---|---|
| <b>Summary:</b> This small runoff stream typically has minimal natural surface flow or is dry and permanently lacks connectivity to Phillips Creek. There is no upstream overwintering habitat. | | | |
| <b>Photos 1.</b> Photograph of the Tote Road crossing CV-153 (red arrow). Note distance from crossing due to lack of areas to safely access the site from the road. | | | |

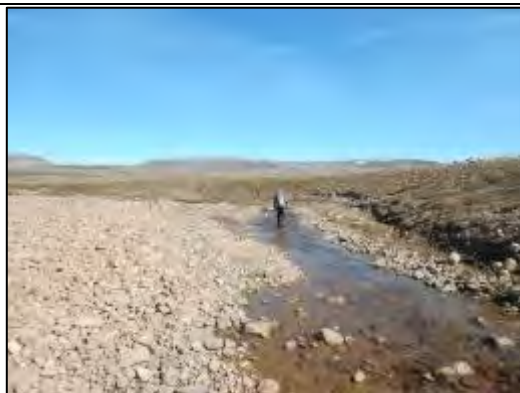
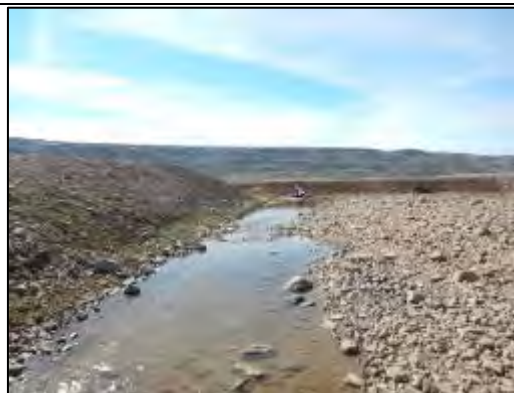
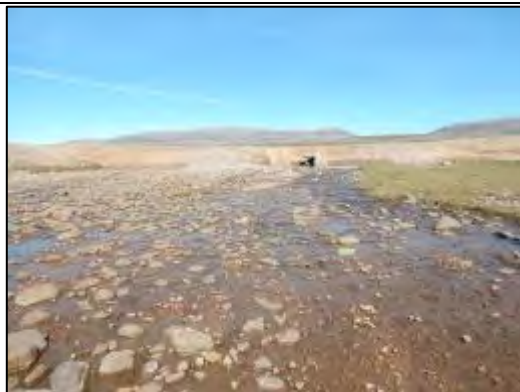
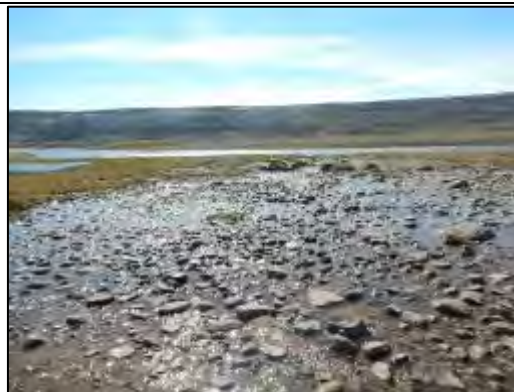
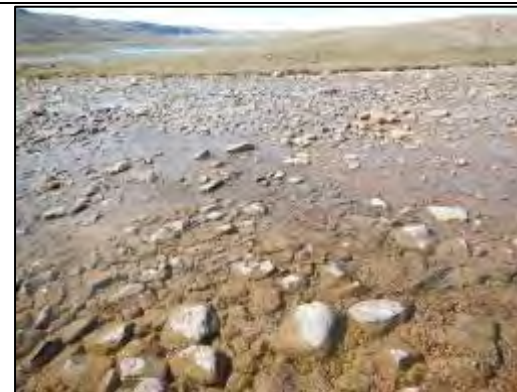
**Summary:** This site has consistently provided good quality summer rearing habitat for juvenile Arctic Char and is the first large stream upstream of the impassable falls on Phillips Creek (i.e., fish use is restricted to land-locked Arctic Char). Small culvert perch was remediated in fall 2019. Upstream overwintering lake provides additional habitat, so fall upstream movements could be as important as downstream, requiring full culvert access.

**Photos 1.** Photographs upstream of the Tote Road crossing CV-129: (A) looking upstream; (B) looking downstream; (C) looking across; and photographs downstream of the Tote Road: (D) looking upstream; (E) looking downstream; and (F) looking across.

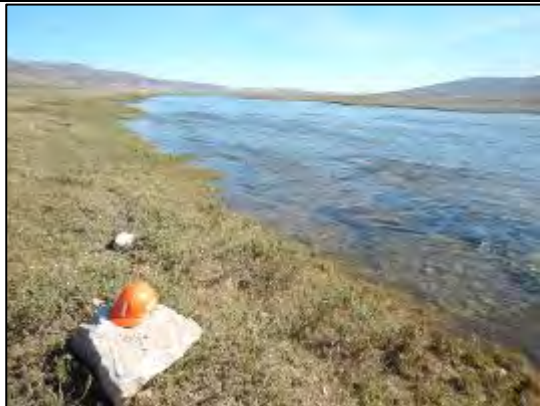
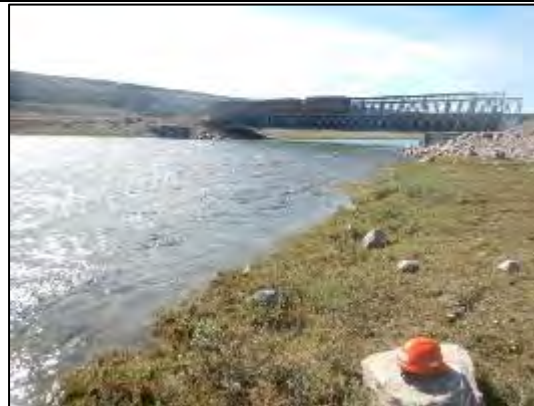
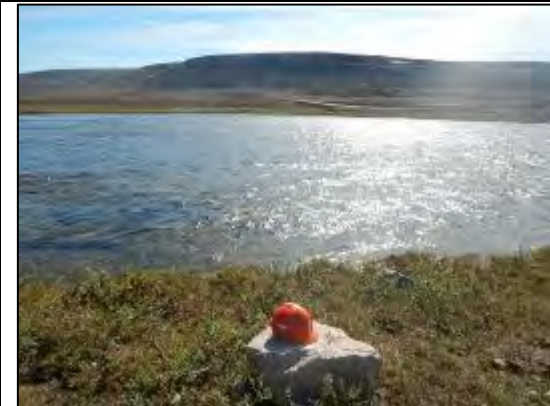
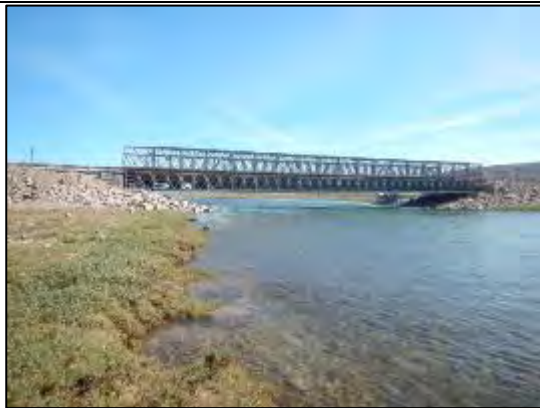
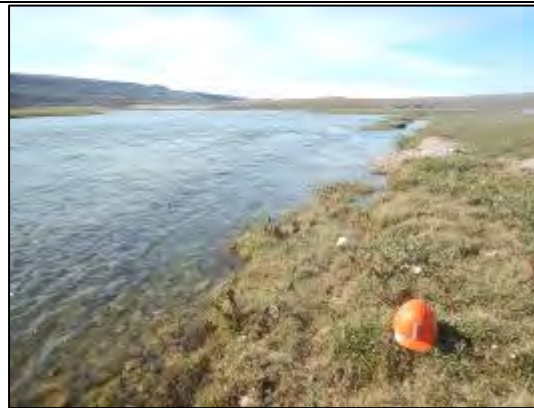
**Summary:** A bridge crossing of a major river that has consistently provided abundant fish habitat with no passage issues.

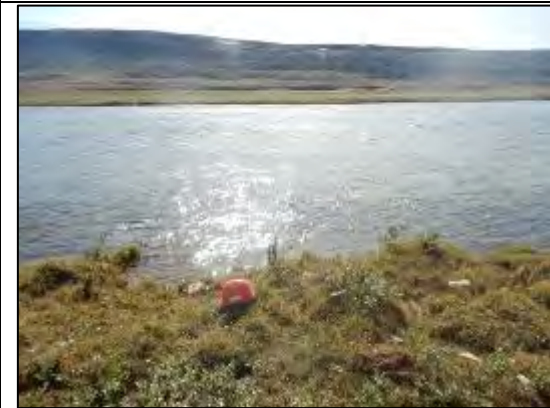
**Photos 1.** Photographs upstream of the Tote Road crossing CV-128: (A) looking upstream; (B) looking downstream; (C) looking across; and photographs downstream of the Tote Road: (D) looking upstream; (E) looking downstream; and (F) looking across.

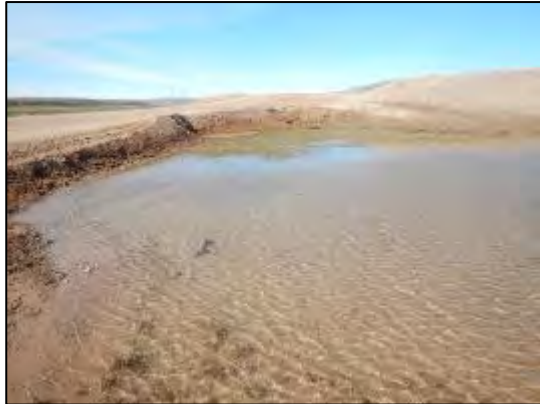
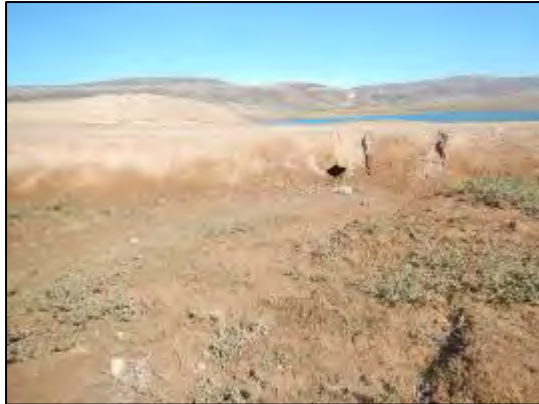
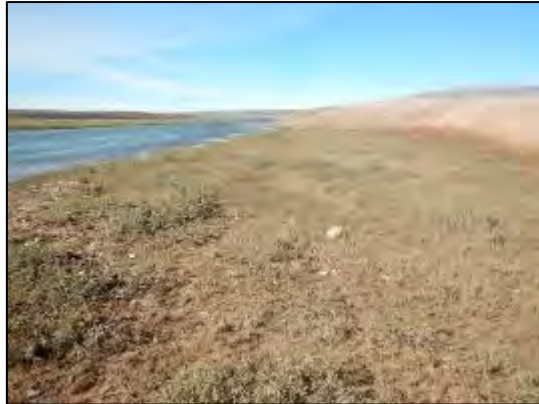
| Tote Road Site CV-125 | | | |
|---|--|---|---|
| Summary: Some ponding upstream of the Tote Road culvert, but no channel and no surface water downstream. There is no access from Phillips Creek. | | | |
| Photos 1. (A) Photograph upstream of the Tote Road crossing CV-125 looking upstream; and photographs downstream of the Tote Road crossing CV-125: (B) looking upstream; and (C) looking downstream. | | | |

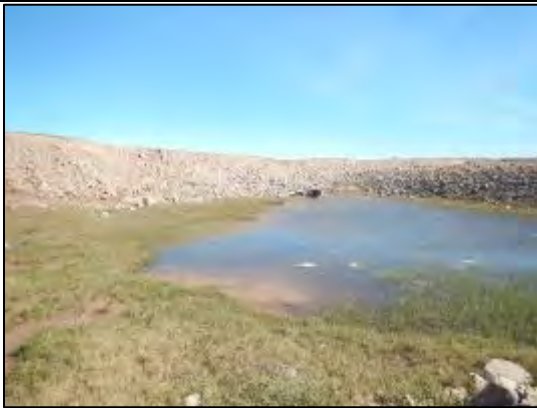
| Tote Road Site CV-120 | | | |
|---|---|---|---|
| <b>Summary:</b> Some ponding upstream of the Tote Road culvert, but no channel and no surface water downstream. There is no connection to or access from Phillips Creek. | | | |
| <b>Photos 1.</b> Photograph of the Tote Road crossing CV-120 from downstream. | | | |

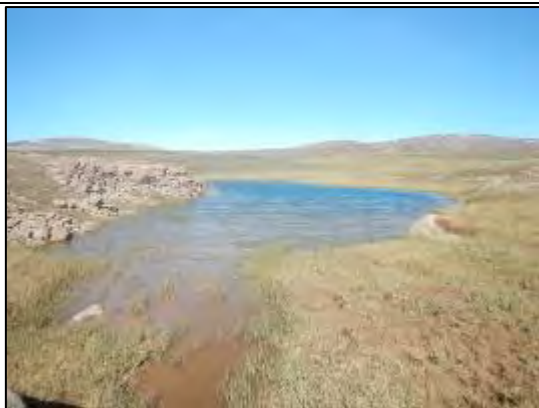
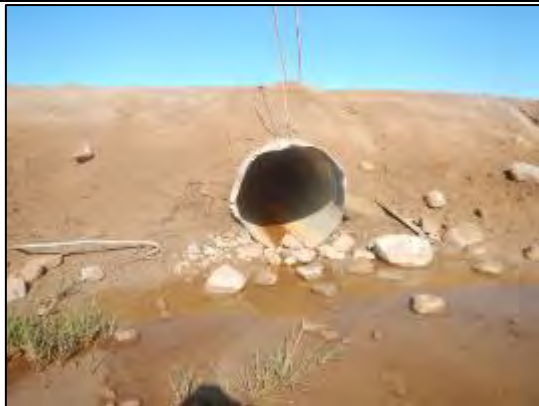
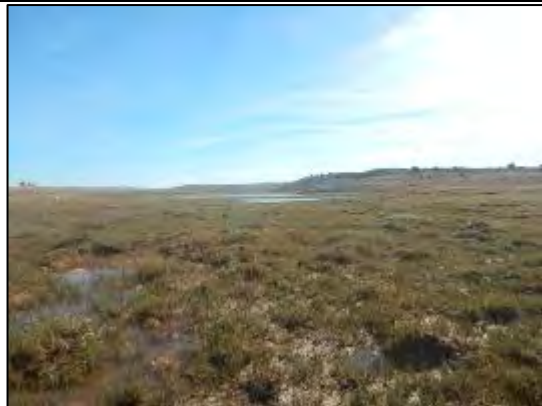
| Tote Road Site CV-119 | | | |
|---|--|---|---|
| Summary: No channel downstream of the Tote Road and surface water shallow and dispersed over terrestrial grasses. No natural connectivity to Phillips Creek. | | | |
| Photos 1. Photographs upstream of the Tote Road crossing CV-119: (A) looking upstream; (B) looking downstream; and photographs downstream of the Tote Road: (C) looking upstream; and (D) looking downstream. | | | |

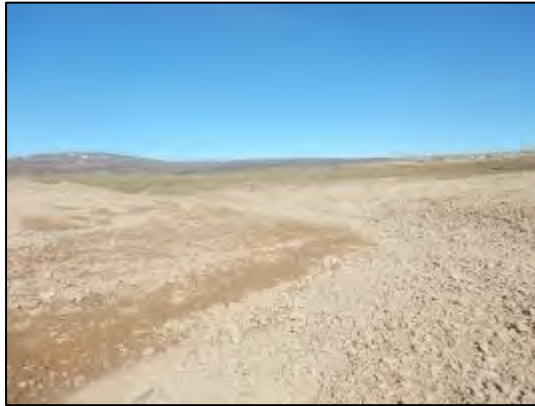
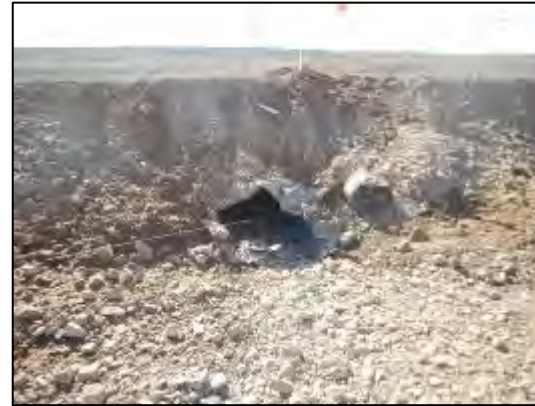
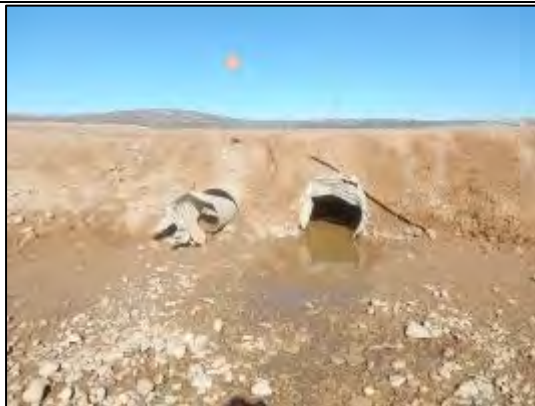
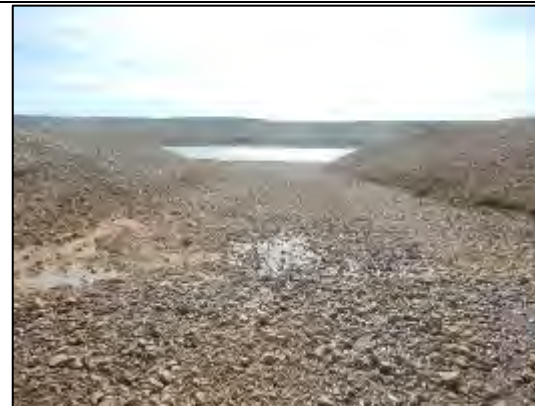
**Summary:** Stream has been regularly surveyed and is dry most years, including 2019. When wetted, small numbers of fish have been observed at the crossing.

**Photos 1.** Photographs upstream of the Tote Road crossing CV-115: (A) looking upstream; (B) looking downstream; and photographs downstream of the Tote Road: (C) looking upstream; and (D) looking downstream.

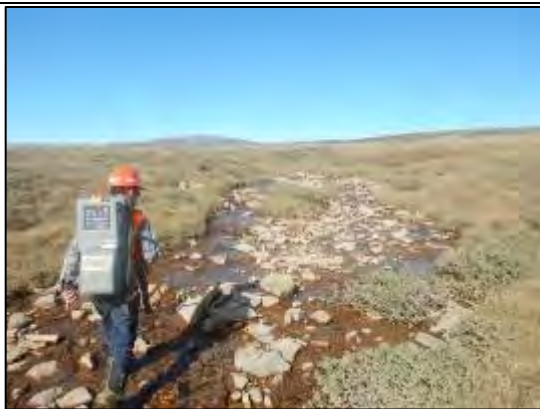
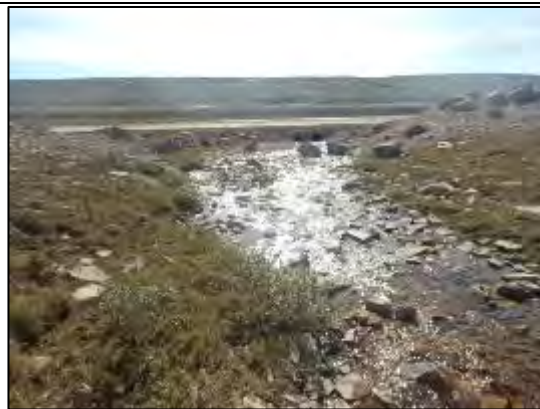
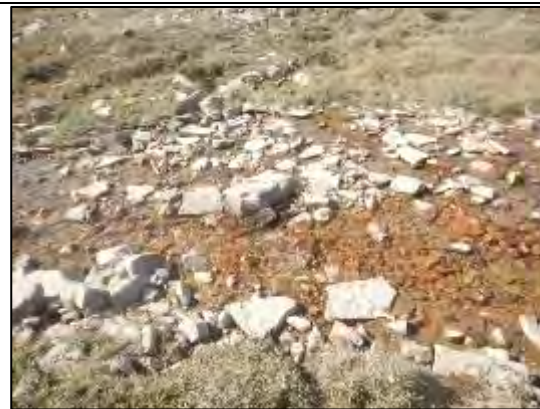
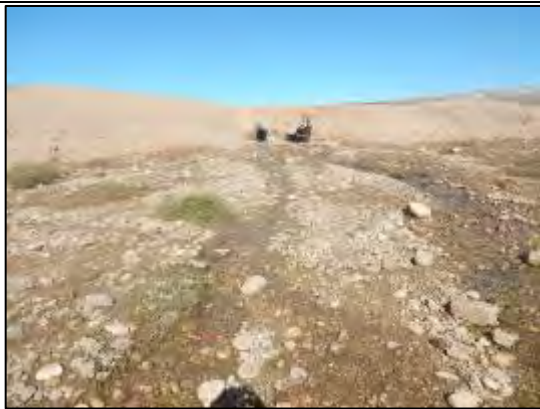
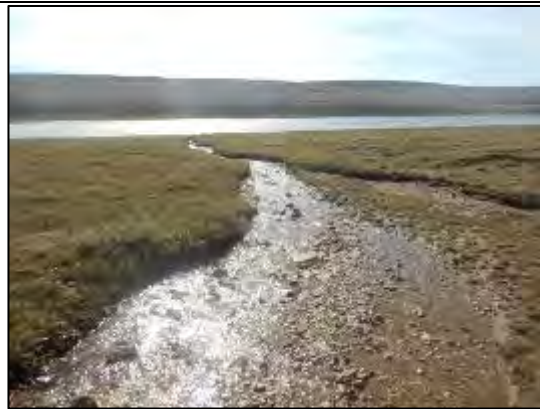
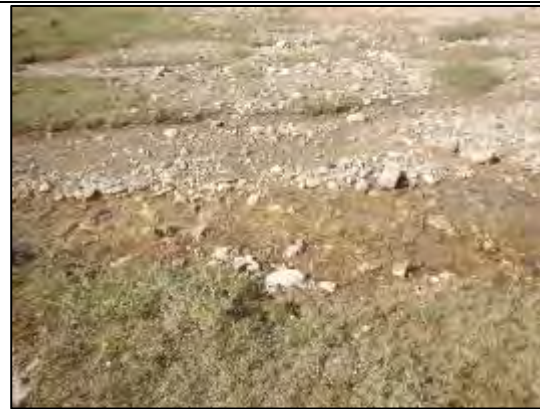
| Tote Road Site CV-114 | | | | | | |
|---|---|---|---|---|---|---|
| UTM Coordinates: 17W 520278 E 7956528 N | | Date Surveyed: 28-Jun-19 | | | | |
| <b>Summary:</b> This stream provides habitat for juvenile Arctic Char. Perched culverts that may affect upstream access were remediated in fall 2019, but may require additional work. | | | | | | |
|

| | | | |
| D | E | F | | | | |
| <b>Photos 1.</b> Photographs upstream of the Tote Road crossing CV-114: (A) looking upstream; (B) looking downstream; (C) looking across; and photographs downstream of the Tote Road: (D) looking upstream; (E) looking downstream; and (F) looking across. | | | | | | |
| Baffinland Iron Mines<br>Mary River Project | |

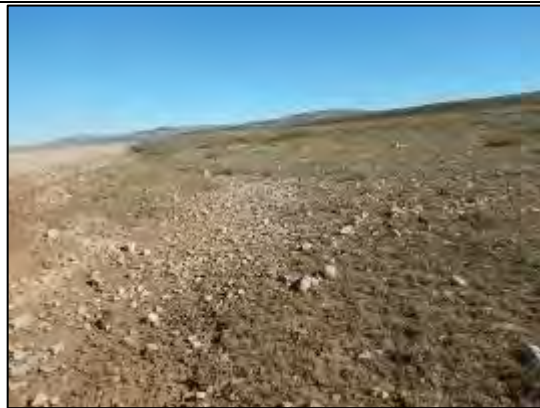
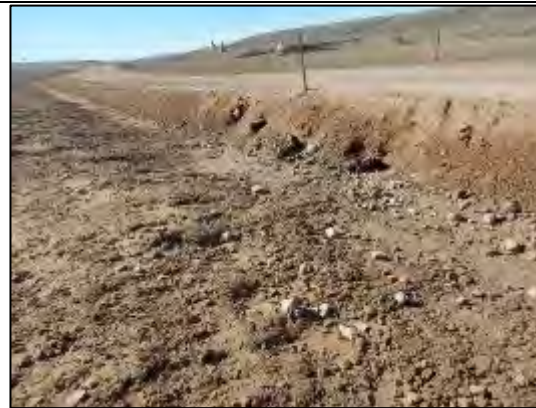
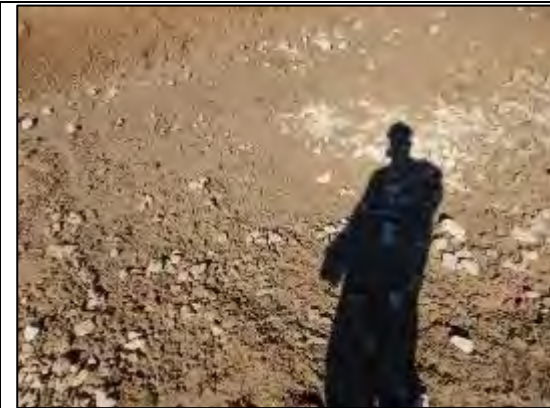
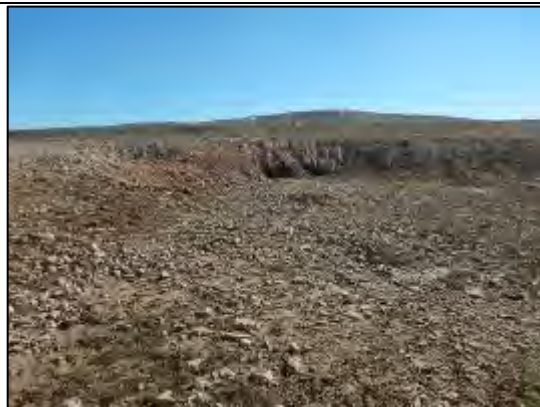
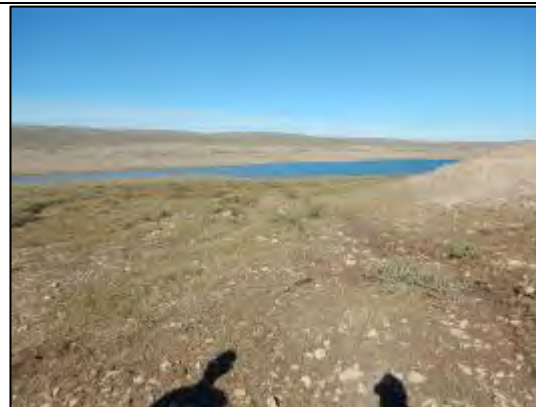
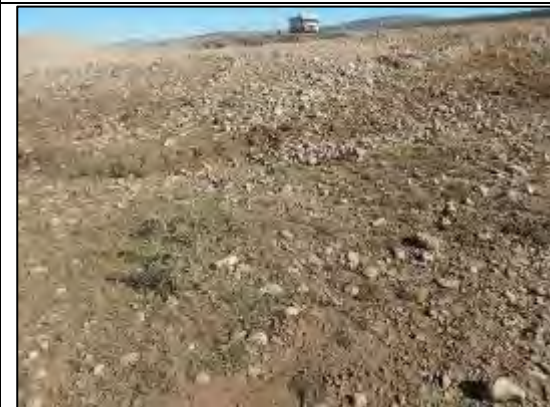
**Summary:** Site is dry with no natural channel and never has connectivity with Phillips Creek.

**Photos 1.** Photographs upstream of the Tote Road crossing CV-113: (A) looking upstream; (B) looking downstream; (C) looking across; and photographs downstream of the Tote Road: (D) looking upstream; (E) looking downstream; and (F) looking across.

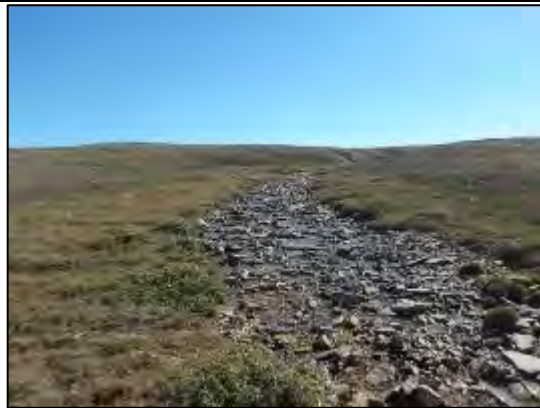
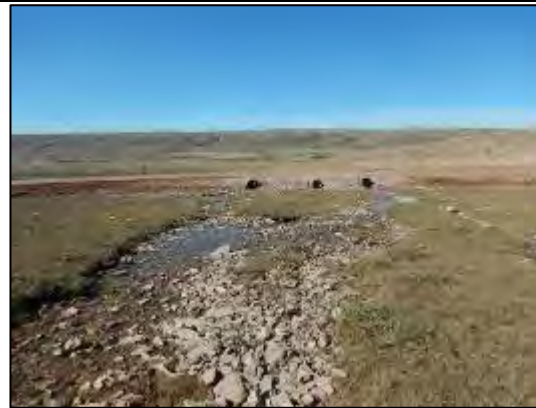
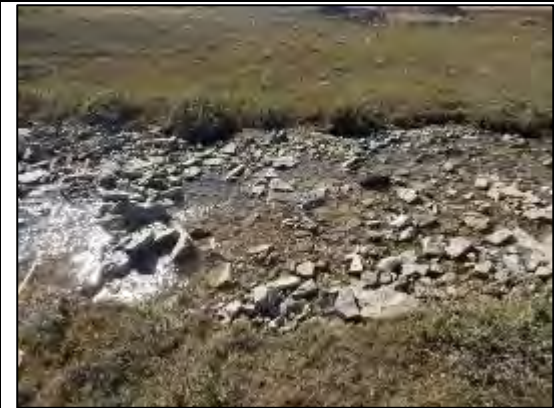
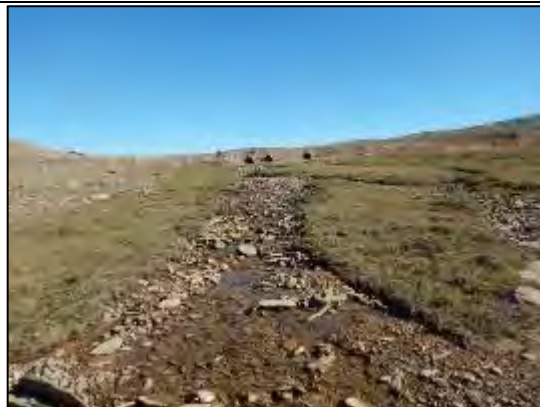
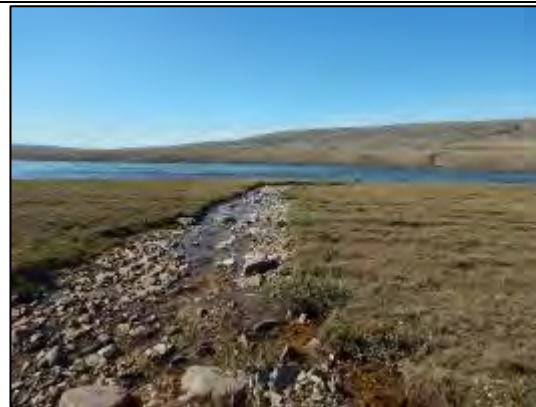
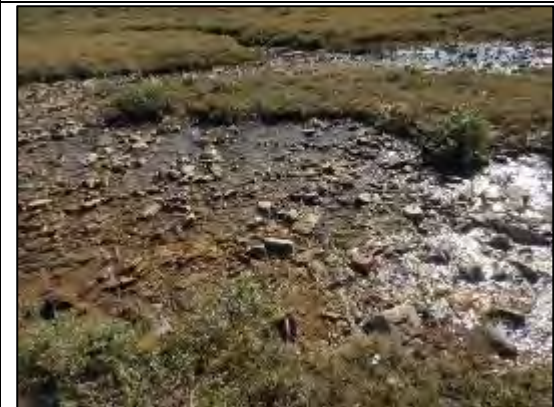
**Summary:** This stream provides summer rearing habitat for juvenile Arctic Char. There are no fish passage issues.

**Photos 1.** Photographs upstream of the Tote Road crossing CV-112: (A) looking upstream; (B) looking downstream; (C) looking across; and photographs downstream of the Tote Road: (D) looking upstream; (E) looking downstream; and (F) looking across.

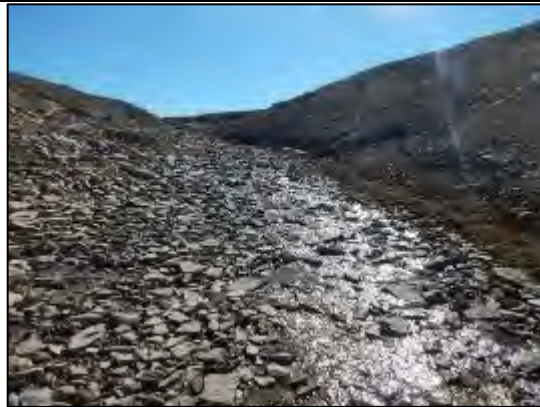
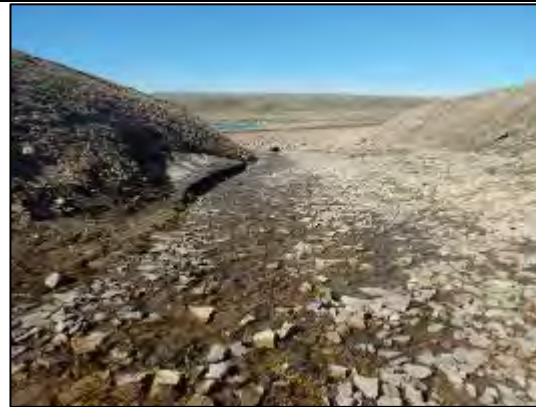
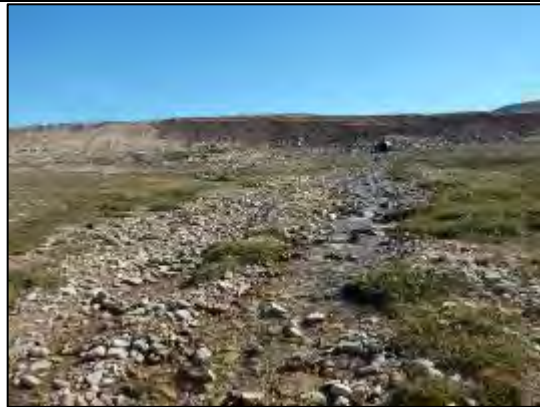
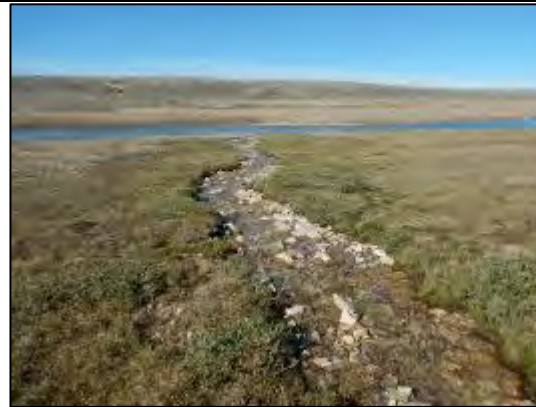
**Summary:** This stream provides summer rearing habitat for juvenile Arctic Char. Culvert was recently reinstalled and is now perched. See remediation Appendix for details.

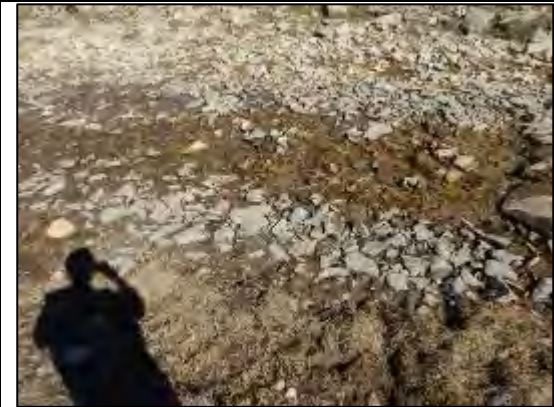
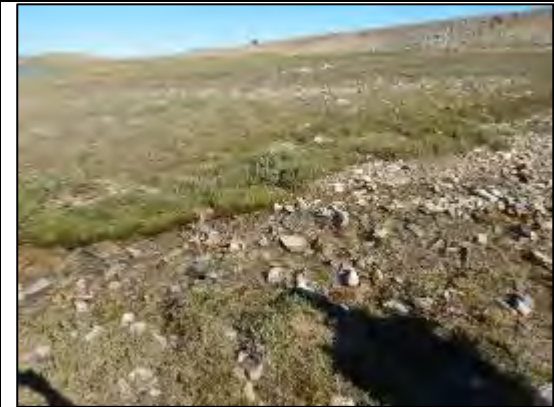
**Photos 1.** Photographs upstream of the Tote Road crossing CV-111: (A) looking upstream; (B) looking downstream; (C) looking across; and photographs downstream of the Tote Road: (D) looking upstream; (E) looking downstream; and (F) looking across.

| Location ID | UTM <sup>2</sup> | | Completed Work | Date Completed | Current Crossing Configuration | Fisheries Survey Conducted 28-June – 1-July 2019 |
|---|---|---|---|---|---|---|
| CV111 | 521,355 | 7,954,524 | Existing culverts were replaced with a single new culvert | 19-Feb-2019 | 1 X 1m diameter | Issues with culvert installation which summer remediation activities attempted to rectify. May require reinstallation of culvert. See tables 6 and 7 for additional detail. |

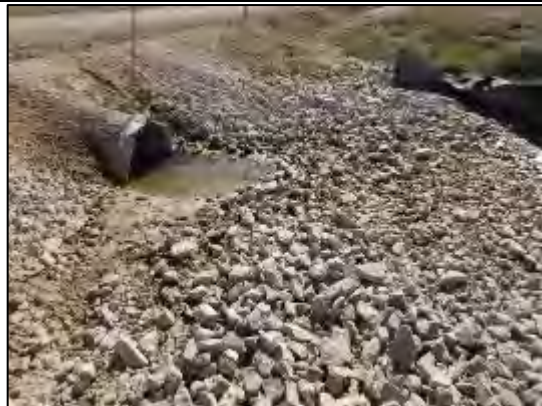
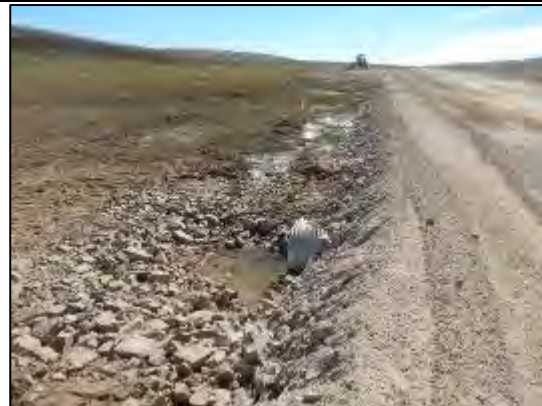
| Tote Road Site CV-202 | | | | | | |
|---|---|---|---|---|---|---|
| UTM Coordinates: 17W 521603 E 7953731 N | | Date Surveyed: 29-Jun-19 | | | | |
| Summary: Site has no natural channel downstream, little surface flow, and is never connected to Phillips Creek. | | | | | | |
|

| | | | |
| A | | B | | | | |
| Photos 1. Photographs of the Tote Road crossing CV-202: (A) upstream end of culvert; and (B) downstream end of culvert. | | | | | | |
| Baffinland Iron Mines<br>Mary River Project | |

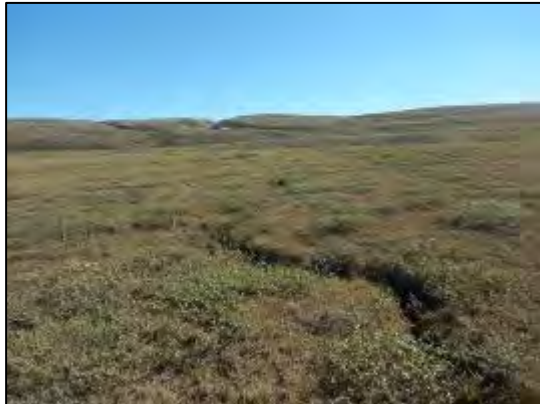
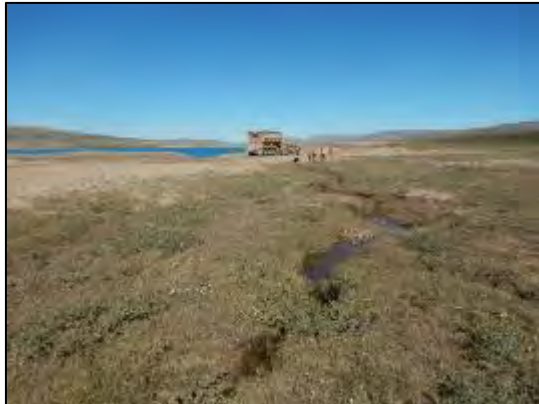
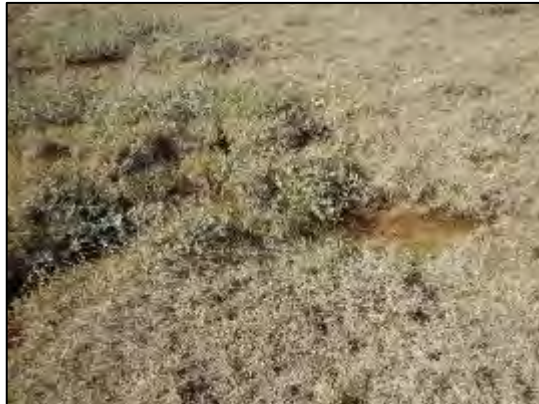
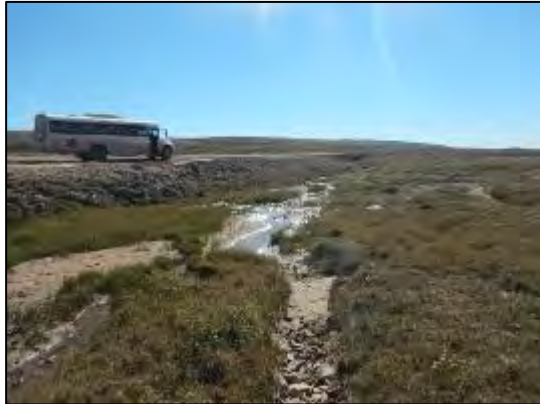
| Tote Road Site CV-106 | | | | | | |
|---|---|---|---|---|---|---|
| UTM Coordinates: 17W 521663 E 7953392 N | | Date Surveyed: 29-Jun-19 | | | | |
| <b>Summary:</b> Stream provides summer rearing habitat for juvenile Arctic Char, though it dries up downstream of the culvert during periods of low water, as was observed in early summer 2019. An existing ramp (2018) designed to improve access received additional modifications in 2019. | | | | | | |
|

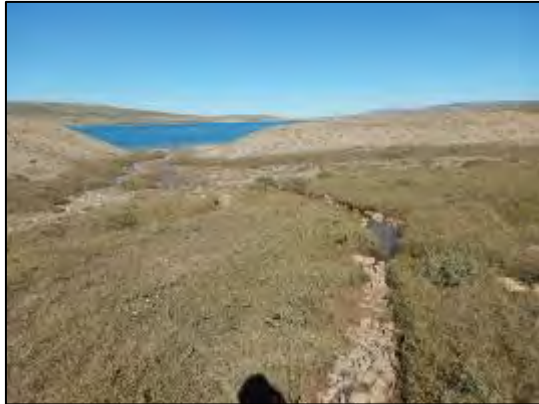
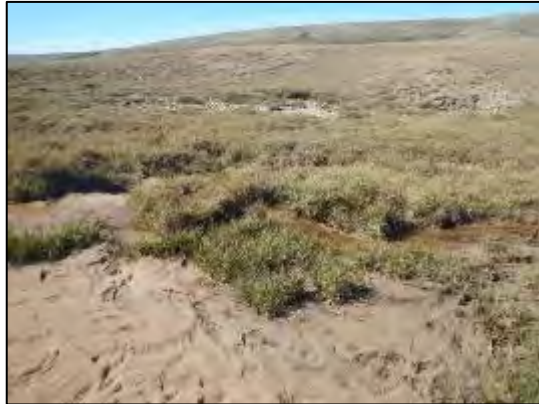
| | | | |
| D | E | F | | | | |
| <b>Photos 1.</b> Photographs upstream of the Tote Road crossing CV-106: (A) looking upstream; (B) looking downstream; (C) looking across; and photographs downstream of the Tote Road: (D) looking upstream; (E) looking downstream; and (F) looking across. | | | | | | |
| Baffinland Iron Mines<br>Mary River Project | |

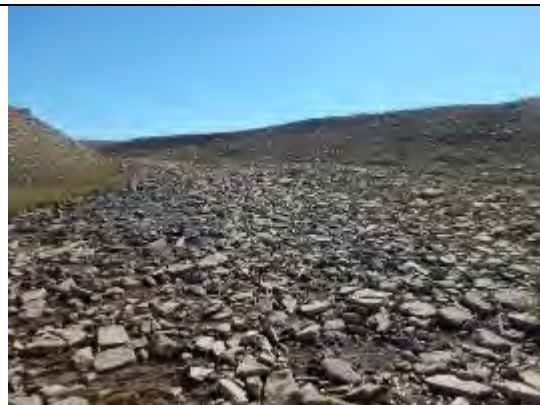
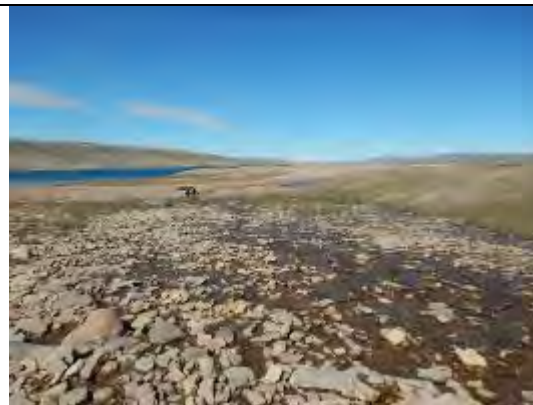
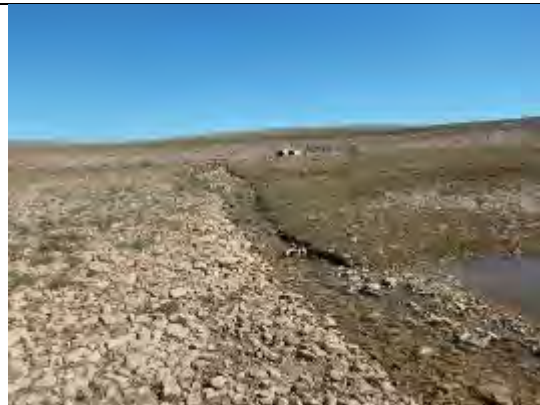
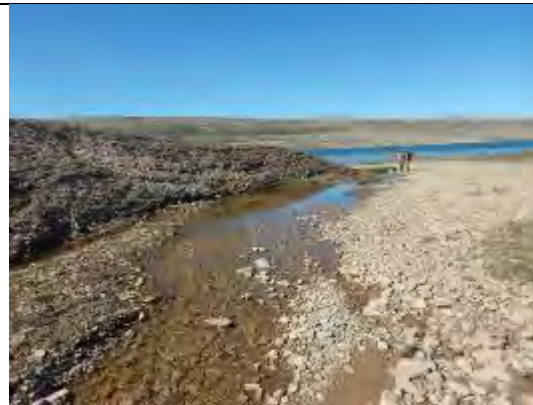
**Summary:** Though water levels are occasionally low (as in 2019), this stream provides summer rearing habitat for juvenile Arctic Char. No passage issues were identified in spring 2019.

| Location ID | Fish Habitat at Crossing (Y/N) | Fish Captured / Observed DS in 2019 | Fish Captured / Observed US in 2019 | Potential Project-Related Fish Passage or Habitat Issues | Fall 2019 Remediation Actions |
|---|---|---|---|---|---|
| CV-104 | Y | Y | N | NONE - Fish observed swimming up the culvert. Despite a lack of fish captured upstream, there are no obvious restrictions to movement. | N/A |

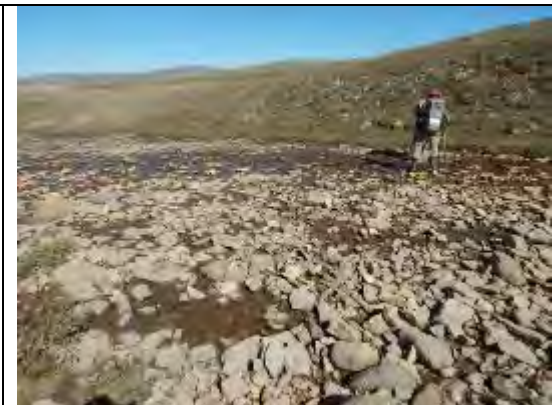
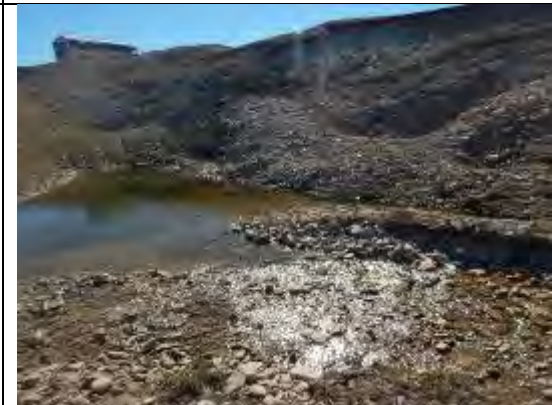
**Photos 1.** Photographs upstream of the Tote Road crossing CV-104: (A) looking upstream; (B) looking downstream; (C) looking across; and photographs downstream of the Tote Road: (D) looking upstream; (E) looking downstream; and (F) looking across.
