### DFO Tote Road Annual Report

**BAFFINLAND IRON MINES CORPORATION  
MARY RIVER PROJECT**

**FISH HABITAT MONITORING  
2019 ANNUAL REPORT  
EARLY REVENUE PHASE - TOTE ROAD UPGRADES**

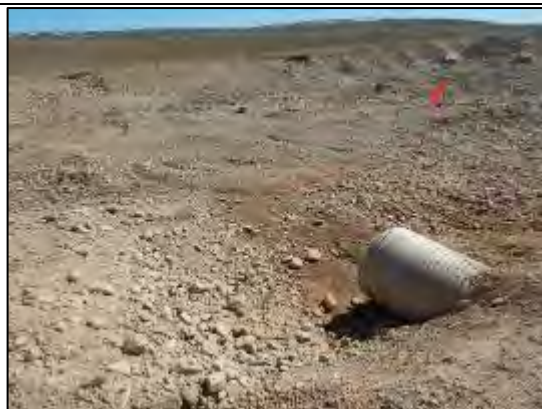
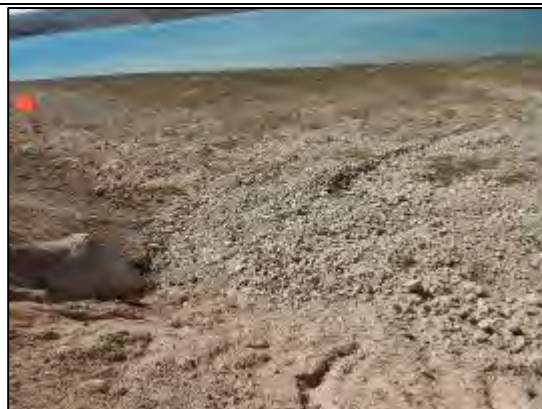
| Tote Road Site CV-203 | | | | | | |
|---|---|---|---|---|---|---|
| UTM Coordinates: 17W 521741 E 7952440 N | | Date Surveyed: 29-Jun-19 | | | | |
| Summary: Stream has been typically dry when surveyed and has no natural channel or habitat downstream and no connectivity to Phillips Creek. | | | | | | |
|

| | | | |
| A | | B | | | | |
| Photos 1. Photographs of the Tote Road crossing CV-203: (A) upstream end of culvert; and (B) downstream end of culvert. | | | | | | |
| Baffinland Iron Mines<br>Mary River Project | |

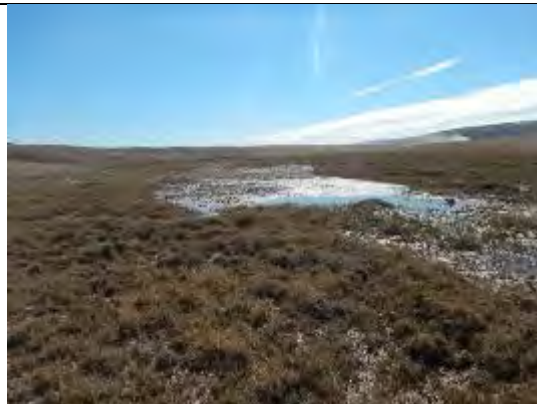
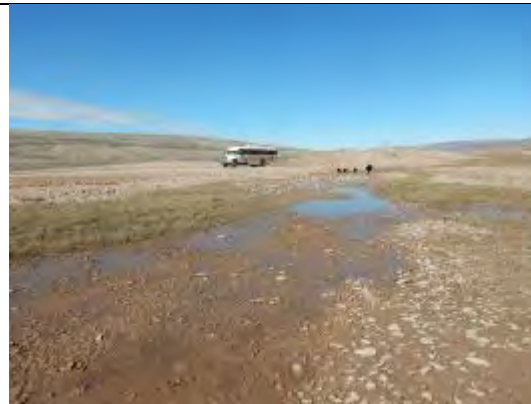
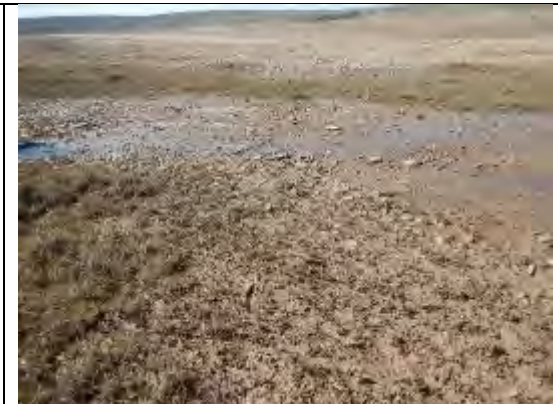
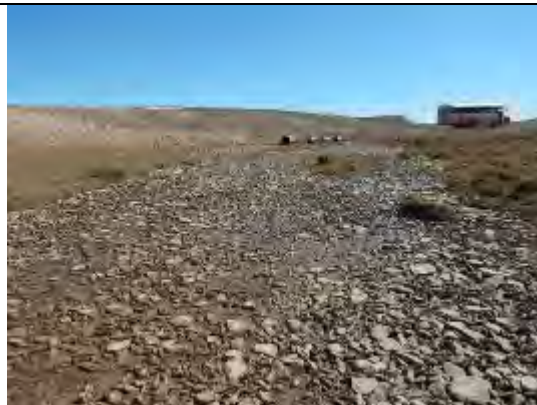
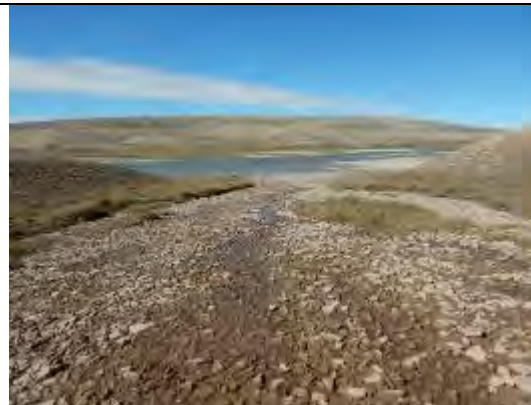
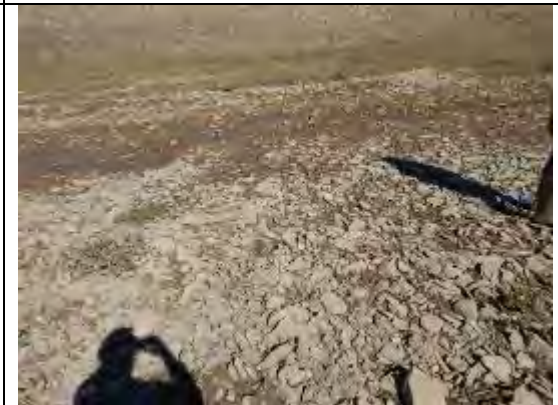
**Photos 1.** Photographs upstream of the Tote Road crossing CV-102: (A) looking upstream; (B) looking downstream; (C) looking across; and photographs downstream of the Tote Road: (D) looking upstream; (E) looking downstream; and (F) looking across.

**Summary:** This stream typically provides summer rearing habitat for juvenile Arctic Char, but low water levels in spring 2019 restricted fish use.

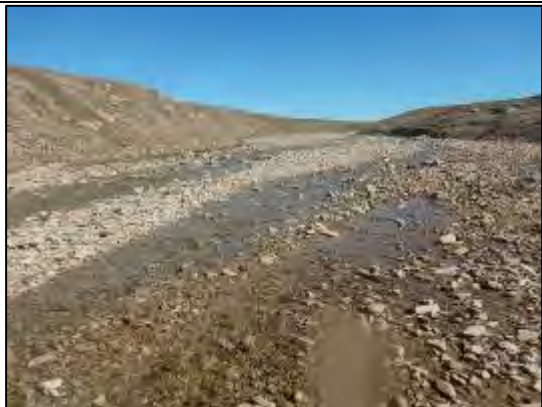
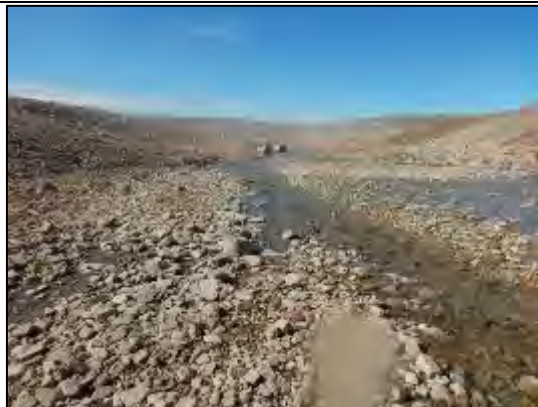
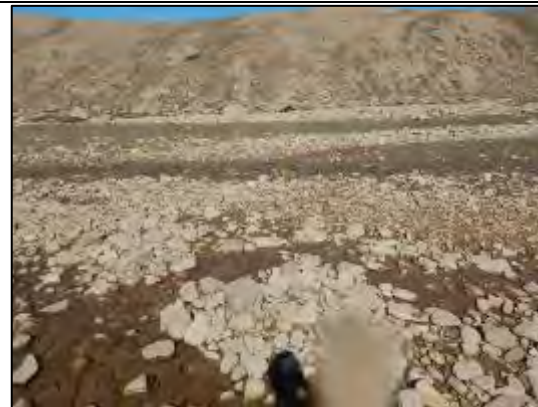
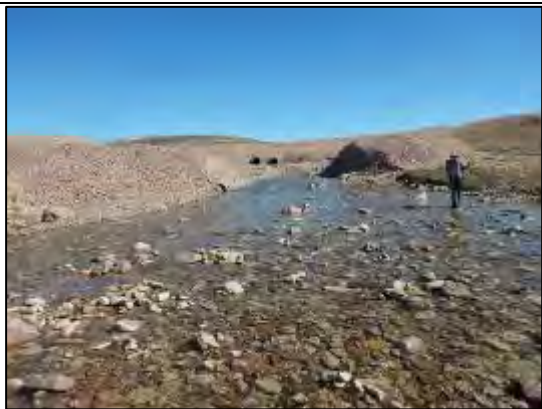
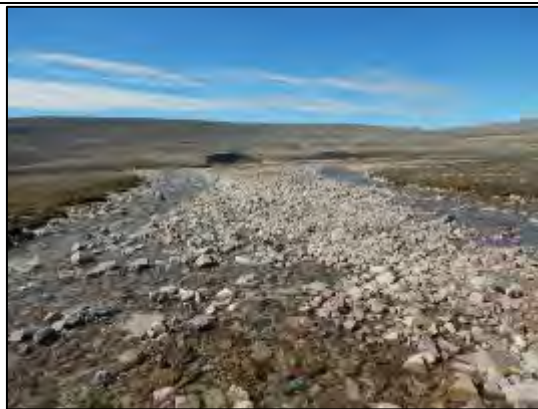
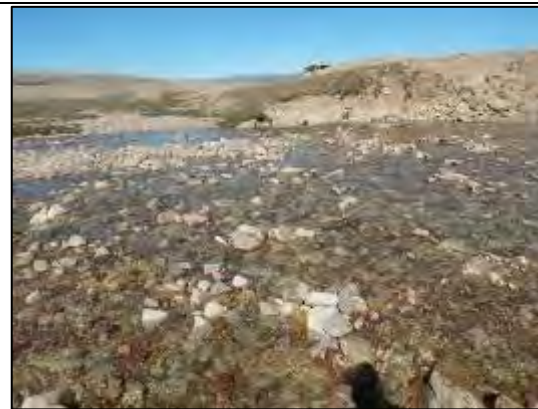
**Photos 1.** Photographs upstream of the Tote Road crossing CV-099: (A) looking upstream; (B) looking downstream; (C) looking across; and photographs downstream of the Tote Road: (D) looking upstream; (E) looking downstream; and (F) looking across.

**Summary:** A large stream with abundant fish habitat. Water velocities in the culverts appeared to have restricted upstream access to larger juveniles during some annual surveys, but no fish passage issues were identified in spring 2019.

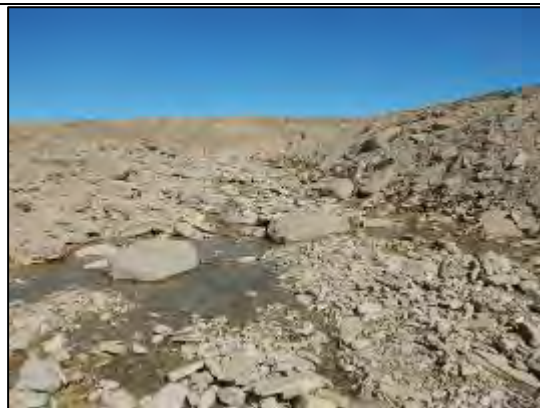
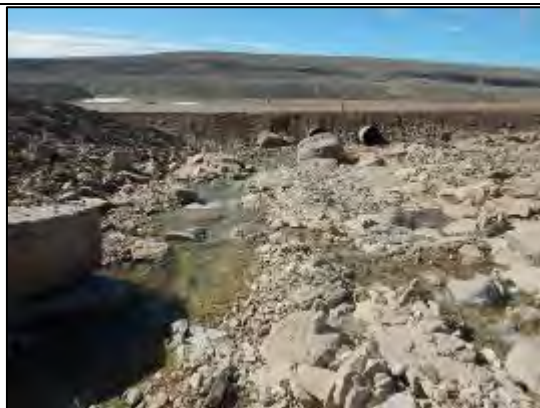
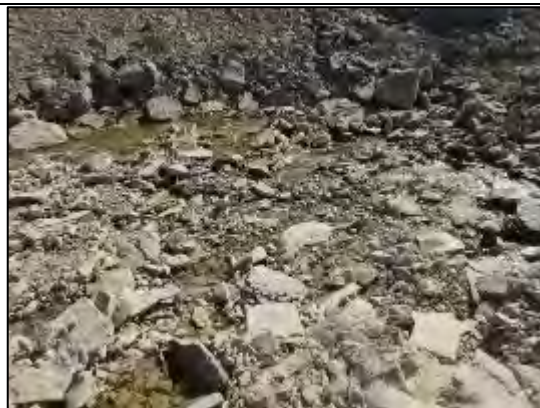
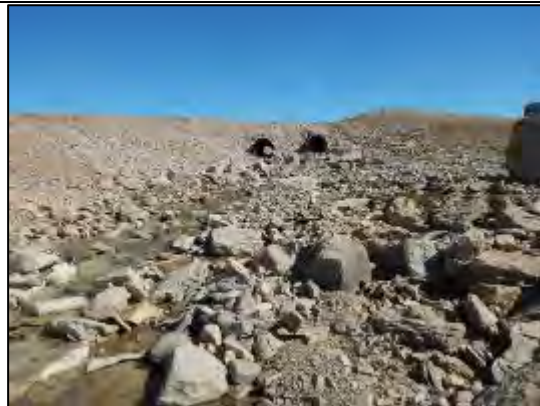
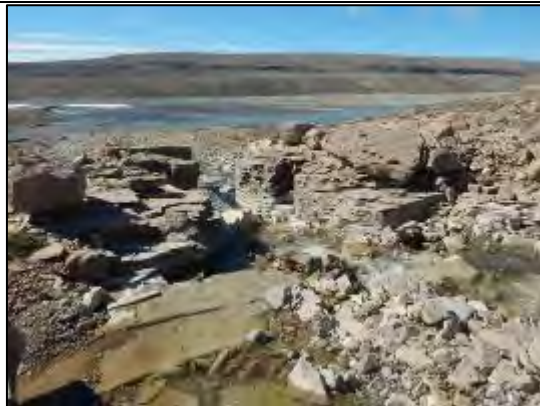
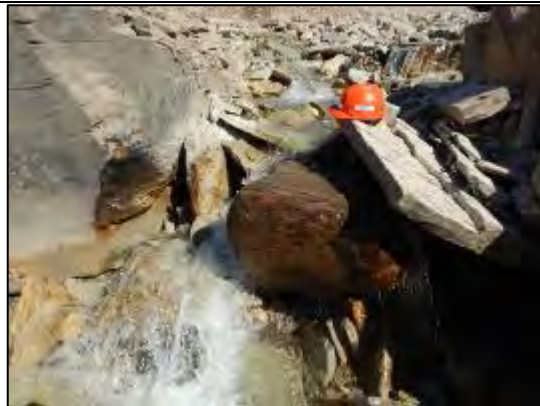
| Tote Road Site CV-094 | | | |
|---|---|---|---|
| Summary: Site provides good quality summer rearing habitat for juvenile Arctic Char but a natural downstream vertical barrier prevents access from overwintering habitat. Fish cannot naturally access upstream habitat. | | | |
| Photos 1. Photographs upstream of the Tote Road crossing CV-094: (A) looking upstream; (B) looking downstream; (C) looking across; and photographs downstream of the Tote Road: (D) looking upstream; (E) looking downstream; and (F) a vertical barrier preventing fish access. | | | |

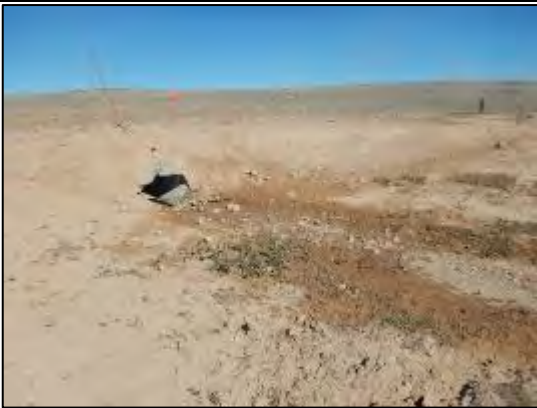
| Tote Road Site CV-086 | | | |
|---|--|---|---|
| <b>Summary:</b> No natural channel or surface water and not connected to overwintering habitat. | | | |
| <b>Photos 1.</b> Photograph of the Tote Road crossing CV-086 from downstream looking upstream. | | | |

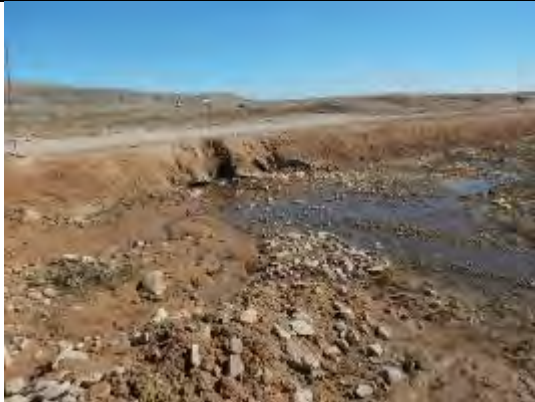
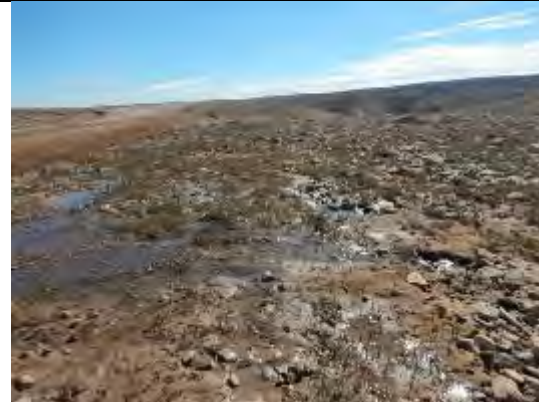
| Tote Road Site CV-082 | | | |
|---|--|---|---|
| Summary: There is consistently very little water, no natural channel, and a steep downstream gradient all of which prevent access from overwintering habitat. | | | |
| Photos 1. Photographs downstream of the Tote Road crossing CV-082: (A) looking upstream; and (B) looking downstream at subflow barrier. | | | |

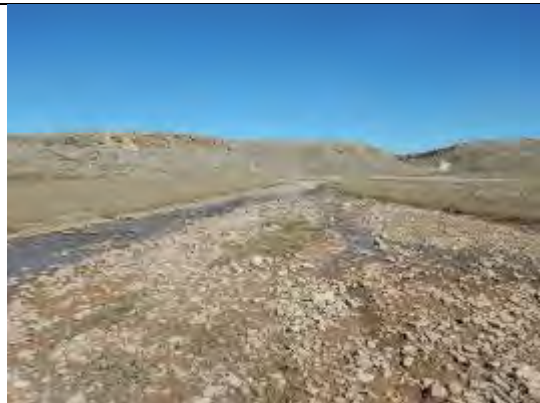
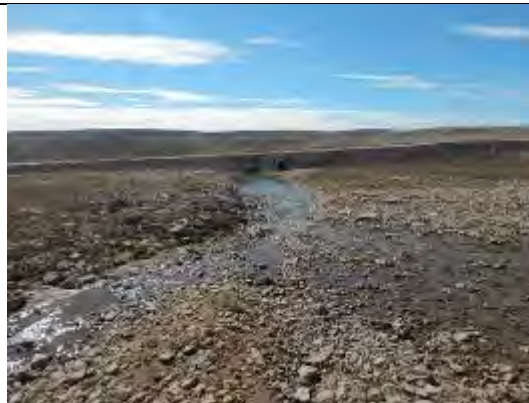
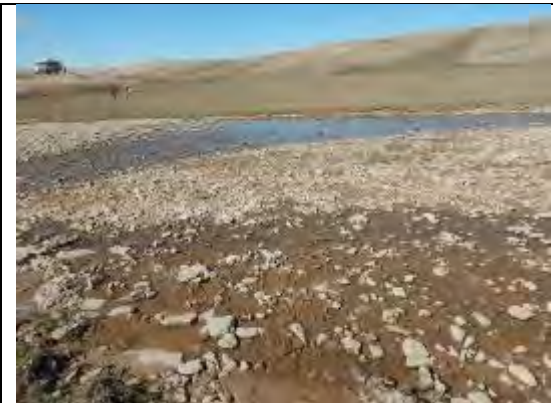
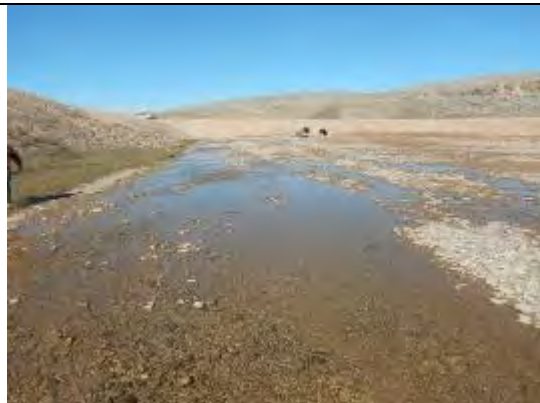
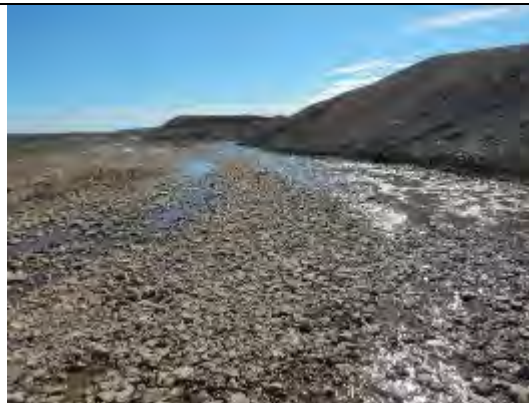
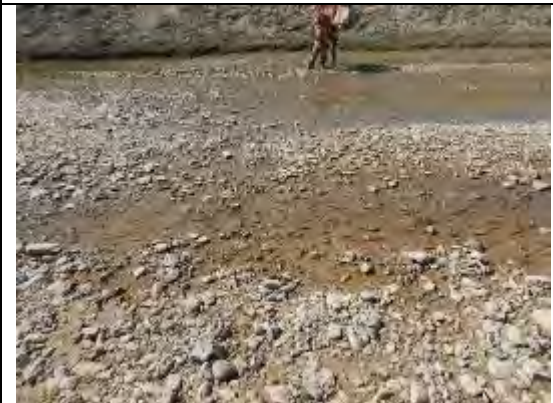
**Photos 1.** Photographs upstream of the Tote Road crossing CV-079: (A) looking upstream; (B) looking downstream; (C) looking across; and photographs downstream of the Tote Road: (D) looking upstream; (E) looking downstream; and (F) looking across.

**Summary:** Site provides abundant summer rearing habitat for juvenile Arctic Char. There were no fish passage issues identified in spring 2019.

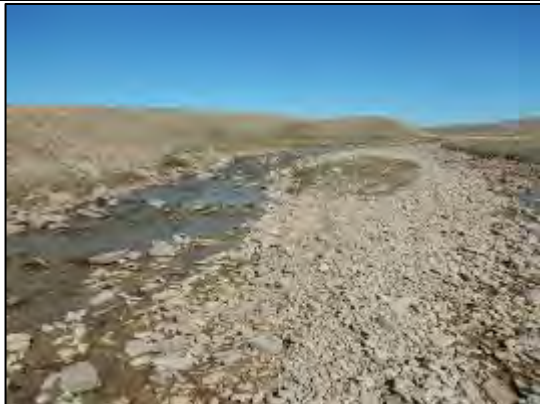
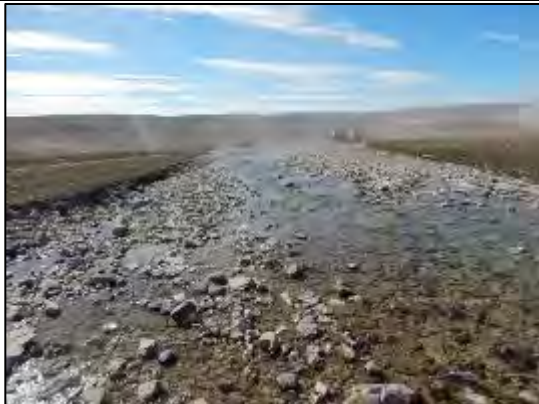
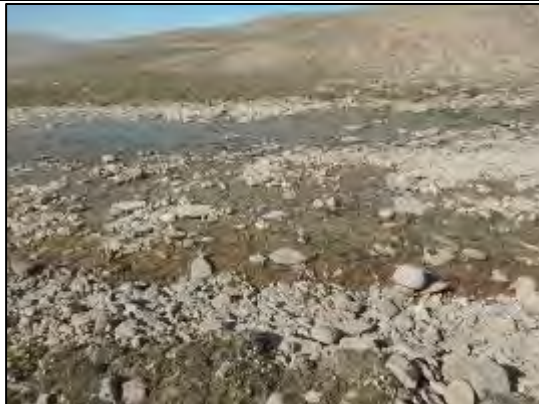
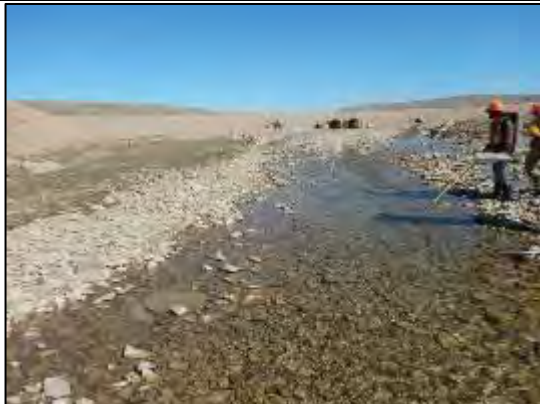
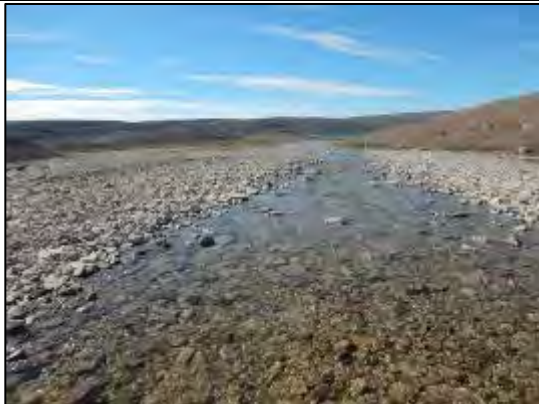
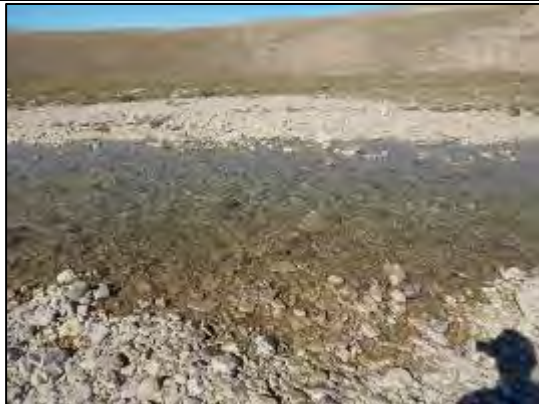
| Tote Road Site CV-078 | | | |
|---|---|---|---|
| Summary: Site provides abundant summer rearing habitat for juvenile Arctic Char. There were no fish passage issues identified in spring 2019. | | | |
| Photos 1. Photographs upstream of the Tote Road crossing CV-078: (A) looking upstream; (B) looking downstream; (C) looking across; and photographs downstream of the Tote Road: (D) looking upstream; (E) looking downstream; and (F) looking across. | | | |

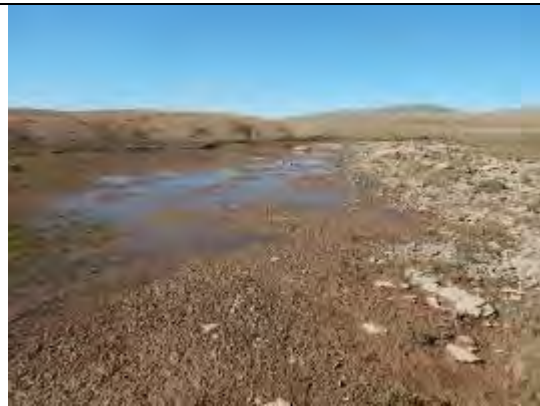
**A**

**Summary:** Small stream providing summer rearing habitat for juvenile Arctic Char. There were no fish passage issues identified in spring 2019.

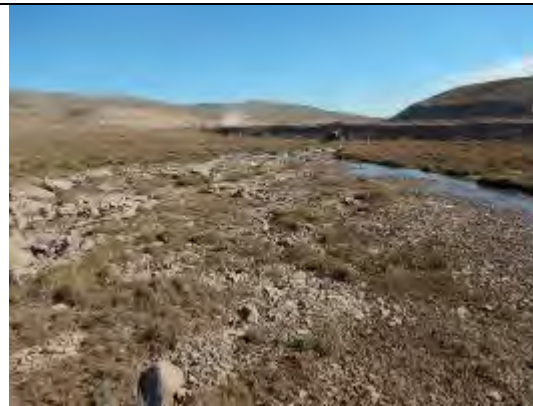
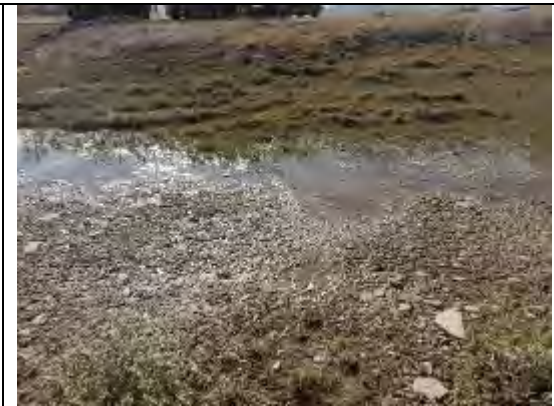
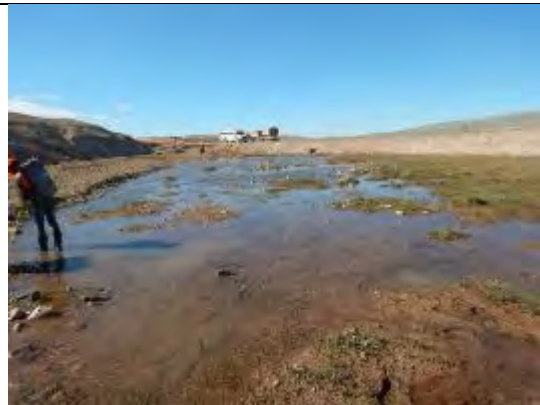
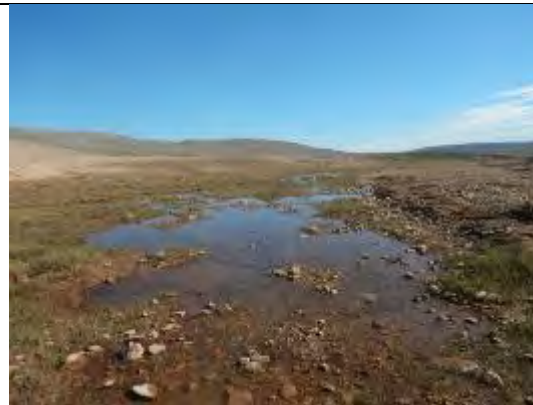
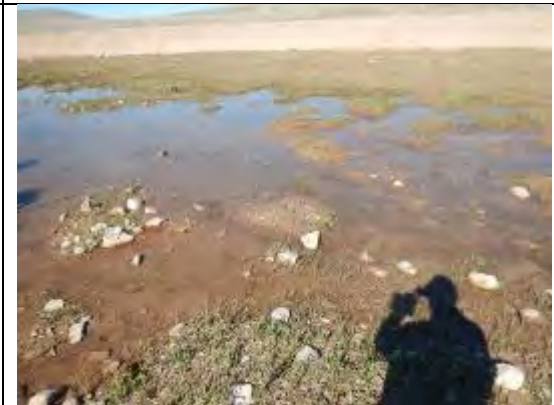
**Photos 1.** Photographs upstream of the Tote Road crossing CV-076: (A) looking upstream; (B) looking downstream; (C) looking across; and photographs downstream of the Tote Road: (D) looking upstream; (E) looking downstream; and (F) looking across.

| Culvert ID | Proposed Culvert Diameter (m) | Proposed Culvert Length (m) | Area of rip rap (m2) | Proposed works to be completed |
|---|---|---|---|---|
| CV076 | 1 | 11.5 | 0 | Replace with new length of 11.5m |

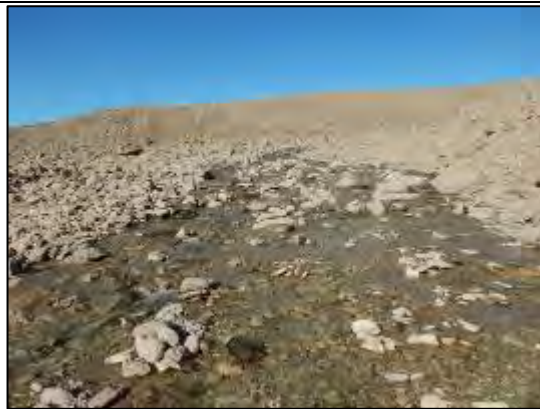
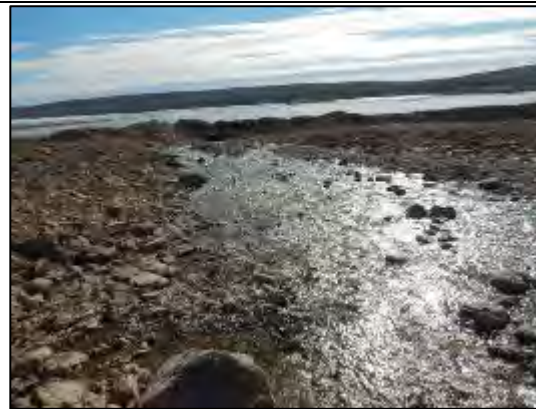
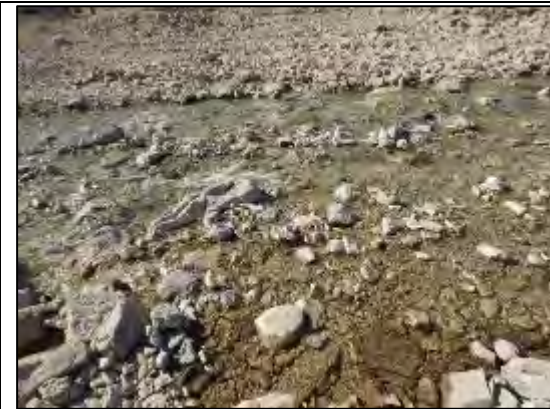
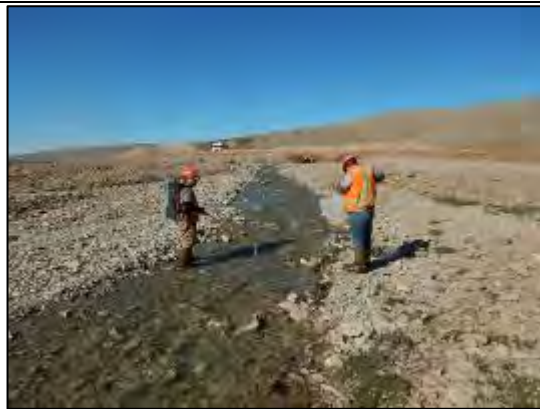
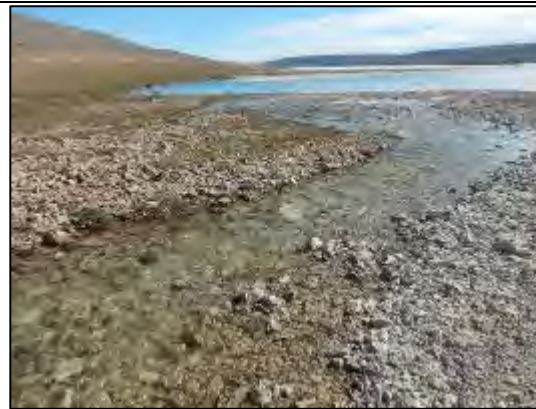
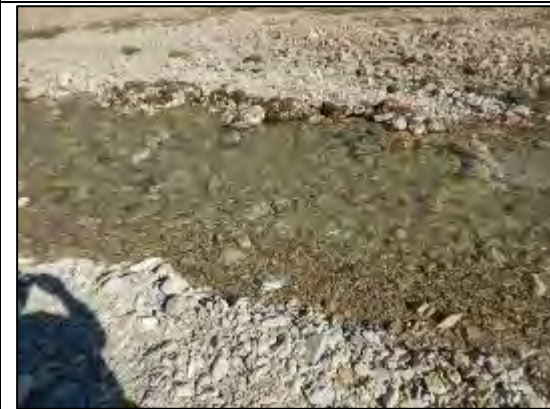
**Summary:** Site provides abundant summer rearing habitat for juvenile Arctic Char. There were no fish passage issues identified in spring 2019.

**Photos 1.** Photographs upstream of the Tote Road crossing CV-072: (A) looking upstream; (B) looking downstream; (C) looking across; and photographs downstream of the Tote Road: (D) looking upstream; (E) looking downstream; and (F) looking across.

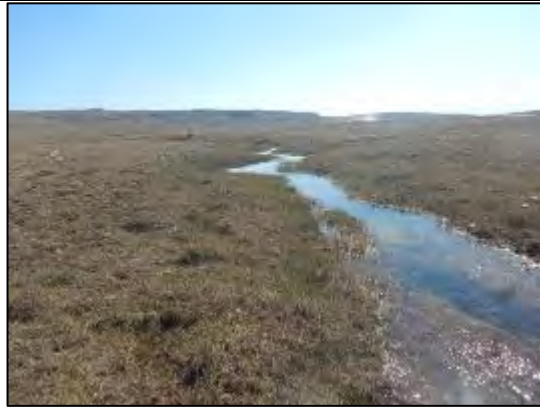
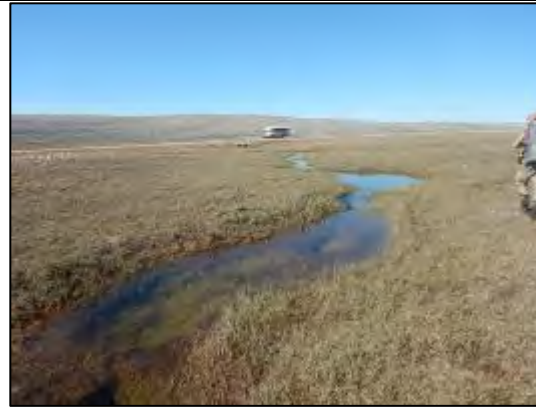
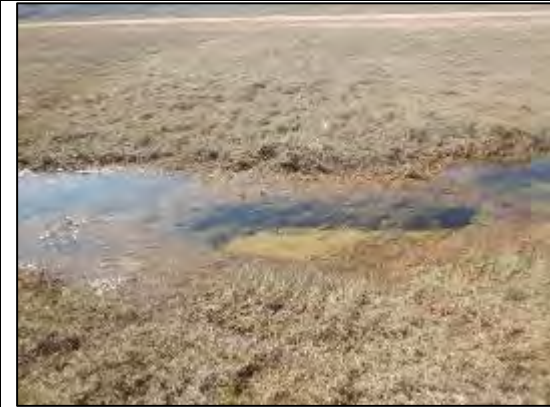
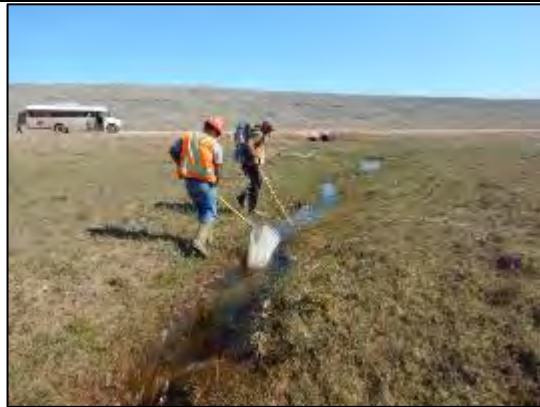
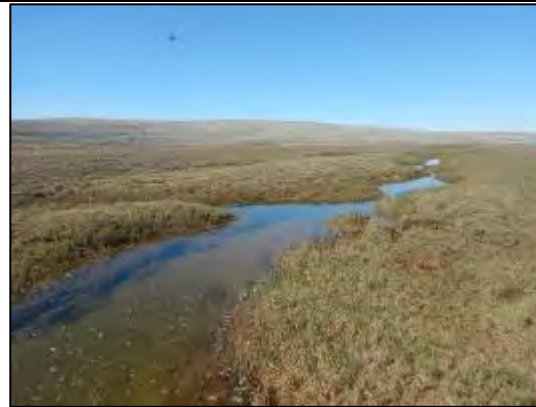
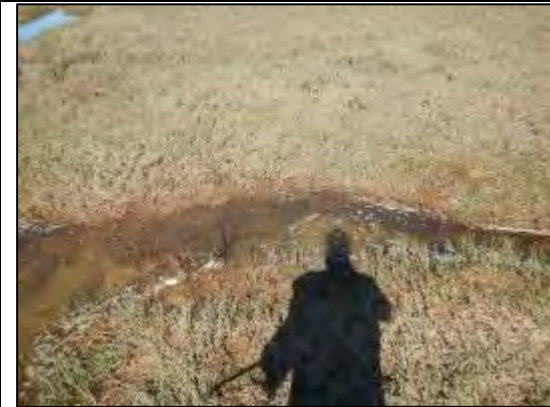
**Summary:** Site provides abundant summer rearing habitat for juvenile Arctic Char. There were no fish passage issues identified in spring 2019.

**Photos 1.** Photographs upstream of the Tote Road crossing CV-060: (A) looking upstream; (B) looking downstream; (C) looking across; and photographs downstream of the Tote Road: (D) looking upstream; (E) looking downstream; and (F) looking across.

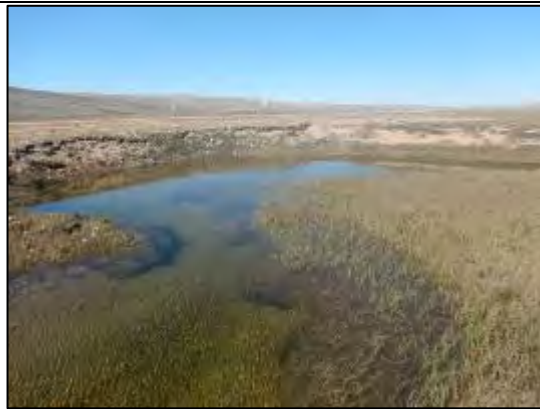
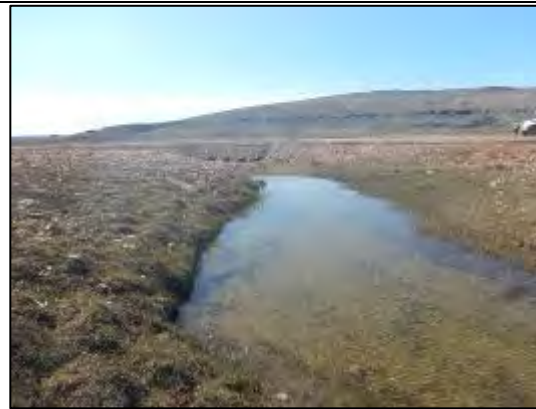
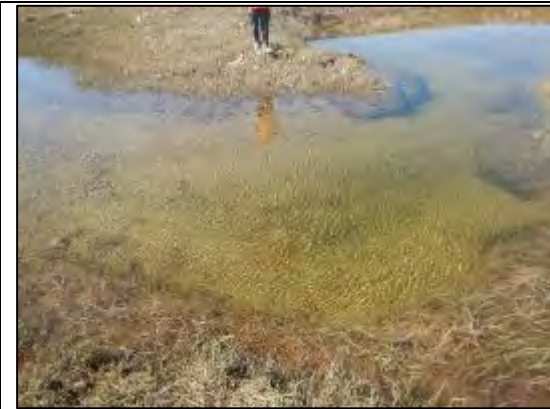
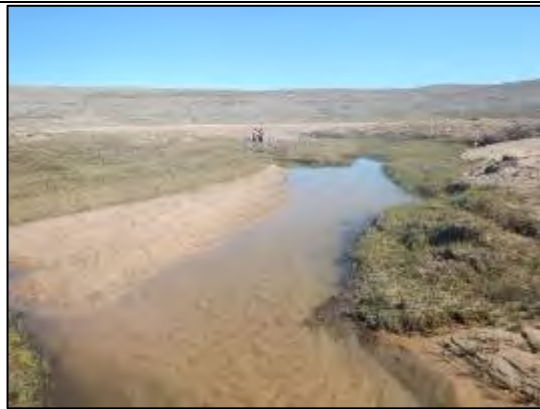
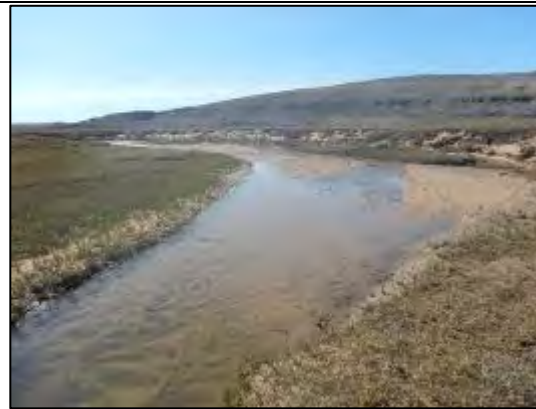
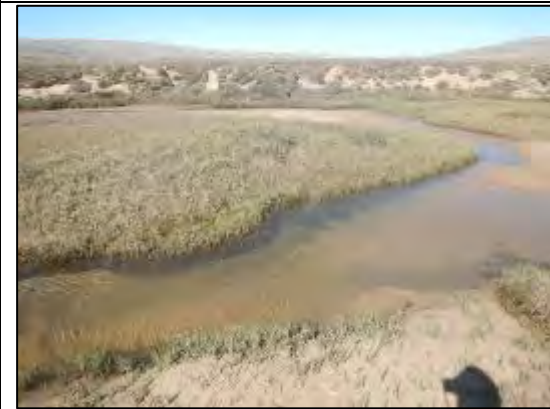
**Summary:** Site provides abundant summer rearing habitat for juvenile Arctic Char. There were no fish passage issues identified in spring 2019.

**Photos 1.** Photographs upstream of the Tote Road crossing CV-059: (A) looking upstream; (B) looking downstream; (C) looking across; and photographs downstream of the Tote Road: (D) looking upstream; (E) looking downstream; and (F) looking across.

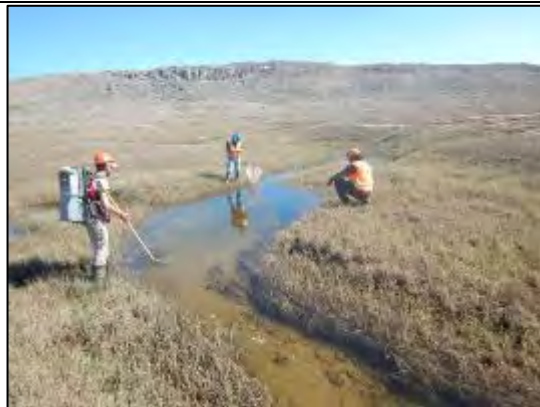
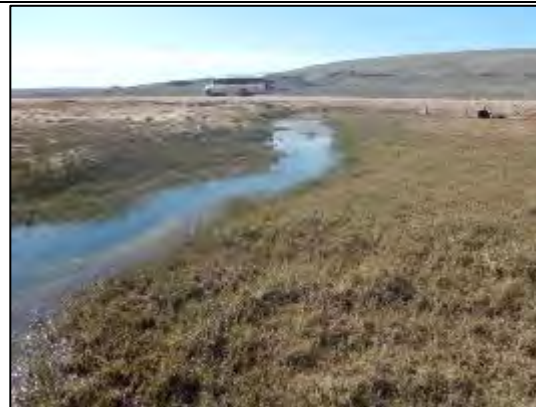
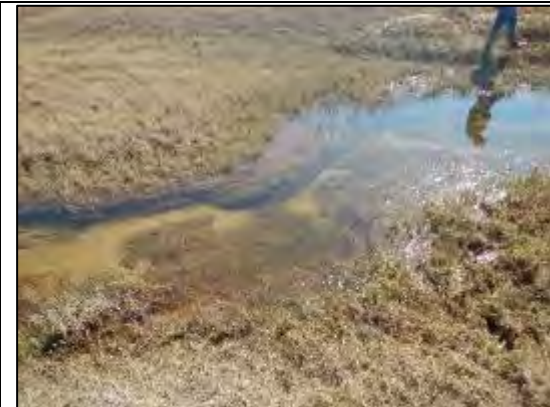
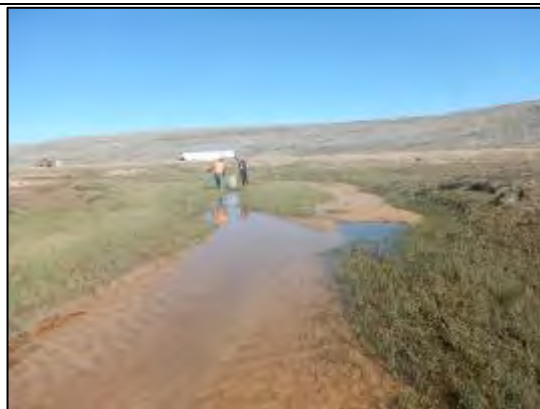
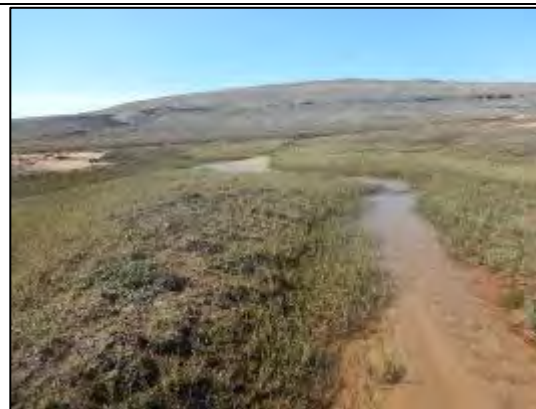
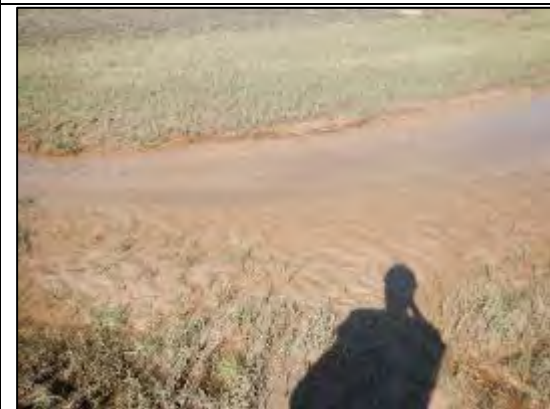
**Summary:** Site provides abundant summer rearing habitat for juvenile Arctic Char. There were no fish passage issues identified in spring 2019.

**Photos 1.** Photographs upstream of the Tote Road crossing CV-058: (A) looking upstream; (B) looking downstream; (C) looking across; and photographs downstream of the Tote Road: (D) looking upstream; (E) looking downstream; and (F) looking across.

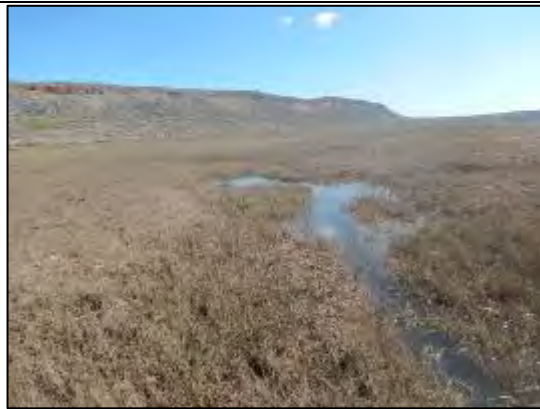
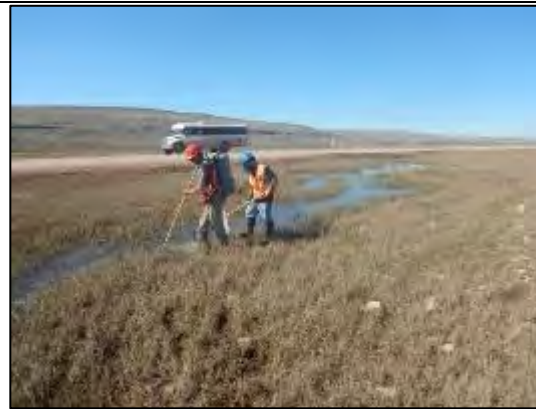
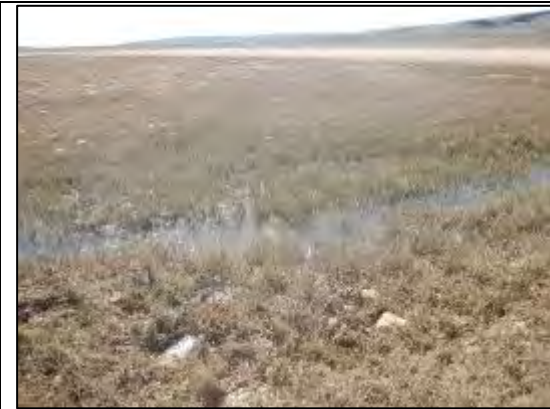
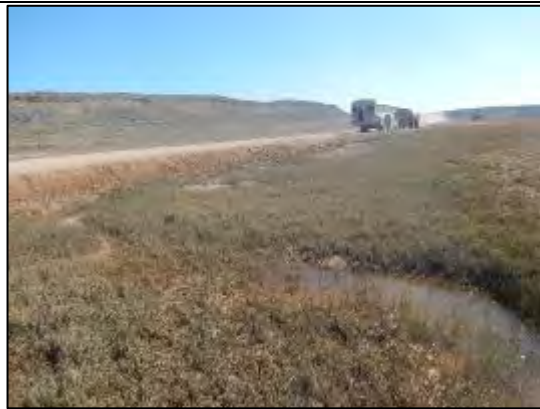
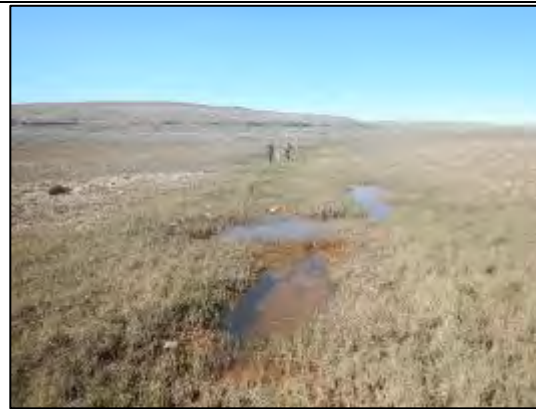
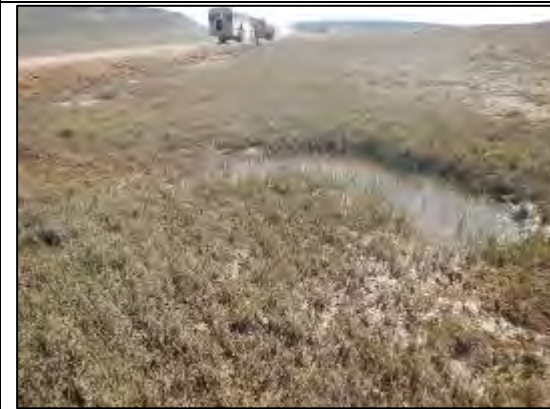
**Summary:** Site provides some summer rearing habitat for juvenile Arctic Char. There were no fish passage issues identified in spring 2019.

**Photos 1.** Photographs upstream of the Tote Road crossing CV-057: (A) looking upstream; (B) looking downstream; (C) looking across; and photographs downstream of the Tote Road: (D) looking upstream; (E) looking downstream; and (F) looking across.

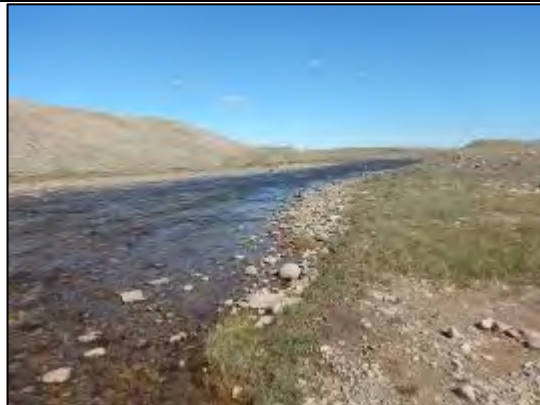
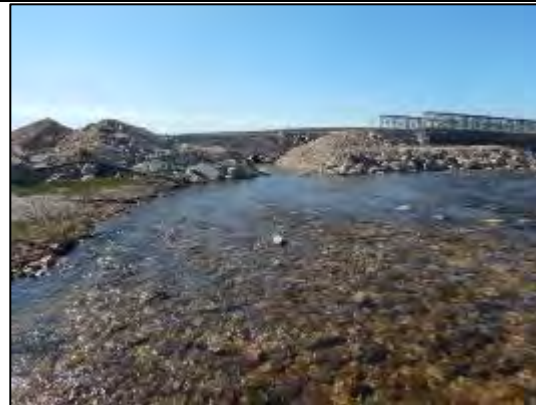
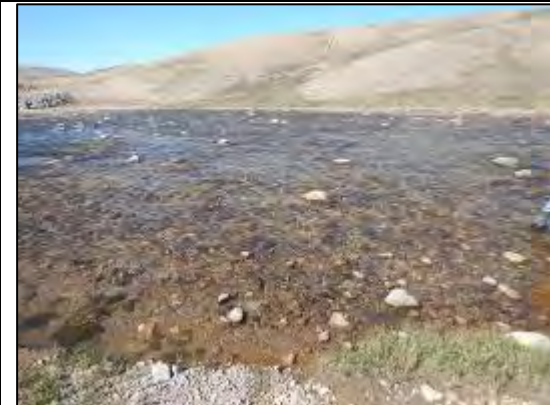
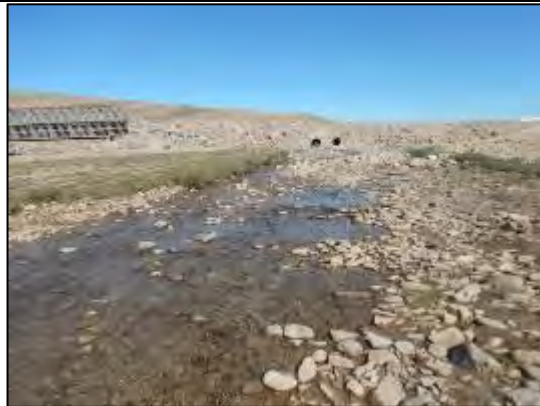
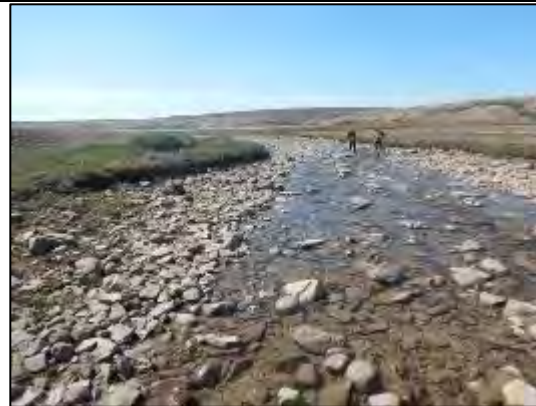
**Summary:** Large river with abundant habitat for both species. One channel is crossed by a bridge and the other with two culverts. Culverts were perched, blocking fish movements, in spring 2019 and remediation work was conducted in fall 2019.

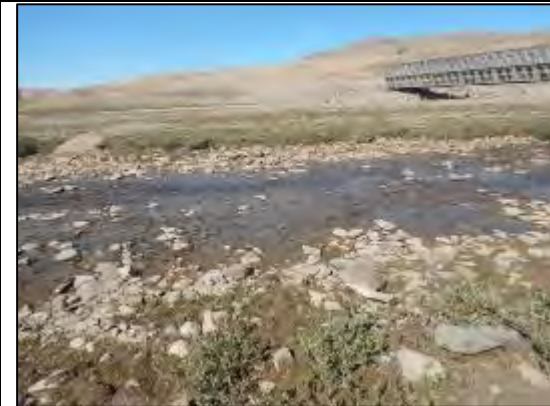
**F**

**Photos 1.** Photographs upstream of the Tote Road crossing BG-50: (A) looking upstream; (B) looking downstream; (C) looking across; and photographs downstream of the Tote Road: (D) looking upstream; (E) looking downstream; and (F) looking across.

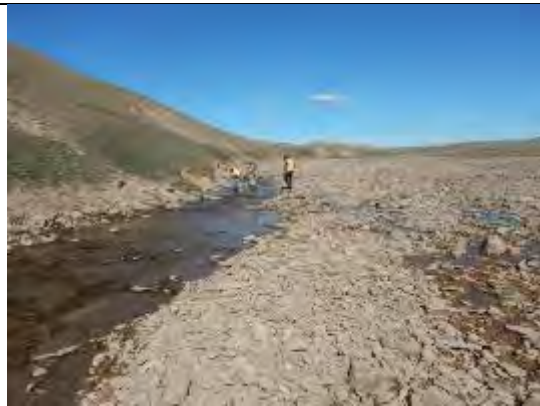
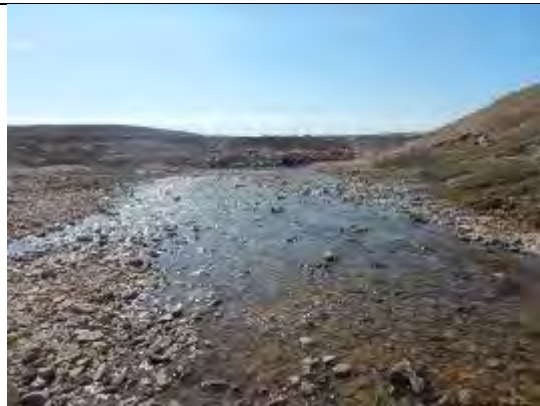
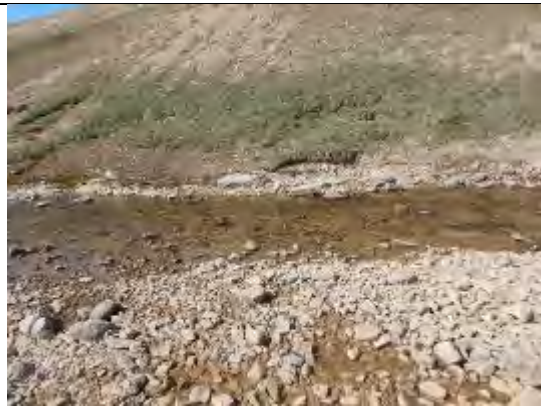
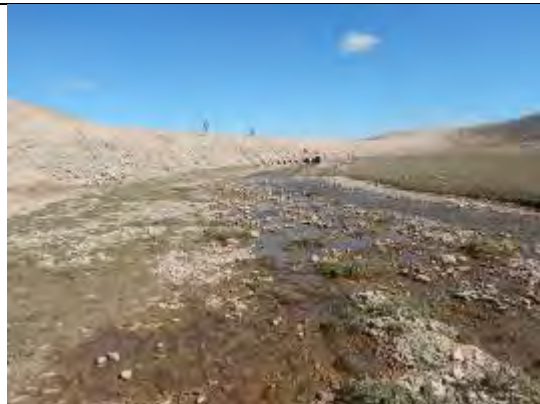
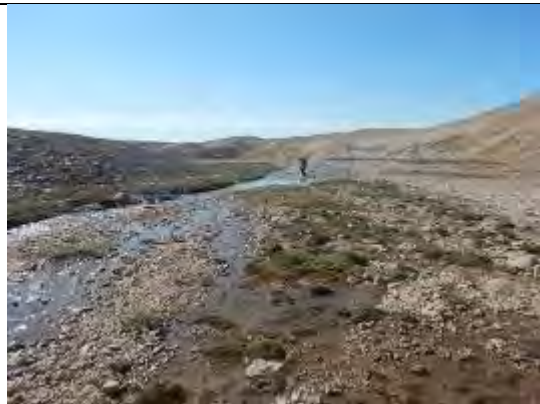
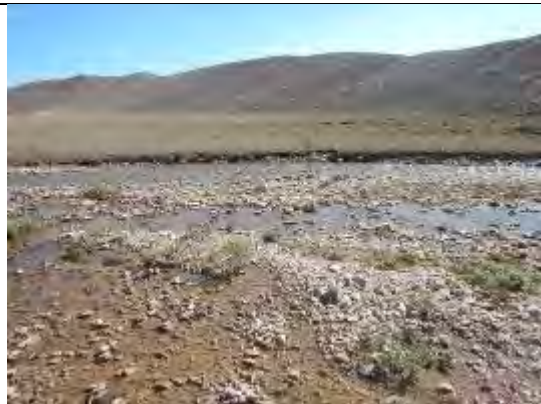
| Tote Road Site CV-049 | | | |
|---|--|---|---|
| Summary: Site provides abundant summer rearing habitat for juvenile Arctic Char. There were no fish passage issues identified in spring 2019. | | | |
| Photos 1. Photographs upstream of the Tote Road crossing CV-049: (A) looking upstream; (B) looking downstream; (C) looking across; and photographs downstream of the Tote Road: (D) looking upstream; (E) looking downstream; and (F) looking across. | | | |

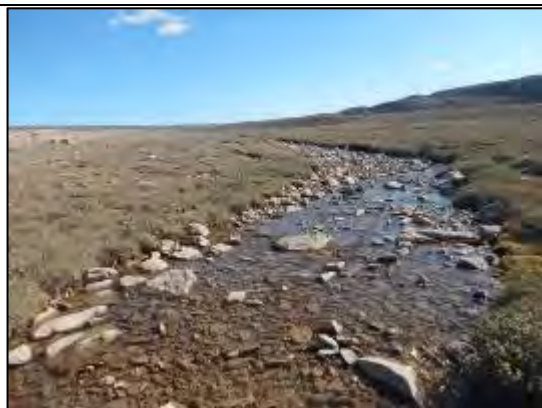
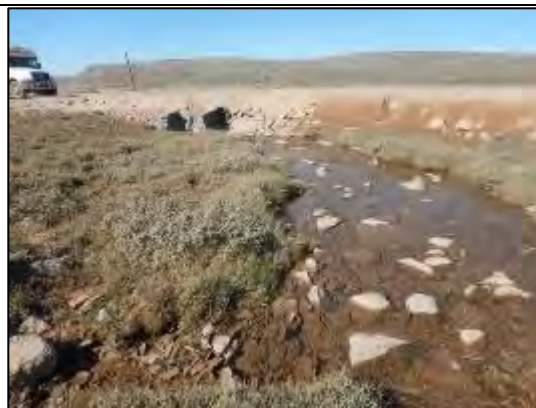
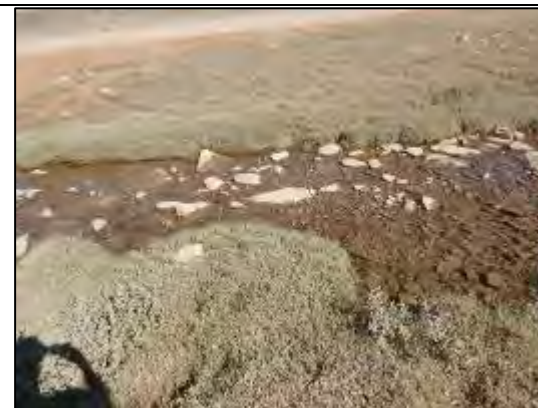
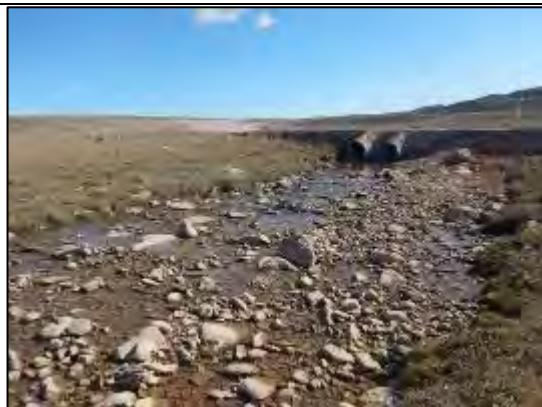
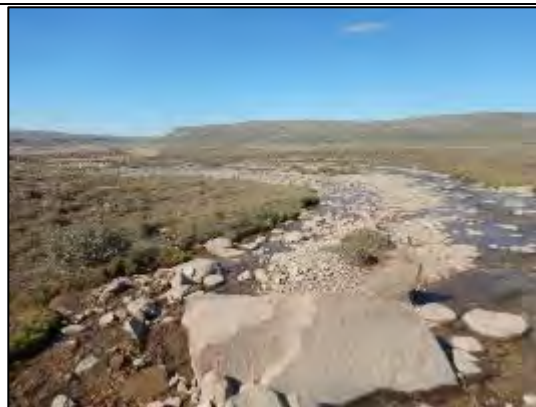
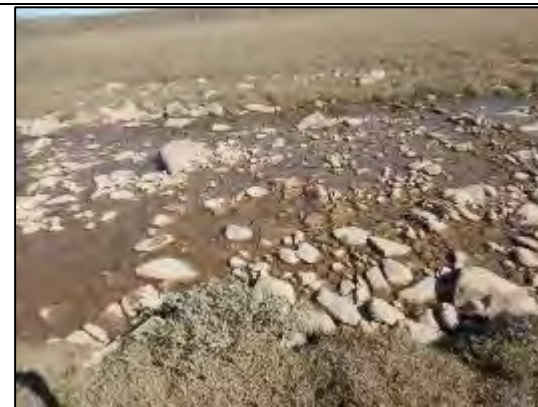
**Summary:** Stream provides aquatic habitat at the Tote Road crossing, but a persistent natural downstream subsurface flow barrier near its confluence with CV-049 prevents access from downstream overwintering lakes.

**Photos 1.** Photographs upstream of the Tote Road crossing CV-048: (A) looking upstream; (B) looking downstream; (C) looking across; and photographs downstream of the Tote Road: (D) looking upstream; (E) looking downstream; and (F) looking across.
