### DFO Tote Road Annual Report

**BAFFINLAND IRON MINES CORPORATION  
MARY RIVER PROJECT**

**FISH HABITAT MONITORING  
2019 ANNUAL REPORT  
EARLY REVENUE PHASE - TOTE ROAD UPGRADES**

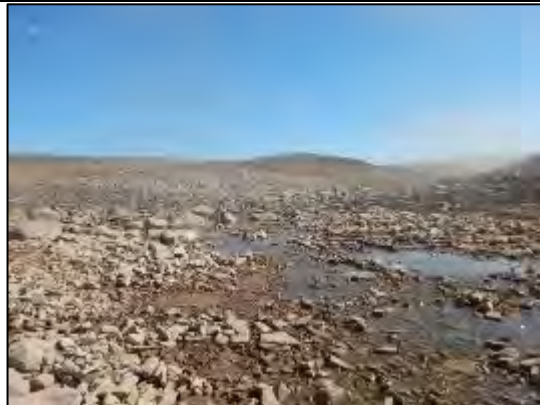
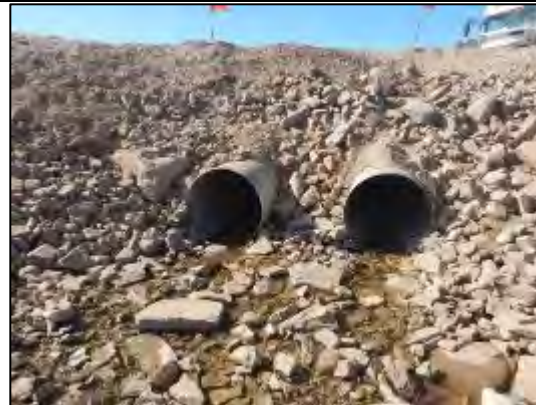
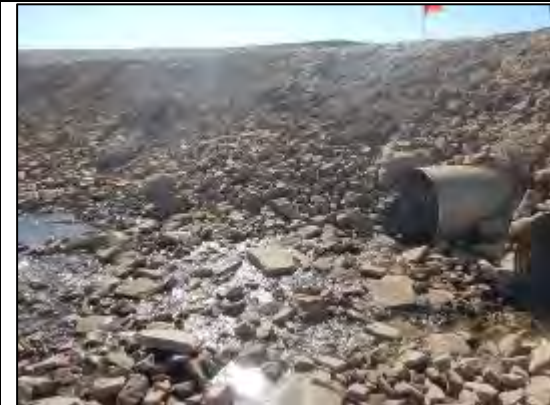
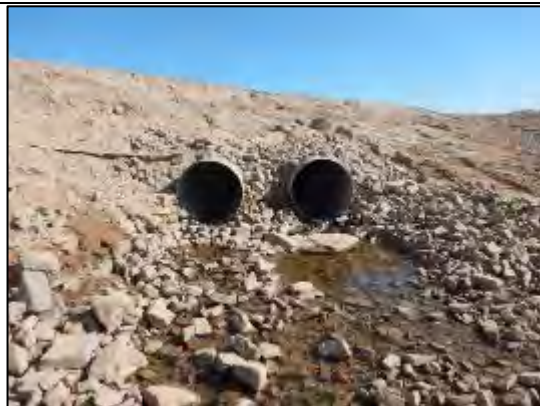
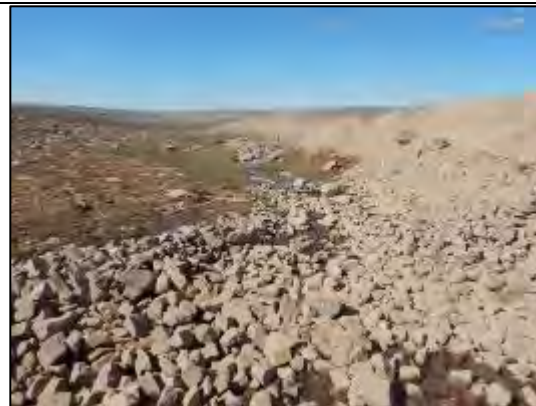
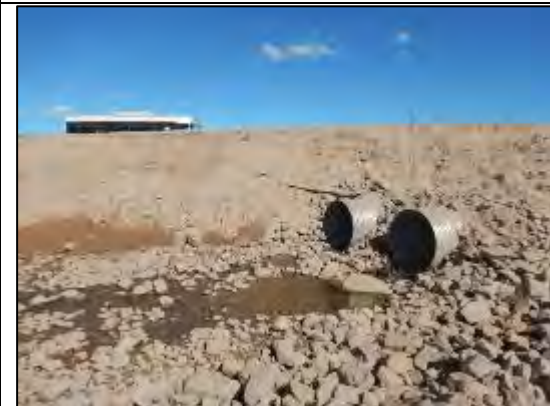
**Summary:** Stream provides aquatic habitat at the Tote Road crossing, but a persistent natural downstream subsurface flow barrier near its confluence with CV-049 prevents access from downstream overwintering lakes.

**Photos 1.** Photographs upstream of the Tote Road crossing CV-046: (A) looking upstream; (B) looking downstream; (C) looking across; and photographs downstream of the Tote Road: (D) looking upstream; (E) looking downstream; and (F) looking across.

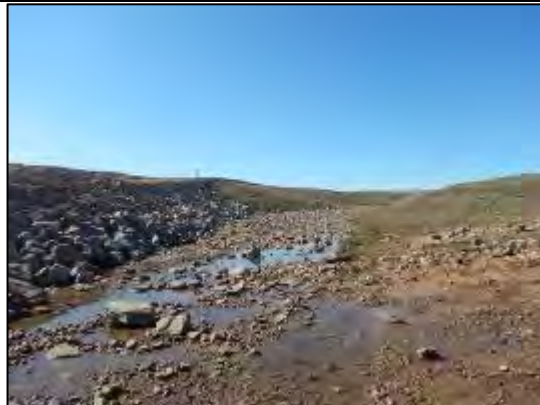
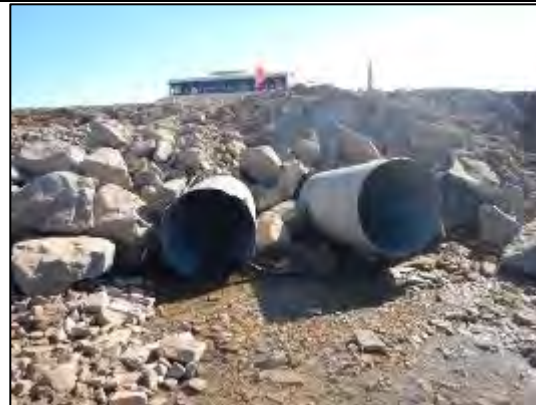
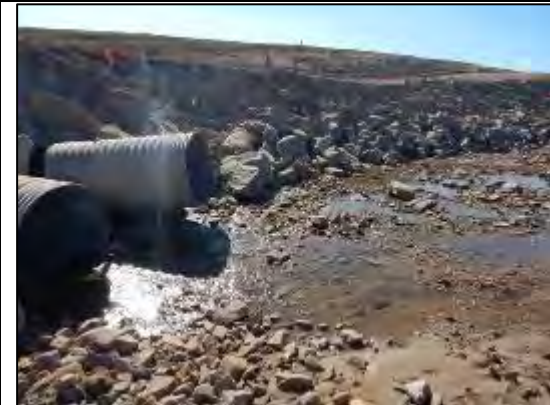
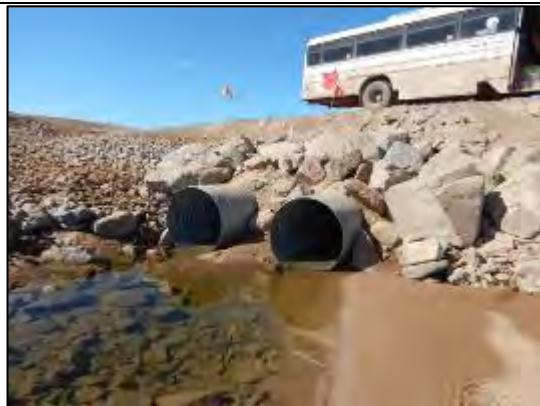
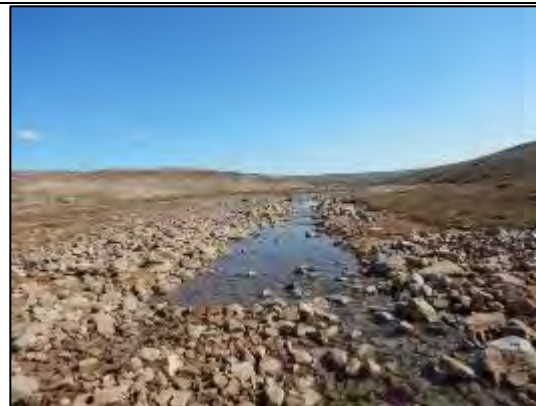
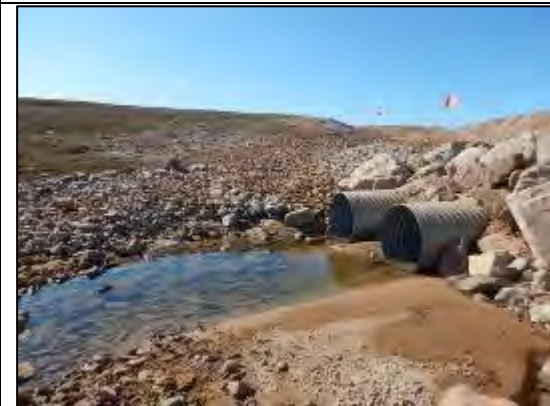
**Summary:** There is consistent surface flow at the crossing, but natural annual subsurface flows several hundred meters downstream, combined with large distance to overwintering habitat prevent fish access to the crossing.

**Photos 1.** Photographs upstream of the Tote Road crossing CV-040: (A) looking upstream; (B) looking downstream; (C) looking across; and photographs downstream of the Tote Road: (D) looking upstream; (E) looking downstream; and (F) looking across.

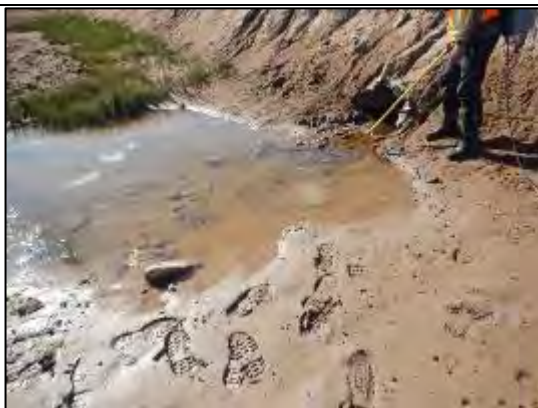
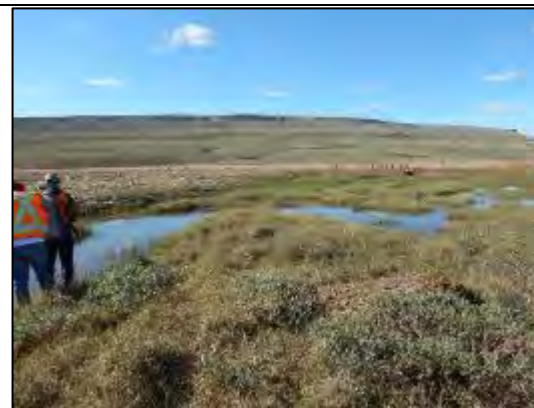
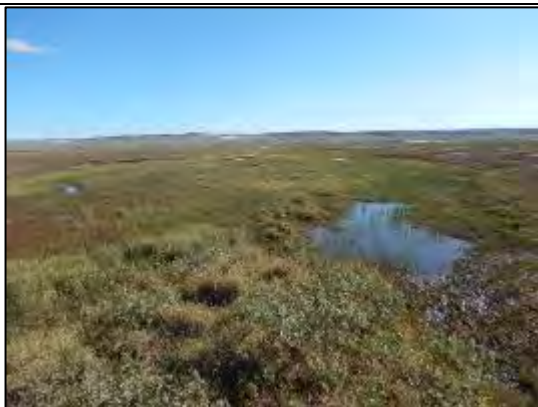
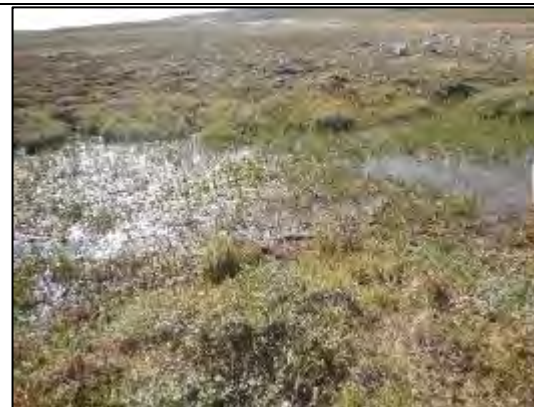
**Summary:** Arctic Char use of this stream is minimal due to consistently low water levels and lack of a clearly defined channel, but Ninespine Stickleback are typically abundant. There were no fish passage issues identified in spring 2019.

**Photos 1.** Photographs downstream of the Tote Road crossing CV-030: (A) showing the culvert; (B) looking upstream; (C) looking downstream; and (D) looking across.

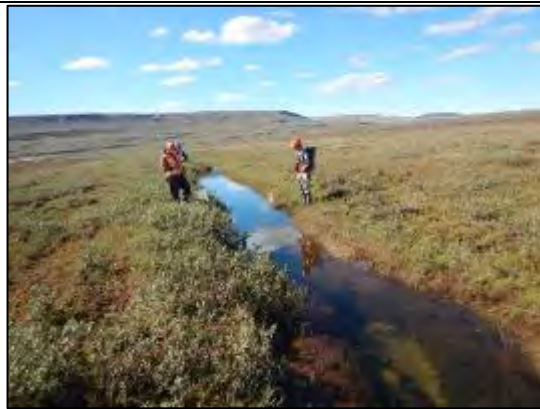
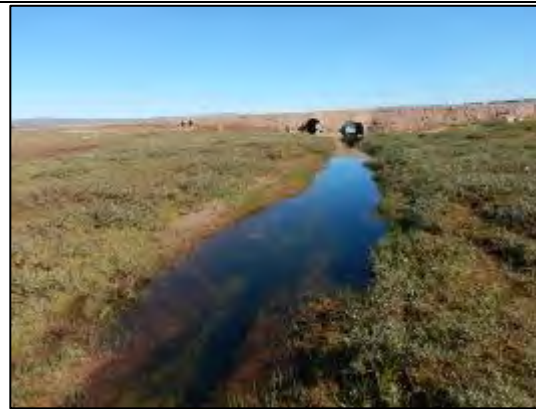
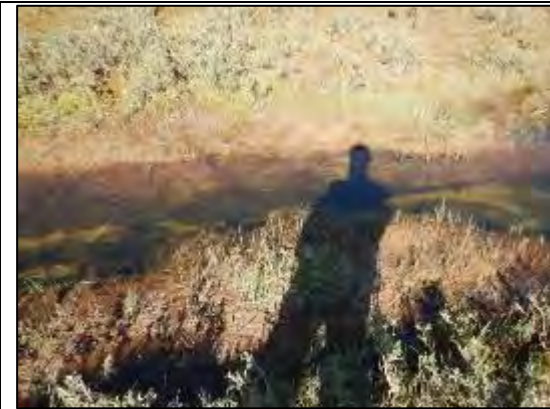
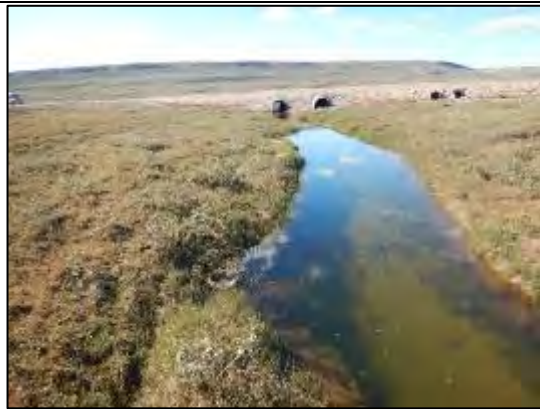
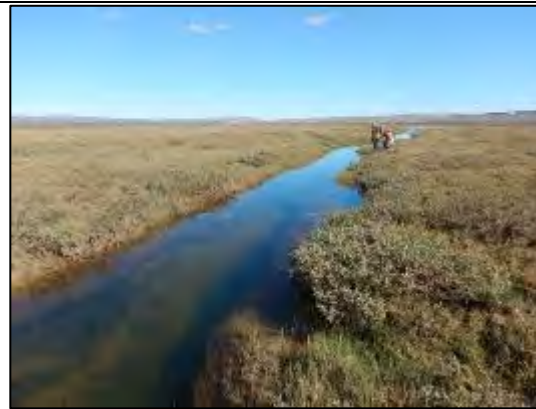
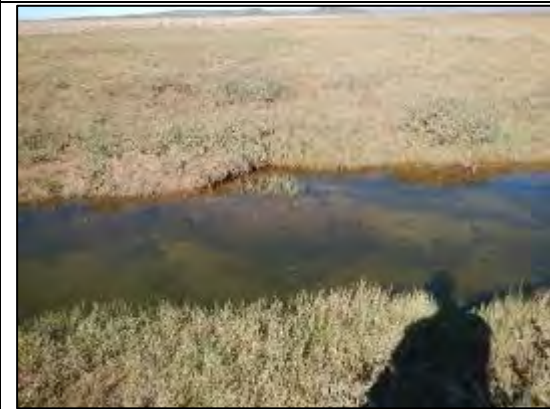
**Summary:** Consistently provides abundant, good quality rearing habitat for both species. There were no fish passage issues identified in spring 2019.

**Photos 1.** Photographs upstream of the Tote Road crossing BG-32 (A) looking upstream; (B) looking downstream; (C) looking across; and photographs downstream of the Tote Road: (D) looking upstream; (E) looking downstream; and (F) looking across.

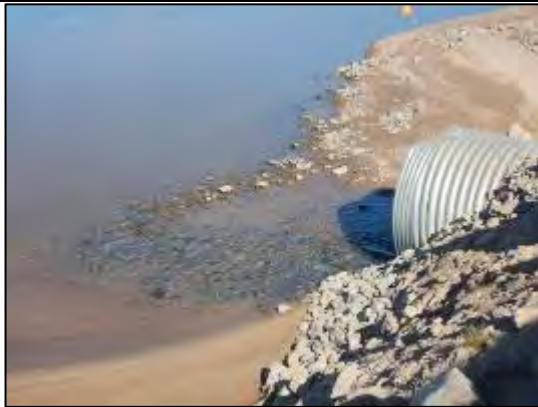
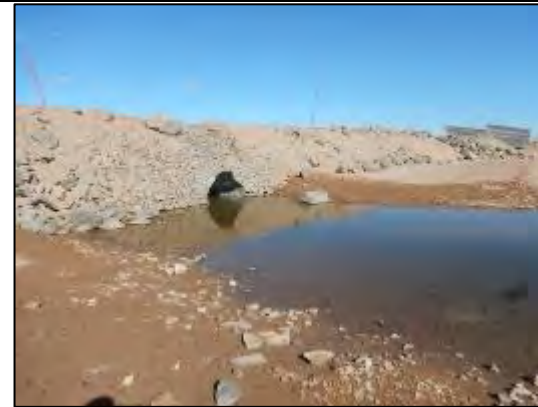
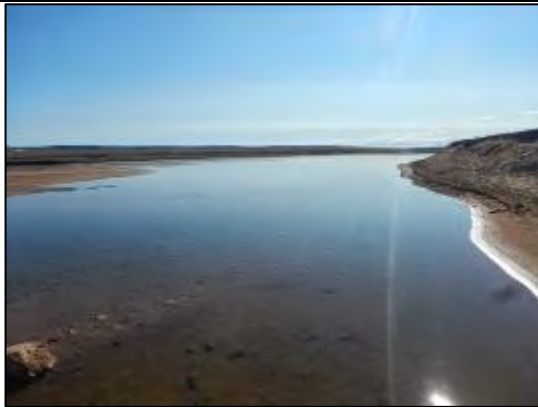
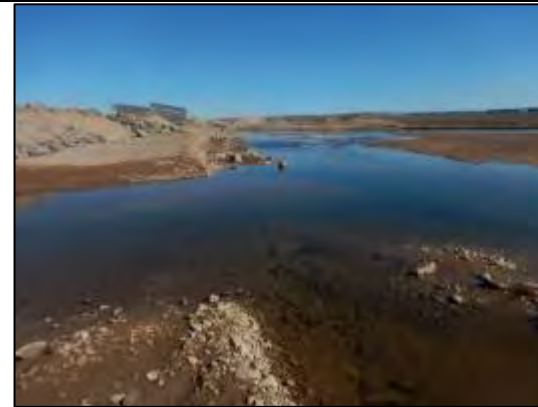
**Summary:** A bridge and culvert crossing with abundant habitat for both species. No fish passage issues were identified for either the bridge or culvert crossings in spring 2019.

**Photos 1.** Photograph upstream of the Tote Road crossing CV-217: (A) showing the culvert; and photographs downstream of the Tote Road: (B) looking upstream; (C) looking downstream; and (D) looking across.

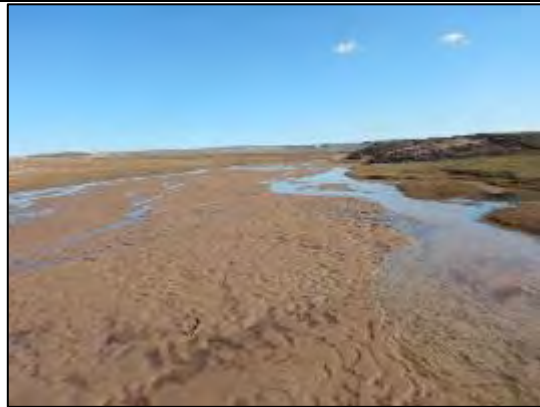
**A**

**Summary:** A small stream that provides habitat for Ninespine Stickleback and small juvenile Arctic Char (especially young-of-the-year from Muriel Lake). A slight perch was remediated in 2019.

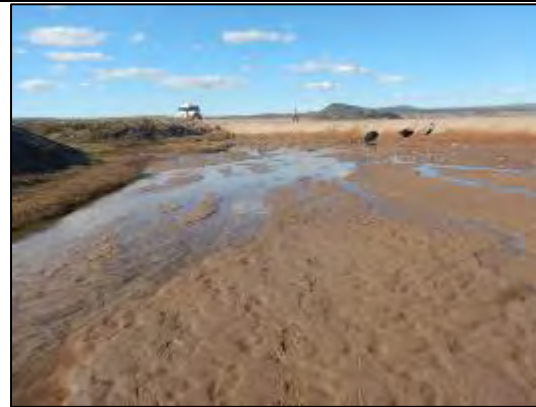
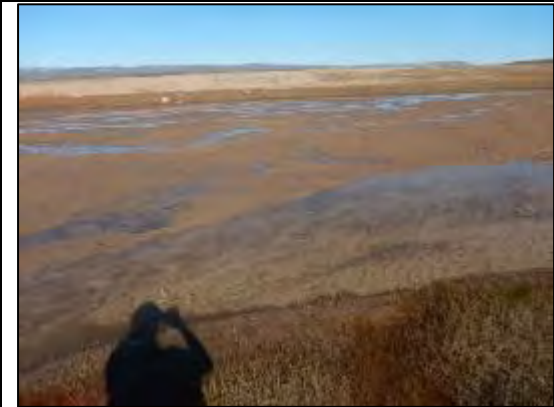
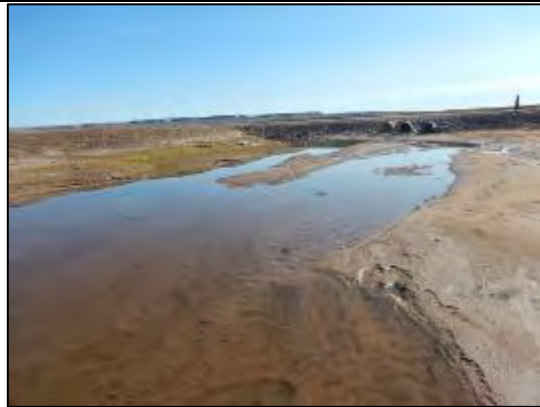
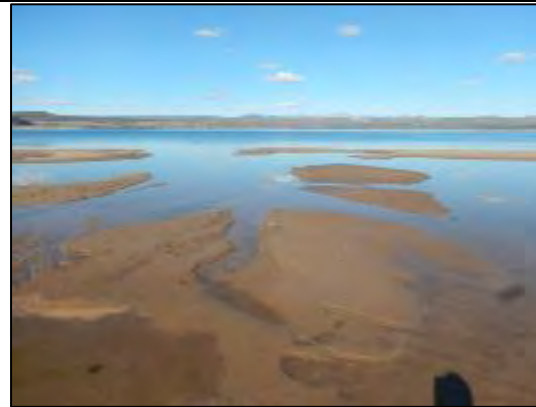
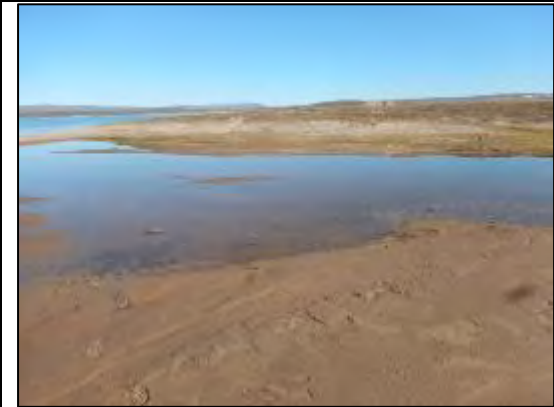
**Photos 1.** Photographs upstream of the Tote Road crossing CV-216: (A) looking upstream; (B) looking downstream; (C) looking across; and photographs downstream of the Tote Road: (D) looking upstream; (E) looking downstream; and (F) looking across.

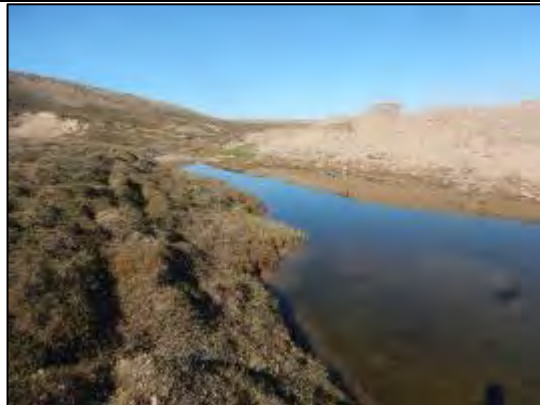
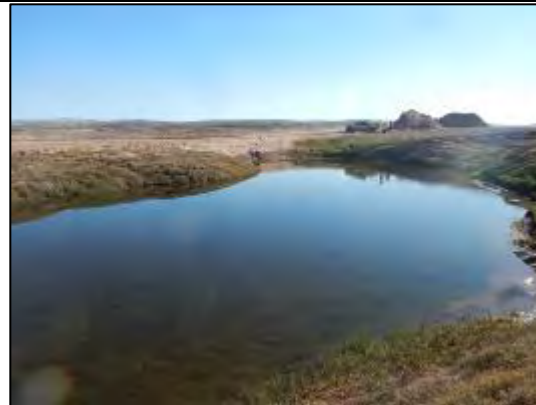
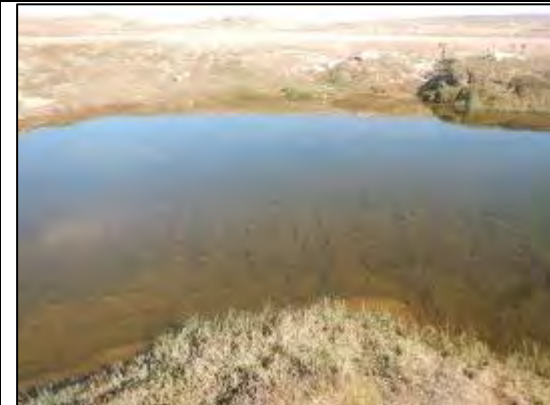
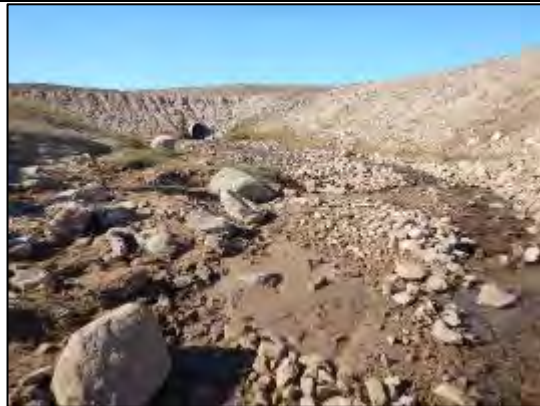
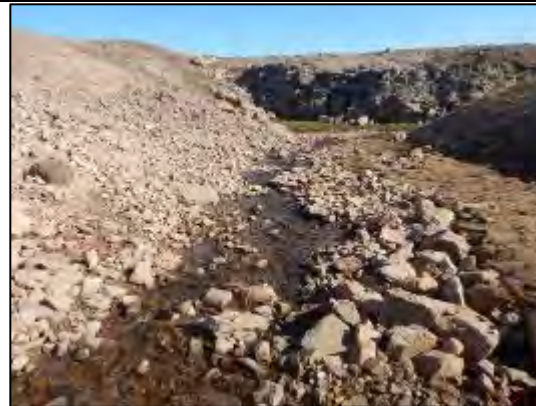
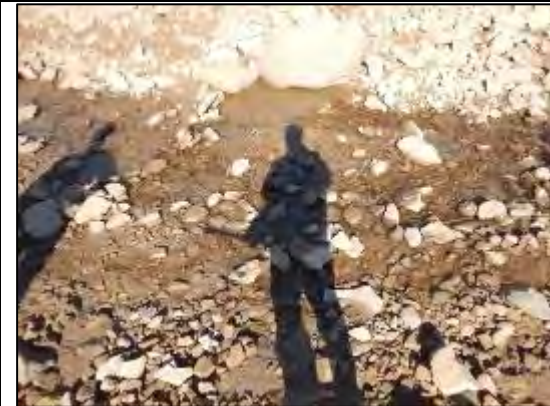
**Summary:** Stream provides abundant rearing habitat, particularly upstream of the road in a large pond. Access to the upstream pond was created with a rocky ramp as part of the Tote Road Compensation Plan. There were no fish passage issues identified in spring 2019.

**Photos 1.** Photographs upstream of the Tote Road crossing BG-30: (A) looking upstream; (B) looking downstream; (C) looking across; and photographs downstream of the Tote Road: (D) looking upstream; (E) looking downstream; and (F) looking across.

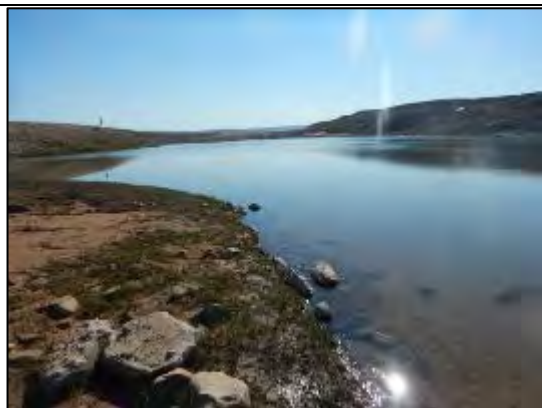
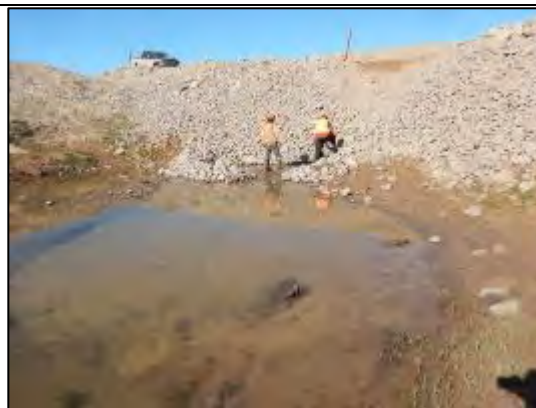
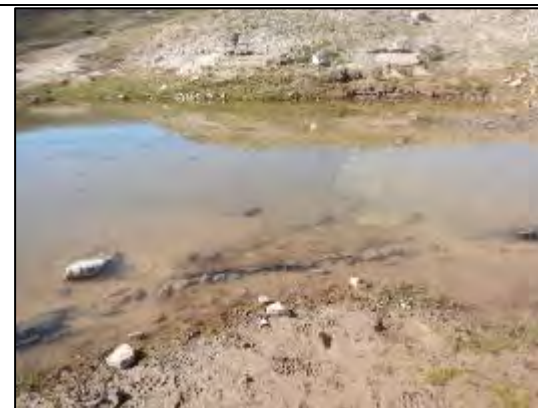
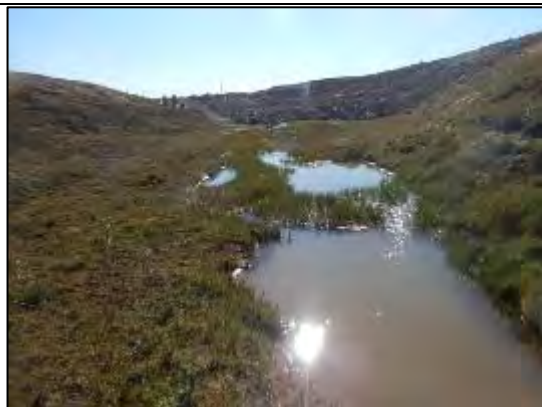
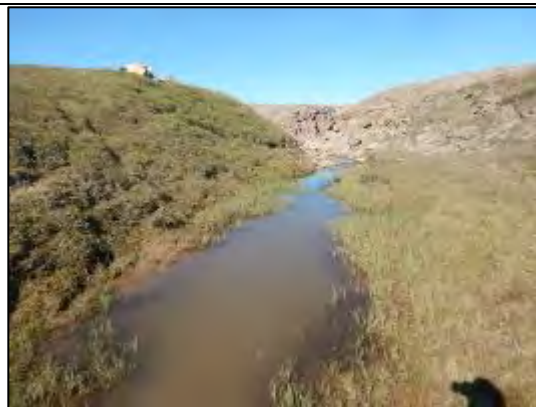
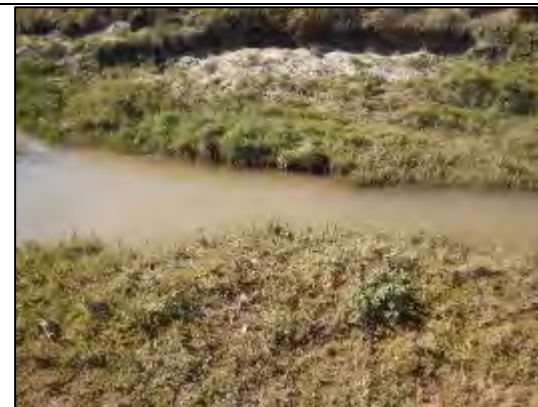
**Summary:** Stream provides abundant summer rearing habitat for both species. Road aggregate partially blocked the upstream end of the culvert in spring 2019. Blockage was removed and full access restored in fall 2019.

**Photos 1.** Photographs upstream of the Tote Road crossing BG-29: (A) looking upstream; (B) looking downstream; (C) looking across; and photographs downstream of the Tote Road: (D) looking upstream; (E) looking downstream; and (F) looking across.

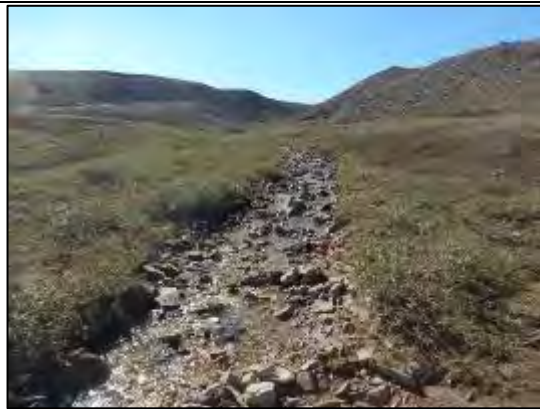
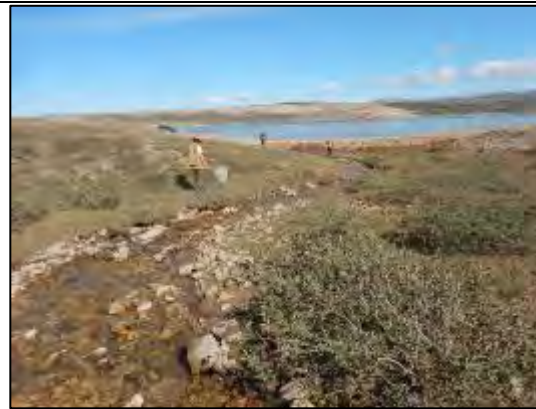
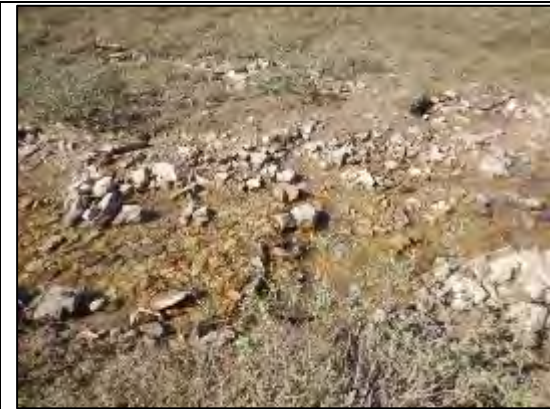
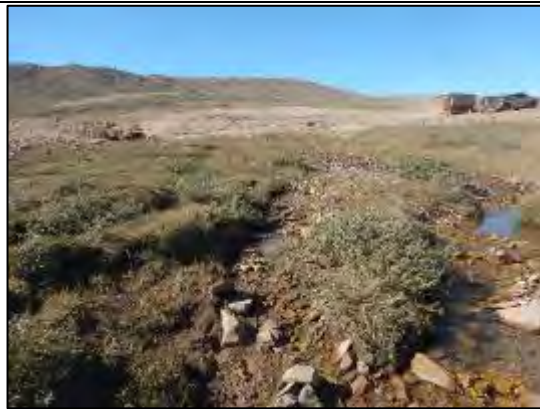
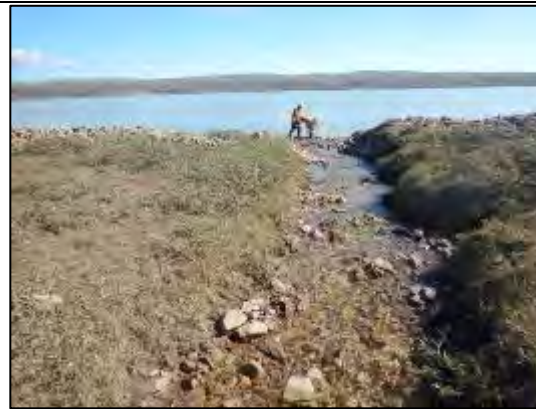
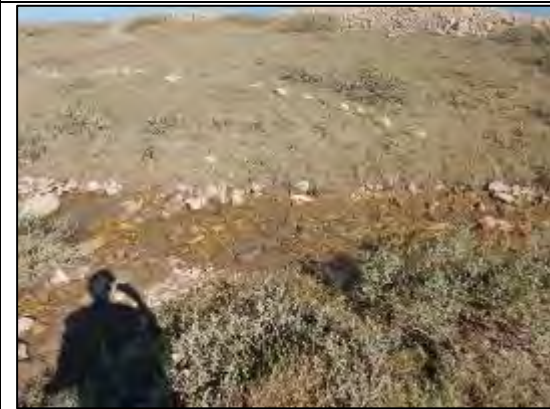
**Summary:** Site provides summer rearing habitat for juvenile Arctic Char. There were no fish passage issues identified in spring 2019.

**Photos 1.** Photographs upstream of the Tote Road crossing BG-27: (A) looking upstream; (B) looking downstream; (C) looking across; and photographs downstream of the Tote Road: (D) looking upstream; (E) looking downstream; and (F) looking across.

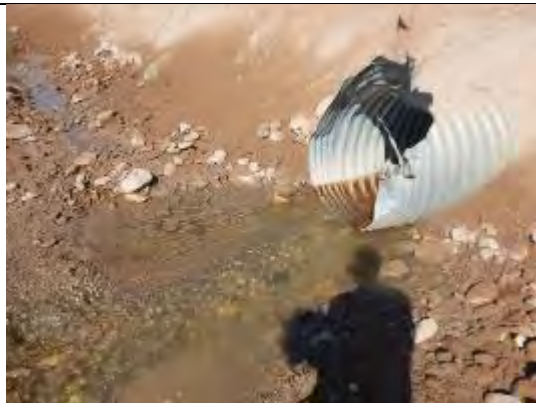
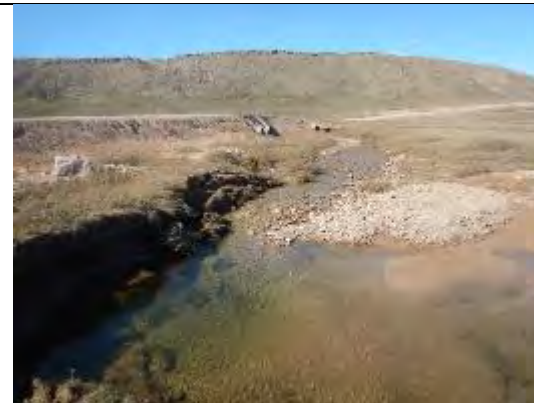
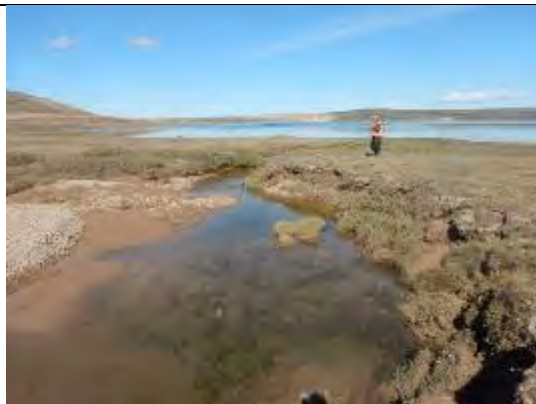
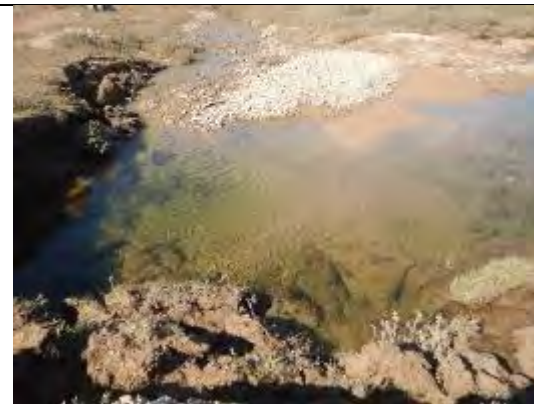
**Summary:** Site provides summer rearing habitat for juvenile Arctic Char. There were no fish passage issues identified in spring 2019.

**Photos 1.** Photographs upstream of the Tote Road crossing BG-24: (A) showing the culvert; and photographs downstream of the Tote Road: (B) looking upstream; (C) looking downstream; and (D) looking across.

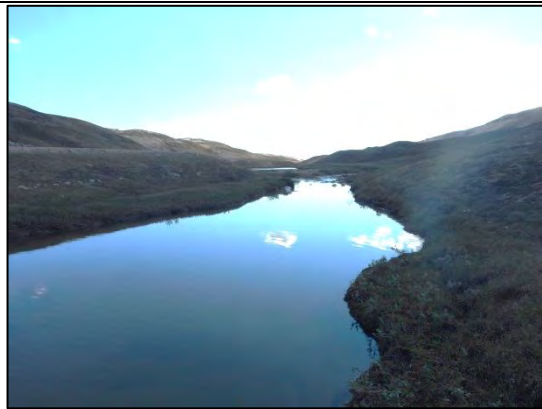
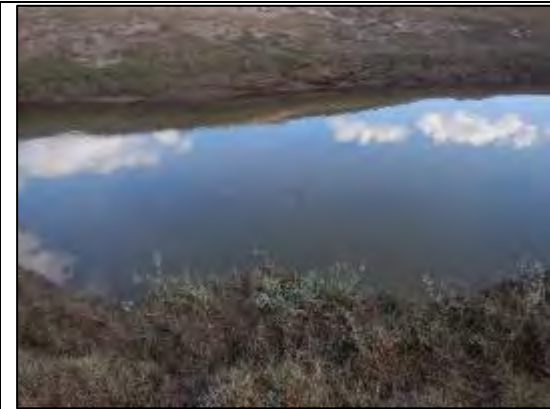
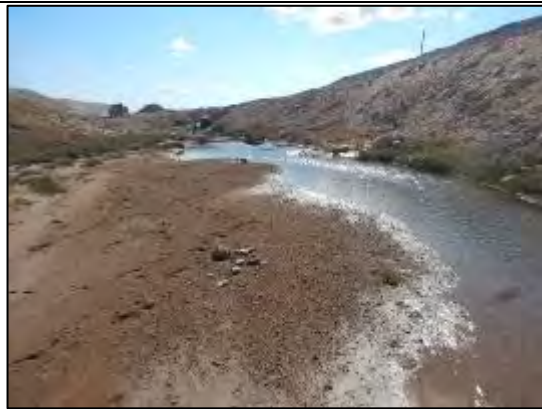
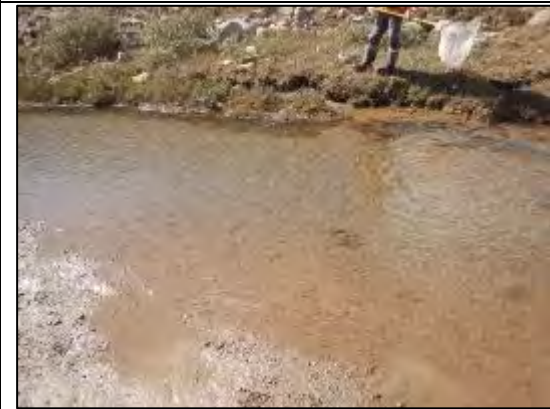
**Summary:** Site provides summer rearing habitat for both species. There were no fish passage issues identified in spring 2019.

**Photos 1.** Photographs upstream of the Tote Road crossing BG-17: (A) looking upstream; (B) looking downstream; (C) looking across; and photographs downstream of the Tote Road: (D) looking upstream; (E) looking downstream; and (F) looking across.

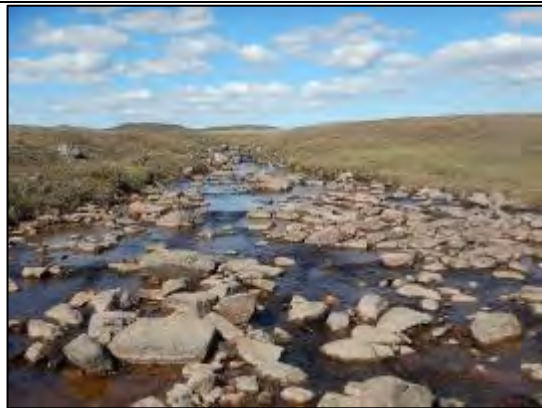
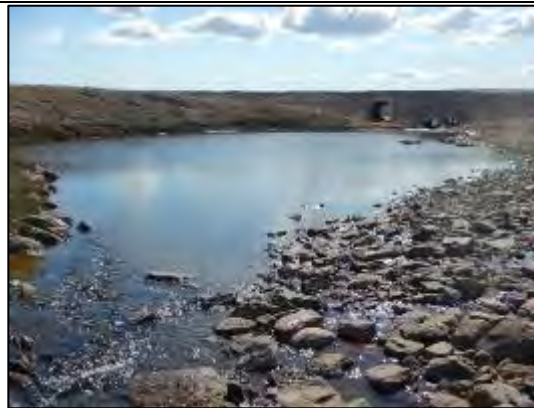
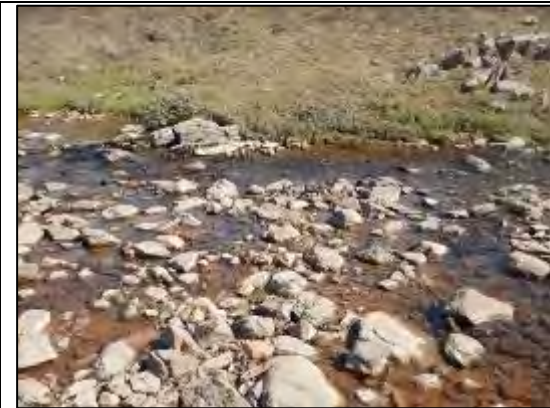
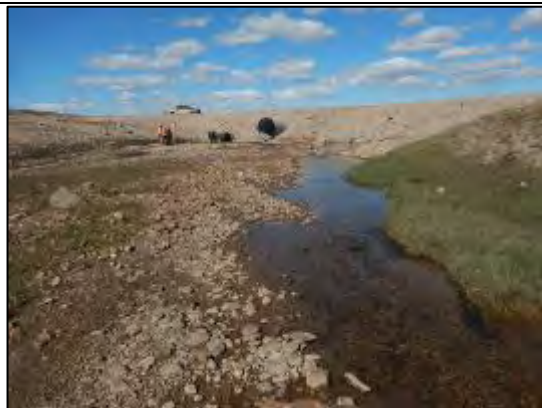
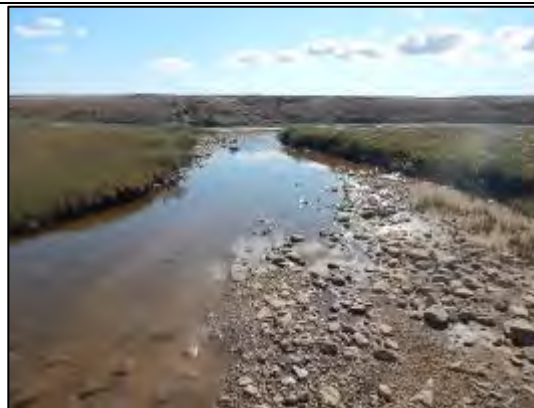
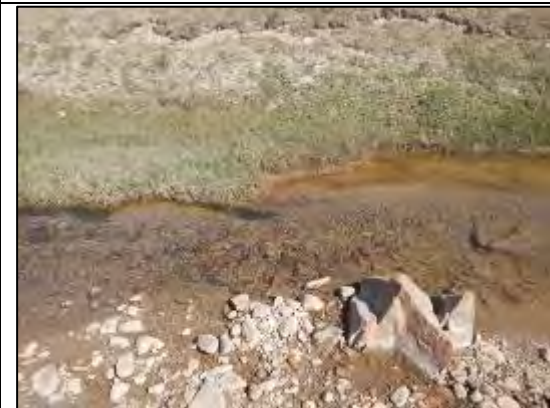
**Summary:** Site provides summer rearing habitat for both species. There were no fish passage issues identified in spring 2019.

**Photos 1.** Photographs upstream of the Tote Road crossing BG-04: (A) looking upstream; (B) looking downstream; (C) looking across; and photographs downstream of the Tote Road: (D) looking upstream; (E) looking downstream; and (F) looking across.

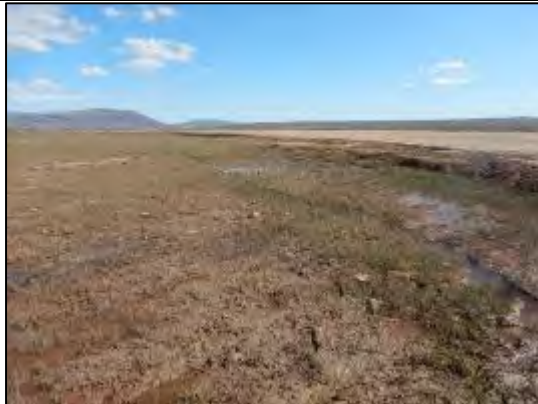
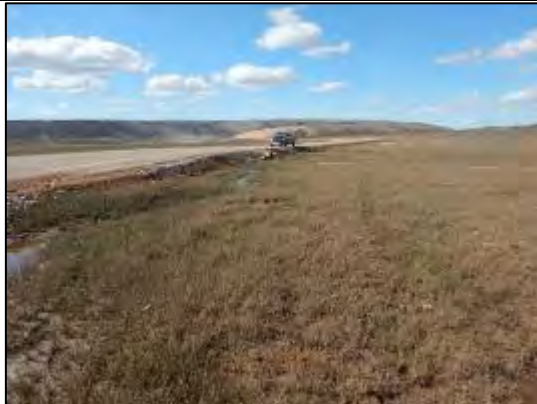
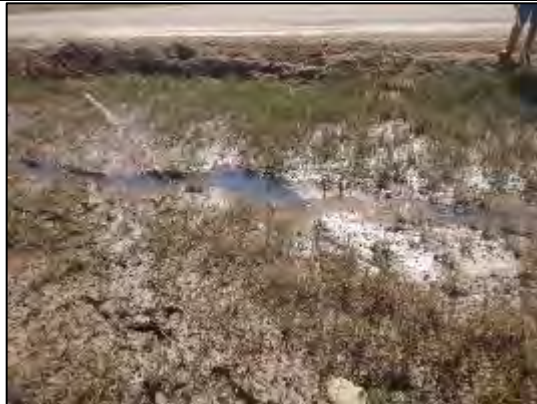
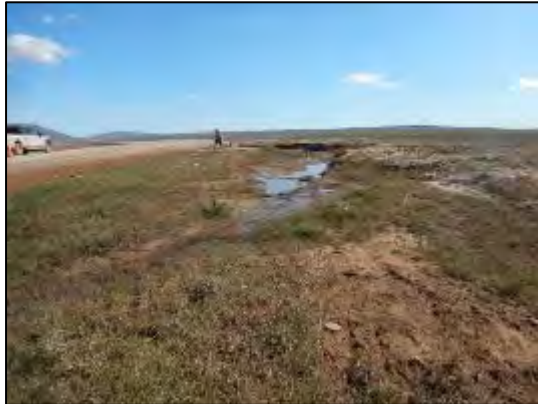
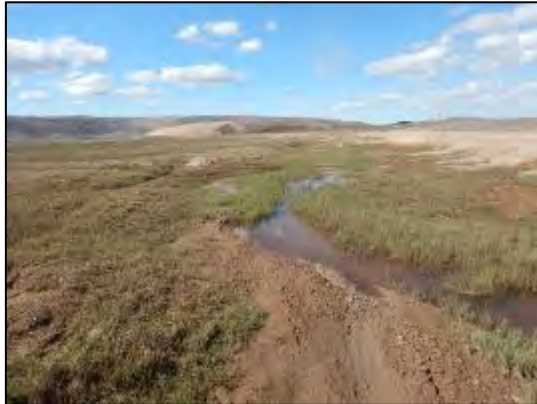
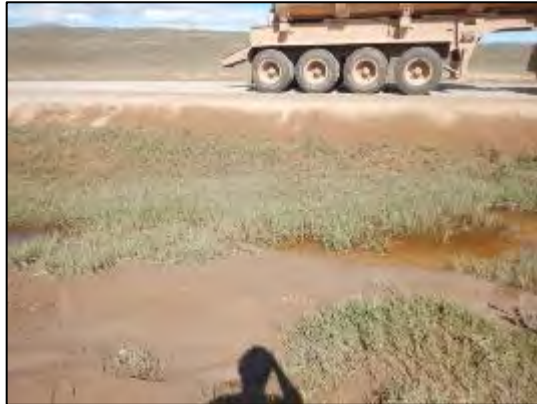
| Tote Road Site CV-001 | | | |
|---|--|---|---|
| Summary: Fish were not present in spring 2019 due to naturally low water levels; however, this stream has typically provided summer rearing habitat for both species when surveyed. There were no fish passage issues identified in spring 2019. | | | |
| Photos 1. Photographs upstream of the Tote Road crossing CV-001: (A) looking upstream; (B) looking downstream; (C) looking across; and photographs downstream of the Tote Road: (D) looking upstream; (E) looking downstream; and (F) looking across. | | | |

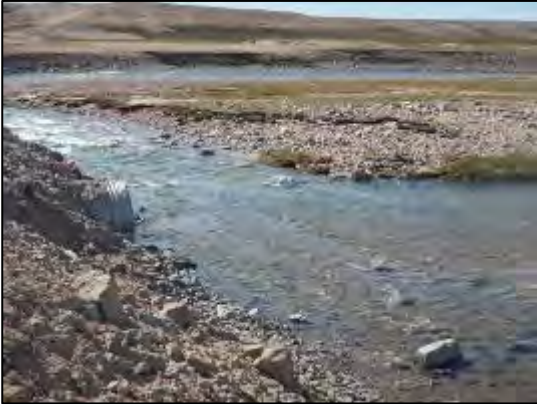
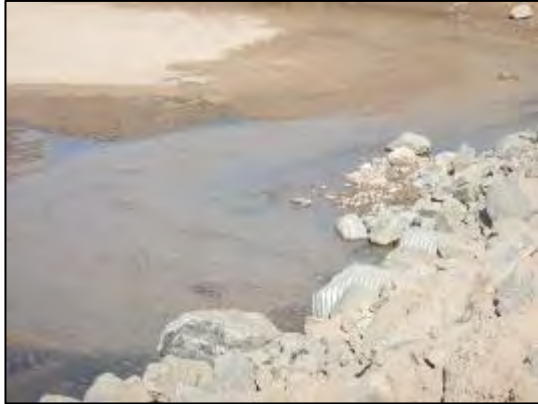
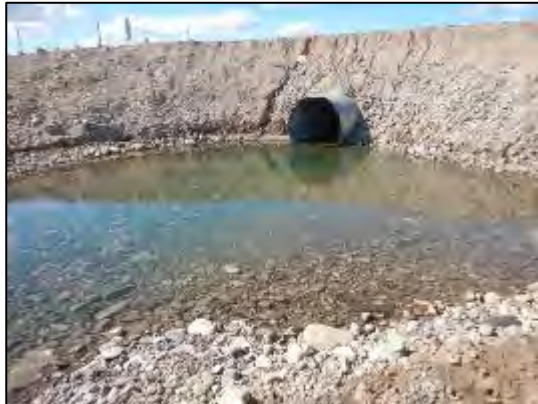
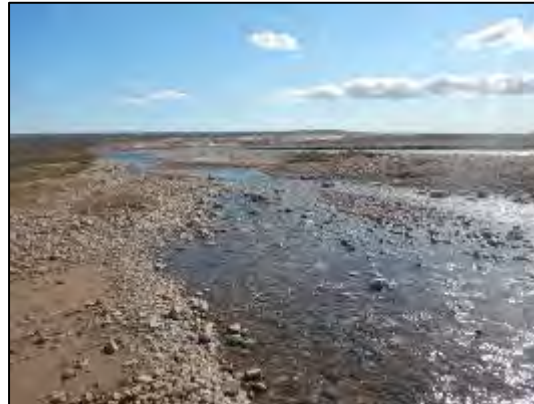
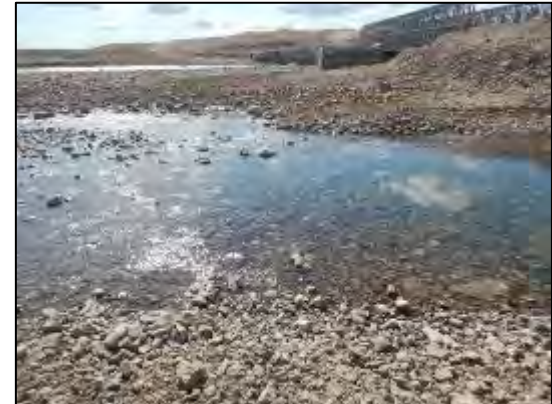
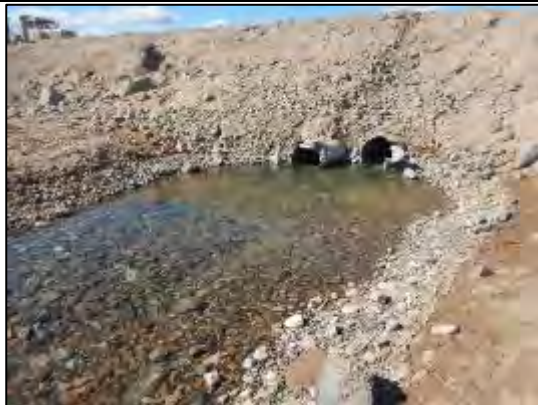
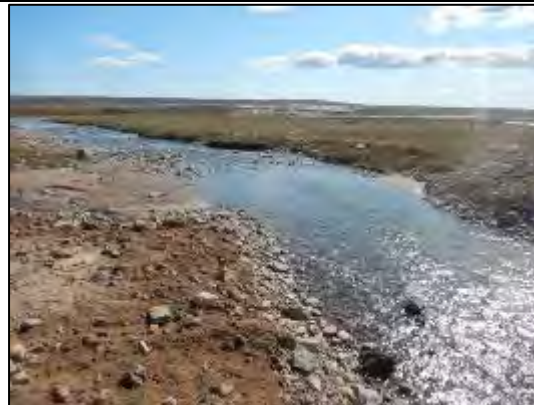
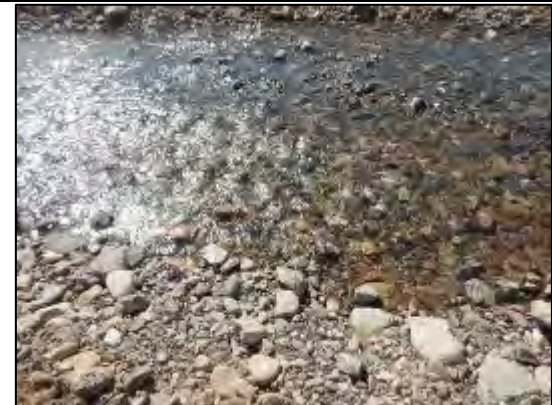
| Tote Road Site CV-223 | |
|---|---|
| <b>Summary:</b> This large river (Tom River) includes both bridge and culvert crossings. All channels provide abundant summer rearing habitat for Arctic Char. There were no fish passage issues identified in spring 2019. | |

**Photos 1.** Photographs upstream of the Tote Road crossing CV-223: left channel downstream of the Tote Road crossing CV-223: (C) looking upstream; (D) looking downstream; (E) looking across; and photographs of right channel downstream of the Tote Road: (F) looking upstream; (G) looking downstream; and (H) looking across.

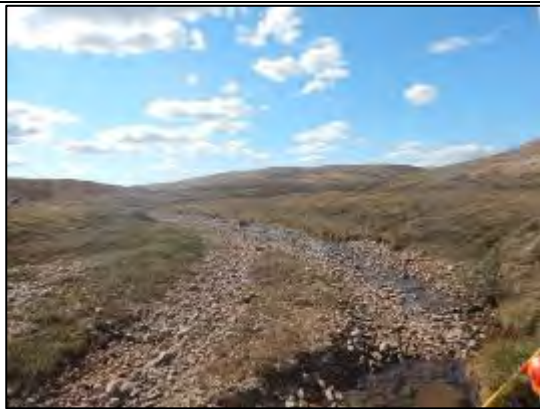
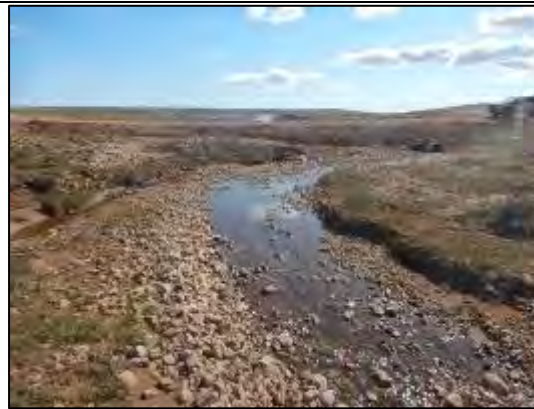
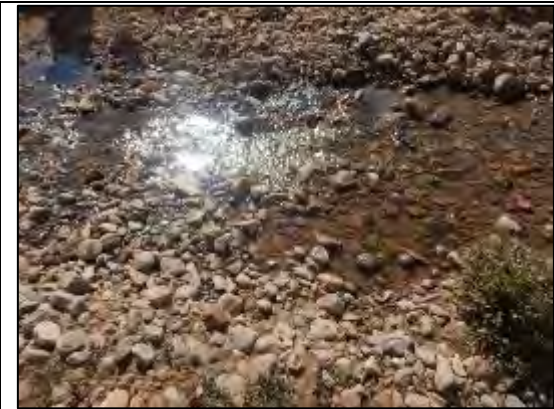
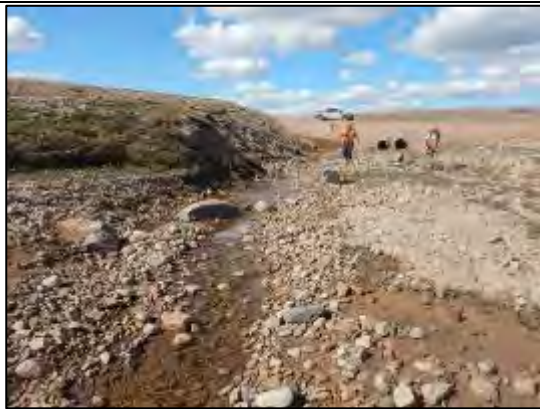
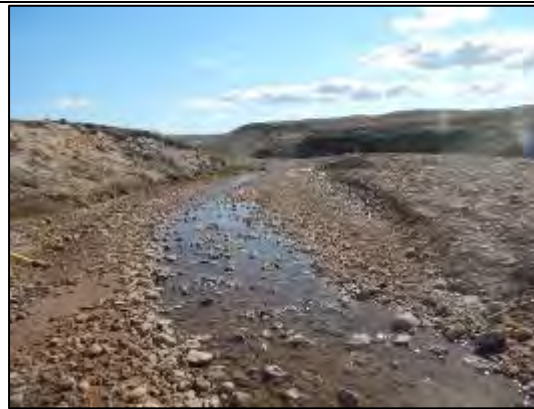
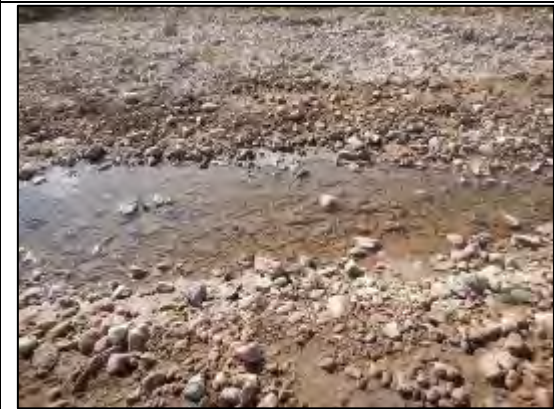
**Summary:** Site provides summer rearing habitat for both species. There were no fish passage issues identified in spring 2019.

**Photos 1.** Photographs upstream of the Tote Road crossing CV-224: (A) looking upstream; (B) looking downstream; (C) looking across; and photographs downstream of the Tote Road: (D) looking upstream; (E) looking downstream; and (F) looking across.

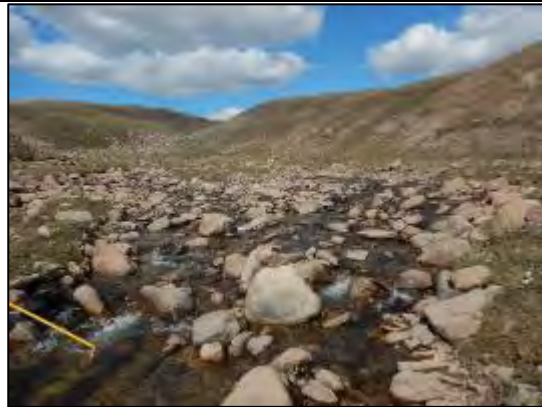
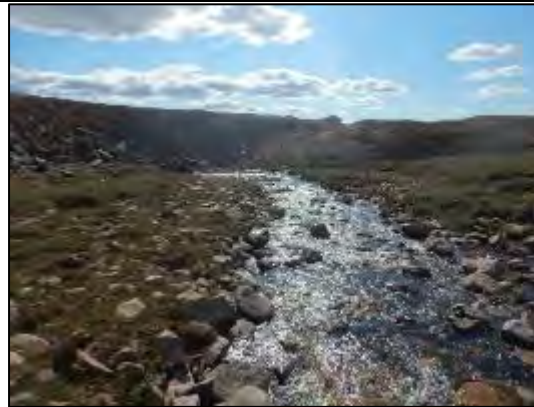
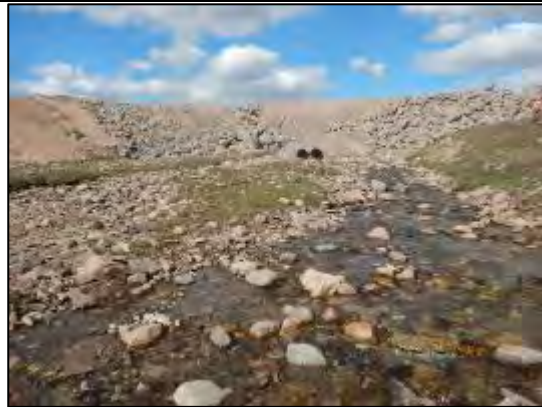
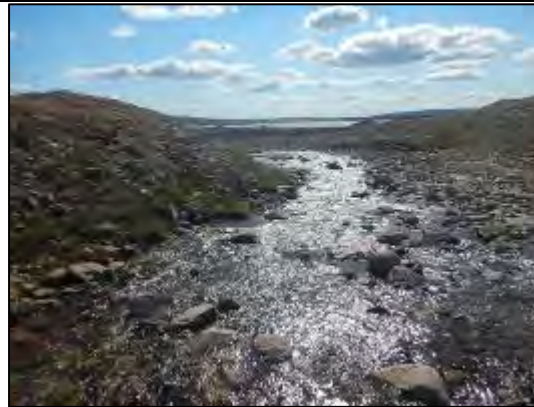
**Summary:** Site provides summer rearing habitat for both species. The culverts were slightly perched and measured velocities were too high for smaller fish at the downstream end of the culverts (0.91-1.42 m/s). Remediation has not yet been completed at this site.

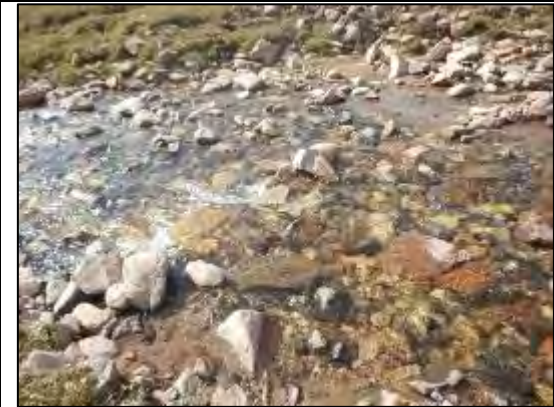
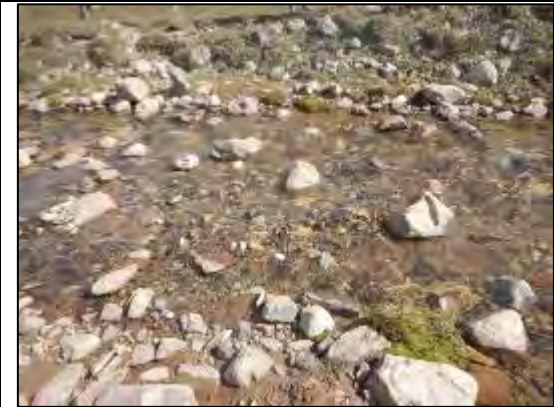
**Photos 1.** Photographs upstream of the Tote Road crossing CV-225: (A) looking upstream; (B) looking downstream; (C) looking across; and photographs downstream of the Tote Road: (D) looking upstream; (E) looking downstream; and (F) looking across.
