### DFO Tote Road Annual Report

**BAFFINLAND IRON MINES CORPORATION  
MARY RIVER PROJECT**

**FISH HABITAT MONITORING  
2019 ANNUAL REPORT  
EARLY REVENUE PHASE - TOTE ROAD UPGRADES**

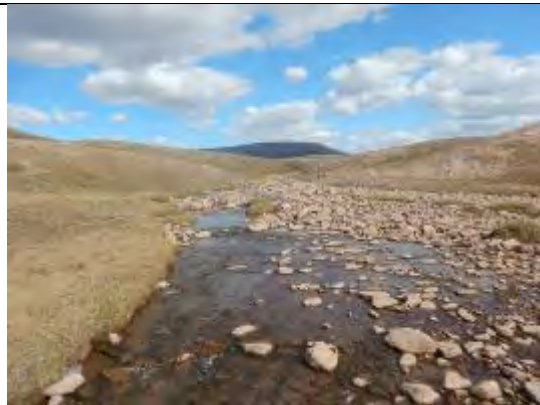
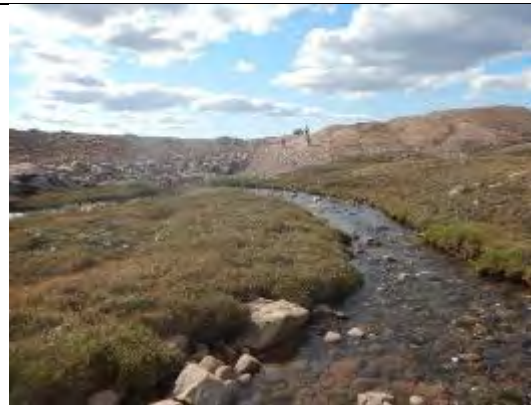
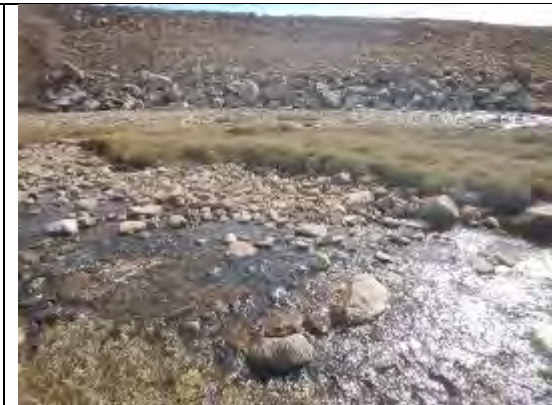
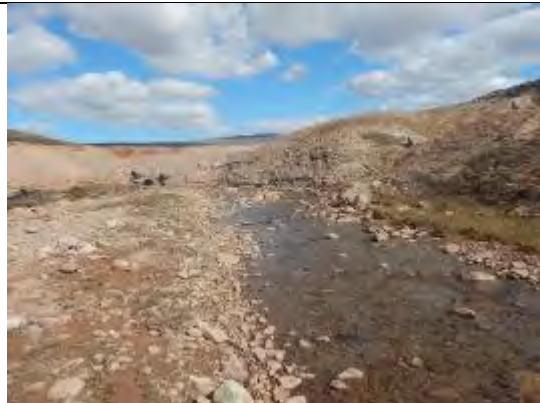
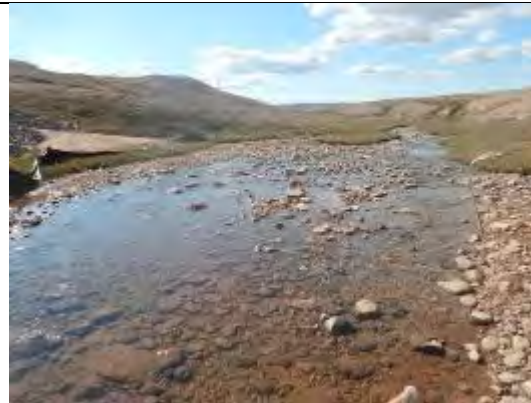
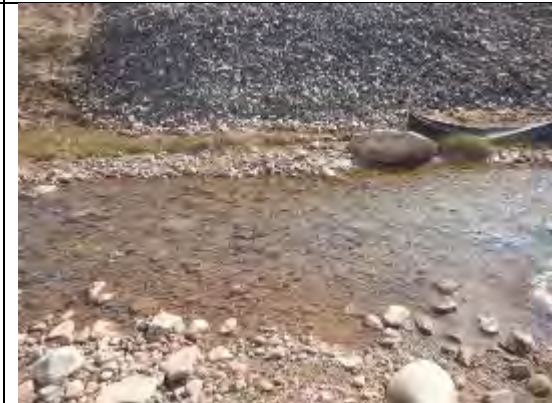
**Summary:** This stream provides summer rearing habitat for both species. Upstream of the road, rip rap had blocked fish access to a smaller tributary stream. Rip rap was removed and access restored in fall 2019.

**Photos 1.** Photographs upstream of the Tote Road crossing BG-01: (A) looking upstream; (B) looking downstream; (C) looking across; and photographs downstream of the Tote Road: (D) looking upstream; (E) looking downstream; and (F) looking across.

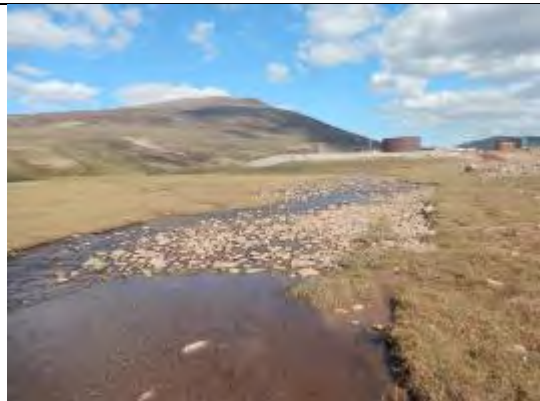
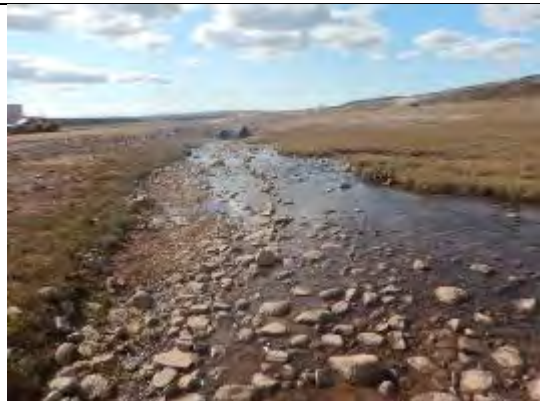
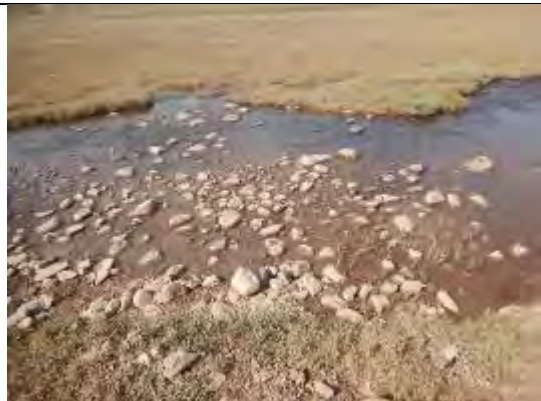
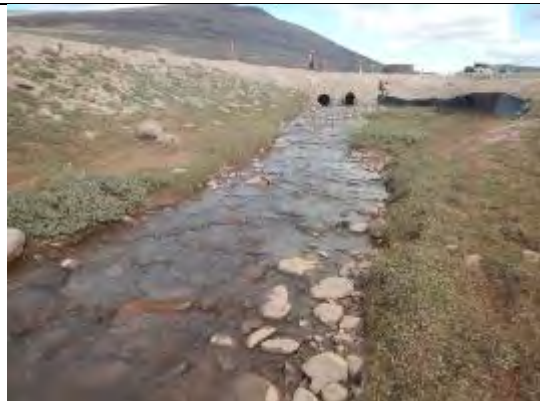
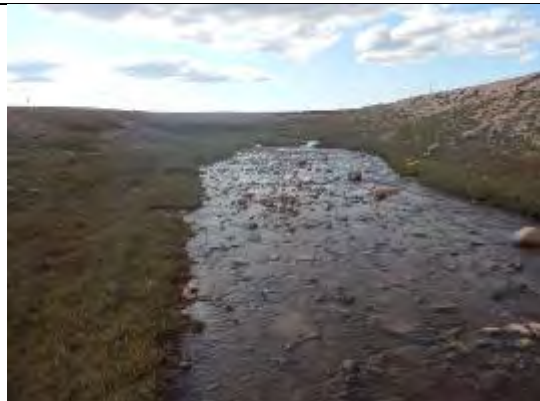
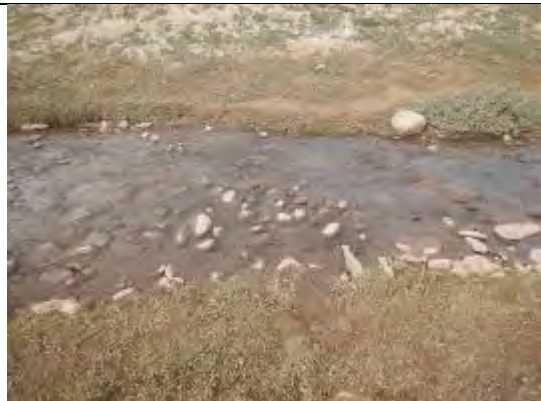
| Tote Road Site CV-186 | | | | | | | |
|---|---|---|---|---|---|--|---|
| UTM Coordinates: 17W 560705 E 7913498 N | | Date Surveyed: 1-Jul-19 | | | | | |
| Summary: Site provides summer rearing habitat for both species. There were no fish passage issues identified in spring 2019. | | | | | | | |
| <div><div>

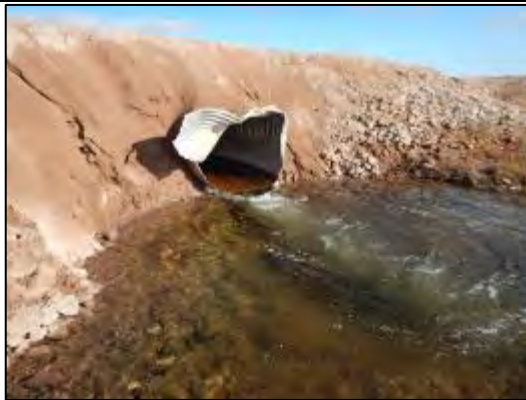
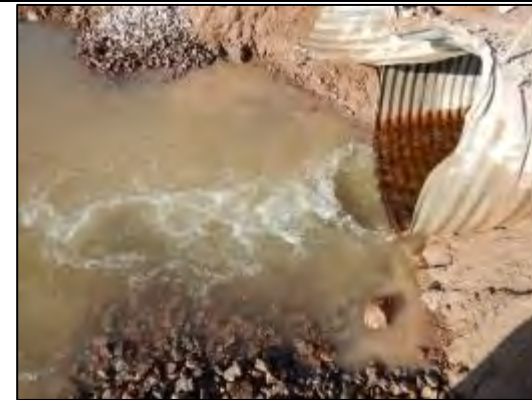
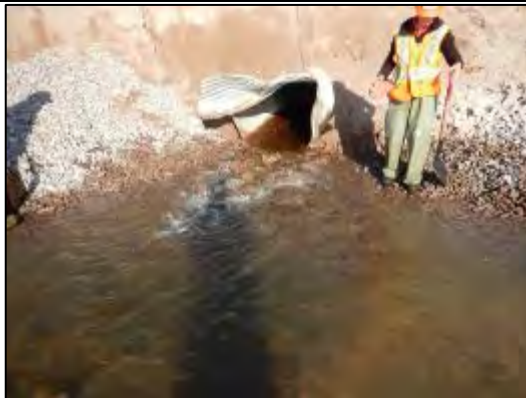
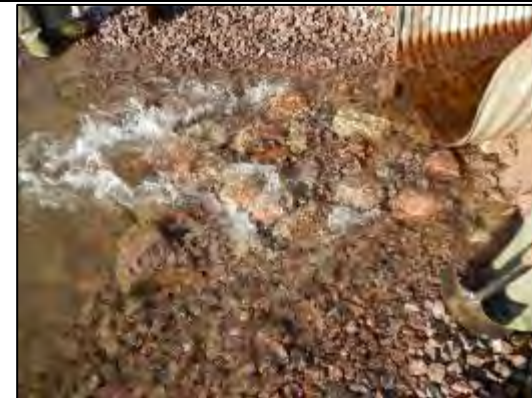
## 2019 Tote Road Stream Crossing Remediation – CV-129

**Photos 1:** Photographs of the downstream end of the perched culvert before remediation at CV-129: (A) showing of the slightly perched culvert; (B) showing the pool under the perched culvert; and photographs after remediation: (C) showing water flowing over constructed step-pool habitat; and D) showing a close-up of large rocks and cobble placed in the former pool to fill spaces, creating riffle habitat.

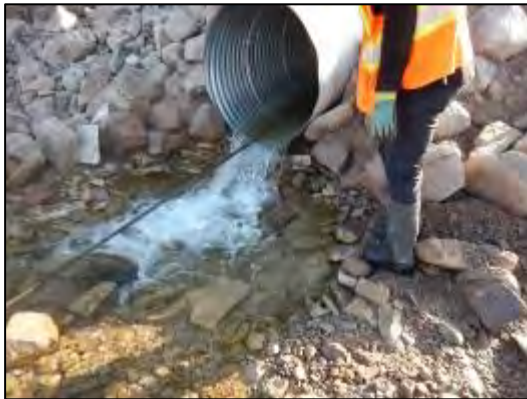
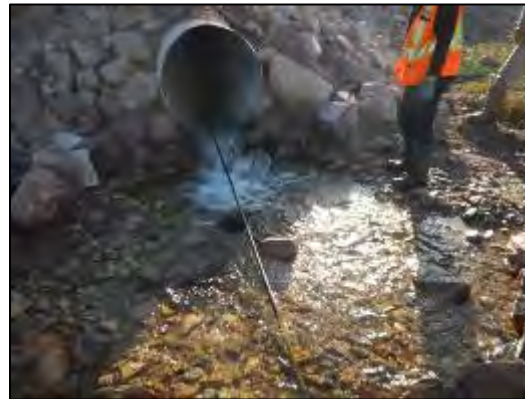
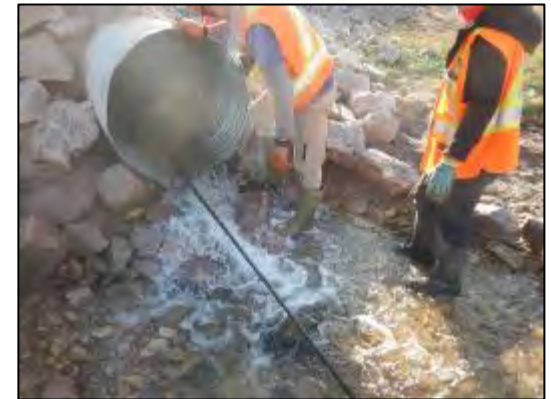
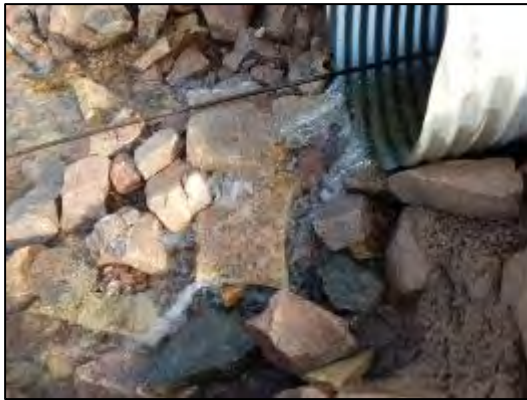
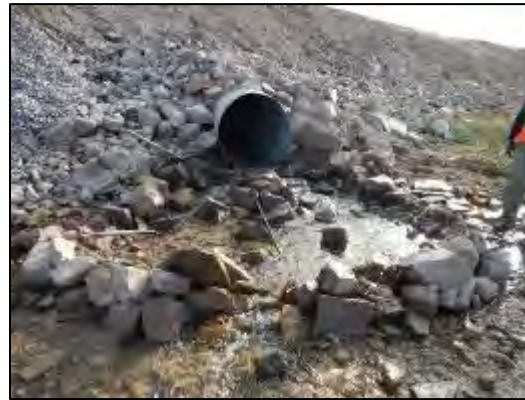
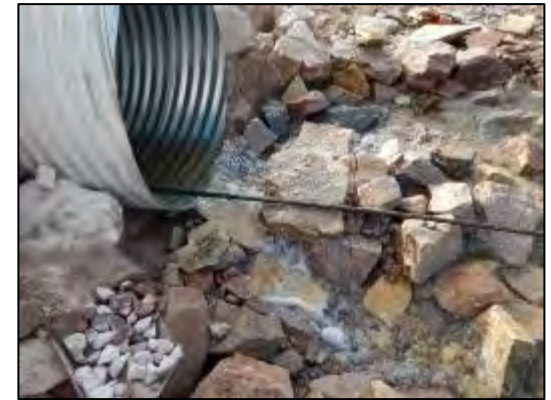
## 2019 Tote Road Stream Crossing Remediation – CV-111

**Photos 3:** Photographs of the downstream end the perched culvert before remediation at CV-111: (A) and (B) showing highly perched culvert; (C) showing the pool partway built and photographs after remediation (D) showing the pool and rock ramp constructed immediately below the culvert to create a backwater effect and lessen the perch; (E) showing the system of rock steps constructed to assist with accessibility; and (F) showing two constructed channels with a small perch remaining.

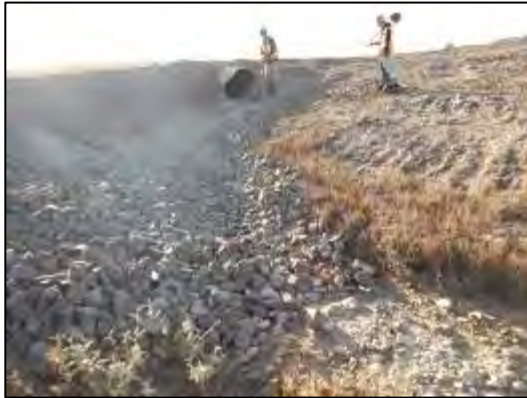
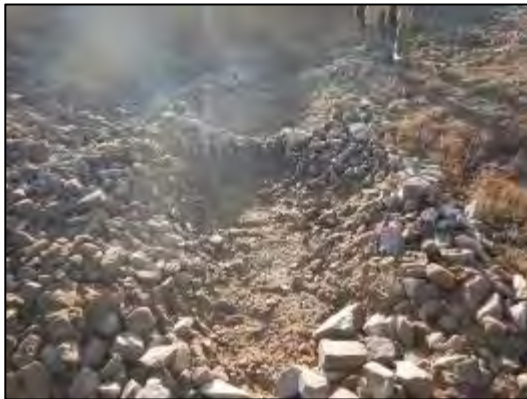
## 2019 Tote Road Stream Crossing Remediation – CV-106

**Photos 4:** Photographs of the downstream end the perched culvert before remediation at CV-106: (A) showing the dry channel with ineffective fish ramp that cannot maintain surface flow when water is present and photographs after remediation (B) Pool constructed immediately below the culvert at CV-106; (C-F) System of step-pools constructed below the culvert with cobble and gravel to help eliminate sub-flow problems.

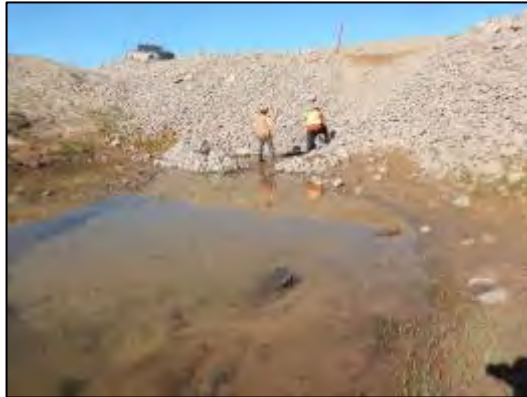
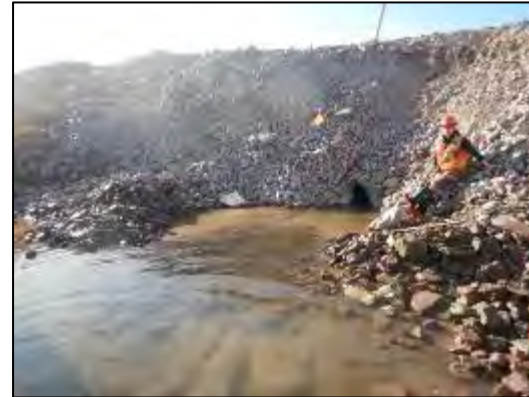
## 2019 Tote Road Stream Crossing Remediation – BG-29

**Photos 5:** Photographs of the upstream end of the perched culvert partway through remediation at BG-29: (A) showing the remaining berm blocking the culvert and photographs after remediation, and (B) showing the rocky material was removed to expose the culvert and improve fish access.

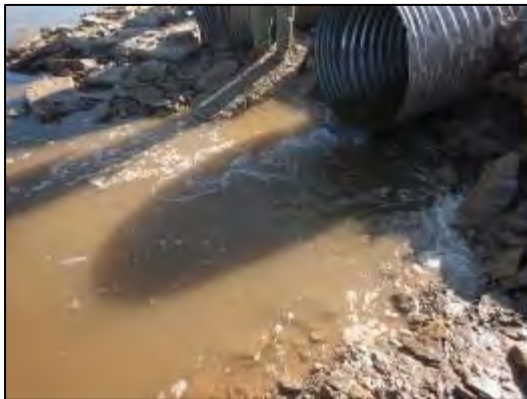
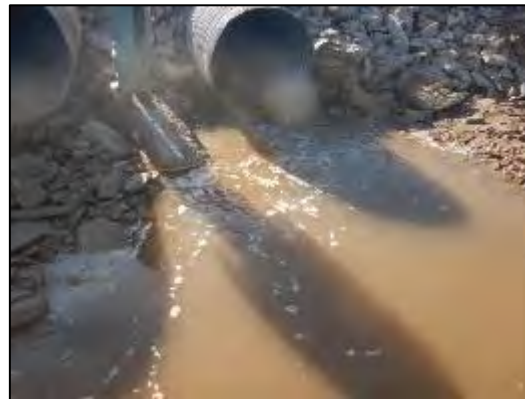
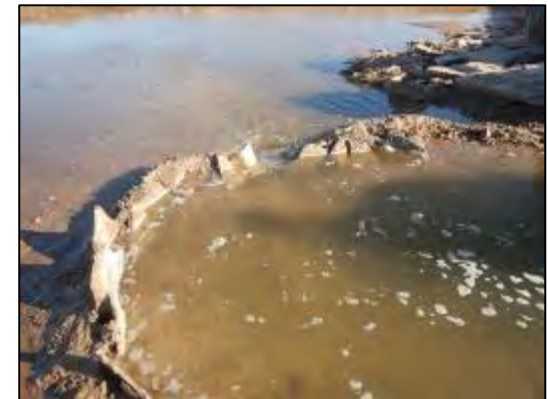
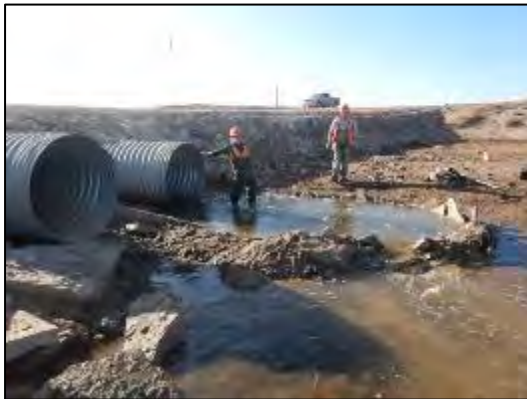
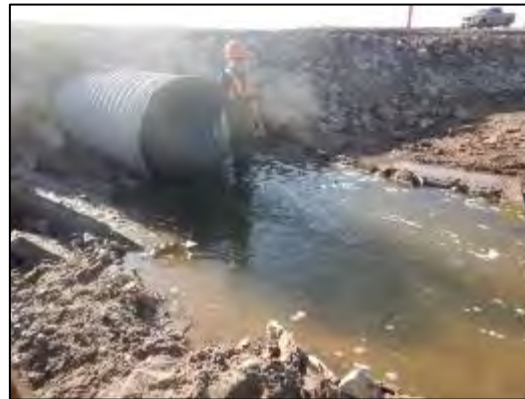
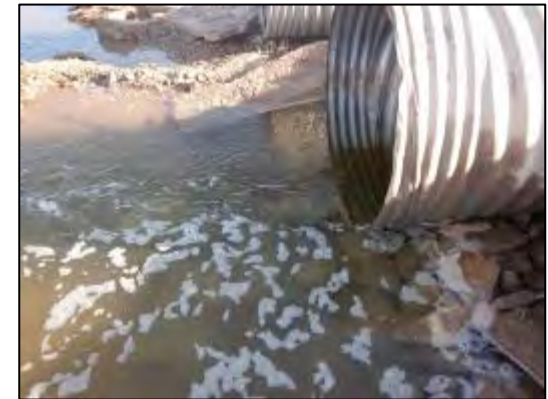
## 2019 Tote Road Stream Crossing Remediation – CV-216

**Photos 6:** Photographs of the downstream end the perched culvert before remediation at CV-216: (A) and (B) showing a slightly perched right culvert and dry perched left culvert; and photographs after remediation: (C) and (D) showing the boundary of the constructed pool around the right culvert, creating a backwater effect with passage through the center of the boundary; (E) showing the backwater effect created by the constructed boundary successfully removing the perch; and (F) showing rocky substrate added under the right culvert to fill empty space.

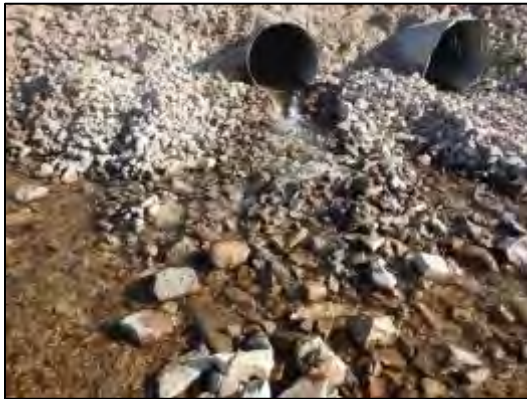
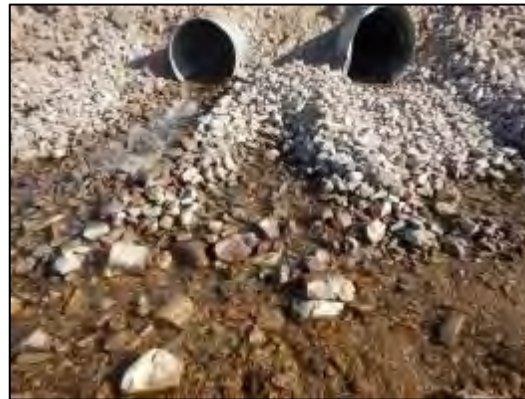
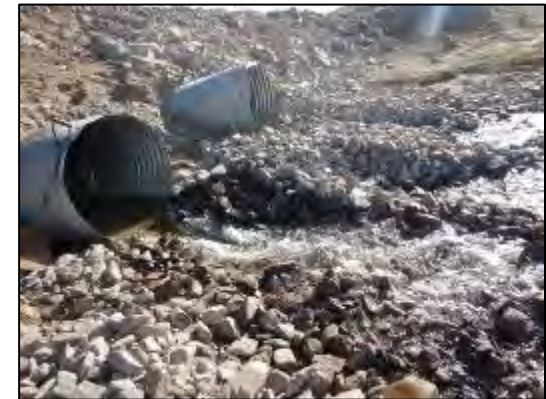
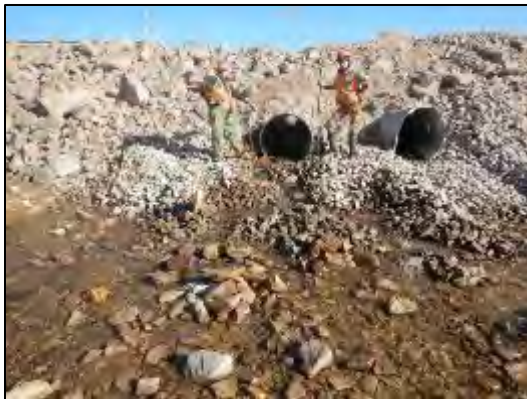
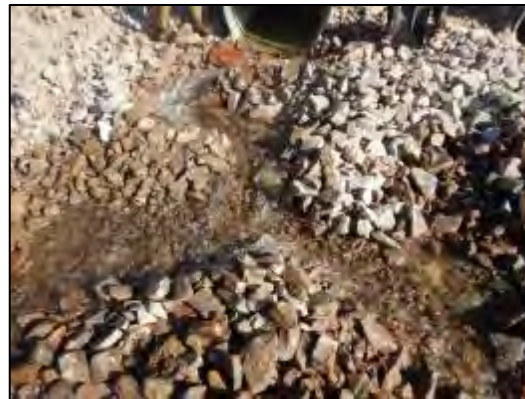
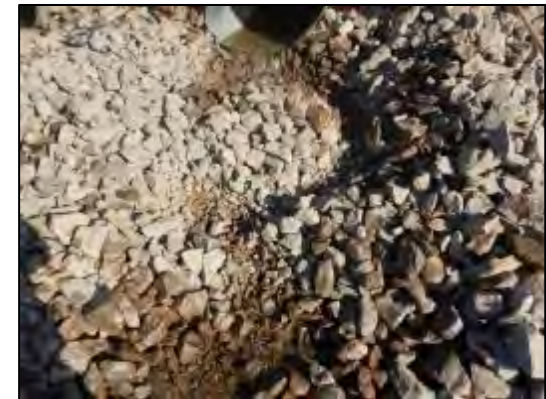
## 2019 Tote Road Stream Crossing Remediation – BG-50

**Photos 7:** Photographs of the downstream end the perched culvert before remediation at BG-50: (A-C) showing ineffective fish ramp at left culvert and dry right culvert with flow under the rocks; and photographs after remediation: (D) and (E) showing system of step pools and channels constructed to connect left culvert to stream below, improving fish access; and (E) showing a similar rocky ramp on right culvert, but insufficient water levels to determine effectiveness.

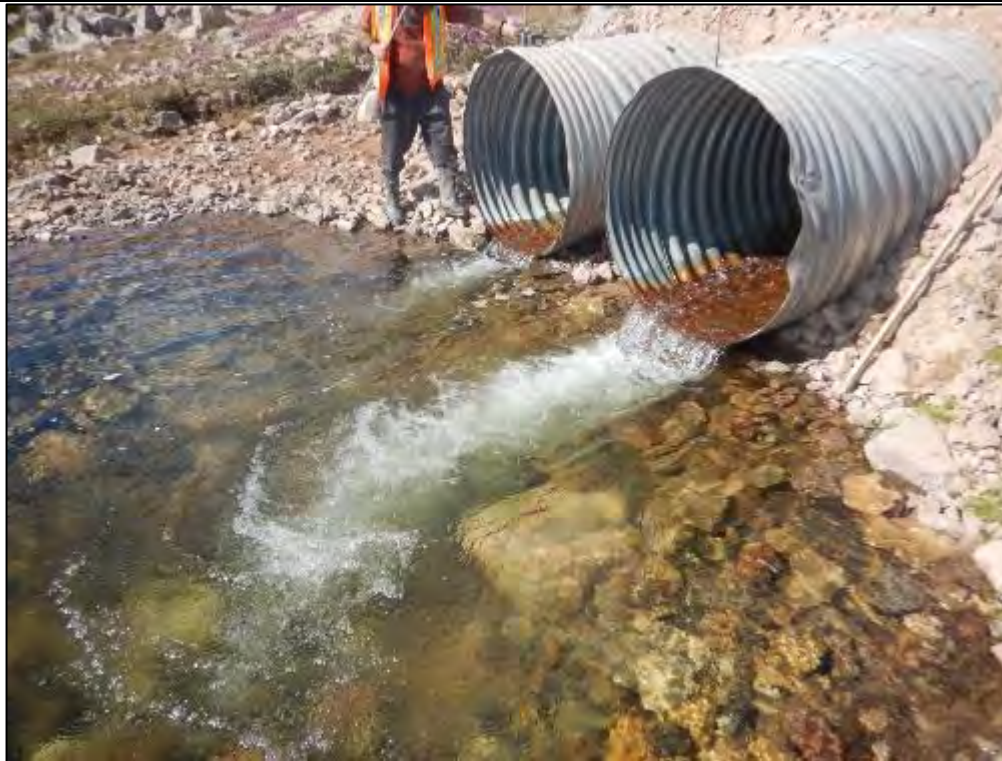
## 2019 Tote Road Stream Crossing Remediation – CV-225

**Photos 8:** Photograph of the downstream end the perched culvert before remediation at CV-225. Remediation could not be completed in 2019.

Remediation could not be completed at two sites (CV-111 and CV-225) in 2019 (Table 6; Appendix D). The culvert at CV-111 was reinstalled during winter 2018/2019 to replace two culverts with a single culvert and reduce erosion of the embankment. However, the new culvert had a 0.25 m perch, preventing upstream access for fish. A rocky ramp was constructed to improve fish access to the culvert and upstream habitat in fall 2019. Unfortunately, though access has likely been improved, due to the height of the original perch, such a drop could not be completely eliminated by this method. Additional/alternative works may be required for all of the size classes of juvenile Arctic Char found downstream of this crossing to have full access to upstream habitat.
