**BAFFINLAND IRON MINES CORPORATION  
MARY RIVER PROJECT**

**TOTE ROAD FISH HABITAT MONITORING  
2020 ANNUAL REPORT  
EARLY REVENUE PHASE - TOTE ROAD UPGRADES**

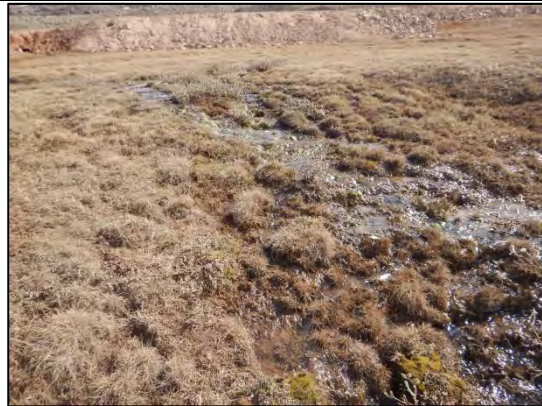
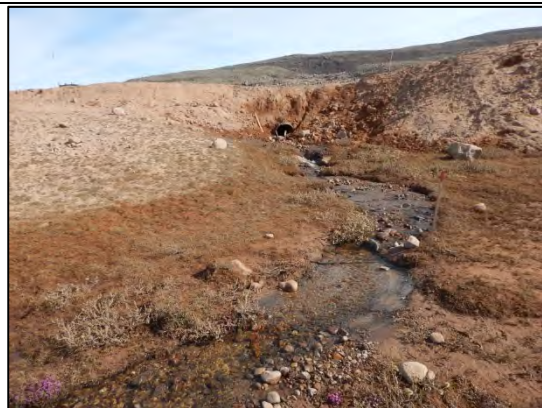
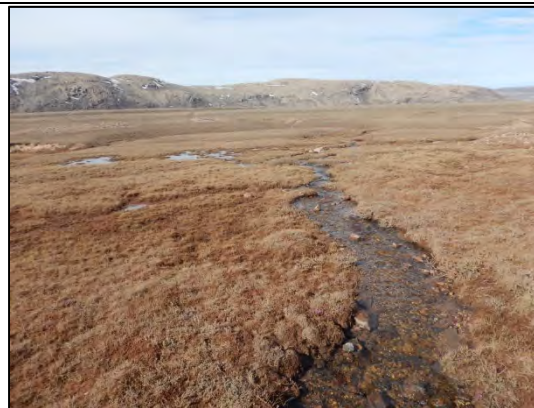
**Summary:** This small stream has several natural steep gradient and vertical drop barriers downstream that prevent fish access to the crossing area from Phillips Creek. There is no upstream overwintering habitat.

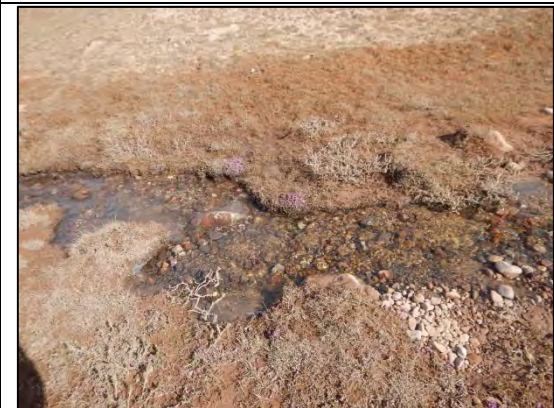
**Photos 1.** Photographs of the barriers downstream from the Tote Road crossing CV-170 (A,B); and photographs of habitat downstream of the Tote Road: (C) looking upstream; (D) looking downstream; and (E) across.

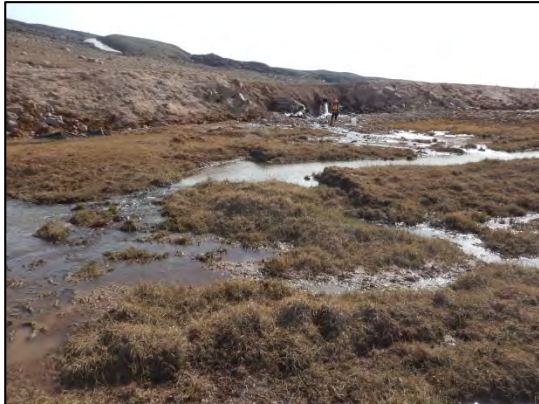
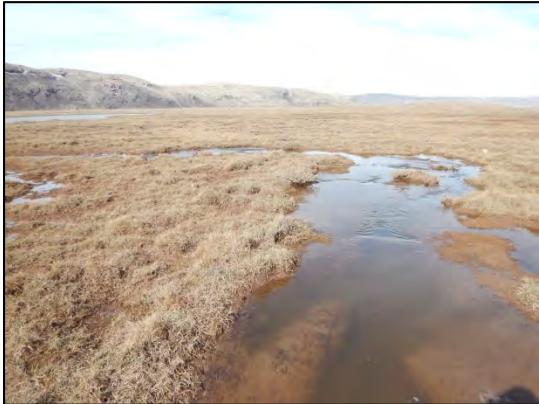
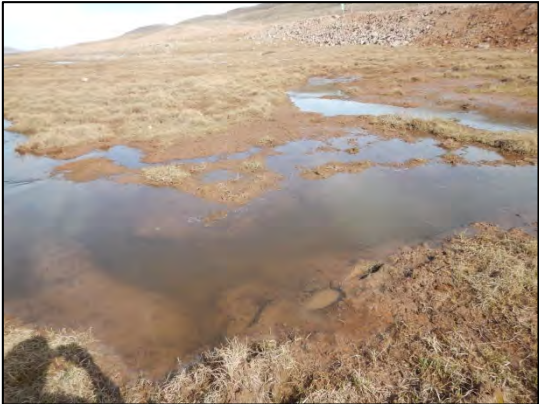
| Tote Road Site CV-166 | | | |
|---|--|---|---|
| <b>Summary:</b> This small stream has a rocky berm barrier downstream that prevents fish access to the crossing area from a fish-bearing stream that flows parallel to the road. There is no habitat at the crossing due to this barrier. There is also no upstream overwintering habitat. | | | |
| <div><div><p><b>A</b></p></div><div><p><b>B</b></p></div><div><p><b>C</b></p></div></div> <p><b>Photos 1.</b> Photographs downstream of the Tote Road crossing CV-166: (A) looking upstream; (B) looking downstream; and (C) looking across.</p> | | | |

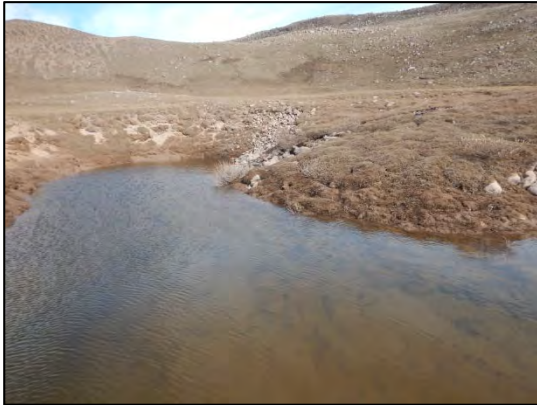
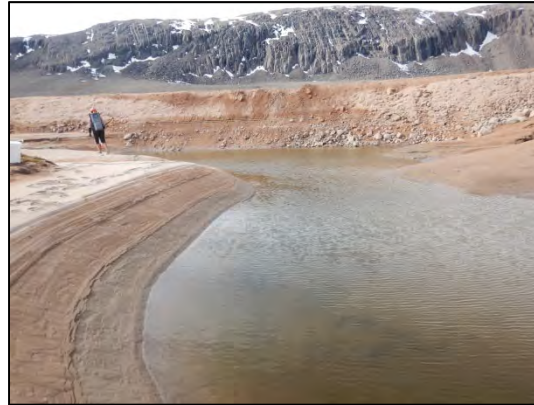
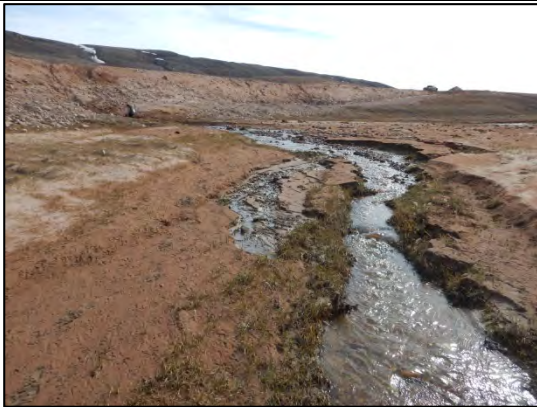
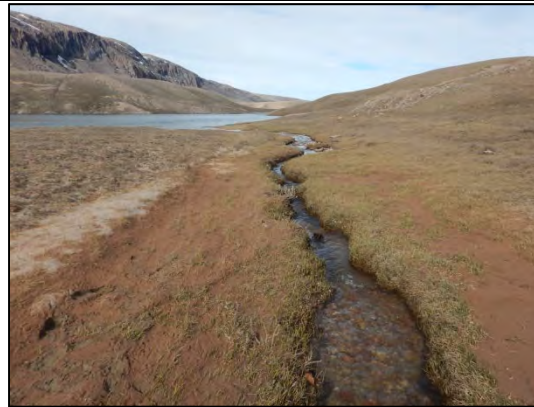
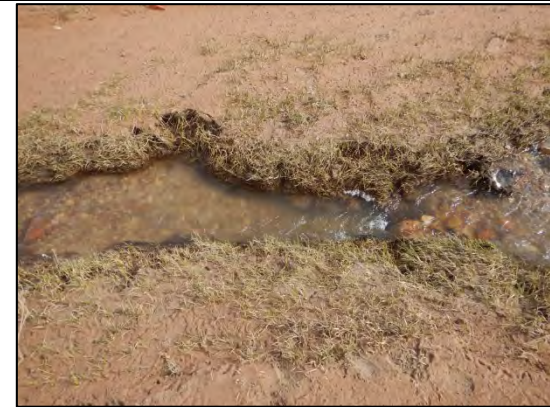
**Summary:** This small stream has several natural steep gradient and vertical drop barriers downstream that prevent fish access to the crossing area from Phillips Creek. There is no upstream overwintering habitat.

**Photos 1.** Photographs upstream (top) and downstream (bottom) of the Tote Road crossing CV-159: (A,D) looking upstream; (B,E) looking downstream; and (C,F) looking across.

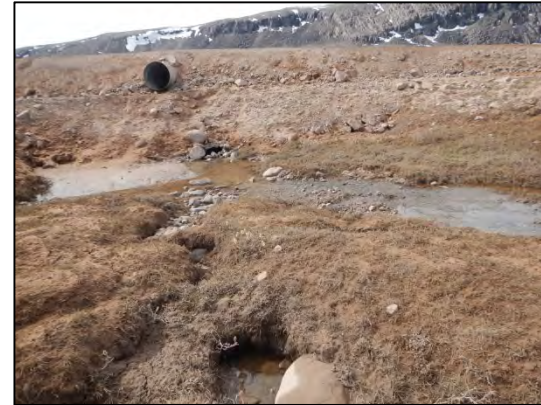
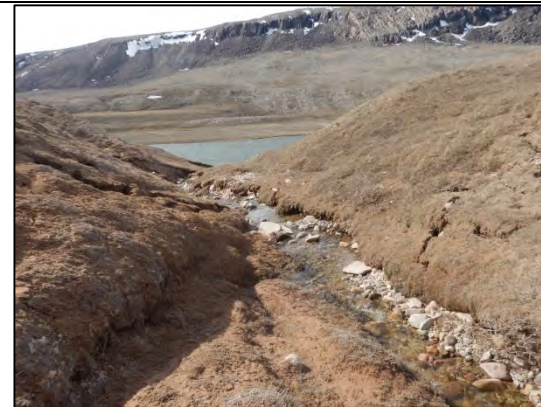
**Summary:** This small stream has several natural steep gradient and vertical drop barriers downstream that prevent fish access to the crossing area from Phillips Creek. There is no upstream overwintering habitat.

**Photos 1.** Photographs upstream (top) and downstream (bottom) of the Tote Road crossing CV-157: (A,C) looking upstream; and (B,D) looking downstream.

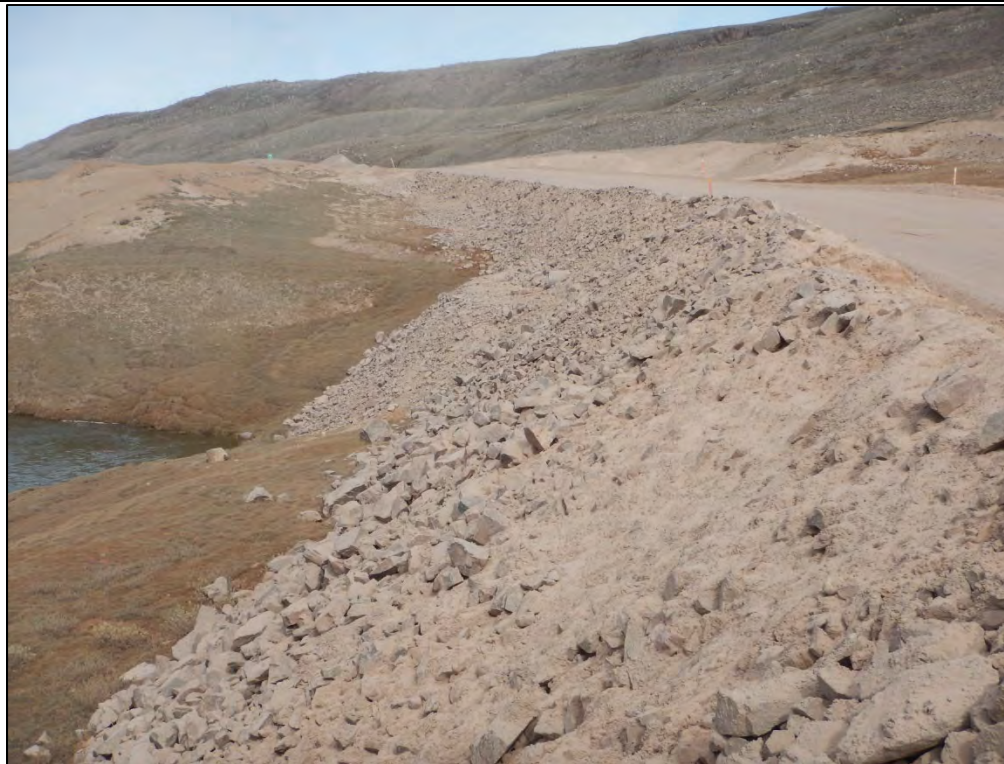
**Summary:** This small runoff stream is typically dry and has several natural steep gradient and vertical drop barriers downstream that prevent fish access to the crossing area from Phillips Creek. There is no upstream overwintering habitat.

**Photos 1.** Photograph of the dry, steep channel downstream of the Tote Road crossing CV-156.

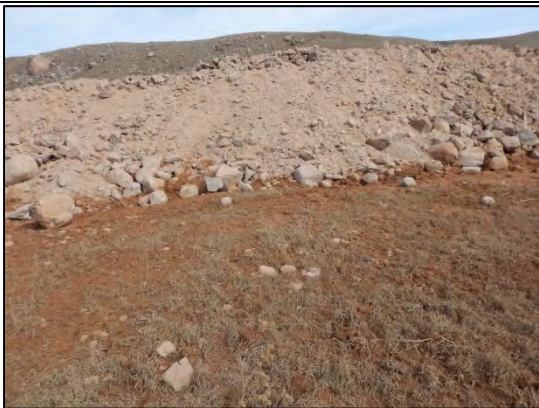
| Tote Road Site CV-153 | | | |
|---|---|---|---|
| <b>Summary:</b> This small runoff area has no channel and is typically dry with several natural steep gradient and vertical drop barriers downstream that prevent fish access to the crossing area from Phillips Creek. There is no longer a culvert at this location on the Tote Road. | | | |
| <b>Photos 1.</b> Photograph of the Tote Road crossing CV-153 from downstream. | | | |

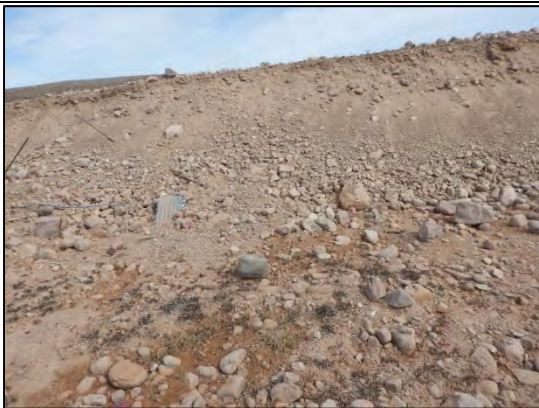
| Tote Road Site CV-152 | | | |
|---|---|---|---|
| <b>Summary:</b> This small runoff area has no channel and is typically dry with several natural steep gradient and vertical drop barriers downstream that prevent fish access to the crossing area from Phillips Creek. There is no longer a culvert at this location on the Tote Road. | | | |
| <b>Photos 1.</b> Photograph of the Tote Road crossing CV-152 from downstream. | | | |

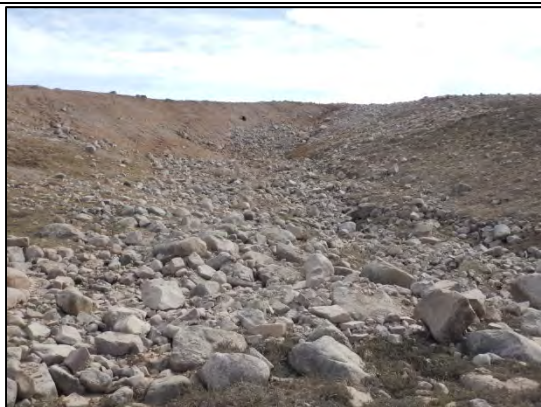
| Tote Road Site CV-151 | | | |
|---|---|---|---|
| <b>Summary:</b> This small runoff area has a poorly defined channel and is typically dry with several natural steep gradient and vertical drop barriers downstream that prevent fish access to the crossing area from Phillips Creek. | | | |
| <b>Photos 1.</b> Photograph of the Tote Road crossing CV-151 from downstream. | | | |

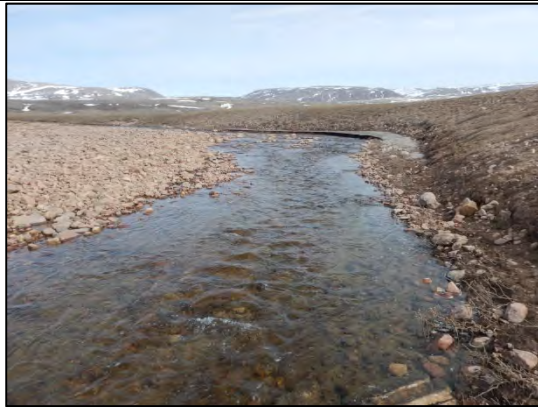
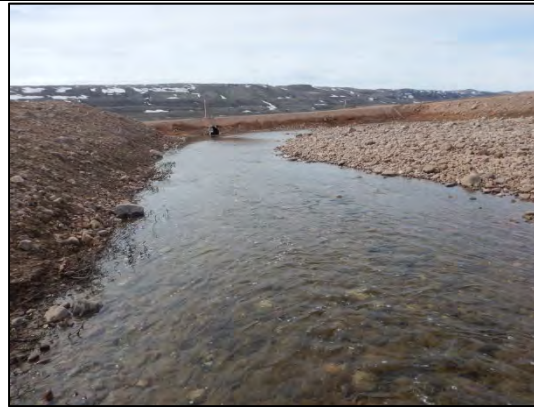
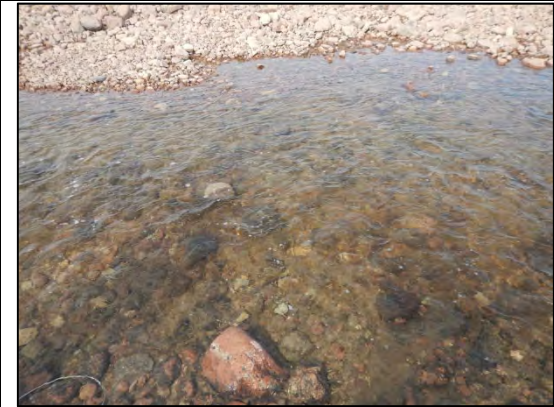
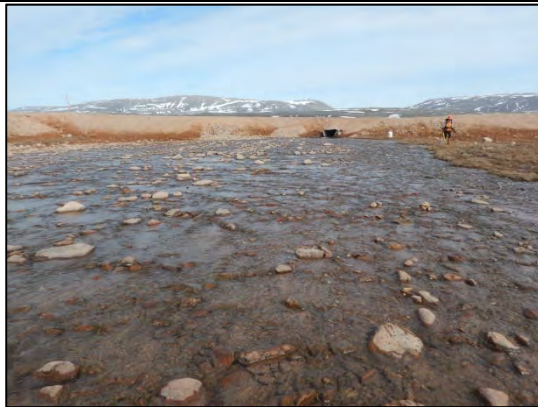
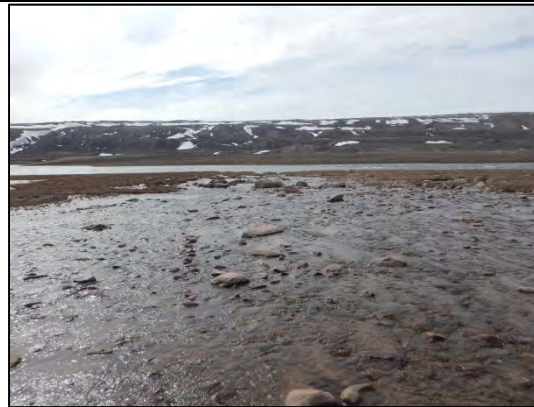
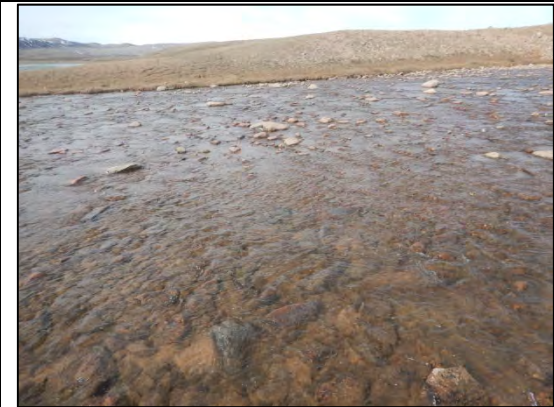
| Location ID | Fish Habitat at Crossing (Y/N) | Fish Captured / Observed DS in 2020 | Fish Captured / Observed US in 2020 | Potential Project-Related Fish Passage or Habitat Issues in Spring 2020 | Fall 2020 Remediation Actions |
|---|---|---|---|---|---|
| CV-129 | Y | N | N | YES - The downstream end of the ramp needs minor repairs and the damaged culvert requires repair. | Repairs to ramp completed. Repairs to culvert pending. |

**Summary:** This site has consistently provided good quality summer rearing habitat for juvenile Arctic Char and is the first large tributary upstream of the impassable falls on Phillips Creek (i.e., fish use is restricted to land-locked Arctic Char). A small culvert perch was remediated in fall 2019 and minor repairs to the remediation works were conducted in fall 2020. An upstream overwintering lake provides additional habitat.

**Photos 1.** Photographs upstream (top) and downstream (bottom) of the Tote Road crossing CV-129: (A,D) looking upstream; (B,E) looking downstream; and (C,F) looking across.

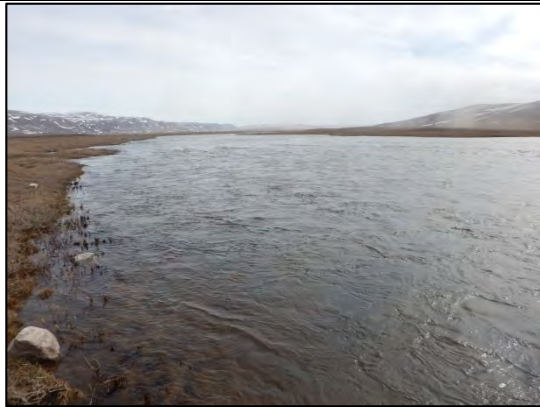
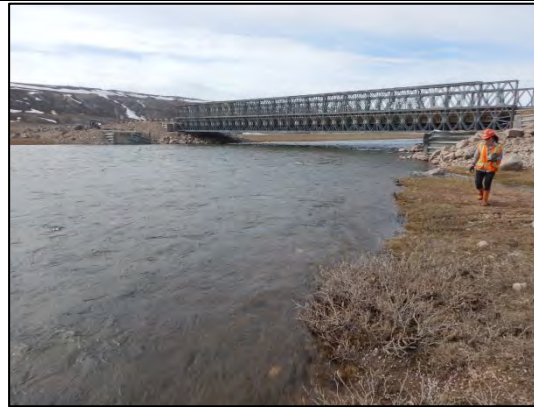
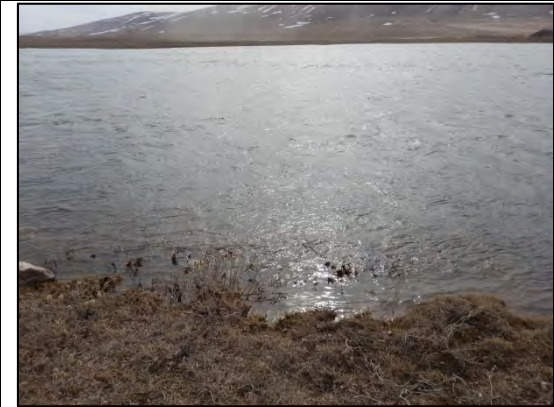
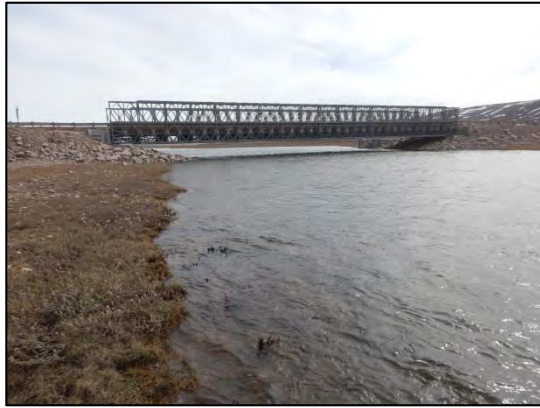
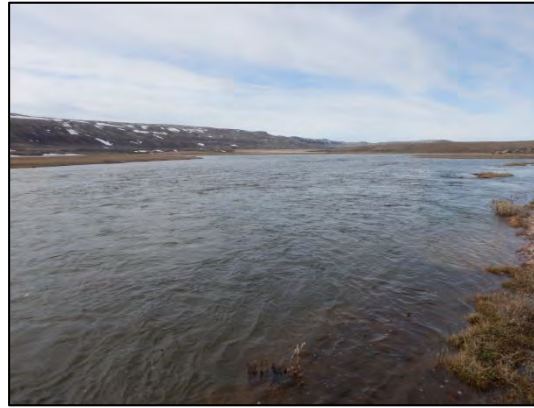
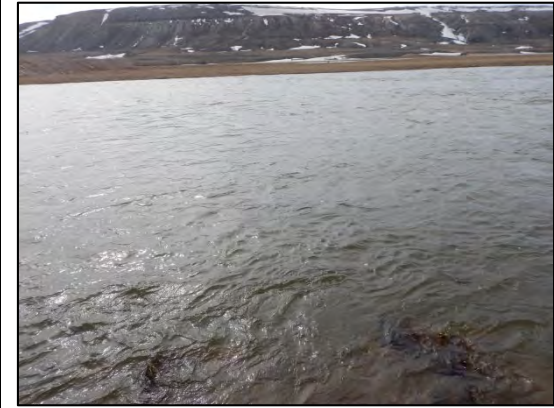
**Summary:** A bridge crossing of a major river that has consistently provided abundant fish habitat with no passage issues identified.

**Photos 1.** Photographs upstream (top) and downstream (bottom) of the Tote Road crossing CV-128: (A,D) looking upstream; (B,E) looking downstream; and (C,F) looking across.

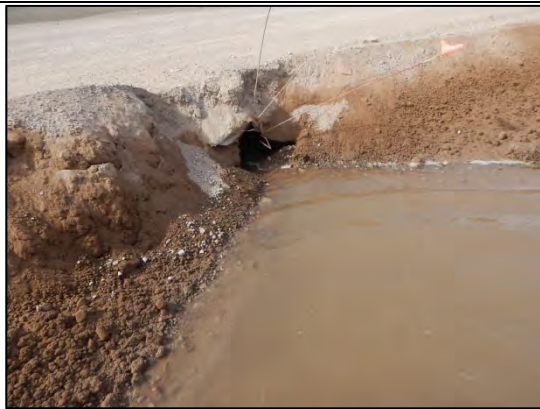
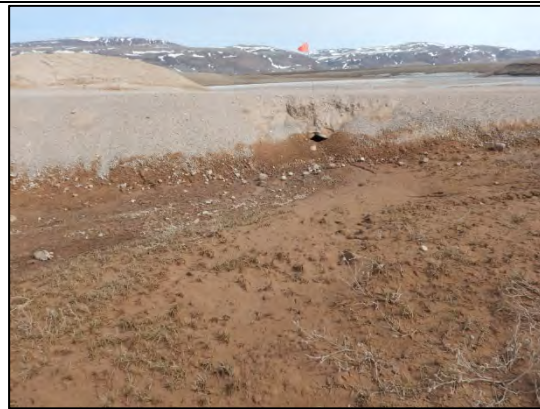
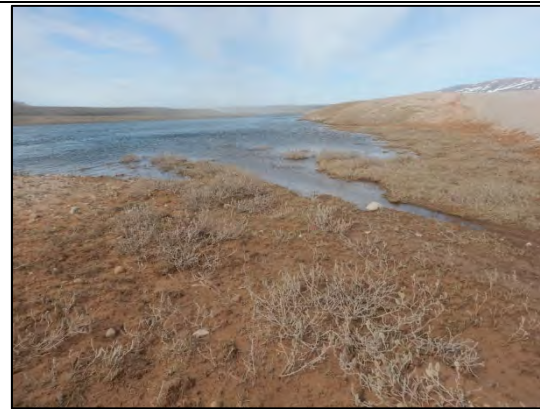
| Tote Road Site CV-125 | | | |
|---|--|---|---|
| Summary: Some ponding occurs upstream of the Tote Road culvert, but there is no channel or surface water downstream of the road. There is no fish access to the site from Phillips Creek. | | | |
| Photos 1. Photograph upstream of the Tote Road crossing CV-125 looking downstream (A); and photographs downstream of the Tote Road crossing CV-125 (B) looking upstream; and (C) looking downstream. | | | |

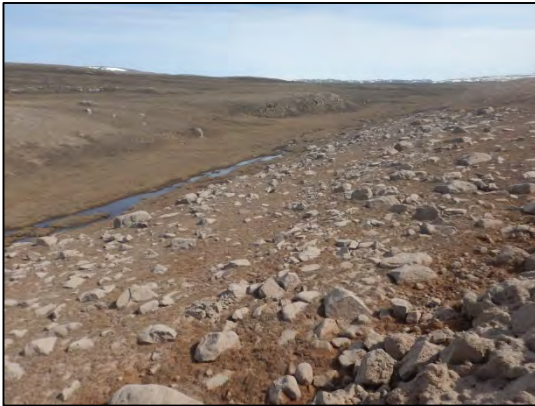
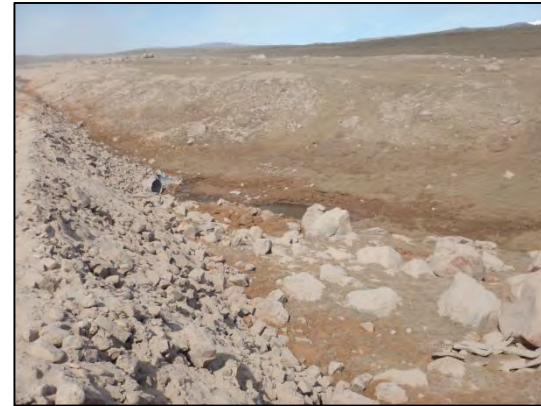
**Summary:** Some ponding occurs upstream of the Tote Road culvert, but there is no channel or surface water downstream of the road. There is no connection to or access from Phillips Creek for fish.

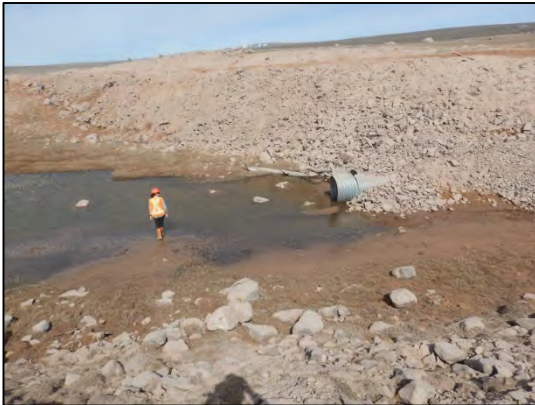
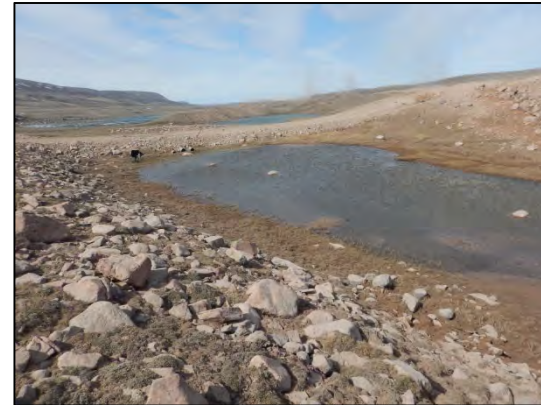
**Photos 1.** Photographs upstream (top) and downstream (bottom) of the Tote Road crossing CV-120; (A,C) looking upstream; and (B,D) looking downstream.

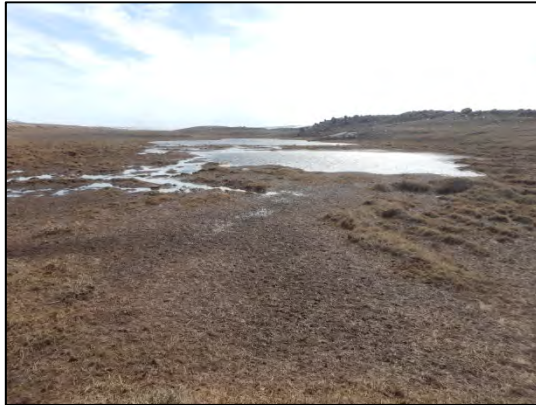
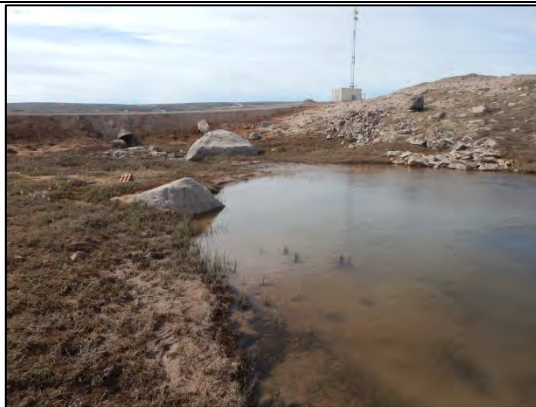
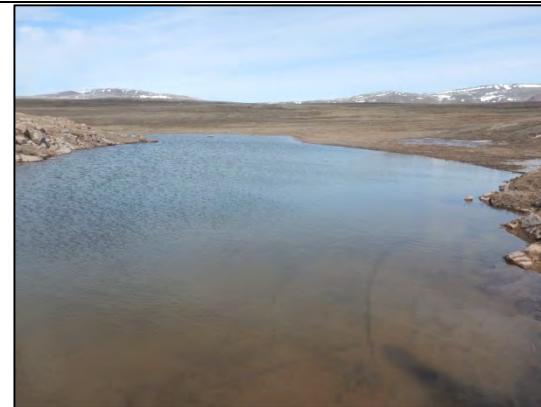
**Summary:** There is a shallow pond immediately downstream from the Tote Road culvert. Downstream from the pond, the channel disappears and surface water becomes patchy, shallow, and dispersed over terrestrial grasses as it flows towards the crossing at CV-120. There is no natural connectivity to Phillips Creek.

**Photos 1.** Photographs upstream of the Tote Road crossing CV-119: (A) looking upstream; (B) looking downstream; and photographs downstream of the Tote Road: (C) looking upstream; and (D) looking downstream.

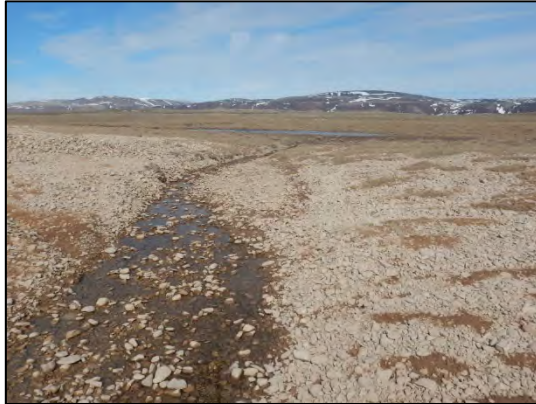
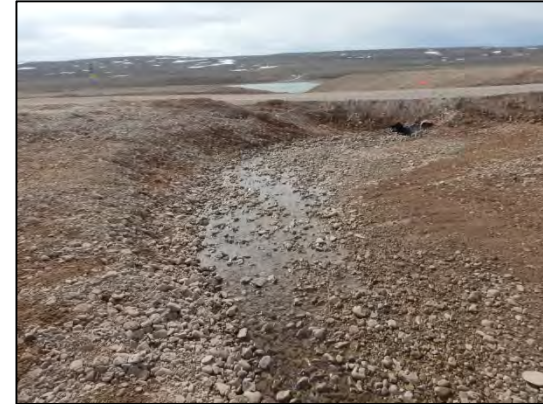
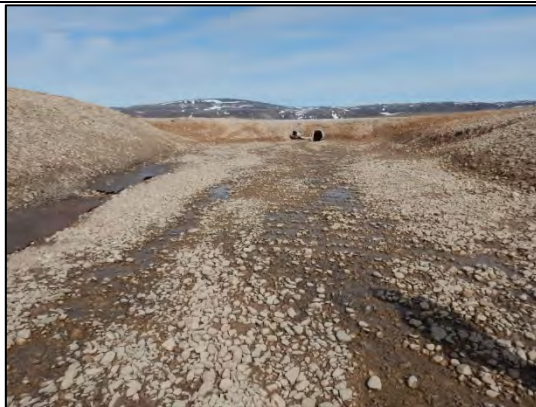
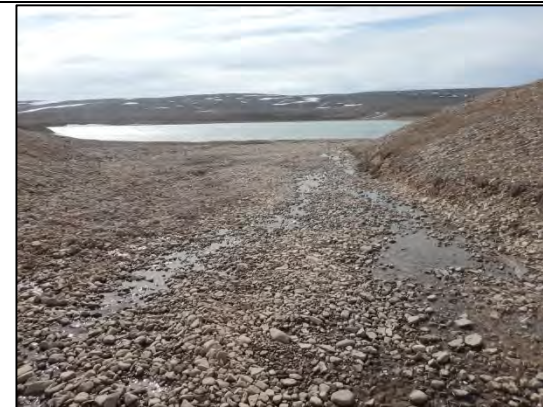
**Summary:** Stream has been regularly surveyed and is dry most years. There was very shallow surface water present during the freshet in 2020, but no fish were present.

**Photos 1.** Photographs upstream (top) and downstream (bottom) of the Tote Road crossing CV-115: (A,C) looking upstream; and (B,D) looking downstream.

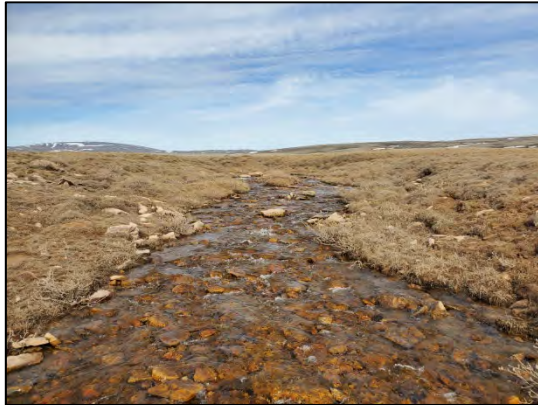
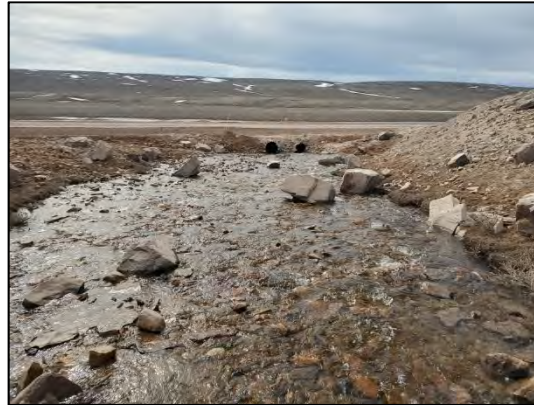
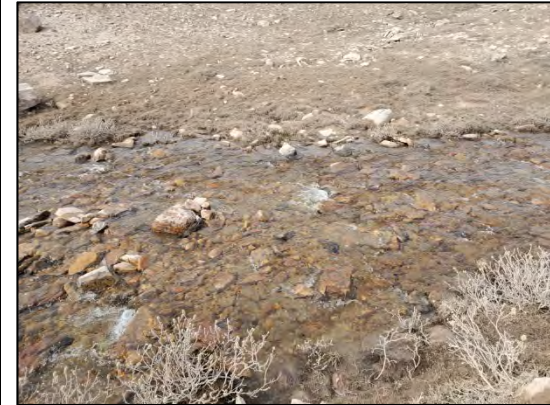
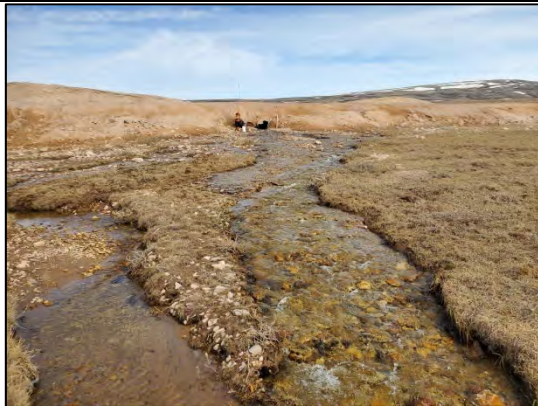
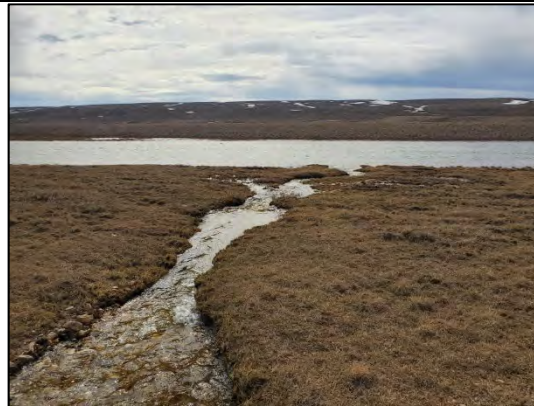
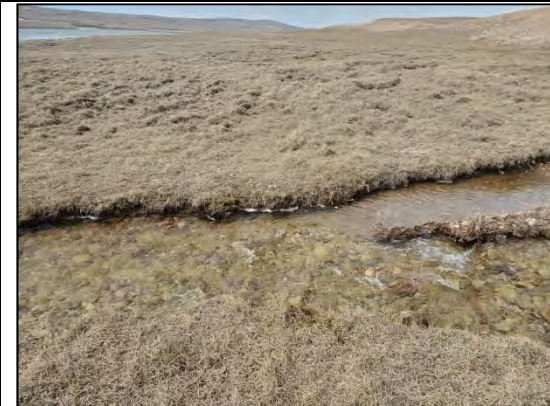
**Summary:** This stream provides habitat for juvenile Arctic Char. Perched culverts that may affect upstream access were remediated in fall 2019 and minor repairs to the works were completed in fall 2020.

**Photos 1.** Photographs upstream (top) and downstream (bottom) of the Tote Road crossing CV-114: (A,D) looking upstream; (B,E) looking downstream; and (C,F) looking across.

| Location ID | Fish Habitat at Crossing (Y/N) | Fish Captured / Observed DS in 2020 | Fish Captured / Observed US in 2020 | Potential Project-Related Fish Passage or Habitat Issues in Spring 2020 | Fall 2020 Remediation Actions |
|---|---|---|---|---|---|
| CV-114 | Y | Y | Y | YES - Adjustments and reinforcement of the ramp and armouring of the banks should be undertaken. | Repairs to ramp completed. |

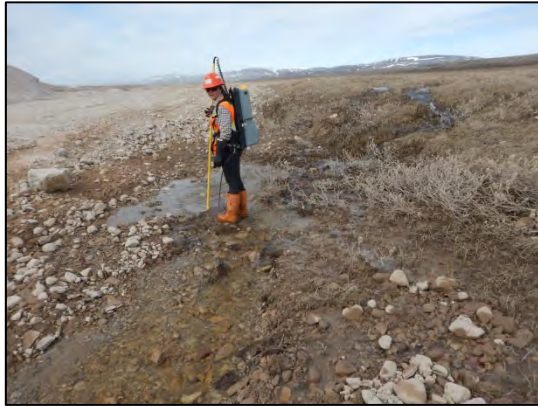
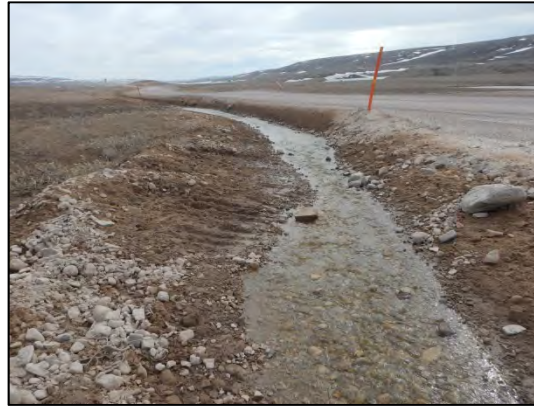
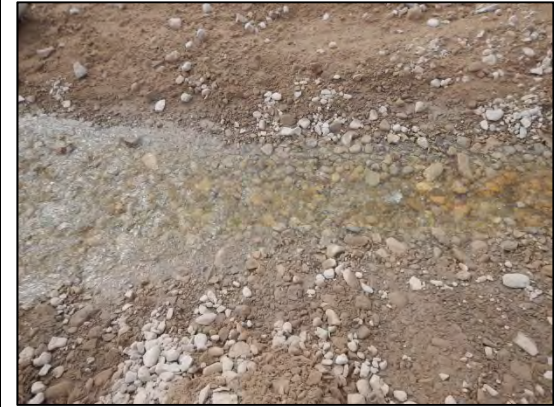
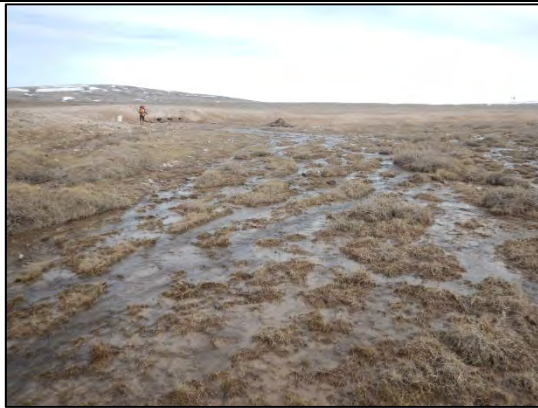
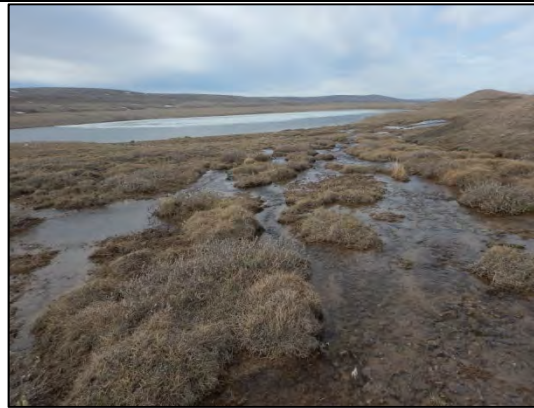
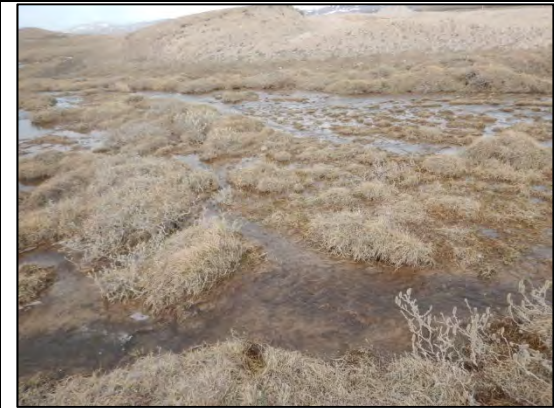
**Summary:** Site is dry most of the open-water season and lacks a defined channel and connectivity with Phillips Creek. Some surface melt was present during the freshet in spring 2020, but flows were dispersed over the tundra downstream of the road. The stream typically dries shortly after freshet.

**Photos 1.** Photographs upstream (top) and downstream (bottom) of the Tote Road crossing CV-113: (A,D) looking upstream; (B,E) looking downstream; and (C,F) looking across.

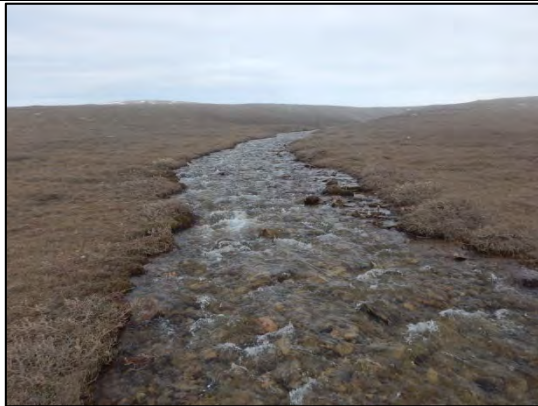
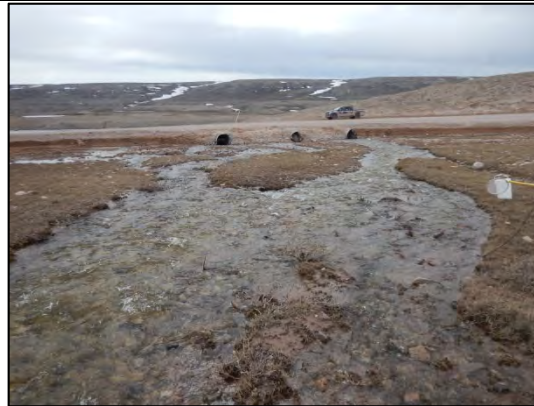
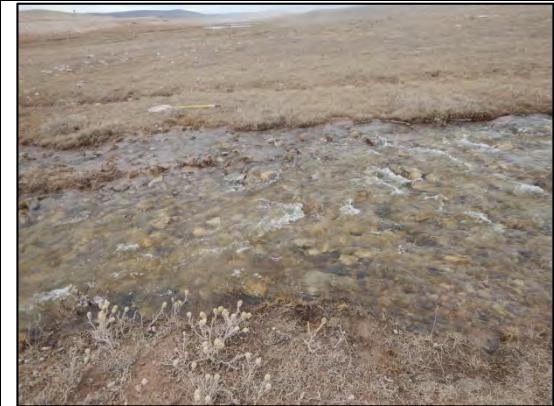
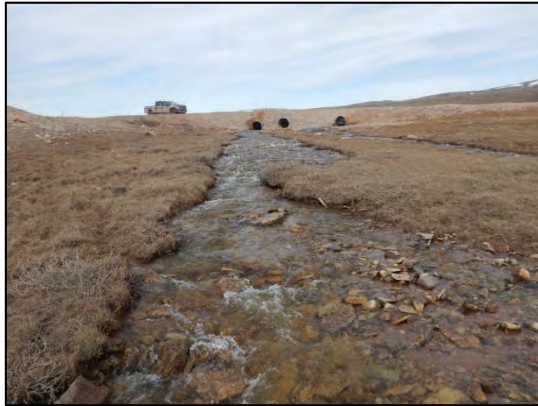
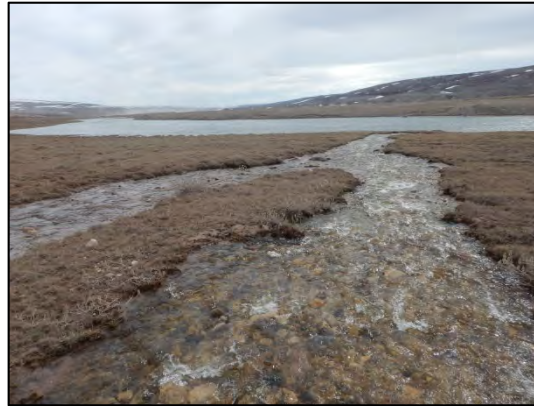
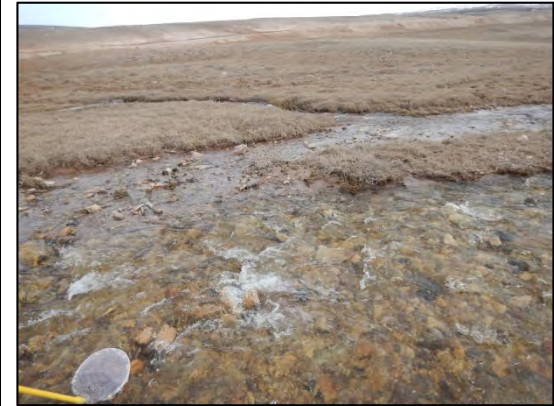
**Summary:** This stream provides summer rearing habitat for juvenile Arctic Char. There are no fish passage issues.

**Photos 1.** Photographs upstream (top) and downstream (bottom) of the Tote Road crossing CV-112: (A,D) looking upstream; (B,E) looking downstream; and (C,F) looking across.

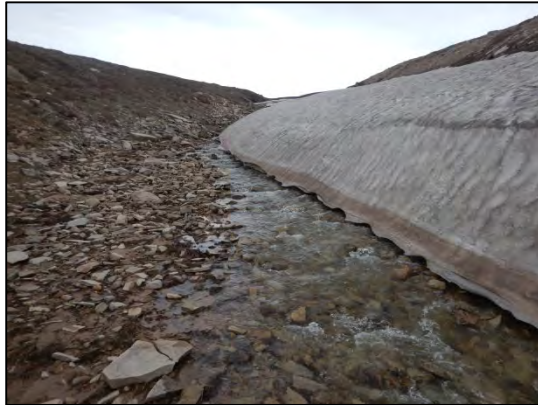
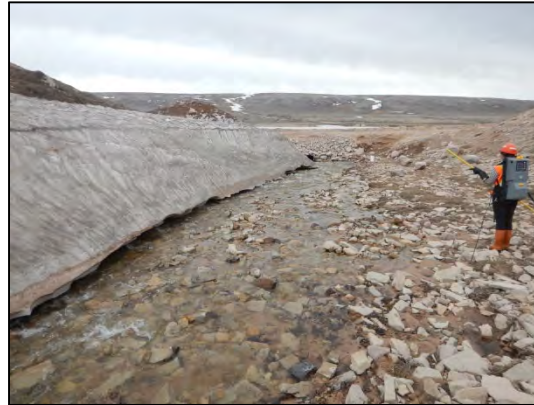
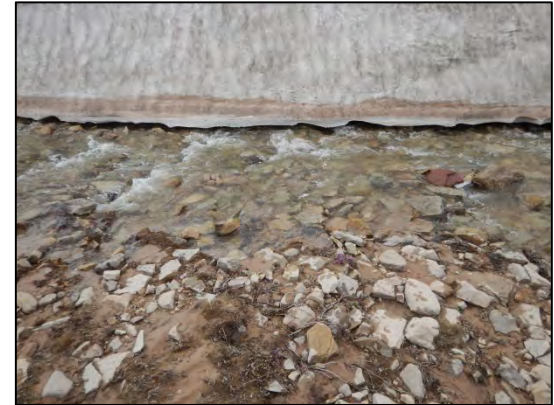
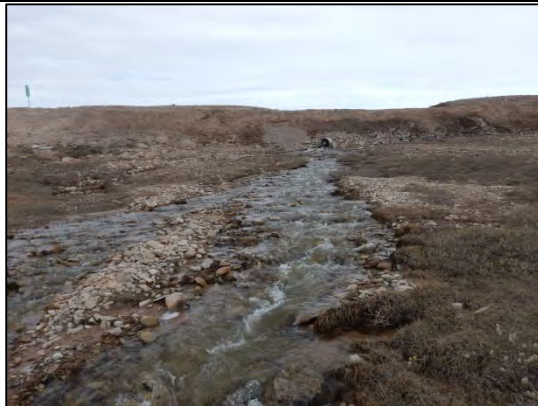
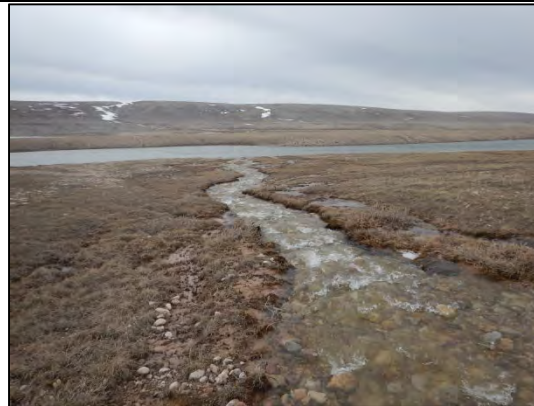
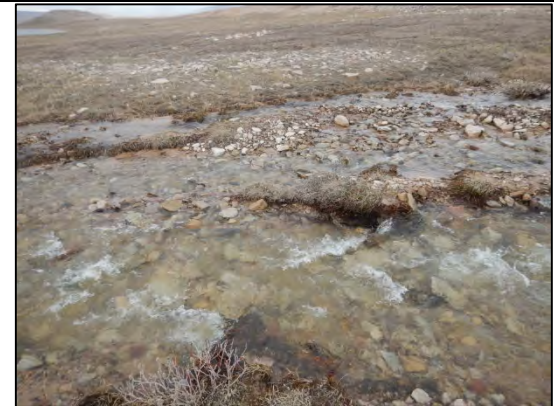
**Summary:** This stream provides summer rearing habitat for juvenile Arctic Char. Culvert was recently reinstalled and is perched. Remediation measures in 2019 were insufficient to improve fish access. Additional remediation required. See remediation Appendix C for details.

**Photos 1.** Photographs upstream (top) and downstream (bottom) of the Tote Road crossing CV-111: (A,D) looking upstream; (B,E) looking downstream; and (C,F) looking across.

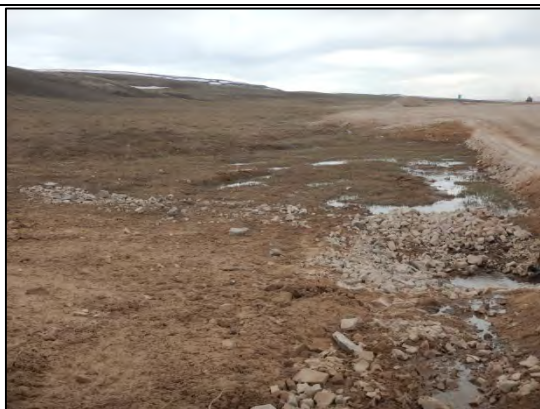
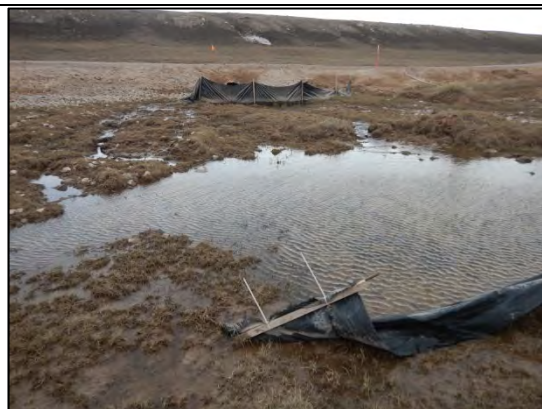
| Tote Road Site CV-202 | | | |
|---|--|---|---|
| Summary: Site has no natural channel downstream, little surface flow, particularly following completion of freshet, and is not connected to Phillips Creek. | | | |
| Photos 1. Photographs of the Tote Road crossing CV-202: (A) looking upstream from culvert; and (B) looking upstream towards culvert. | | | |

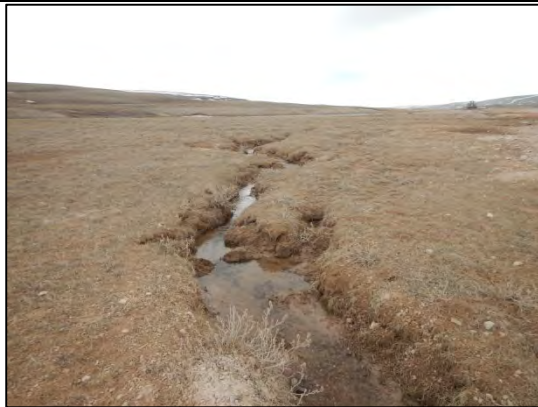
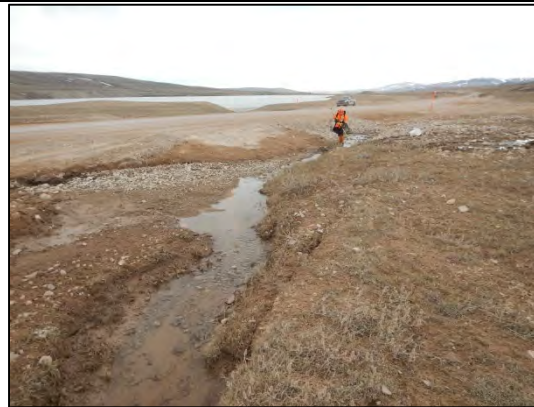
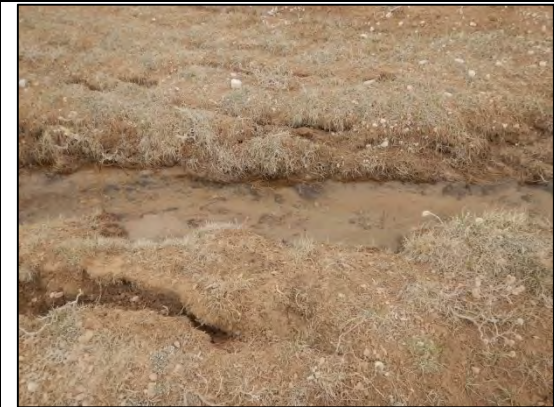
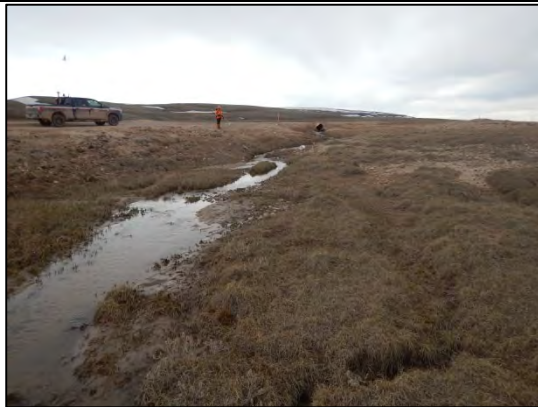
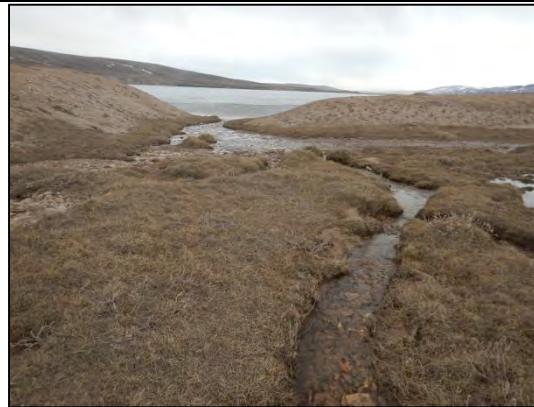
**Summary:** Stream provides summer rearing habitat for juvenile Arctic Char, though it frequently becomes dry following freshet without additional inputs of precipitation. An existing ramp (2018) designed to improve access received additional modifications in 2019 and 2020.

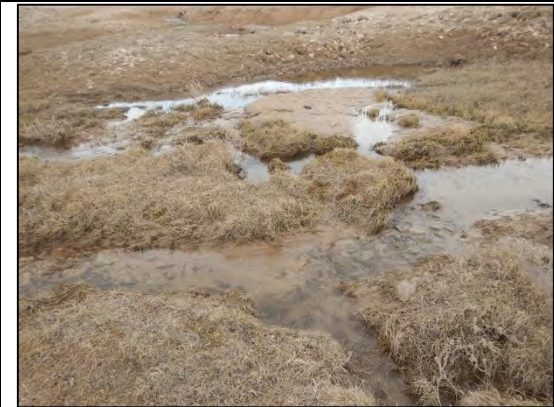
**F**

**Photos 1.** Photographs upstream (top) and downstream (bottom) of the Tote Road crossing CV-106: (A,D) looking upstream; (B,E) looking downstream; and (C,F) looking across.

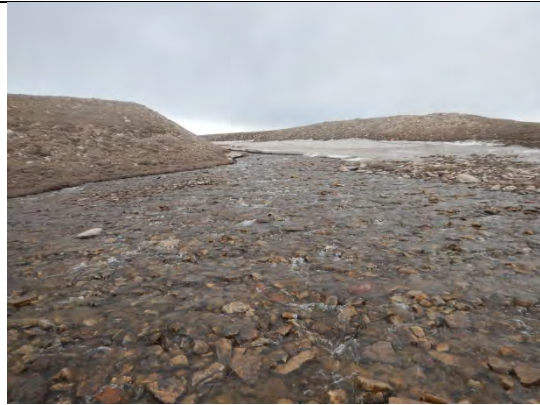
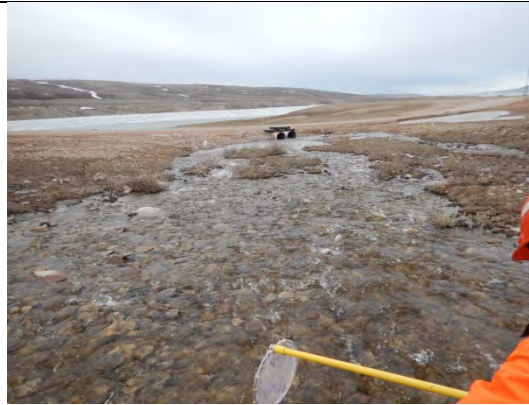
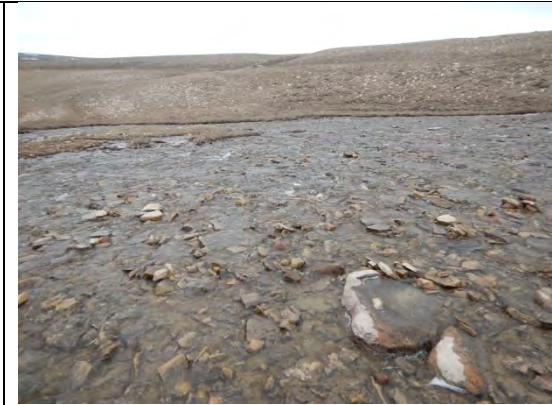
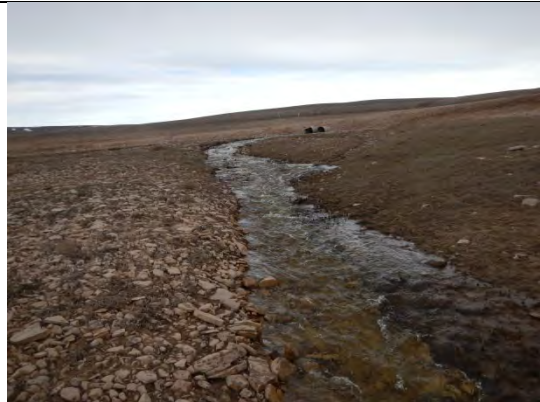
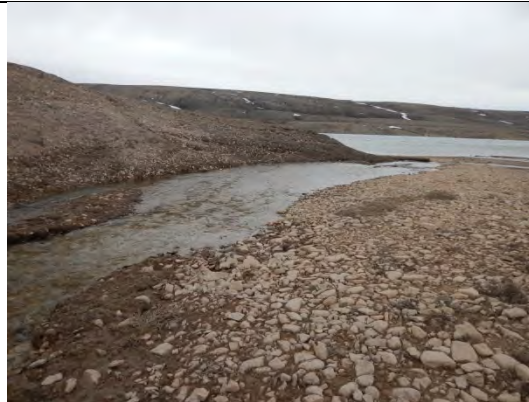
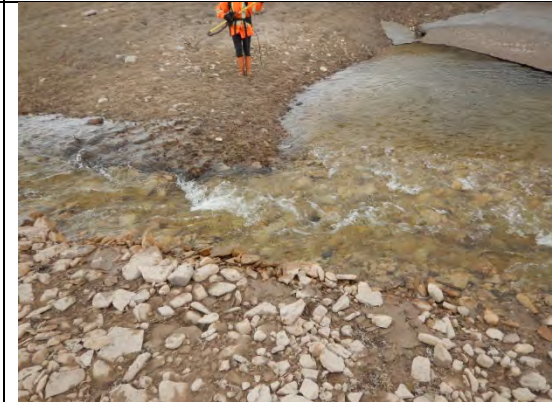
**Summary:** Though water levels are occasionally low (as in 2019), this stream typically provides summer rearing habitat for juvenile Arctic Char. There were no passage issues identified in 2020.

**Photos 1.** Photographs upstream (top) and downstream (bottom) of the Tote Road crossing CV-104: (A,D) looking upstream; (B,E) looking downstream; and (C,F) looking across.

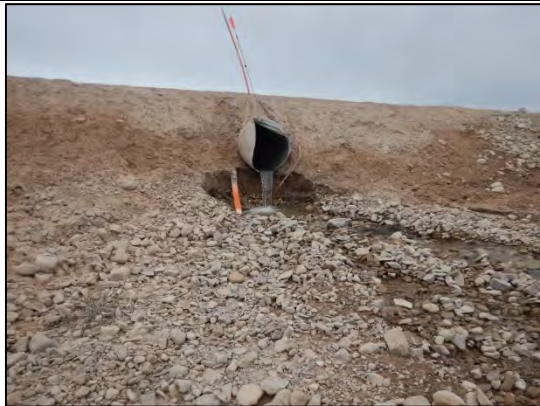
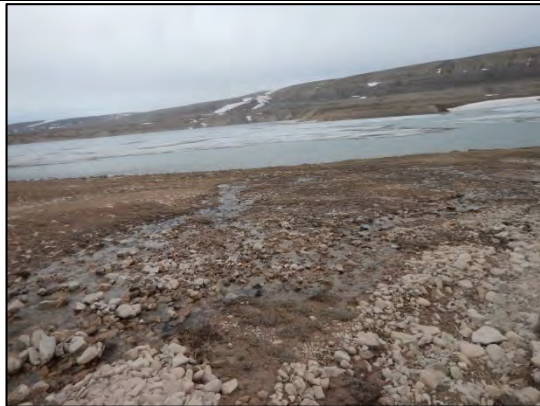
| | | | |
| A | | B | | | | |
| <b>Photos 1.</b> Photographs downstream of the Tote Road crossing CV-203: (A) looking upstream; and (B) looking downstream towards Phillips Creek. | | | | | | |
| Baffinland Iron Mines<br>Mary River Project | |

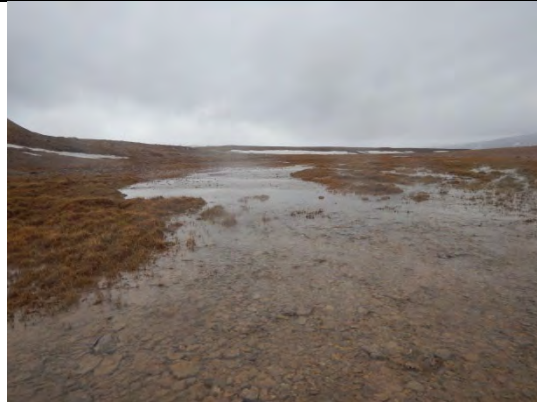
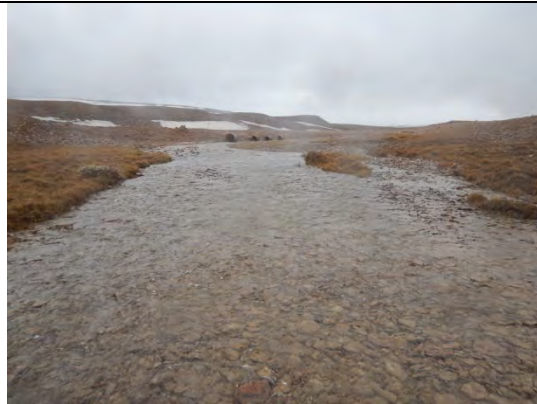
**Summary:** This stream typically provides summer rearing habitat for juvenile Arctic Char. There were no fish passage issues identified in 2020.

**Photos 1.** Photographs upstream (top) and downstream (bottom) of the Tote Road crossing CV-102: (A,D) looking upstream; (B,E) looking downstream; and (C,F) looking across.
