**BAFFINLAND IRON MINES CORPORATION  
MARY RIVER PROJECT**

**TOTE ROAD FISH HABITAT MONITORING  
2020 ANNUAL REPORT  
EARLY REVENUE PHASE - TOTE ROAD UPGRADES**

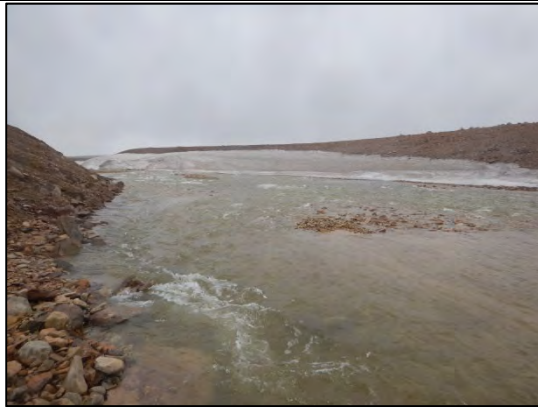
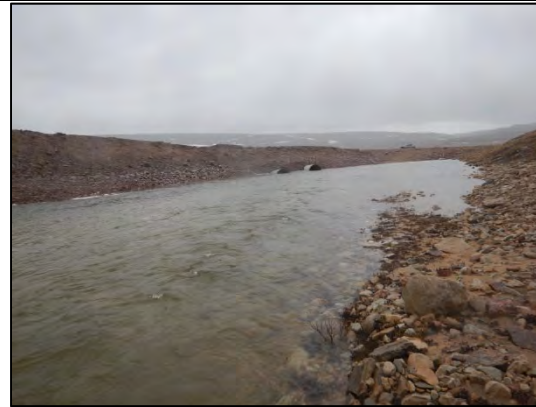
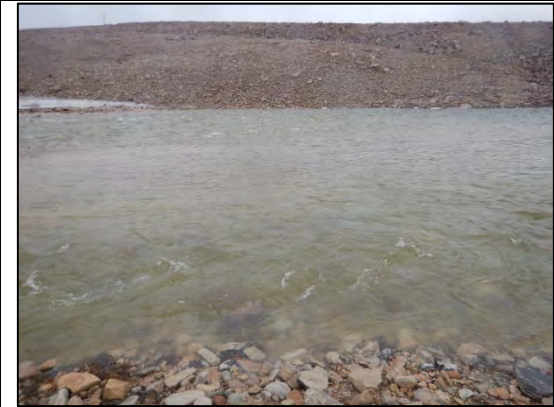
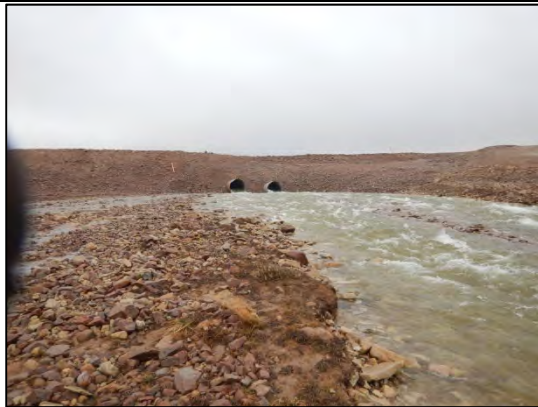
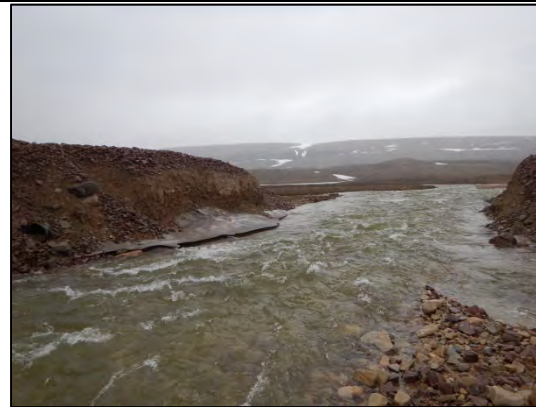
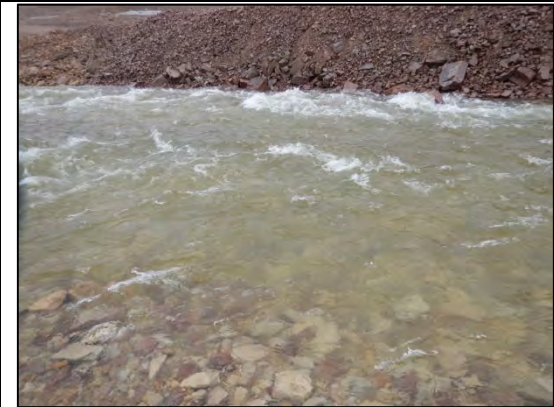
**Summary:** A large stream with abundant fish habitat. During high flows, water velocities in the culverts can be sufficiently high to restrict upstream access to larger juvenile char. Electrofishing could not be safely conducted in this stream during peak freshet in 2020 due to high flows. Fish use was not assessed for CV-099, but other streams in the study area showed minimal fish use during this period.

**Photos 1.** Photographs upstream (top) and downstream (bottom) of the Tote Road crossing CV-099: (A,D) looking upstream; (B,E) looking downstream; and (C,F) looking across.

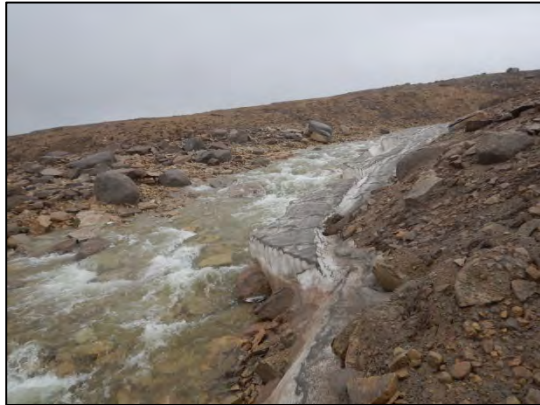
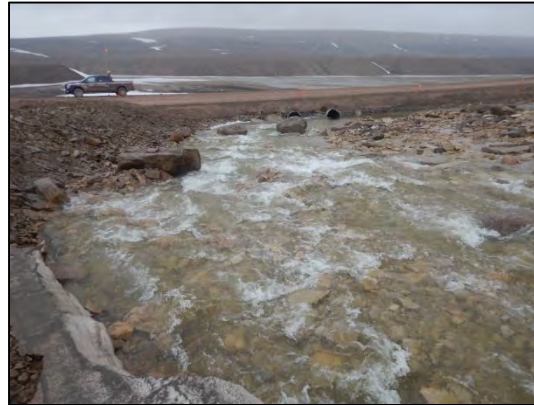
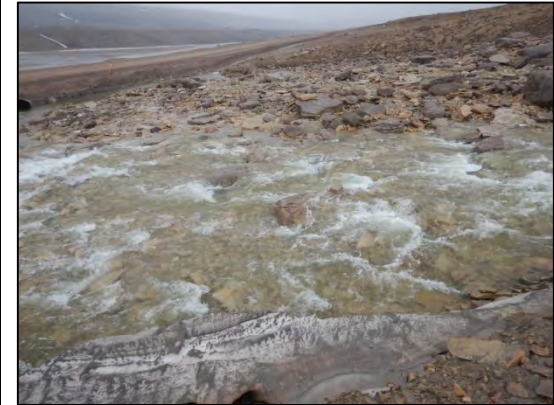
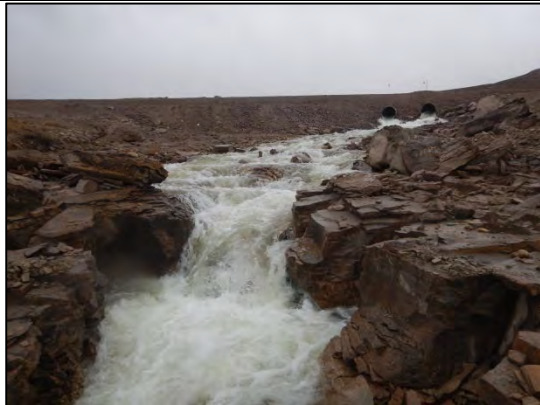
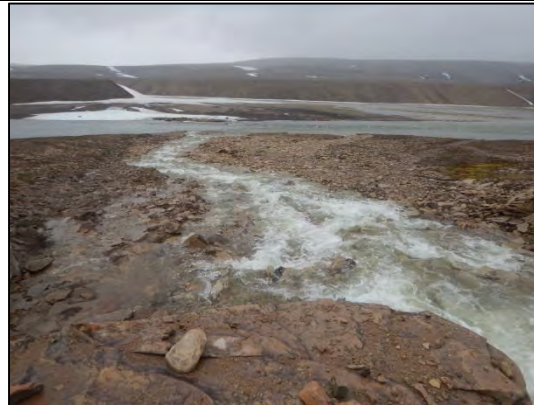
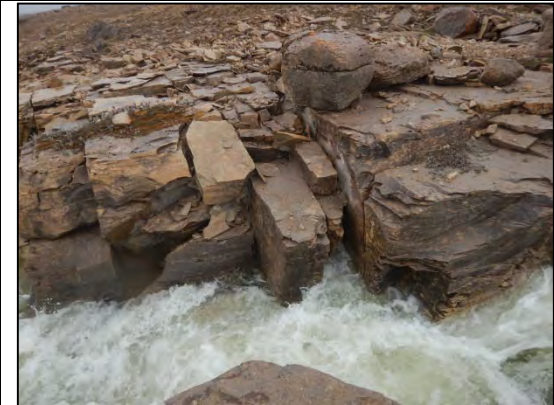
**Summary:** Site provides good quality summer rearing habitat for juvenile Arctic Char, but a natural downstream vertical barrier prevents access from overwintering habitat. Fish cannot naturally access the crossing or farther upstream habitat.

**Photos 1.** Photographs upstream (top) and downstream (bottom) of the Tote Road crossing CV-094: (A,D) looking upstream; (B,E) looking downstream; and (C,F) looking across.

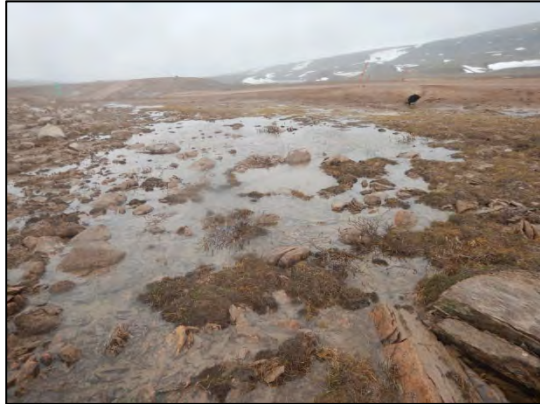
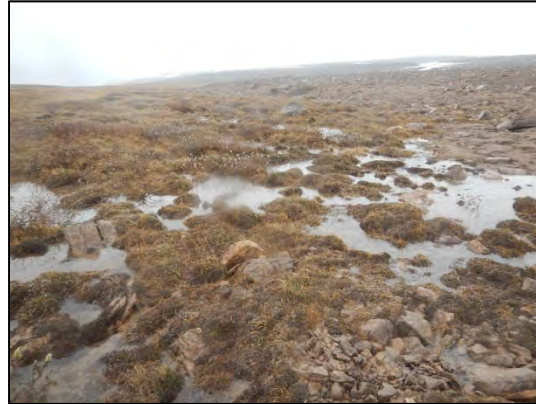
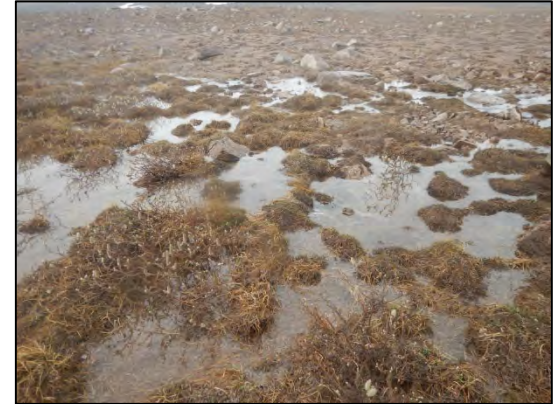
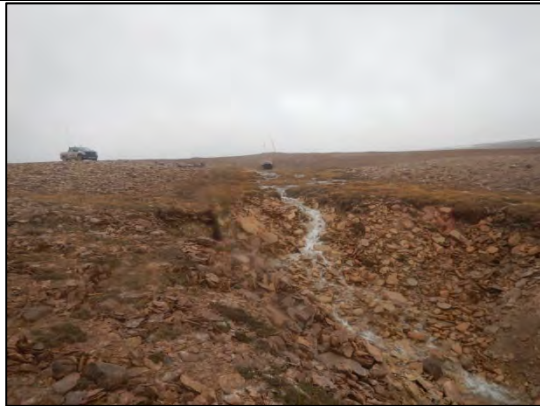
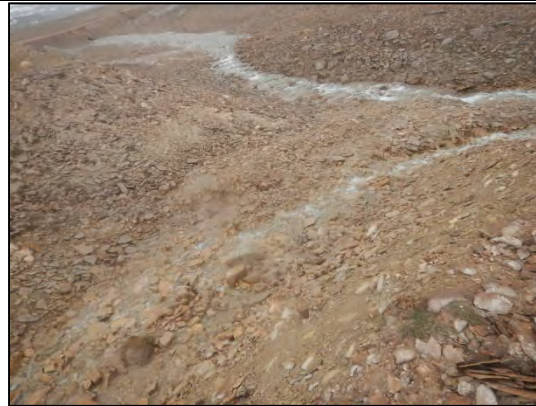
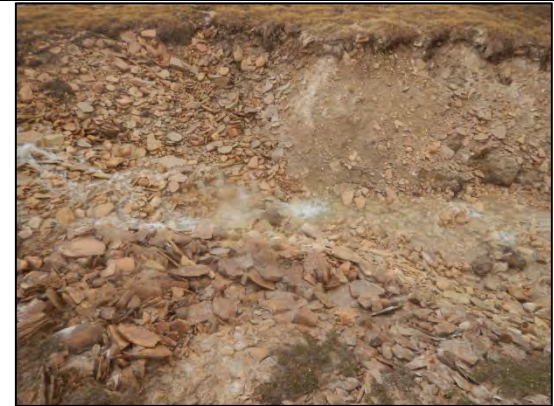
**Summary:** No natural channel and surface water dries up shortly after peak freshet. There is also a steep gradient downstream from the road that prevents fish access to the area and the crossing lacks connectivity to overwintering habitat.

**Photos 1.** Photographs upstream (top) and downstream (bottom) of the Tote Road crossing CV-086: (A,D) looking upstream; (B,E) looking downstream; and (C,F) looking across.

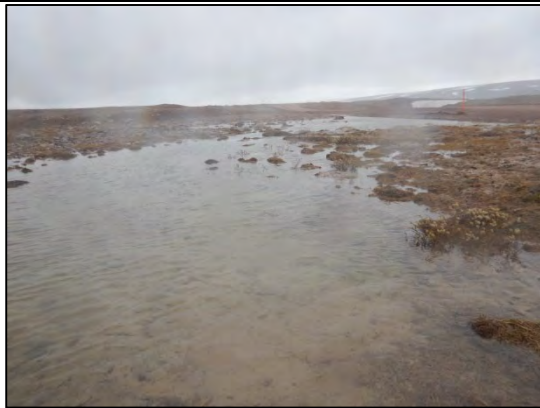
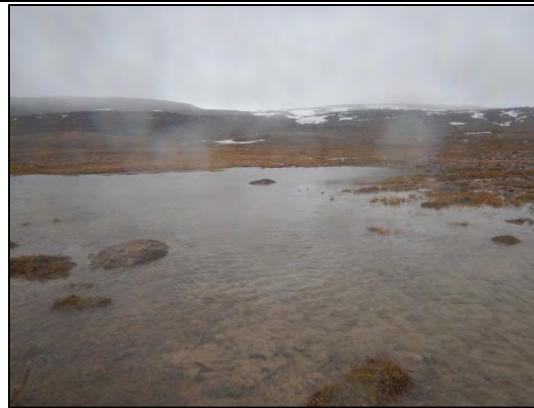
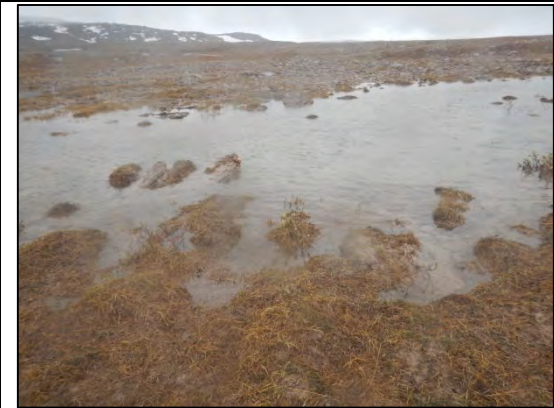
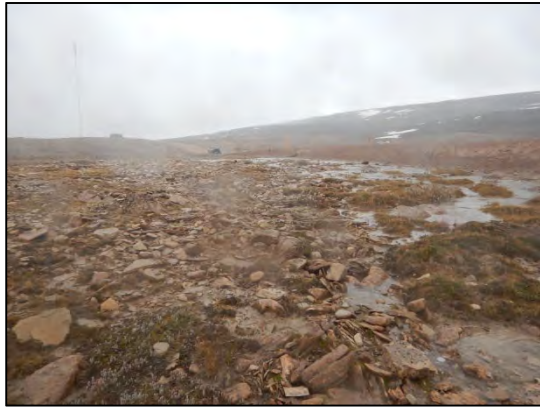
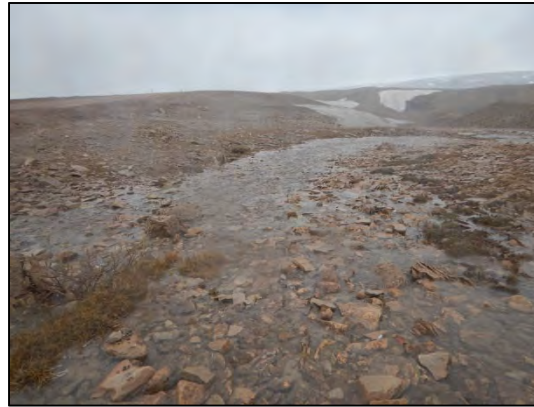
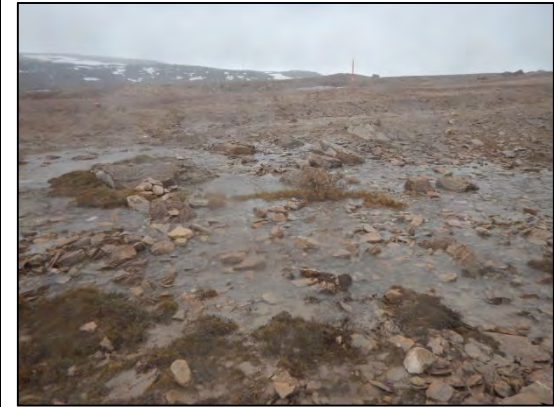
**Summary:** No natural channel upstream from the road where meltwater pools on terrestrial habitat and subsequently dries up shortly after peak freshet. There is also a steep gradient downstream from the road and the crossing lacks connectivity to overwintering habitat.

**Photos 1.** Photographs upstream (top) and downstream (bottom) of the Tote Road crossing CV-082: (A,D) looking upstream; (B,E) looking downstream; and (C,F) looking across.

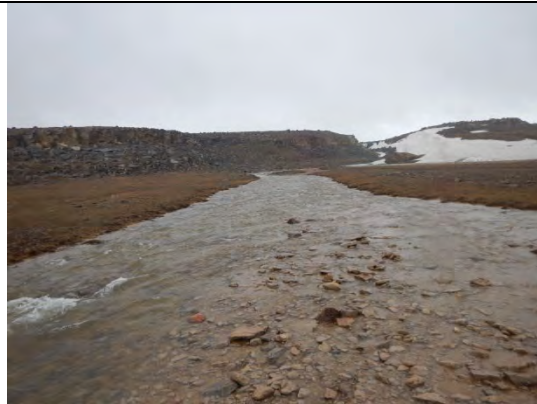
**A**

**Summary:** Site provides abundant summer rearing habitat for juvenile Arctic Char. There were no fish passage issues identified in 2020.

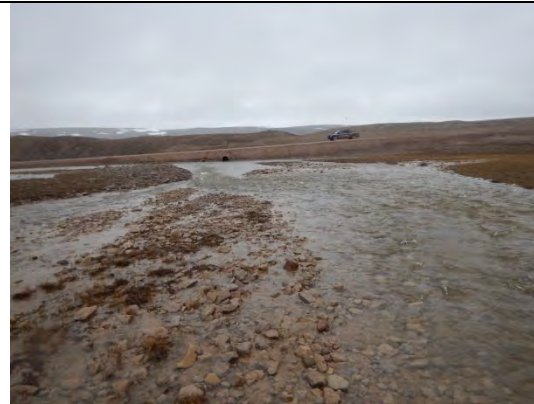
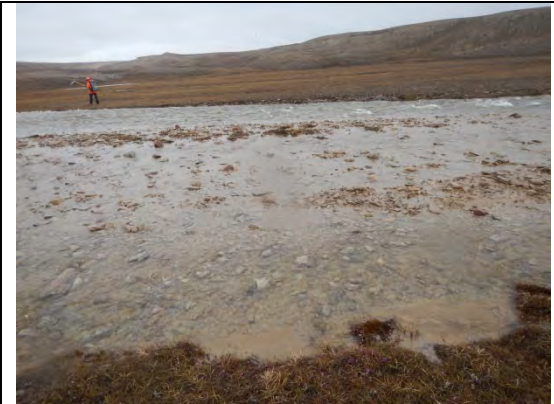
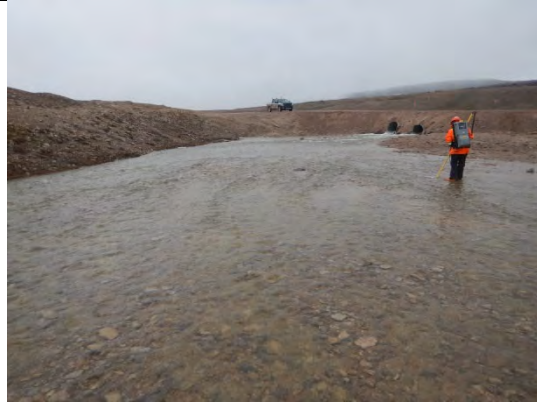
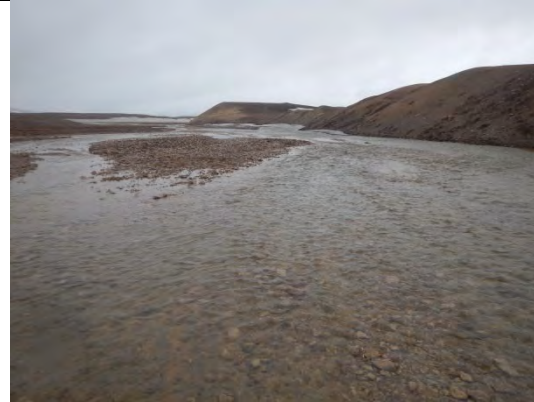
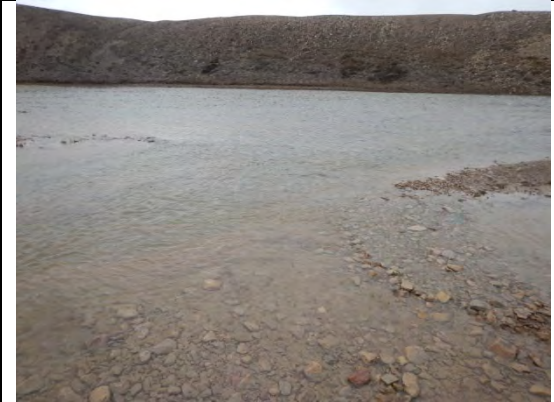
**Photos 1.** Photographs upstream (top) and downstream (bottom) of the Tote Road crossing CV-079: (A,D) looking upstream; (B,E) looking downstream; and (C,F) looking across.

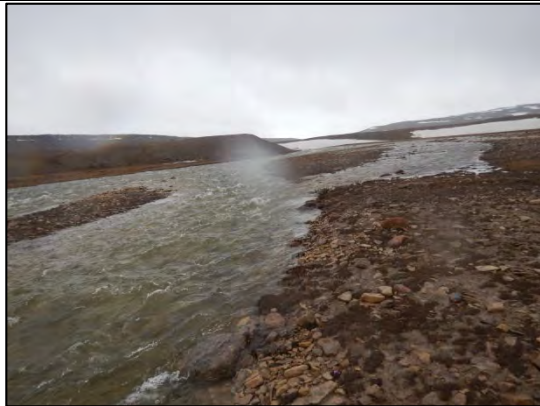
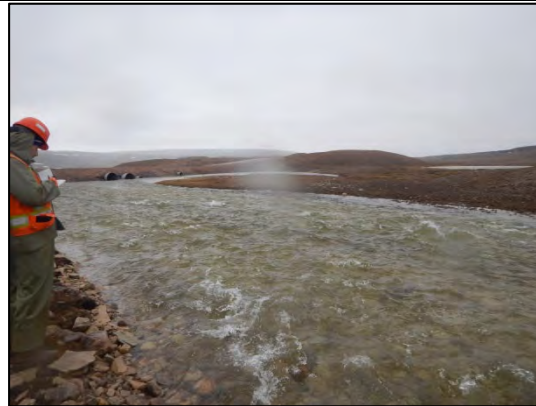
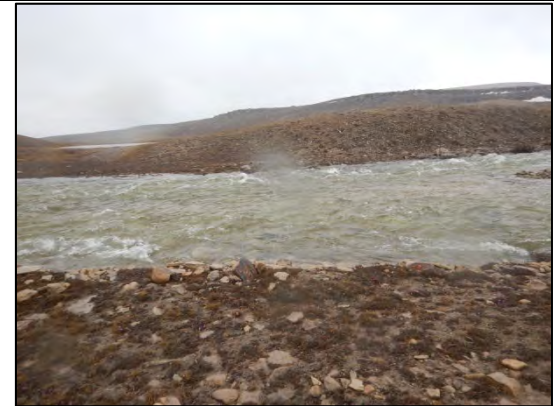
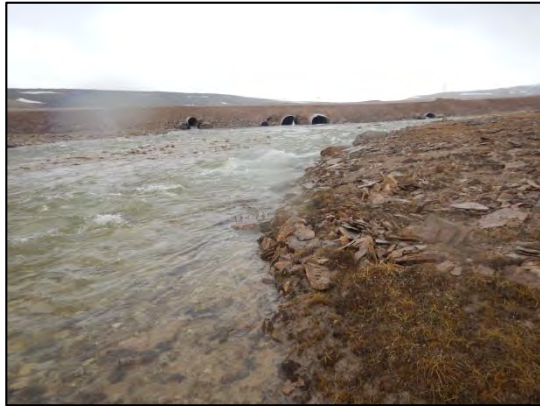
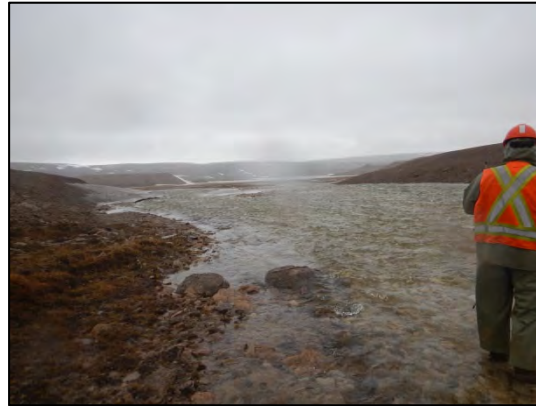
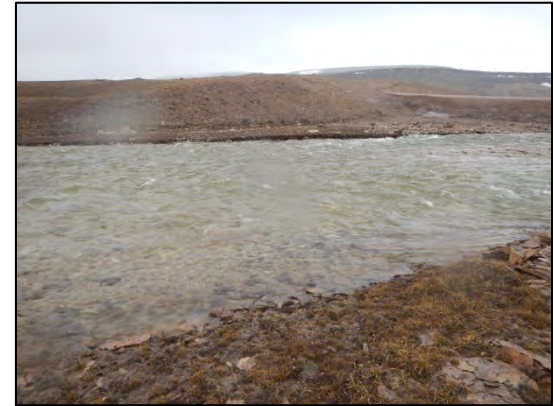
**Summary:** Site provides abundant summer rearing habitat for juvenile Arctic Char. There were no fish passage issues identified in 2020.

**Photos 1.** Photographs upstream (top) and downstream (bottom) of the Tote Road crossing CV-078: (A,D) looking upstream; (B,E) looking downstream; and (C,F) looking across.

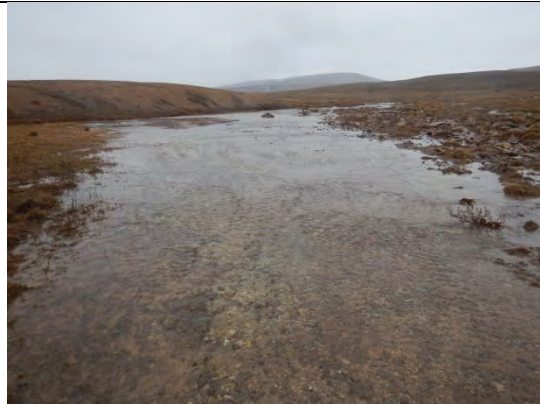
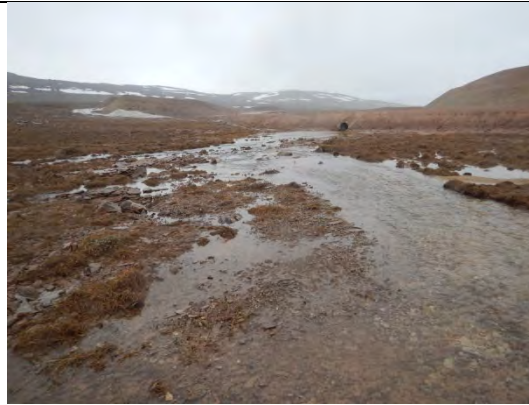
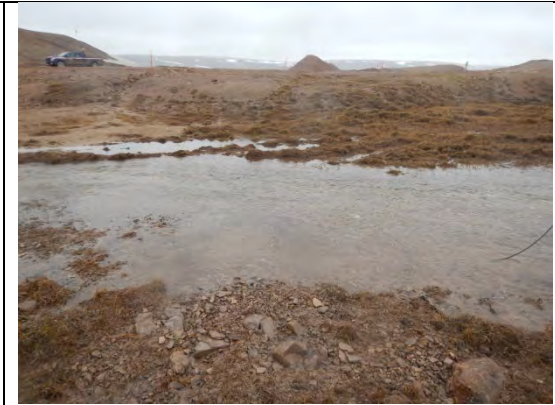
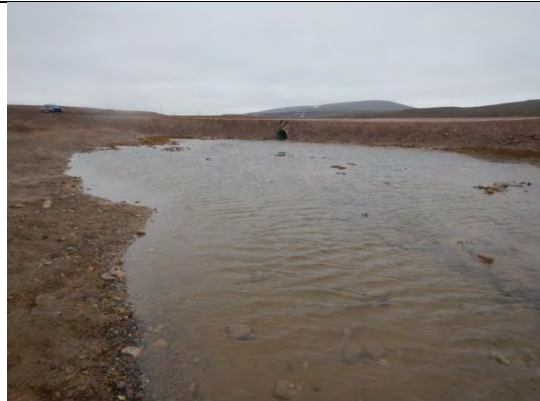
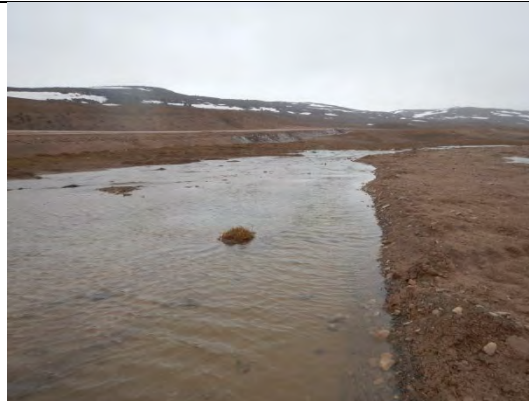
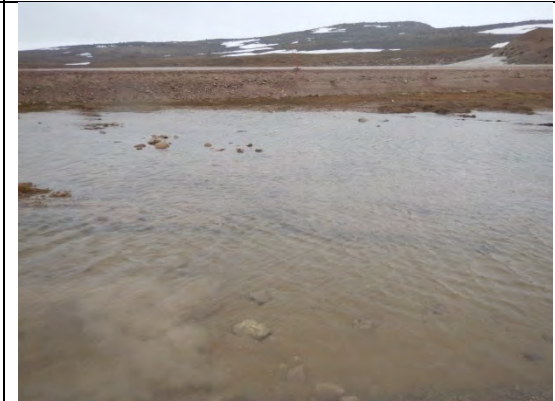
**Summary:** Small stream providing summer rearing habitat for juvenile Arctic Char. There was some flow observed underneath the road 5 m south of the culvert. This has not been previously observed and likely only occurs during peak freshet. There were no issues affecting fish passage in 2020.

**Photos 1.** Photographs upstream (top) and downstream (bottom) of the Tote Road crossing CV-076: (A,D) looking upstream; (B,E) looking downstream; and (C,F) looking across.

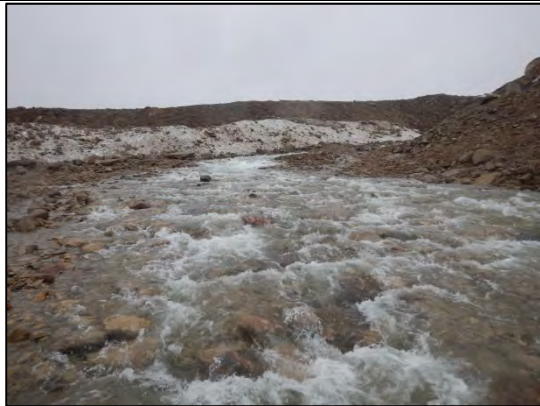
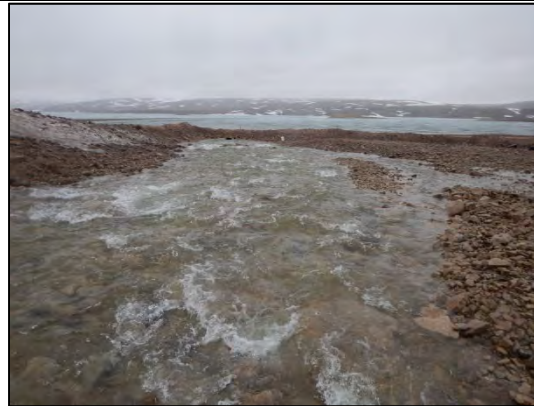
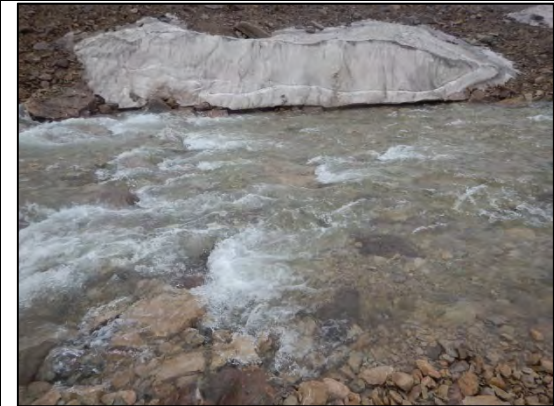
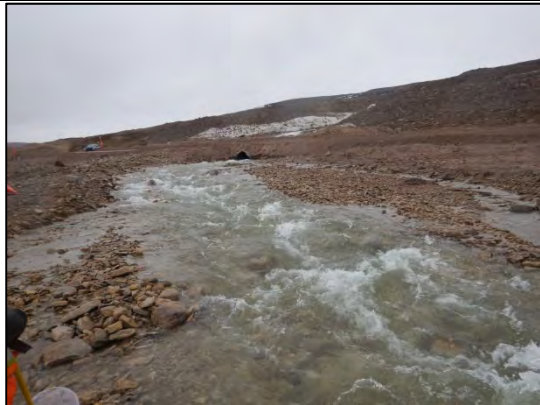
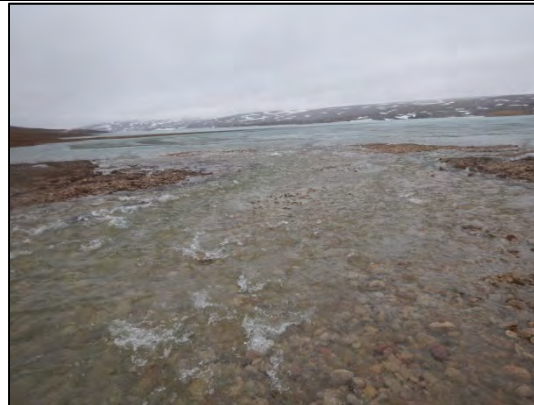
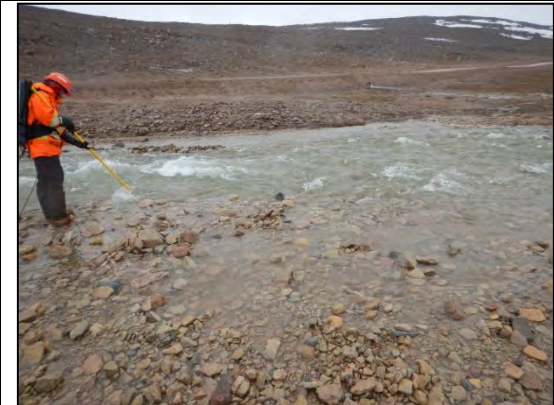
**Summary:** Site provides abundant summer rearing habitat for juvenile Arctic Char. There were no fish passage issues identified in 2020.

**Photos 1.** Photographs upstream (top) and downstream (bottom) of the Tote Road crossing CV-072: (A,D) looking upstream; (B,E) looking downstream; and (C,F) looking across.

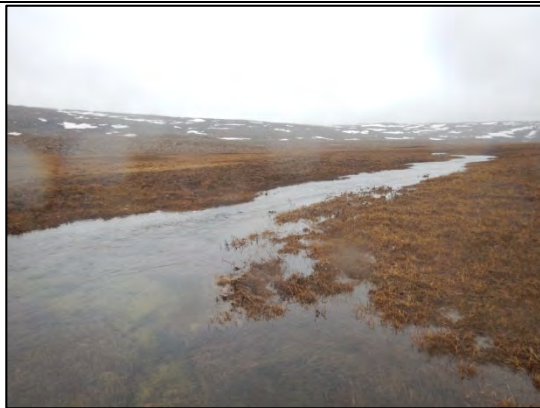
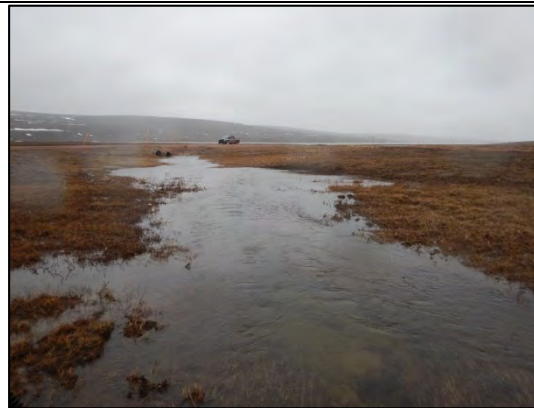
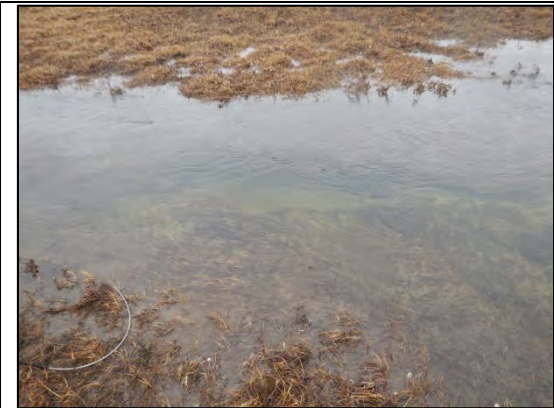
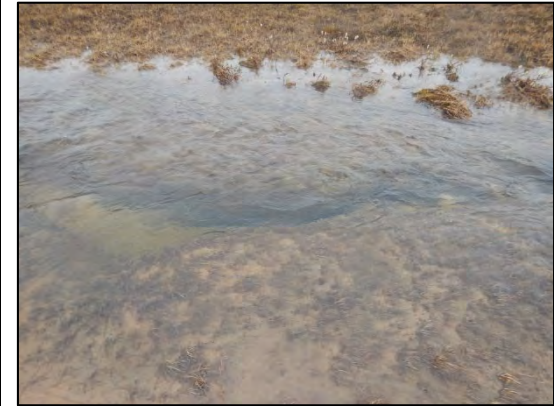
**Summary:** Site provides abundant summer rearing habitat for juvenile Arctic Char. There were no fish passage issues identified in 2020.

**Photos 1.** Photographs upstream (top) and downstream (bottom) of the Tote Road crossing CV-060: (A,D) looking upstream; (B,E) looking downstream; and (C,F) looking across.

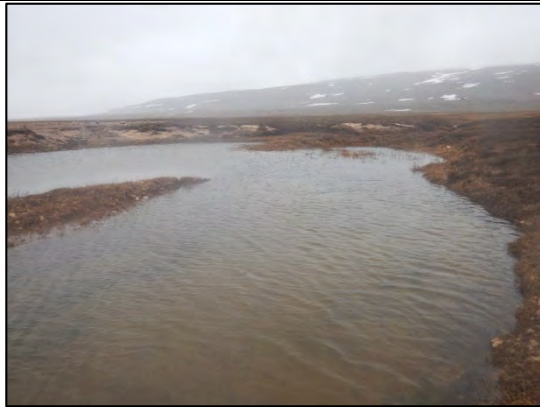
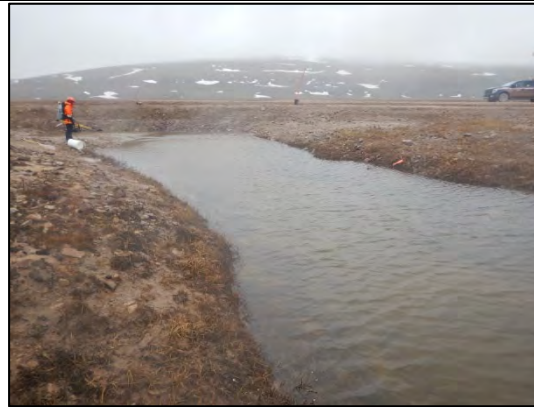
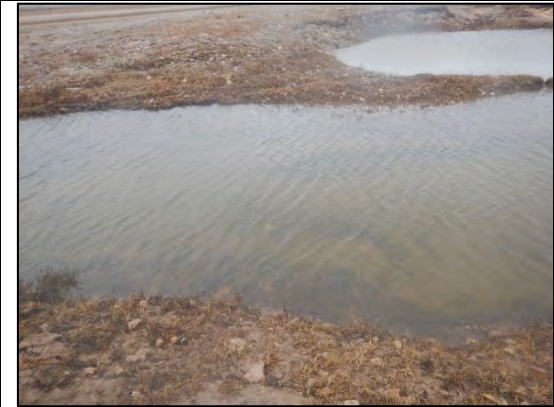
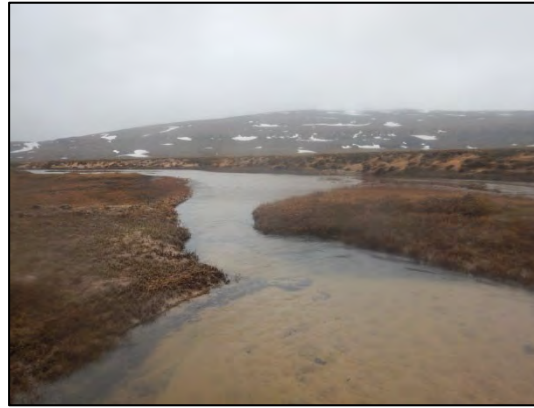
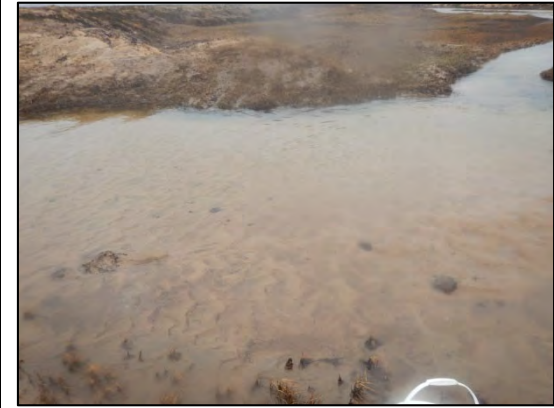
**Summary:** Site provides abundant summer rearing habitat for juvenile Arctic Char. There were no fish passage issues identified in 2020.

**Photos 1.** Photographs upstream (top) and downstream (bottom) of the Tote Road crossing CV-059: (A,D) looking upstream; (B,E) looking downstream; and (C,F) looking across.

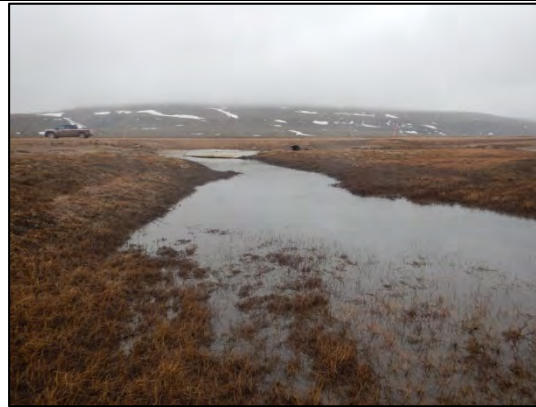
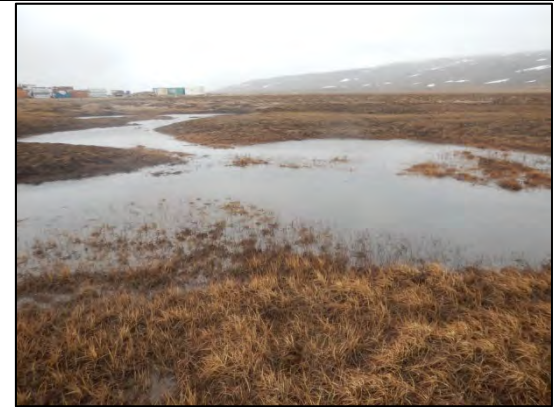
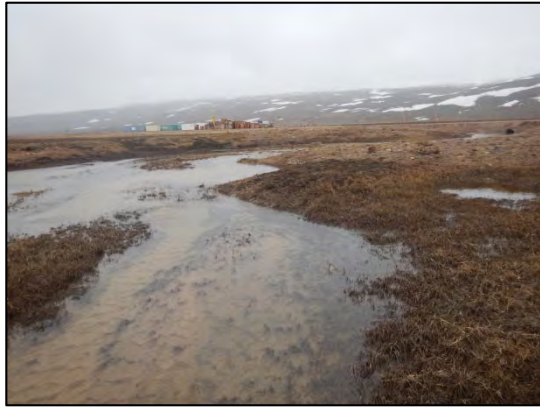
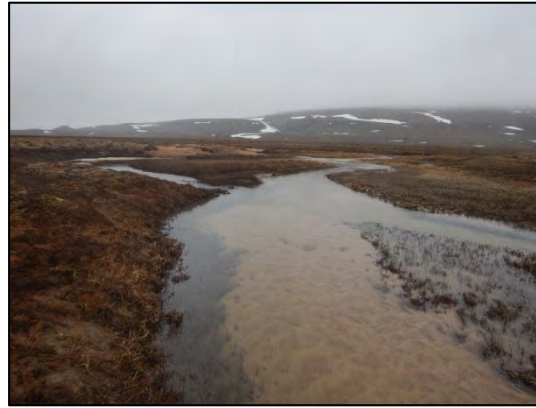
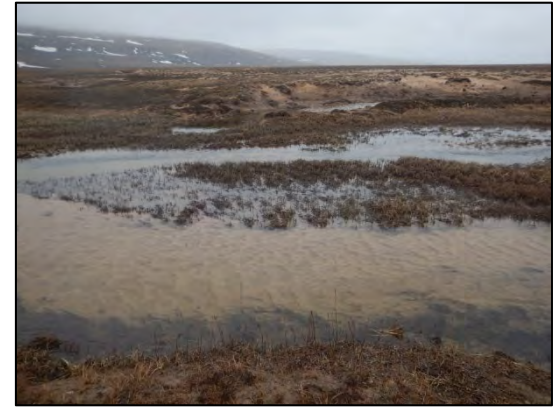
**Photos 1.** Photographs upstream (top) and downstream (bottom) of the Tote Road crossing CV-058: (A,D) looking upstream; (B,E) looking downstream; and (C,F) looking across.

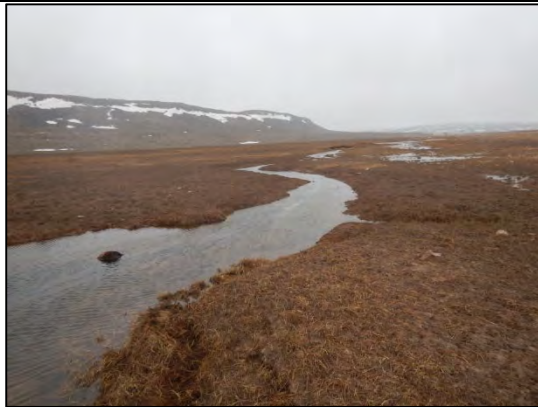
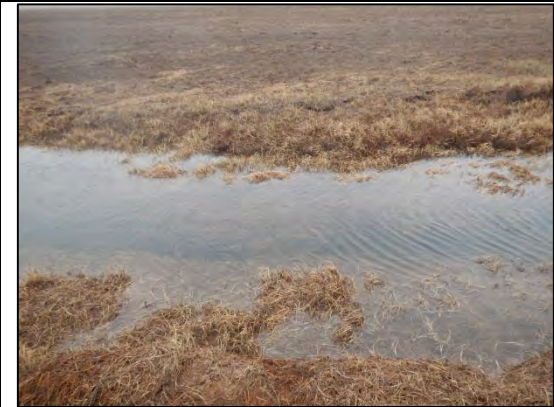
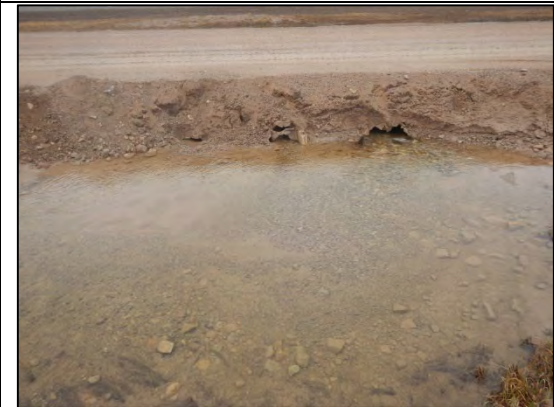
The spring 2020 survey identified that culverts at CV-057 were nearly completely buried by sediment, which is a recurring problem at this site. The ongoing sedimentation at CV-057 is potentially caused by erosion of the road embankment and/or elevated sediment transport due to erosion of fine-grained glaciofluvial deposits upstream of the crossing during spring freshet conditions. Baffinland will remove the accumulated sediment during non-flowing winter months. This work was not completed during the open-water season to prevent mobilization of sediment in the stream. Larger culverts, improved armouring of the road embankments, and implementation of upstream sediment control measures at locations where sediment enters the water body may also be required to prevent ongoing infilling of the culverts. Options for addressing the sedimentation at CV-057 will be discussed with the DFO prior to remediation work proceeding during non-flowing winter conditions. During the 2021 open-water season, Baffinland will monitor turbidity upstream and downstream of this crossing and inspect the road embankment and upstream sections of the stream to identify and address potential sources of sedimentation with control measures if required.

**Summary:** Site provides some summer rearing habitat for juvenile Arctic Char. There were no fish passage issues identified in 2020; however, culverts are becoming increasingly filled with sediment, which may create a blockage to fish movements if not remediated. Remediation recommended for winter months.

**Photos 1.** Photographs upstream (top) and downstream (bottom) of the Tote Road crossing CV-057: (A,D) looking upstream; (B,E) looking downstream; (C) looking across; and (F) sediment-filled culverts.

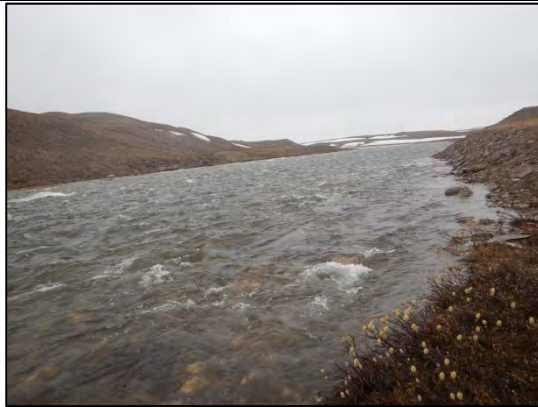
**Summary:** Large river with abundant habitat for both species. One channel is crossed by a bridge and the other with two culverts. Culverts were perched, blocking fish movements in spring 2019; remediation work was conducted in fall 2019 but the structures were destroyed by high flows during the 2020 freshet. Alternative remediation will be required going forward.

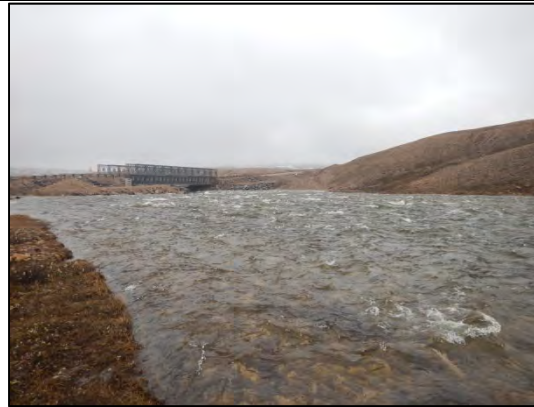
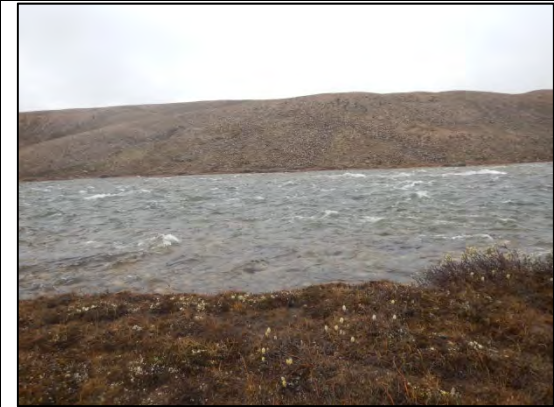
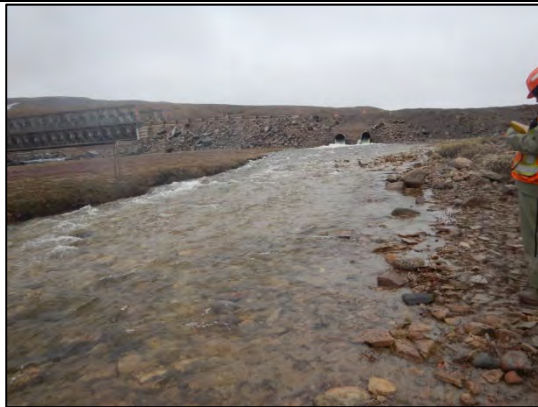
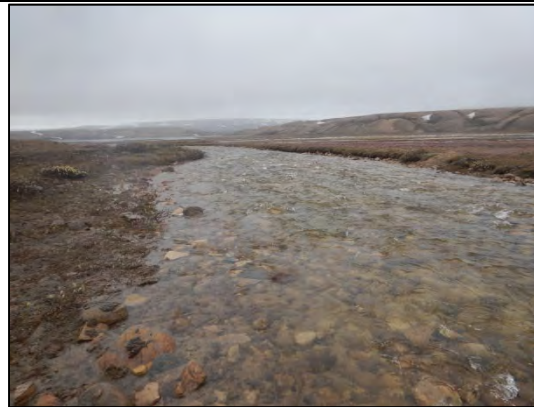
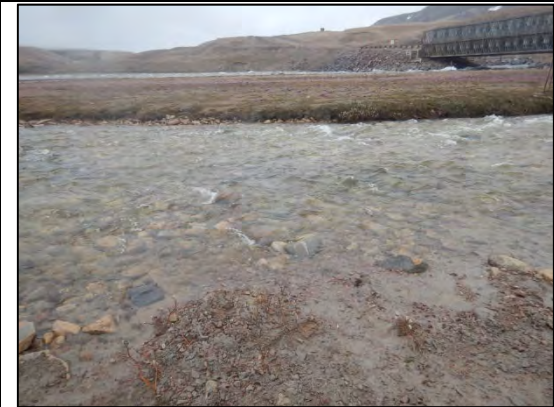
**Photos 1.** Photographs upstream (top) downstream (bottom) of the Tote Road crossing BG-50: (A,D) looking upstream; (B,E) looking downstream; and (C,F) looking across.

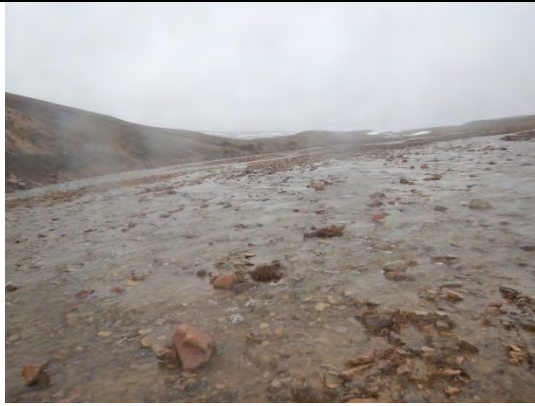
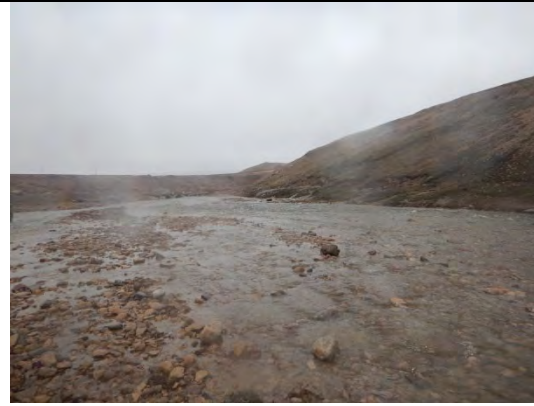
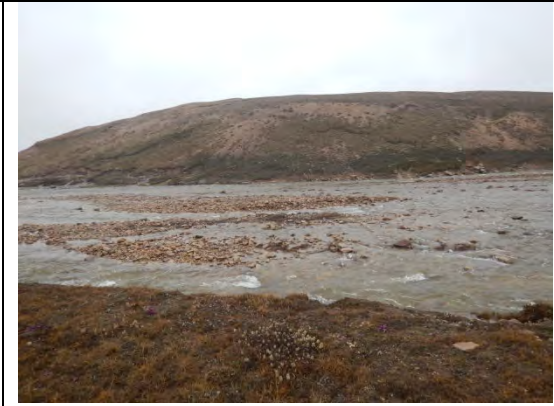
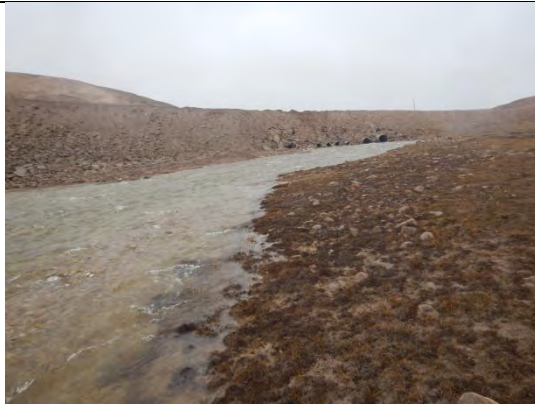
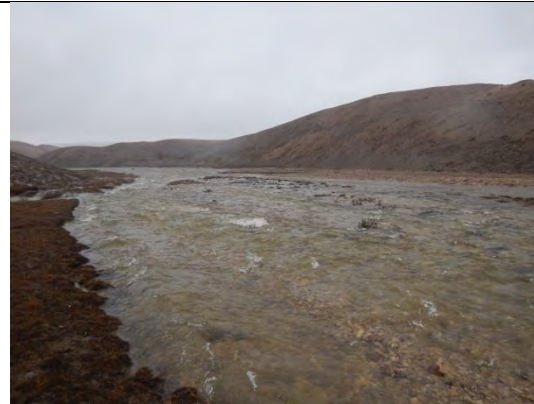
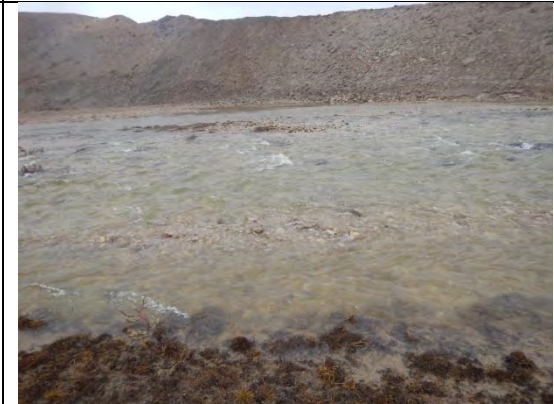
**Summary:** Site provides abundant summer rearing habitat for juvenile Arctic Char. There were no fish passage issues identified in 2020.

**Photos 1.** Photographs upstream (top) and downstream (bottom) of the Tote Road crossing CV-049: (A,D) looking upstream; (B,E) looking downstream; (C,F) looking across.

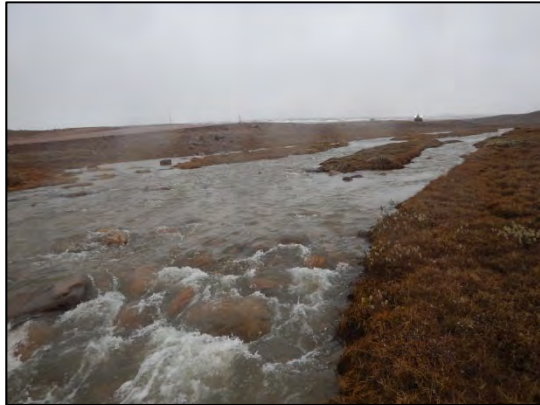
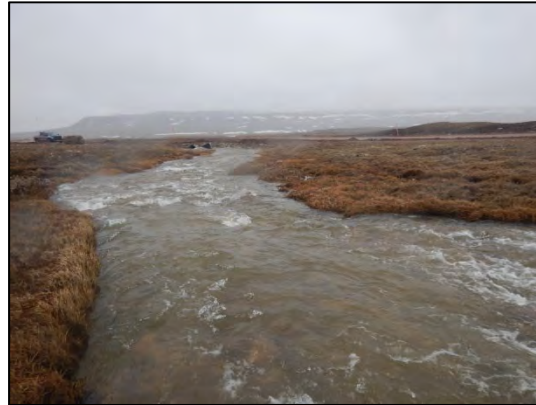
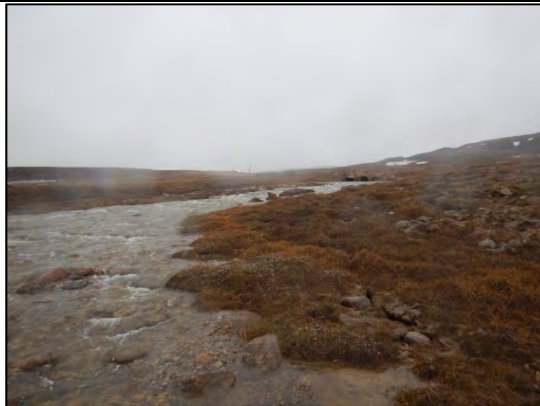
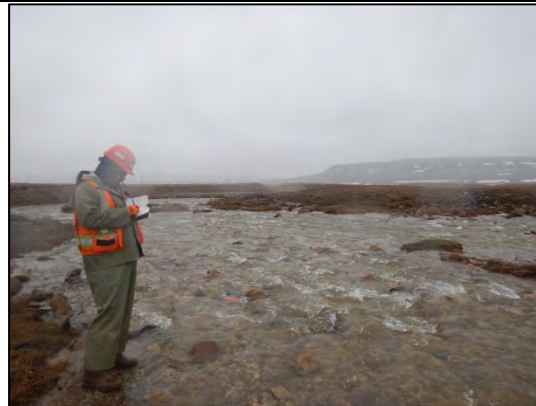
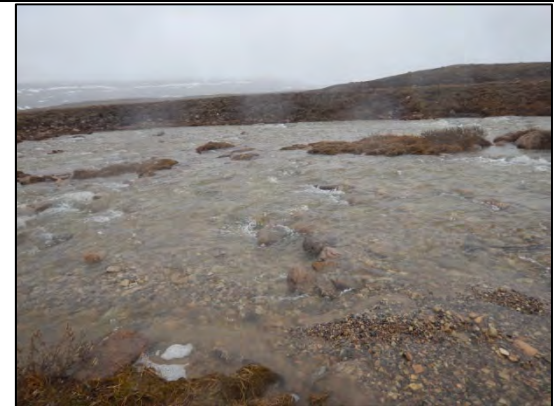
**Summary:** A persistent natural downstream subsurface flow barrier near the confluence with crossing CV-049 prevents fish access from downstream overwintering lakes.

**Photos 1.** Photographs upstream (top) and downstream (bottom) of the Tote Road crossing CV-048: (A,D) looking upstream; (B,E) looking downstream; and (C,F) looking across.

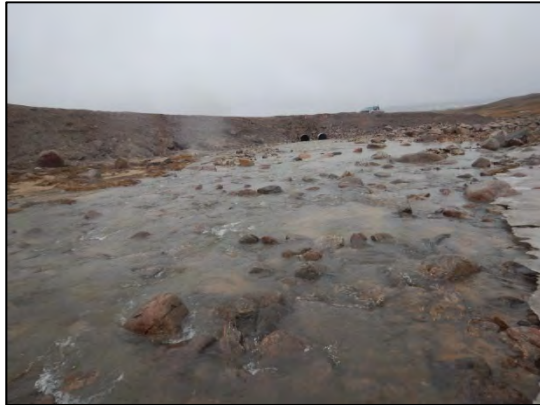
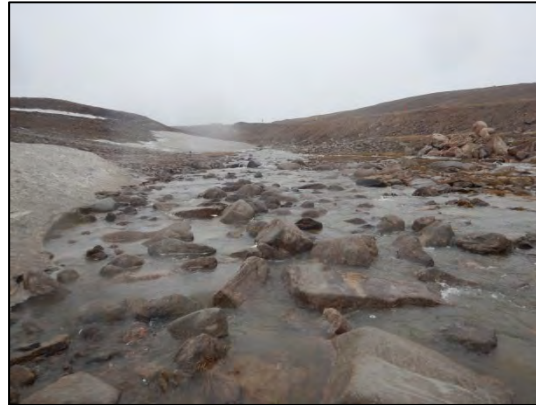
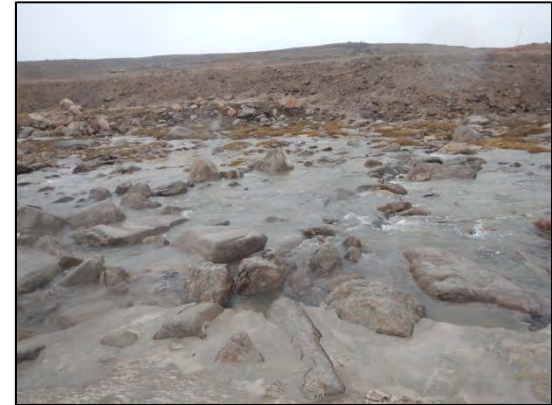
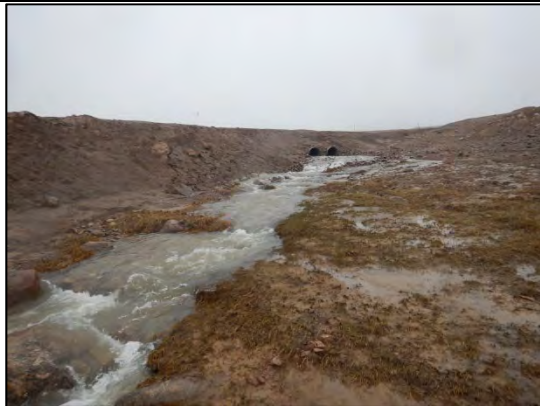
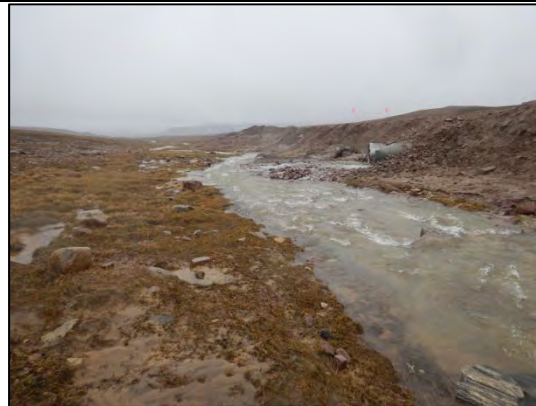
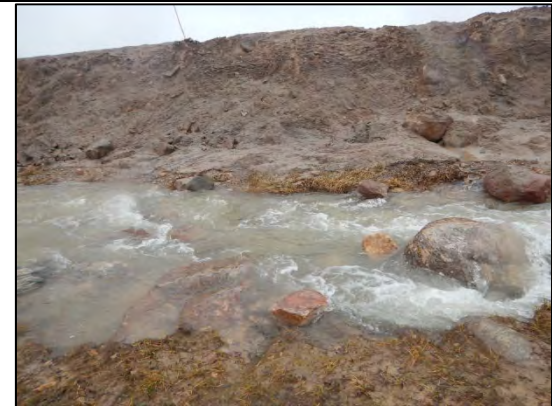
**Summary:** A persistent natural downstream subsurface flow barrier near the confluence with crossing CV-049 prevents fish access from downstream overwintering lakes.

**Photos 1.** Photographs upstream (top) and downstream (bottom) of the Tote Road crossing CV-046: (A,D) looking upstream; (B,E) looking downstream; (C,F) looking across.

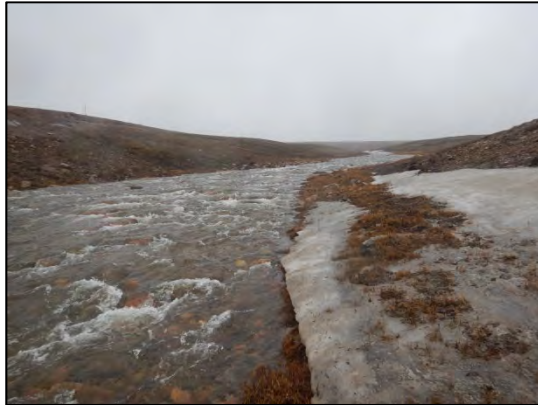
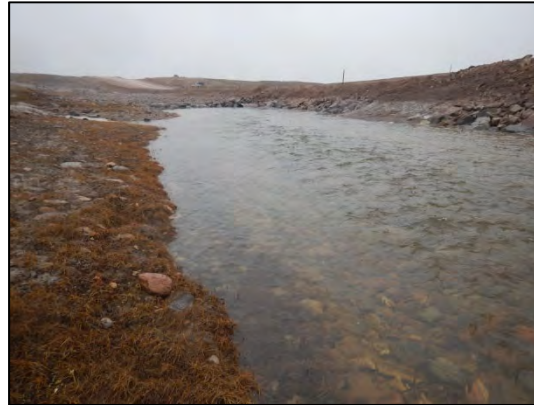
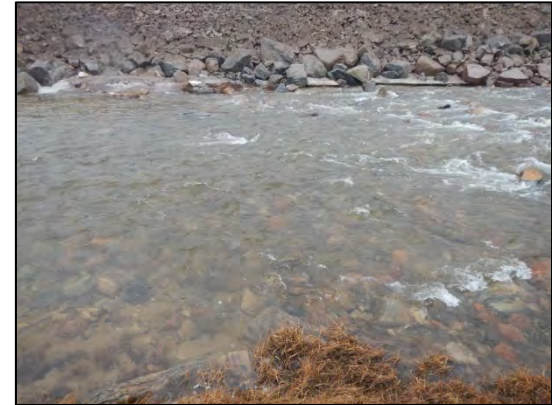
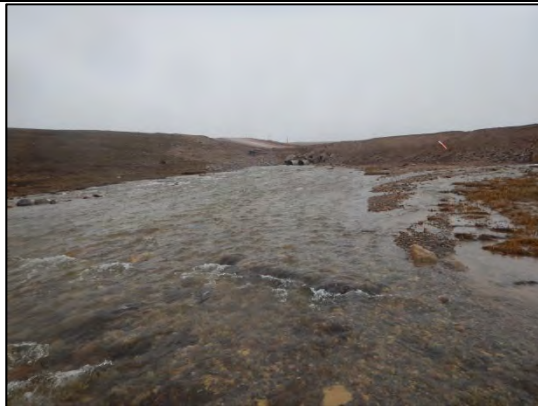
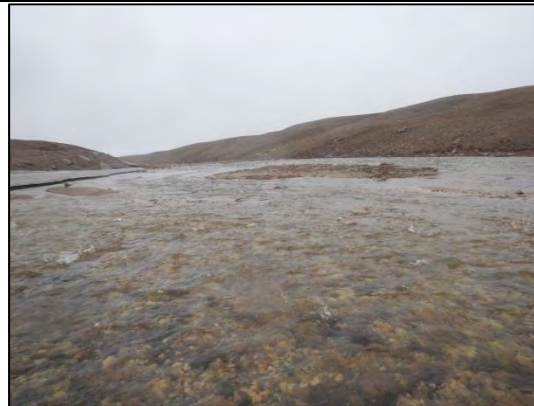
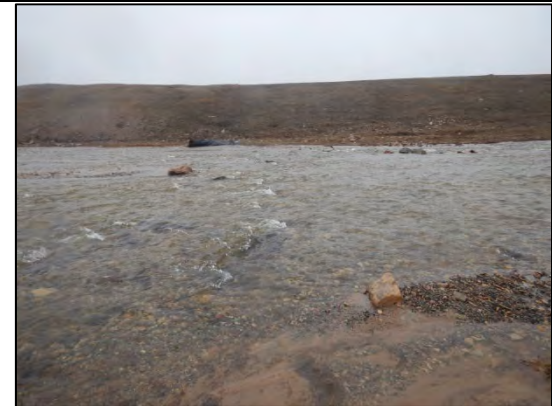
**Summary:** There is consistent surface flow at the crossing, but natural seasonal subsurface flows (during spring) several hundred metres downstream combined with great distance to overwintering habitat prevent fish access to the crossing.

**Photos 1.** Photographs upstream (top) and downstream (bottom) of the Tote Road crossing CV-040: (A,D) looking upstream; (B,E) looking downstream; (C,F) looking across.
