**BAFFINLAND IRON MINES CORPORATION  
MARY RIVER PROJECT**

**TOTE ROAD FISH HABITAT MONITORING  
2020 ANNUAL REPORT  
EARLY REVENUE PHASE - TOTE ROAD UPGRADES**

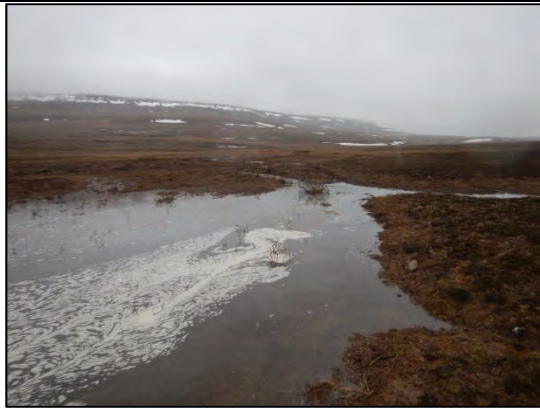
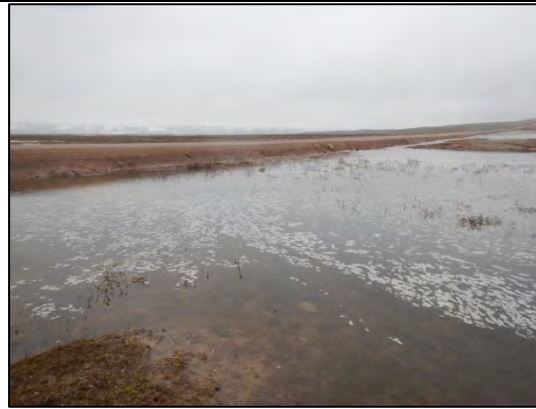
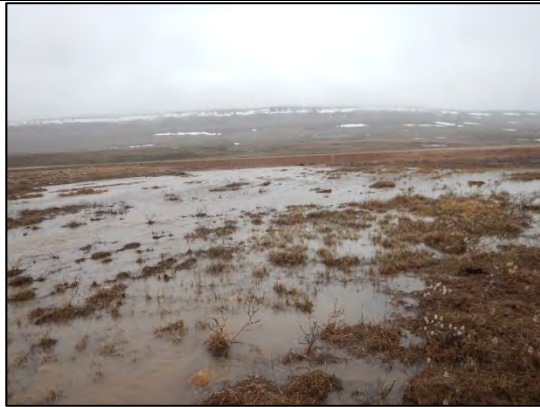
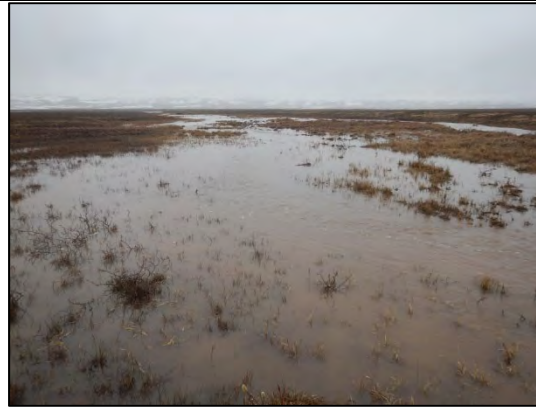
**Summary:** Arctic Char use of this stream is minimal due to consistently low water levels and lack of a defined channel, but Ninespine Stickleback are typically abundant. No culvert fish passage issues were identified in 2020; however a large amount of flow was diverted from CV-031 into CV-030 during freshet due to ice blockage of a culvert that increased sedimentation and erosion of riparian habitat.

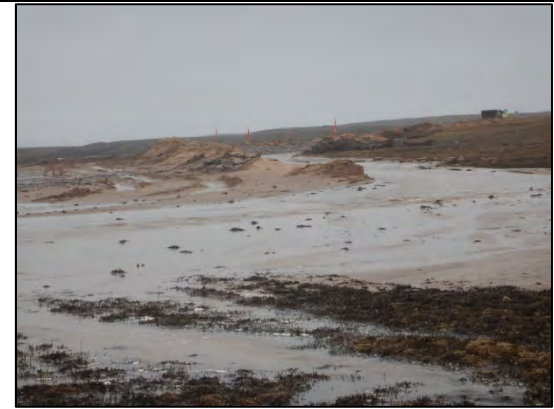
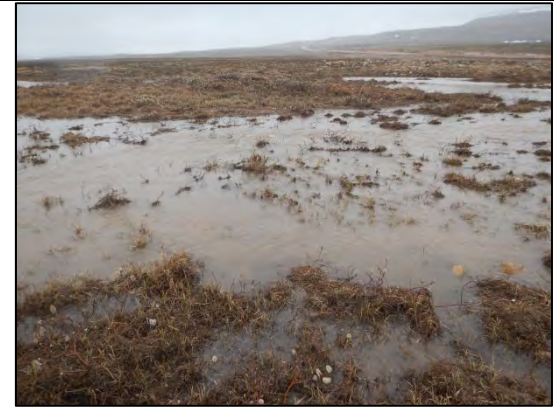
During spring 2020, water was diverted from non fish-bearing crossing (CV-031), due to a frozen culvert, which caused ponding upstream of the crossing. The flow was diverted to a fish-bearing crossing (CV-030) to alleviate potential flooding of the road. Diverting stream flow was done as a safety and environmental measure to prevent washing out of the road embankment and resulting greater sedimentation of downstream fish bearing waters at the Muriel Lake outfall. This diversion caused flooding, erosion, and increased turbidity in the area of the stream at crossing CV-030. Water diversion was ceased after alleviation of flooding upstream of CV-031 shortly after peak freshet.

**Photos 1.** Photographs upstream (top) and downstream (bottom) of the Tote Road crossing CV-030: (A,D) looking upstream; (B,E) looking downstream; (C) diversion flow from CV-031; and (F) looking across flooded terrestrial vegetation downstream.

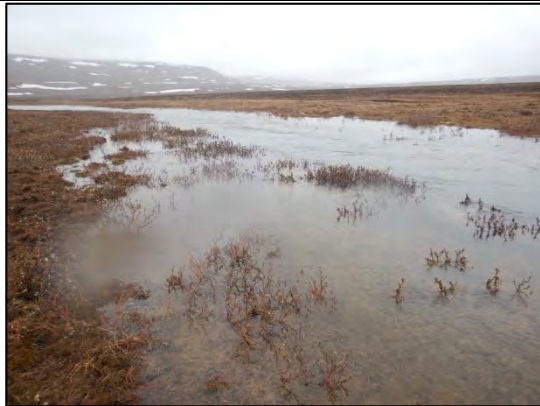
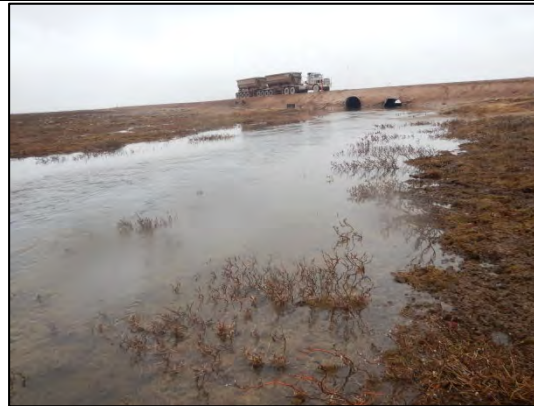
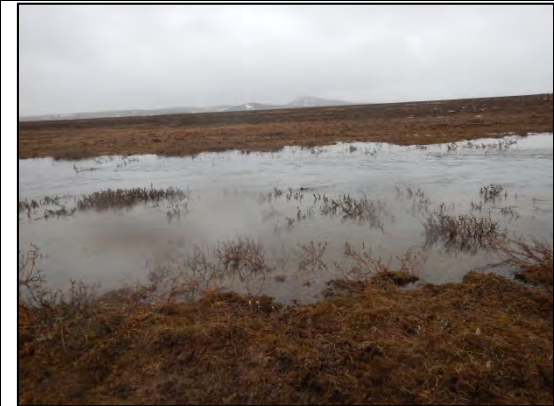
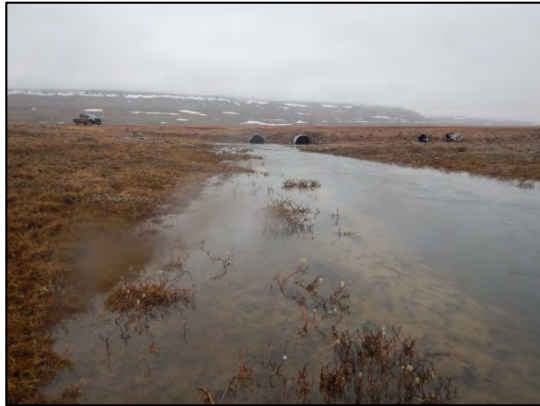
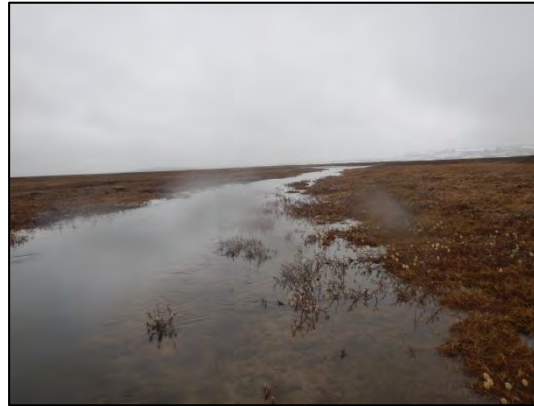
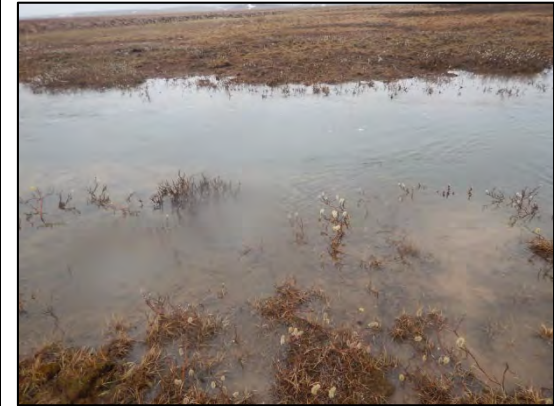
**Summary:** Consistently provides abundant, good quality rearing habitat for both species. No fish passage issues identified in 2020.

**Photos 1.** Photographs upstream (top) and downstream (bottom) of the Tote Road crossing BG-32 (A,D) looking upstream; (B,E) looking downstream; and (C,F) looking across.

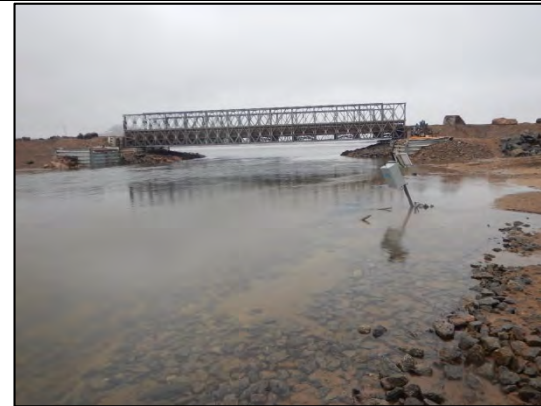
**Summary:** A bridge and culvert crossing with abundant habitat for both species and no passage issues identified in 2020.

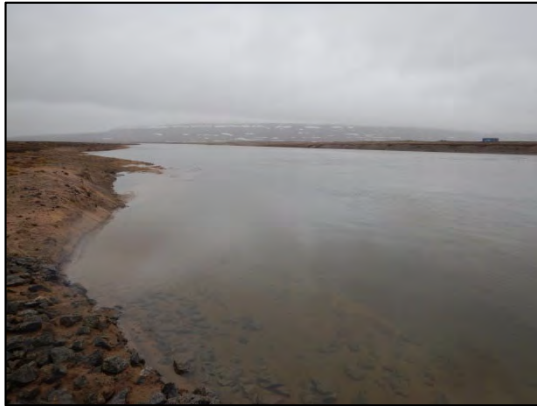
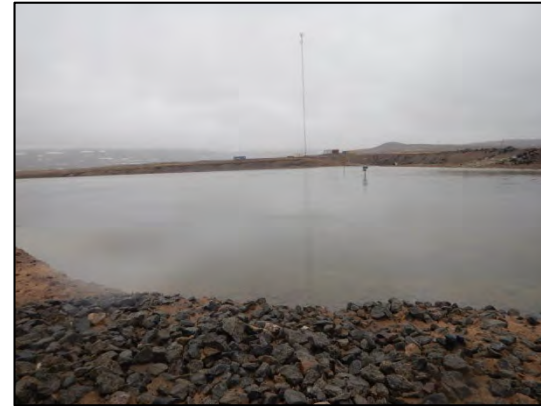
**Photos 1.** Photograph upstream of the Tote Road crossing CV-217: (A) showing Muriel Lake; and photographs downstream of the Tote Road: (B) looking upstream; (C) looking downstream; and (D) looking across.

**Summary:** A small stream that provides habitat for Ninespine Stickleback and small juvenile Arctic Char (particularly young-of-the-year from Muriel Lake). A slight perch was remediated in 2019 and small repairs to the structure were completed in fall 2020.

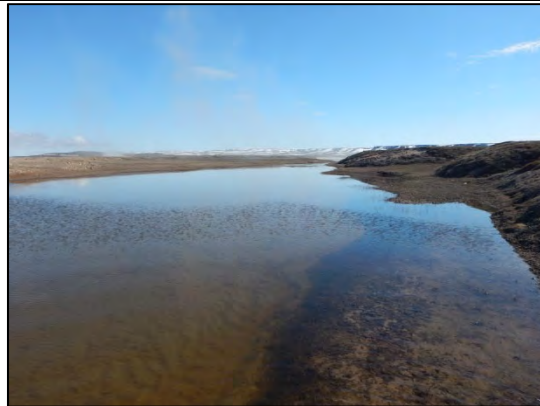
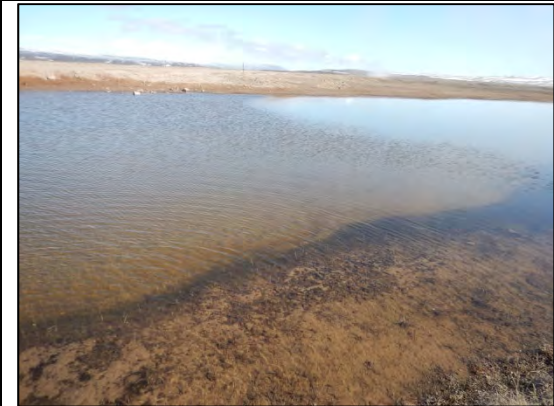
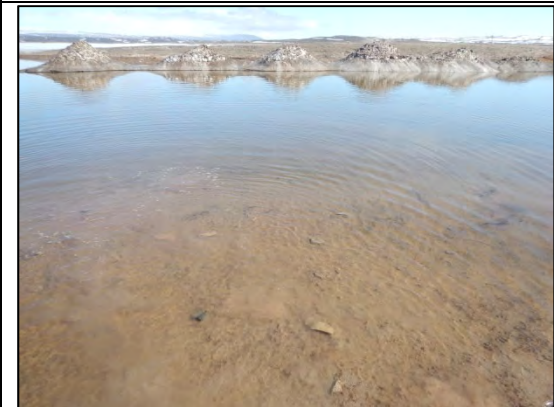
**Photos 1.** Photographs upstream of the Tote Road crossing CV-216: (A) looking upstream; (B) looking downstream; (C) looking across; and photographs downstream of the Tote Road: (D) looking upstream; (E) looking downstream; and (F) looking across (with snow stockpile visible in the channel).

| Location ID | Fish Habitat at Crossing (Y/N) | Fish Captured / Observed DS in 2020 | Fish Captured / Observed US in 2020 | Potential Project-Related Fish Passage or Habitat Issues in Spring 2020 | Fall 2020 Remediation Actions |
|---|---|---|---|---|---|
| CV-216 | Y | Y | Y | YES - Remediation implemented in fall 2019 successful but in need of minor repairs. | Repairs to structure completed. |

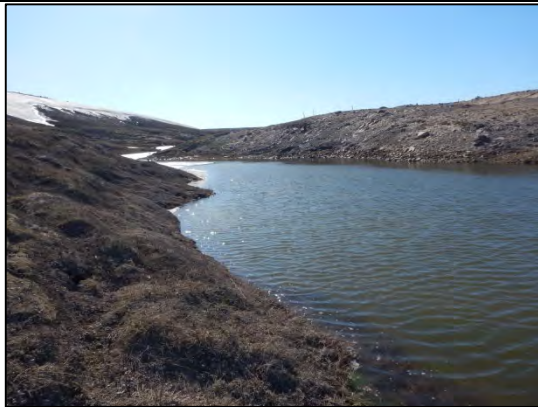
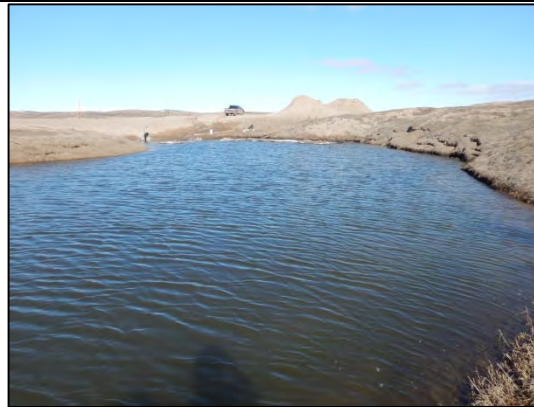
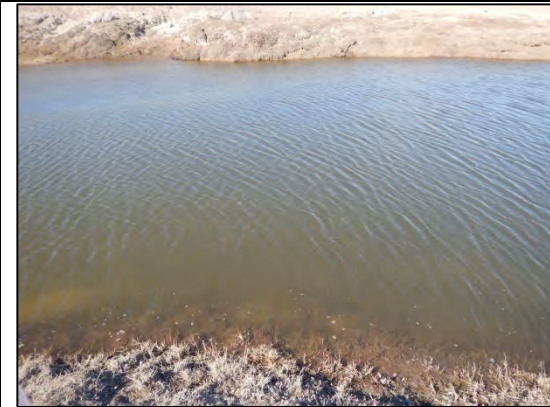
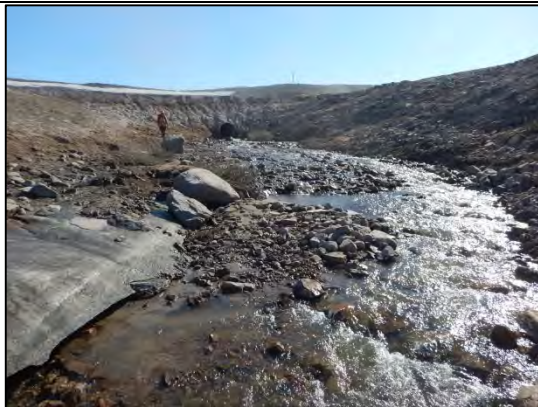
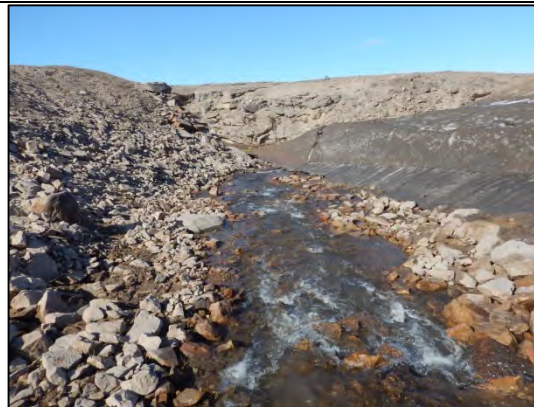
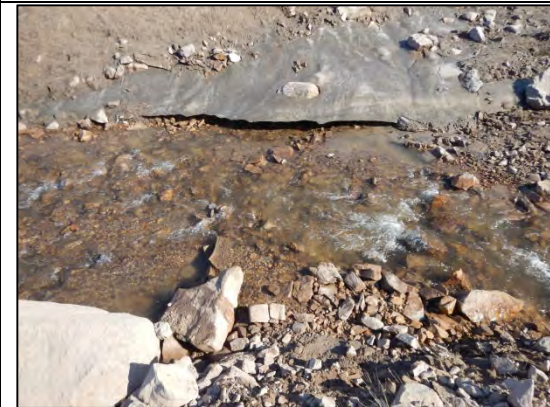
**Summary:** Stream provides abundant rearing habitat, particularly upstream of the road in a large pond. Access to the upstream pond was created with a rocky ramp as part of the Tote Road Compensation Plan. There were no fish access issues identified in 2020.

**Photos 1.** Photographs upstream of the Tote Road crossing BG-30: (A) looking upstream; (B) looking downstream; (C) looking across; and photographs downstream of the Tote Road: (D) looking upstream; (E) looking downstream; and (F) looking across.

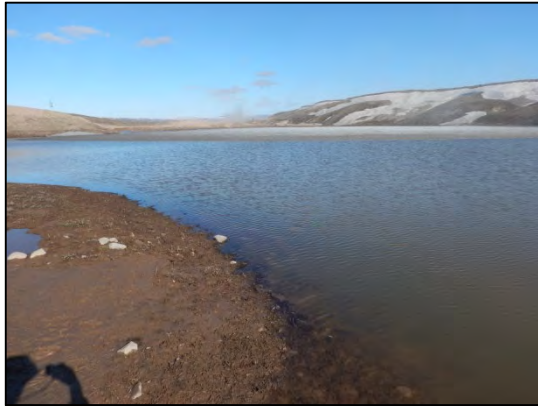
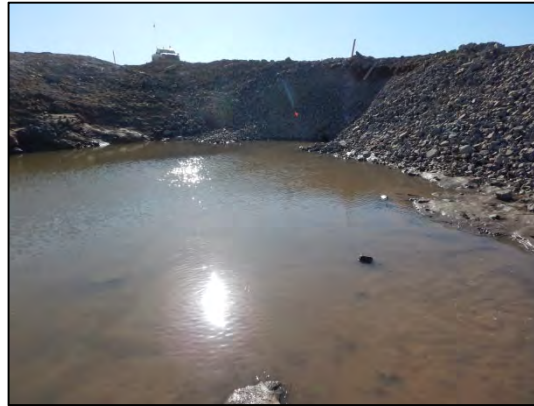
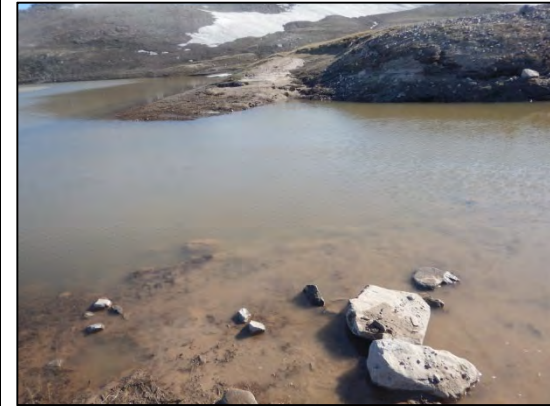
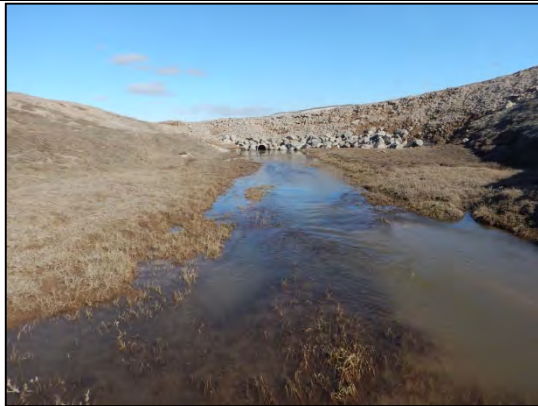
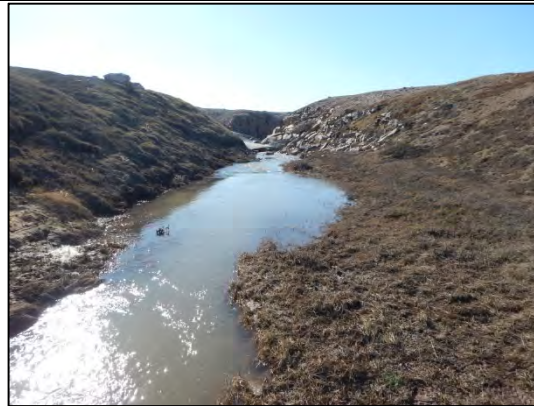
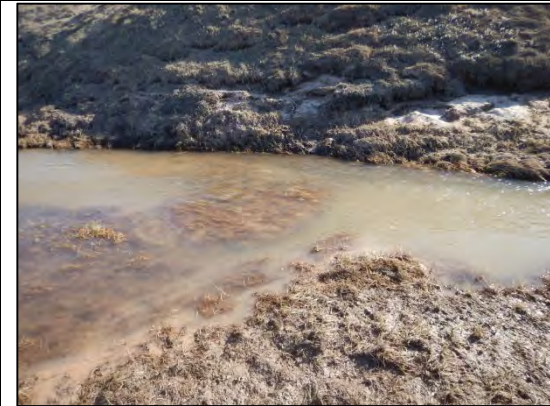
**Summary:** Stream provides abundant summer rearing habitat for both species. There were no fish access issues identified in 2020.

**Photos 1.** Photographs upstream of the Tote Road crossing BG-29: (A) looking upstream; (B) looking downstream; (C) looking across; and photographs downstream of the Tote Road: (D) looking upstream; (E) looking downstream; and (F) looking across.

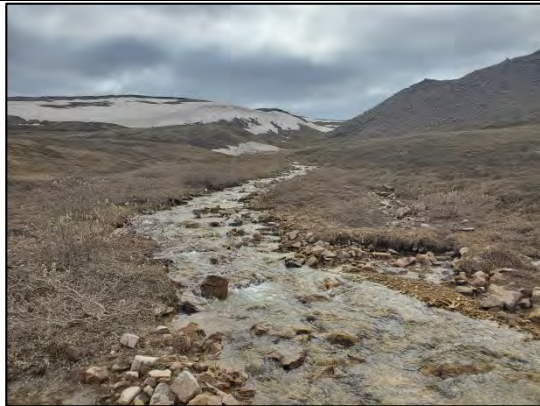
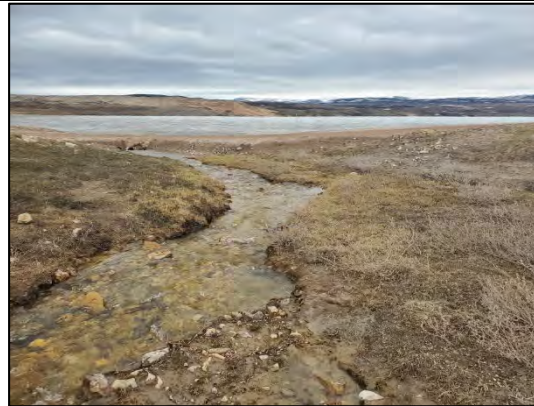
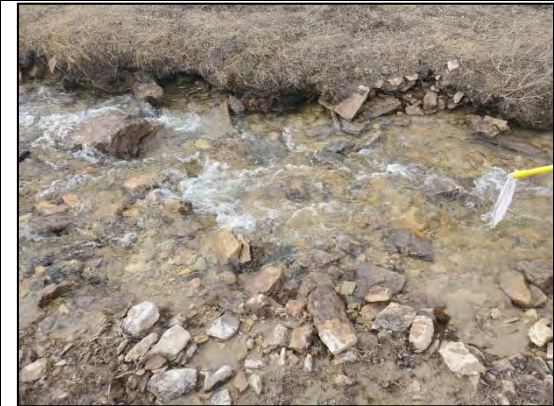
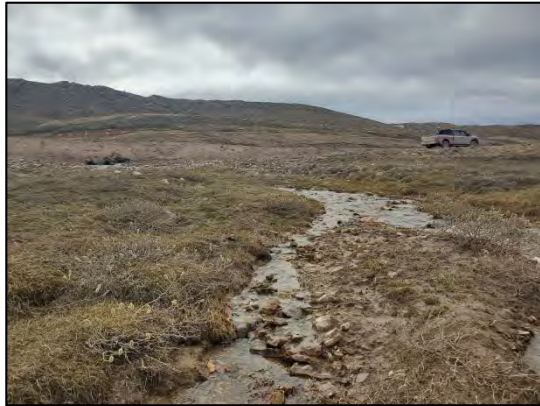
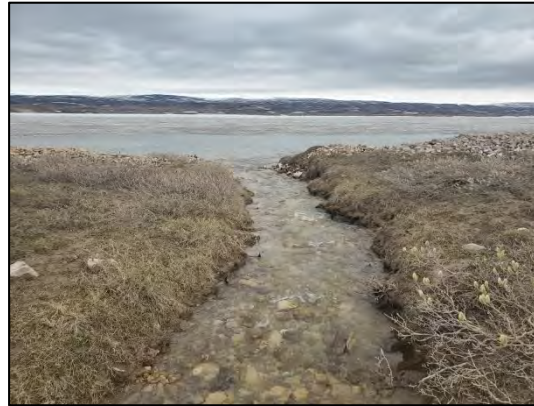
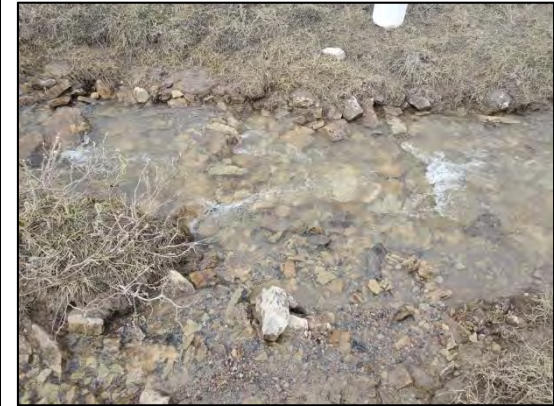
**Summary:** Site provides summer rearing habitat for juvenile Arctic Char. No fish passage issues were identified in 2020.

**Photos 1.** Photographs upstream (top) and downstream (bottom) of the Tote Road crossing BG-27: (A,D) looking upstream; (B,E) looking downstream; and (C,F) looking across.

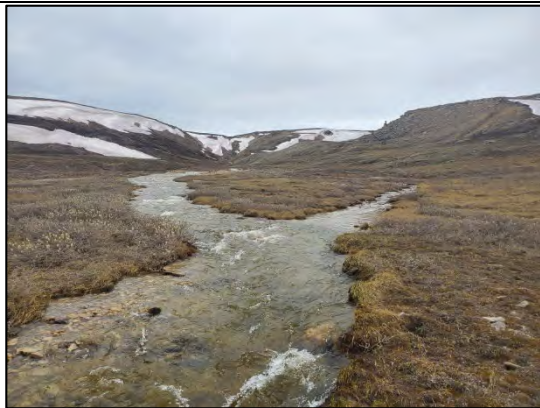
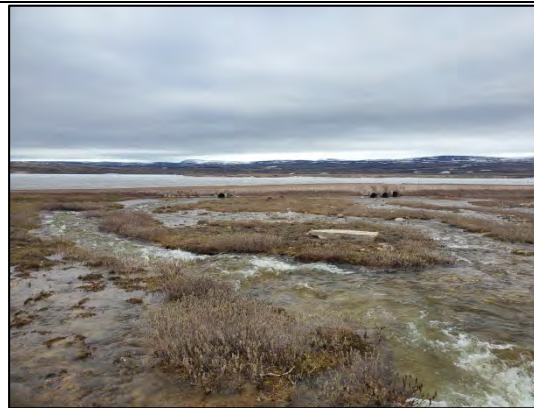
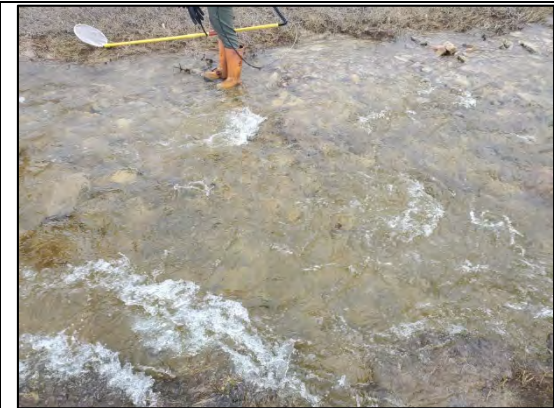
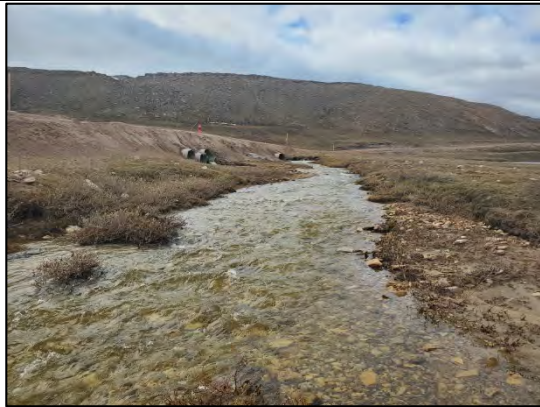
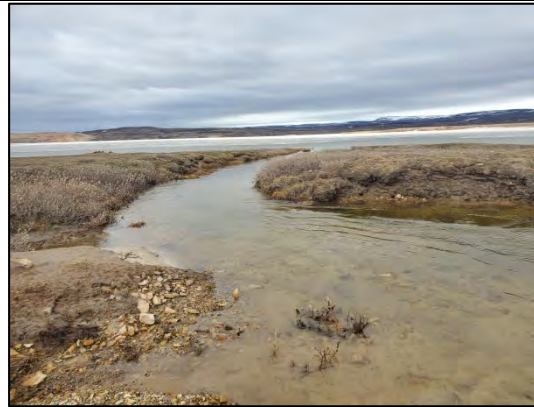
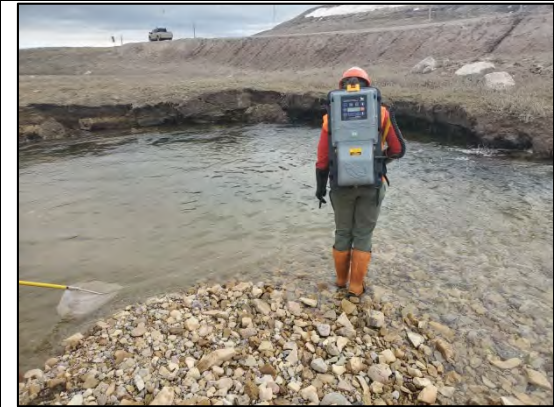
**Summary:** Site provides summer rearing habitat for juvenile Arctic Char. No fish passage issues were identified in 2020.

**Photos 1.** Photographs upstream (top) and downstream (bottom) of the Tote Road crossing BG-24: (A,D) looking upstream; (B,E) looking downstream; and (C,F) looking across.

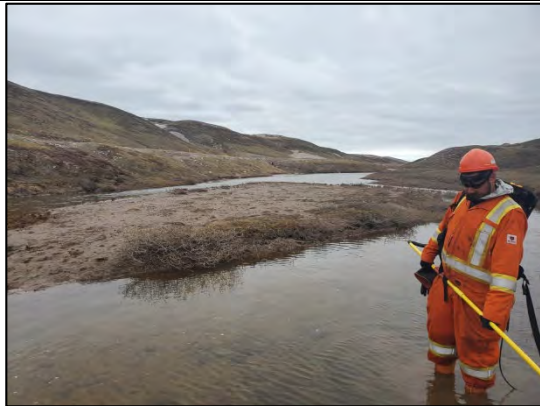
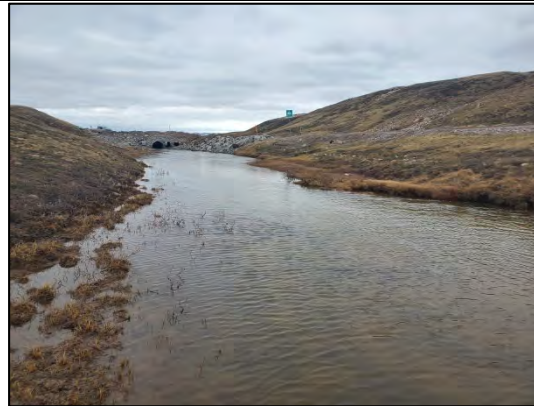
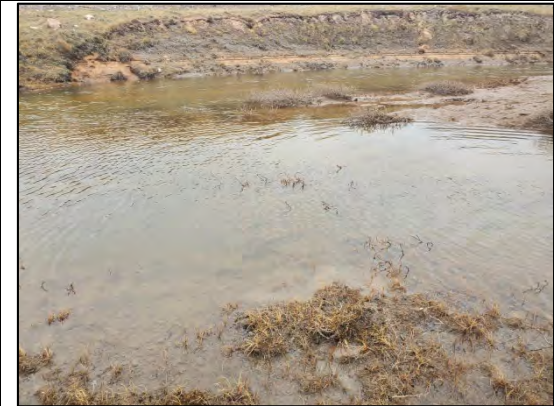
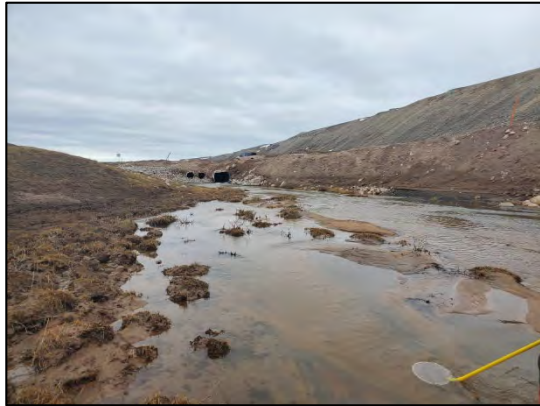
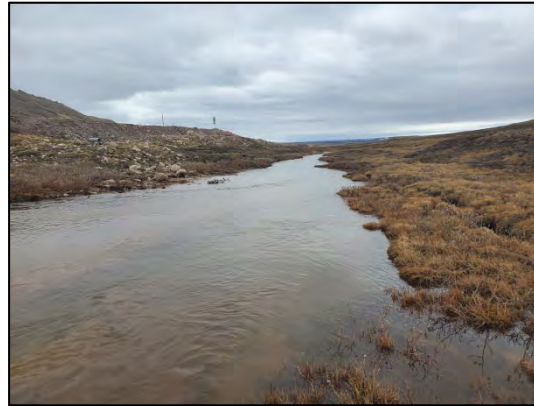
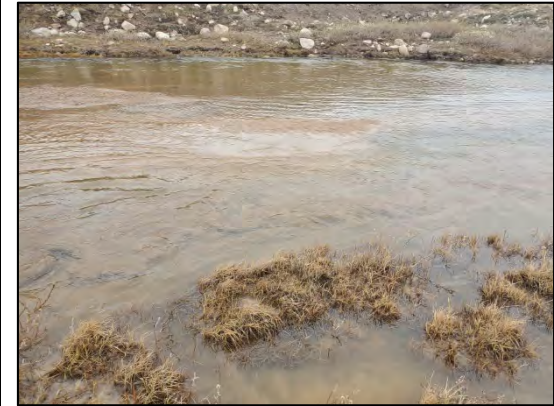
**Summary:** Site provides summer rearing habitat for both species. No fish passage issues were identified in 2020.

**Photos 1.** Photographs upstream (top) and downstream (bottom) of the Tote Road crossing BG-17: (A,D) looking upstream; (B,E) looking downstream; and (C,F) looking across.

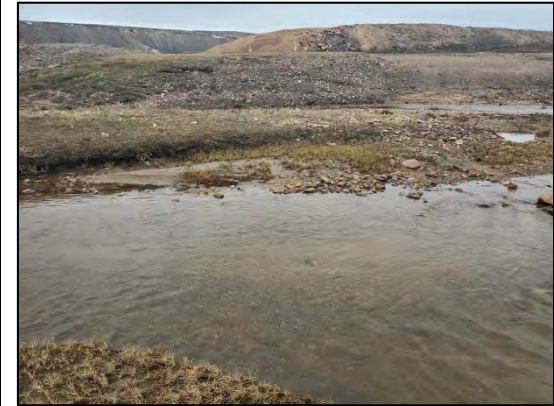
**F**

**Photos 1.** Photographs upstream (top) and downstream (bottom) of the Tote Road crossing BG-04: (A,D) looking upstream; (B,E) looking downstream; and (C,F) looking across.

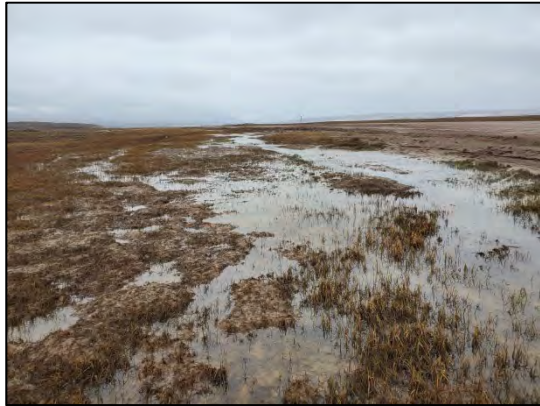
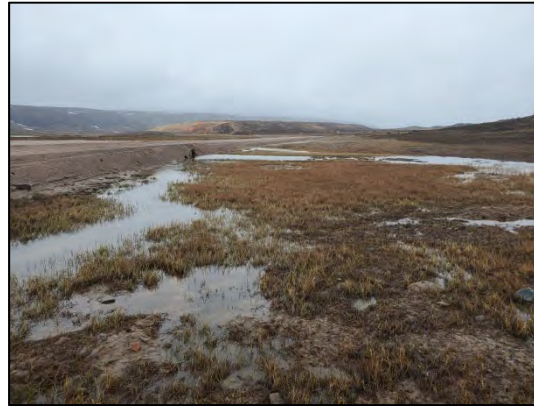
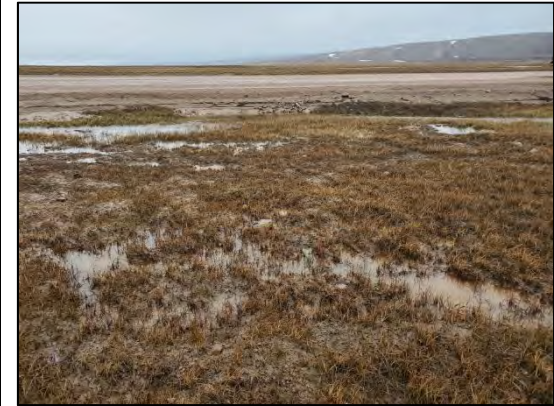
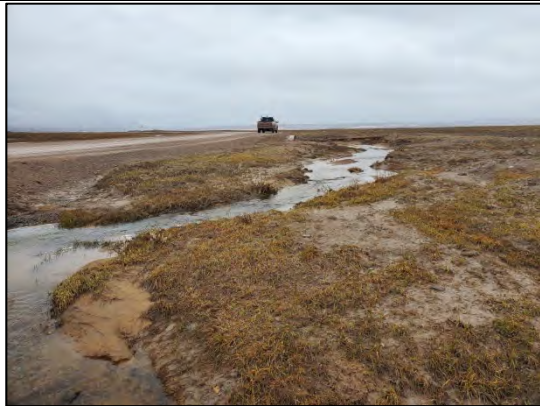
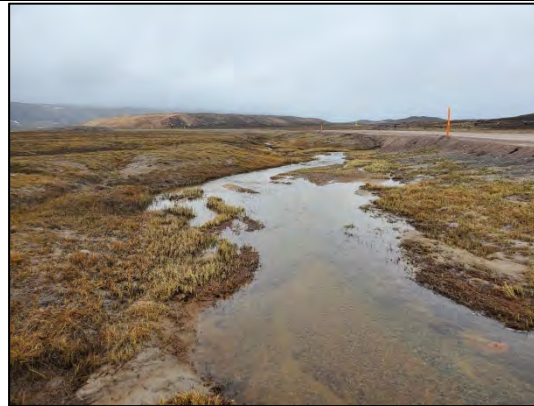
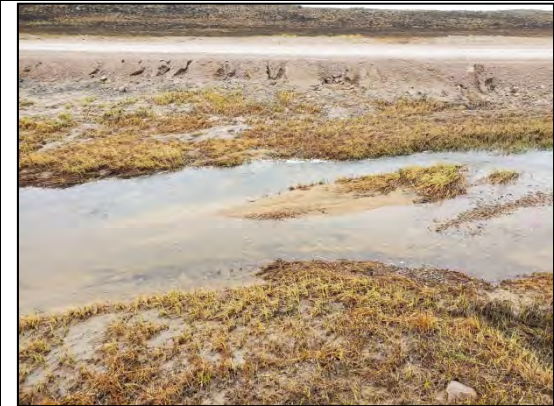
**Summary:** This stream typically provides summer rearing habitat for both species. No fish passage issues were identified in 2020.

**Photos 1.** Photographs upstream (top) and downstream (bottom) of the Tote Road crossing CV-001: (A,D) looking upstream; (B,E) looking downstream; and (C,F) looking across.

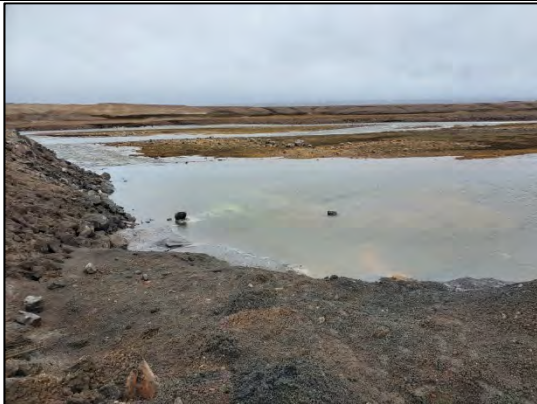
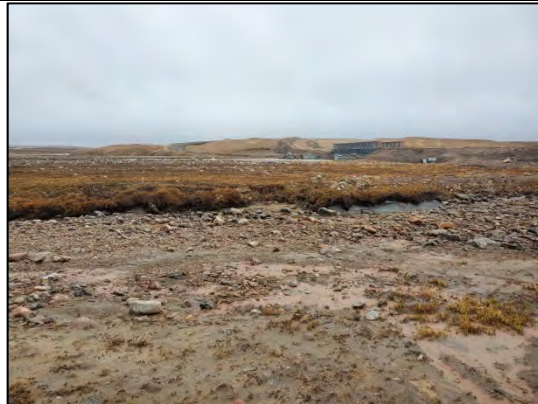
| Tote Road Site CV-223 | | | |
|---|---|---|---|
| <b>Summary:</b> This large river (Tom River) includes both bridge and culvert crossings. All channels crossed by the road provide abundant summer rearing habitat for Arctic Char. No fish passage issues were identified in 2020. | | | |
| <b>Photos 1.</b> Photographs upstream (A) and downstream (B) of the Tote Road crossing CV-223 culverts. | | | |

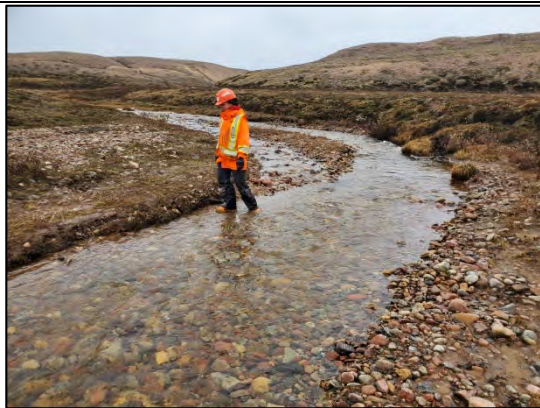
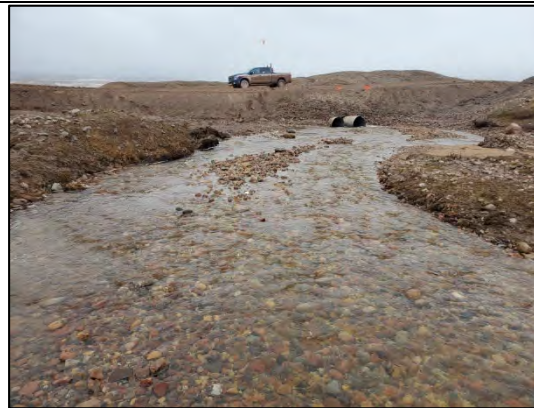
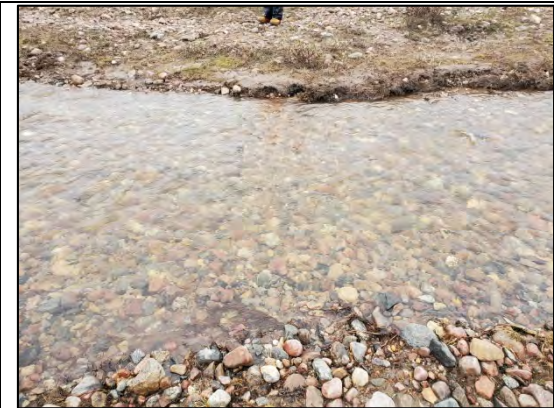
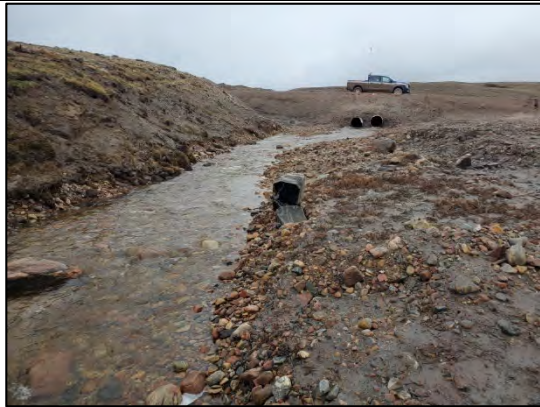
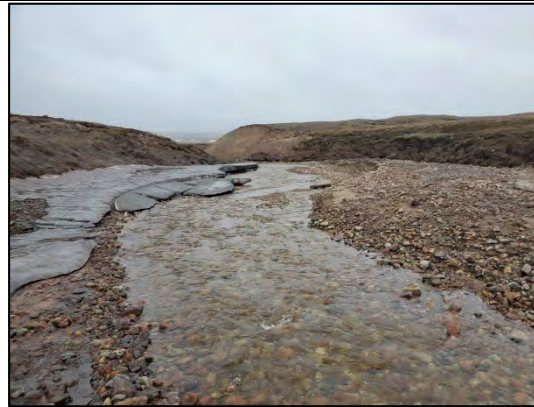
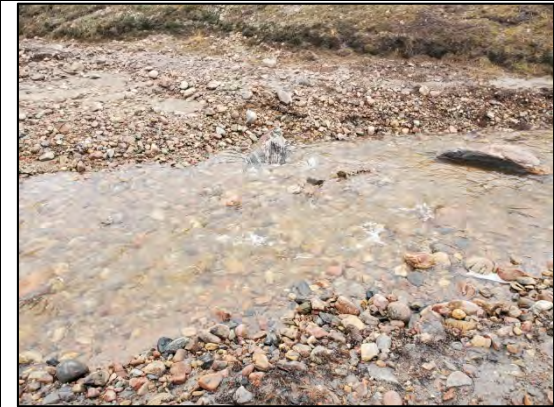
**Summary:** Site provides summer rearing habitat for both species. No fish passage issues were identified in 2020.

**Photos 1.** Photographs upstream (top) and downstream (bottom) of the Tote Road crossing CV-224: (A,D) looking upstream; (B,E) looking downstream; and (C,F) looking across.

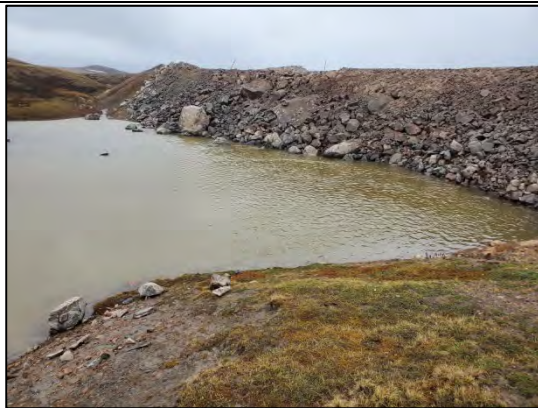
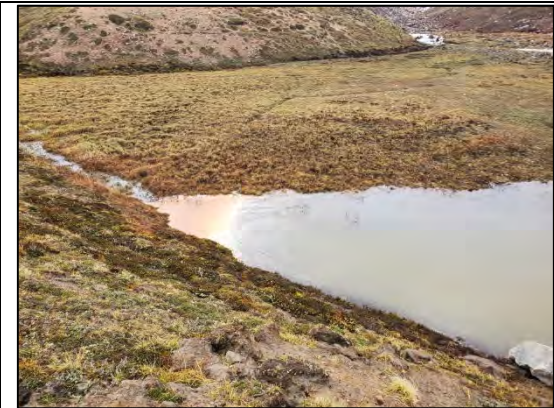
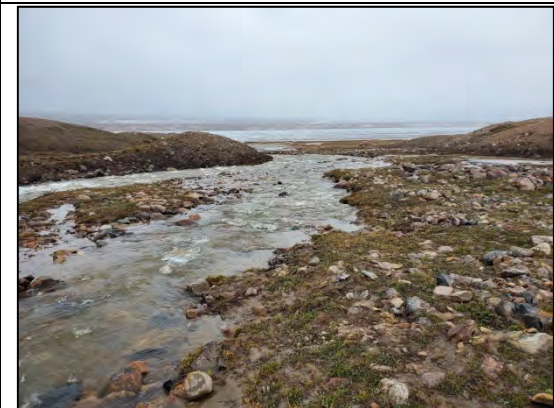
**Summary:** Site provides summer rearing habitat for both species. Remediation completed in early spring 2020 successfully reduced much of the culvert perching. However, water flow observed under the road due to frozen culverts at three locations, had caused erosion of the embankment and riparian habitat in spring 2020. Culverts were successfully cleared with steam immediately following the crossing survey. Continue monitoring of road and culverts going forward.

**Photos 1.** Photographs upstream (top) and downstream (bottom) of the Tote Road crossing CV-225 showing flooding caused by frozen culverts (A,B,C); flows underneath the road embankment (D,E); and (F) looking downstream.

| Location ID | Fish Habitat at Crossing (Y/N) | Fish Captured / Observed DS in 2020 | Fish Captured / Observed US in 2020 | Potential Project-Related Fish Passage or Habitat Issues in Spring 2020 | Fall 2020 Remediation Actions |
|---|---|---|---|---|---|
| CV-225 | Y | N | N | YES – Spring 2020: Assess culvert backwater structure under lower flows in summer/fall and adjust as needed.<br>Monitor locations where water flowed under road for additional leakage and erosion.<br>Remove more of old road crossing to allow flow to other channel (which remains blocked). | Remediation completed in early spring 2020 reduced the perch and improved access.<br>No damage from leakage noted during fall.<br>Recommend monitoring of leakage locations in spring 2021.<br>Removal of old road still to be completed. |

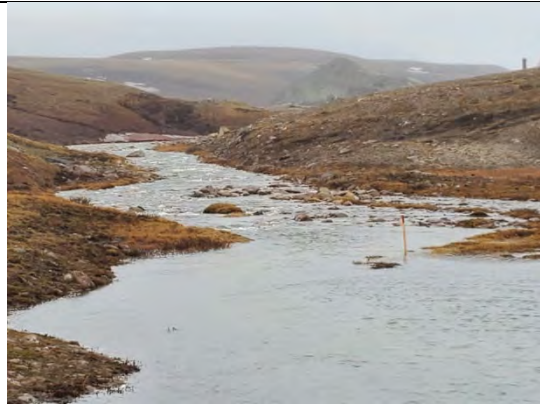
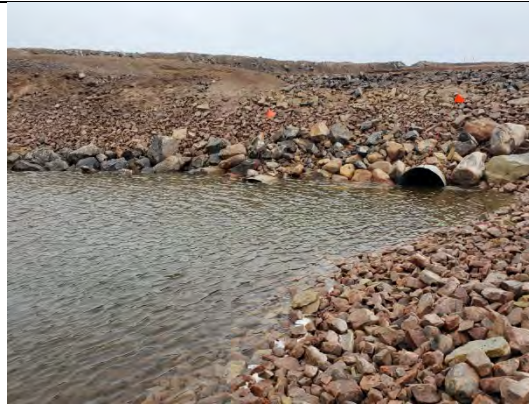
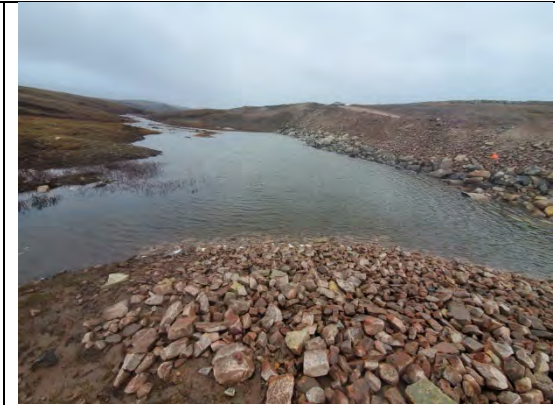
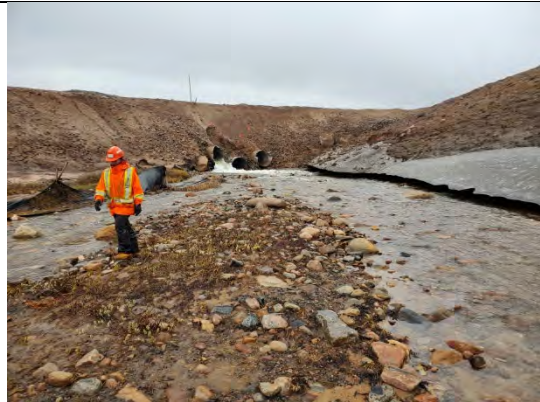
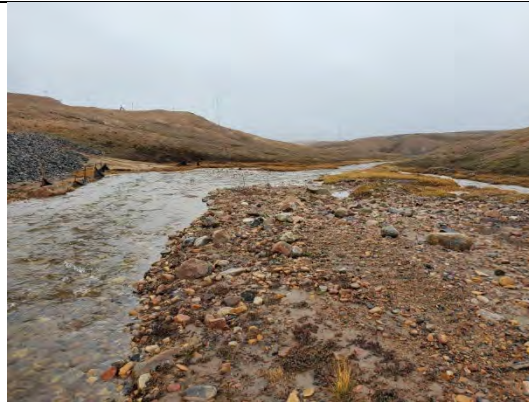
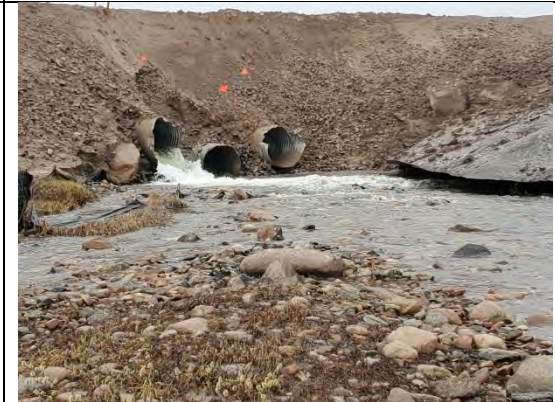
**Summary:** This stream provides summer rearing habitat for both species. During the spring 2020 survey, two of three culverts remained frozen causing constriction of flows. Culverts were steamed free of ice immediately following site survey to restore normal flows.

**Photos 1.** Photographs upstream (top) and downstream (bottom) of the Tote Road crossing BG-01: (A,D) looking upstream; (B,E) looking downstream; (C) looking across; and (F) looking at culverts.

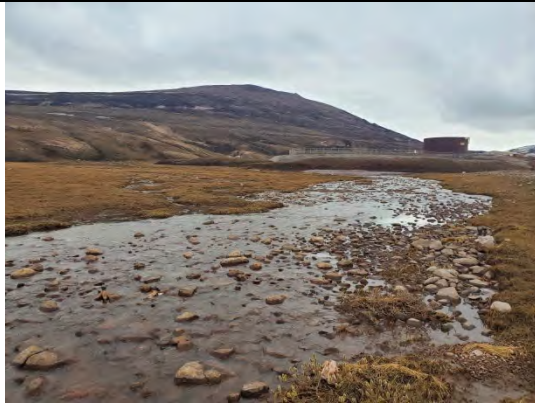
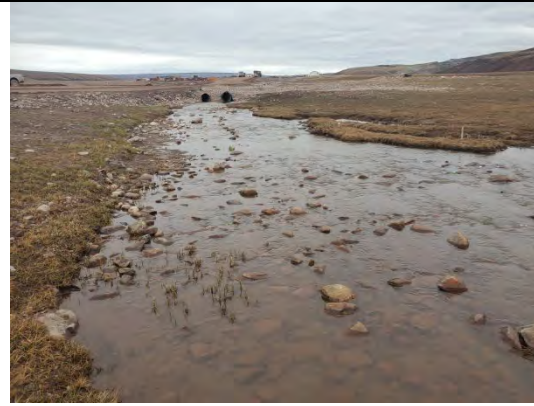
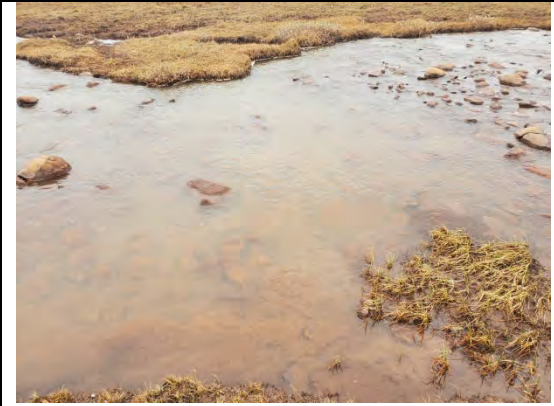
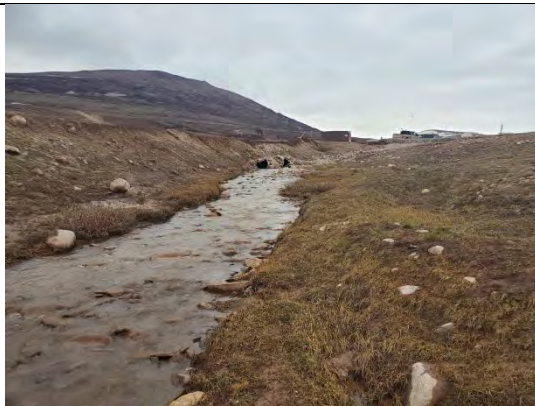
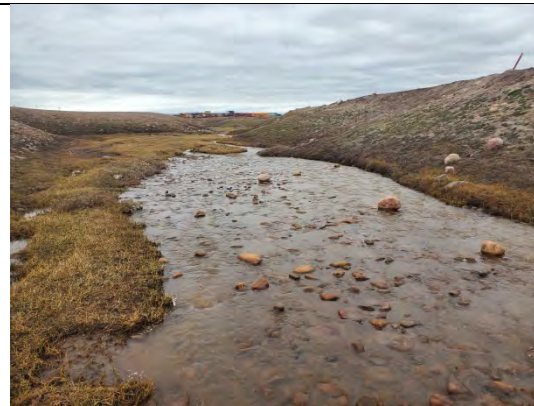
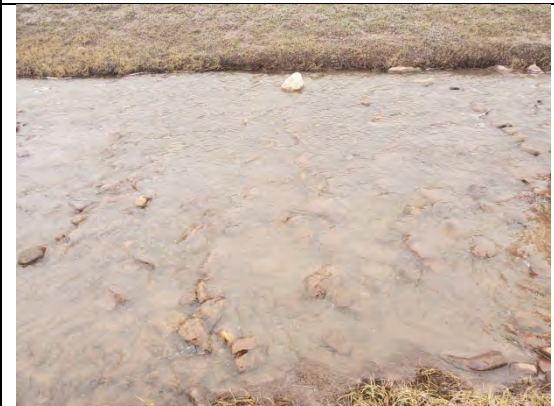
**Summary:** Site provides summer rearing habitat for both species. No fish passage issues were identified in 2020.

**Photos 1.** Photographs upstream (top) and downstream (bottom) of the Tote Road crossing CV-186: (A,D) looking upstream; (B,E) looking downstream; and (C,F) looking across.

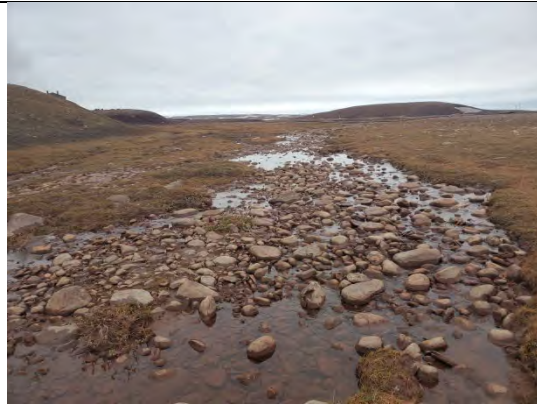
**Summary:** Site provides summer rearing habitat for both species, though upstream reaches become dry as water levels decrease. No fish passage issues were identified in 2020.

**Photos 1.** Photographs upstream (top) and downstream (bottom) of the Tote Road crossing CV-187: (A,D) looking upstream; (B,E) looking downstream; and (C,F) looking across.

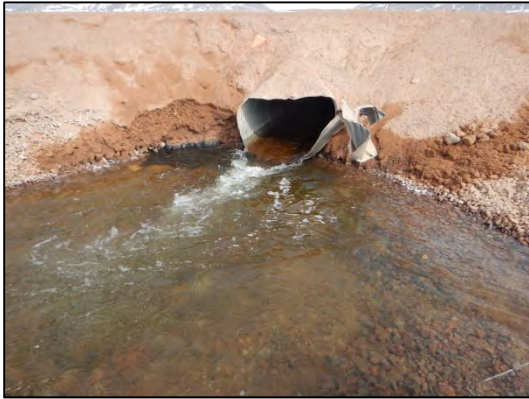
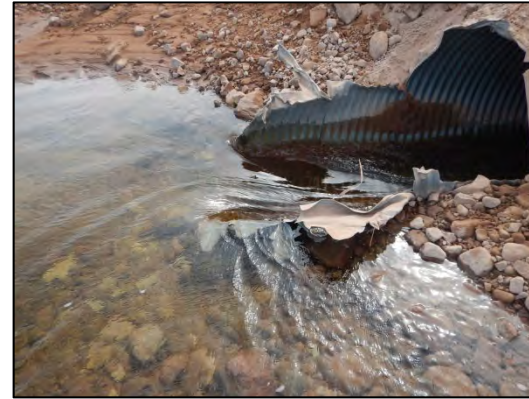
**Photos 1:** Photographs of the downstream end of the perched culvert at CV-129 in spring 2020: (A) the damaged upstream end of the culvert in spring 2020; (B) the rocky ramp downstream of the road in spring 2020; and (C) the rocky ramp at the downstream end following repairs made in fall 2020.

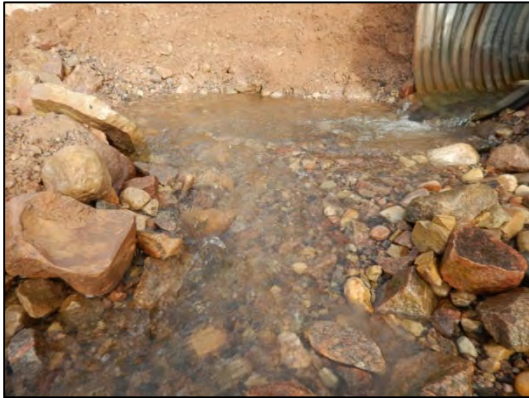
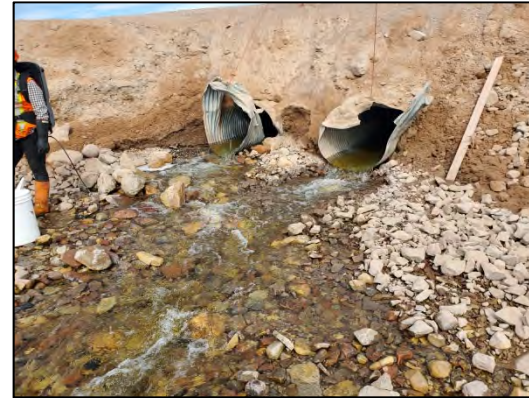
**Photos 1:** Photographs of the downstream end of the perched culvert at CV-114: (A) after remediation in fall 2019; (B) during freshet 2020; and (C) after repairs to the ramp in fall 2020.

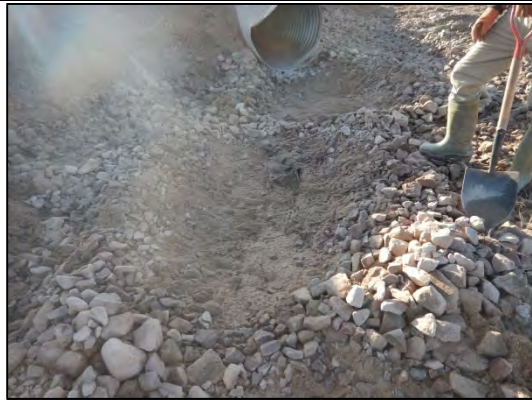
A

**Photos 1:** Photographs of the downstream end of the perched culvert at CV-106: (A) after remediation in fall 2019 when the channel was dry; (B) during freshet 2020 when the channel was wetted, showing a slight perch; and (C) during fall 2020 when channel was dry again and some additional repairs were made to the structure. Effectiveness of measures at this site are difficult to quantify due to the short period during which there is surface flow in this stream.

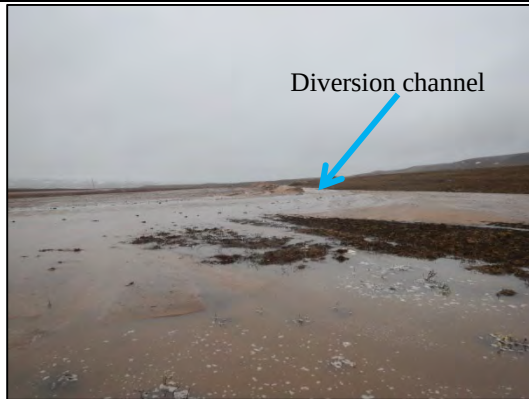
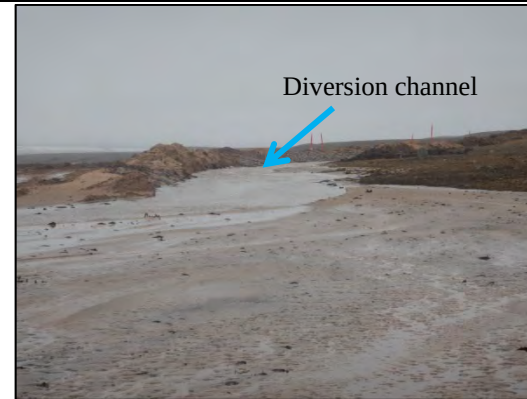
**Photos 1:** Photographs of the diversion of water from CV-031 to CV-030 in spring 2020: (A,B) the diversion channel from CV-031; (C,D) flooding, erosion and sedimentation at the upstream end of the CV-30 culverts.
