## **APPENDIX 4**

### **Km 63.5 As-built Drawing**

KM 63.5 CULVERT REPAIRS

KM 63.5 Photo Key

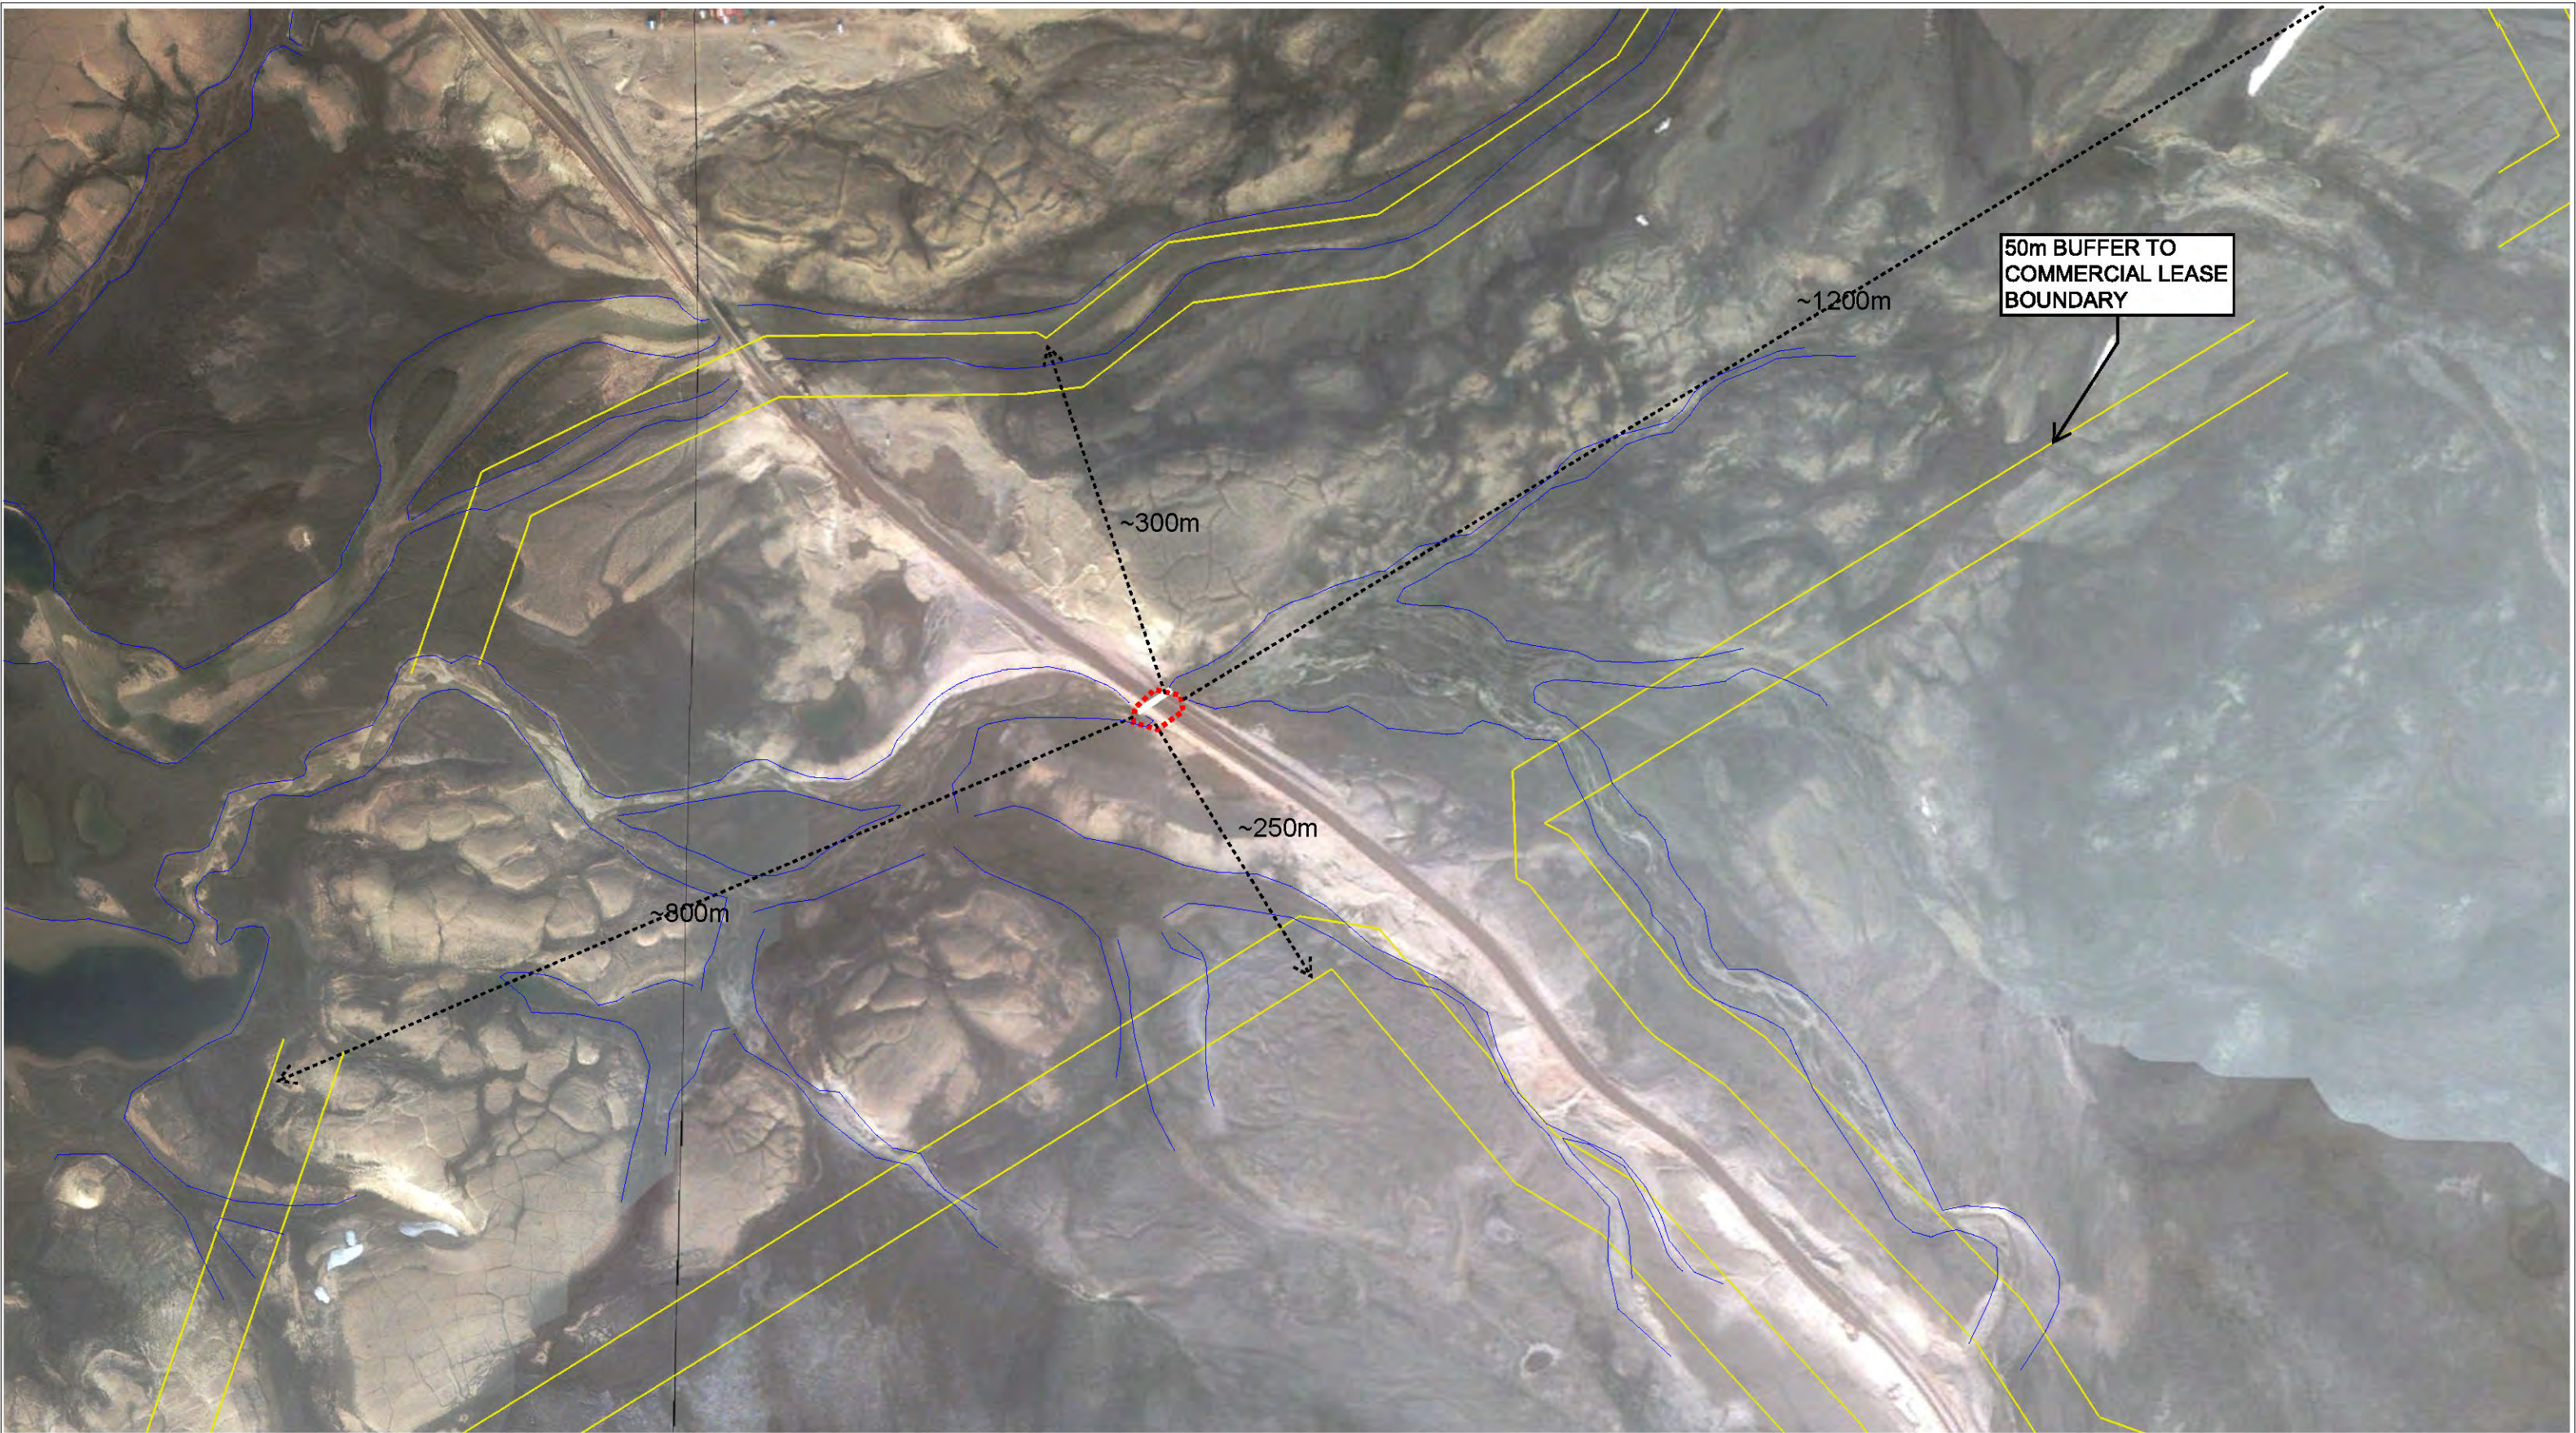
NOTES: PROJECT EXTENTS

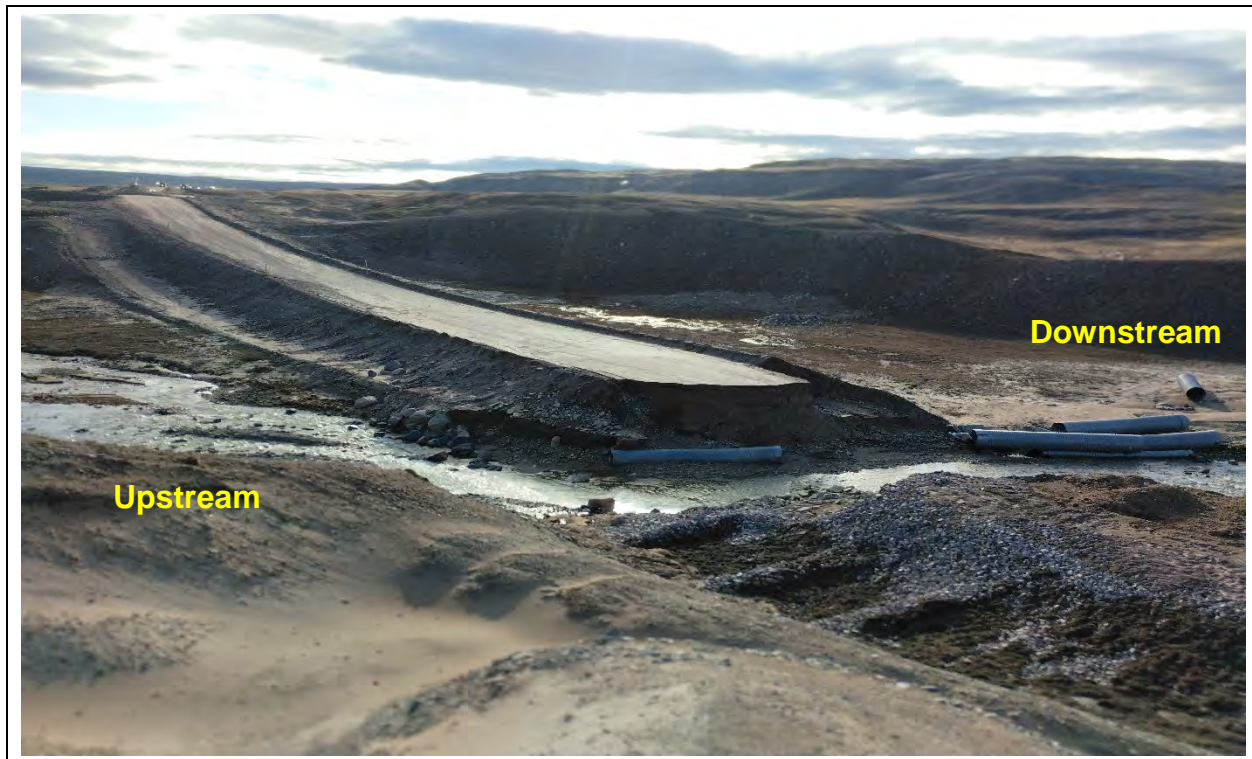
**Photo 1.** KM 63.5, looking south at crossing, 2024-09-24

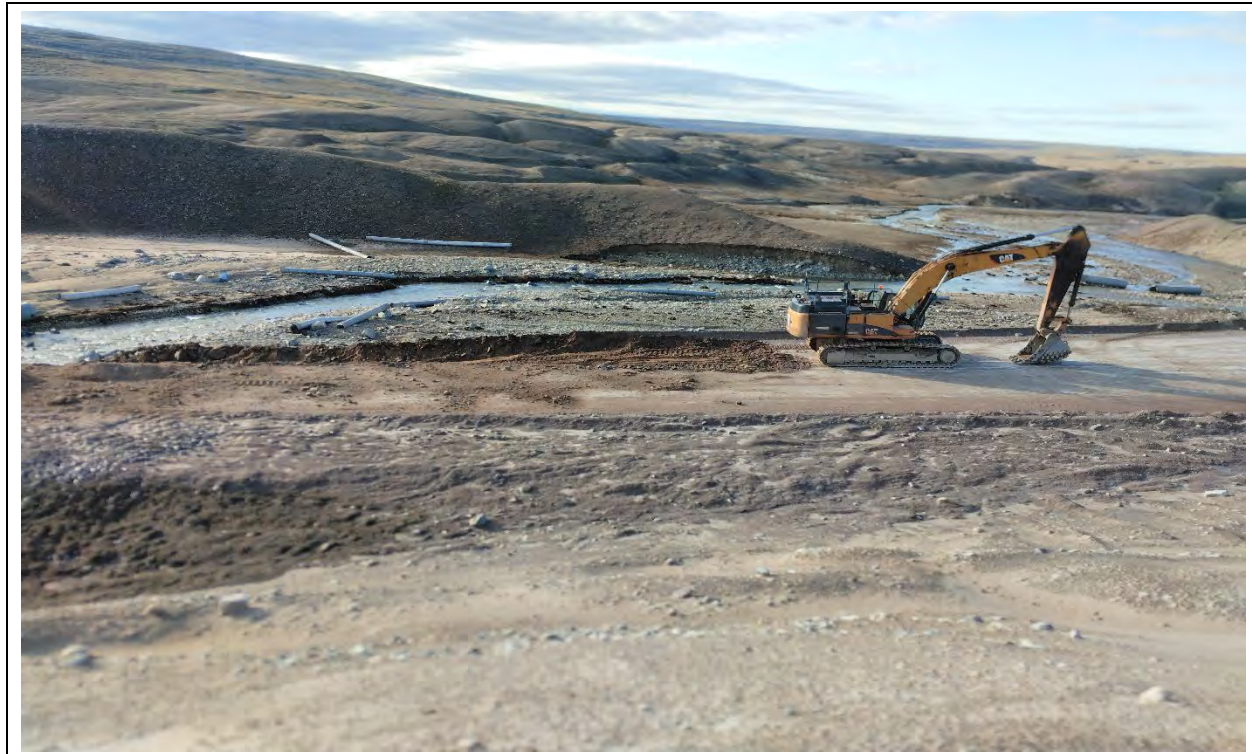
**Photo 2.** KM 63.5, looking southwest downstream of crossing, 2024-09-24

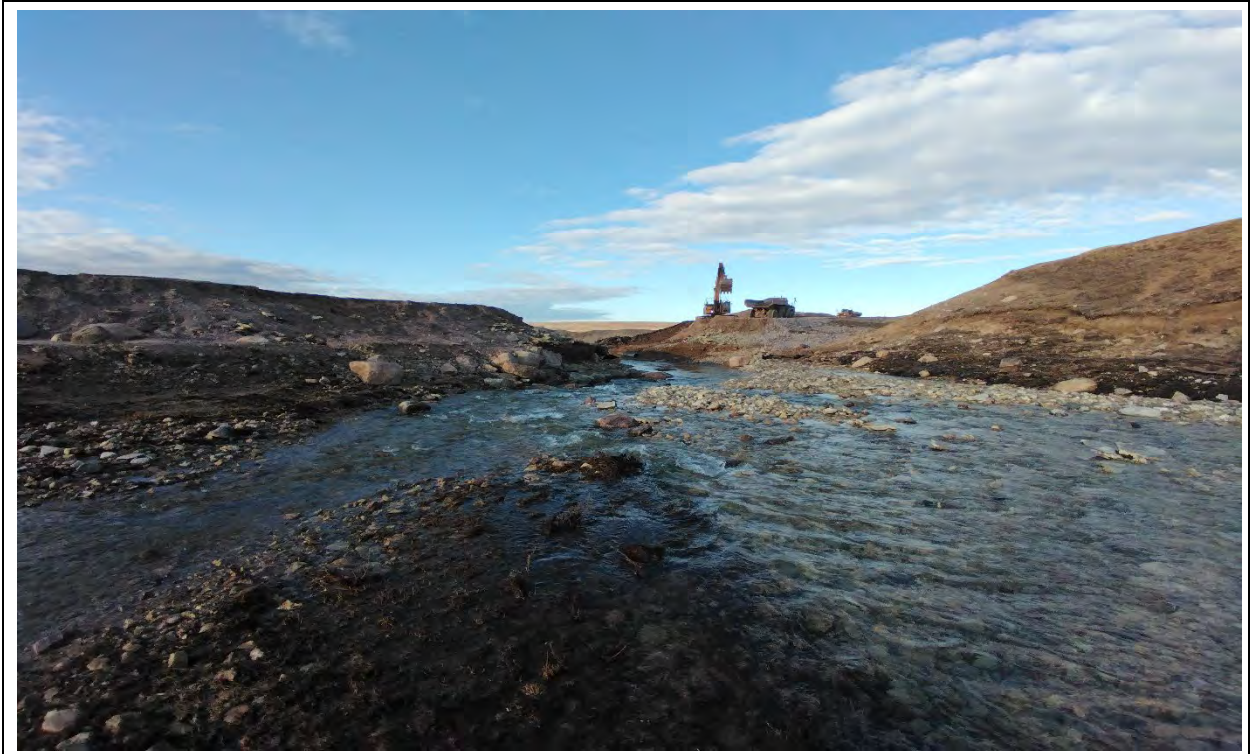
**Photo 3.** KM 63.5, upstream, looking west at crossing, 2024-09-24

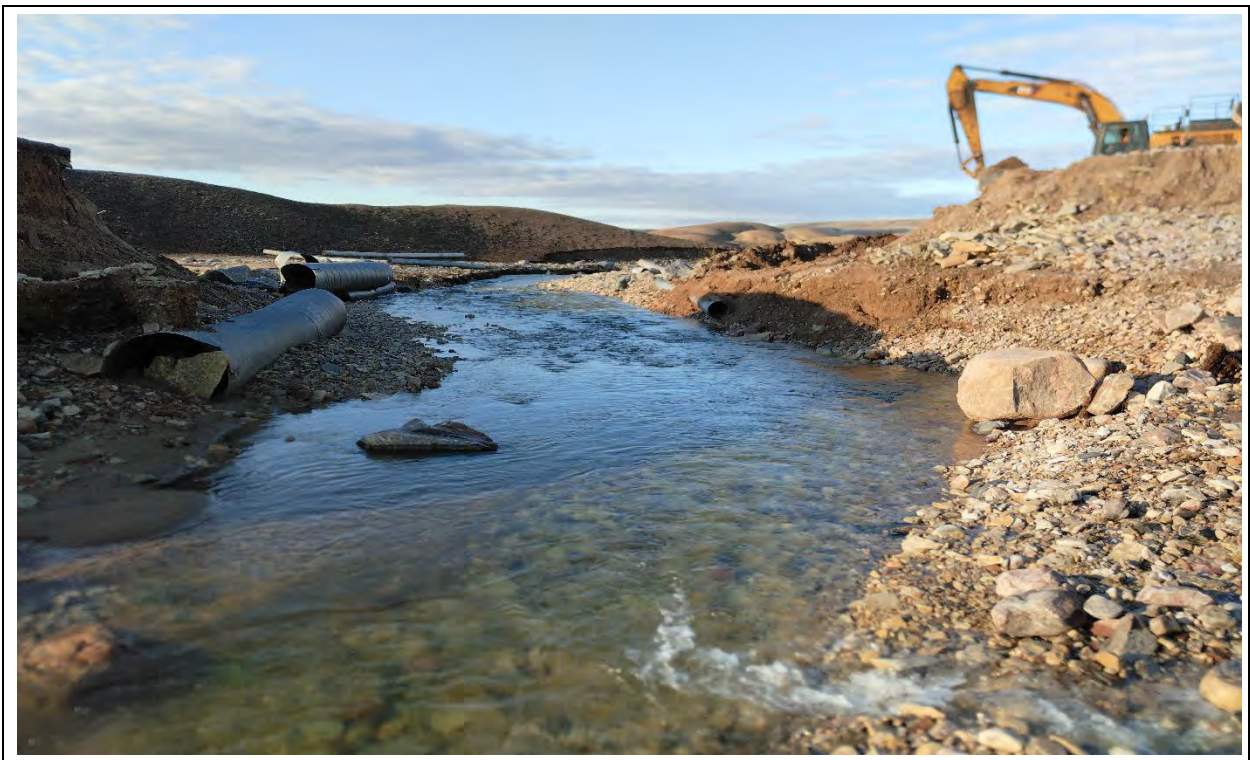
**Photo 3.** KM 63.5, upstream, looking west at crossing, 2024-09-24

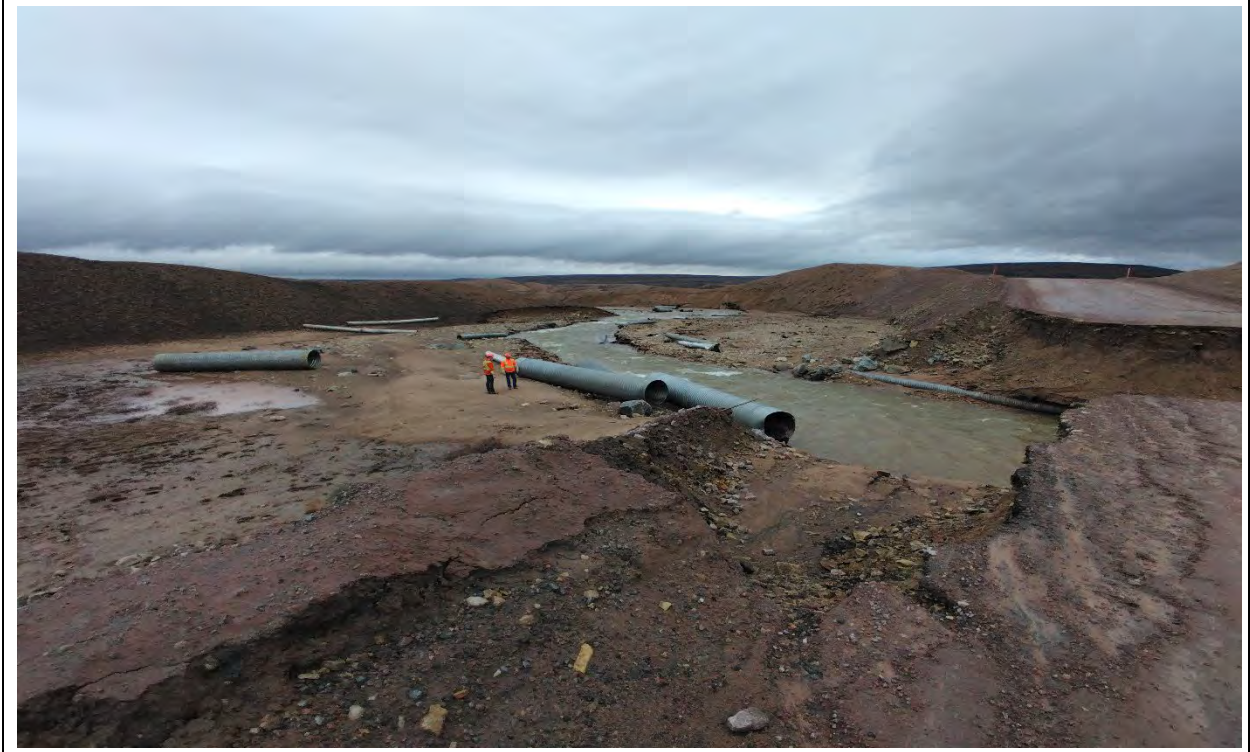
**Photo 5.** KM 63.5, downstream, looking northwest at crossing, 2024-09-24

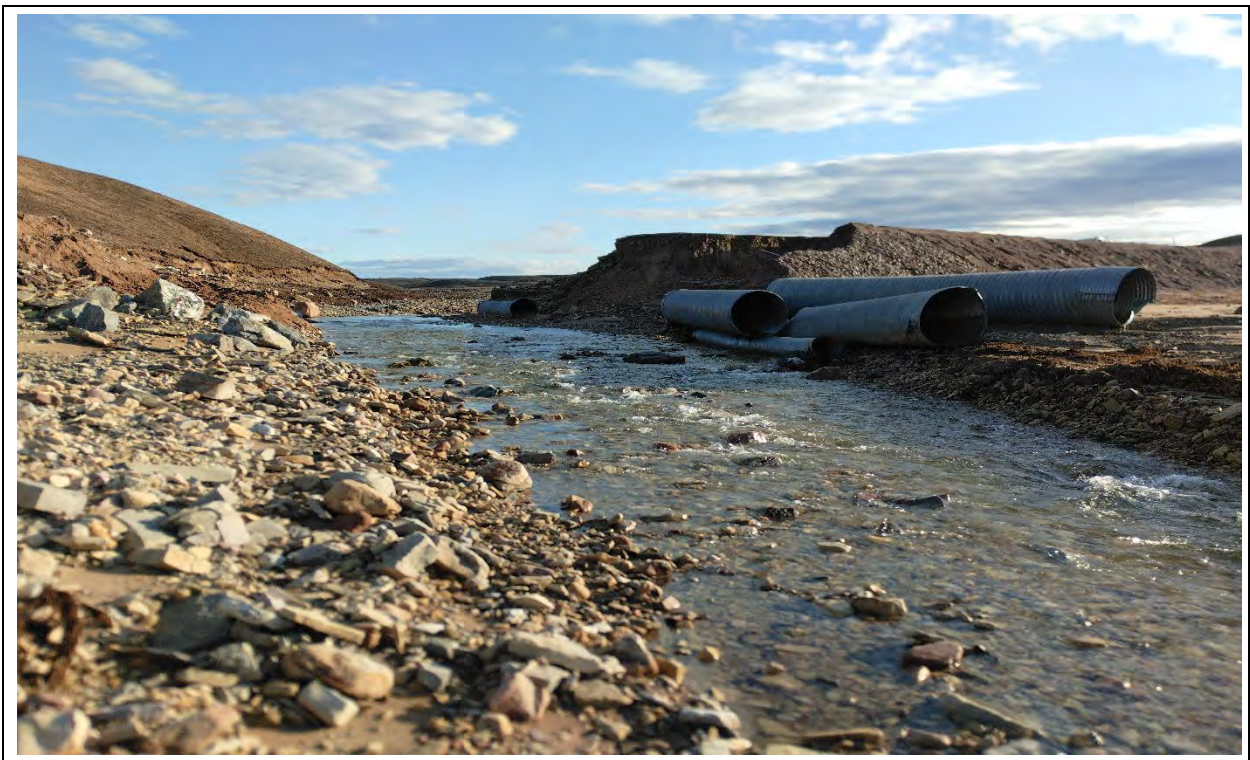
**Photo 6.** KM 63.5, downstream, looking northeast at crossing, 2024-09-24

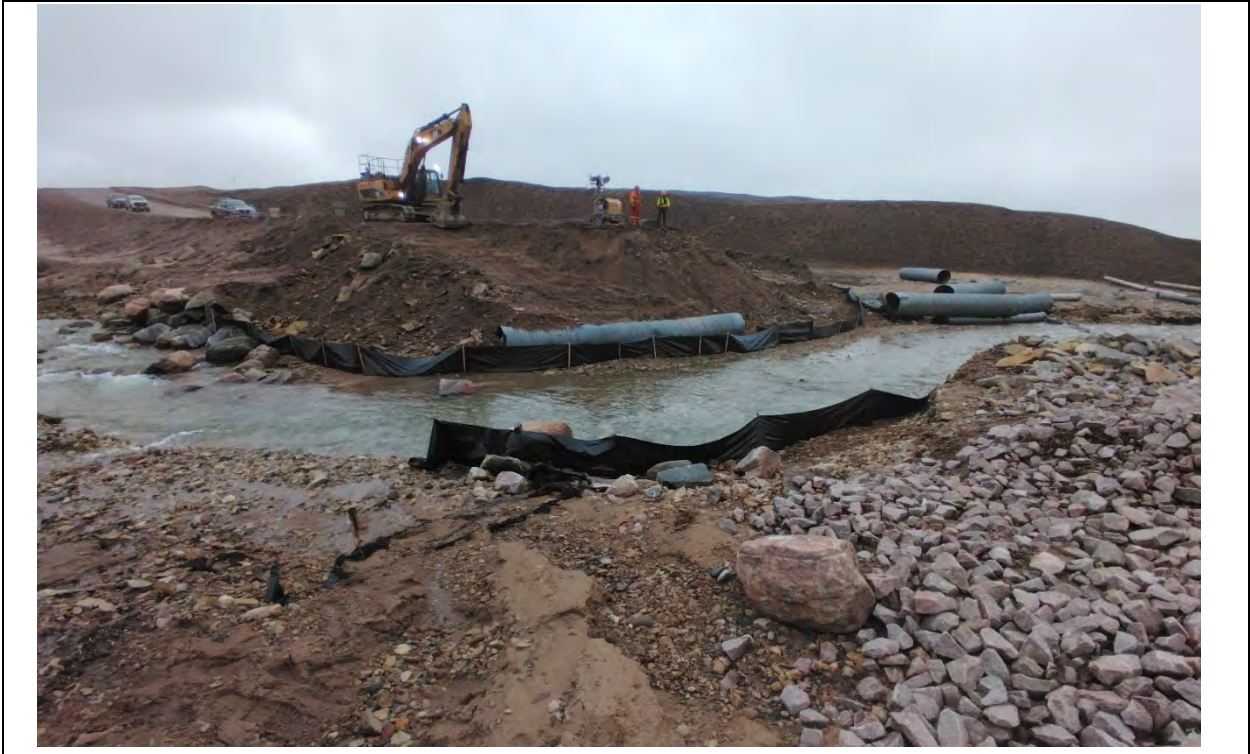
**Photo 7.** KM 63.5, looking south at crossing, 2024-09-25 ESC Installed.

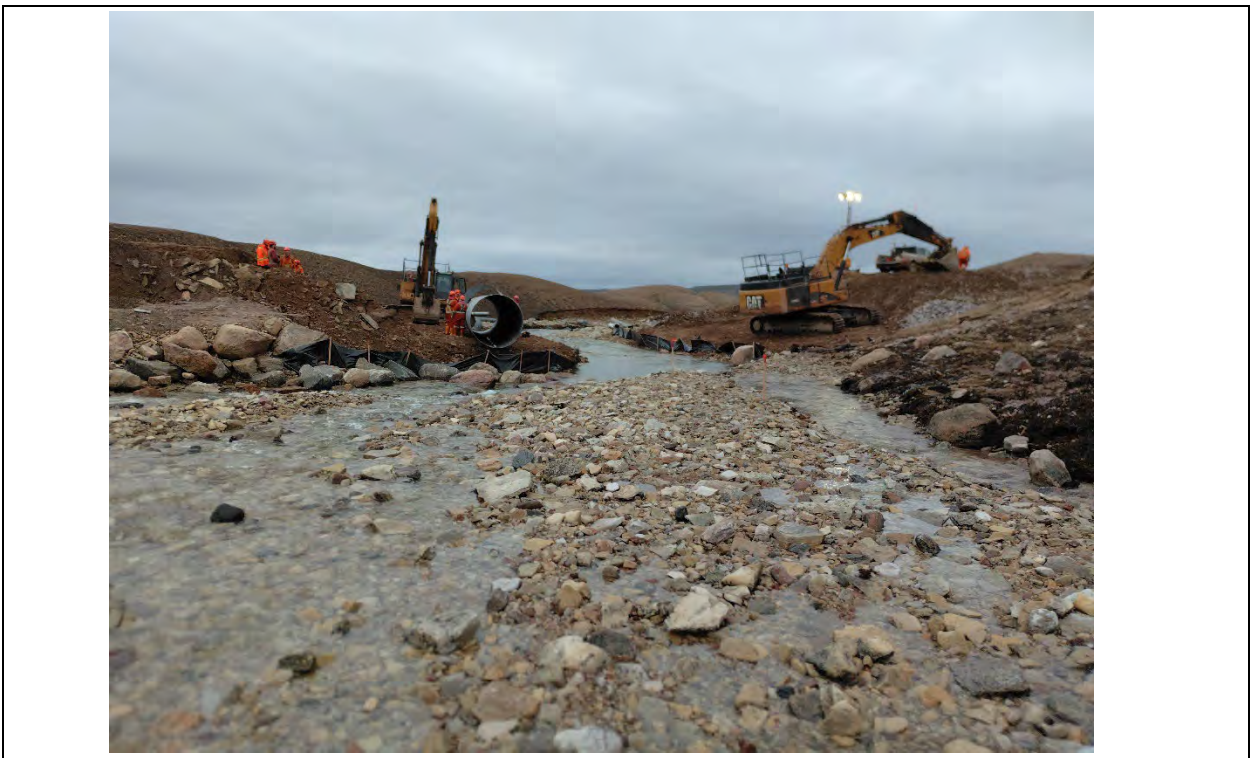
**Photo 8.** KM 63.5, east of crossing, 2024-09-26, 1800mm culvert staged for assembly.

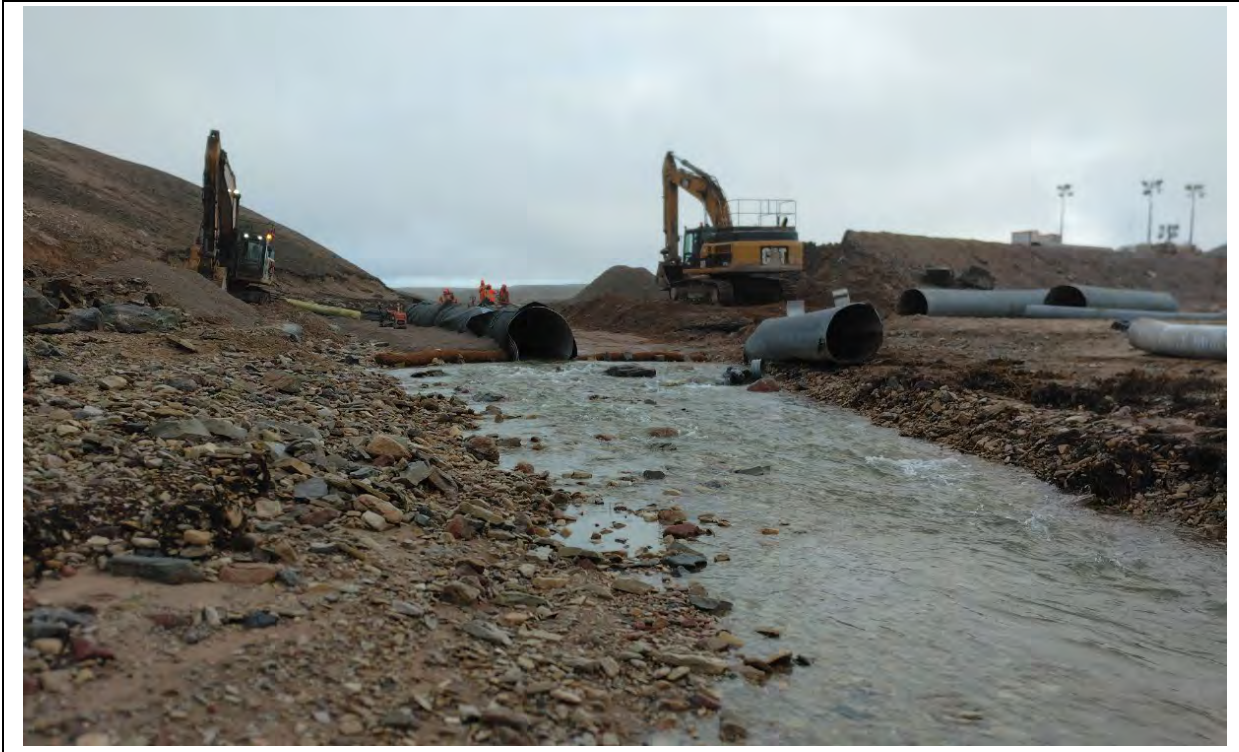
**Photo 9.** KM 63.5, looking west at crossing, 2024-09-27 1800mm culvert and ESC Installed.

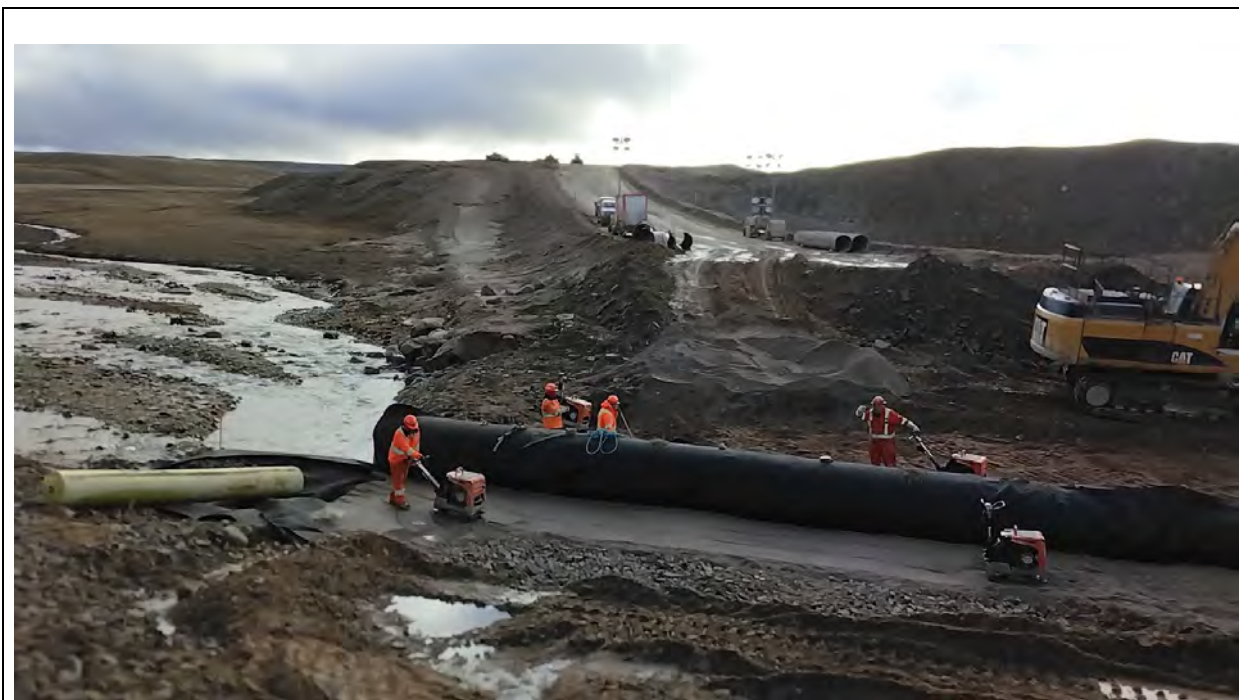
**Photo 10.** KM 63.5, north of crossing, 2024-09-25, 1800mm installed, compaction ongoing.

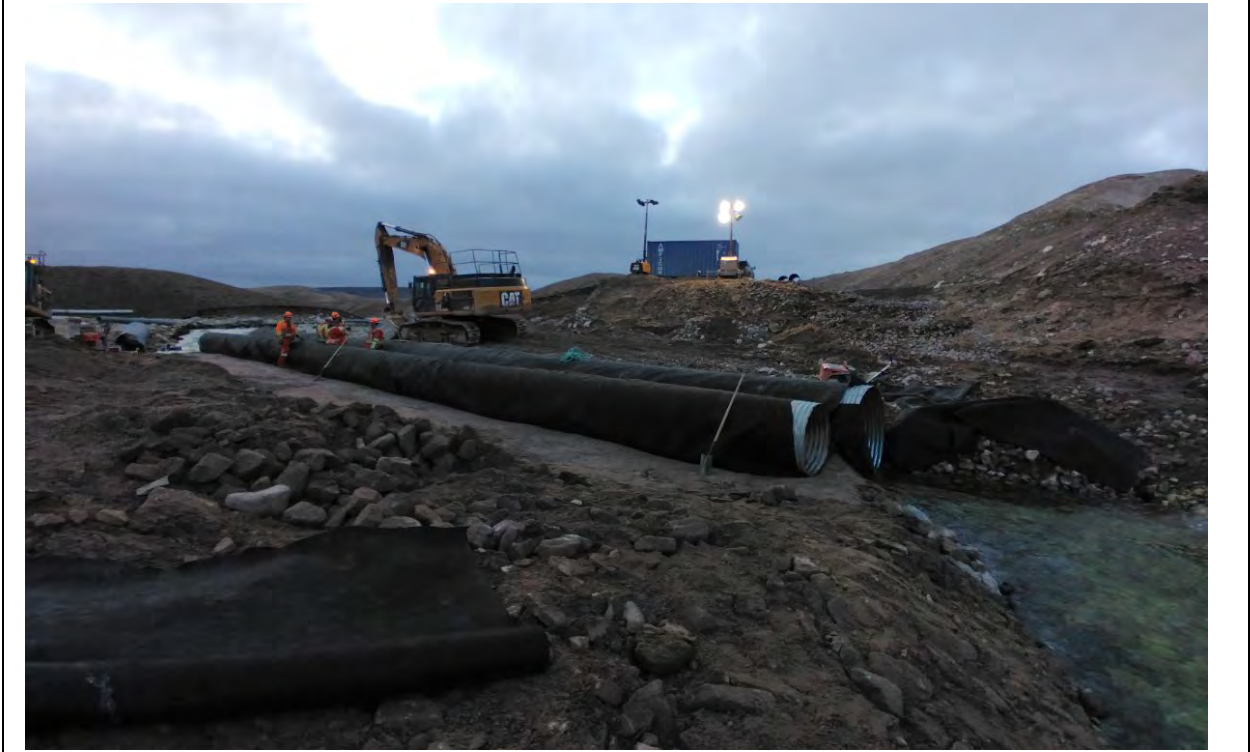
**Photo 11.** KM 63.5, looking northwest at crossing, 2024-09-27, high flow culvert installed.

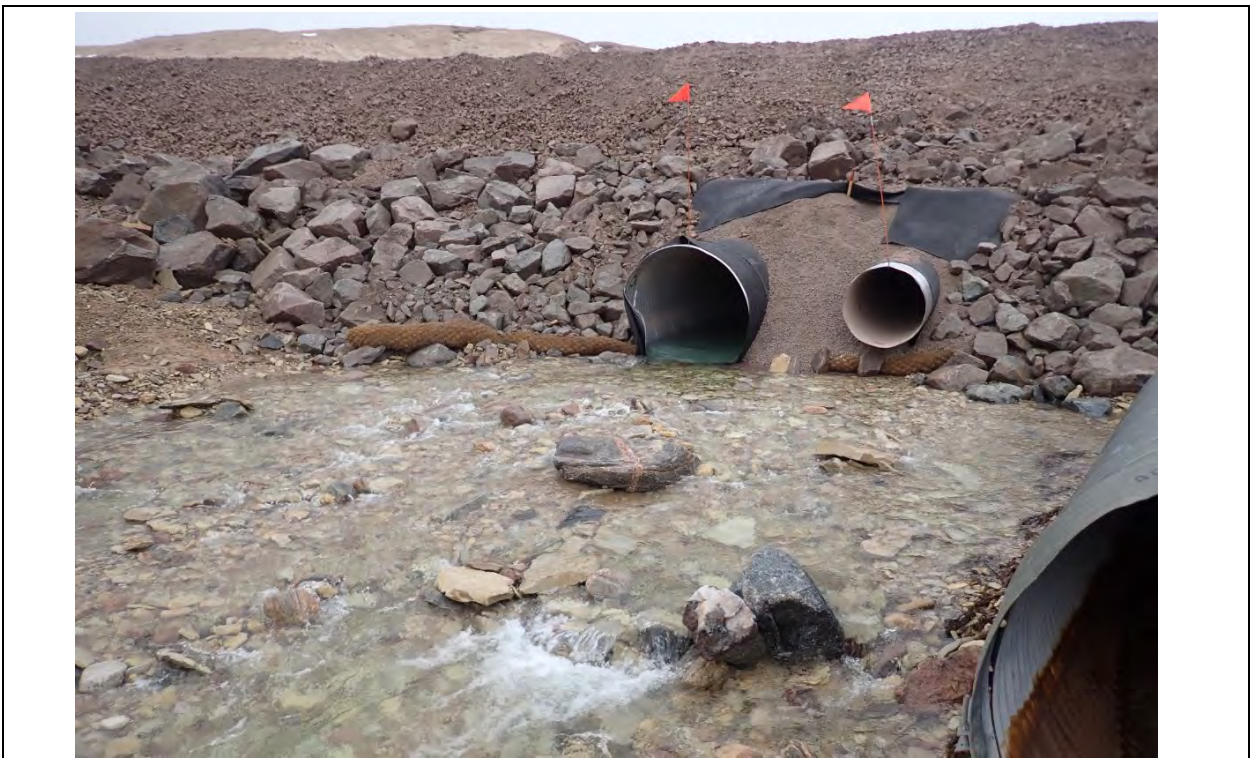
**Photo 12.** KM 63.5, west of crossing, 2024-10-02, construction completed.
