APPENDIX C.1.2  
Construction Summary Report  
CV-187 Culvert Replacement

## **Construction Summary Report CV-187 Culvert Replacement**

**June 2025**

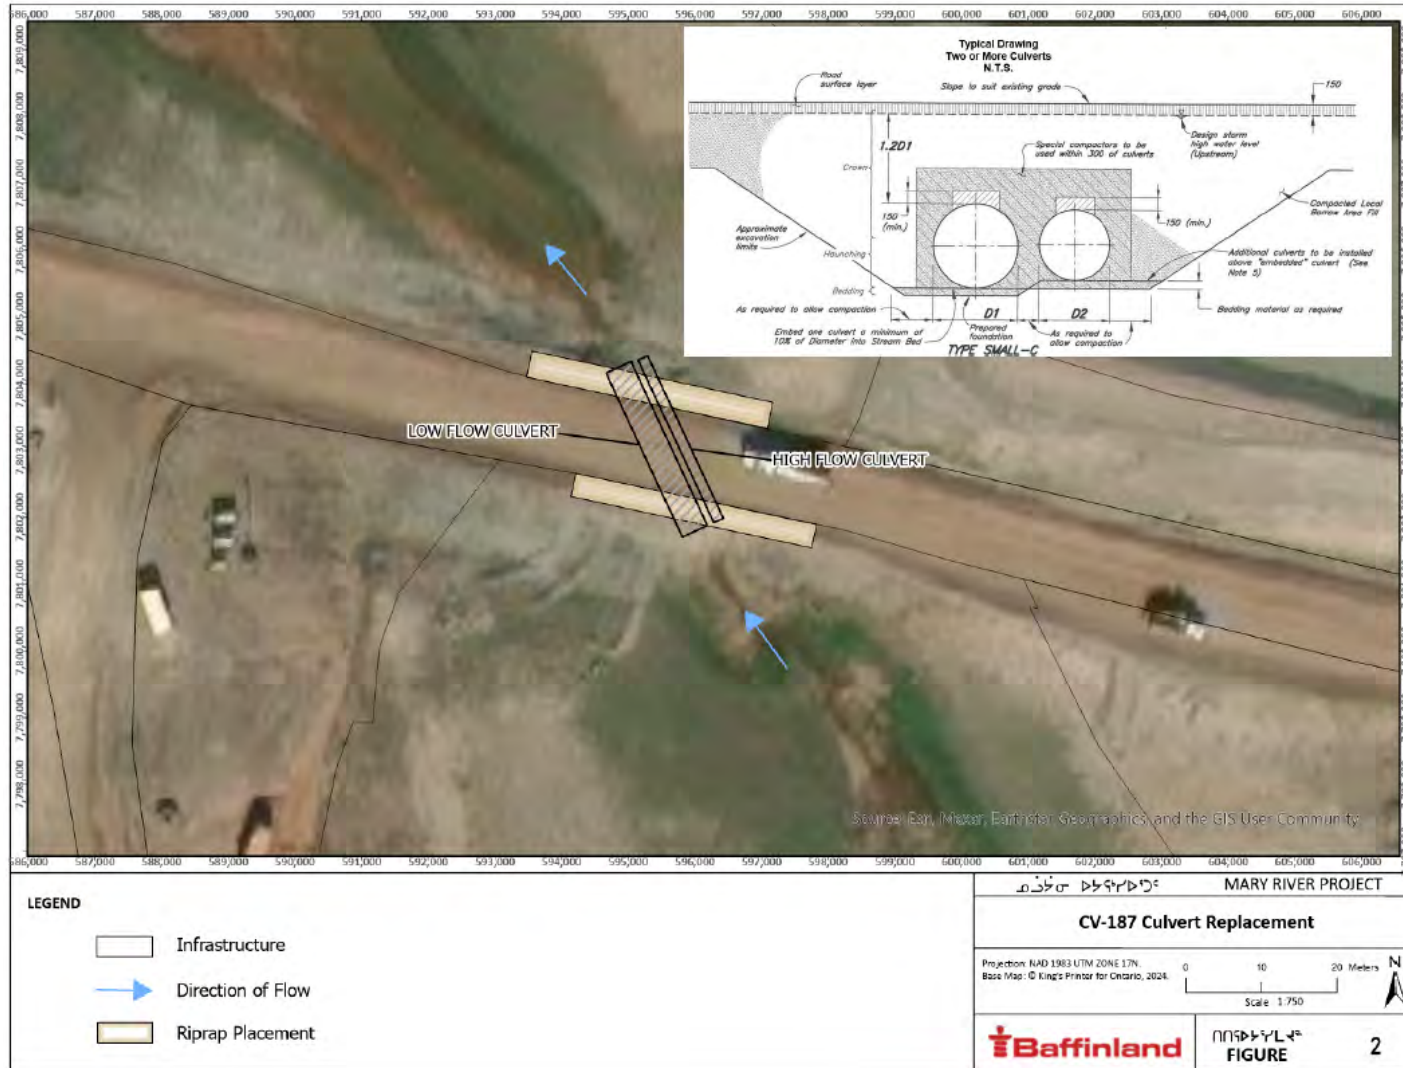
Figure 2. IFC Drawing for CV-187 Culvert Replacement

Culvert replacement consisted of removing the two existing culverts and replacing, in-kind, with one 900 mm diameter, low flow culvert and one 600 mm diameter, high flow culvert. See Appendix A for IFC and As-built drawings.

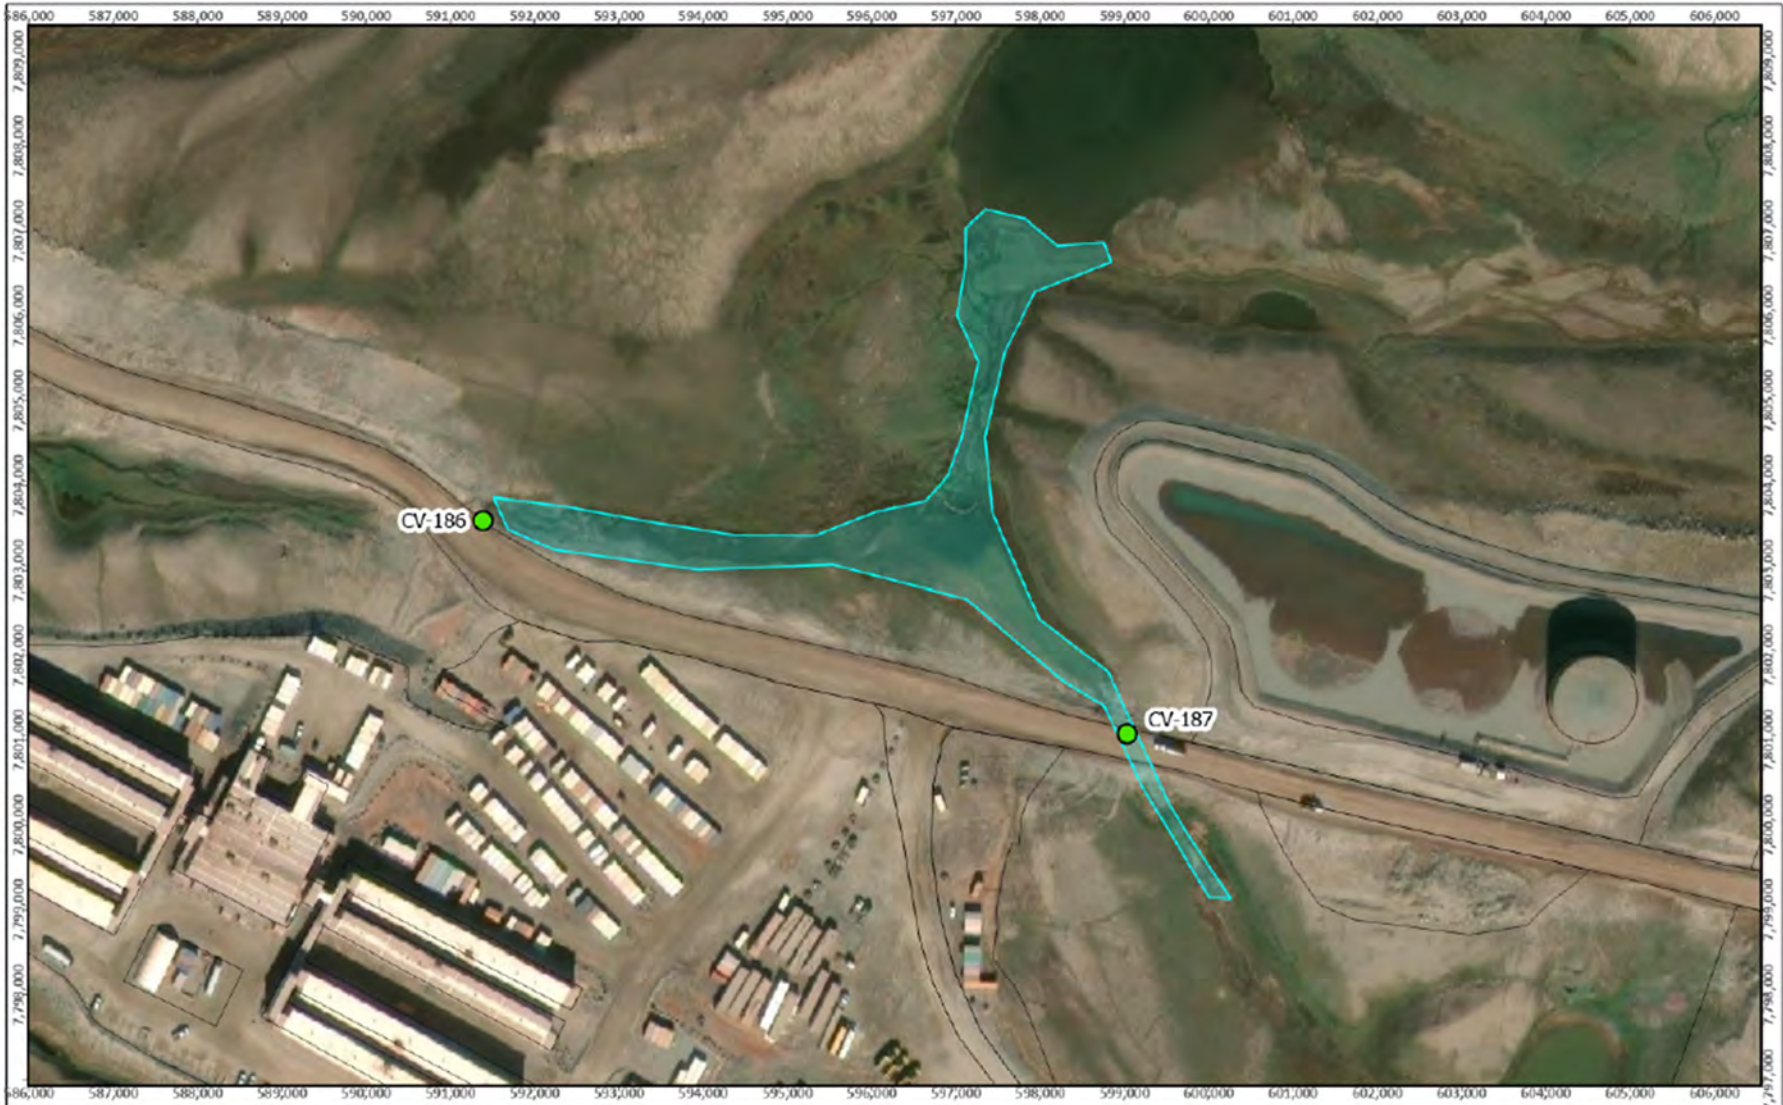
**Baffinland** ᑭᓄᓐ ᑭᓄᓐ ᑭᓄᓐ  
**FIGURE 5**

Prior to initiating this work, Baffinland engaged our fisheries Biologist to ensure the planned installation was sufficient from a fish passage and hydrologic perspective. A visual assessment for fish presence within the watercourse, was completed prior to initiating construction, see Figure 5. Due to the water temperatures and lake conditions at the time, it was not expected that any fish would be utilizing the stream and none were observed in this tributary.

**CV-187 Visual Fish Assessment Area**

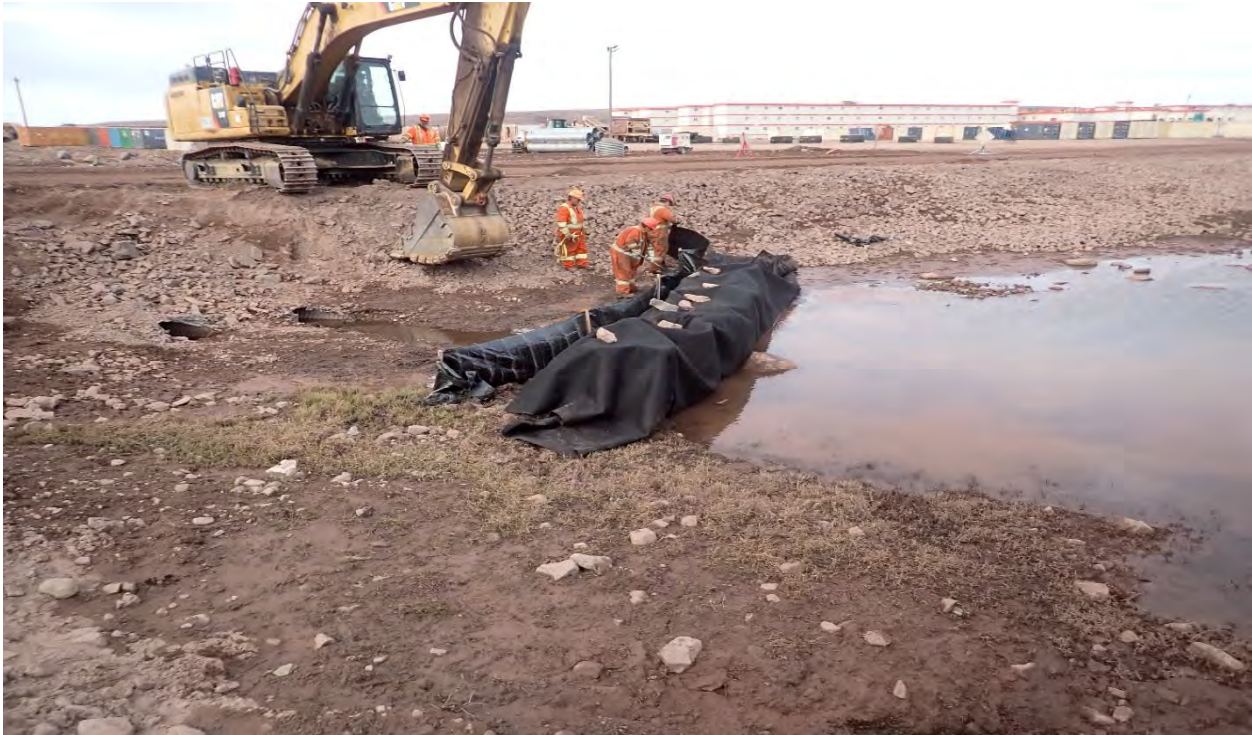
**Photo 1.** Downstream, looking south west, watercourse isolation and silt fence installed, 2025-06-21

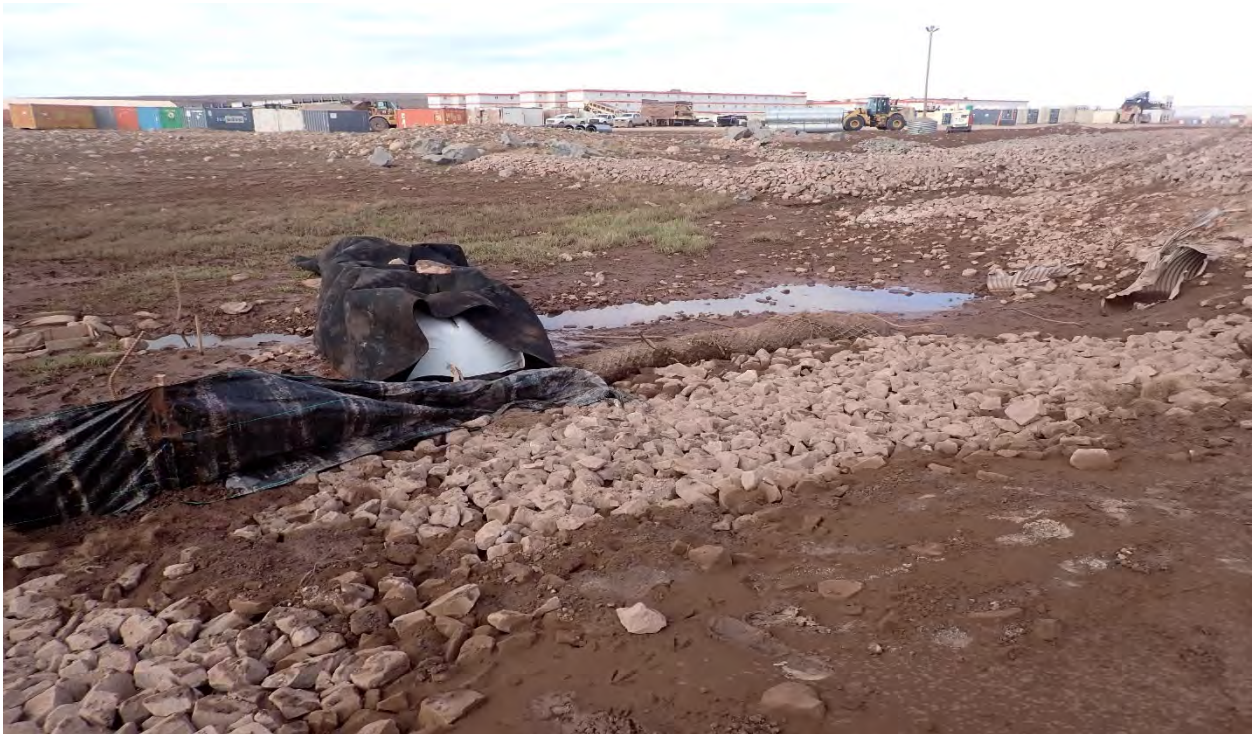
**Photo 2.** Upstream, looking west, watercourse isolation, silt fence and coir log installed, 2025-06-21

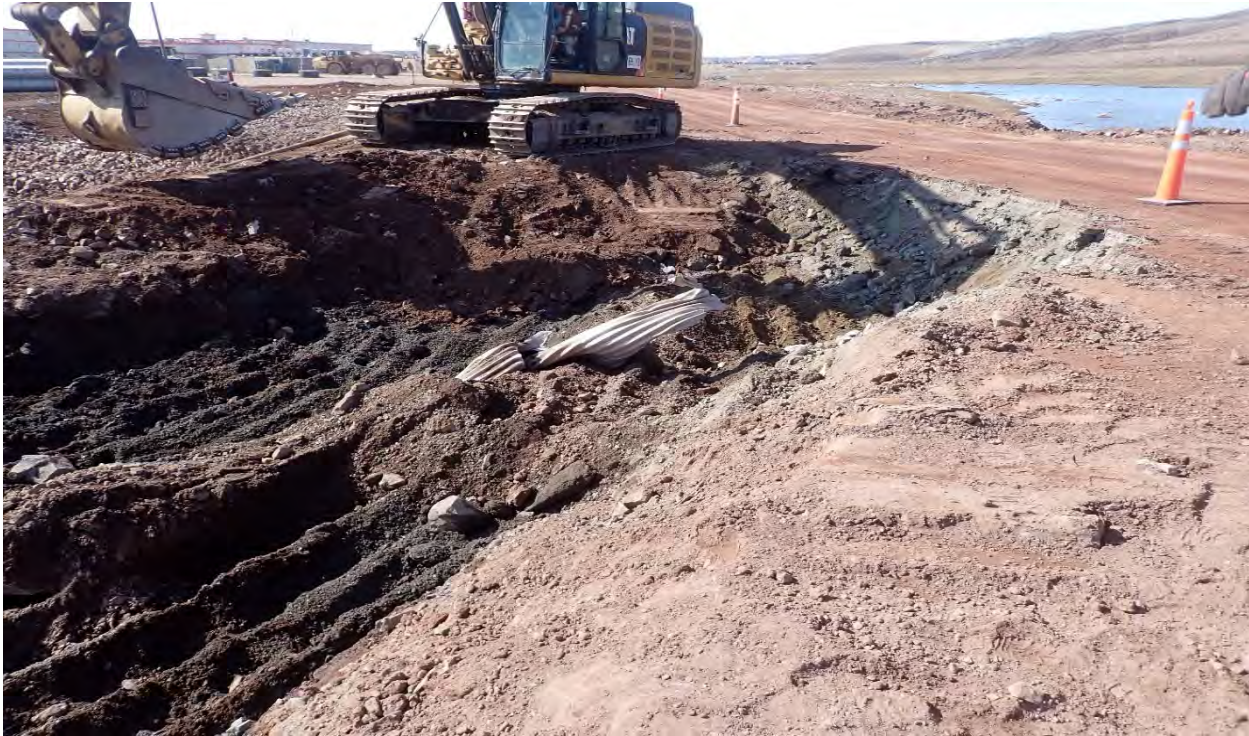
**Photo 3.** Excavating and removing existing upstream culverts, up to the road centre line, 2025-06-21

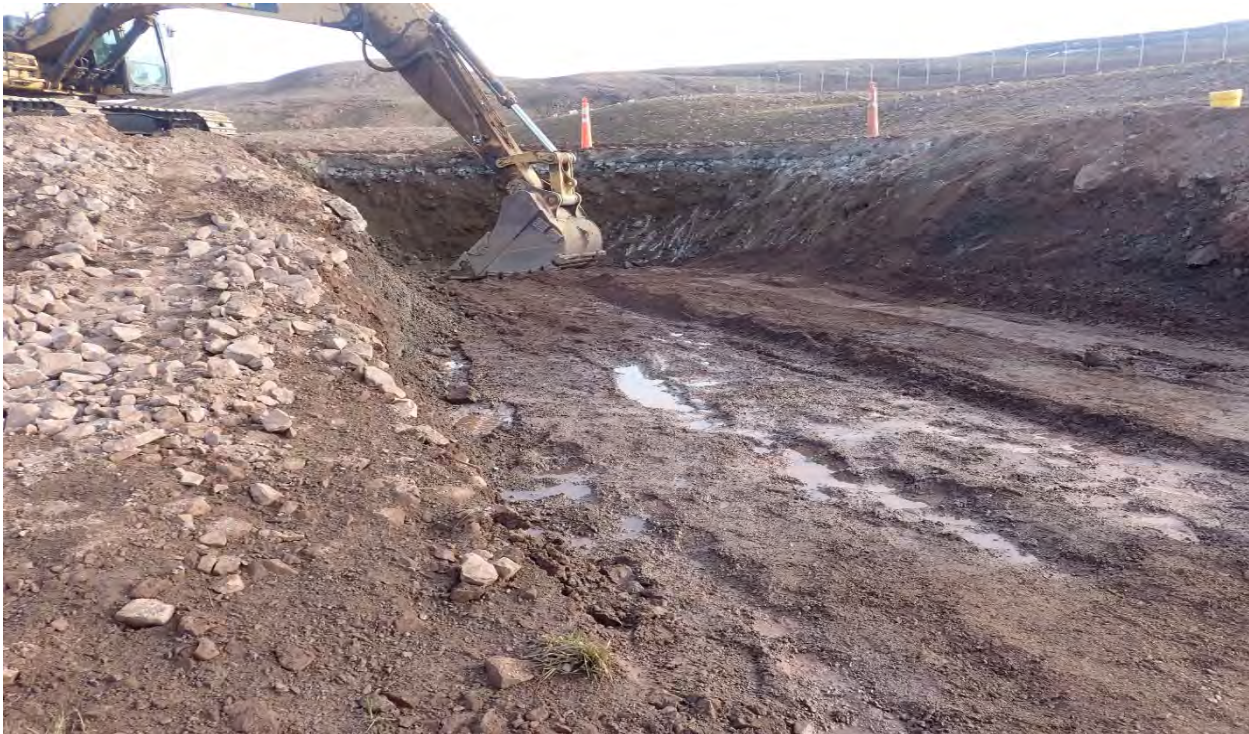
**Photo 4.** Upstream looking north,  $\frac{3}{4}$ " minus aggregate placement for crossing foundation, 2025-06-22

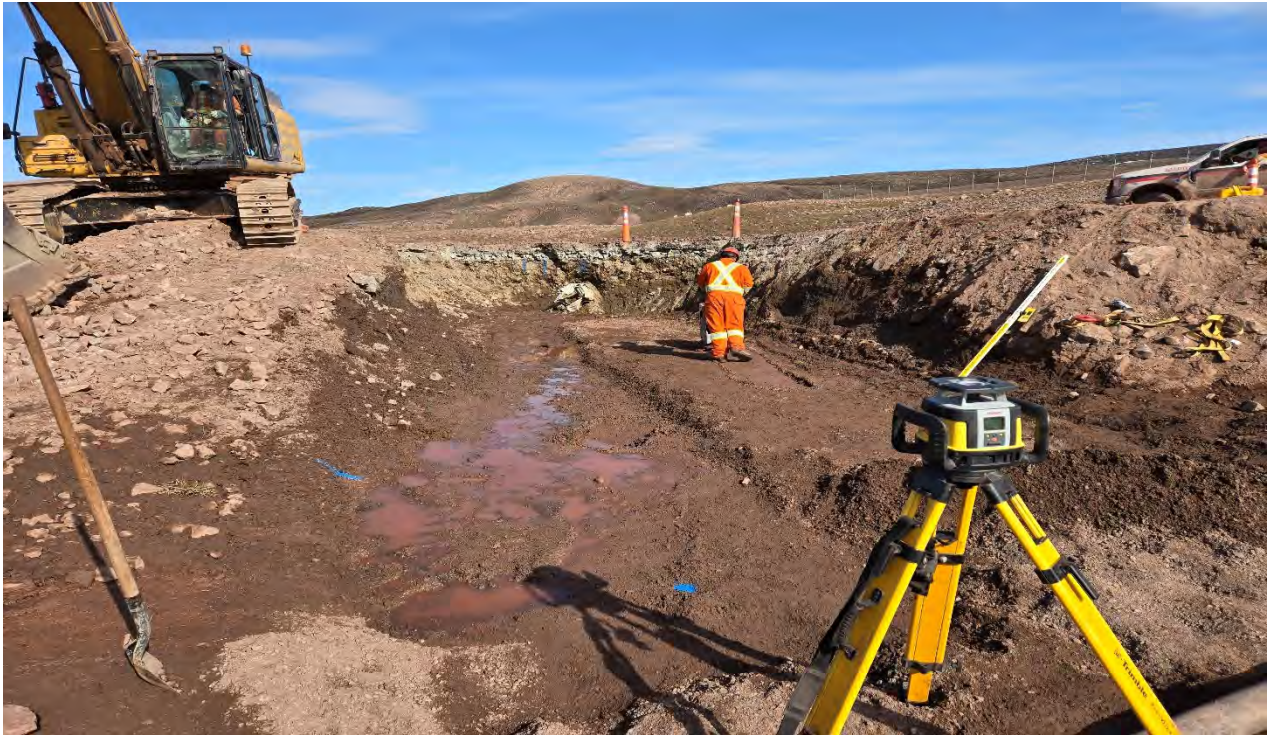
**Photo 5.** Survey and grading of channel to achieve proper slope for culverts, 2025-06-22

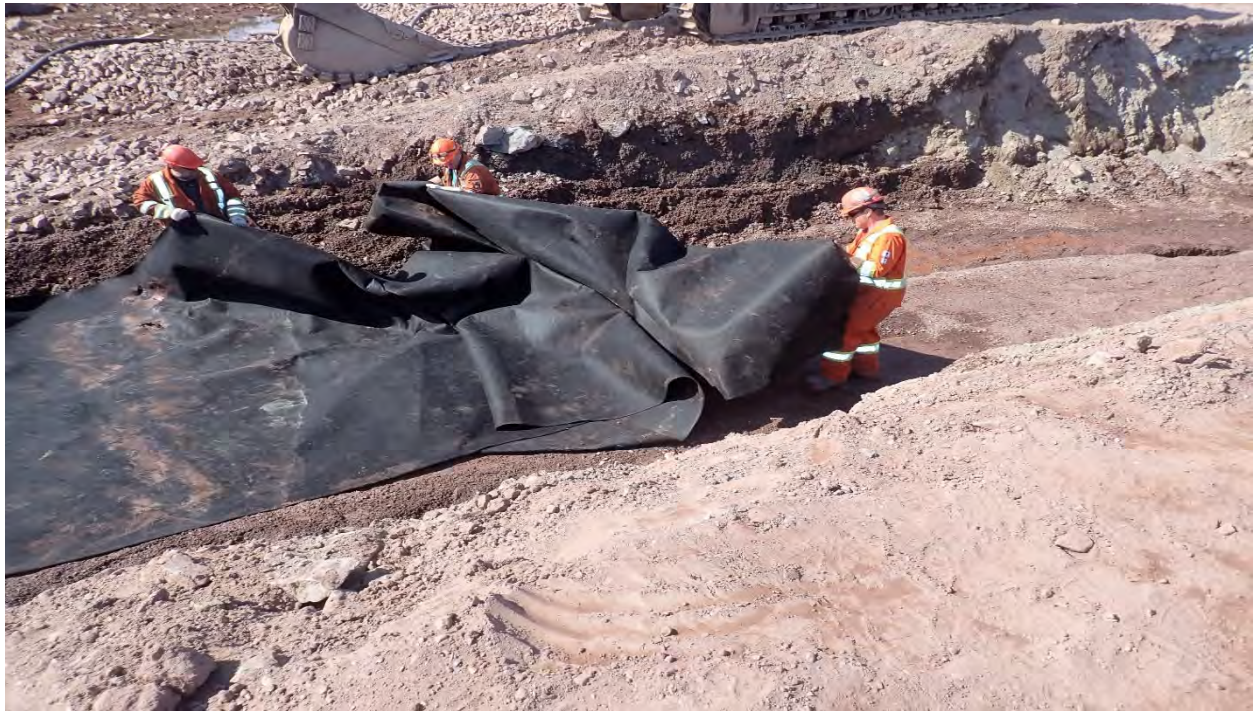
**Photo 6.** Installing non-woven geotextile over channel bed, prior to culvert placement, 2025-06-22

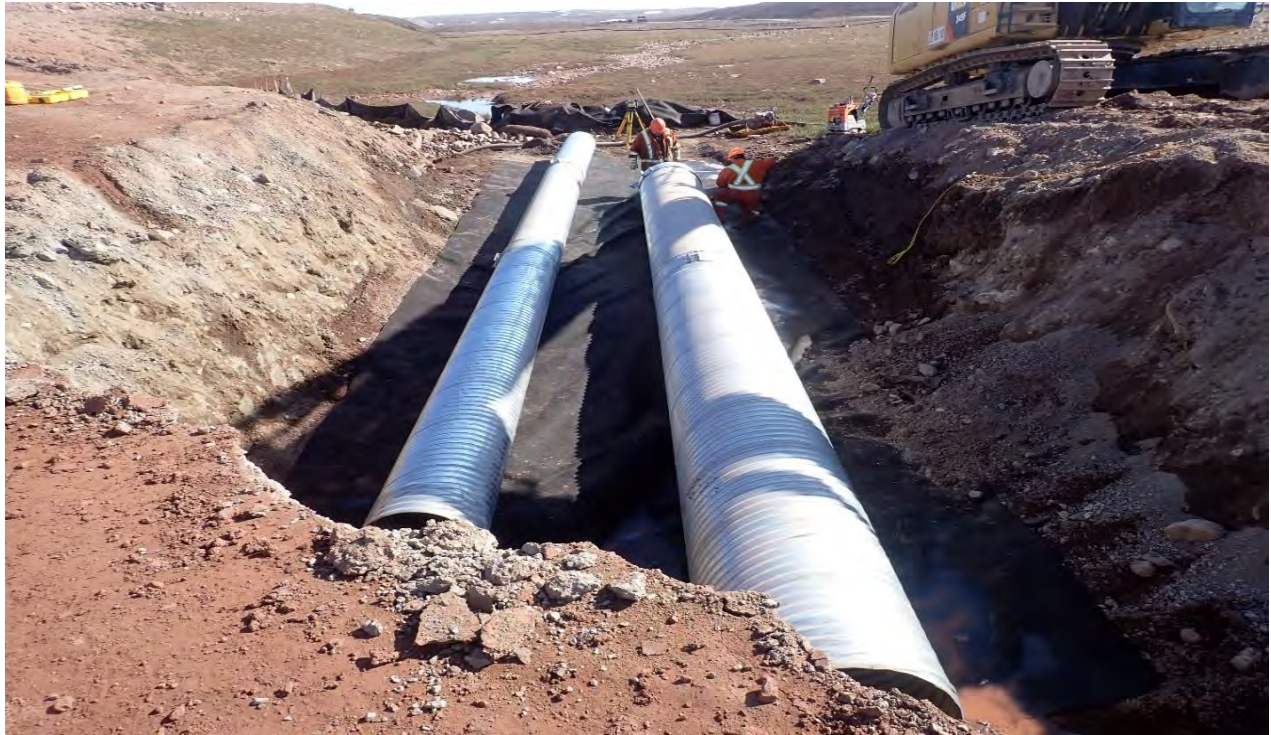
**Photo 7.** High flow and low flow culverts installed in the upstream half of the crossing, 2025-06-22

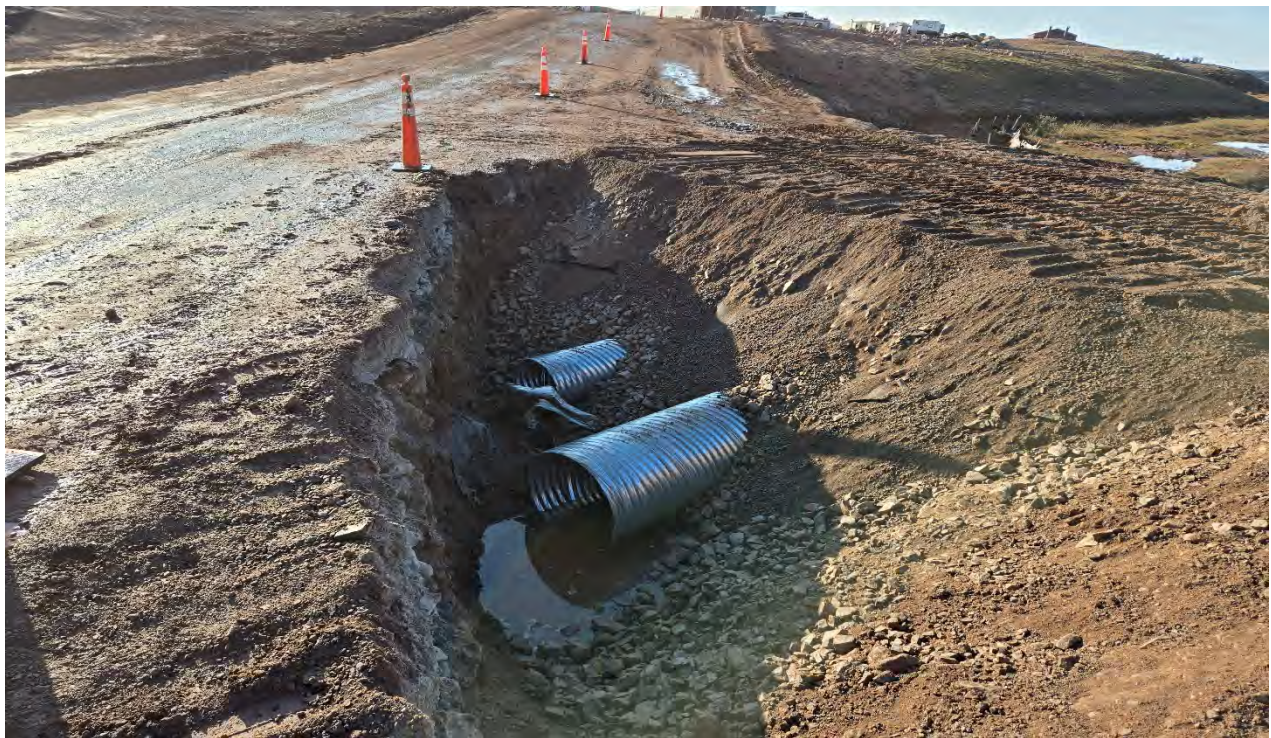
**Photo 8.** Upstream culverts backfilled and compacted, 2025-06-23

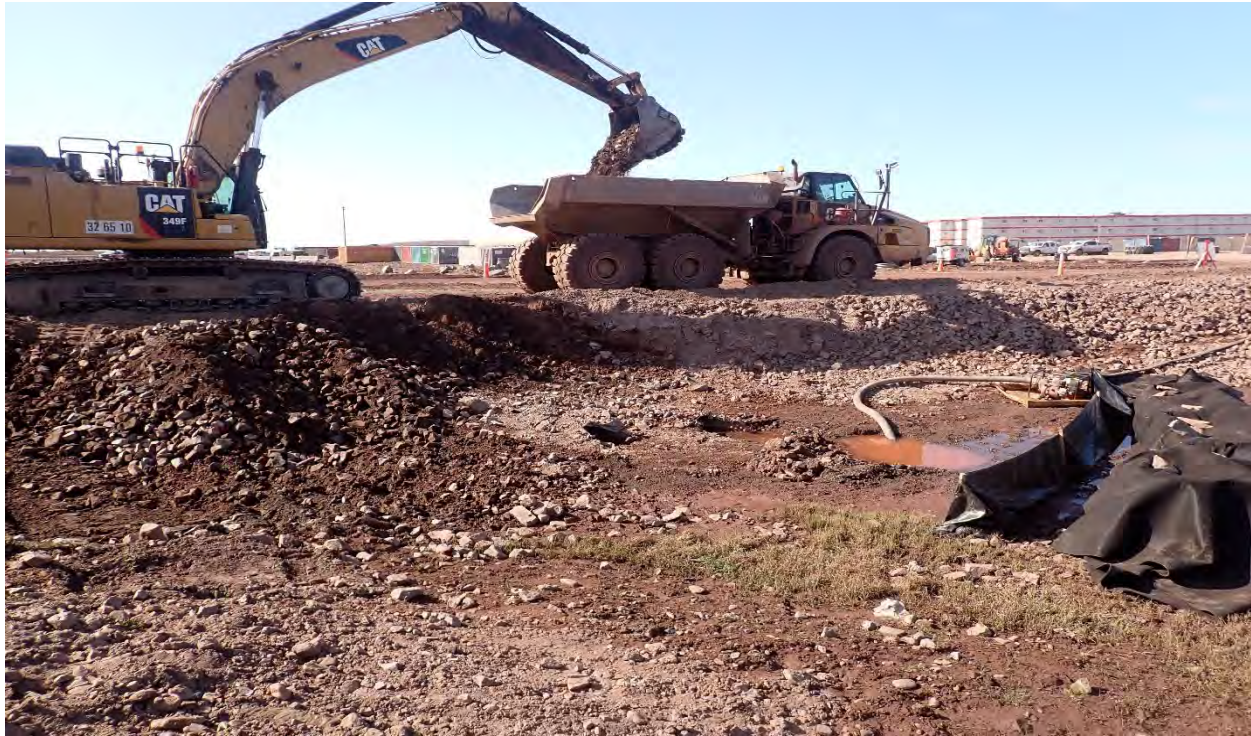
**Photo 9.** Downstream looking south west, de-watering work area, removing existing rip rap embankment, 2025-06-23

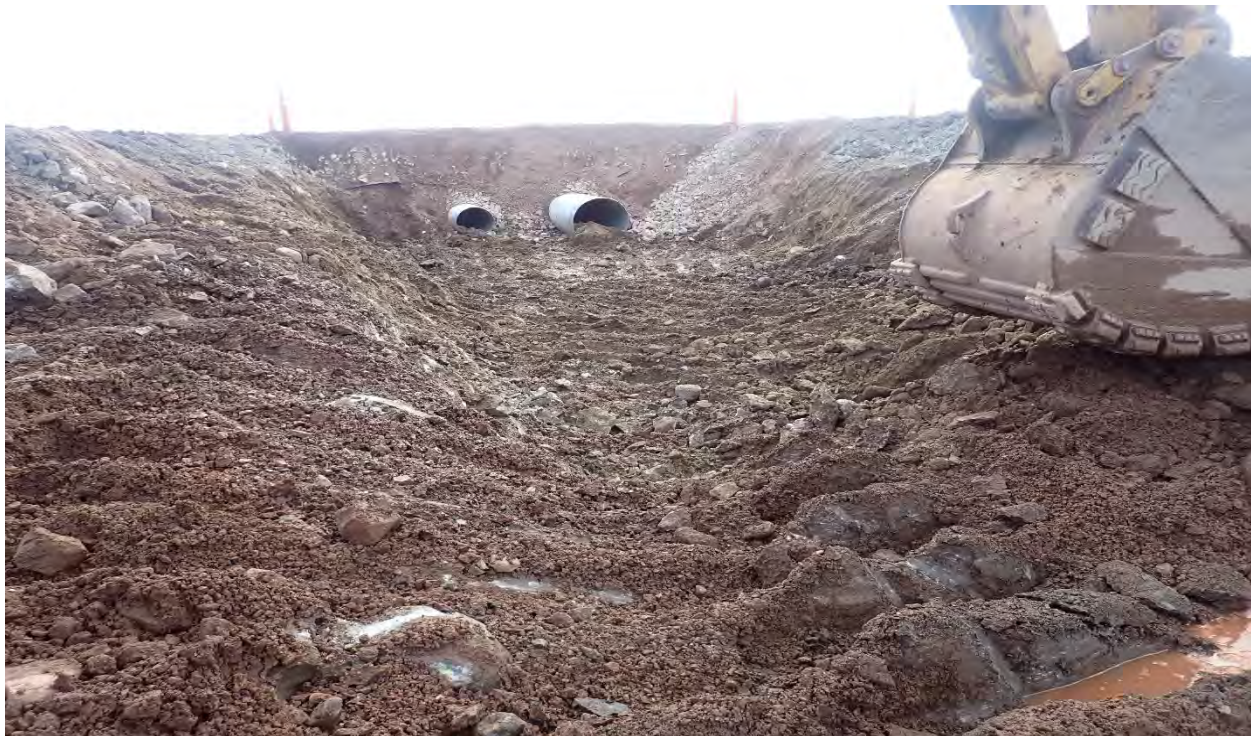
**Photo 10.** Downstream looking south, crossing excavated to road centreline and existing culverts removed, new upstream culvert visible, 2025-06-23

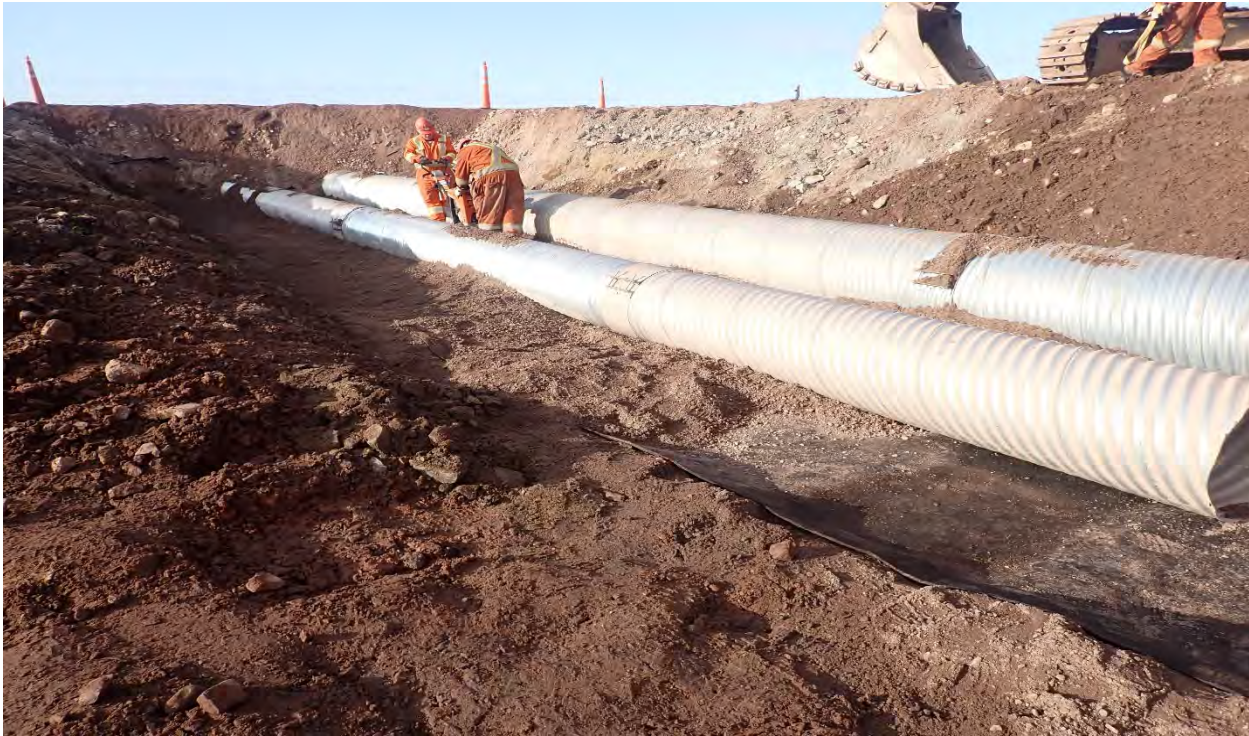
**Photo 11.** Downstream looking south west, connection of downstream culvert section to upstream section, assembly of culverts, 2025-06-24

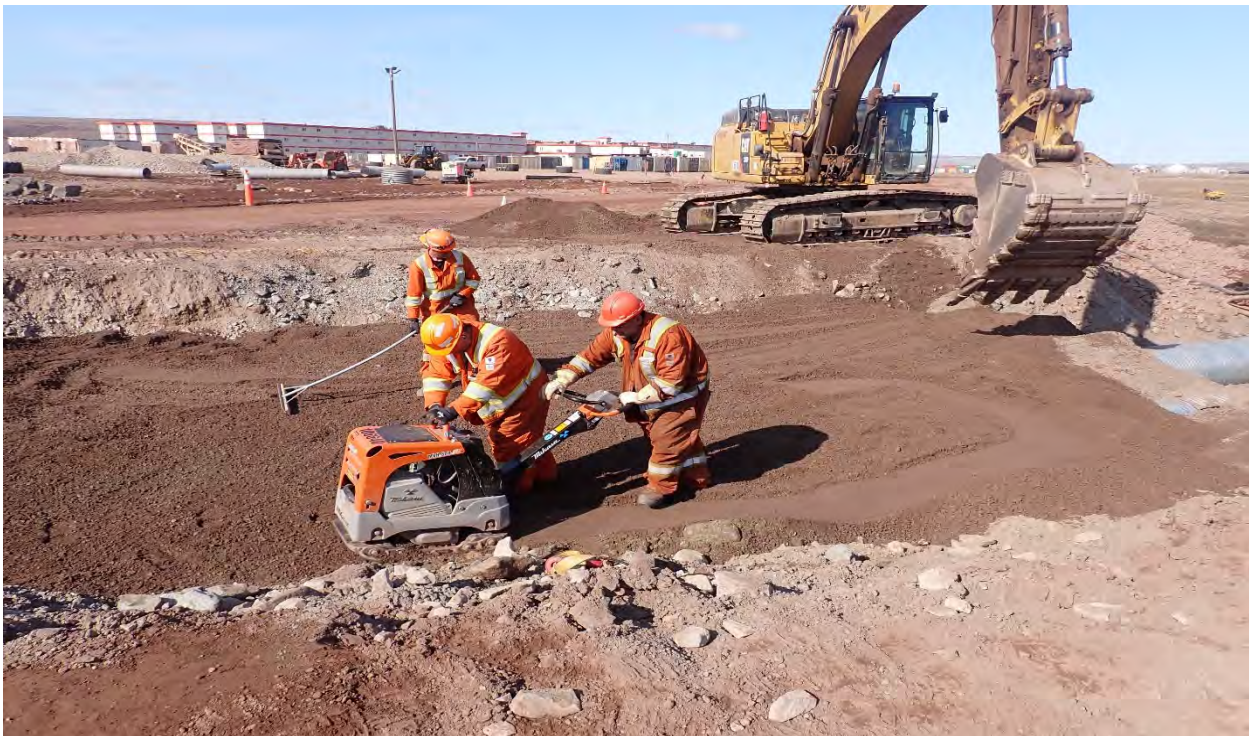
**Photo 12.** Downstream looking north west, compaction of  $\frac{3}{4}$ " minus around and on top of culverts, 2025-06-24

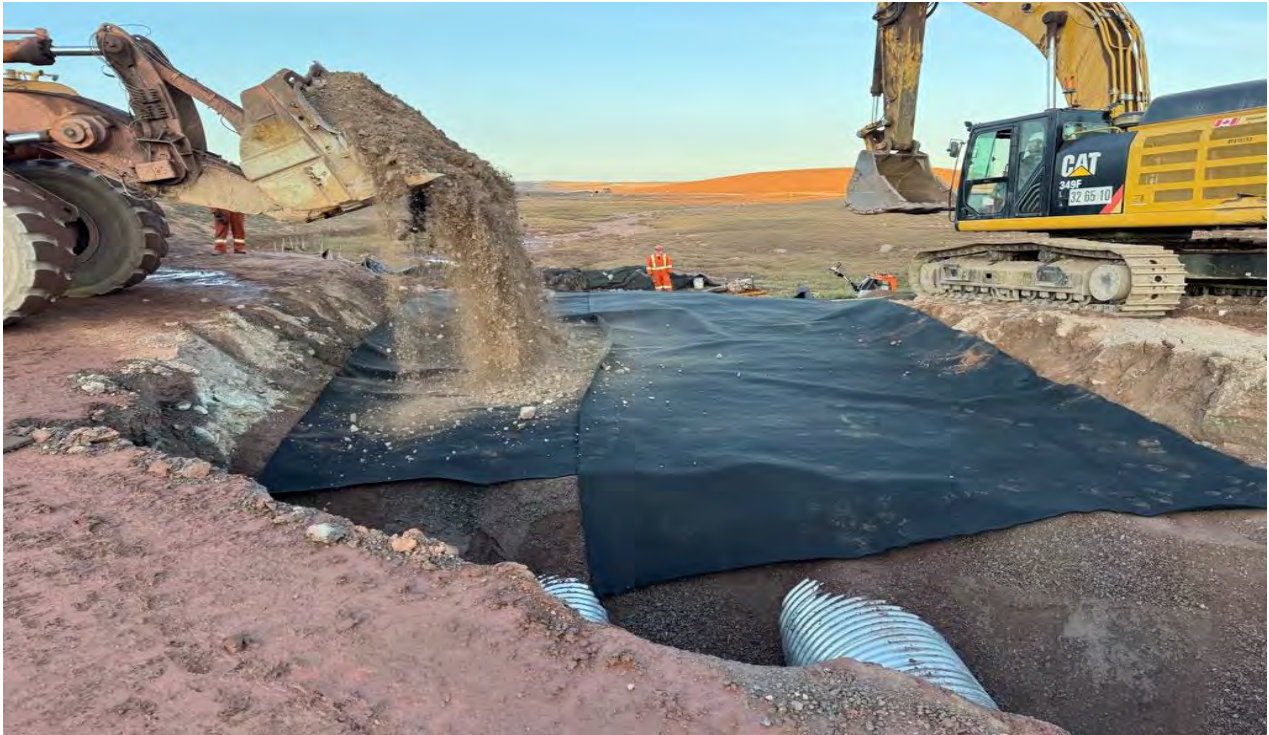
**Photo 11.** Placing road base aggregate over backfilled downstream culverts, 2025-06-24

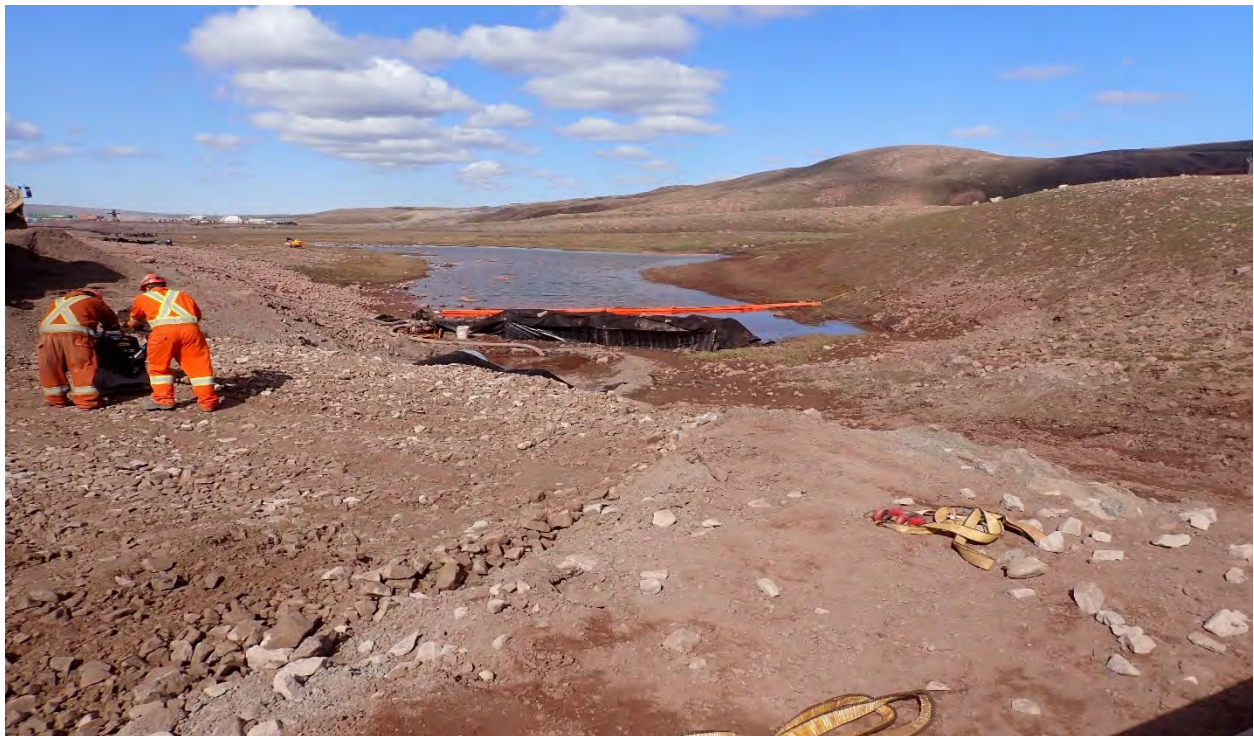
**Photo 12.** Downstream looking north, road base compaction, watercourse isolation and downstream silt curtain, 2025-06-24

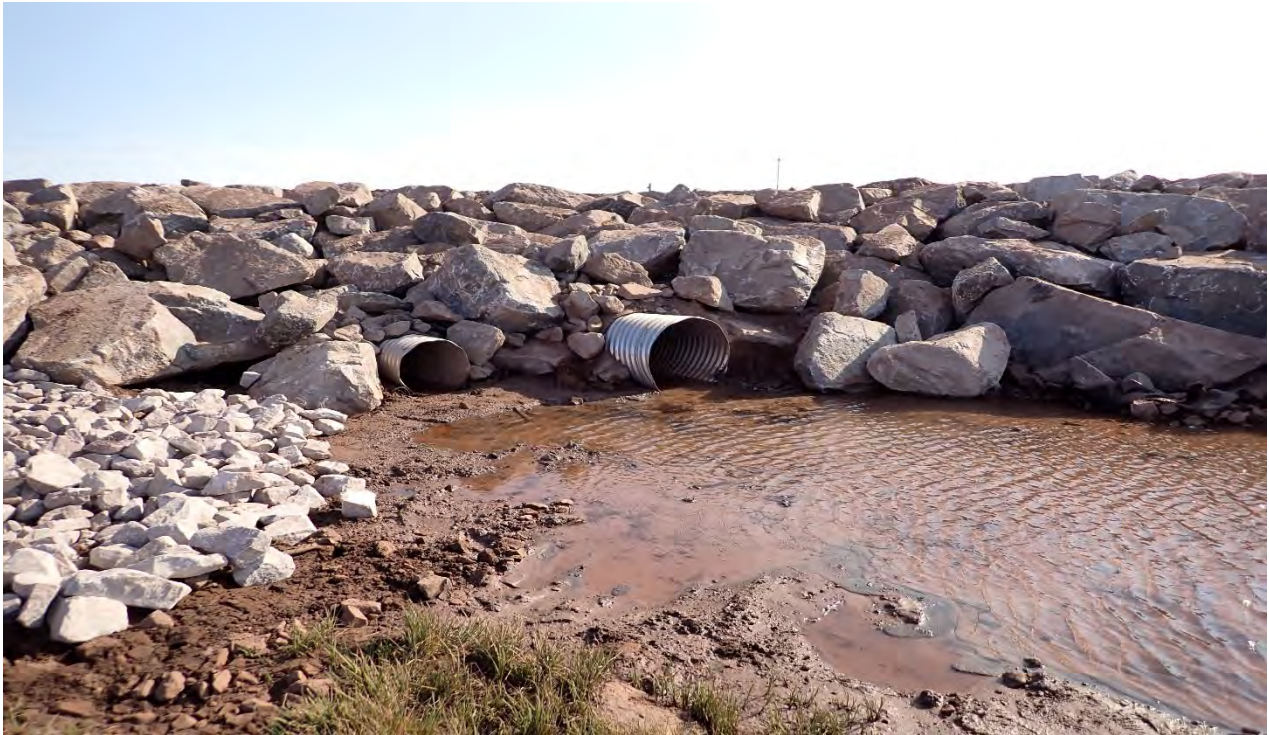
**Photo 11.** Downstream embankment armoured with over-sized rip rap, 2025-06-27

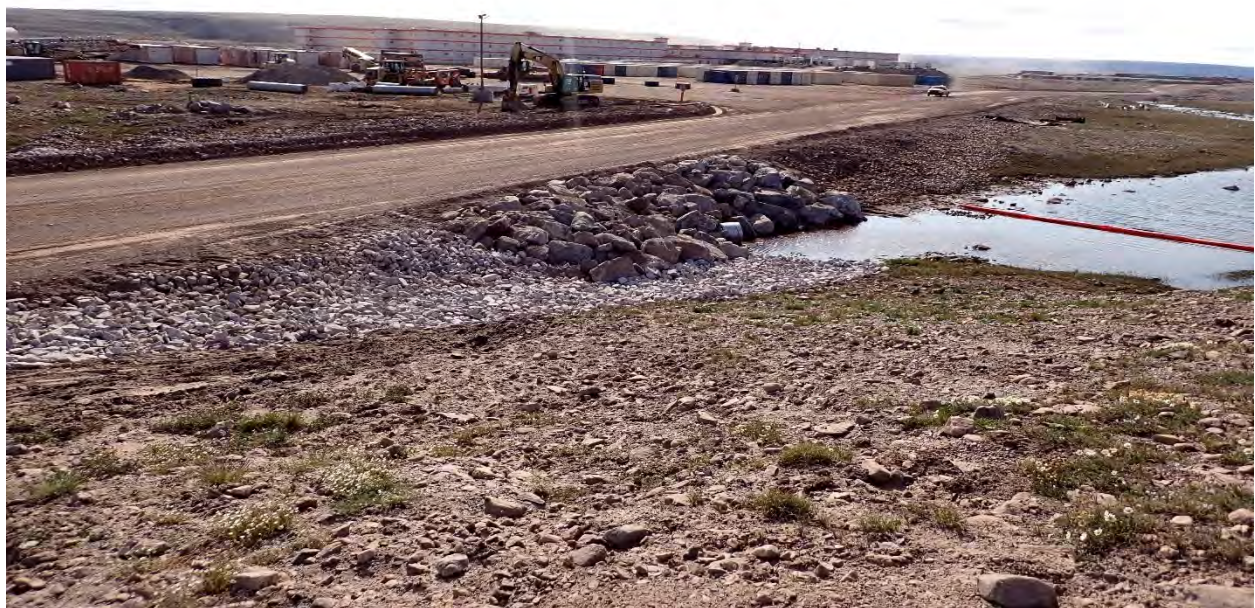
**Photo 12.** Downstream embankment armoured with over-sized rip rap, rock check dams reconstructed in roadside swale, 2025-06-28

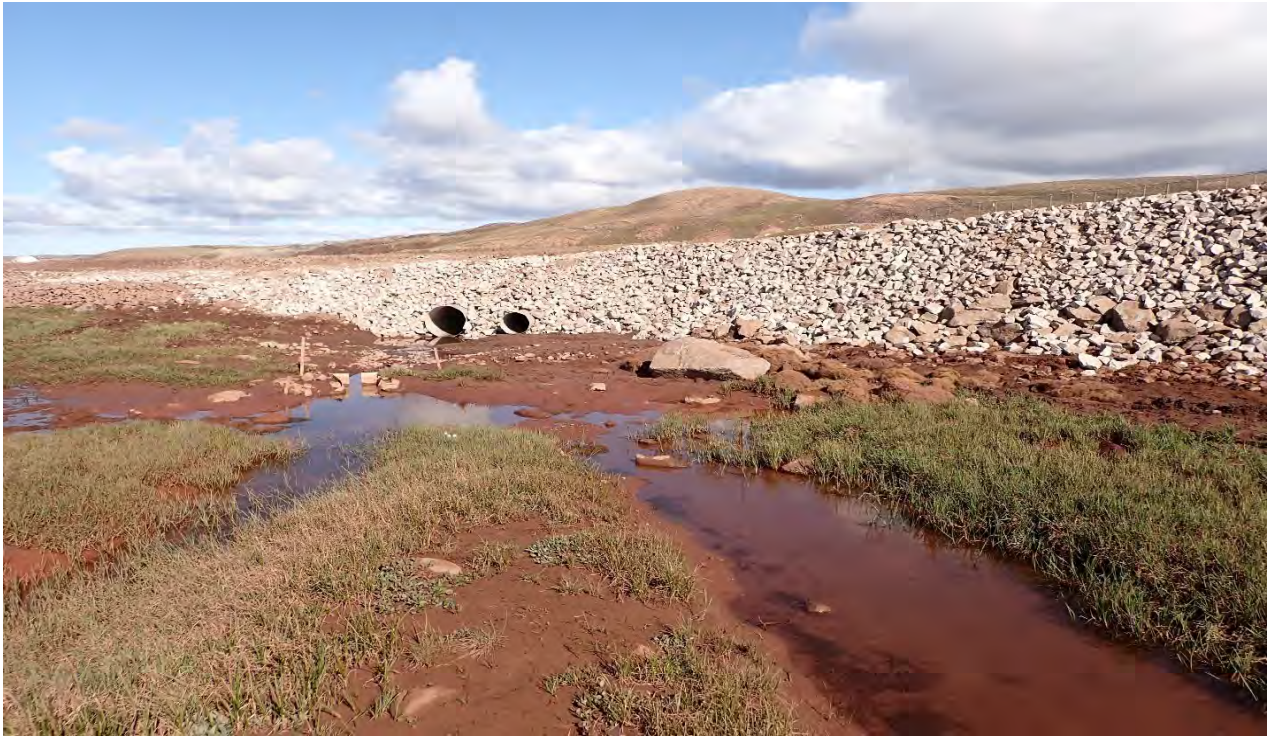
During completion of the upstream embankment armouring, a smaller sized aggregate, 12" minus, was used in error. The embankment armouring was replaced with over-sized stone on September 9, 2025.

**Photo 13.** Upstream embankment armoured with 12" minus rip rap, 2025-06-29

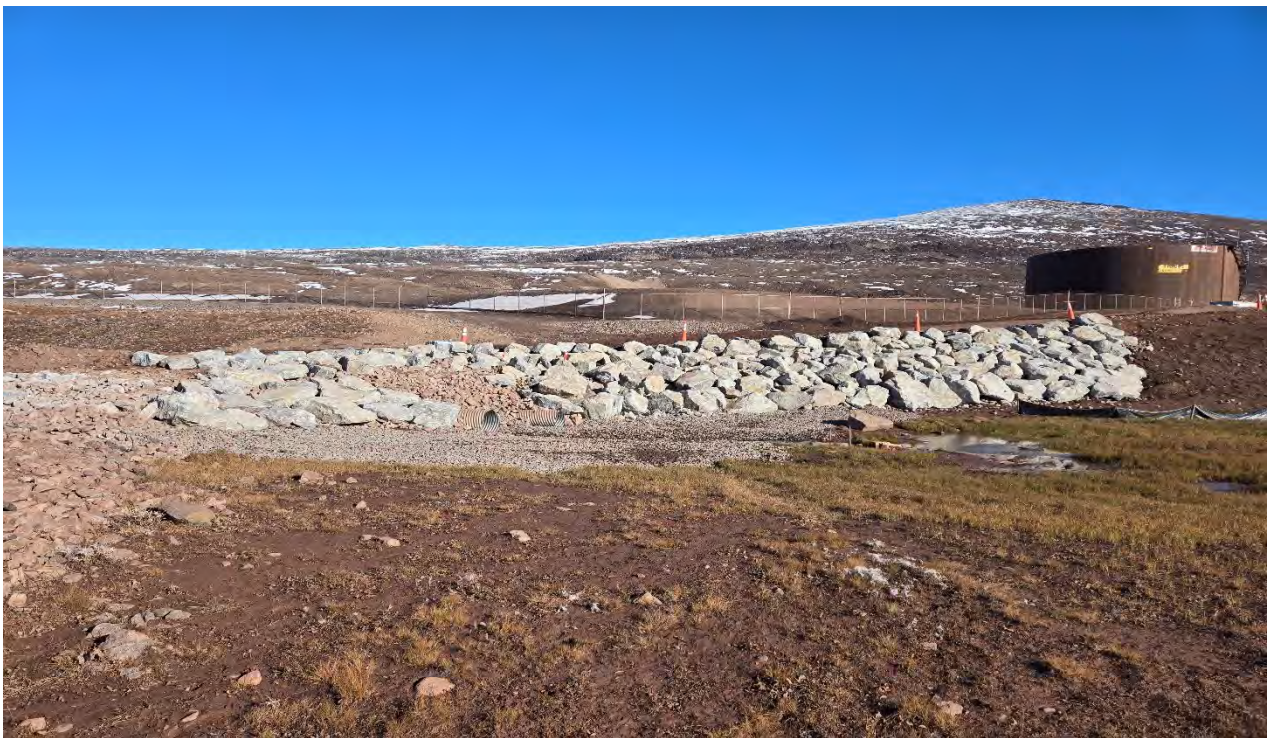
**Photo 14.** Upstream embankment re-armoured with over-sized rip rap, 2025-09-09
