APPENDIX D.1

Mine Site Photo Journal

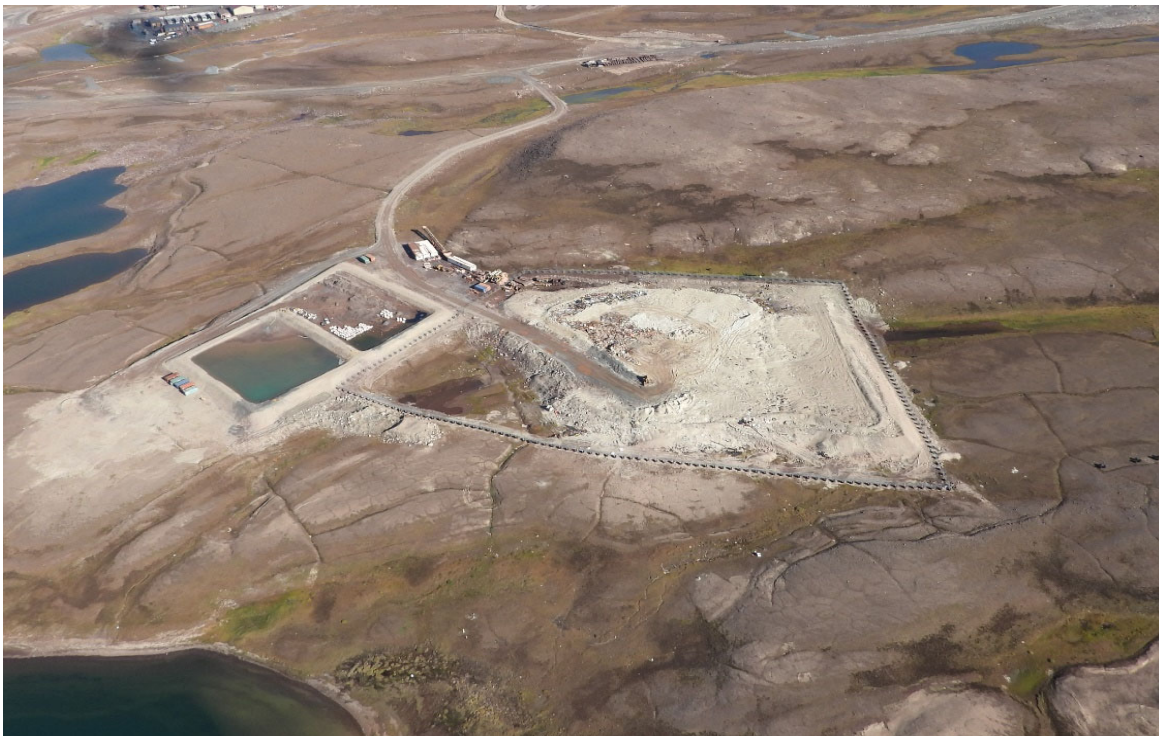
Photo 50. Non-Hazardous Waste Landfill and Landfarm Facility – August

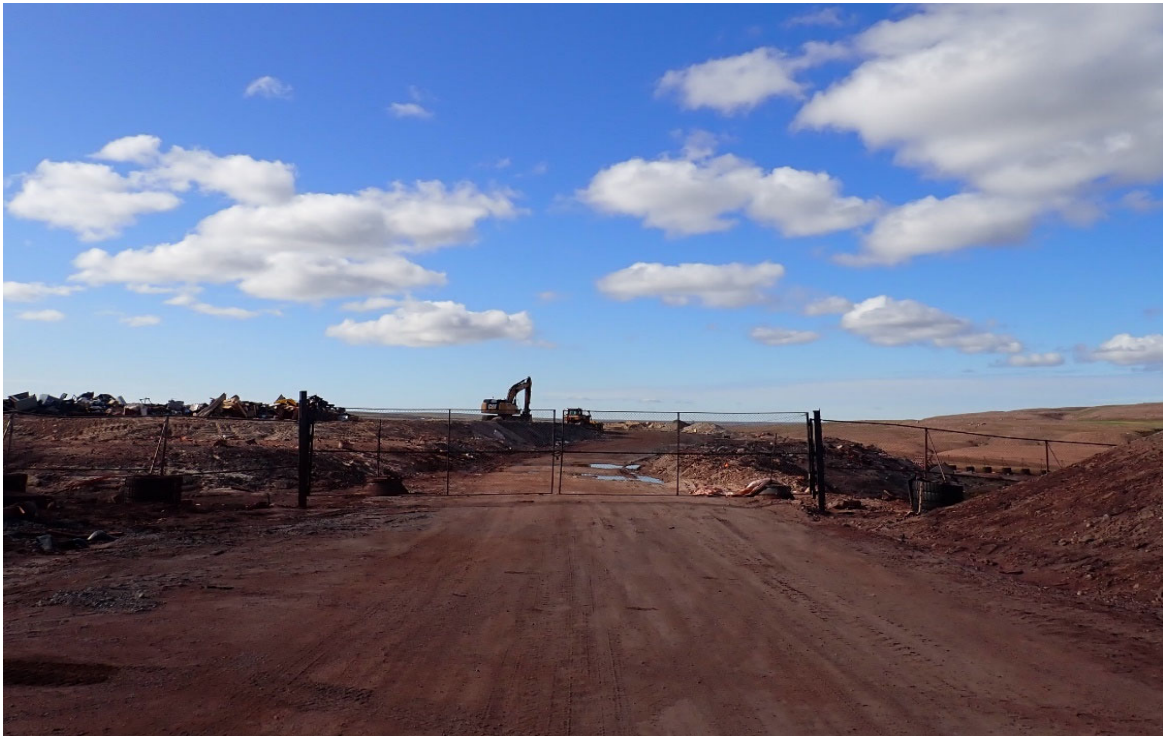
Photo 51. Non-Hazardous Waste Landfill Entrance – July

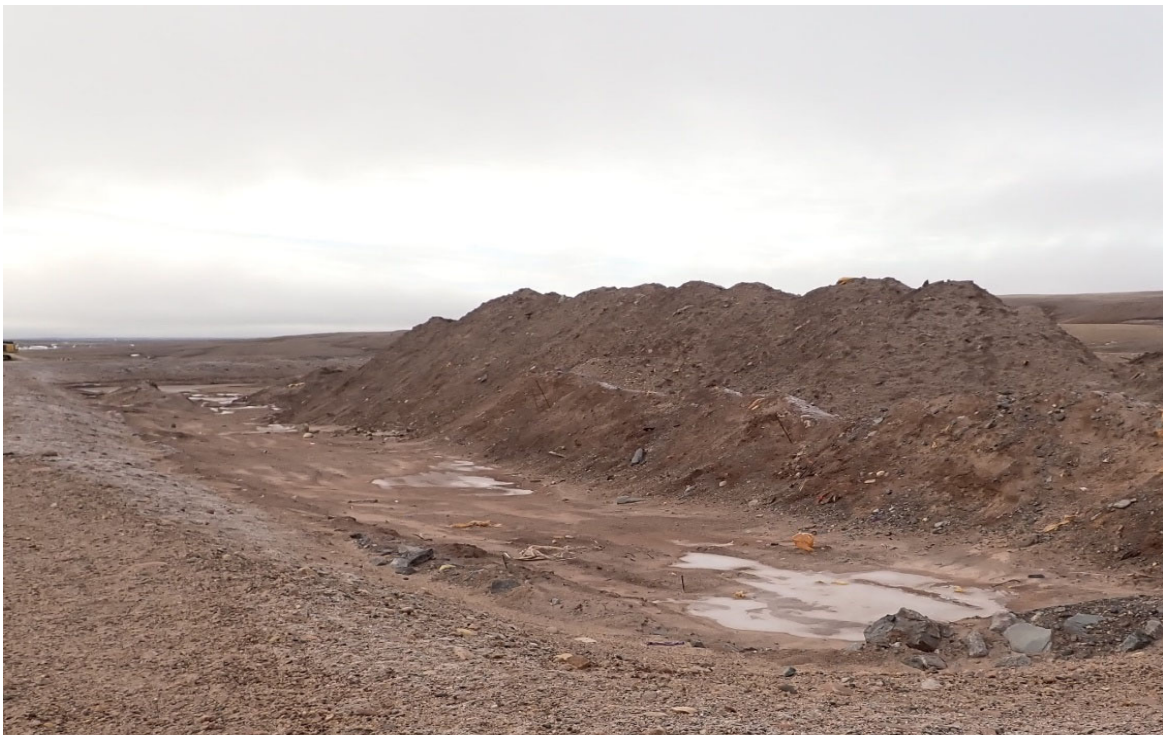
Photo 52. Soil Windrows in the Landfarm Facility Cell 1 - September

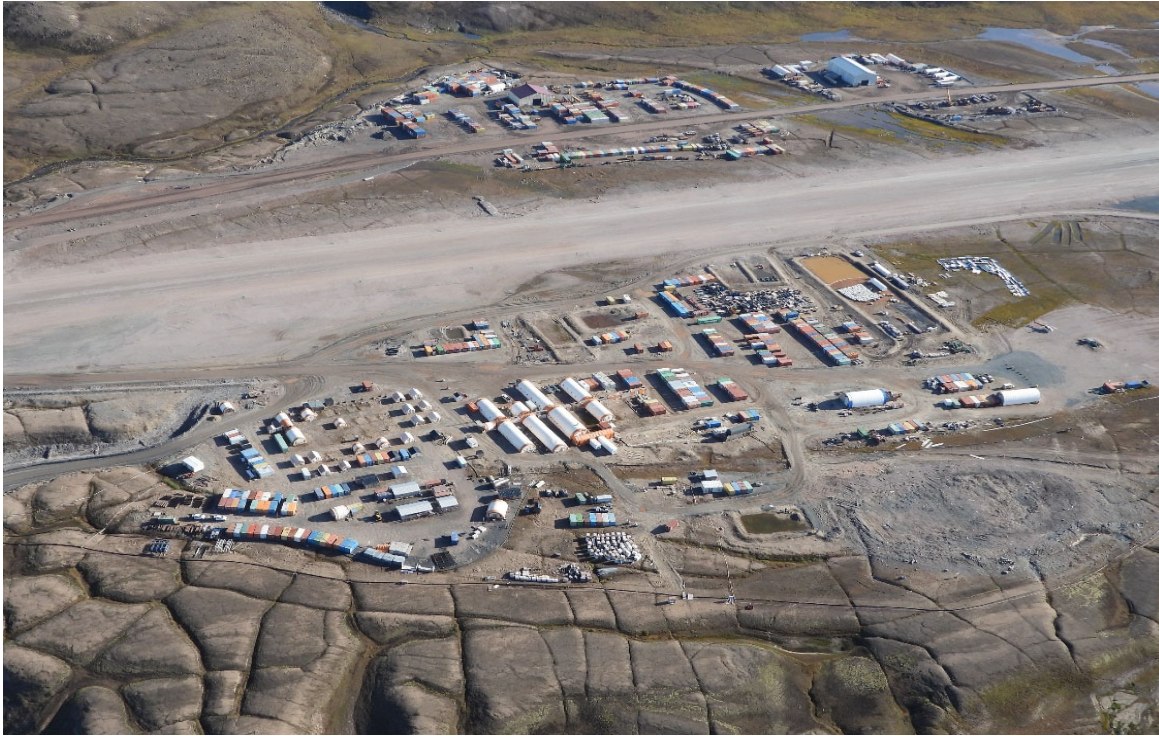
Photo 69. Weatherhaven Complex and Hazardous Waste Berms - August

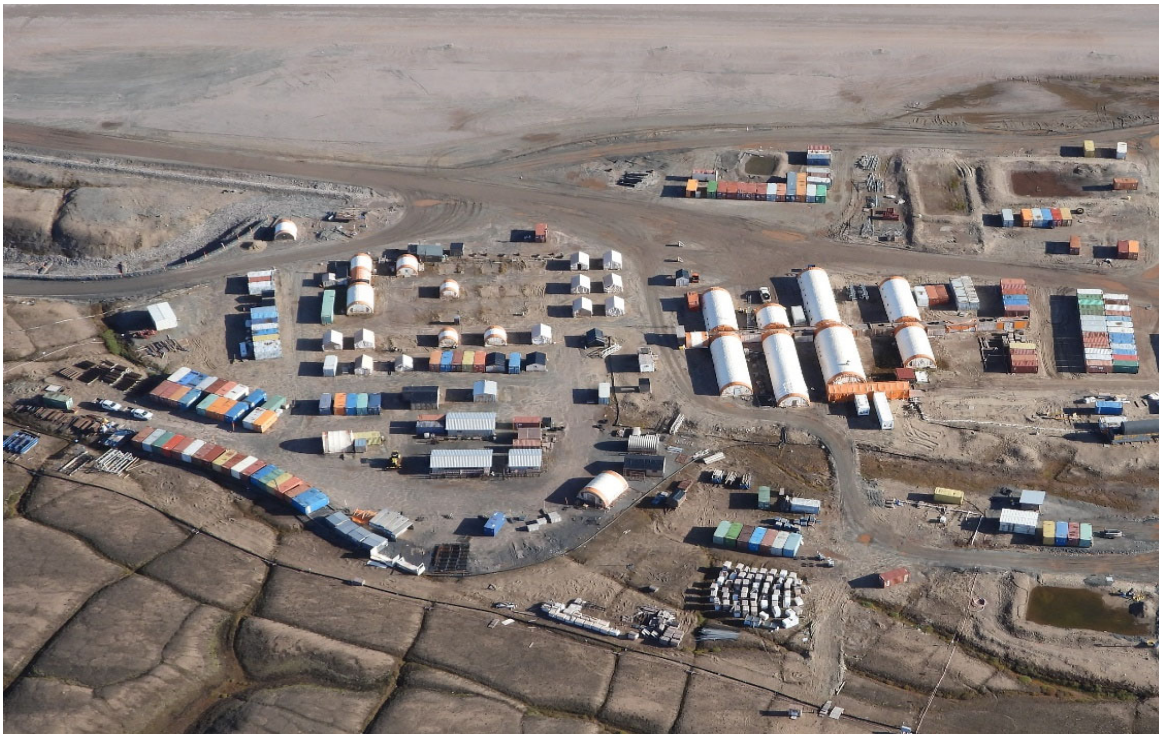
Photo 70. Weatherhaven Complex - August

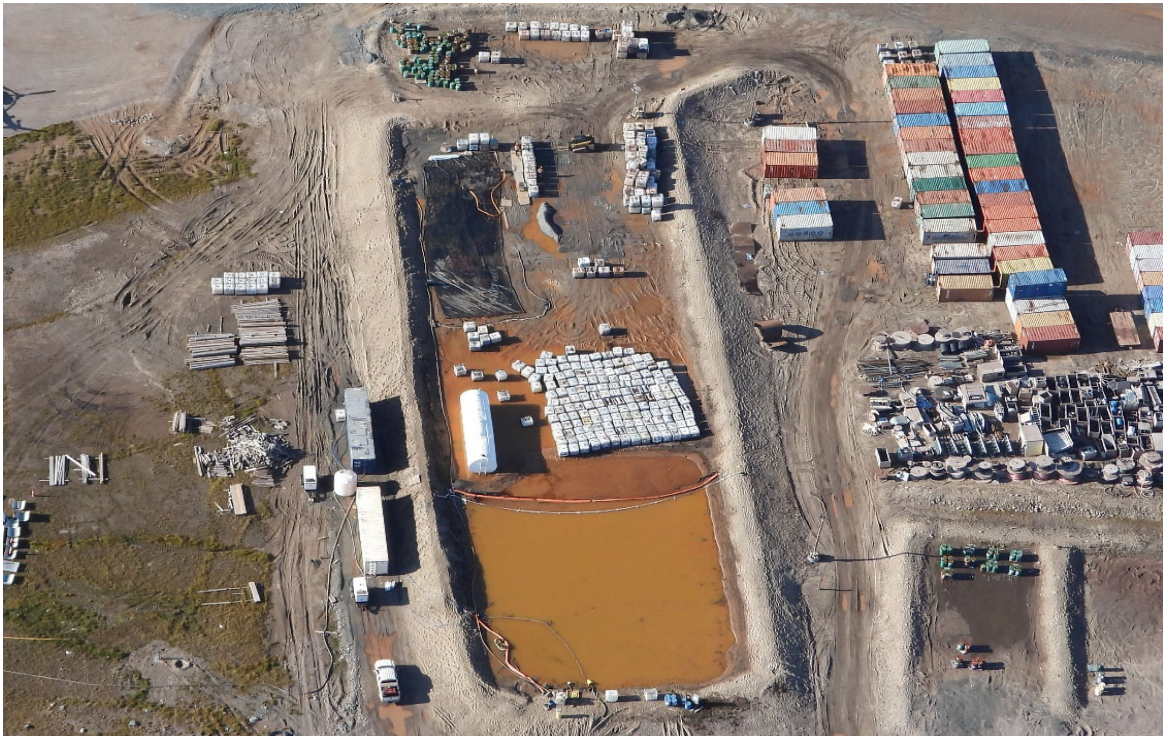
Photo 71. Oily Waste Water Treatment at Hazardous Waste Berm 7 – August

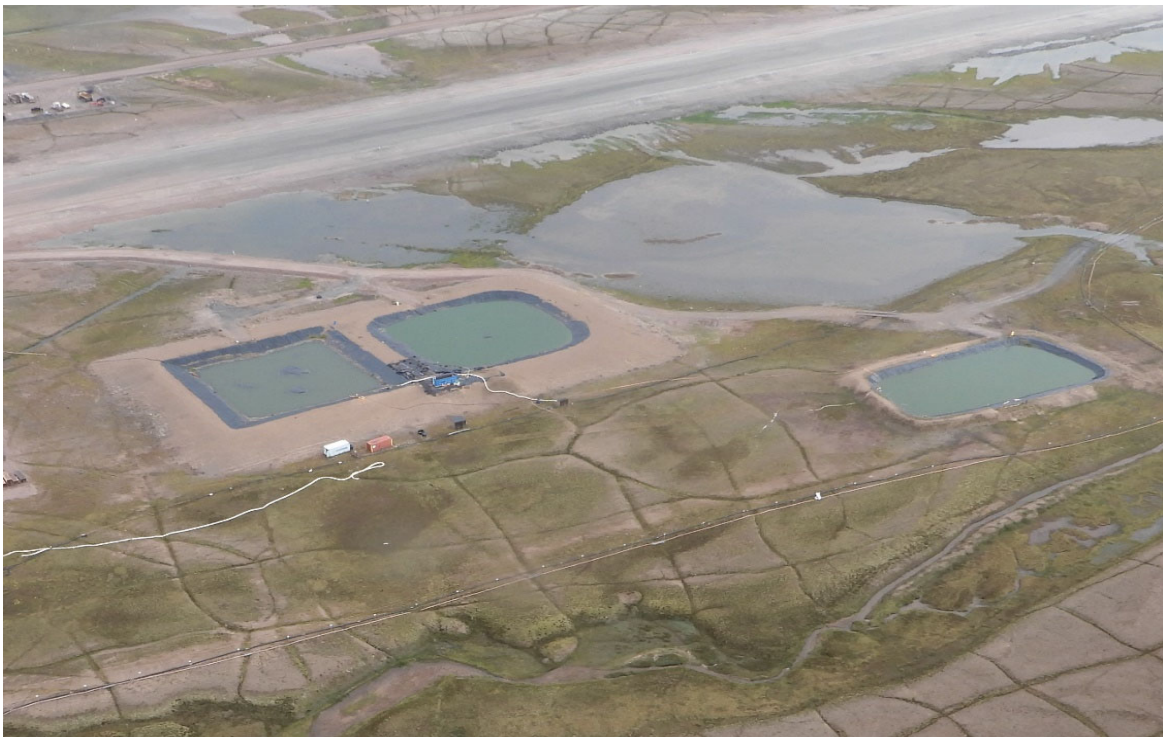
Photo 72. Polishing Waste Stabilization Ponds – July

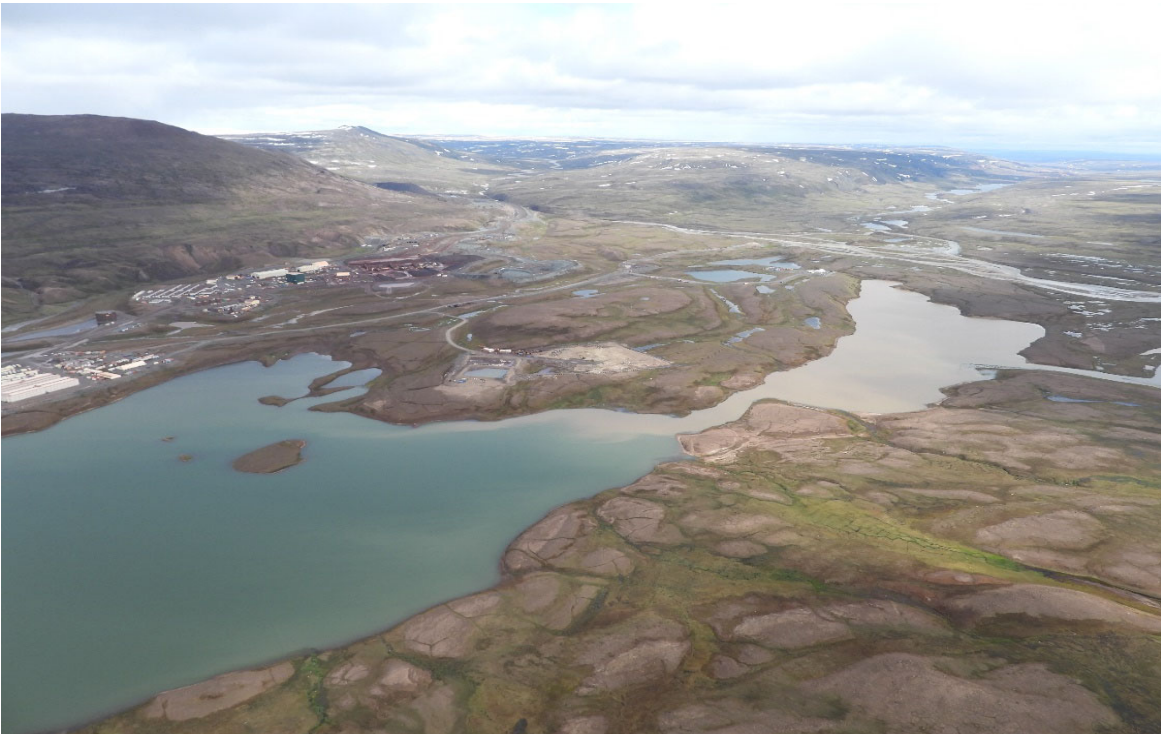
Photo 98. Natural Sedimentation Event in the Mary River and Sheardown Lake SE Basin – July
