**Baffinland Iron Mines Corporation
Mary River Project**

Construction Summary Report: Milne Port Stockpile Settling Ponds

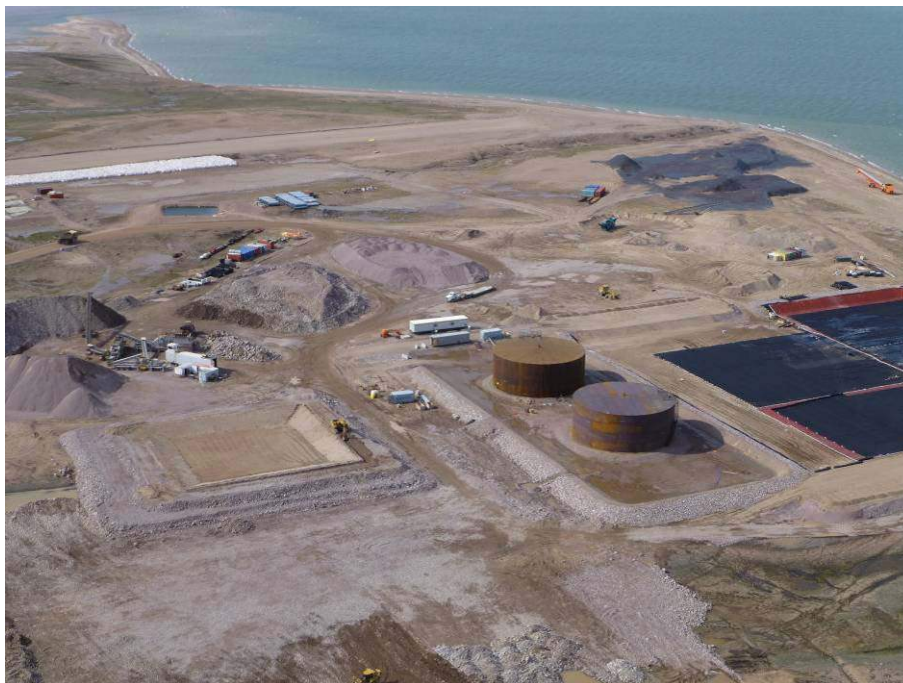
Figure 1: Pre-construction of the Milne Port Stockpile Settling Ponds (east and west of the bladder farm and airstrip shown in this photo) [northwest view].

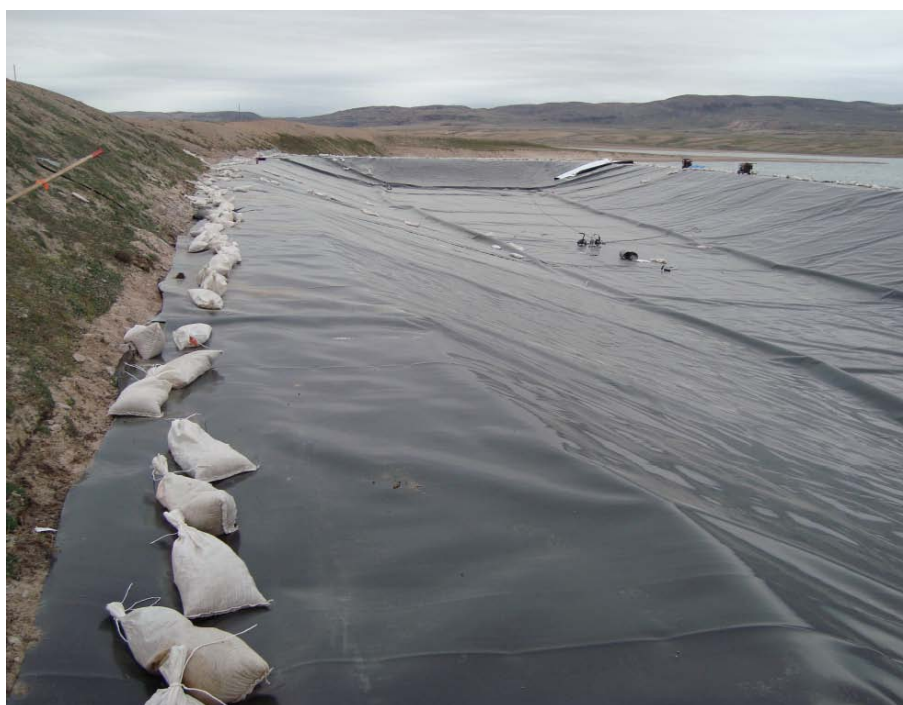
Figure 2: Pond No. 1 (west pond) placing the liner [southwest view].

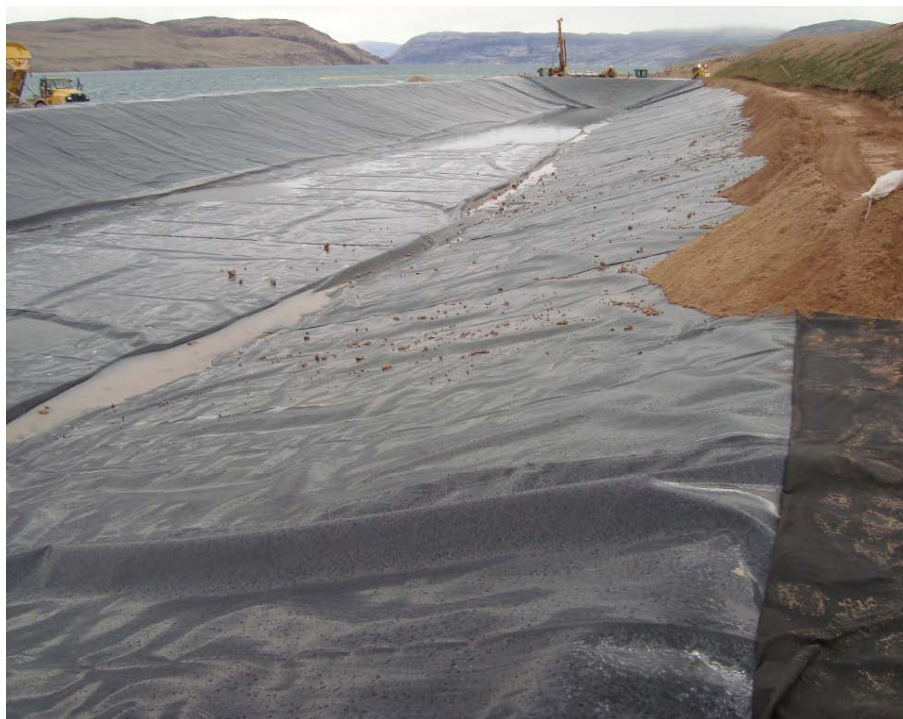
Figure 3: Pond No. 1 (west pond) liner installed [northeast view].

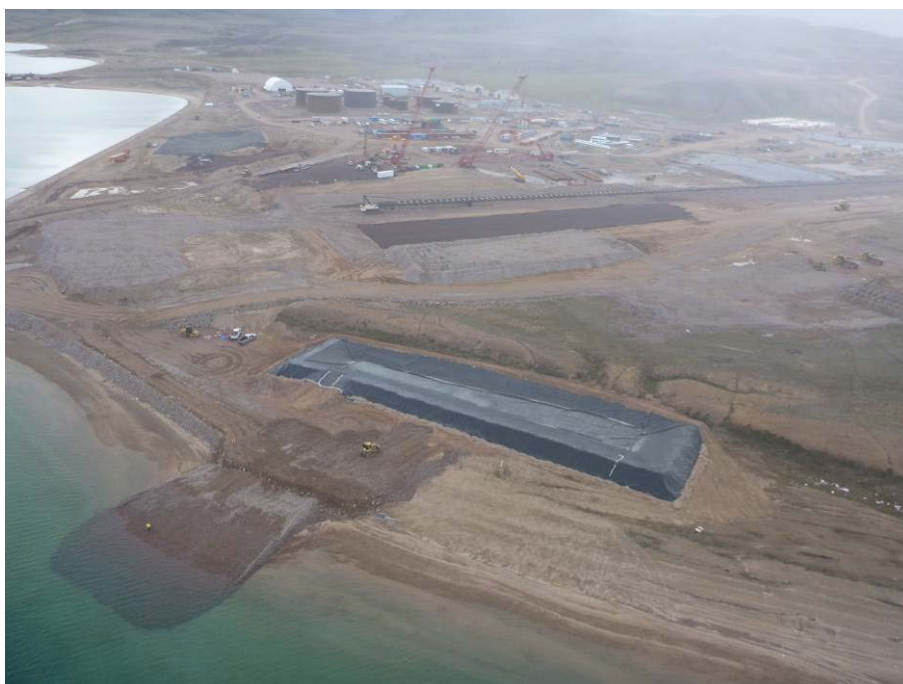
Figure 4: Aerial photo of in-progress Pond No. 1 (west pond) with liner in place [east view].

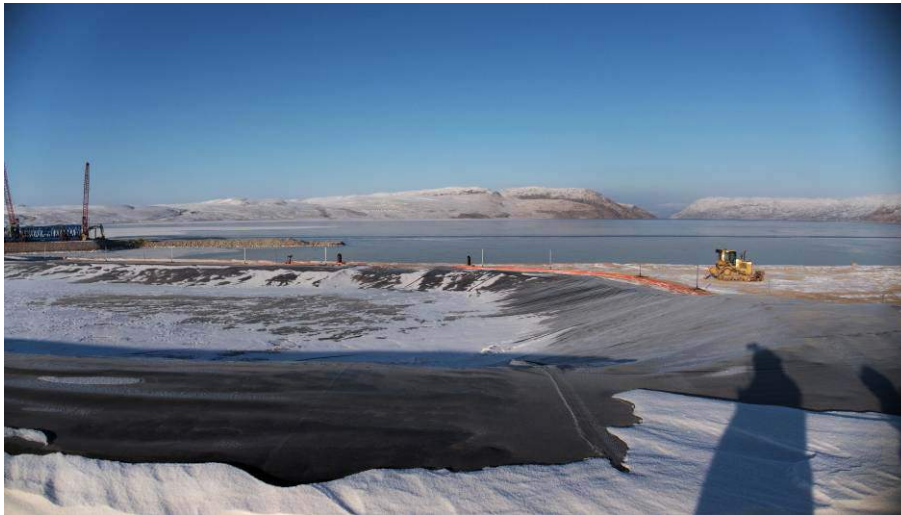
Figure 5: East side of completed Pond No. 1 (west) stockpile settling pond [north view].

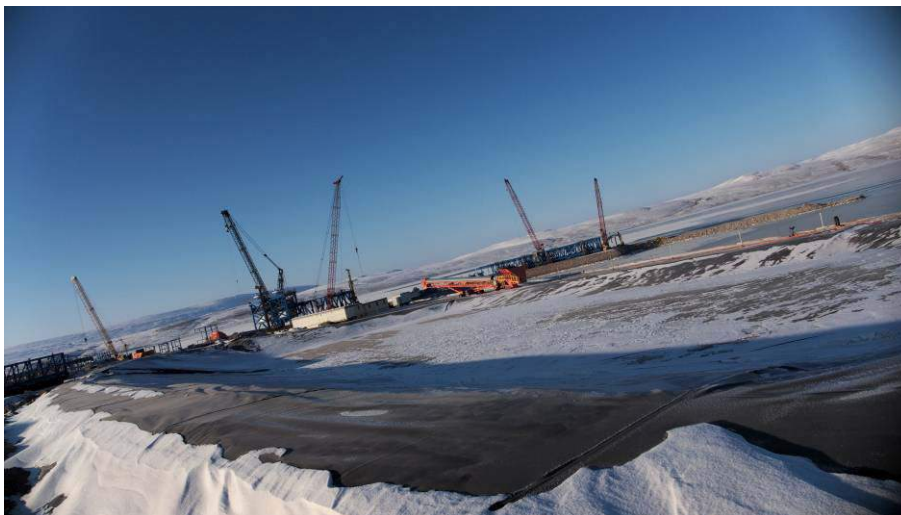
Figure 6: Length view of the completed Pond No. 1 (west) stockpile settling pond [southwest view].

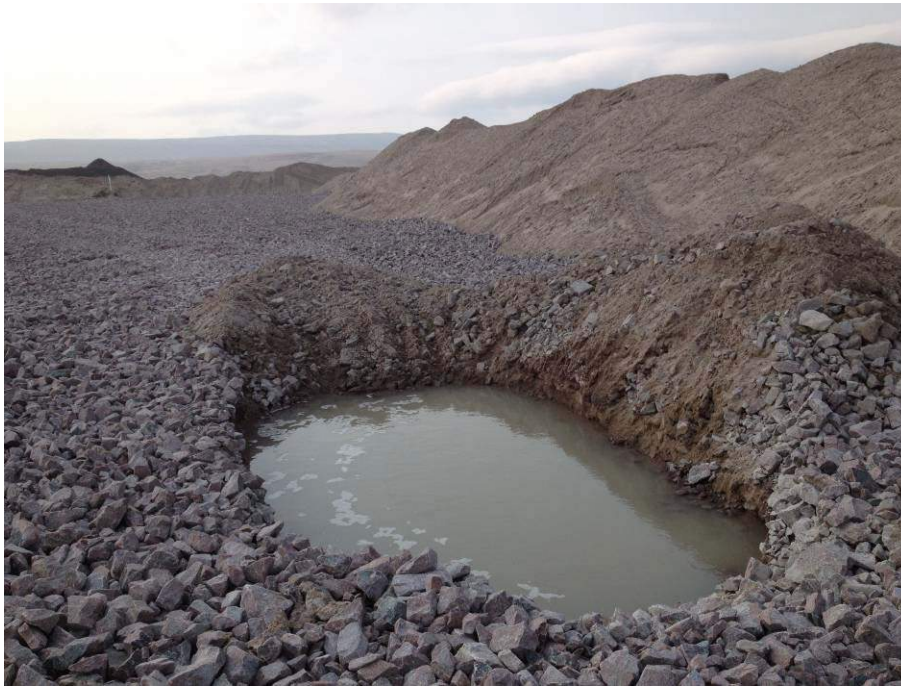
**Figure 7: Pond No. 2 (east) high moisture sub-grade soils encountered during excavation.
Discussed further in Section 5 Field Decisions, below.**

As discussed in Section 5 above, the Baffinland self-perform earthworks construction team reached the water table before achieving the design depth during the excavation of Pond No. 2 (the east stockpile settling pond). As a result the Pond No. 2 berm height was raised by approximately 300mm and the pond bottom elevation was raised by approximately 1400mm during construction to facilitate appropriate installation of the liner.

- a. During the excavation of Pond No. 2 (the east stockpile settling pond), the Baffinland self-perform earthworks construction team found sub-grade soils with high moisture content before reaching the design floor depth. HDPE liner materials cannot be appropriately installed on saturated sub-grade soils. As a result the Pond No. 2 berm height was raised by approximately 300mm and the pond bottom elevation was raised by approximately 1400mm during construction to facilitate appropriate installation of the liner. The raised floor results in more conservative (less steep) berm slopes than the design for Pond No. 2.

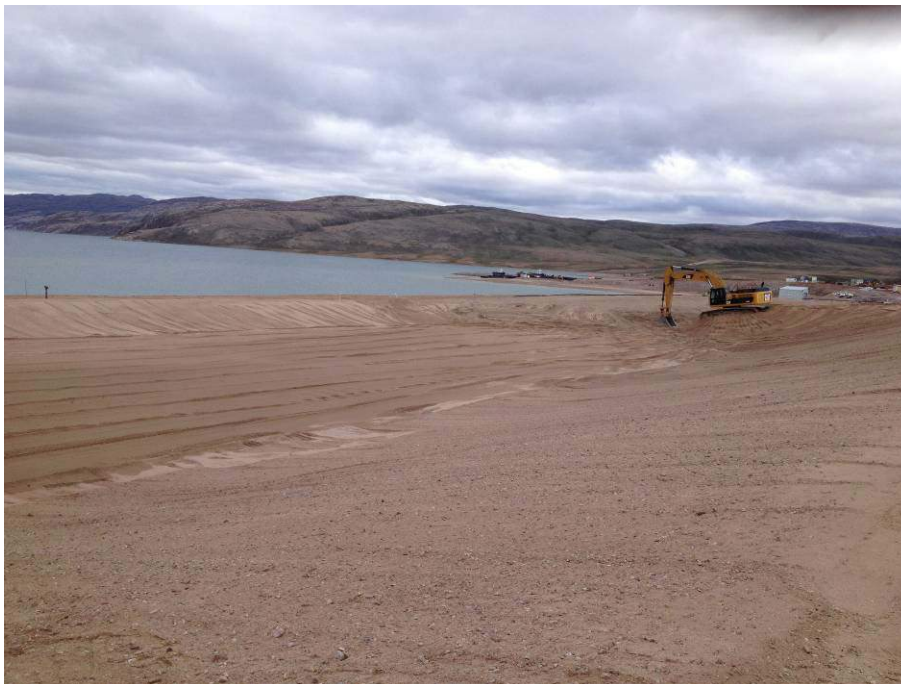
Figure 8: Pond No. 2 (east) earthworks in-progress [northeast view].

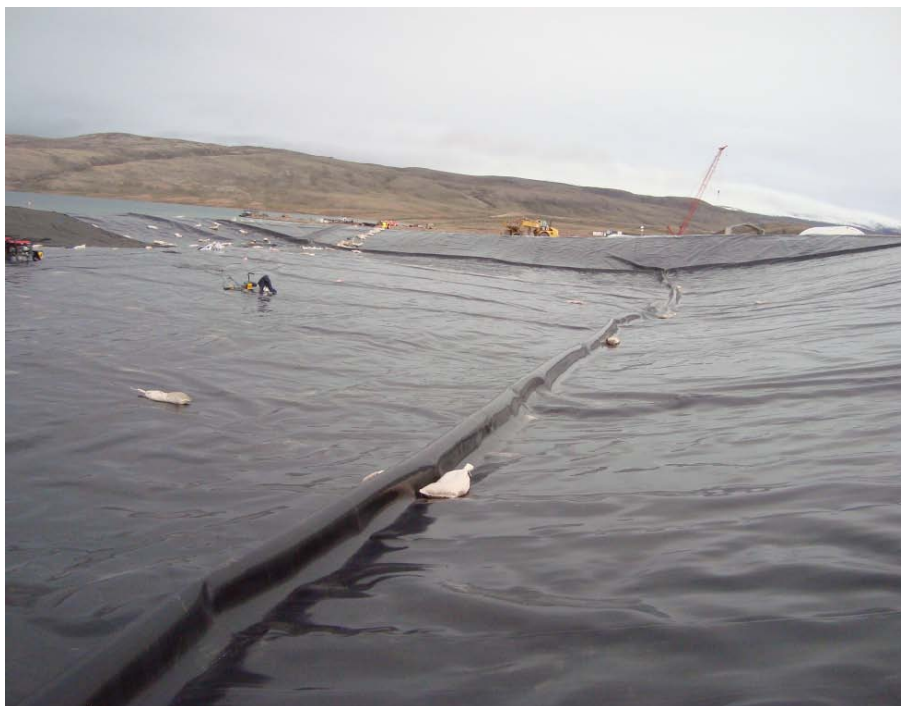
Figure 9: Pond No. 2 (east) placing the liner [southeast view].

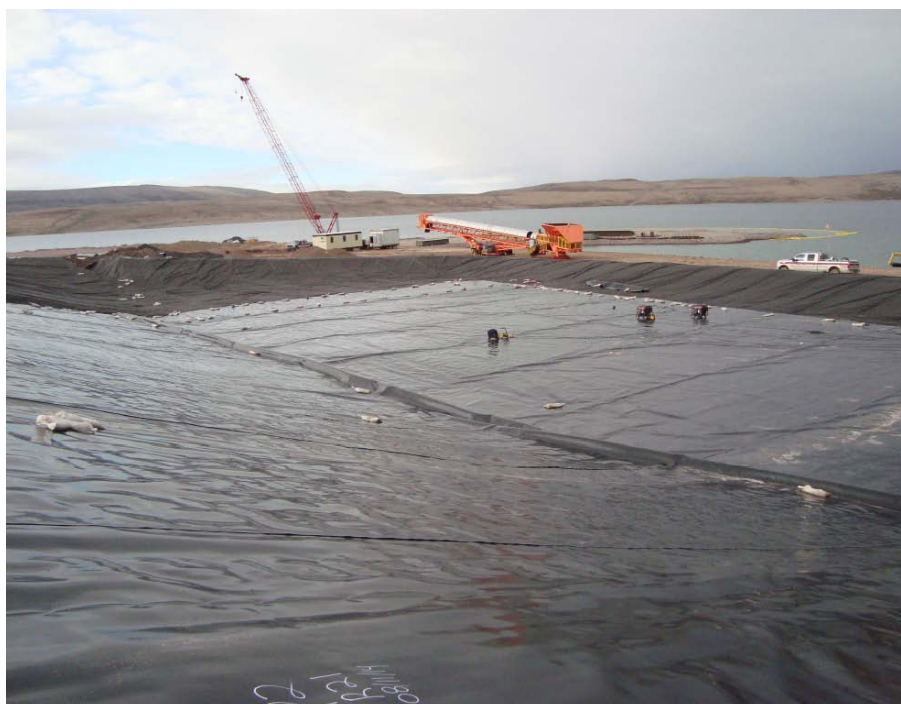
Figure 10: Pond No. 2 (east pond) liner installed [northwest view].

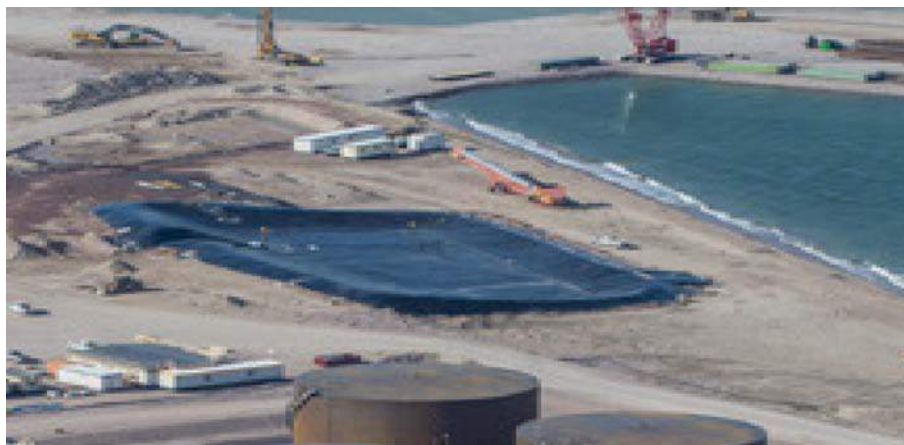
Figure 11: Aerial photo of in-progress Pond No. 2 (east pond) liner being sealed [north view].

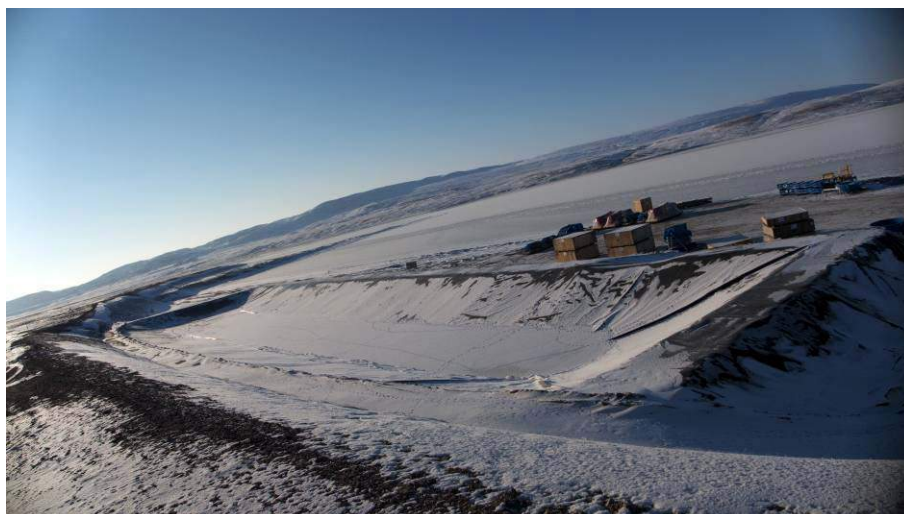
Figure 12: Length view of the completed Pond No. 2 (east) stockpile settling pond [northwest view].
