**Baffinland Iron Mines Corporation  
Mary River Project**

**Construction Summary Report: Mine Site Water System**

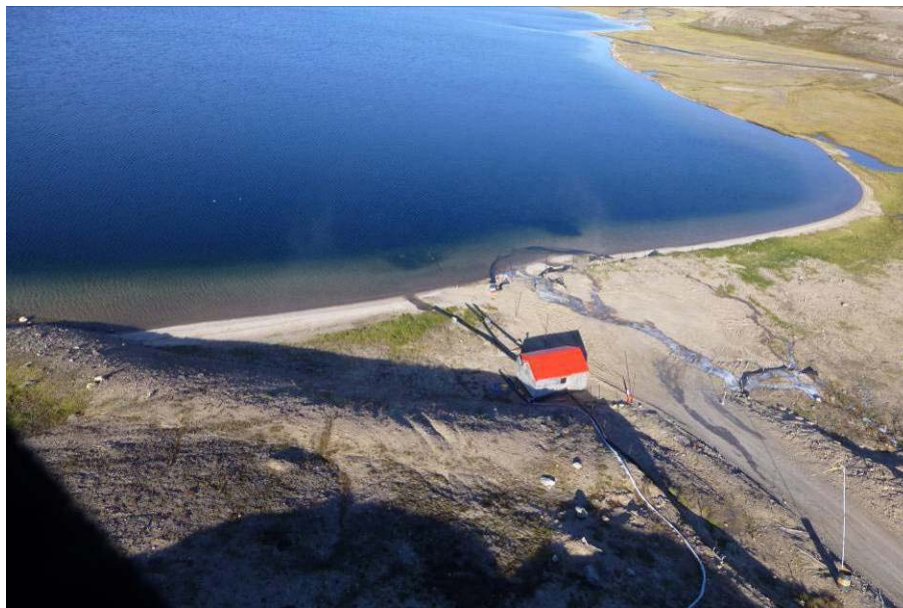
**Figure 1: Pre-construction location for the raw water jetty (existing pumphouse shown with red roof) [west view]**

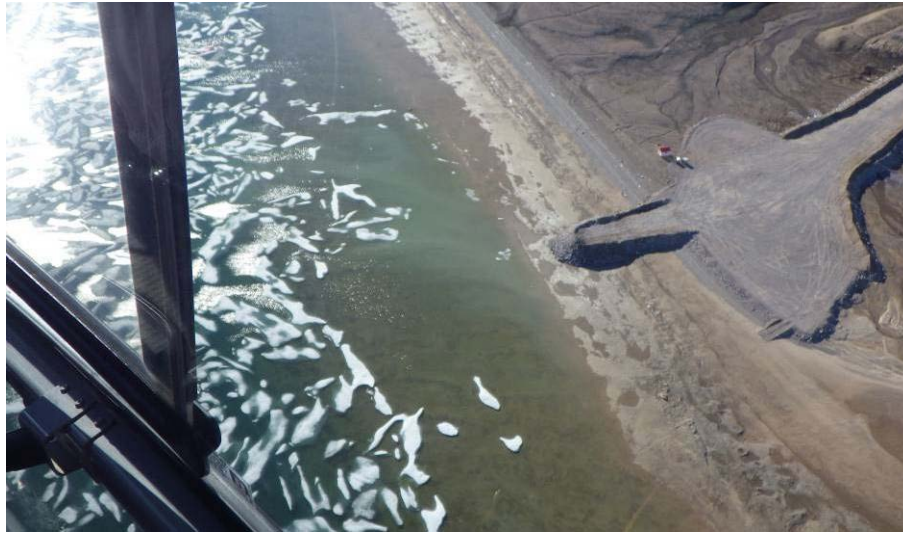
**Figure 2: Raw water jetty earthworks in-progress [northeast view]**

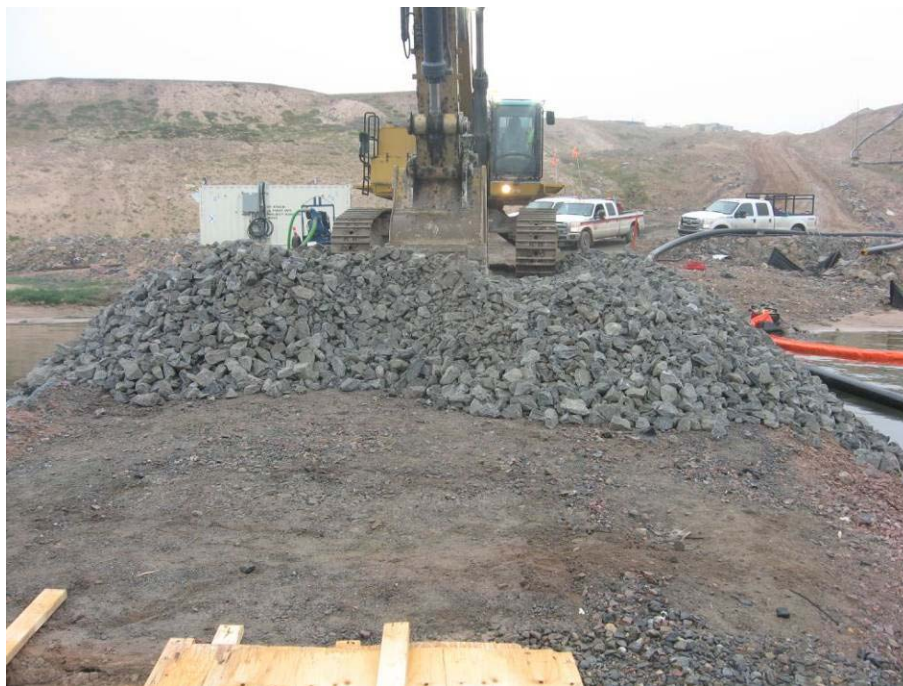
**Figure 3: Installing armour stone at raw water jetty [east view]**

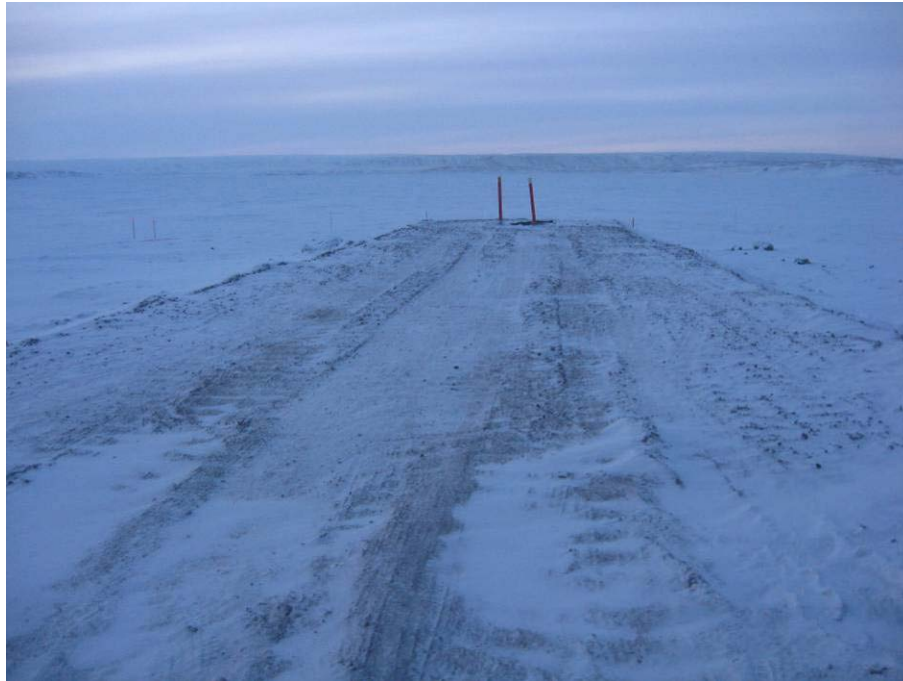
**Figure 4: Raw water jetty earthworks complete [west view]**

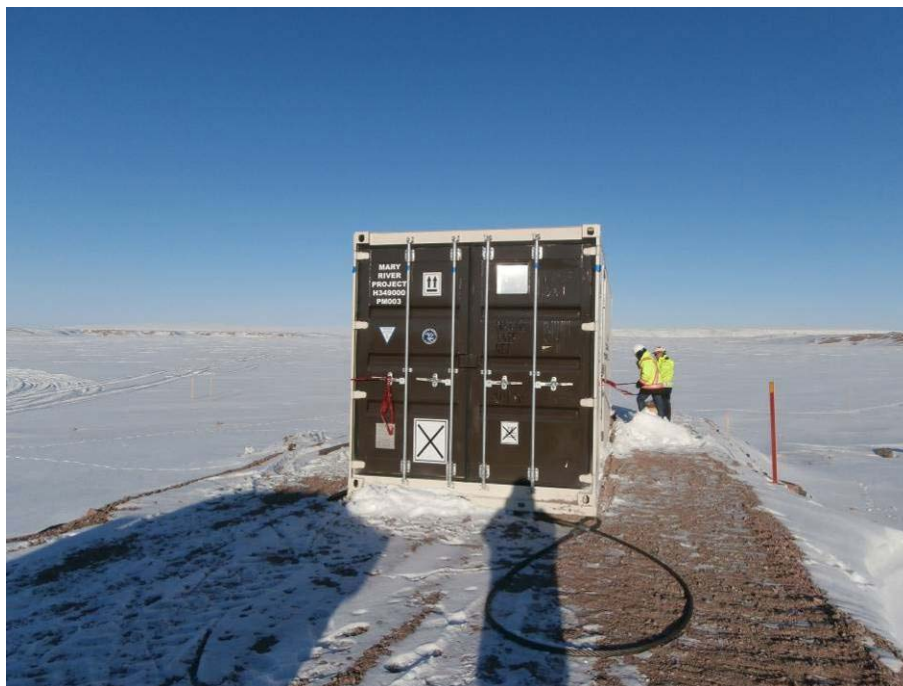
**Figure 5: Installation of the raw water pumphouse [west view]**

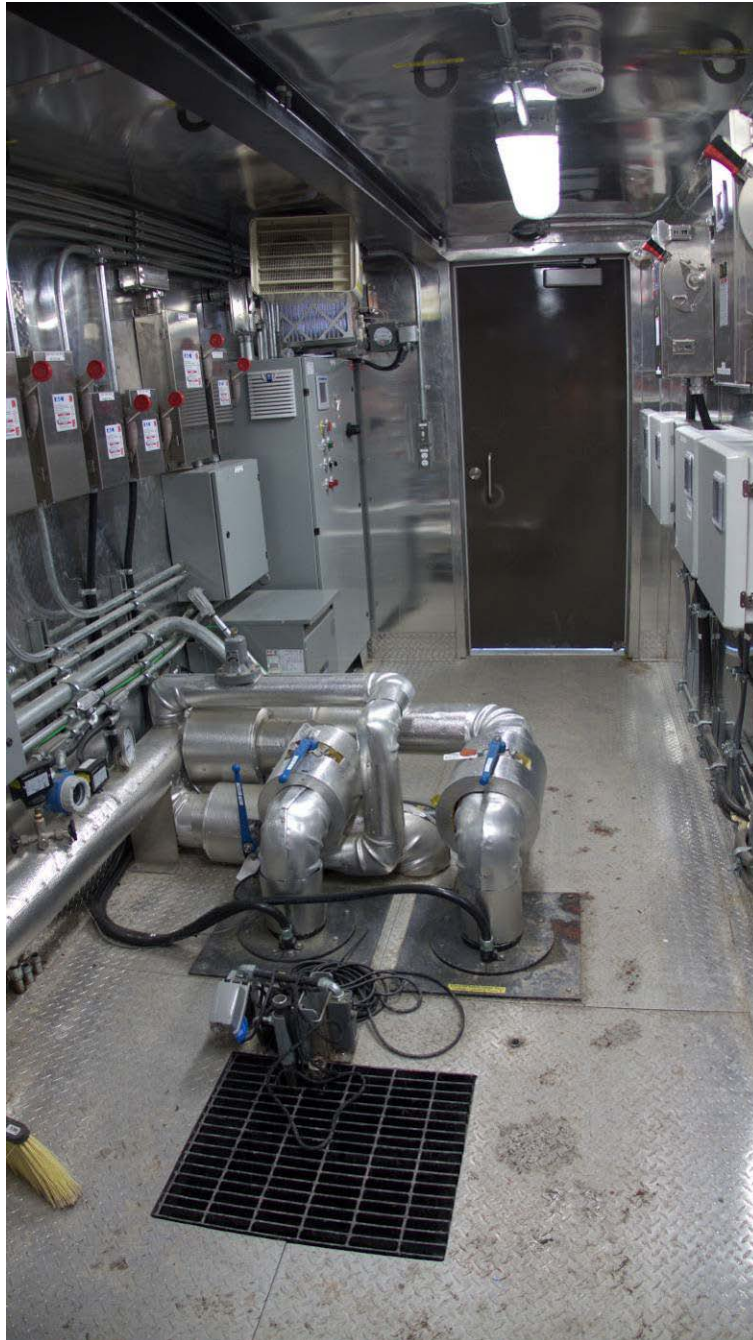
**Figure 6: Inside the completed raw water pumphouse [west view]**

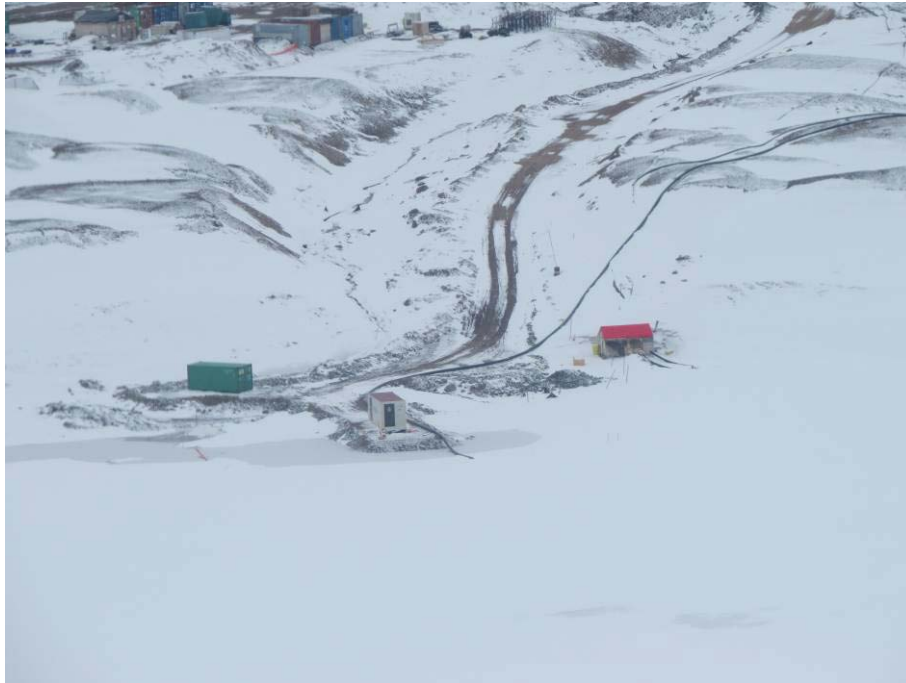
Figure 7: Completed raw water jetty and pumphouse [east view]

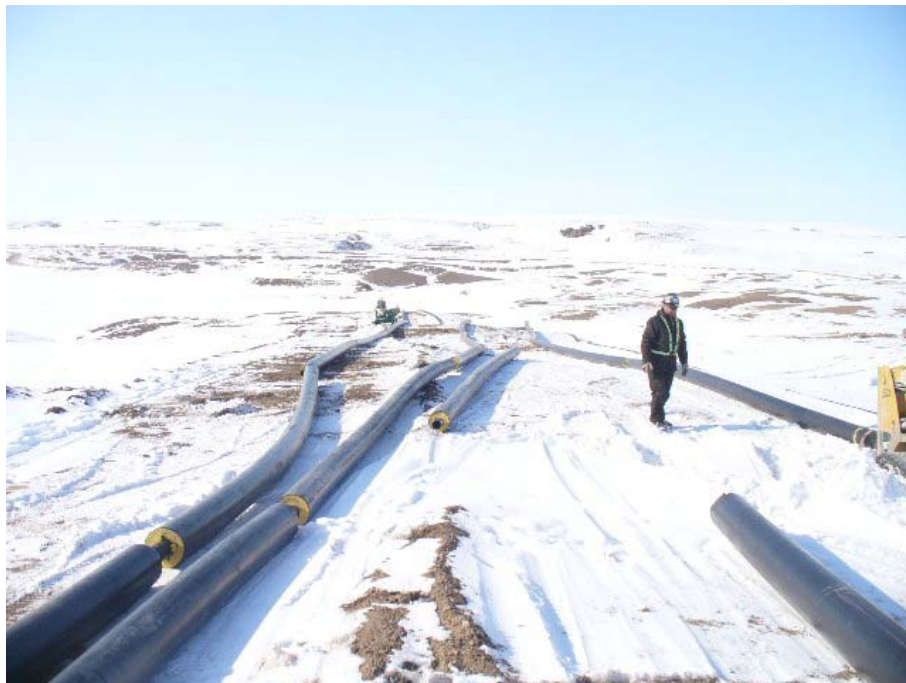
Figure 8: Laying out the piping lengths

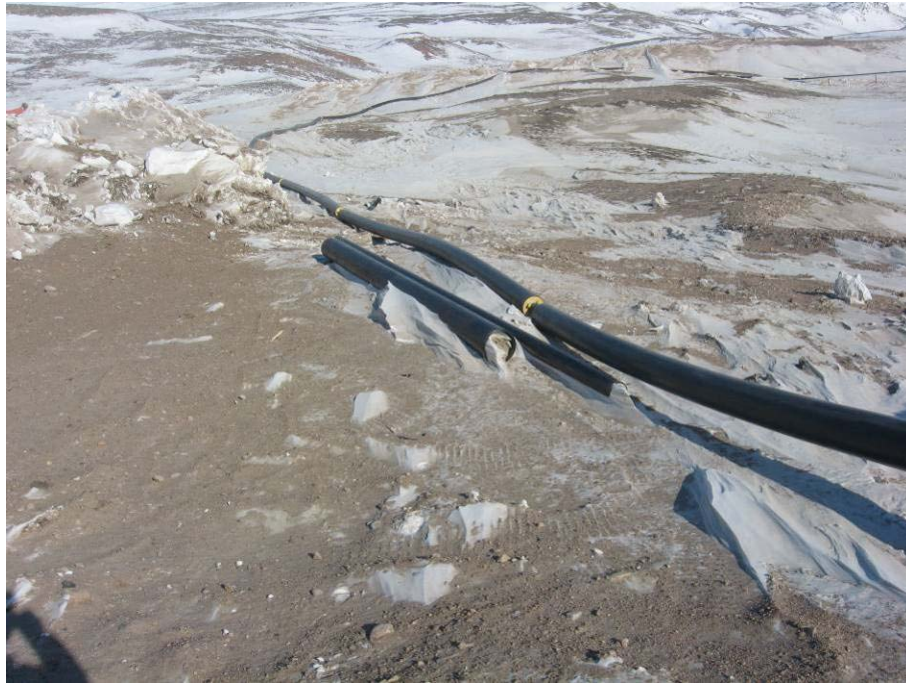
**Figure 9: Raw water line "snaking" across the tundra**

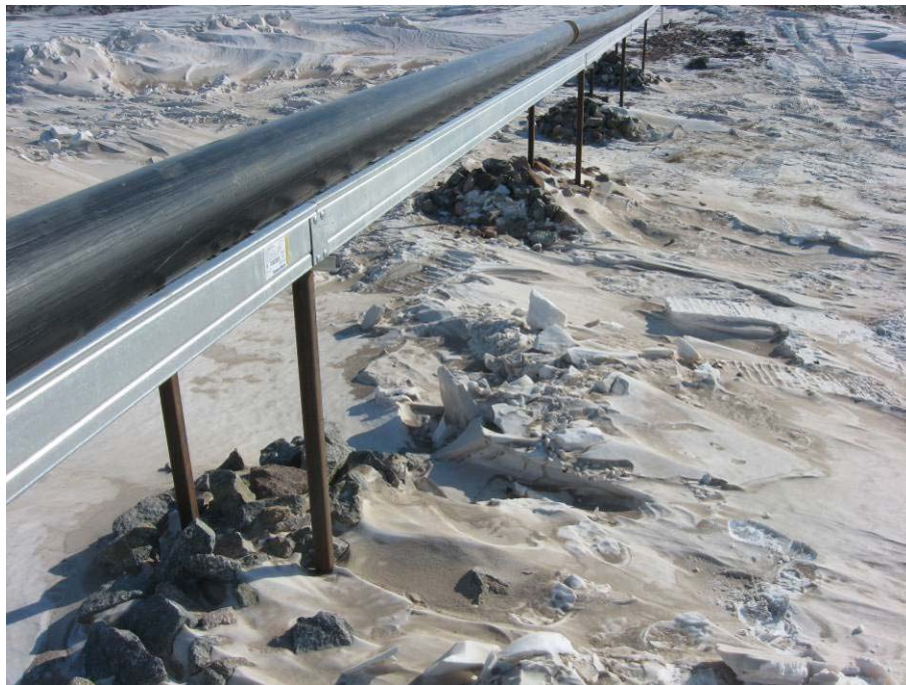
**Figure 10: Raw water line raised to cross a low point**

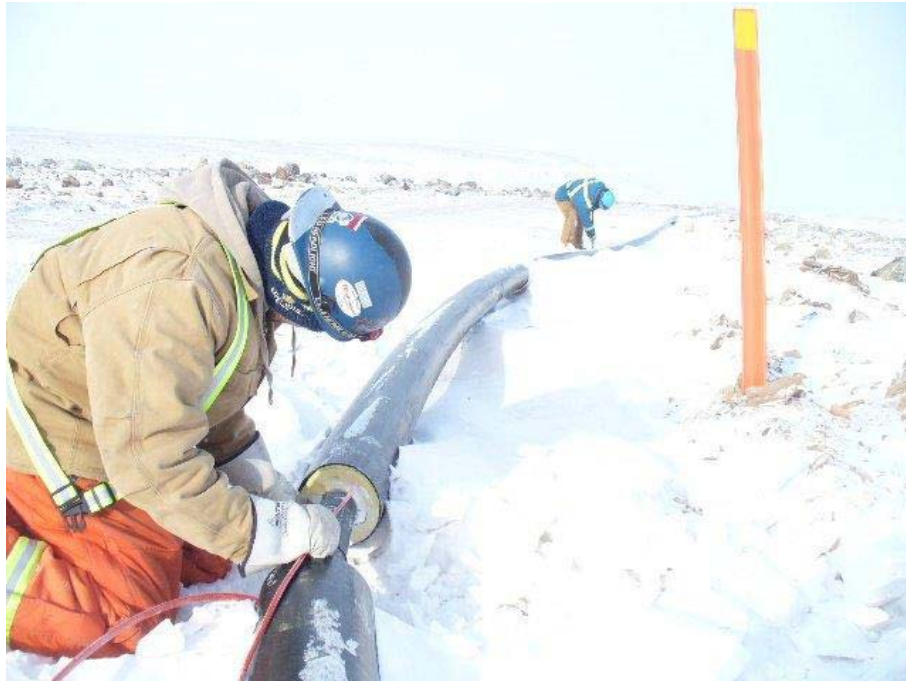
**Figure 11: Feeding the heat trace cable through sleeve in the insulation**

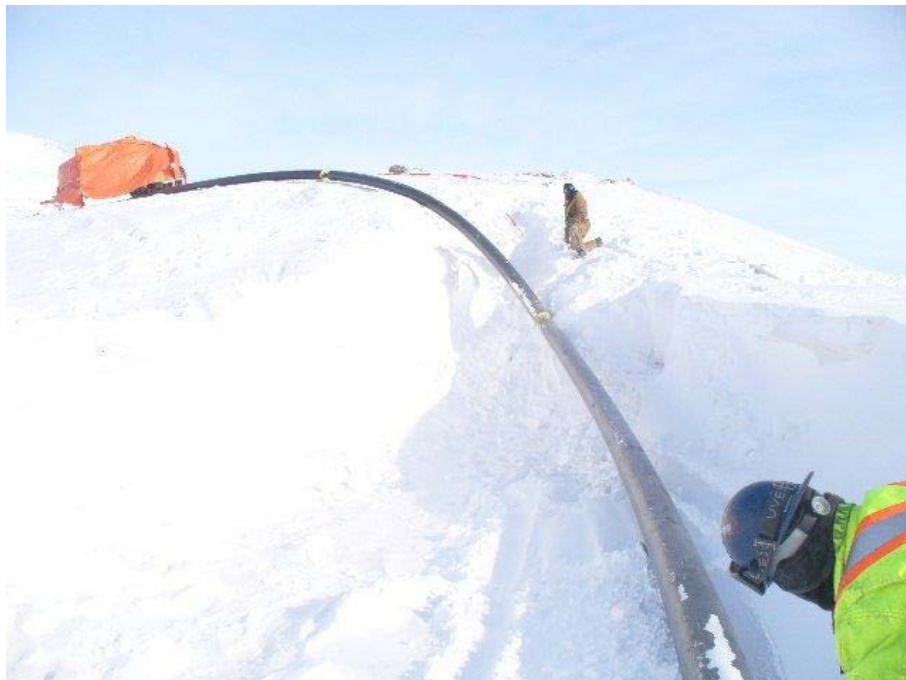
**Figure 12: Laying out the piping route (tent shelter for pipe fusing activities in back left)**

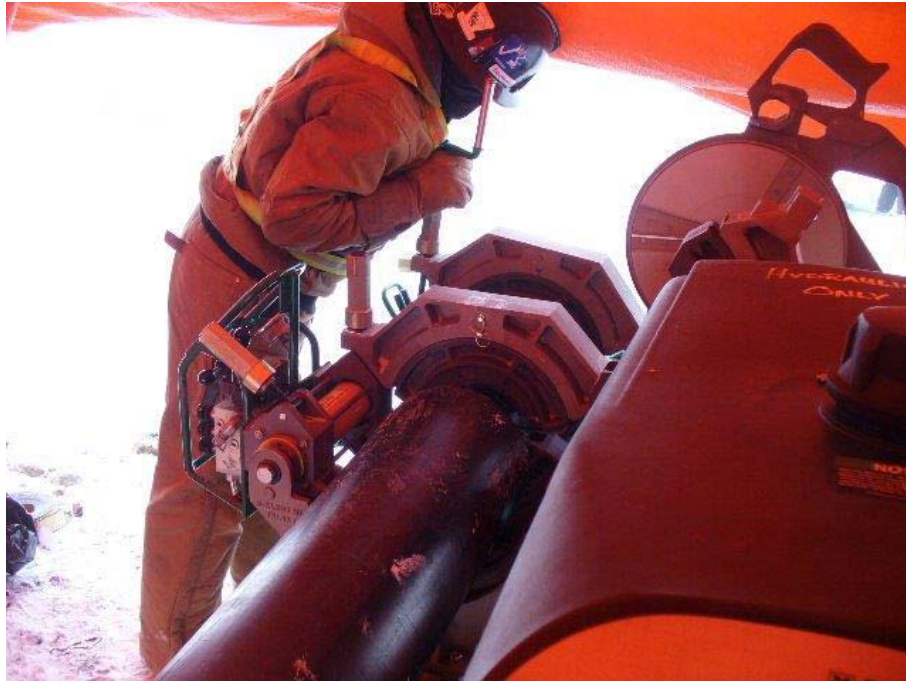
**Figure 13: Pipe fusing inside the tent shelter (activity enclosed in protective tenting to retain heat required for fusing)**

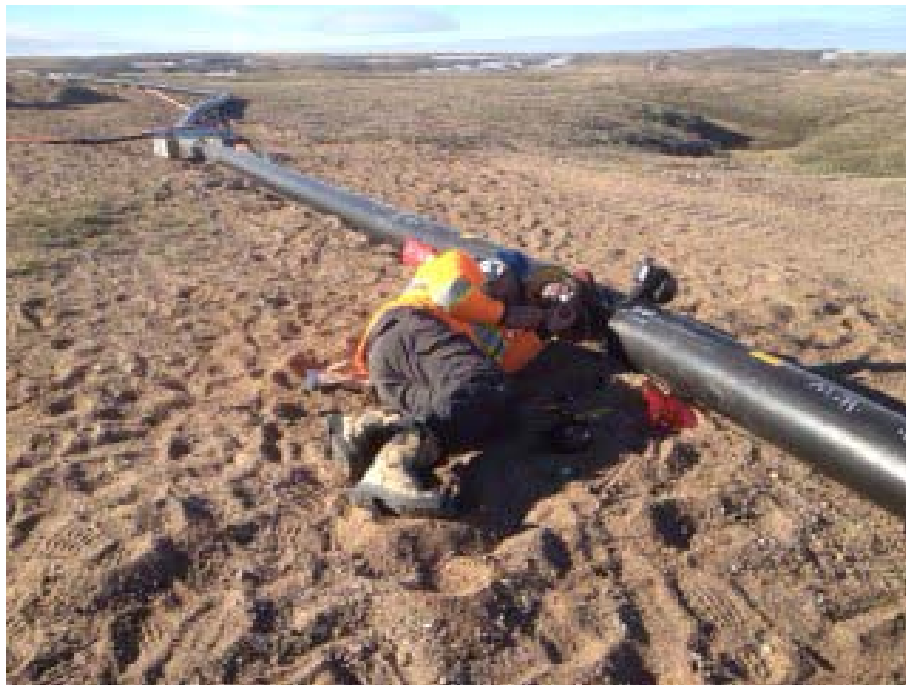
**Figure 14: Testing of the finished line**

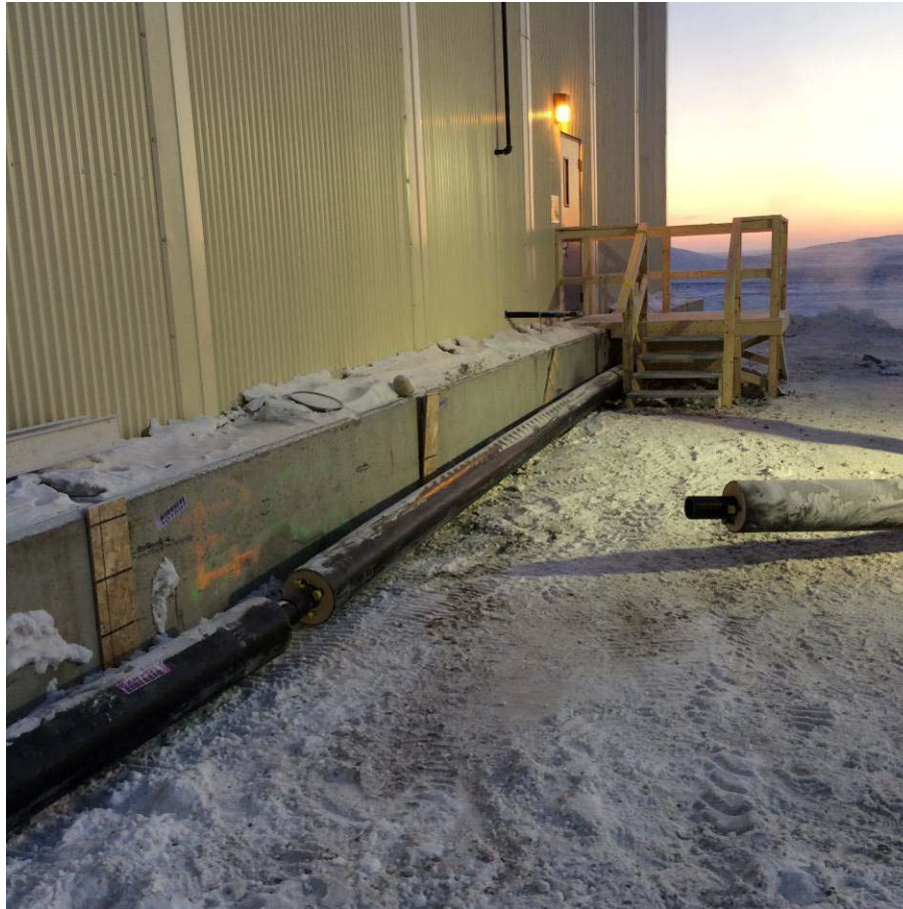
**Figure 15: Raw water intake piping entering the water building**

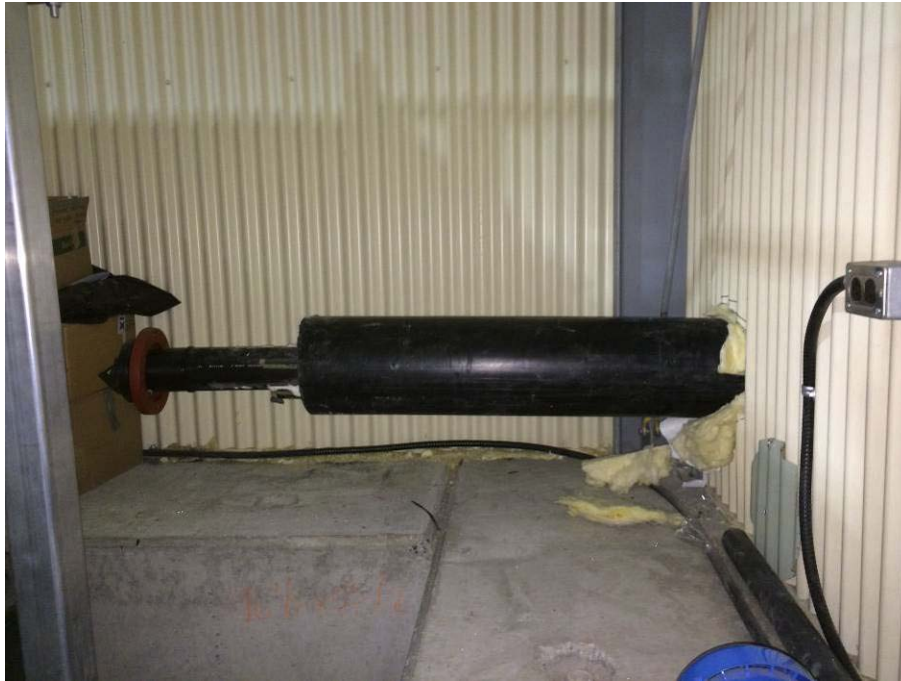
Figure 16: Raw water pipeline entering the water building

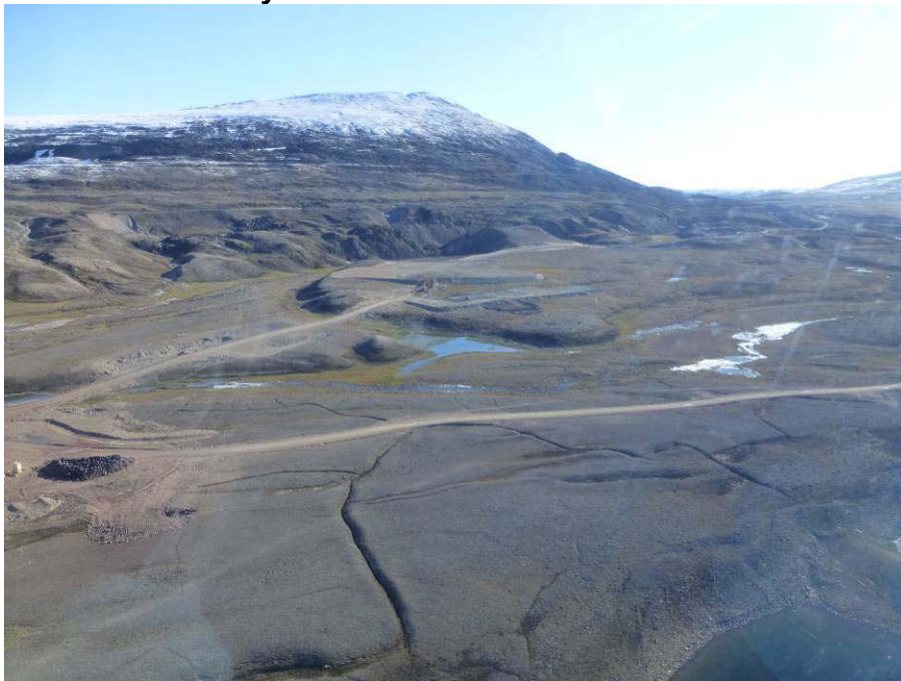
Figure 17: Pre-construction of the water system at Mine Site [northeast view]

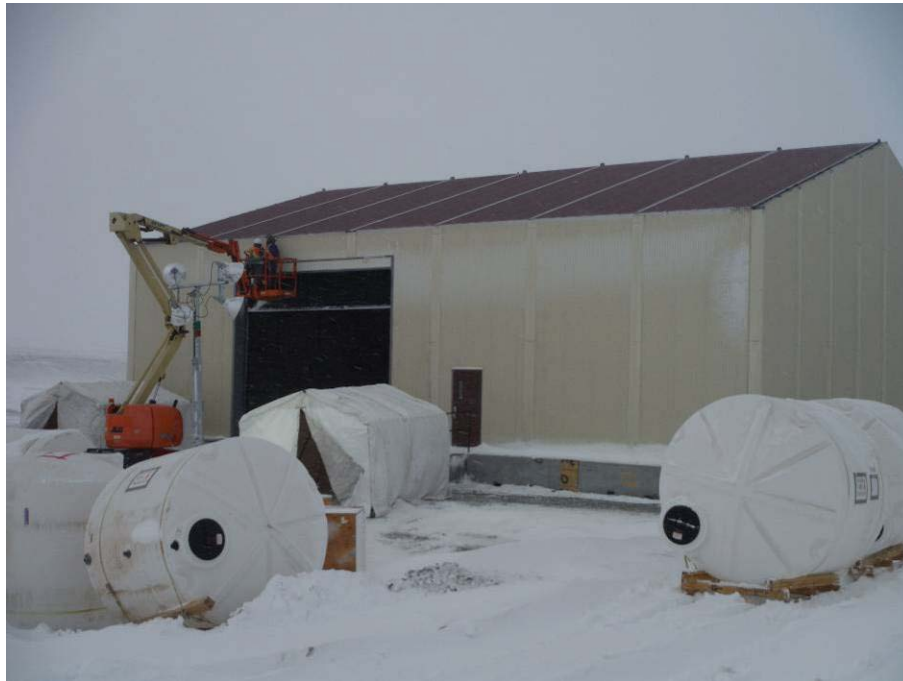
**Figure 18: Preparing water building for water treatment equipment (fire water tanks shown outside)**

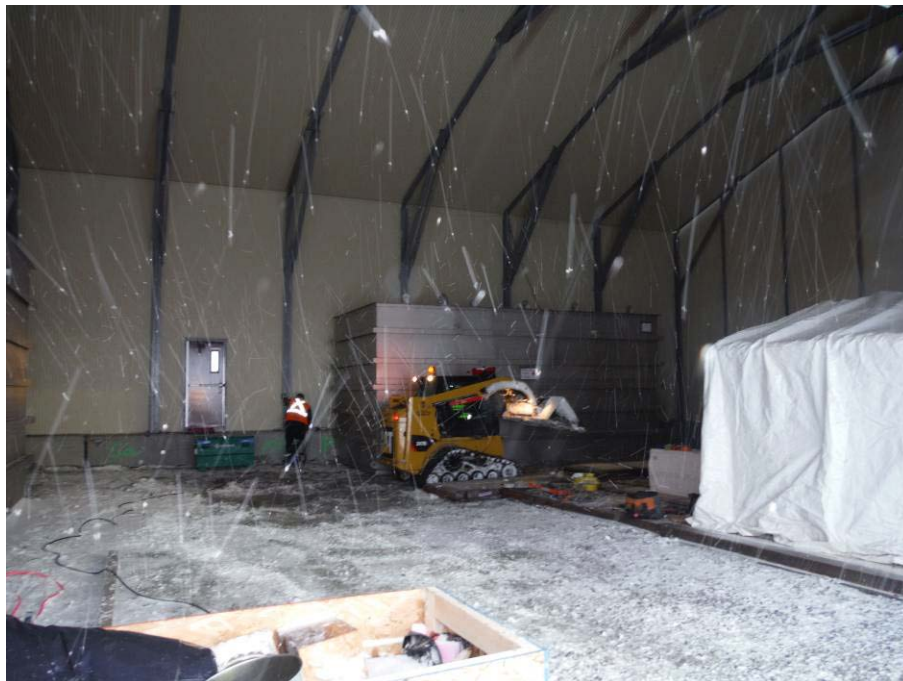
**Figure 19: Placement of interior equipment in water building**

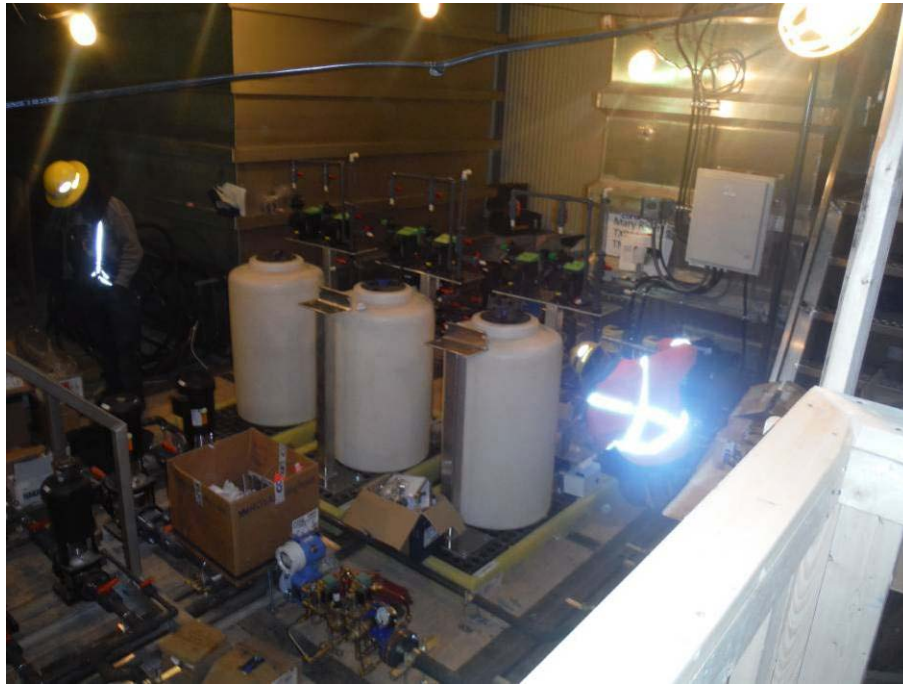
**Figure 20: Installation of skid mounted tanks, piping, valving and equipment**

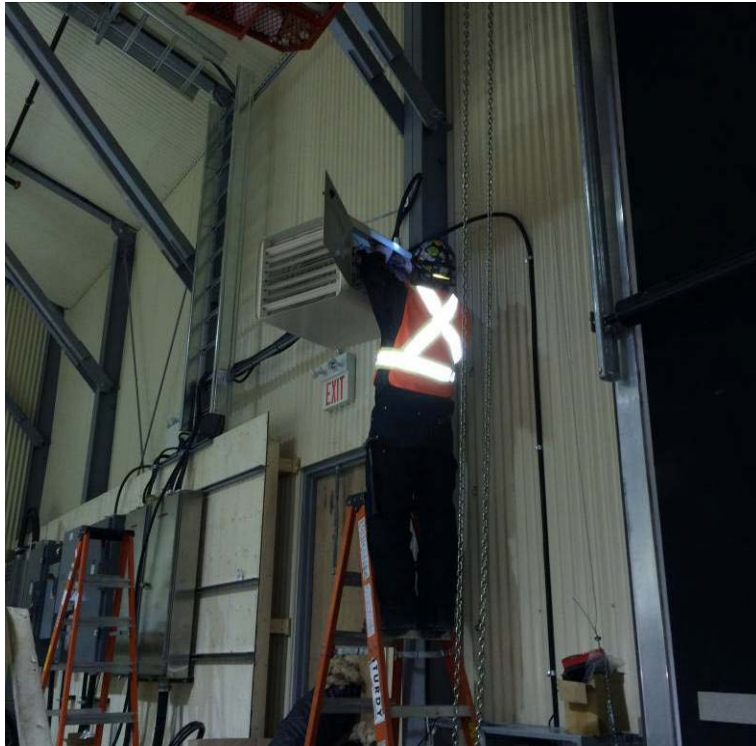
**Figure 21: Outfitting the HVAC inside the building**

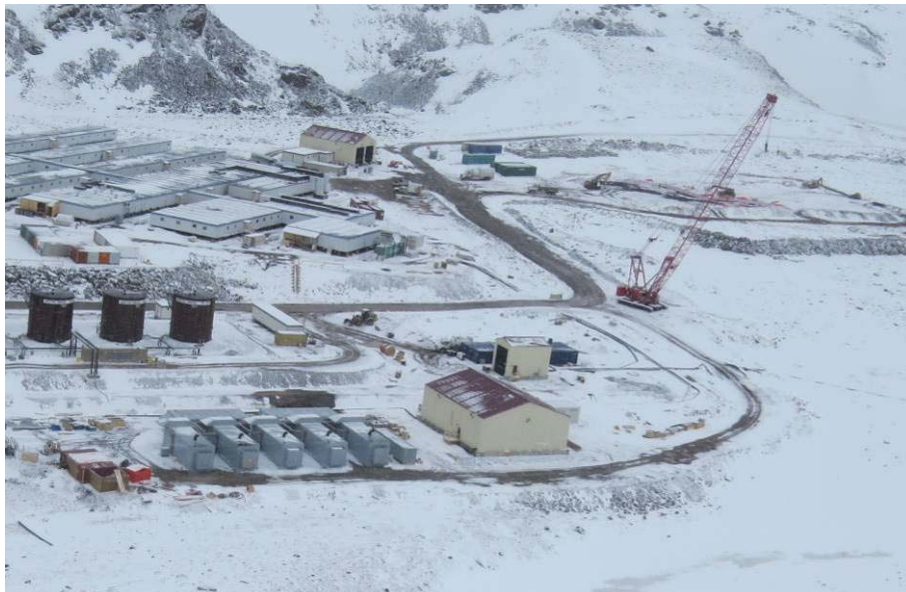
**Figure 22: Completed water systems [northeast view]**

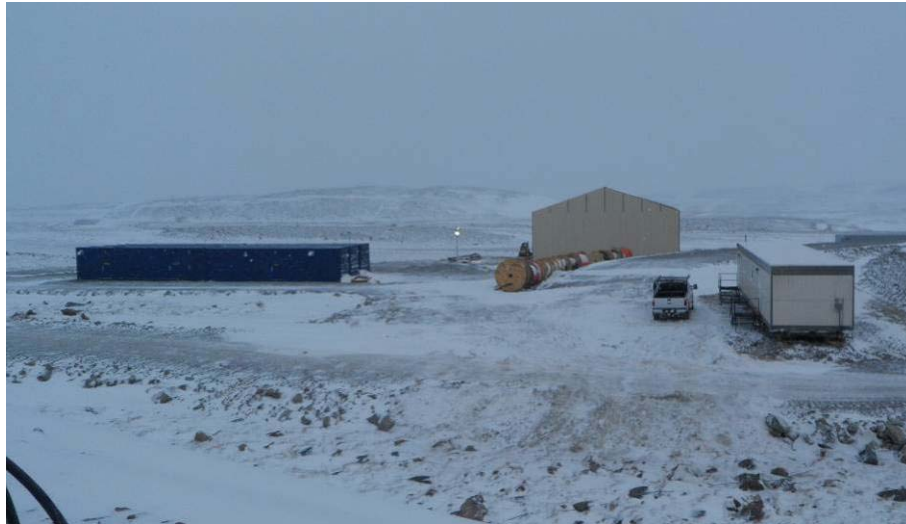
Figure 23: Sewage treatment facility (left) and water treatment plant (center) [south view]

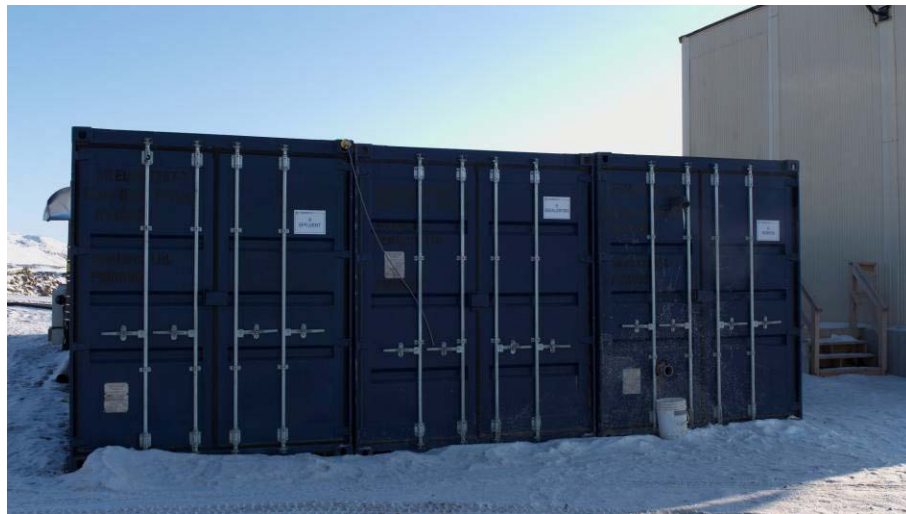
Figure 24: Completed sewage treatment system [east view]

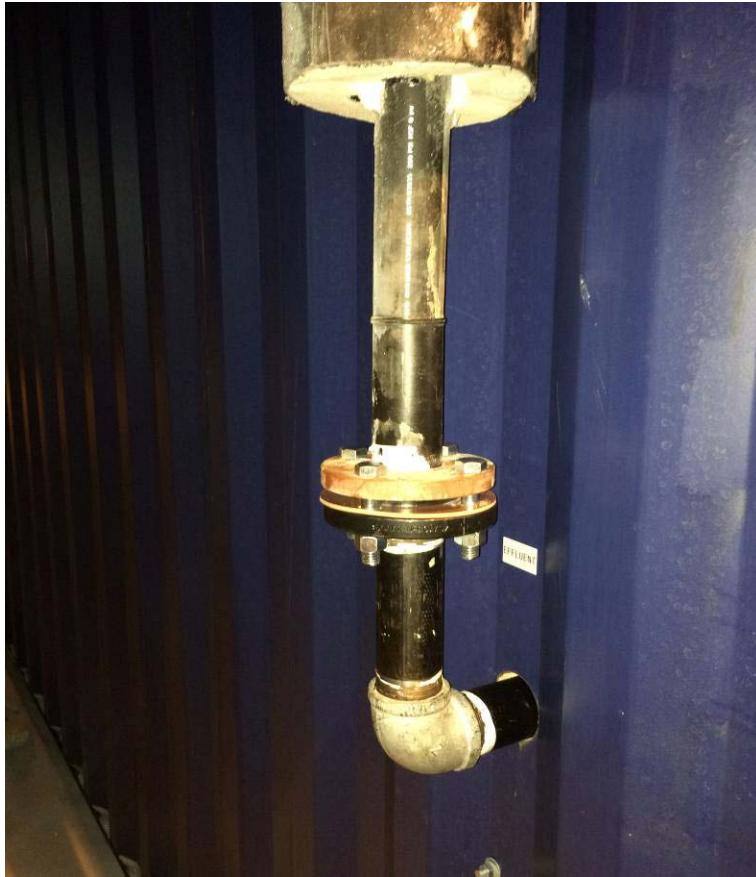
**Figure 25: Treated effluent discharge connection on north side of sewage treatment plant**

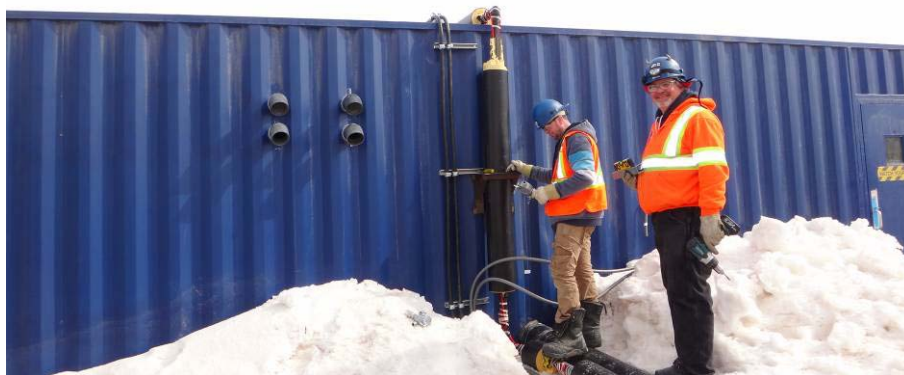
**Figure 26: Installation of heat trace lines on treated effluent discharge piping**

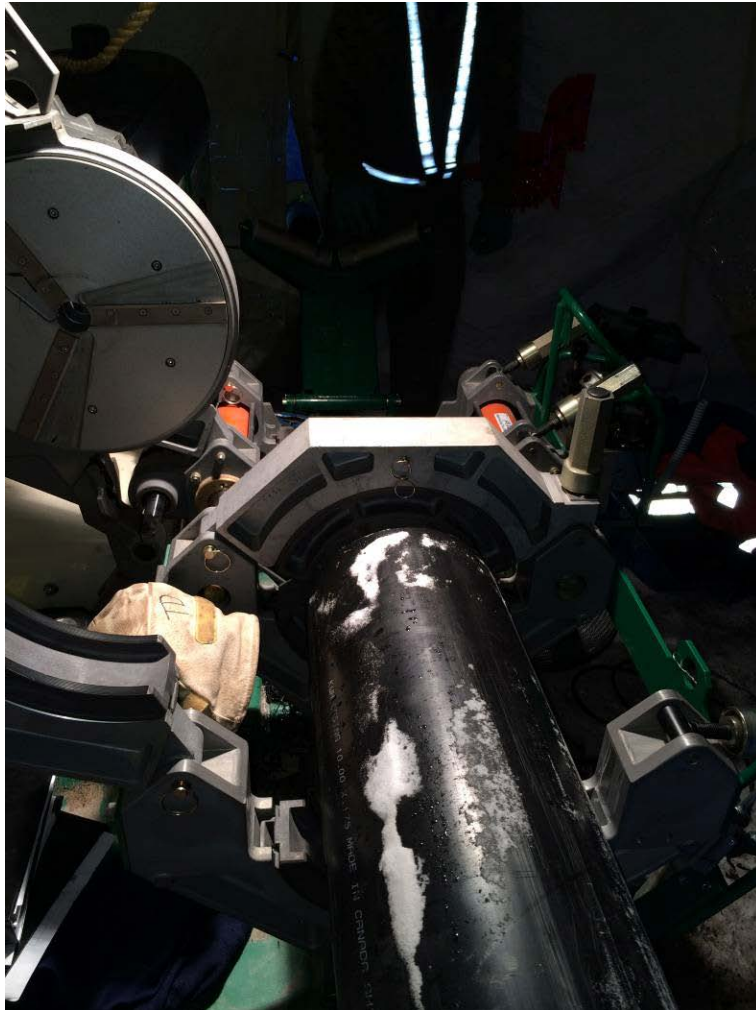
Figure 28: Preparing to fuse two HDPE piping lengths (activity enclosed in protective tenting)

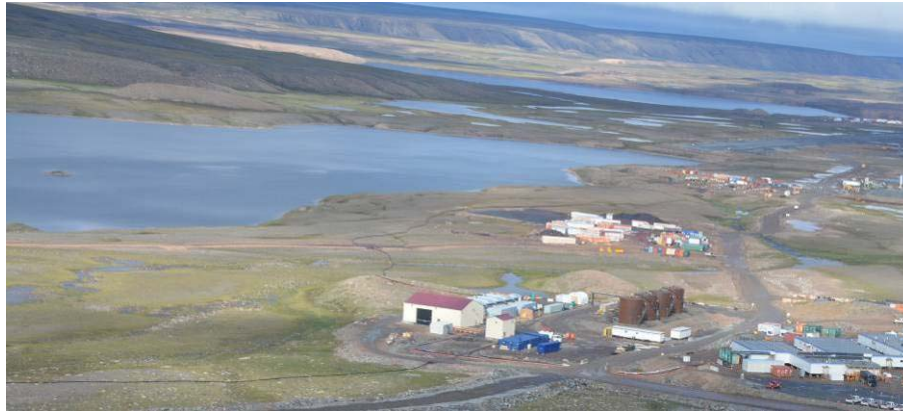
**Figure 29: Treated effluent pipeline exiting sewage treatment plant (bottom/center of photo) and running east to bottom/left of photo [west view]**

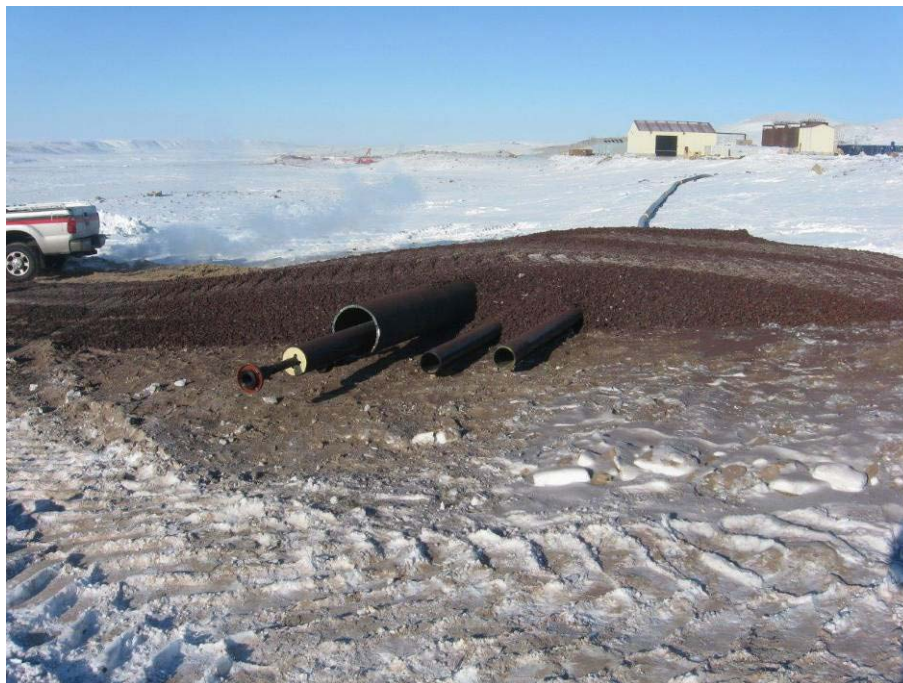
**Figure 30: Treated effluent discharge road crossing construction**

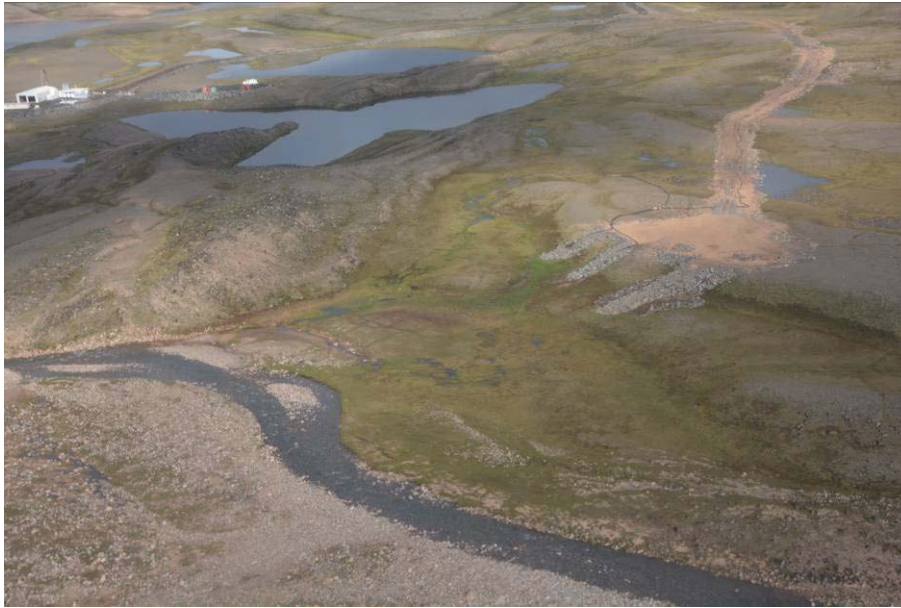
**Figure 31: Treated effluent pipeline entering top/right of photo, discharging in three (3) locations: 2 heat traced/ insulated for all-weather use over rip-rap (furthest two rip-rap from camera, left to right), 1 non-insulated for summer discharge only [northwest view]**

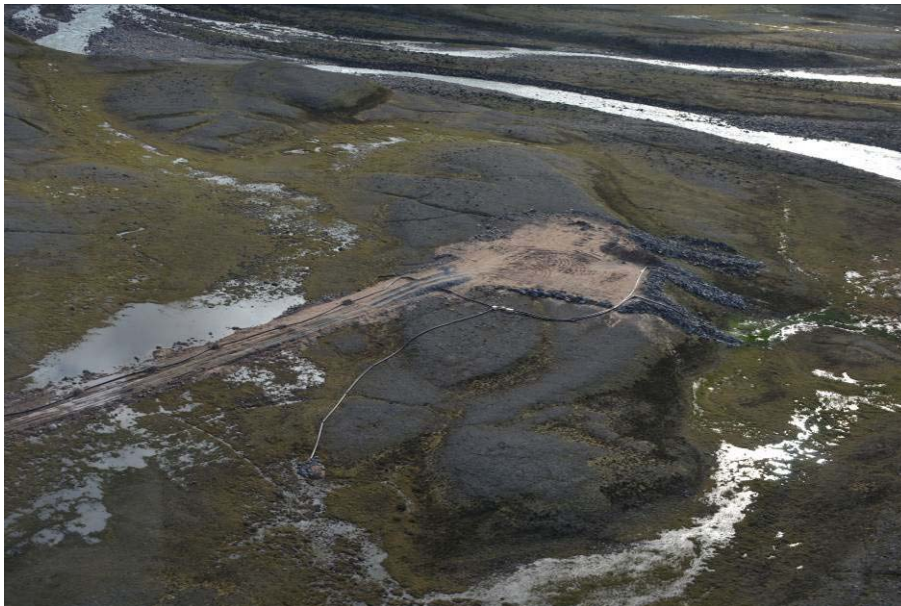
**Figure 32: Treated effluent pipeline discharge locations [west view]. Summer discharge line discharges in lower left/center of photo.**

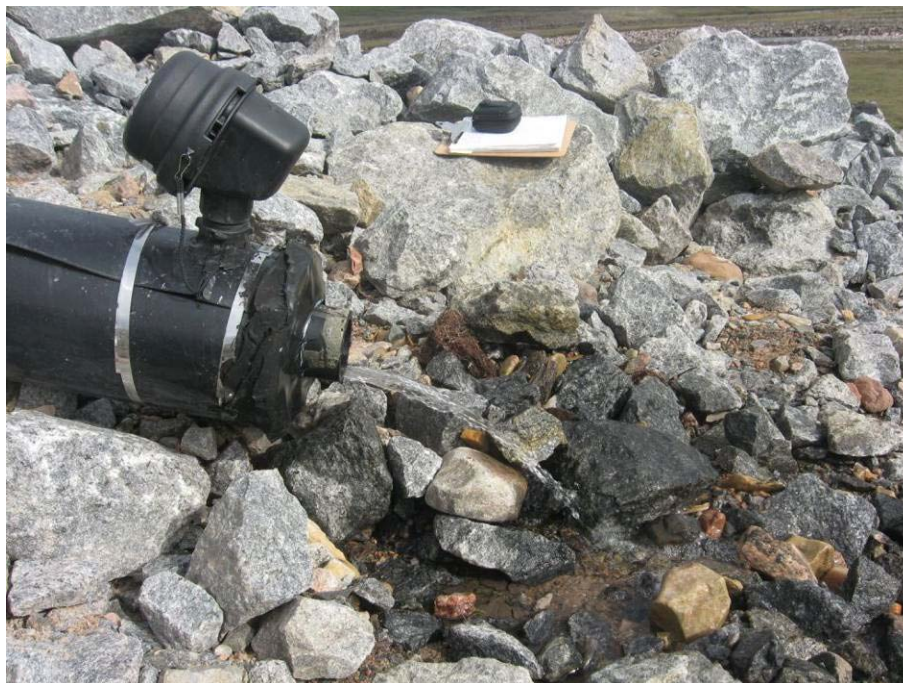
Figure 33: All-weather treated effluent discharge point over rip rap
