RE: Response to Teleconference Comments
Mary River Project - Modification Request No. 12
Type 'A' Water Licence - 2AM-MRY1325 - Amend. No. 1

Spring 2019 Fish Habitat Survey at Drainages in the Milne Port Area

Subject: **Preliminary Results of Spring 2019 Fish Habitat Survey in Drainages in the Milne Port Area**

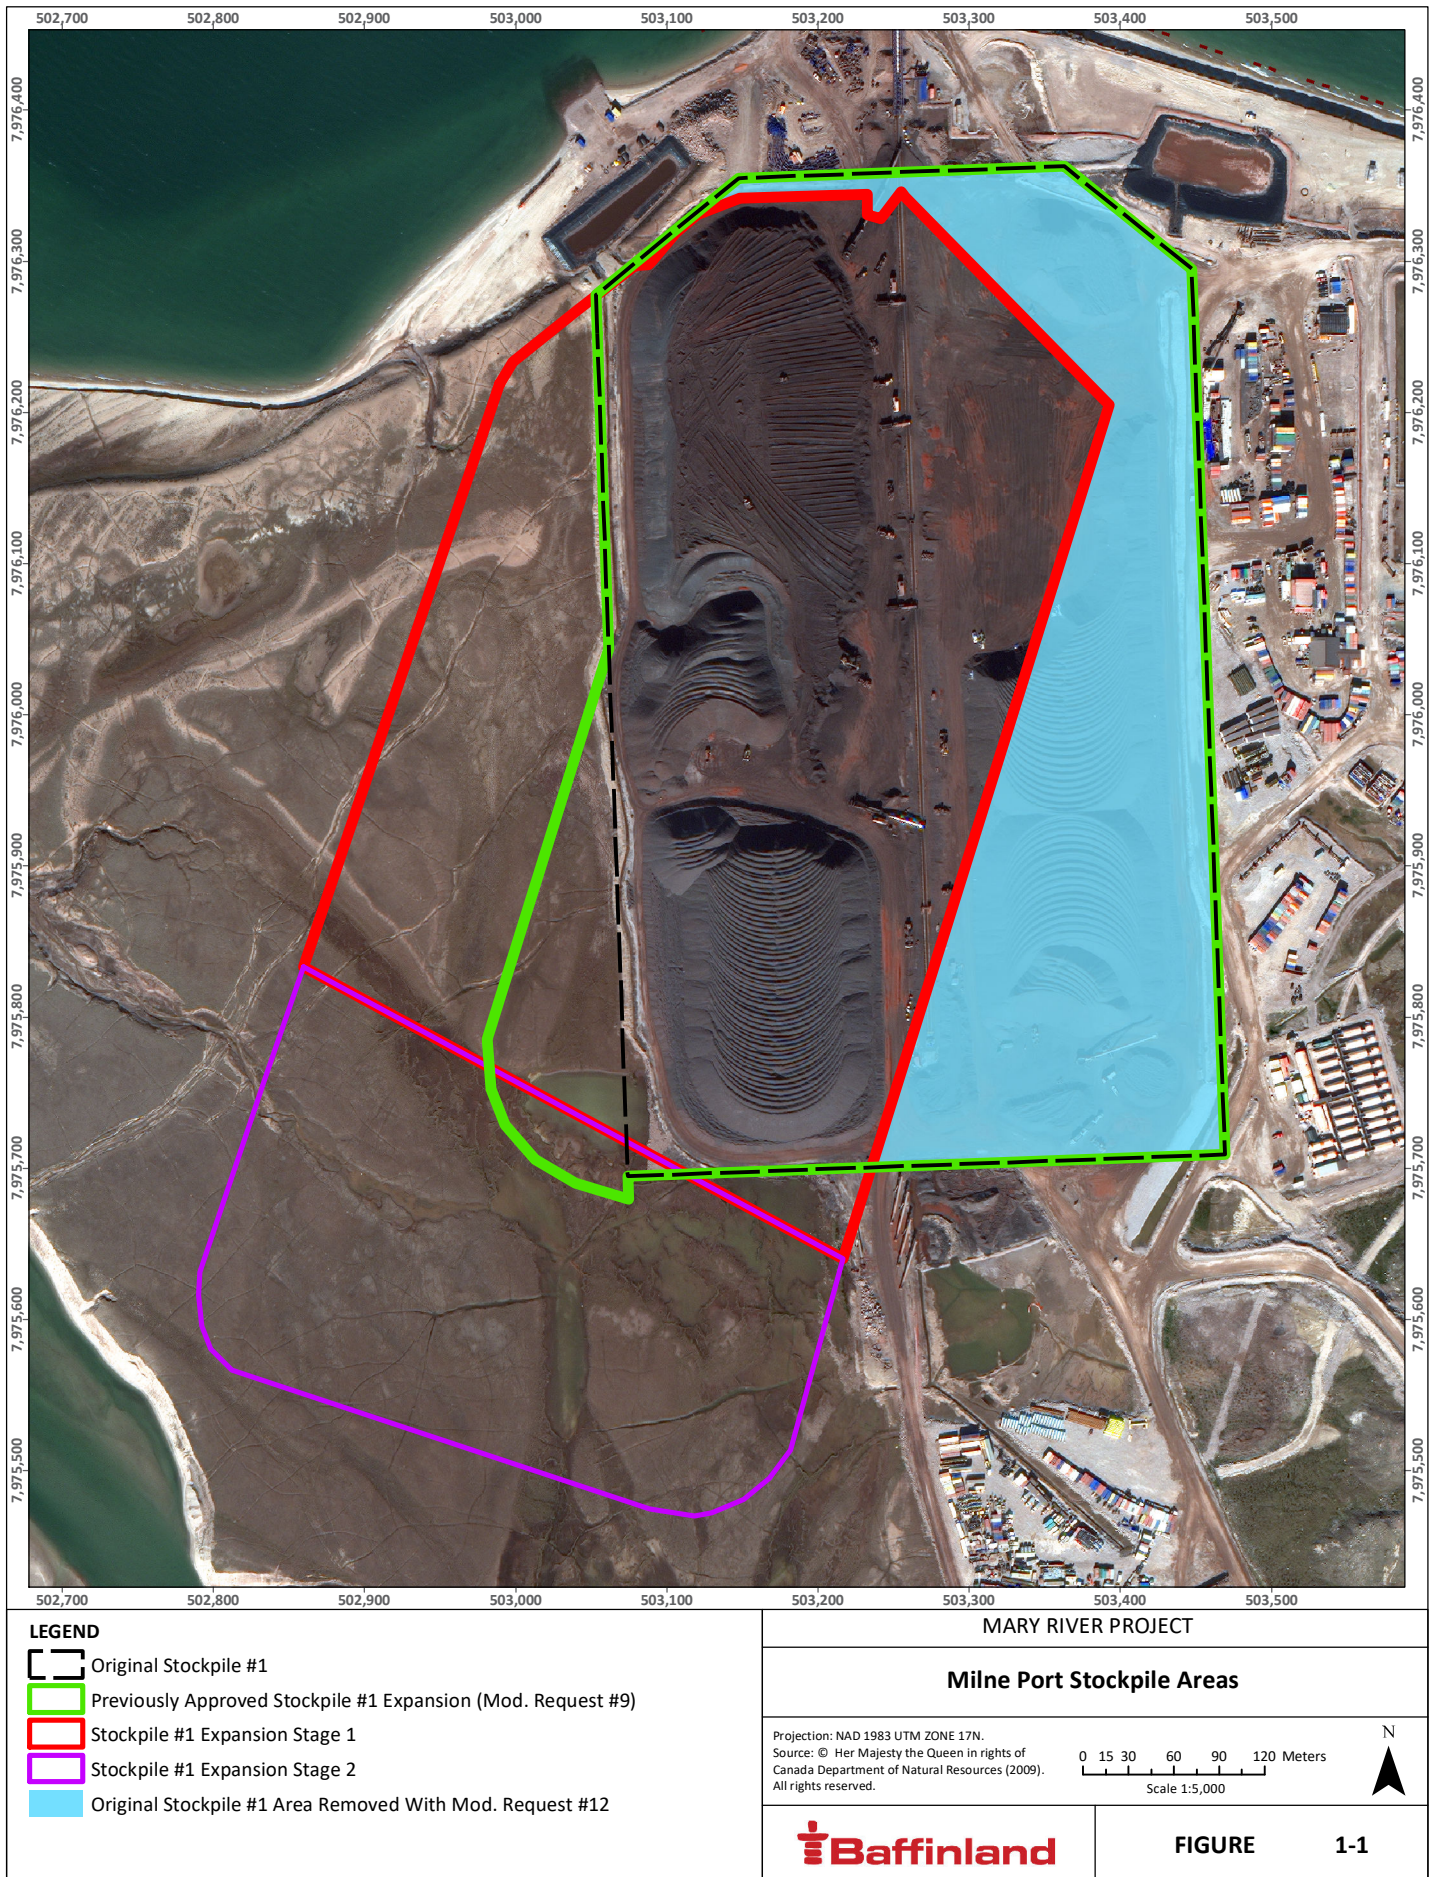
Figure 1-1: Milne Port Stockpile Areas

Stockpile #1 originally occupied an area of 25.32 ha, denoted by the dashed line on Figure 1-1 in Attachment 1. Water Licence Modification Request #9 subsequently allowed an increase in the area of Stockpile #1 to 27.22 ha, denoted in green on Figure 1-1.

Stage 1 of the Stockpile #1 expansion will occupy an area of 23.11 ha, denoted by the red line on Figure 1-1. Stage 2 will occupy an area of 9.23 ha, denoted by the purple line on Figure 1-1, for a total available stockpile area following completion of 32.34 ha. Also denoted on the map is an area of the original stockpile footprint which will no longer be usable for ore stockpiling as a consequence of realigning the stockpile and conveyor, which is 9.26 ha and denoted in blue on Figure 1-1.

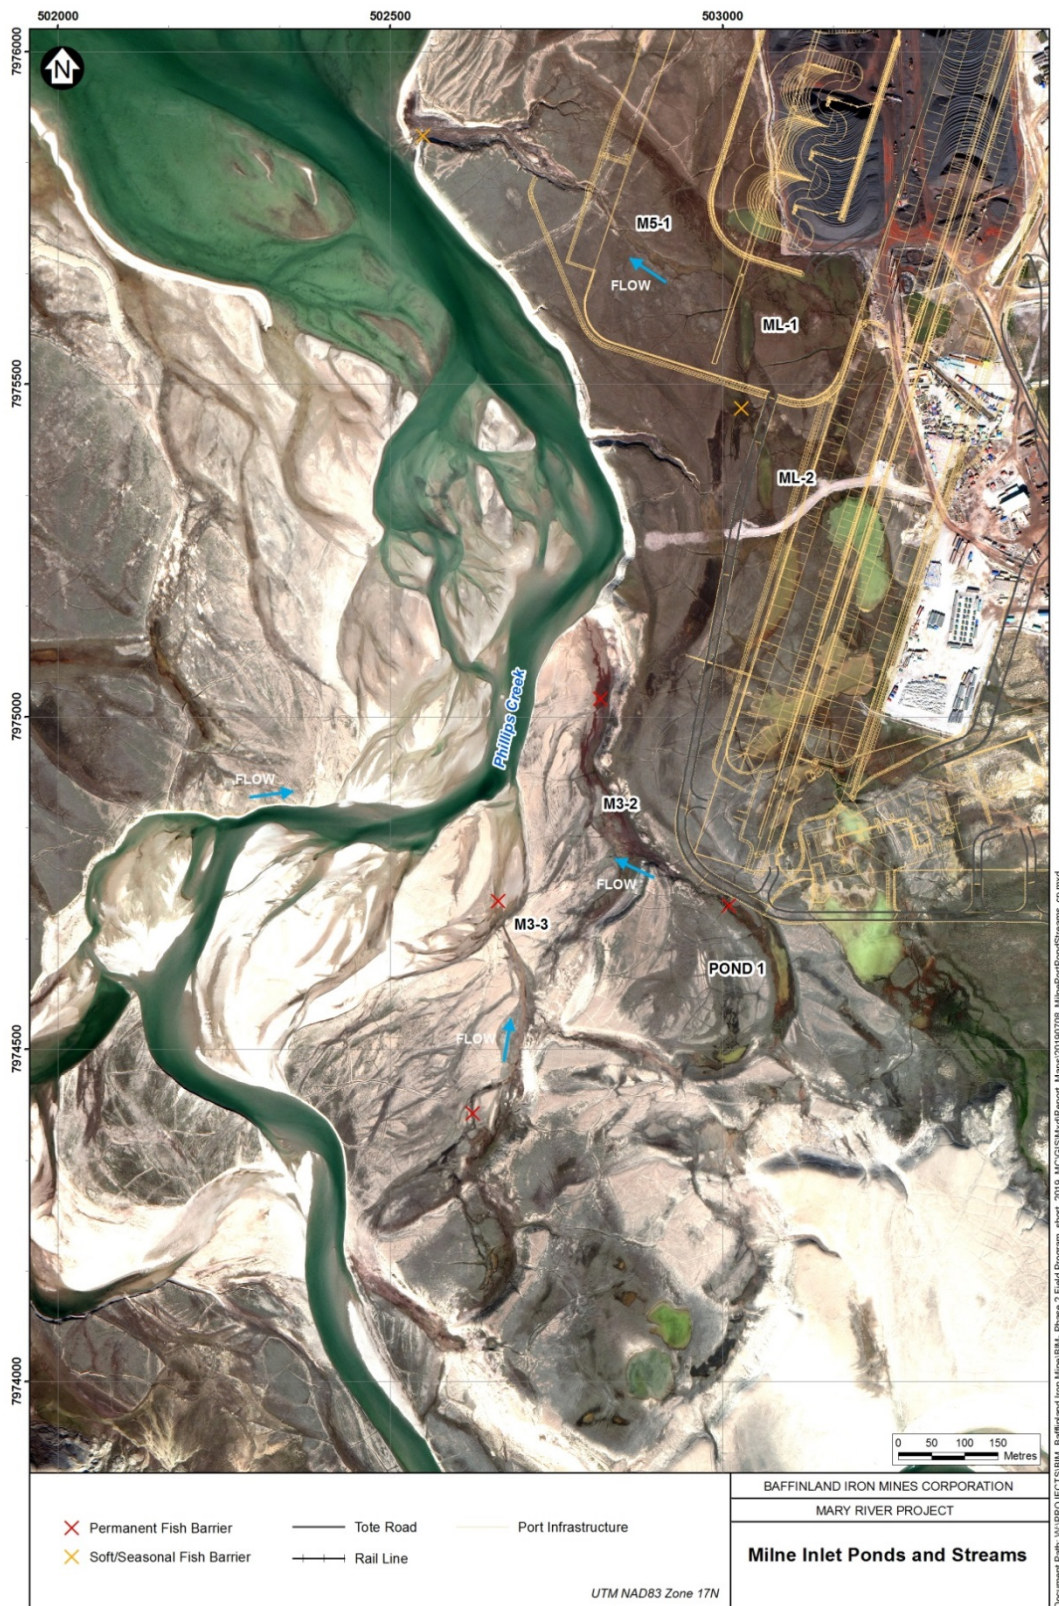
Figure 1. Location of the drainages surveyed in the Milne Port area.

The following provides a brief description of the results of the spring 2019 fish habitat surveys conducted in the Milne Port area. Fish and fish habitat surveys were conducted in portions of three drainages (M5-1, M3-2, and M3-3) in the Milne Inlet area on 18 and 25 June 2019 (Figure 1).

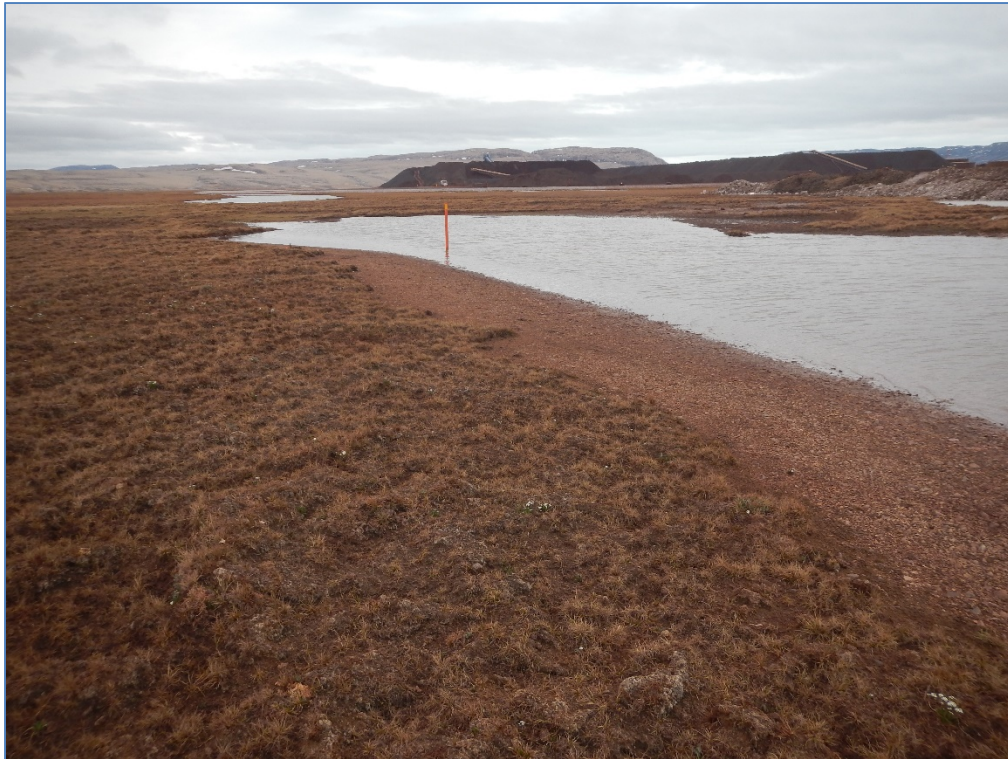
Substrate in both ponds was primarily fines with occasional cobble and maximum depths did not exceed 0.3 m (Figure 2). Water temperature was 8.5°C. There was no connectivity between the two ponds; the area between the two ponds was diffuse slightly wetted tundra (never exceeding 0.02 m depth) with frequent grassy hillocks blocking potential access (Figure 3). There was no fish use of either pond.

Figure 2. North end of Pond ML-2 in drainage M5-1.

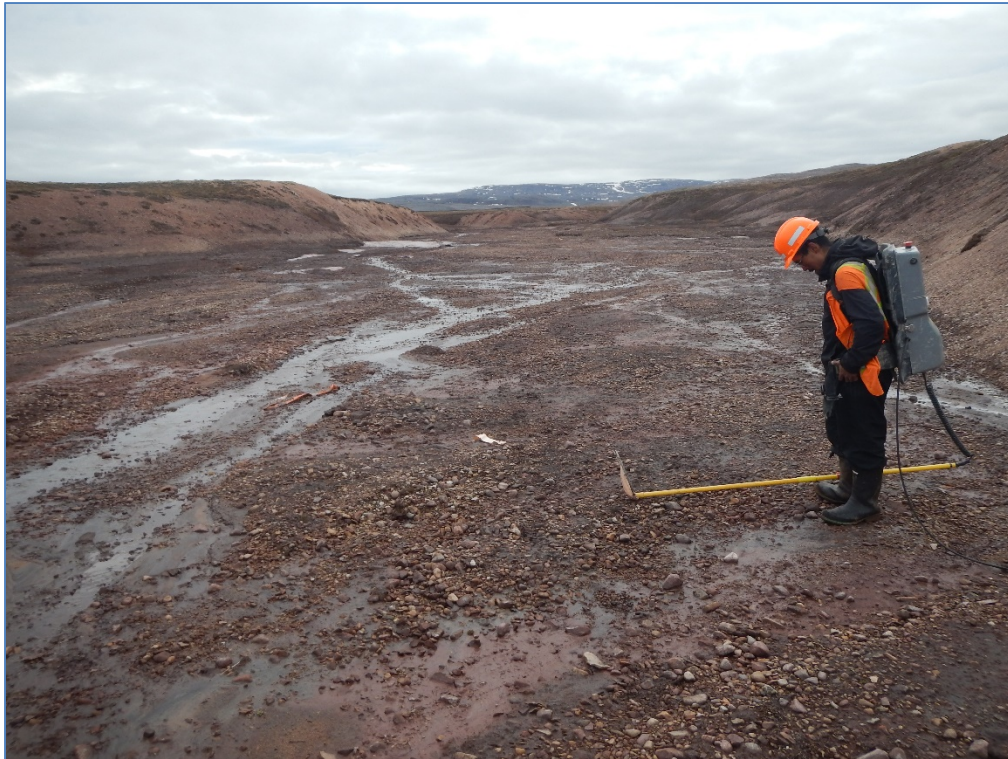
Stream M5-1 drains Pond ML-1 towards the confluence of Phillips Creek and Milne Inlet (Figure 3). The stream was very shallow (< 0.02 m) and wide (Figure 4) with a gradient of 5 degrees. It could not be electrofished due to insufficient water depths. However, visibility was high and no fish were observed in the entire length of the stream, which was surveyed on foot from Pond ML-1 to the confluence. The watershed drains local snow melt and, given the lack of channelization downstream towards Phillips Creek, depths in M5-1 are likely never sufficient to support use by anadromous juveniles. Anadromous char do not spawn in Phillips Creek drainage due to the presence of an upstream waterfall and the absence of accessible freshwater waterbodies of sufficient depth to provide spawning and/or egg incubation habitat downstream of the waterfall. Therefore, anadromous char potentially using freshwater habitat in the survey area for summer feeding originate from other river systems that drain into Milne Inlet.

Figure 4. Stream M5-1 habitat.

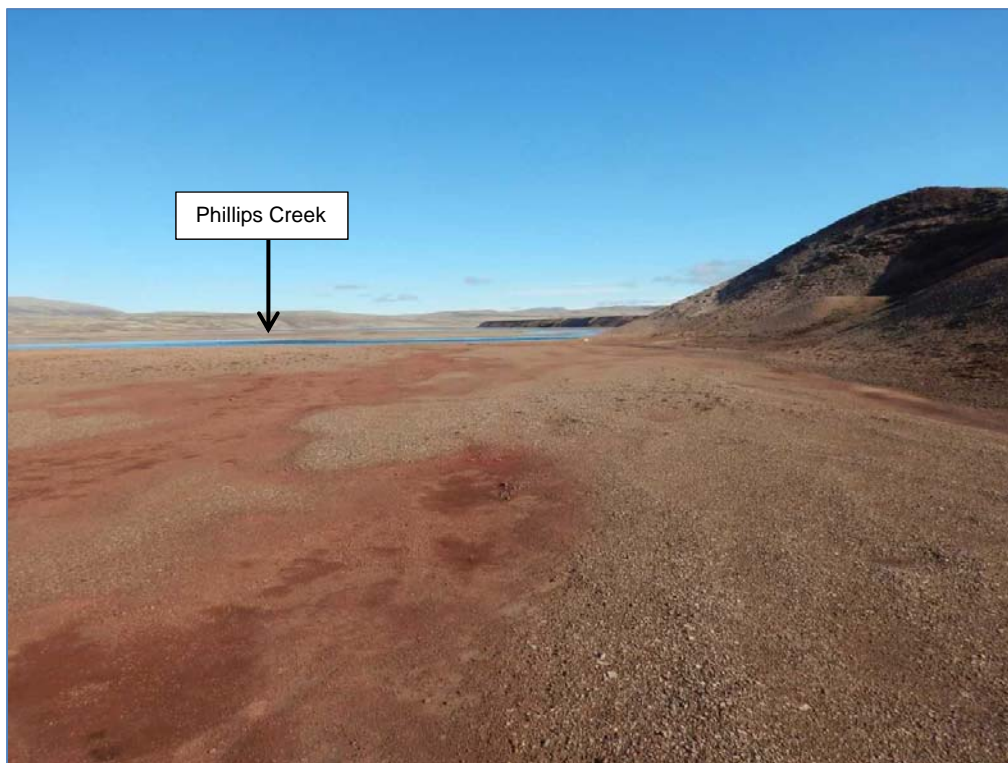
Stream M3-2 was assessed on 25 June 2019. There is no fish habitat in Stream M3-2; the stream was completely dry from Pond 1 upstream down to its confluence with Phillips Creek except for a small, shallow isolated pond (Figures 5 and 6). The entire pond was electrofished for 144 s and no fish were captured or observed.

Figure 5. View of Stream M3-2 looking downstream towards Phillips Creek.

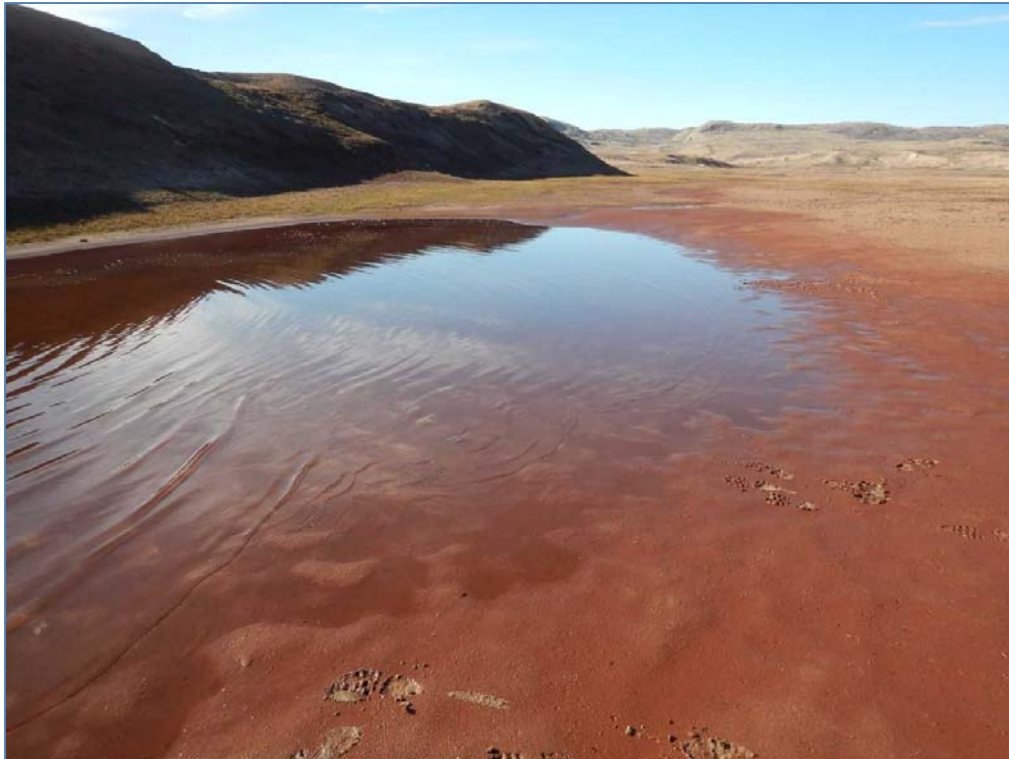
Figure 6. View of the only wetted area of the entire M3-2 drainage.

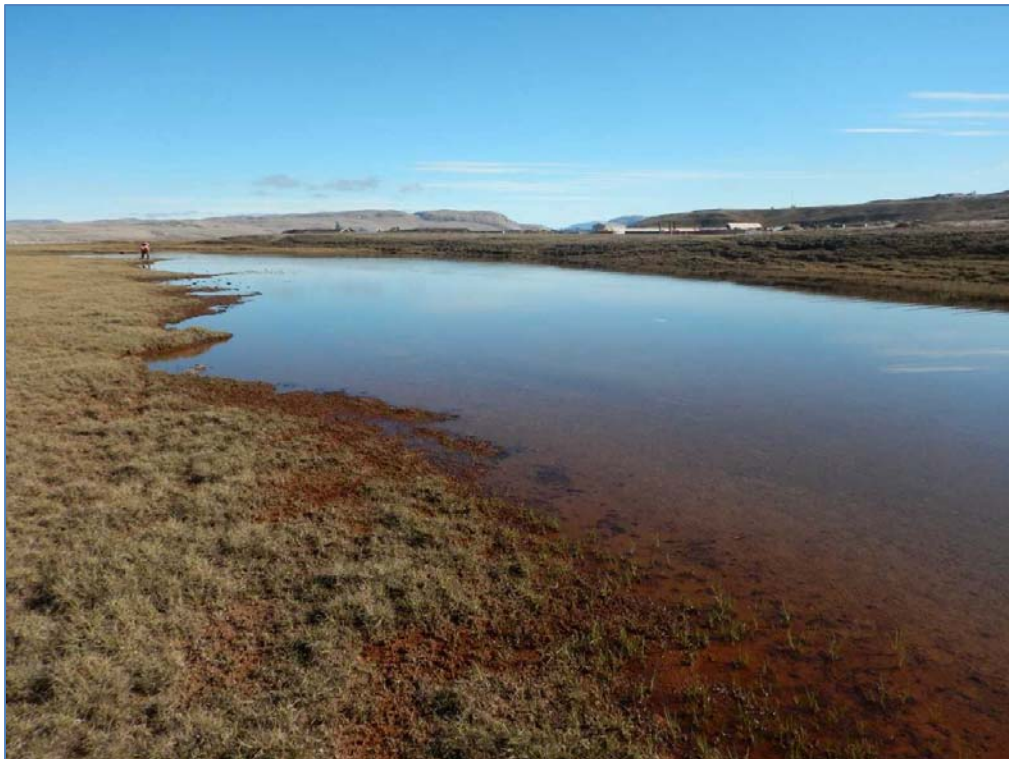
Pond 1 at the upstream end of the M3-2 drainage was approximately 135 x 35 m with a maximum measured depth of 0.28 m (Figure 7). The pond appears to be isolated as there are no channels or surface water inflows to, or outflows from, the pond (Figure 8). The pond was electrofished for 529 s covering its entire perimeter and no fish were captured or observed.

Figure 7. Pond 1 at the upstream end of stream M3-2.

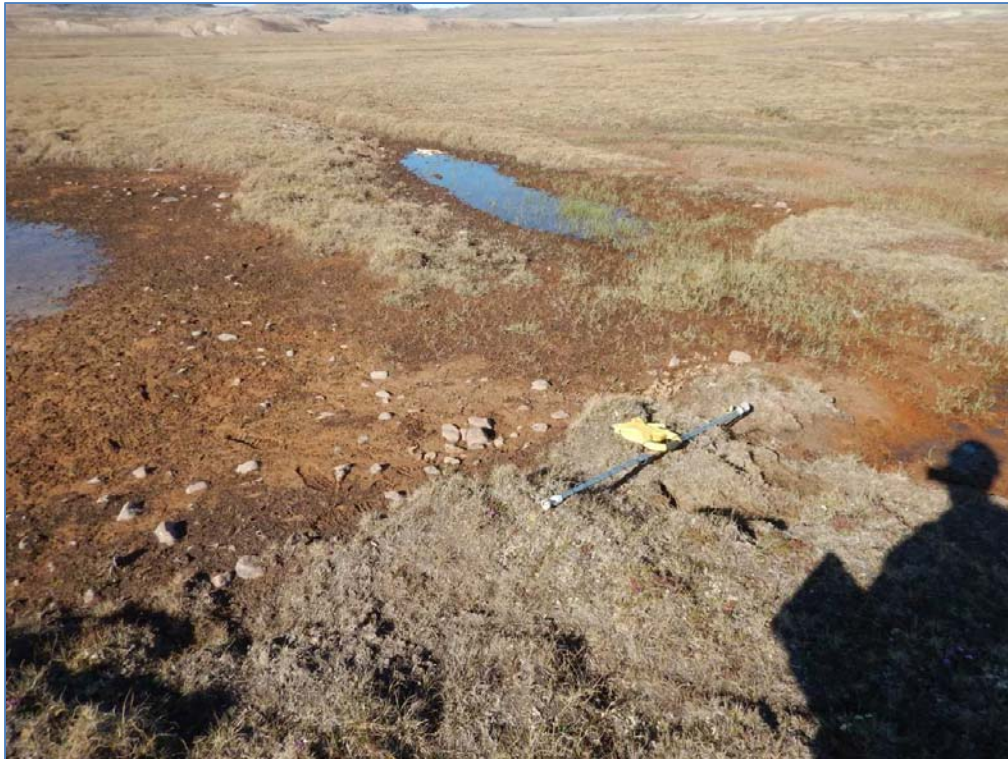
Figure 8. Downstream end of Pond 1 showing lack of connectivity to other waterbodies.

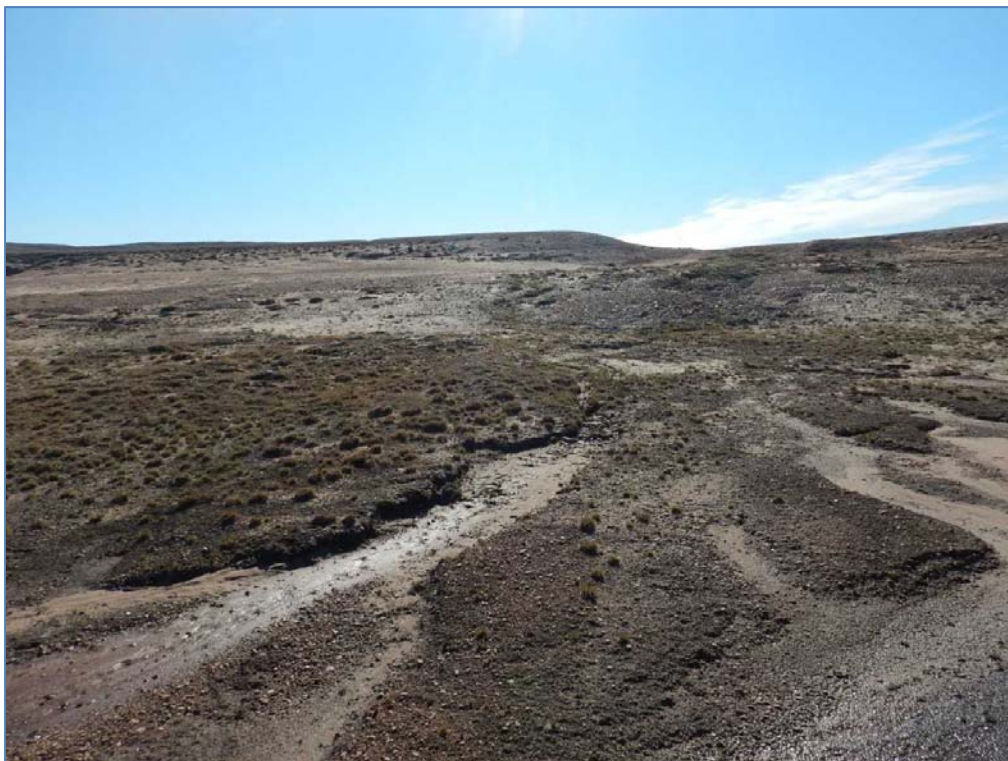
The stream is meandering and sandy, and was shallow (<0.03 m) with sections of subsurface flows (Figure 9). At the downstream confluence with Phillips Creek, there was a vertical gradient barrier of 0.35 m height that, in combination with shallow water, prevents all potential fish access to the stream (Figure 10). In addition, habitat in Phillips Creek at the confluence was a small pond isolated from the main channel of the river. Where depths were sufficient, Stream M3-3 was electrofished (fishing was conducted for 178 s over a 100 m reach) and no fish were captured or observed. All inflows to Stream M3-3 from the southeast and southwest were increasingly dry in an upstream direction.

Figure 9. Typical habitat in Stream M3-3 near the confluence with Phillips Creek.

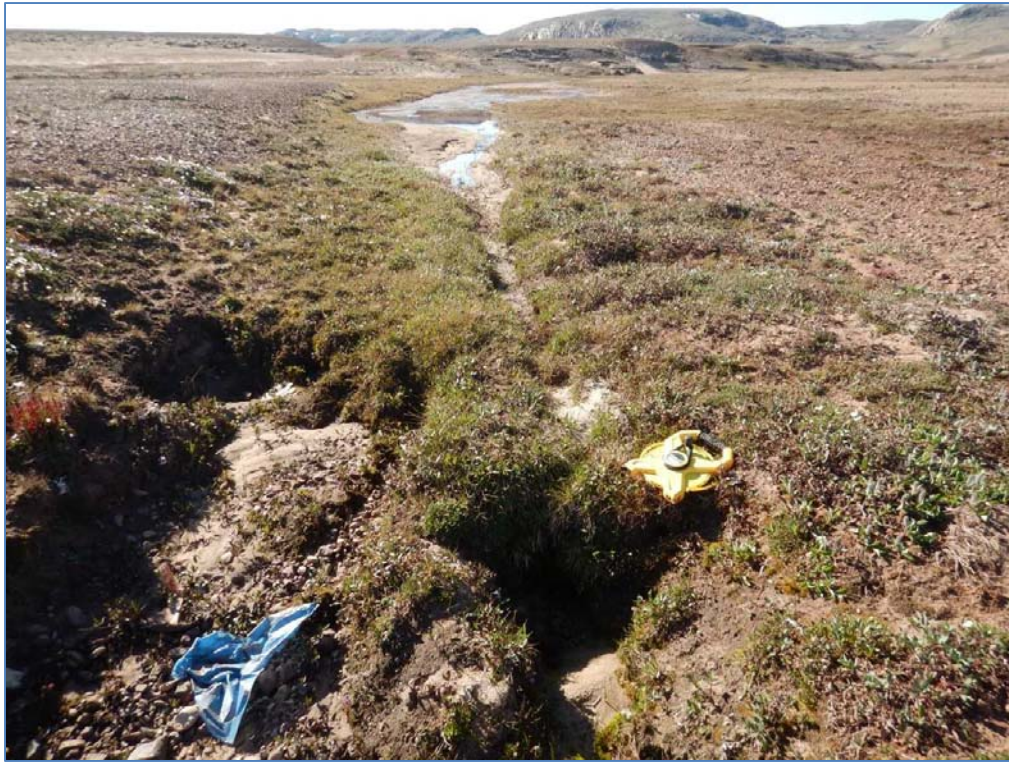
Figure 10. Vertical/shallow water barrier at the downstream end of M3-3.
