Re: Follow-up to Spill Reported on Jan 1st, 2014
Mary River Project - Water Licence No. 2AM-MRY1325

Summary:

On January 1st, 2014, at approximately 2230h, the operator of a 14M grader was attempting to plow some snow from the shoulder of road in the new road construction area when the grader suddenly dropped and became hung up on a rock underneath the blade. The operator was attempting to move the grader off the rock when the bottom of the fuel tank struck a rock and knocked off the fuel line at the bottom of the fuel tank. The operator remained unaware of the spill until the grader began to stall due to low fuel. The quantity of fuel spilt was approximately 200 L and contaminated an area of 4 square meters.

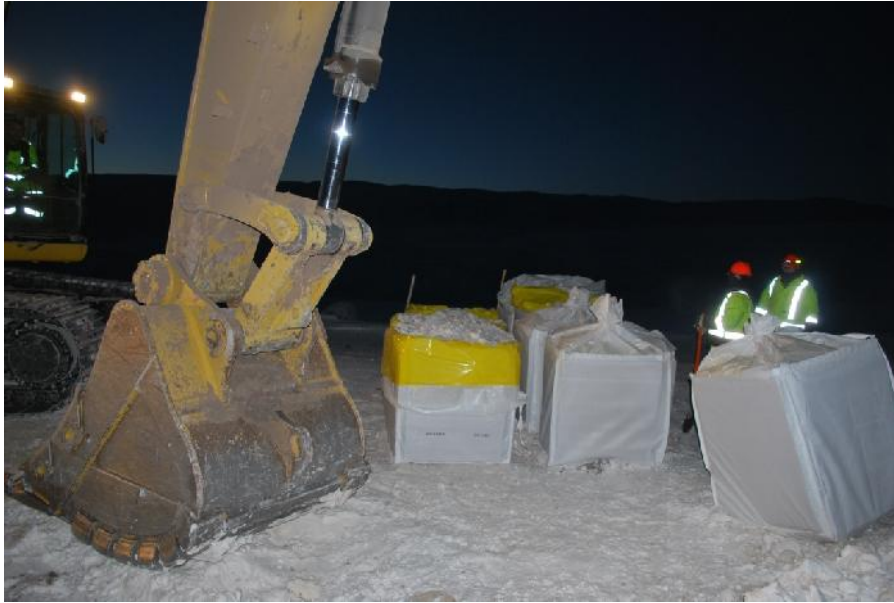
January 21, 2014, taken during spill cleanup

Upon noticing the spill, the operator immediately notified his supervisor and the acting environmental coordinator. After inspecting the scene, the grader was transported back onto the road and the spill response plan was initiated. Approximately nine cubic meters of contaminated snow was removed from the spill location and stored temporarily in a secured lined area for processing in the contaminated snow dump (to be constructed later this year). The spill location was greater than 30 m from the nearest water body.

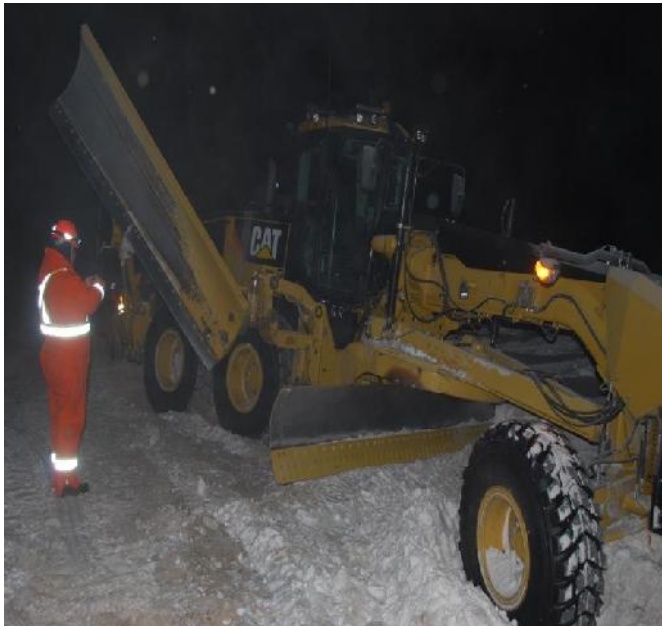
January 2, 2014, taken after spill cleanup
