## **Portt 2014 Baseline Road Report**

# AMARUQ EXPLORATION ROAD AQUATICS BASELINE REPORT 2014 AGNICO EAGLE MINES LTD. - MEADOWBANK DIVISION

January 22, 2015.

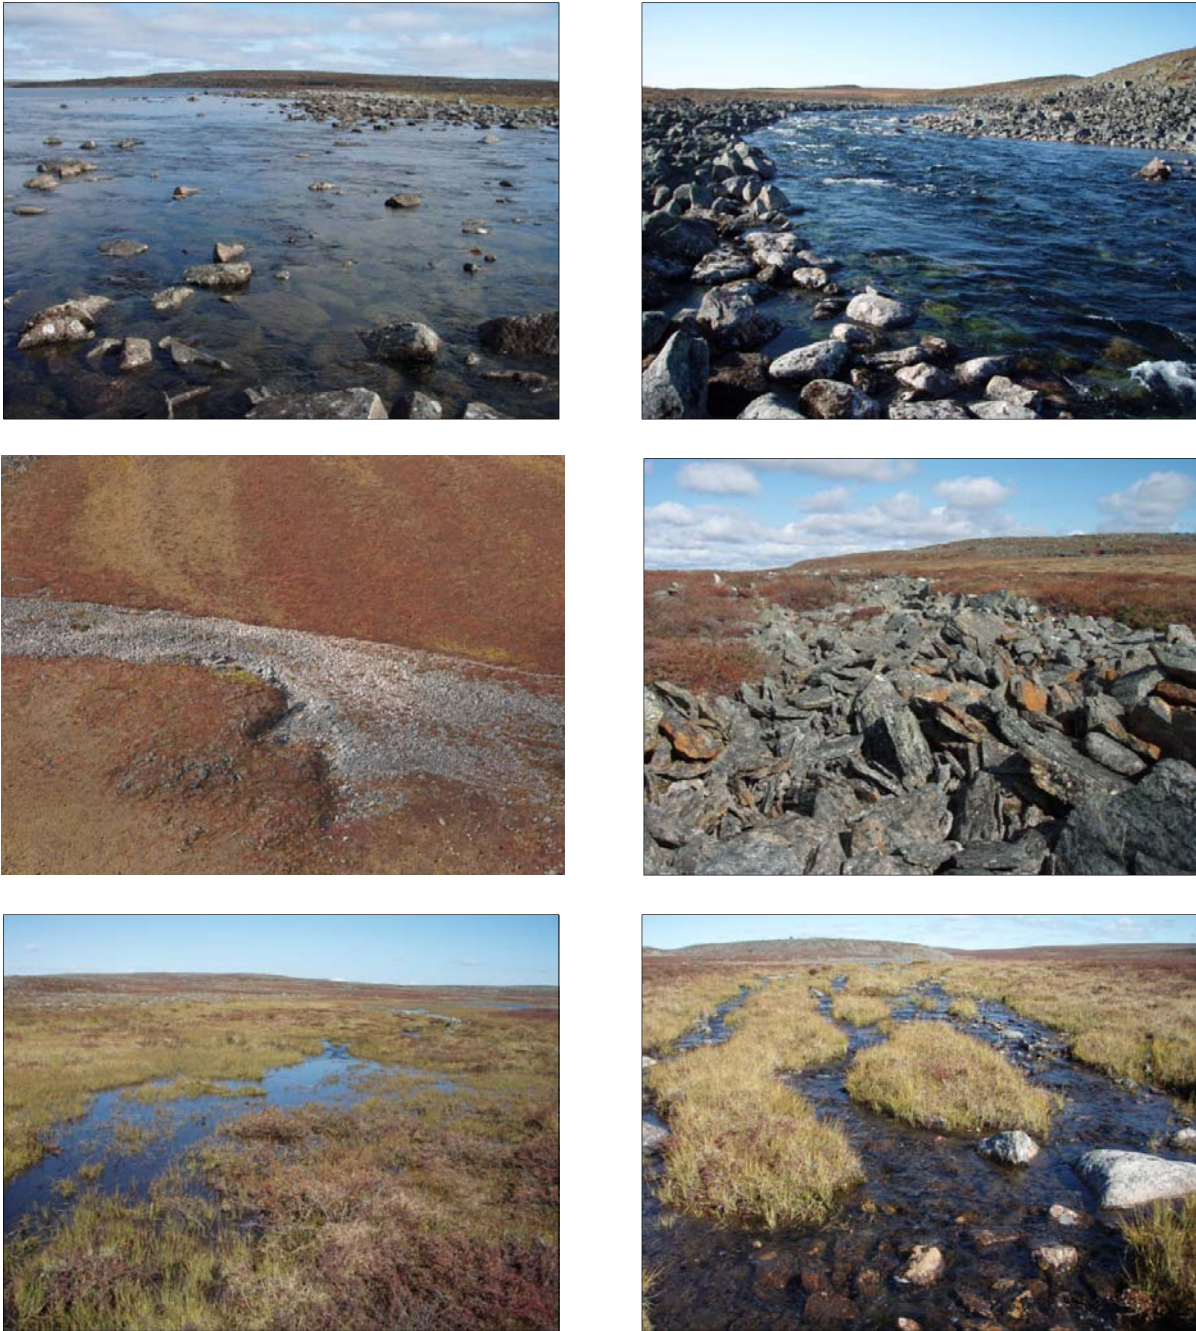
Figure 2-1. Examples of habitat types encountered. From top left, moving clockwise: river, river, boulder, graminoid with coarse substrate, graminoid with organic substrate, boulder.

The watercourse habitats were divided into three categories, river, boulder, and graminoid. Examples of each are shown in **Figure 2-1**. River habitats were large, flowing, open channels, which occurred at only three locations. Boulder habitats typically appear in the aerial photographs as well-defined, linear, boulder fields associated with depressions on the landscape. Often there is no water visible along some or most of their length, but there may be interstitial flow that is obscured by the upper boulder layers. The size of most of these boulder features appears disproportionately large relative to the magnitude of the flows observed in late summer, which were small. It is not known if the boulder field widths are the result of higher flows during spring freshet or if these features were formed by post-glacial meltwater or periglacial processes. Graminoid habitats are reaches of small watercourses whose banks are vegetated primarily by graminoids growing on peat. Often there are multiple smaller channels that branch and coalesce. Some of these habitats that were examined on the ground have a significant sand/gravel fraction in the substrate.

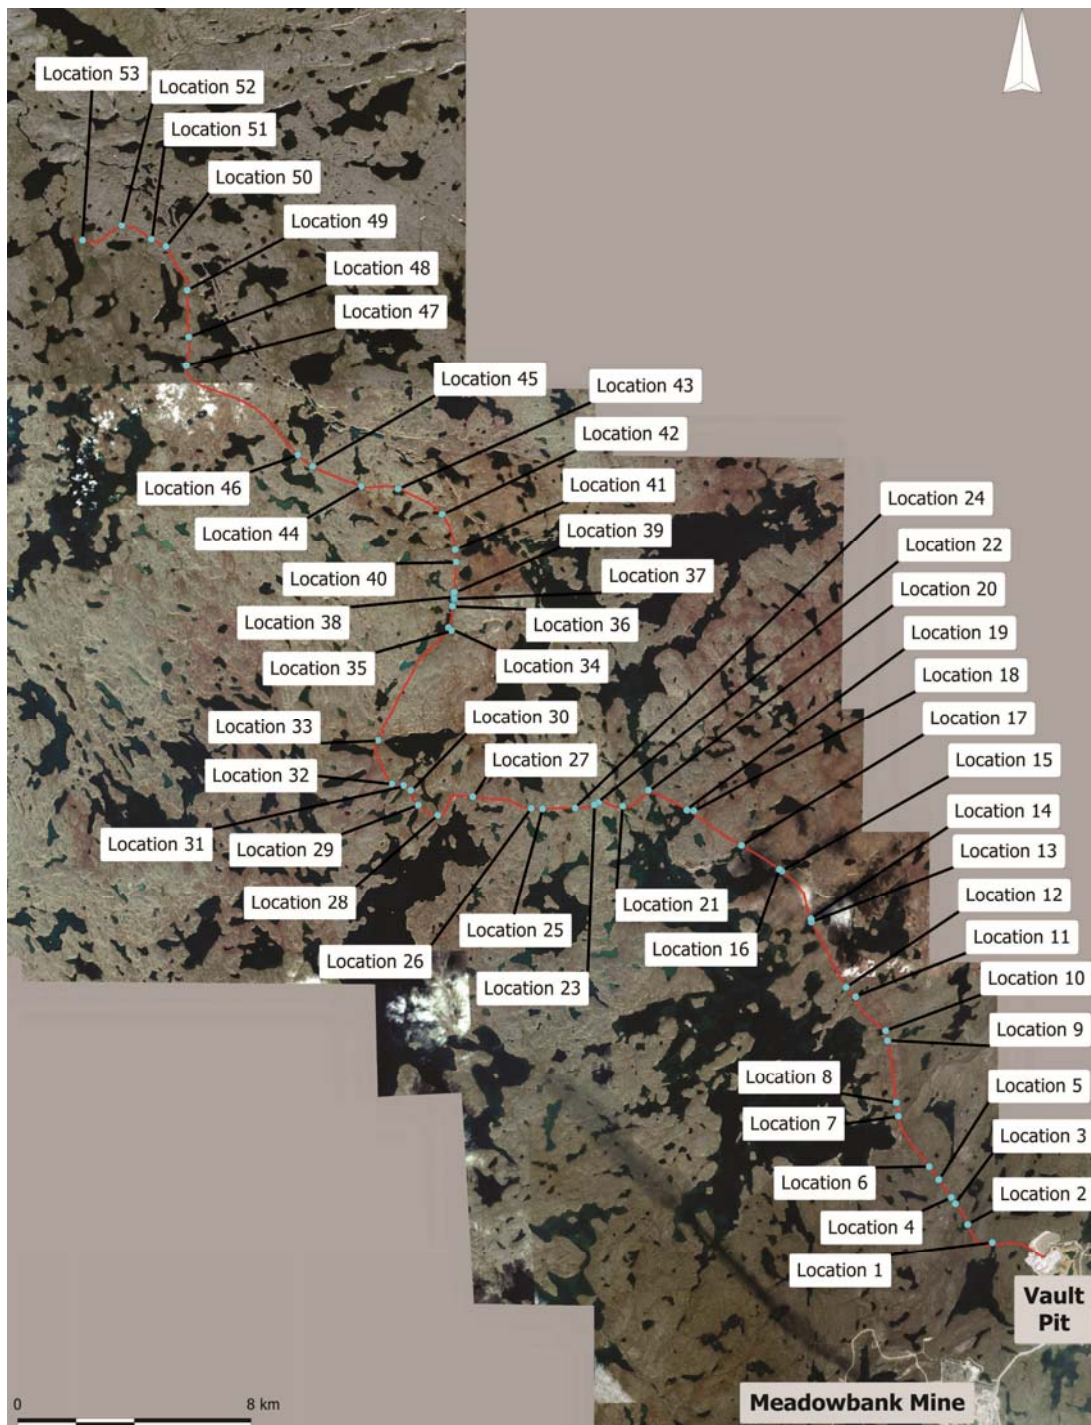
Figure 3-1. Route of the proposed Amaruq Exploration Road (red line) and the 53 locations examined (blue dots).

A total of 53 locations were examined along the proposed road alignment (Figure 3-1). Of these, 7 are along shorelines of larger lakes, 6 are portions of small lakes or ponds less than 150 m wide, and 40 are

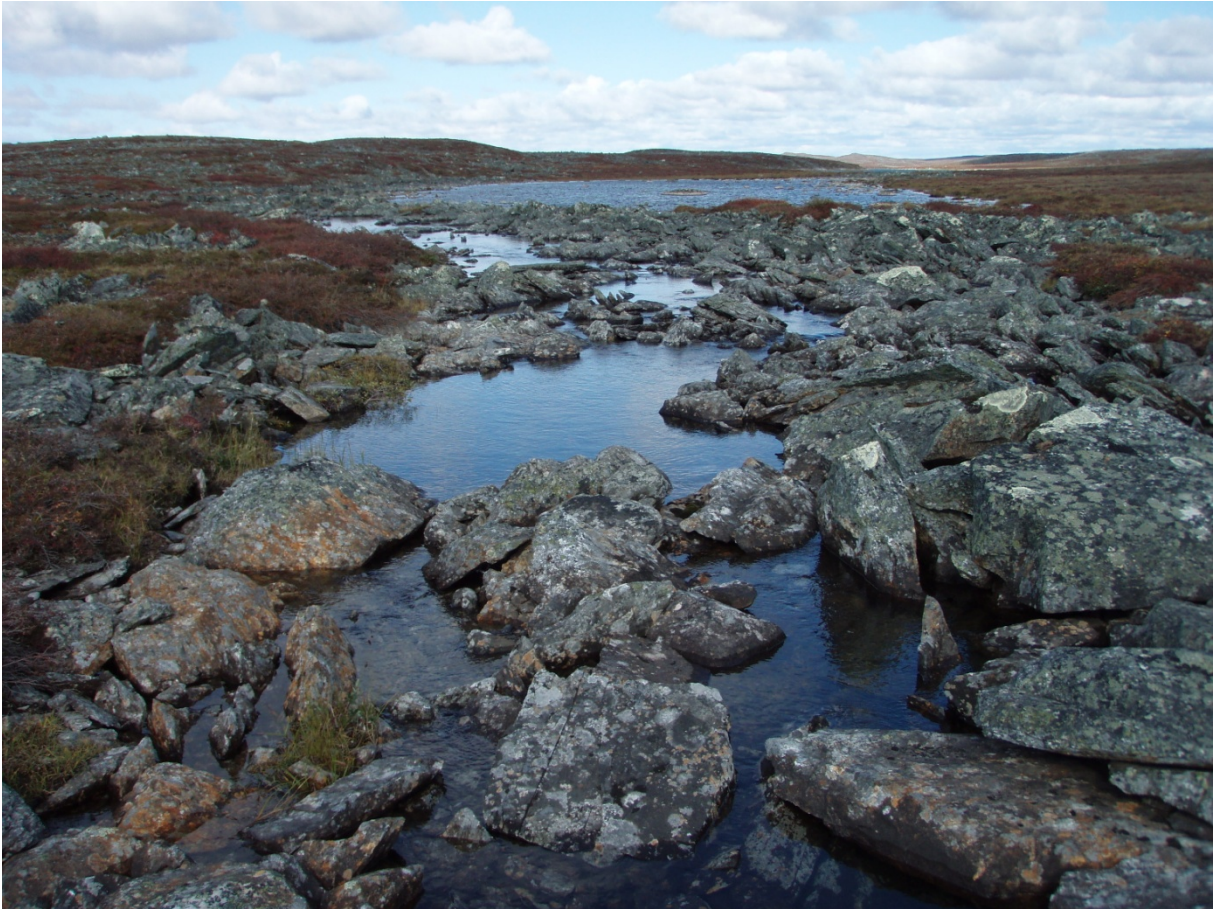
Location 2. Photograph from the ground. Upstream view approximately 100 m upstream from the proposed road crossing.

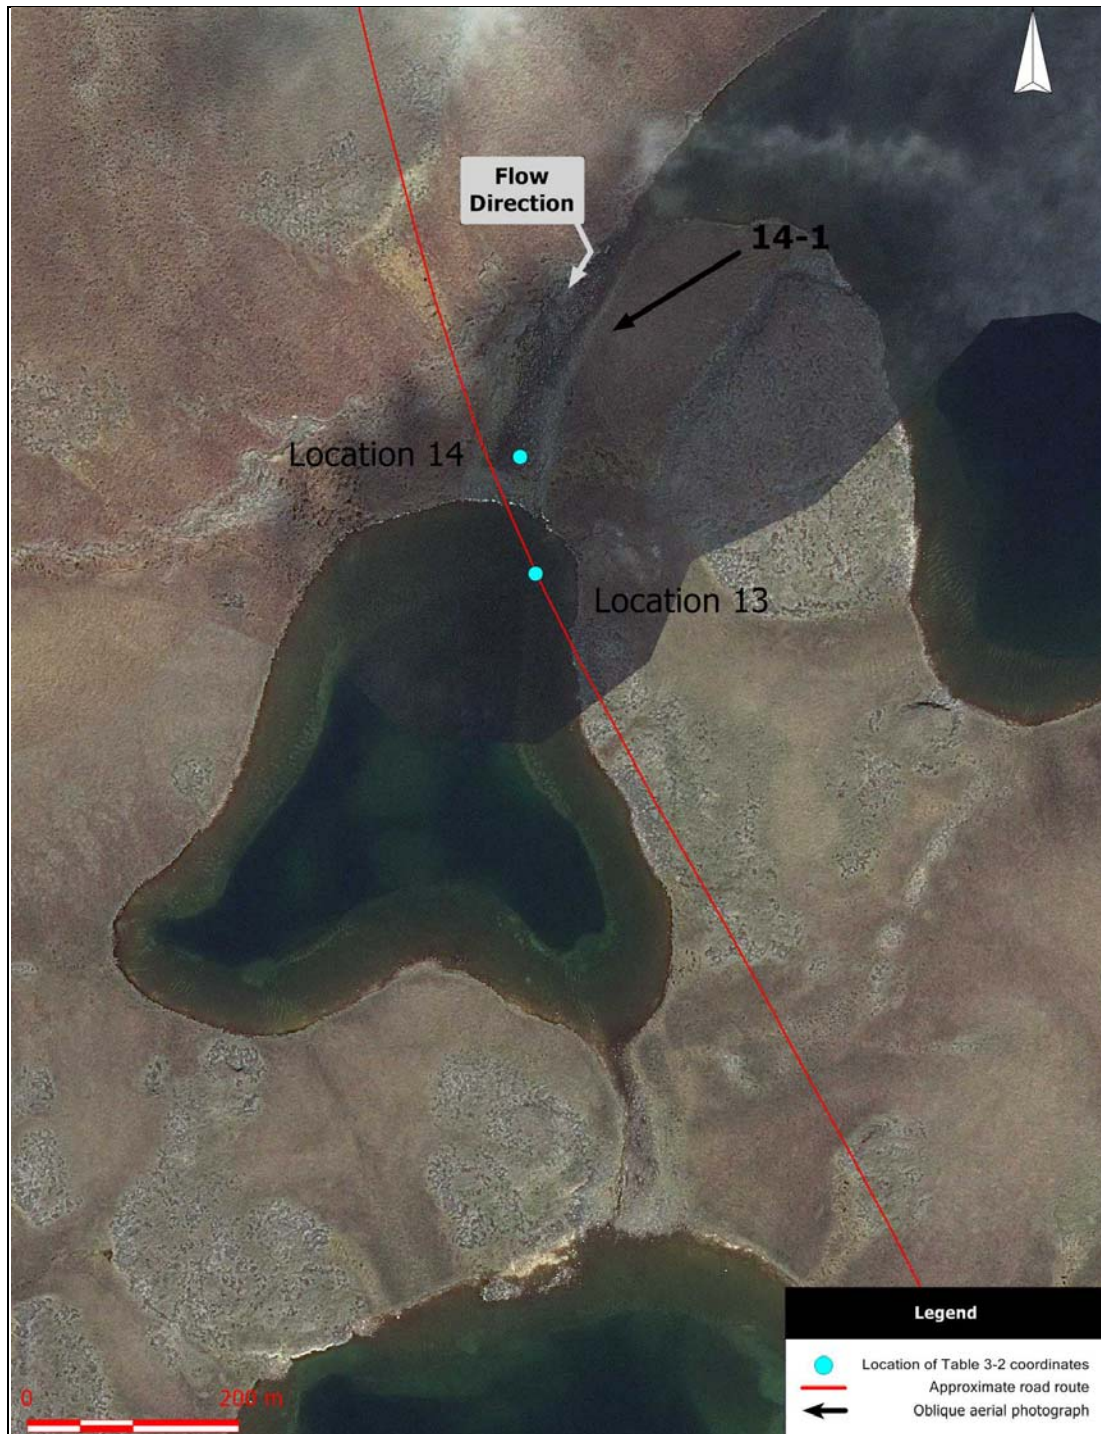
Locations 13 and 14. Aerial photograph (scale 1:5000) showing the approximate road route, the location of coordinates provided in Table 3-2, the flow direction, and the location of oblique aerial photographs. Lake at Location 13 will be avoided.

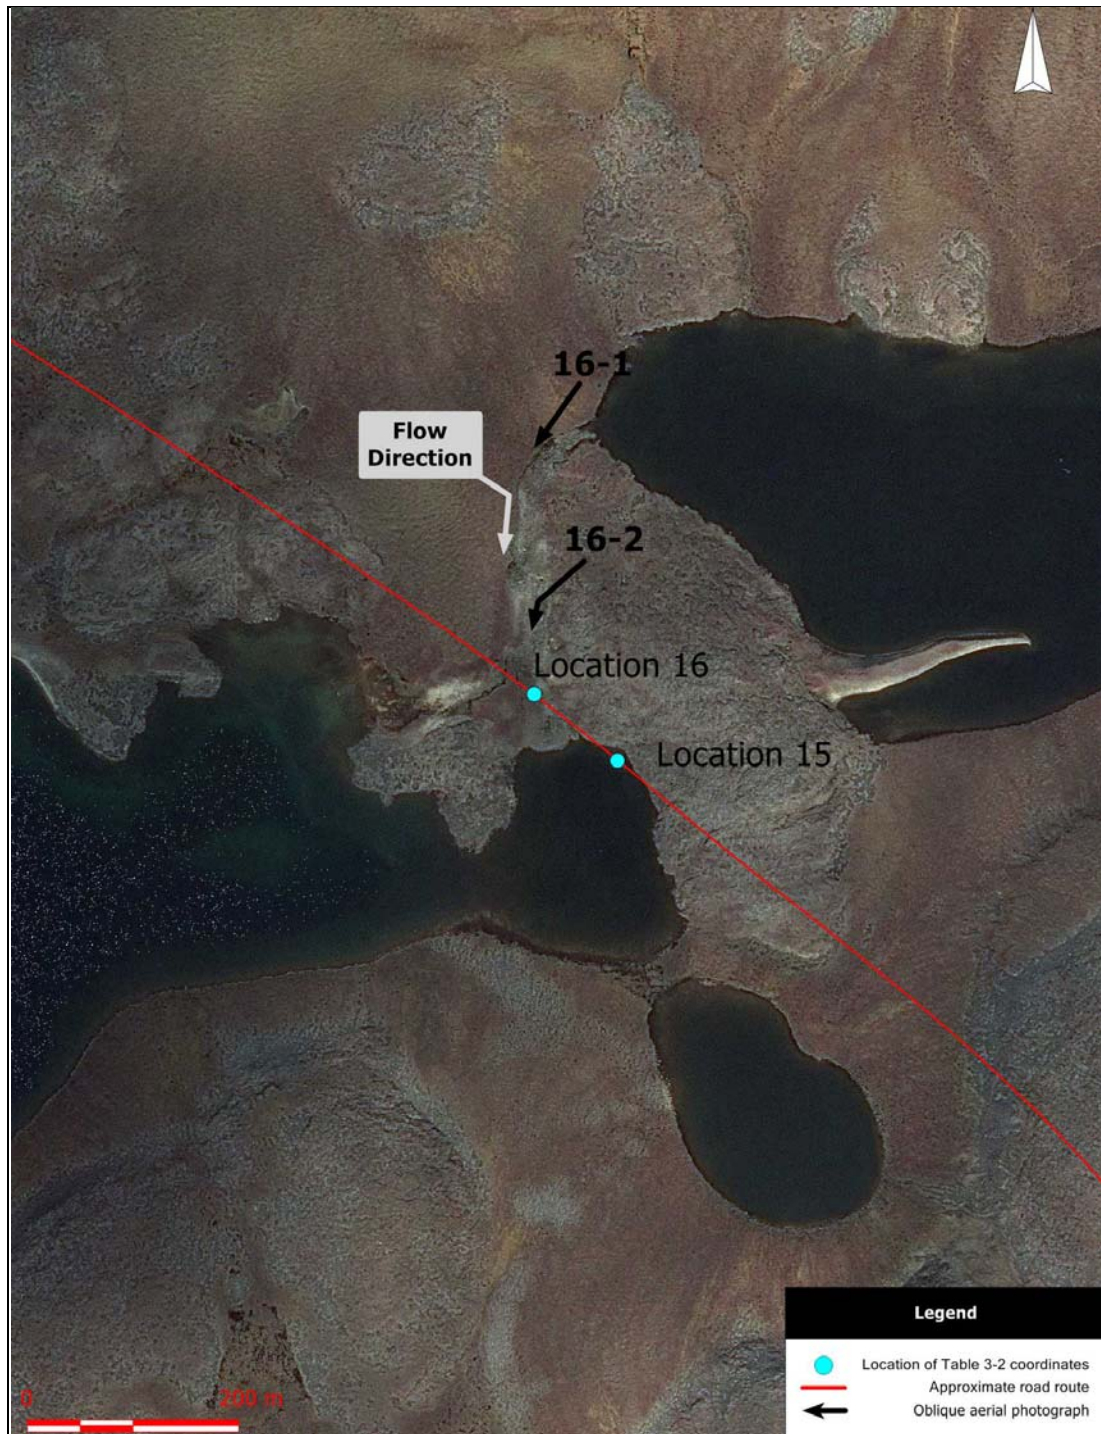
Locations 15 and 16. Aerial photograph (scale 1:5000) showing the approximate road route, the location of coordinates provided in Table 3-2, the flow direction, and the location of oblique aerial photographs. Lake at Location 15 will be avoided.

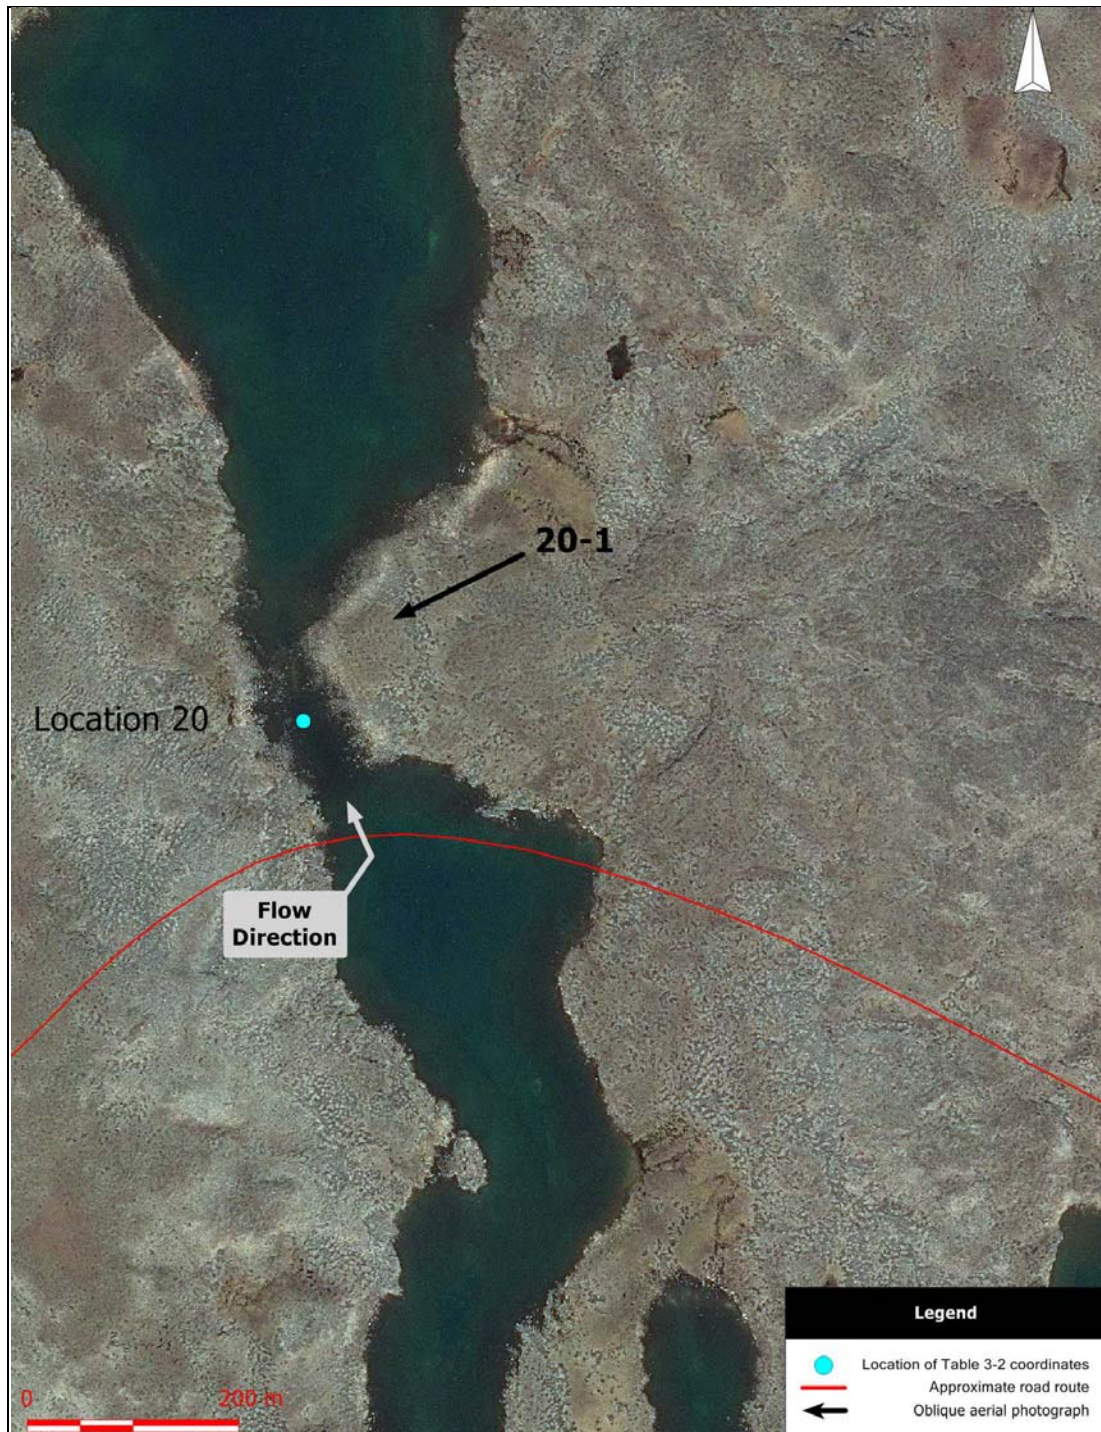
Location 20. Aerial photograph (scale 1:5000) showing the approximate road route, the location of coordinates provided in Table 3-2, the flow direction, and the location of oblique aerial photographs. Lakes near Location 20 will be avoided.

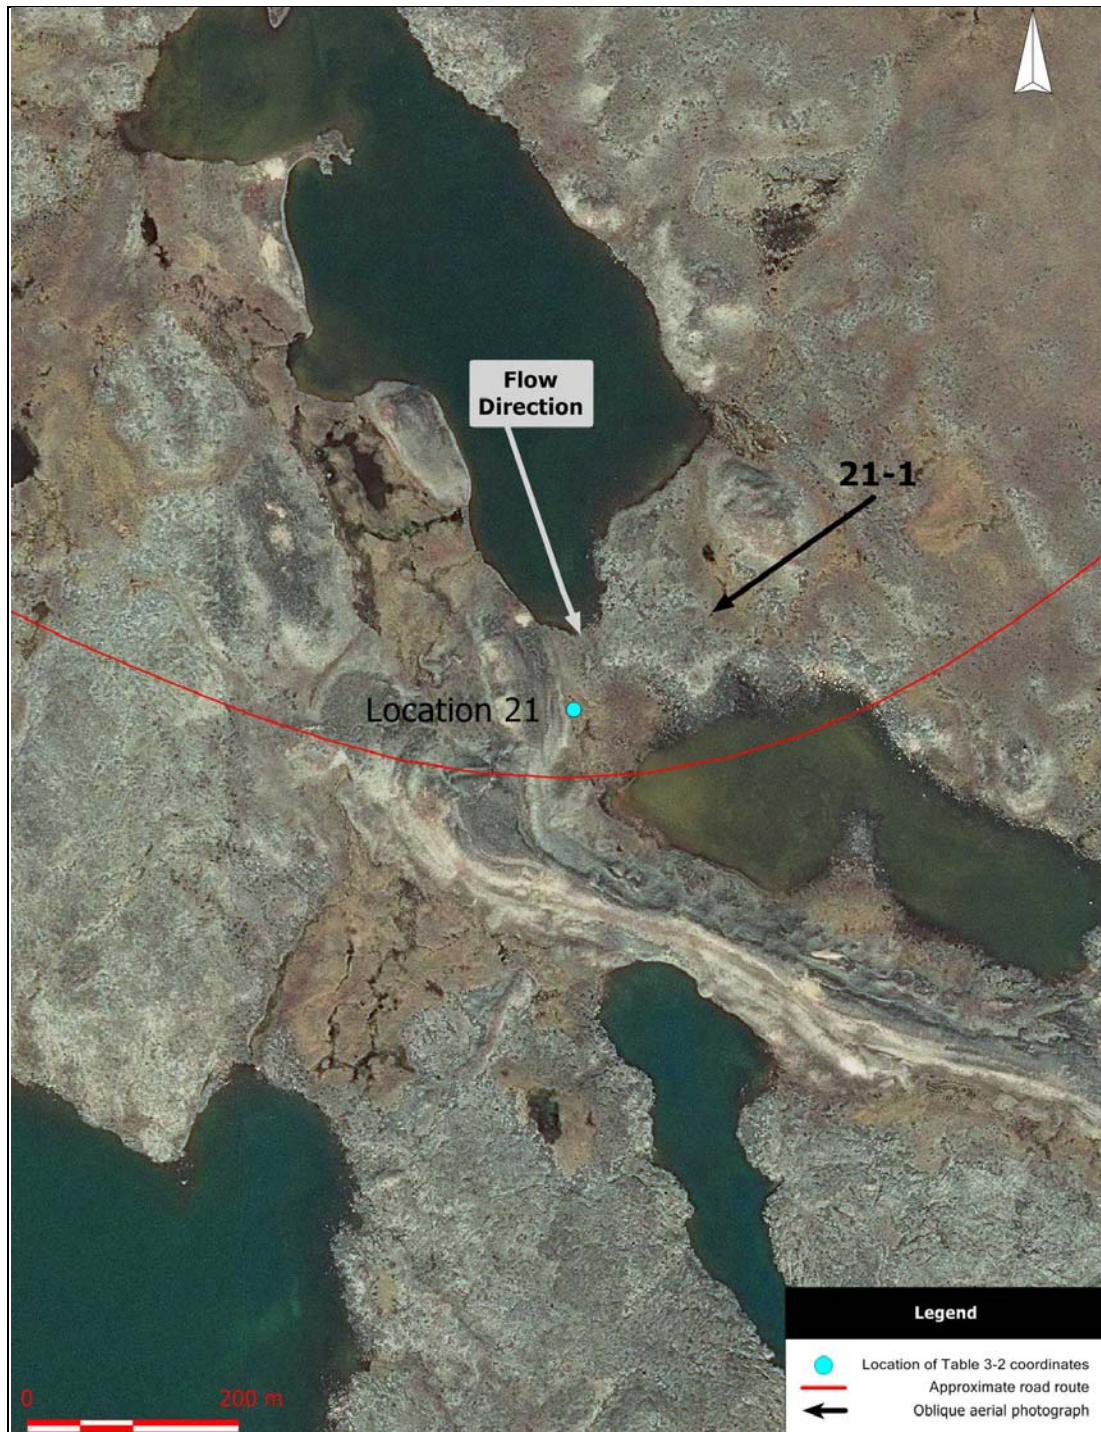
Location 21. Aerial photograph (scale 1:5000) showing the approximate road route, the location of coordinates provided in Table 3-2, the flow direction, and the location of oblique aerial photographs. Lake near Location 21 will be avoided.

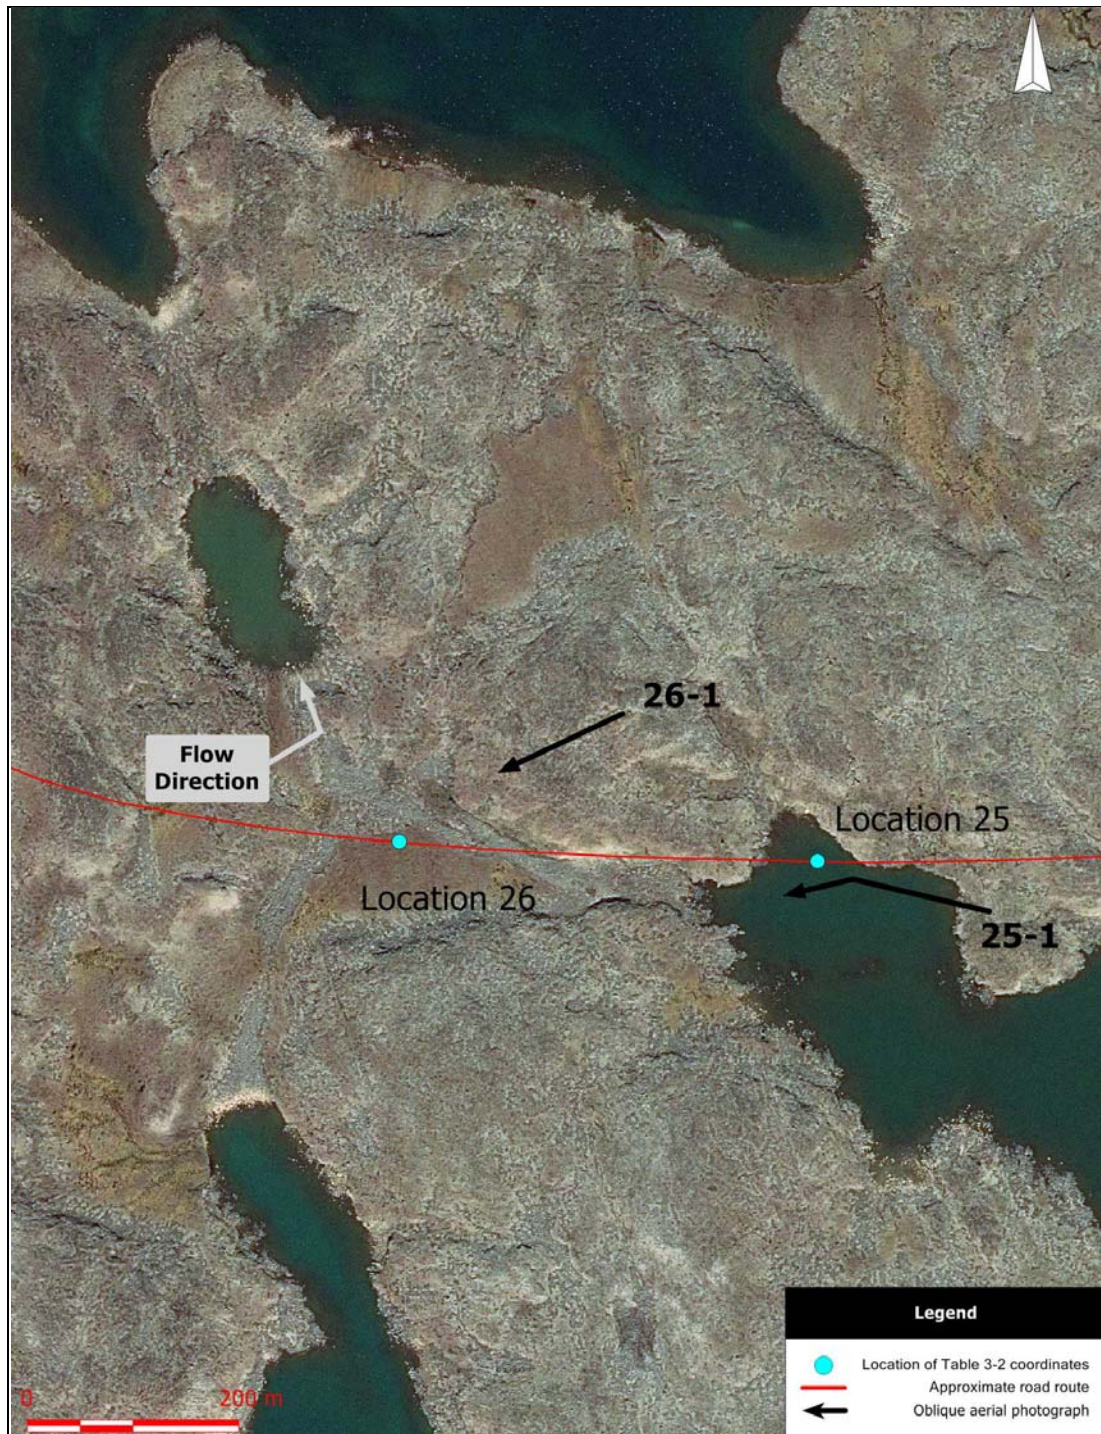
Locations 25 and 26. Aerial photograph (scale 1:5000) showing the approximate road route, the location of coordinates provided in Table 3-2, the flow direction, and the location of oblique aerial photographs. Lake at Location 25 will be avoided.

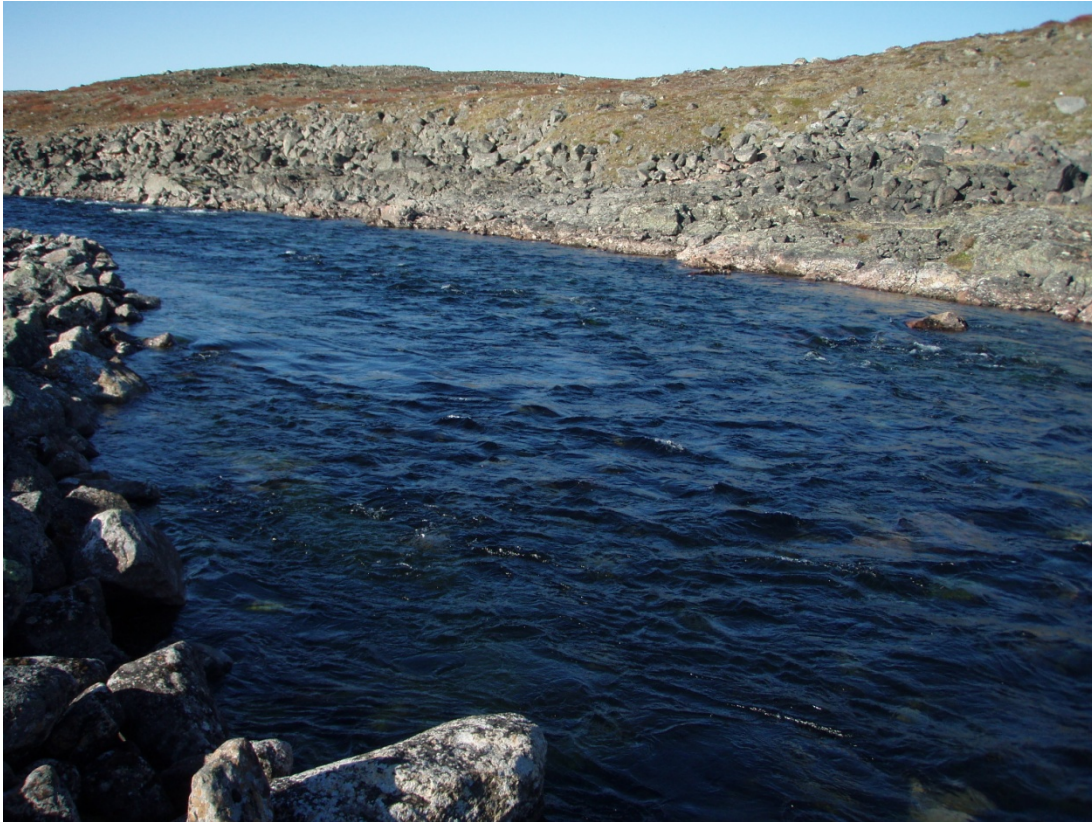
Location 28. Photograph from the ground. Upstream view from previous photograph location.

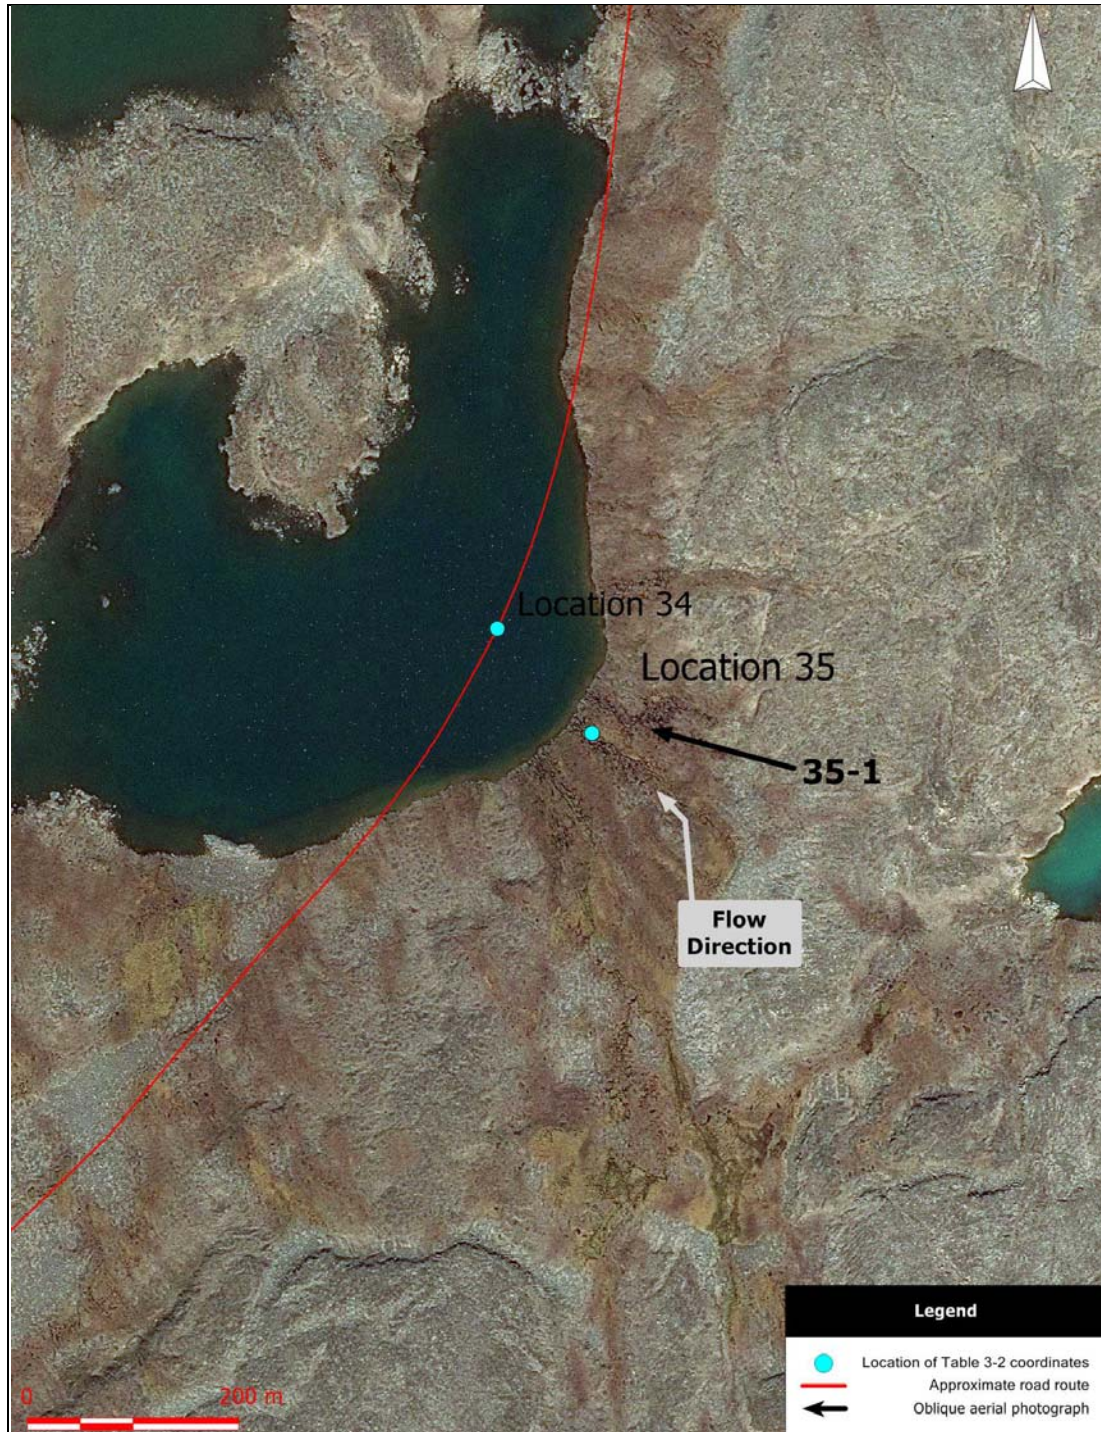
Locations 34 and 35. Aerial photograph (scale 1:5000) showing the approximate road route, the location of coordinates provided in Table 3-2, the flow direction, and the location of oblique aerial photographs. Lake at Location 34 will be avoided.

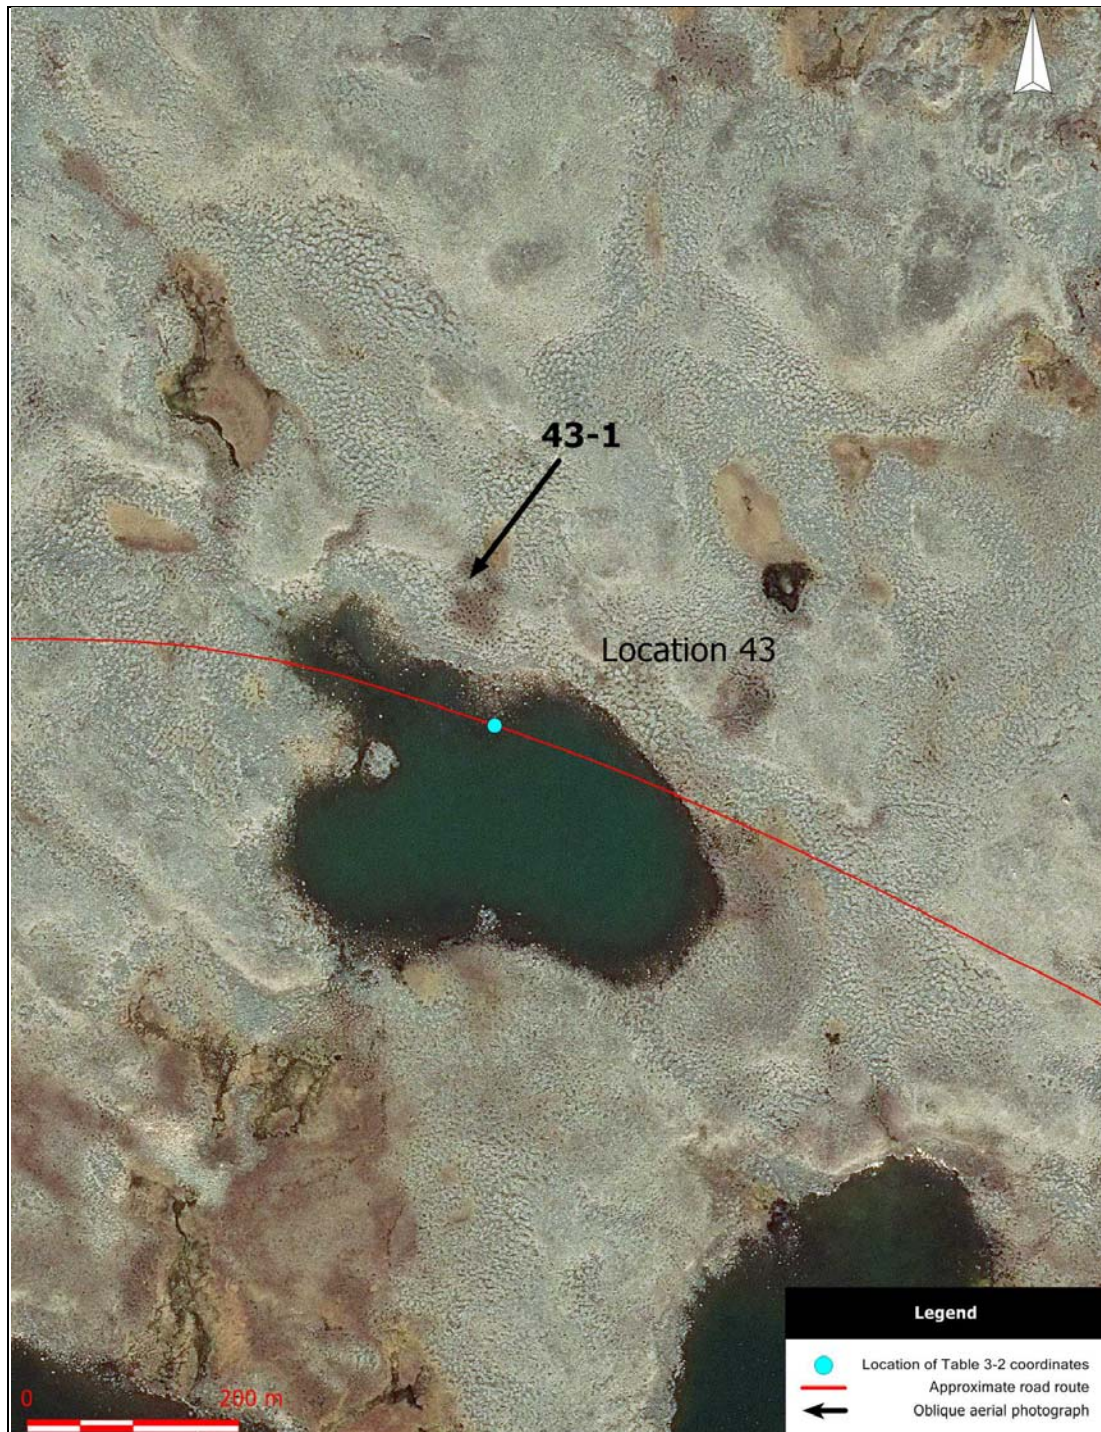
Location 43. Aerial photograph (scale 1:5000) showing the approximate road route, the location of coordinates provided in Table 3-2, the flow direction, and the location of oblique aerial photographs. Lake at Location 43 will be avoided.

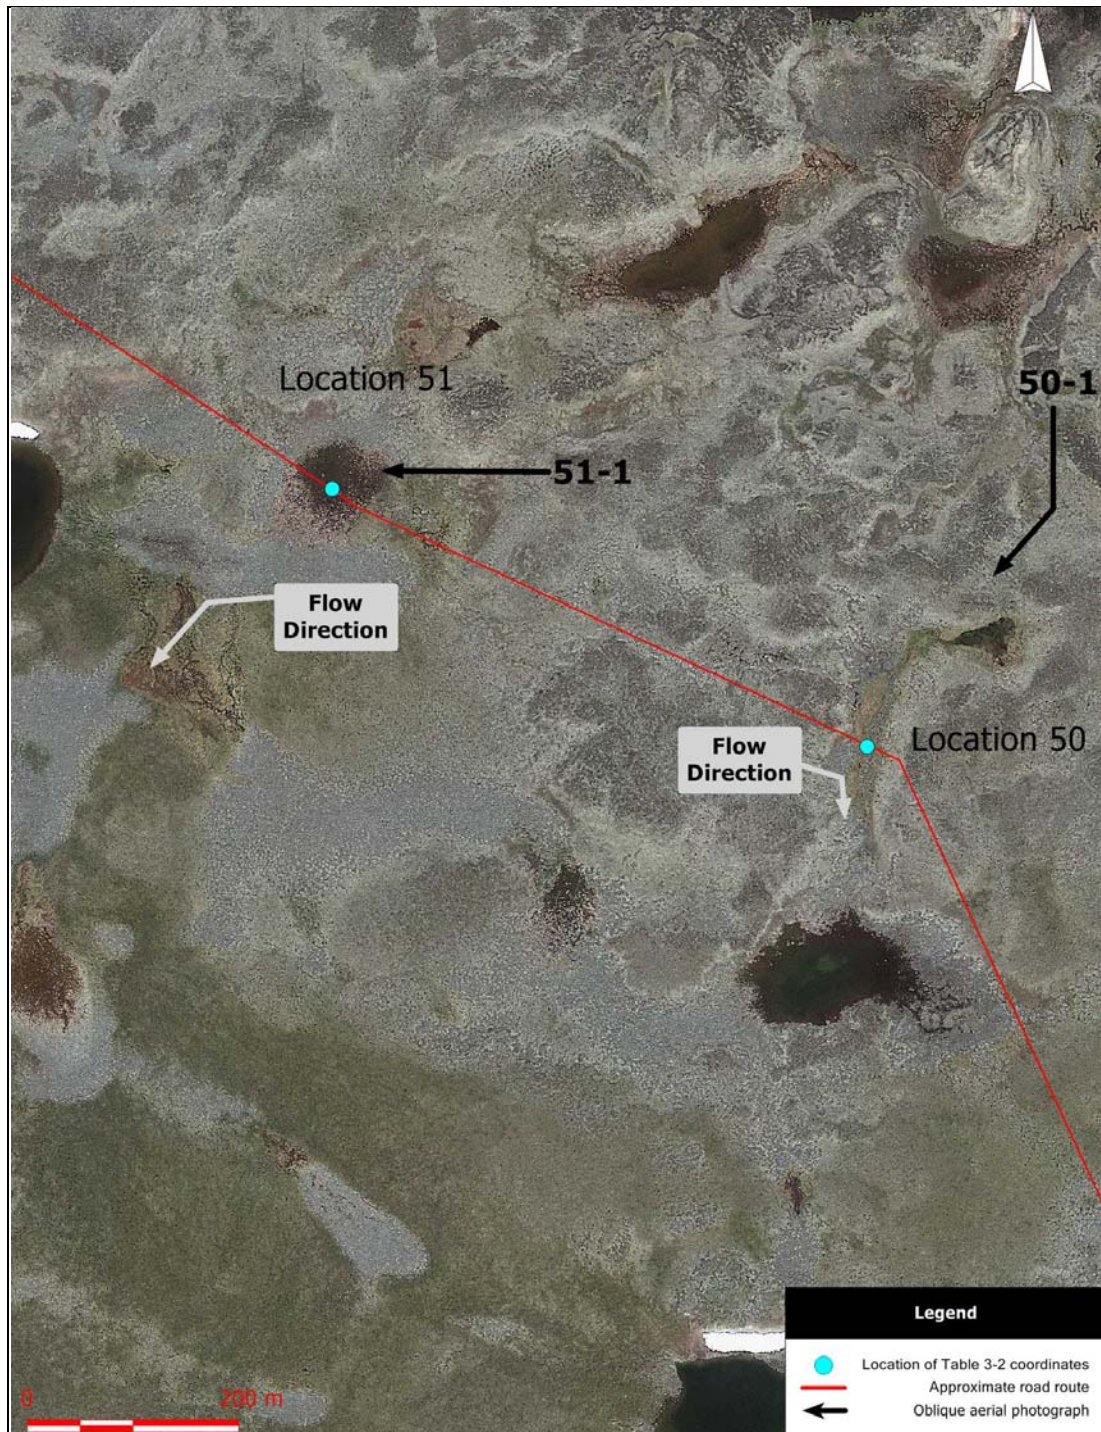
Locations 50 and 51. Aerial photograph (scale 1:5000) showing the approximate road route, the location of coordinates provided in Table 3-2, the flow direction, and the location of oblique aerial photographs. Pond at Location 51 will be avoided.

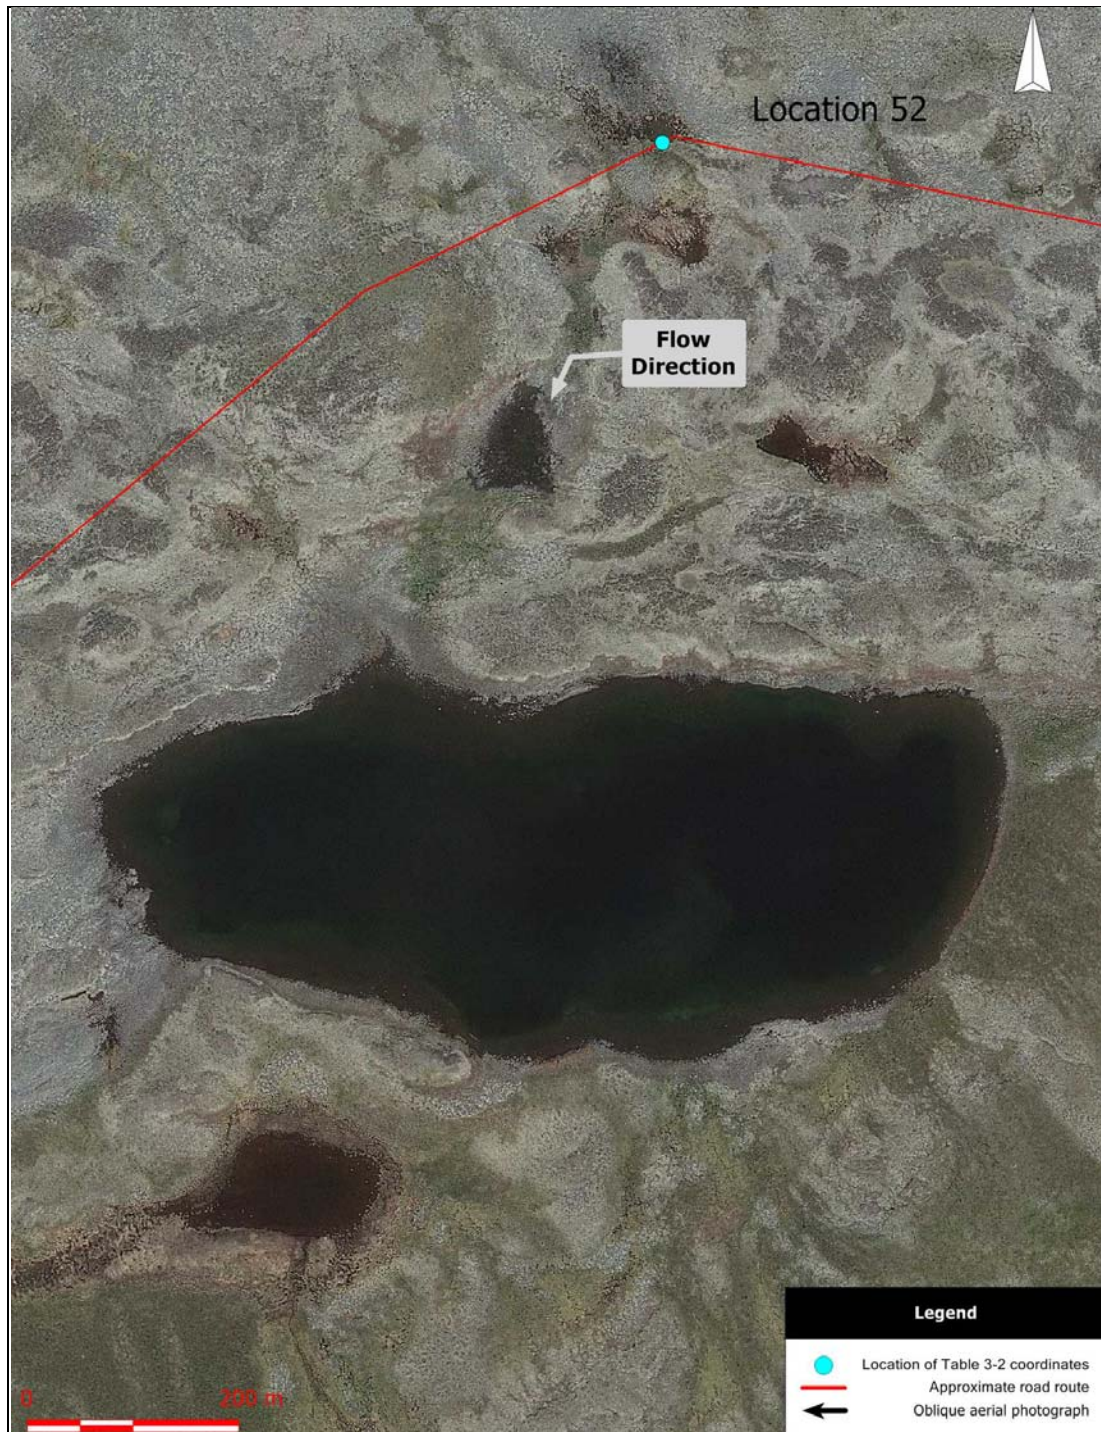
Location 52. Aerial photograph (scale 1:5000) showing the approximate road route, the location of coordinates provided in Table 3-2, and the flow direction. Pond at Location 52 will be avoided.
