Hydrology Baseline

AGNICO EAGLE MINES: MEADOWBANK DIVISION - WHALE TAIL PIT PROJECT

2015 Hydrology Baseline Report

Report Number: Doc 037-1524321.1300 Ver 1

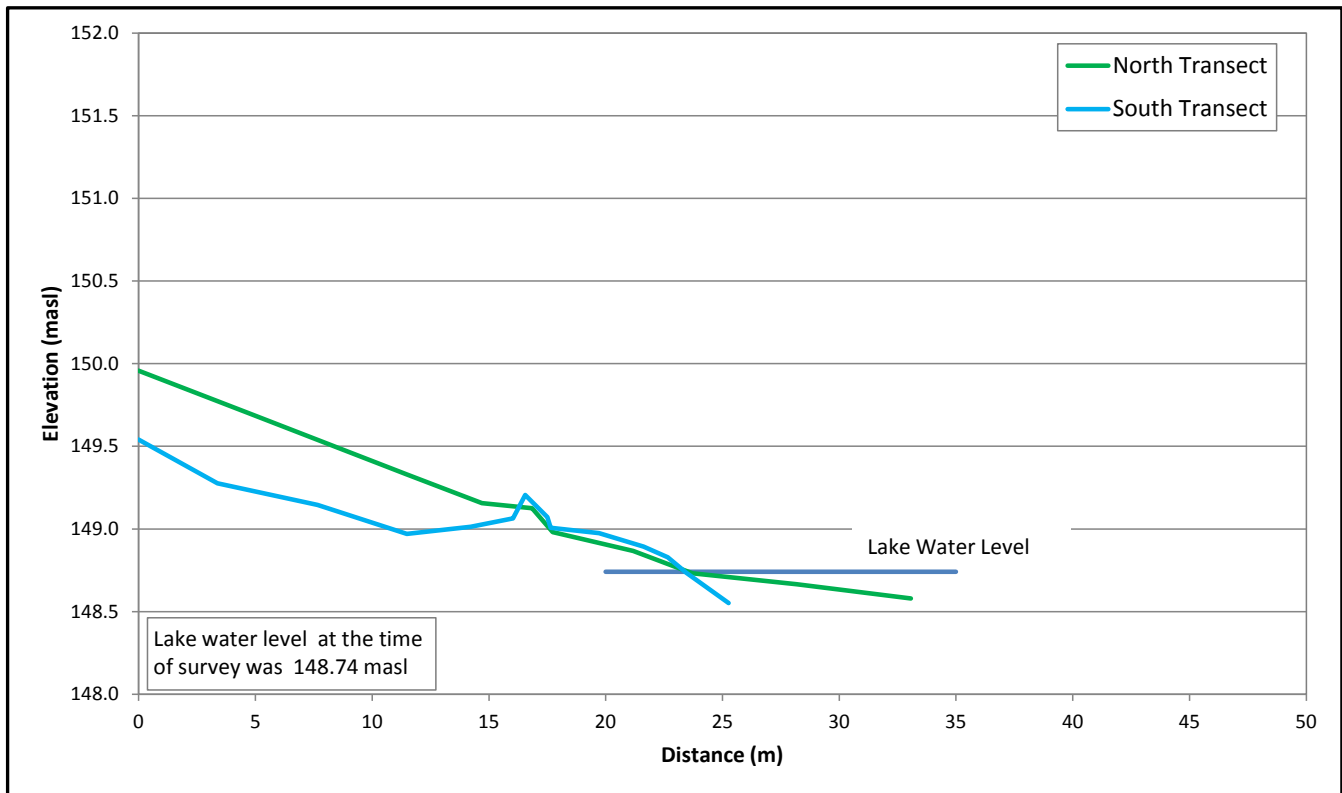
Figure 3-15: Cross-section Profiles of the Surveyed Transects, Lake A12

Two shore-normal transects were surveyed, one closer to the lake inlet (South Transect), and a second one closer to the lake outlet (North Transect) (Figure 3-15). At both locations, the shoreline is composed of boulders intercalated (cobble inserted between boulders) with cobble. The terrain slopes are similar, at typically less than 5% gradient.

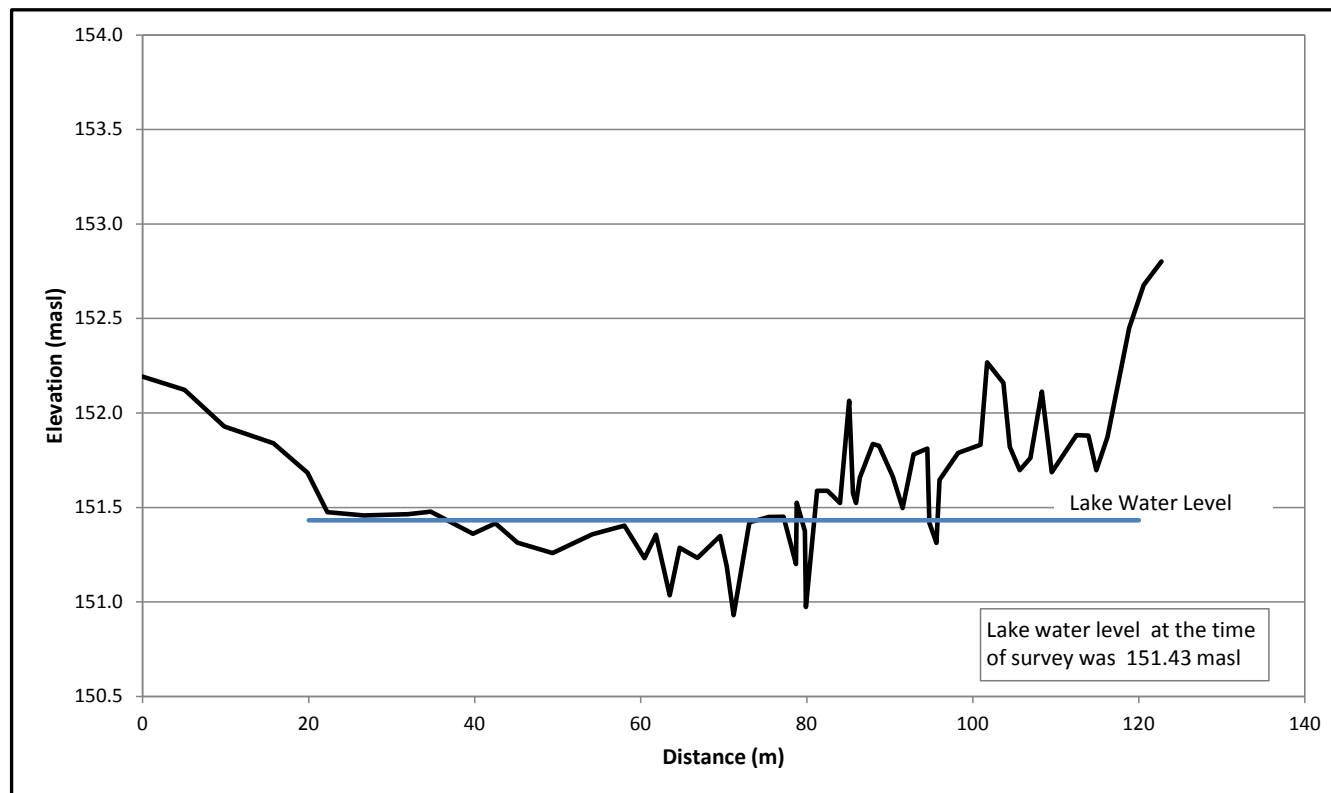
Figure 3-16: Lake A15 Outlet Channel Cross-Section, 2015

The outlet channel is approximately 50 m wide (Figure 3-16), with a poorly defined channel that is mainly comprised of large boulders. The water flows through or under the boulders for almost the entire width of the channel. The slope of the water surface in the channel could not be measured because no water was observed and the flow was determined to be through the boulders and below the surface.

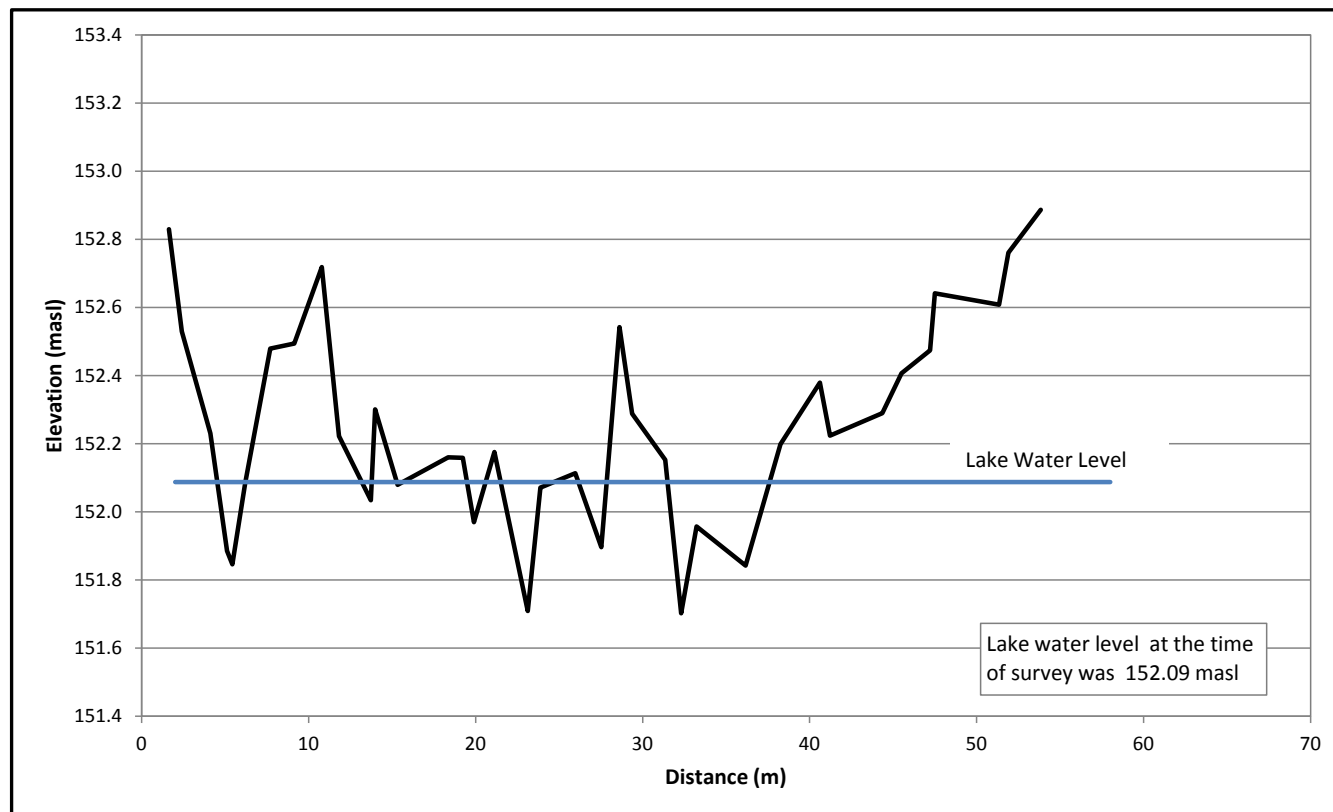
Figure 3-19: Lake A16 (Mammoth Lake) Outlet Channel Cross-Section, 2015

The outlet channel is approximately 45 m wide (Figure 3-19), with a poorly defined channel that is mainly comprised of large boulders. The water flows through or under the boulders for almost the entire length of the channel. A secondary channel was observed to the west of the main channel and it appears to function only during the high water levels, with the flow mostly through boulders and below surface. The slope of the water surface in the channel could not be measured because no water was observed. It was determined that the flow was through the boulders and below the surface.

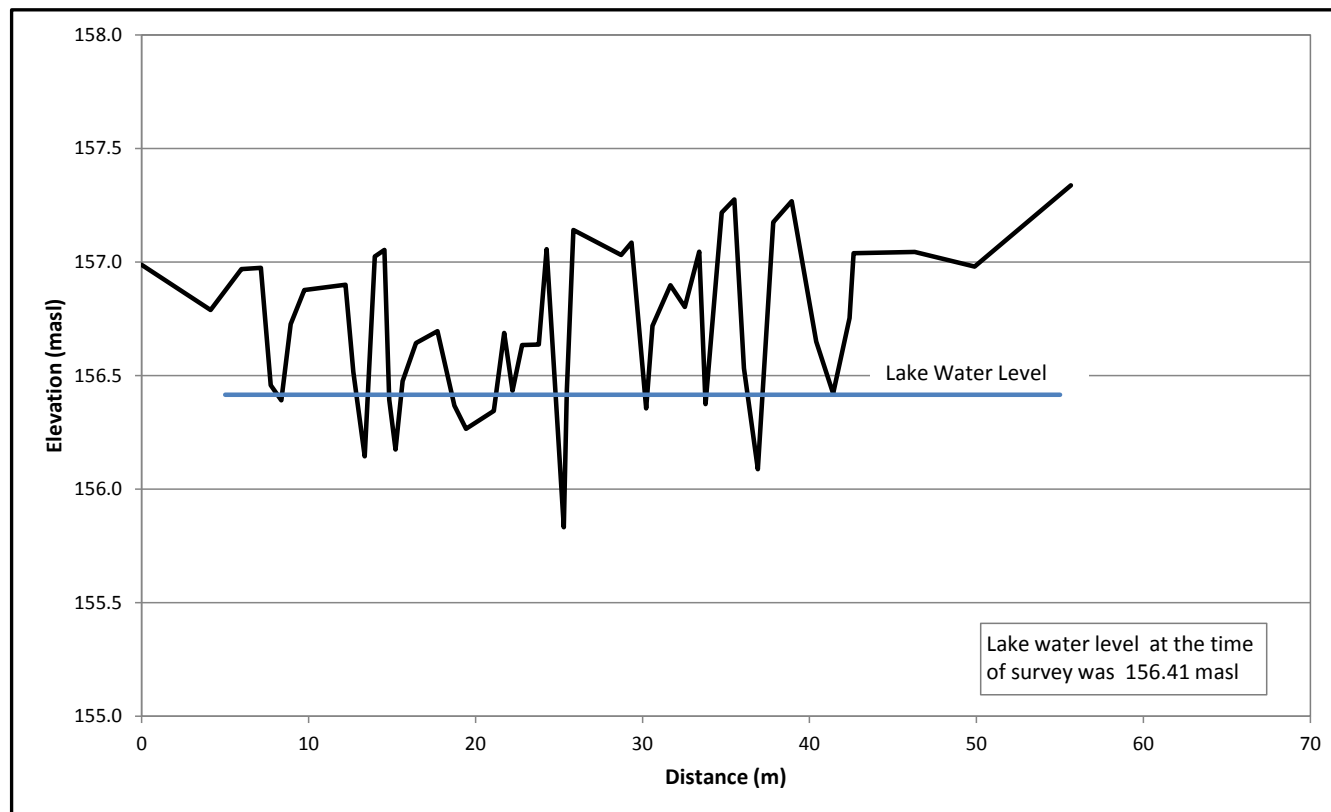
Figure 3-25: Lake A45 Outlet Channel Cross-Section, 2015

The lake outlet channel is approximately 35 m wide, poorly defined and composed of a boulder garden. Its banks have organic materials with vegetation on top of the boulders Figure 3-25. The slope of the water surface in the outlet channel could not be measured because no water was observed and the flow was determined to be through the boulders and below the surface.

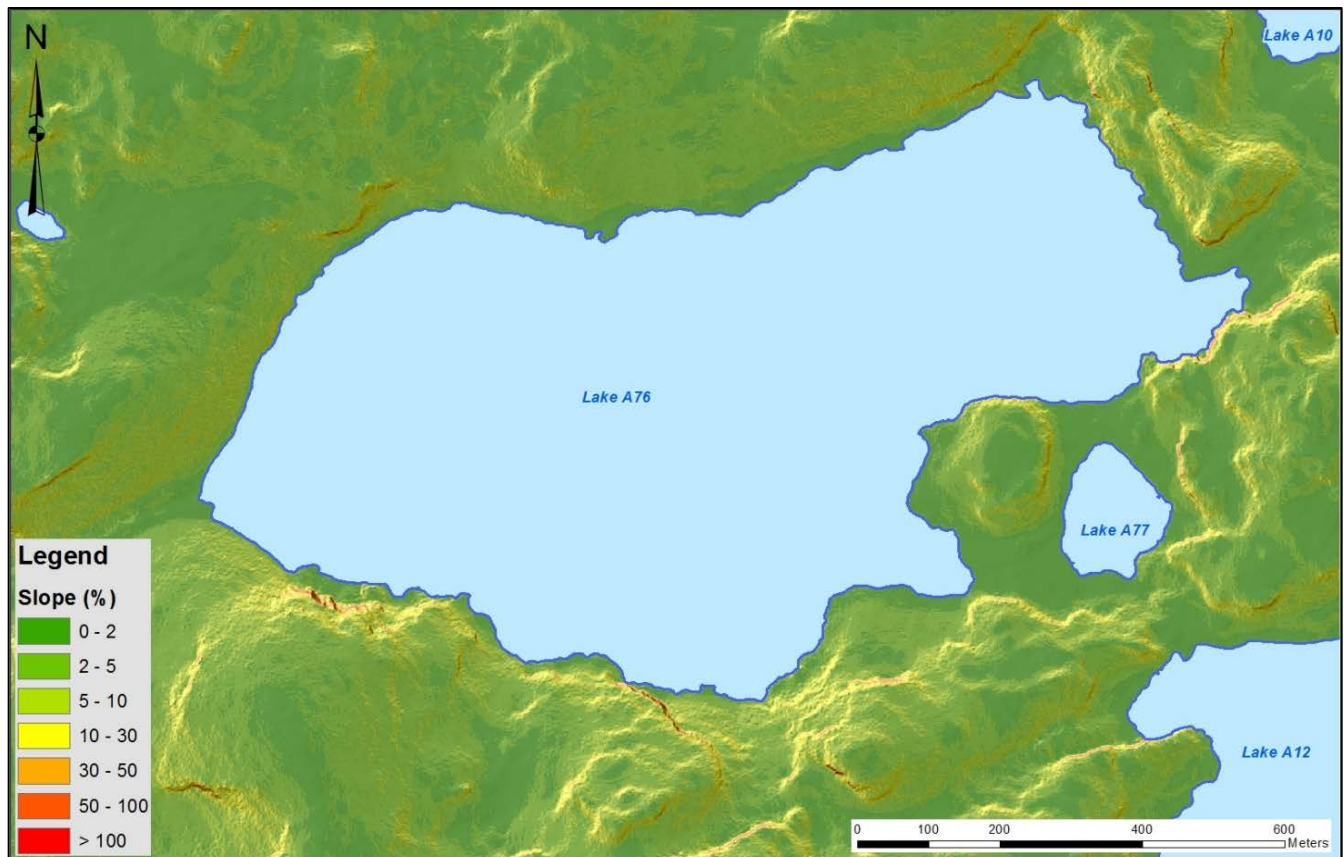
Figure 3-32: Lake A76 Shoreline Slope (Based on available DEM data [PhotoSat 2015])

The water surface elevation at Lake A76 at the time of survey (i.e., 18 September 2015) was measured as 147.48 masl, and the ordinary high water level was estimated as 147.70 masl. A more detailed description of the lake shoreline is presented in Table 3-20, and is based on the field reconnaissance and satellite imagery provided by Agnico Eagle (PhotoSat 2015). Terrain slopes calculated for the Lake A76 shoreline are shown in Figure 3-32.
