# APPENDIX 6-D

## Portt 2015 Road Baseline Report

# **AMARUQ EXPLORATION ACCESS ROAD AQUATICS BASELINE REPORT 2015 AGNICO EAGLE MINES LTD. - MEADOWBANK DIVISION**

November 25, 2015.

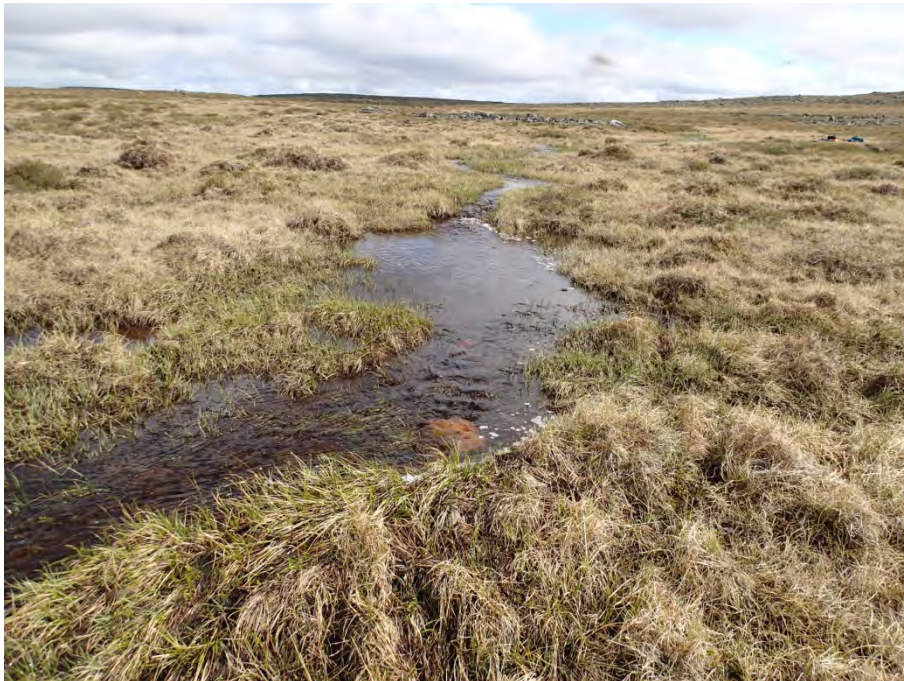
Kilometre 11.1. Photograph from the ground. View upstream from near the downstream lake.  
July 11, 2015.

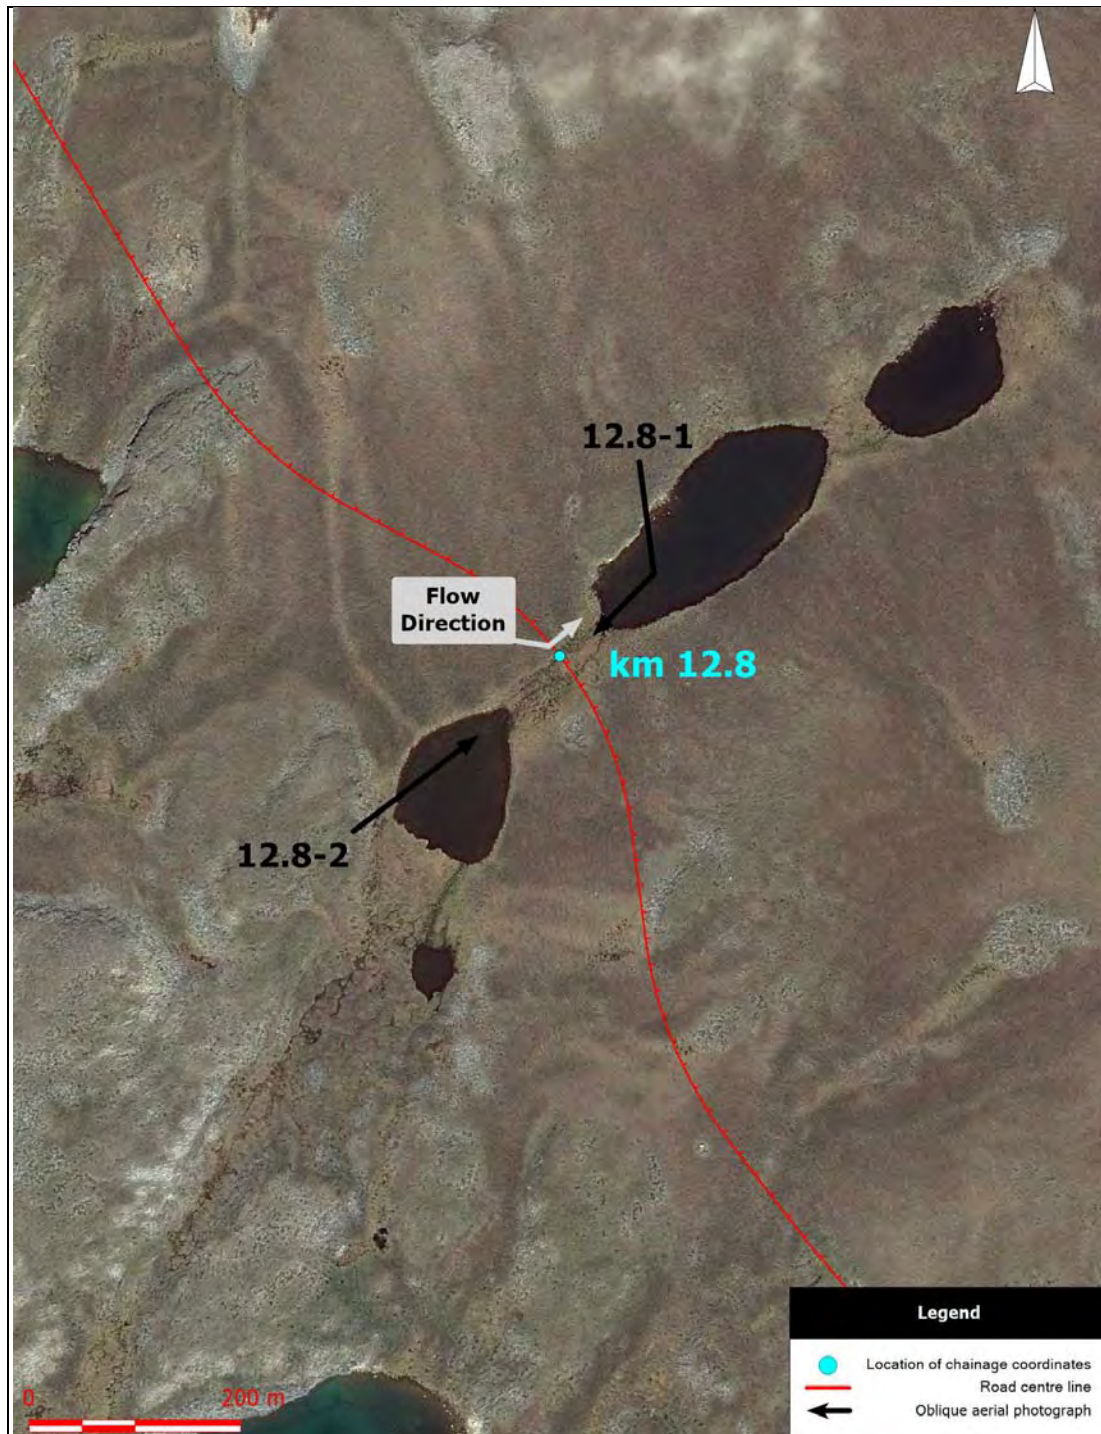
Kilometre 12.8. Aerial photograph showing the road centre line, the location of chainage coordinates provided in Table 3-2, the flow direction, and the location of oblique aerial photographs.

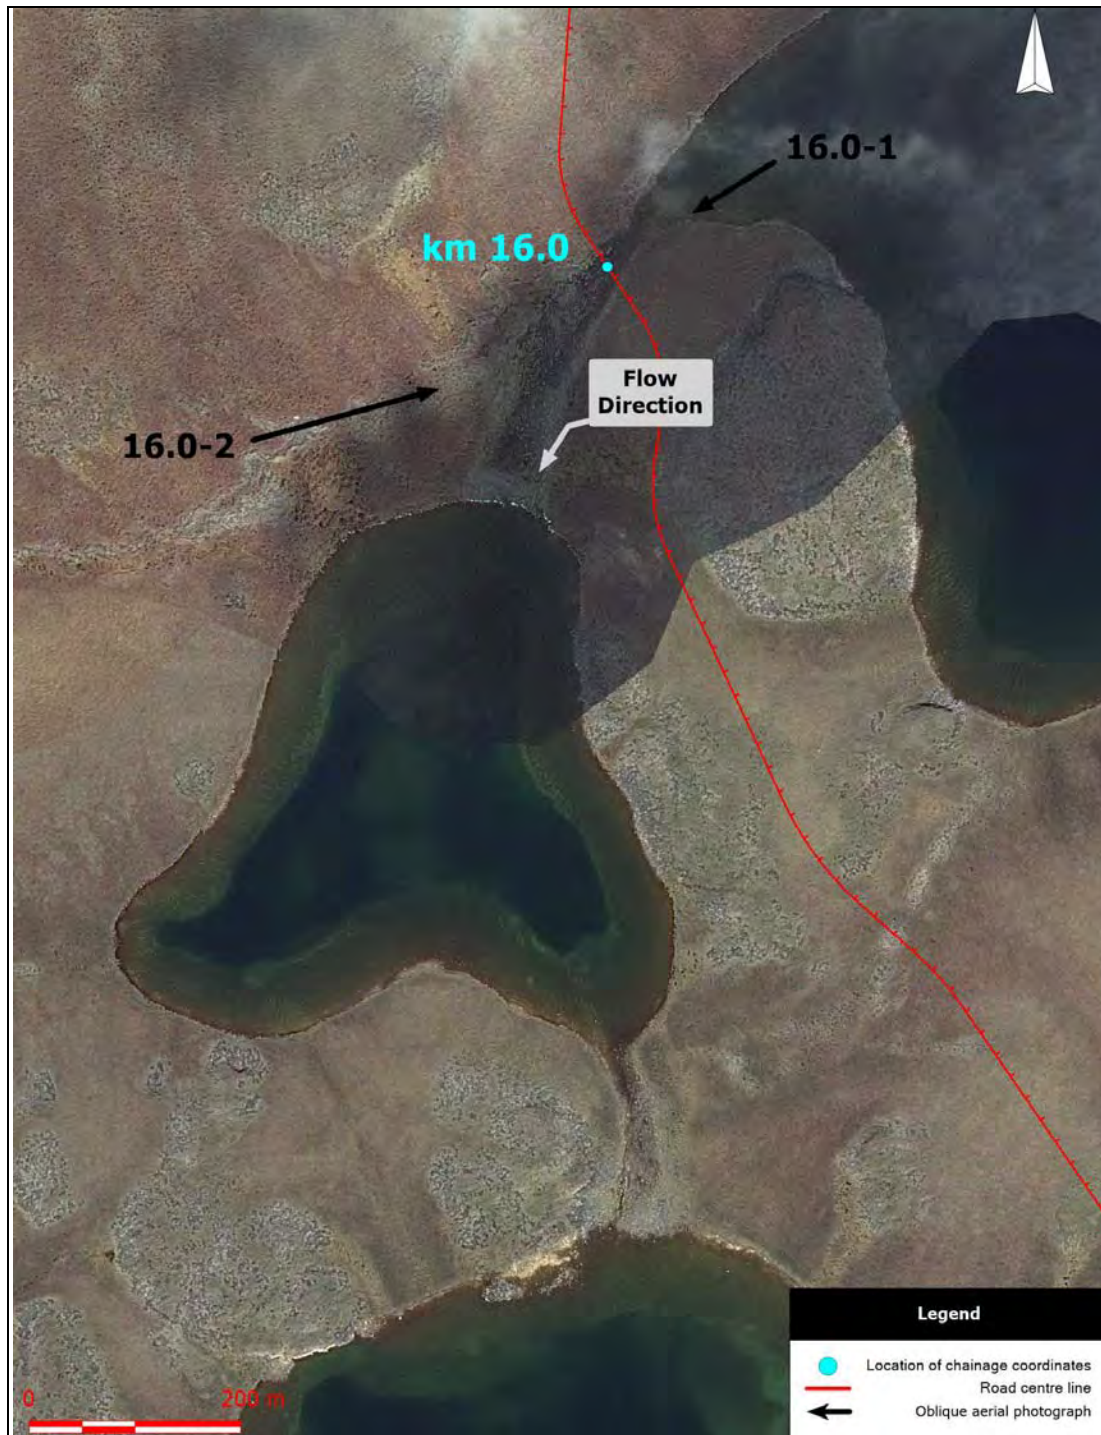
Kilometre 16.0. Aerial photograph showing the road centre line, the location of chainage coordinates provided in Table 3-2, the flow direction, and the location of oblique aerial photographs.

The total number of locations where fish habitat exists or may exist, based on the observed habitat conditions along the road alignment, is 28. The watercourses at three of the locations (km 16.0, km 23.9 and km 32.3) were characterized as rivers. These provide habitat for small-bodied fish, and potentially also for large-bodied fish, throughout the open-water period. Due to their depth and flow, these watercourses are also potential migration routes for large-bodied fish throughout the open water period. Clear-span bridges are recommended for these locations.

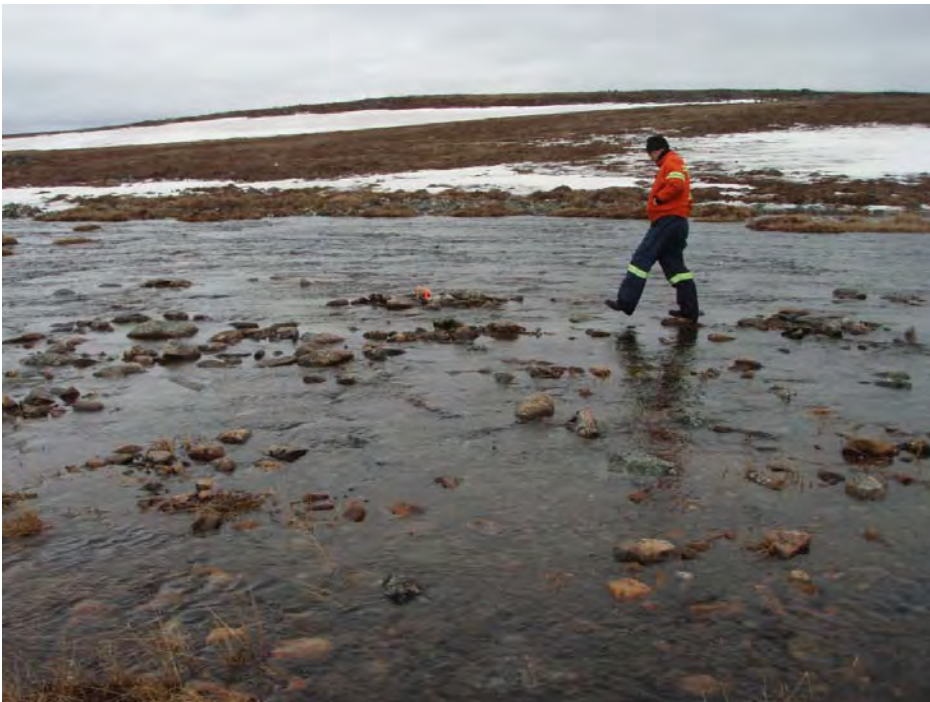
Kilometre 16.0. Photograph from the ground. Approximately 250 m upstream from lake at the proposed bridge location. June 23, 2015.
