## 6-D: Portt 2015 Road Baseline Report

# AMARUQ EXPLORATION ACCESS ROAD AQUATICS BASELINE REPORT 2015 AGNICO EAGLE MINES LTD. - MEADOWBANK DIVISION

November 25, 2015.

C. PORTT and ASSOCIATES  
63 Waterloo Avenue  
Guelph, Ontario, N1H 3H5  
[cportt@sentex.net](mailto:cportt@sentex.net)

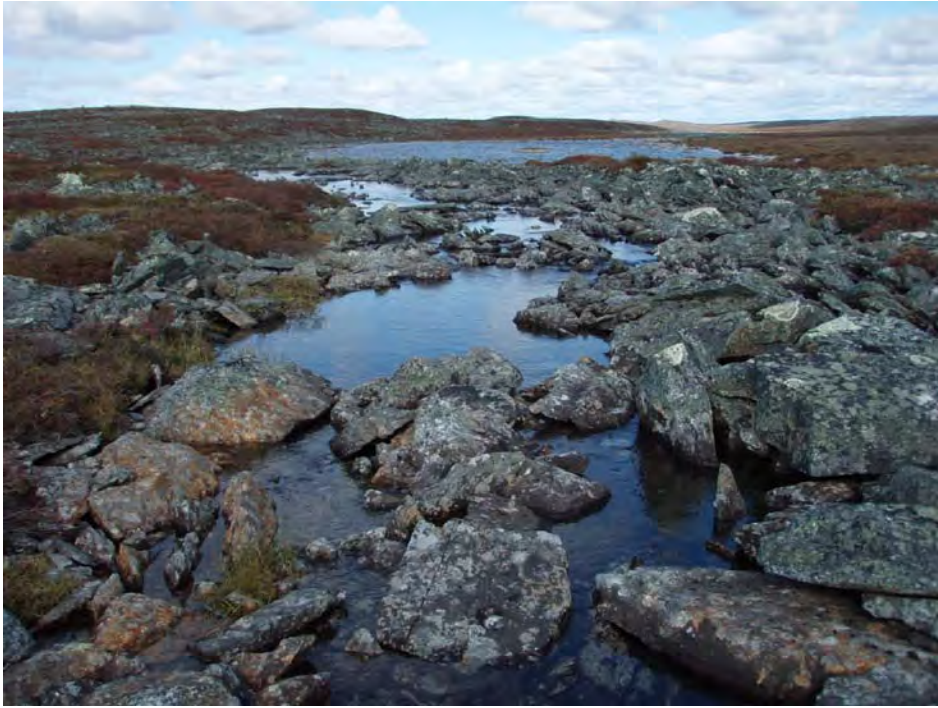
Kilometre 3.4. Photograph from the ground. Upstream view from the proposed road crossing. August 30, 2014.

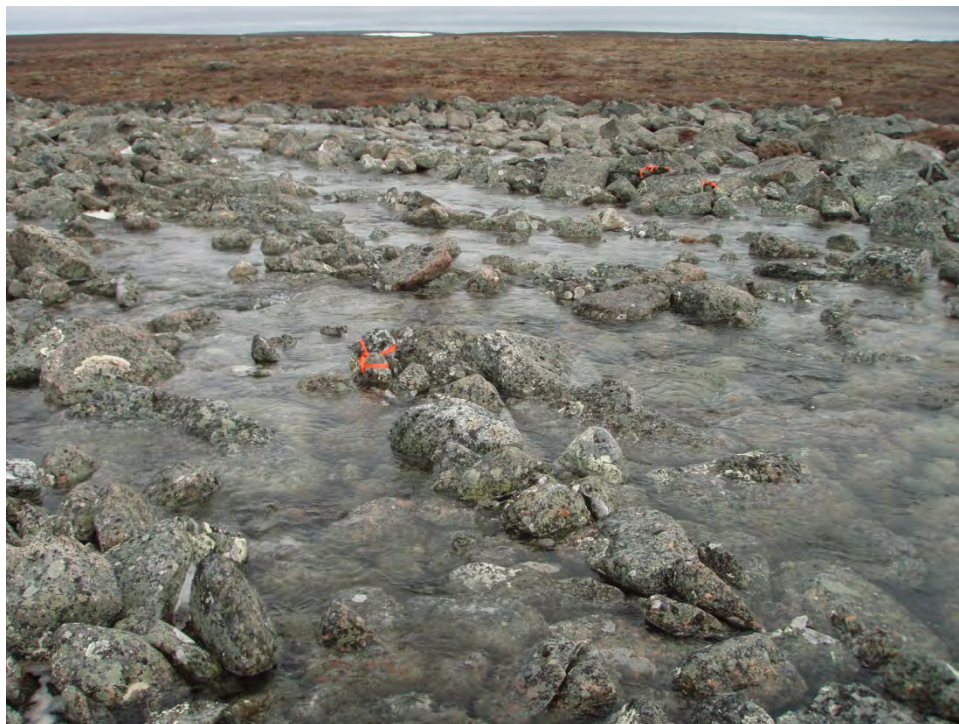
Kilometre 10.7. Photograph from the ground. View of the proposed road crossing. June 23, 2015.

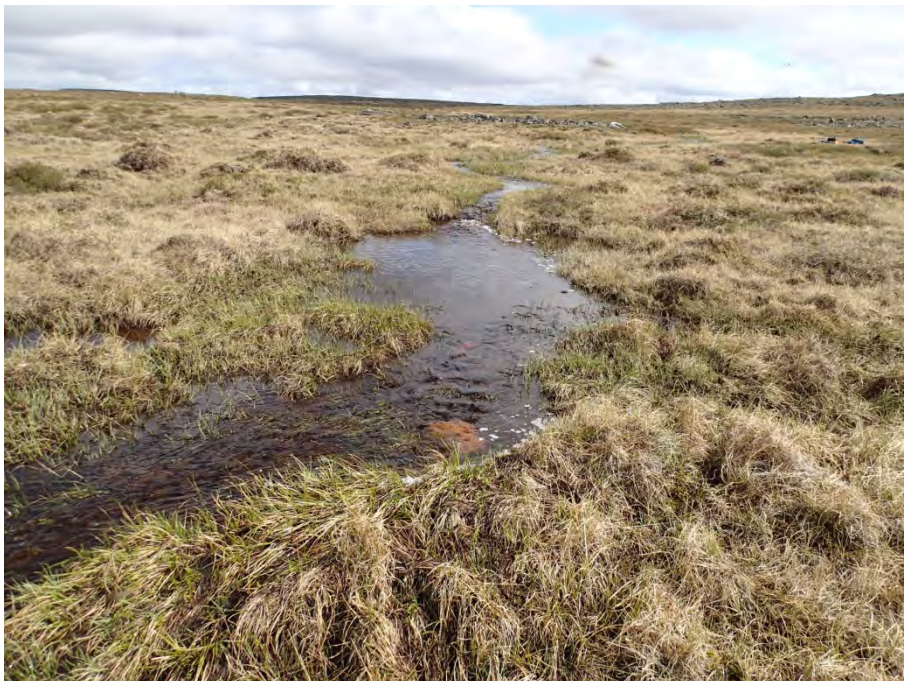
Kilometre 11.1. Photograph from the ground. View upstream from near the downstream lake.  
July 11, 2015.

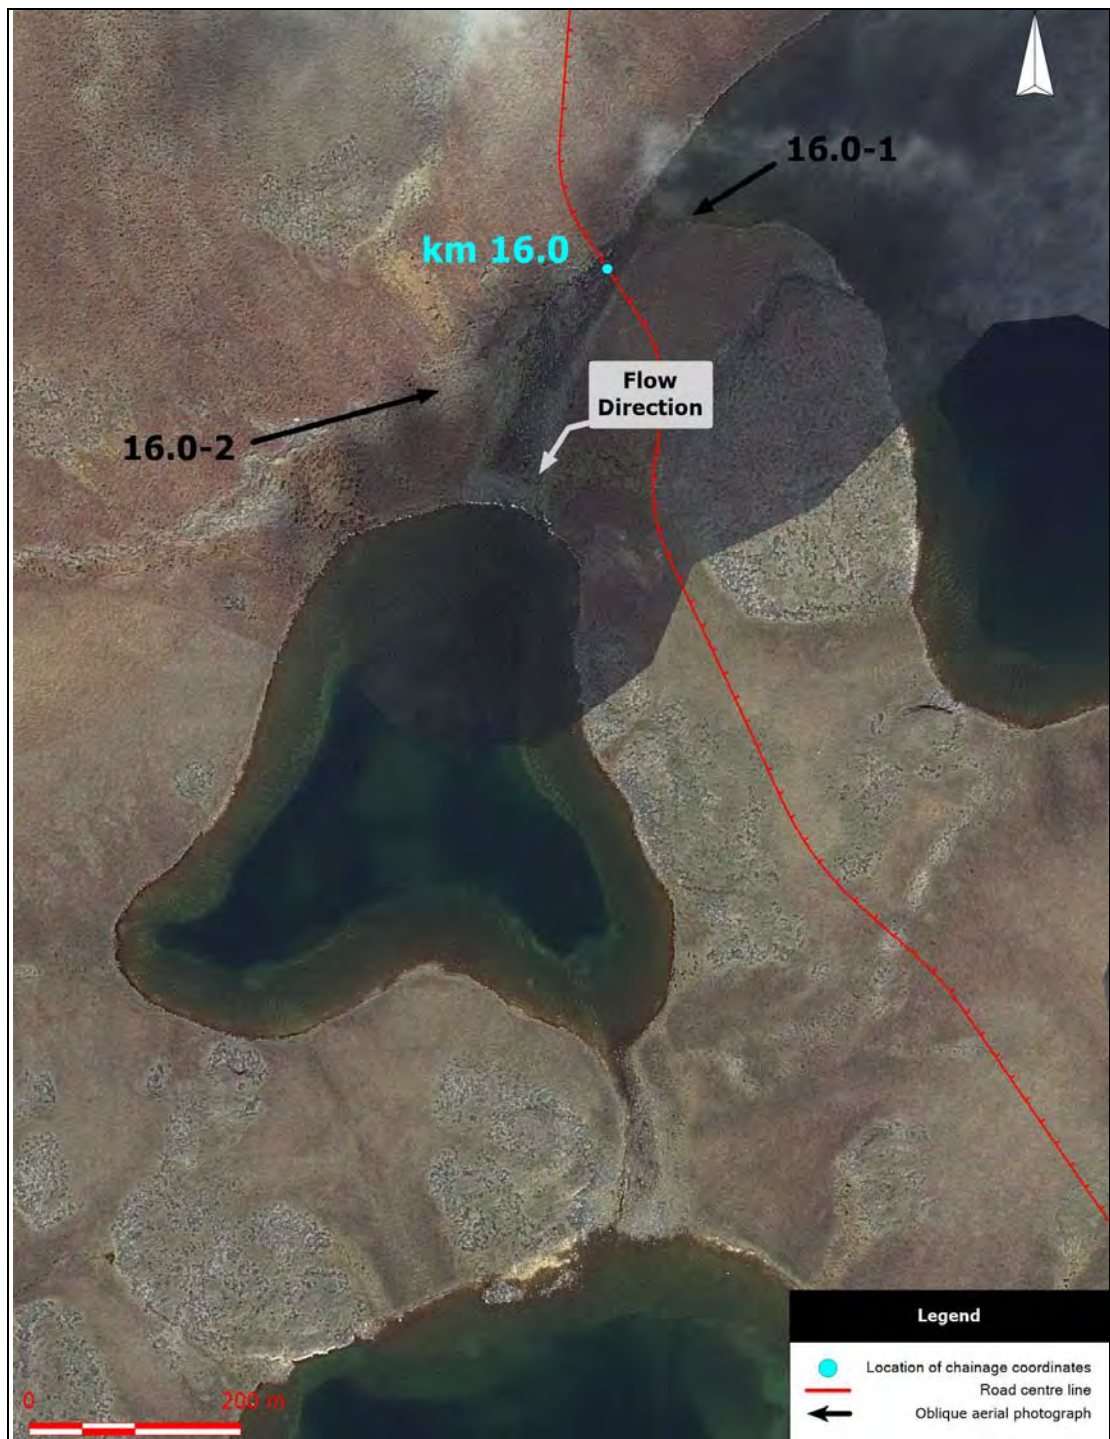
Kilometre 16.0. Aerial photograph showing the road centre line, the location of chainage coordinates provided in Table 3-2, the flow direction, and the location of oblique aerial photographs.

The total number of locations where fish habitat exists or may exist, based on the observed habitat conditions along the road alignment, is 28. The watercourses at three of the locations (km 16.0, km 23.9 and km 32.3) were characterized as rivers. These provide habitat for small-bodied fish, and potentially also for large-bodied fish, throughout the open-water period. Due to their depth and flow, these watercourses are also potential migration routes for large-bodied fish throughout the open water period. Clear-span bridges are recommended for these locations.

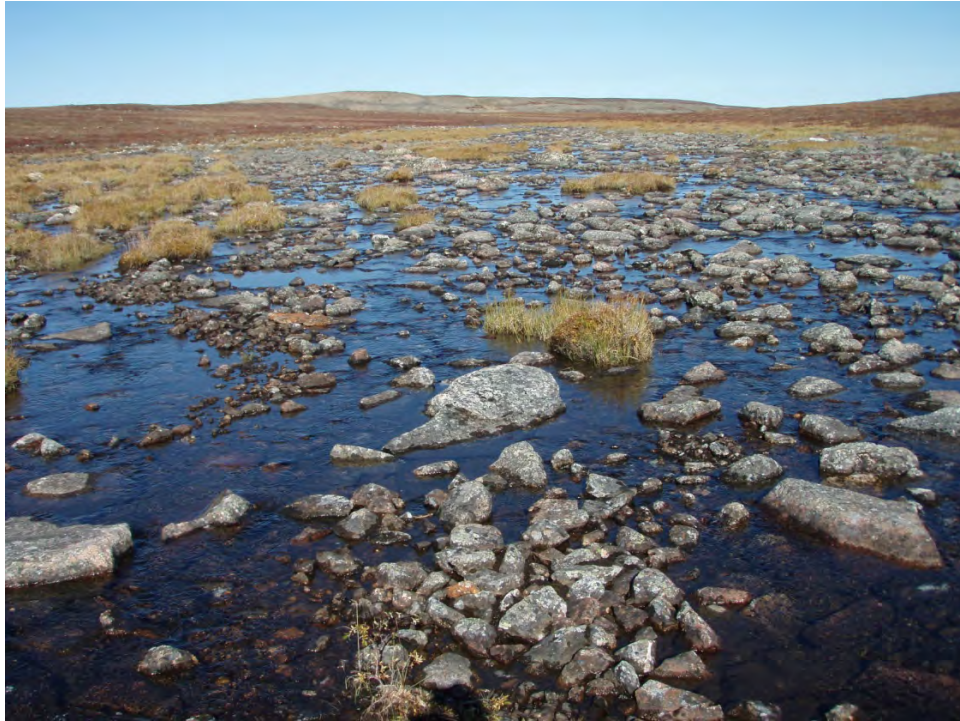
Kilometre 16.0. Photograph from the ground. Approximately 100 m upstream from lake.

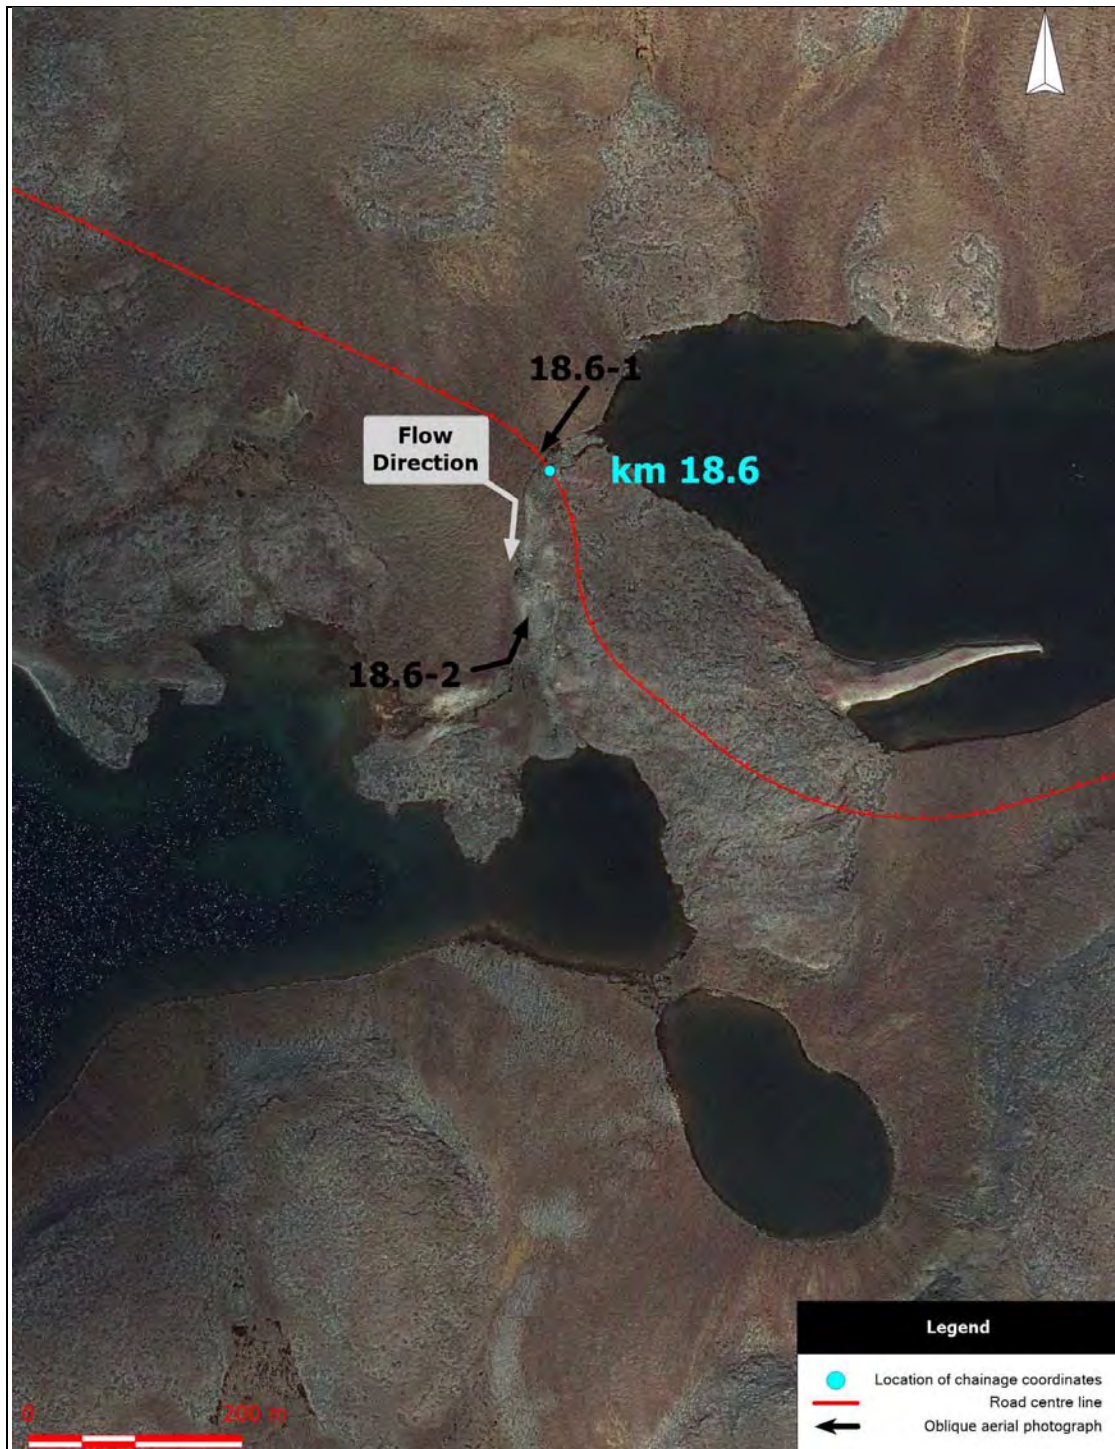
Kilometre 18.6. Aerial photograph showing the road centre line, the location of chainage coordinates provided in Table 3-2, the flow direction, and the location of oblique aerial photographs.

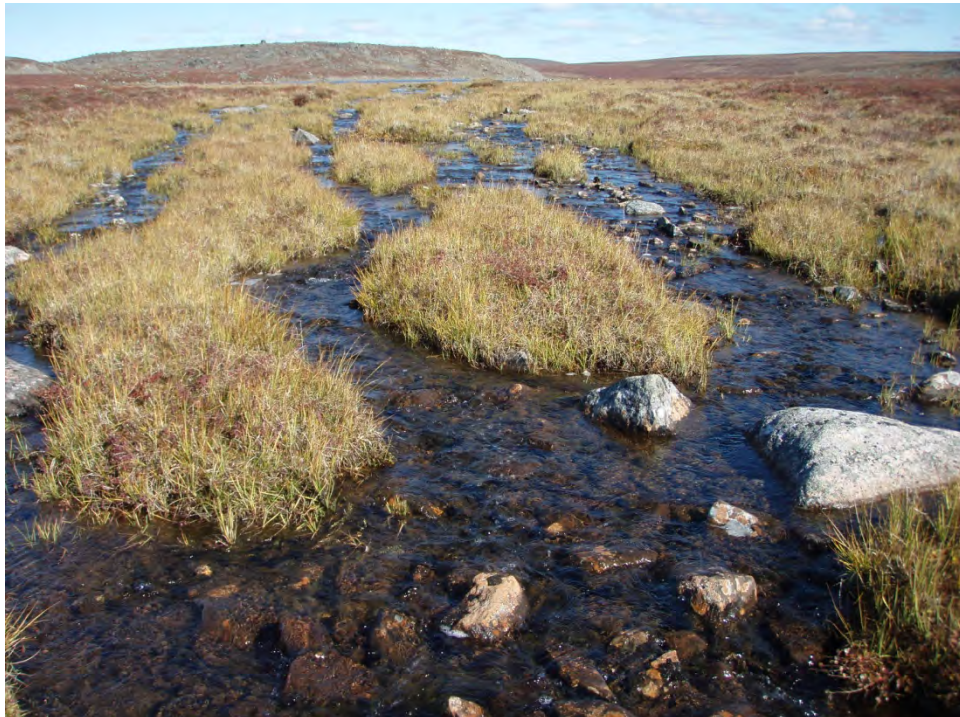
Kilometre 20.0. Photograph from the ground. Upstream view approximately 200 m upstream of watercourse mouth. September 2, 2014.

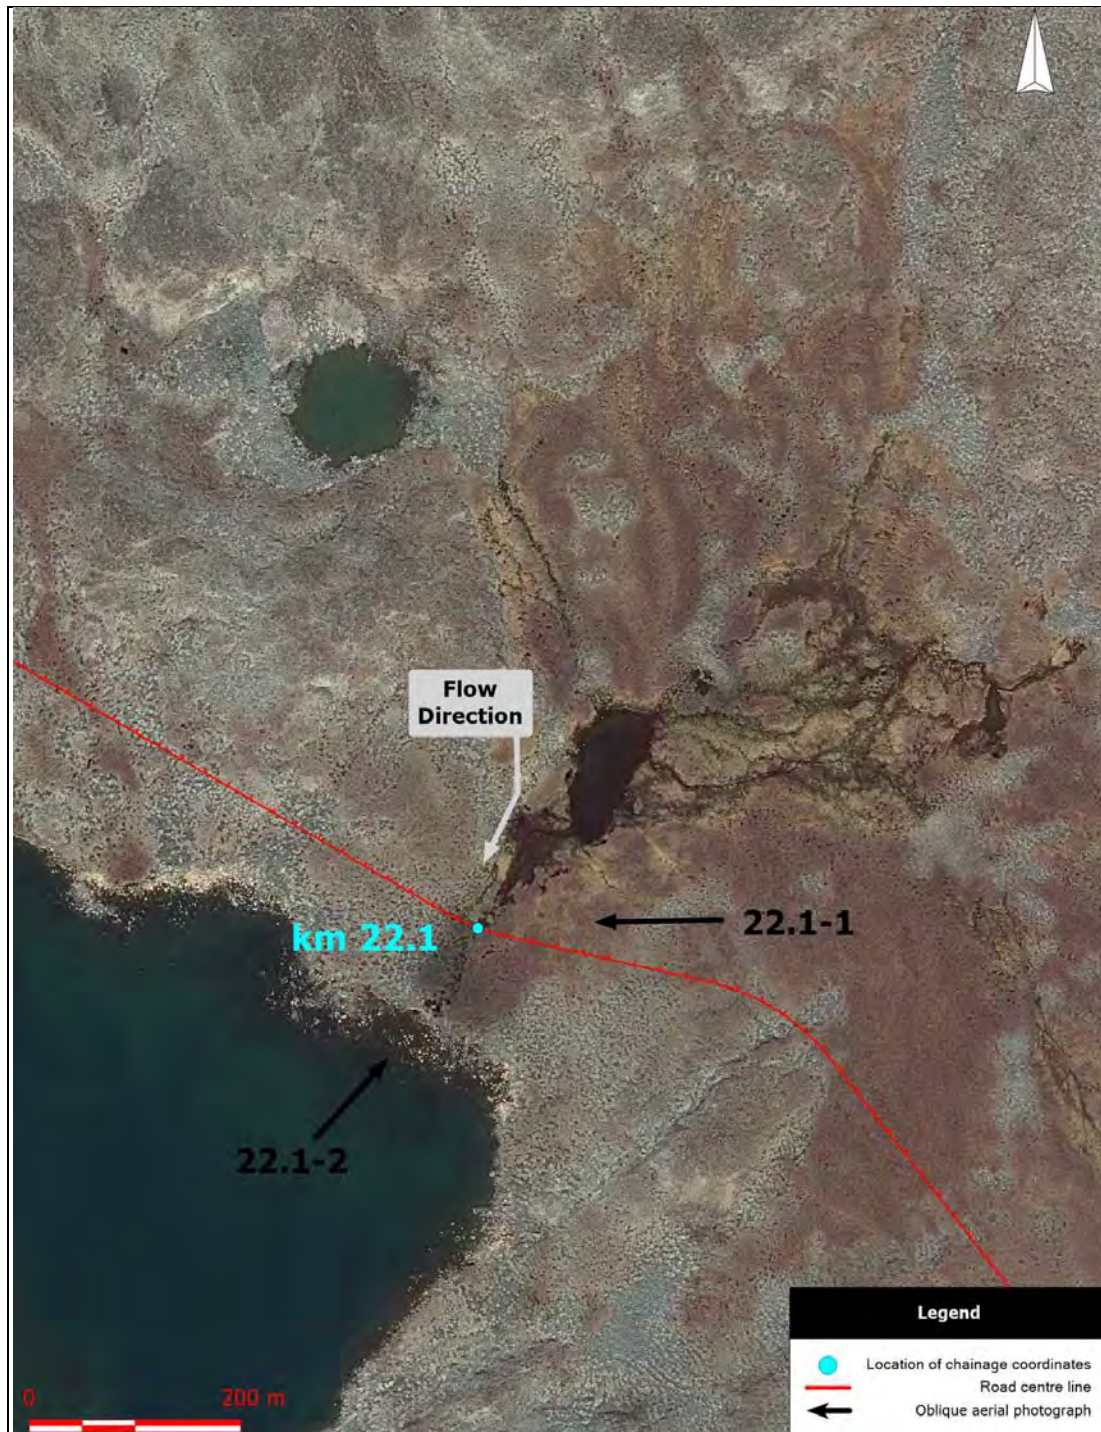
Kilometre 22.1. Aerial photograph showing the road centre line, the location of chainage coordinates provided in Table 3-2, the flow direction, and the location of oblique aerial photographs.

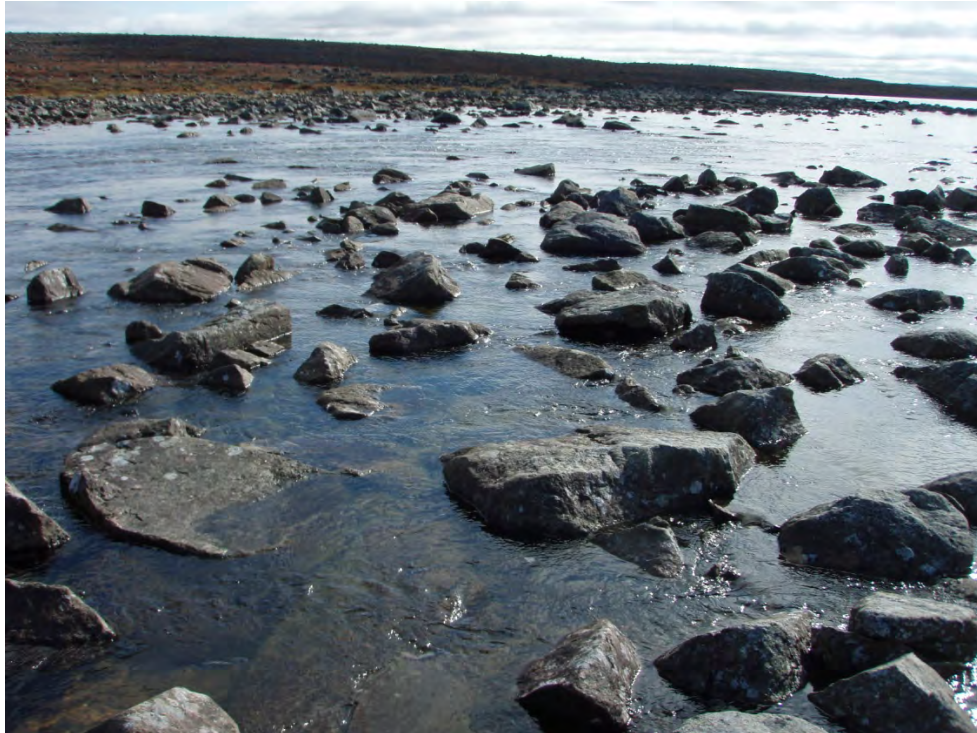
Kilometre 23.9. Photograph from the ground. Note flow through narrows. August 31, 2014.

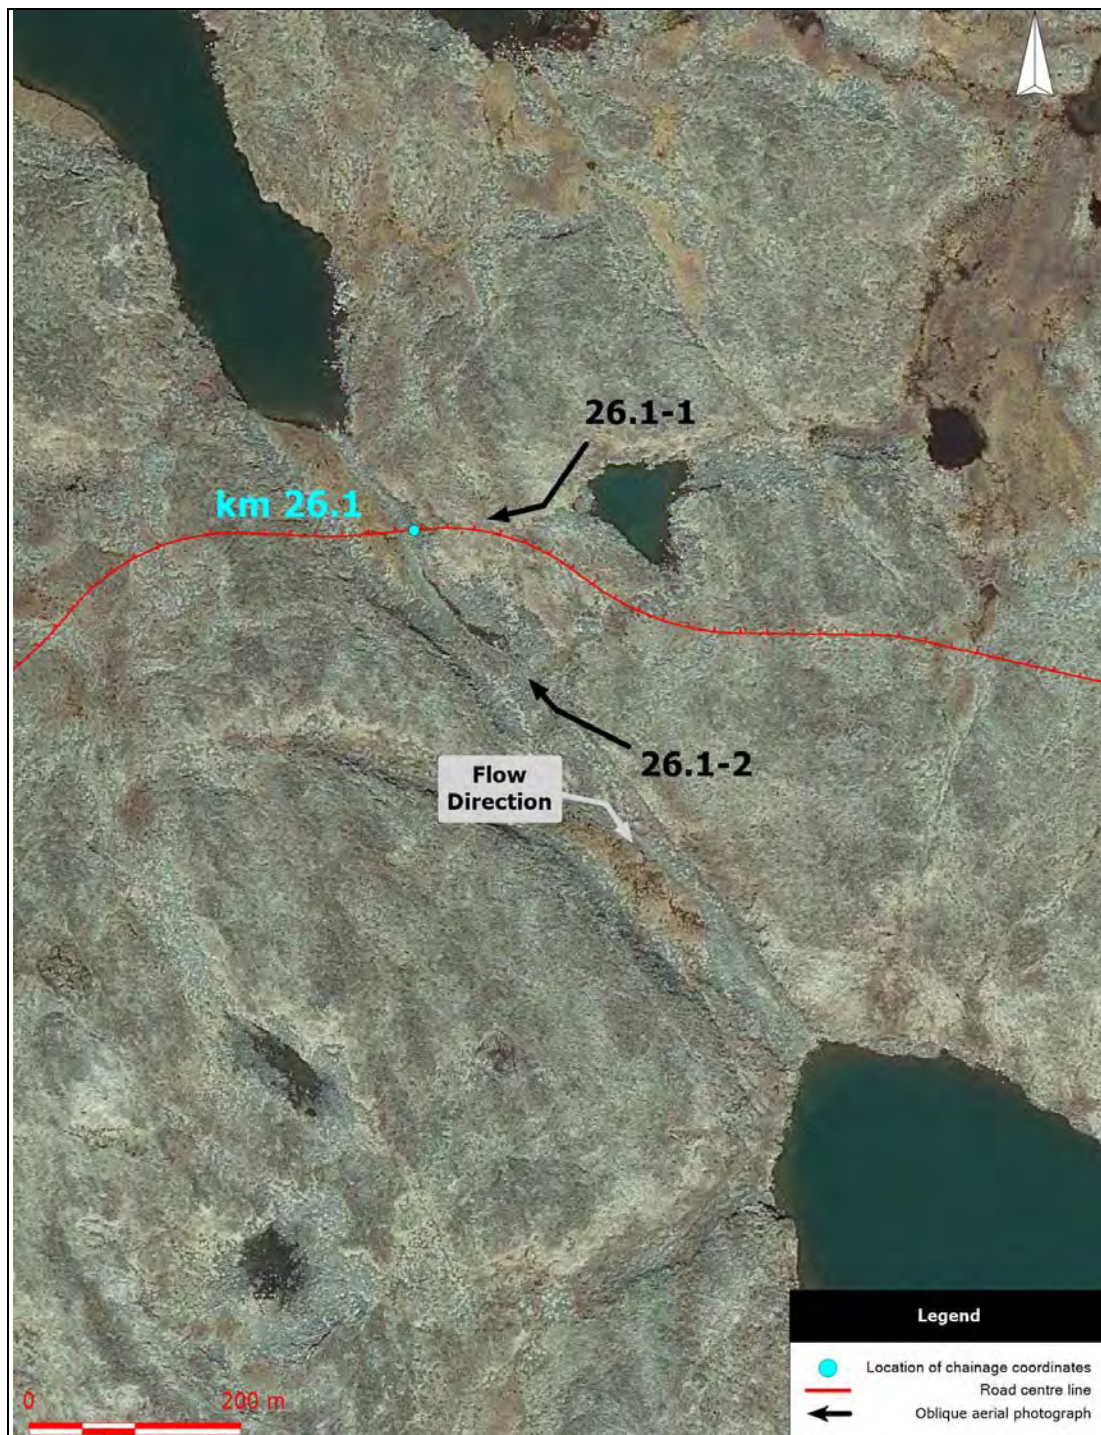
Kilometre 26.1. Aerial photograph showing the road centre line, the location of chainage coordinates provided in Table 3-2, the flow direction, and the location of oblique aerial photographs.

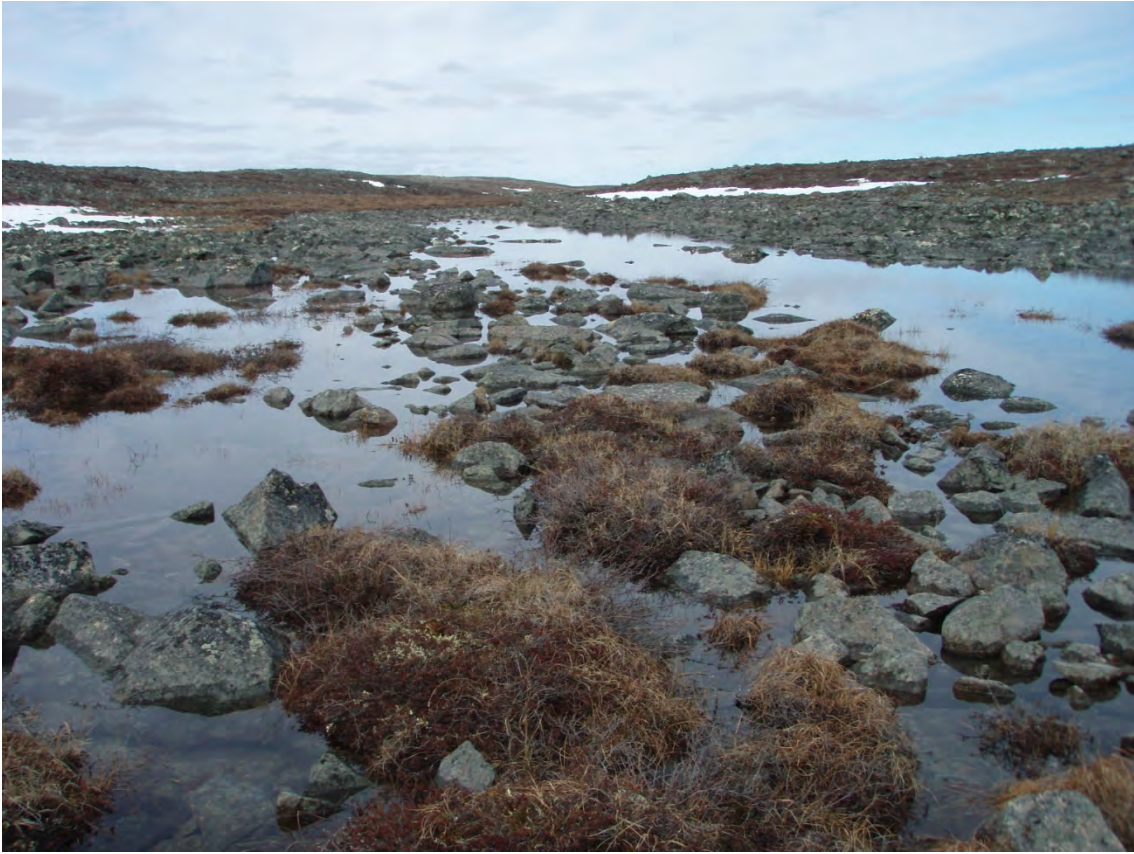
Kilometre 26.1. Photograph from the ground. Upstream view approximately 130 m downstream from road crossing location. June 23, 2015.

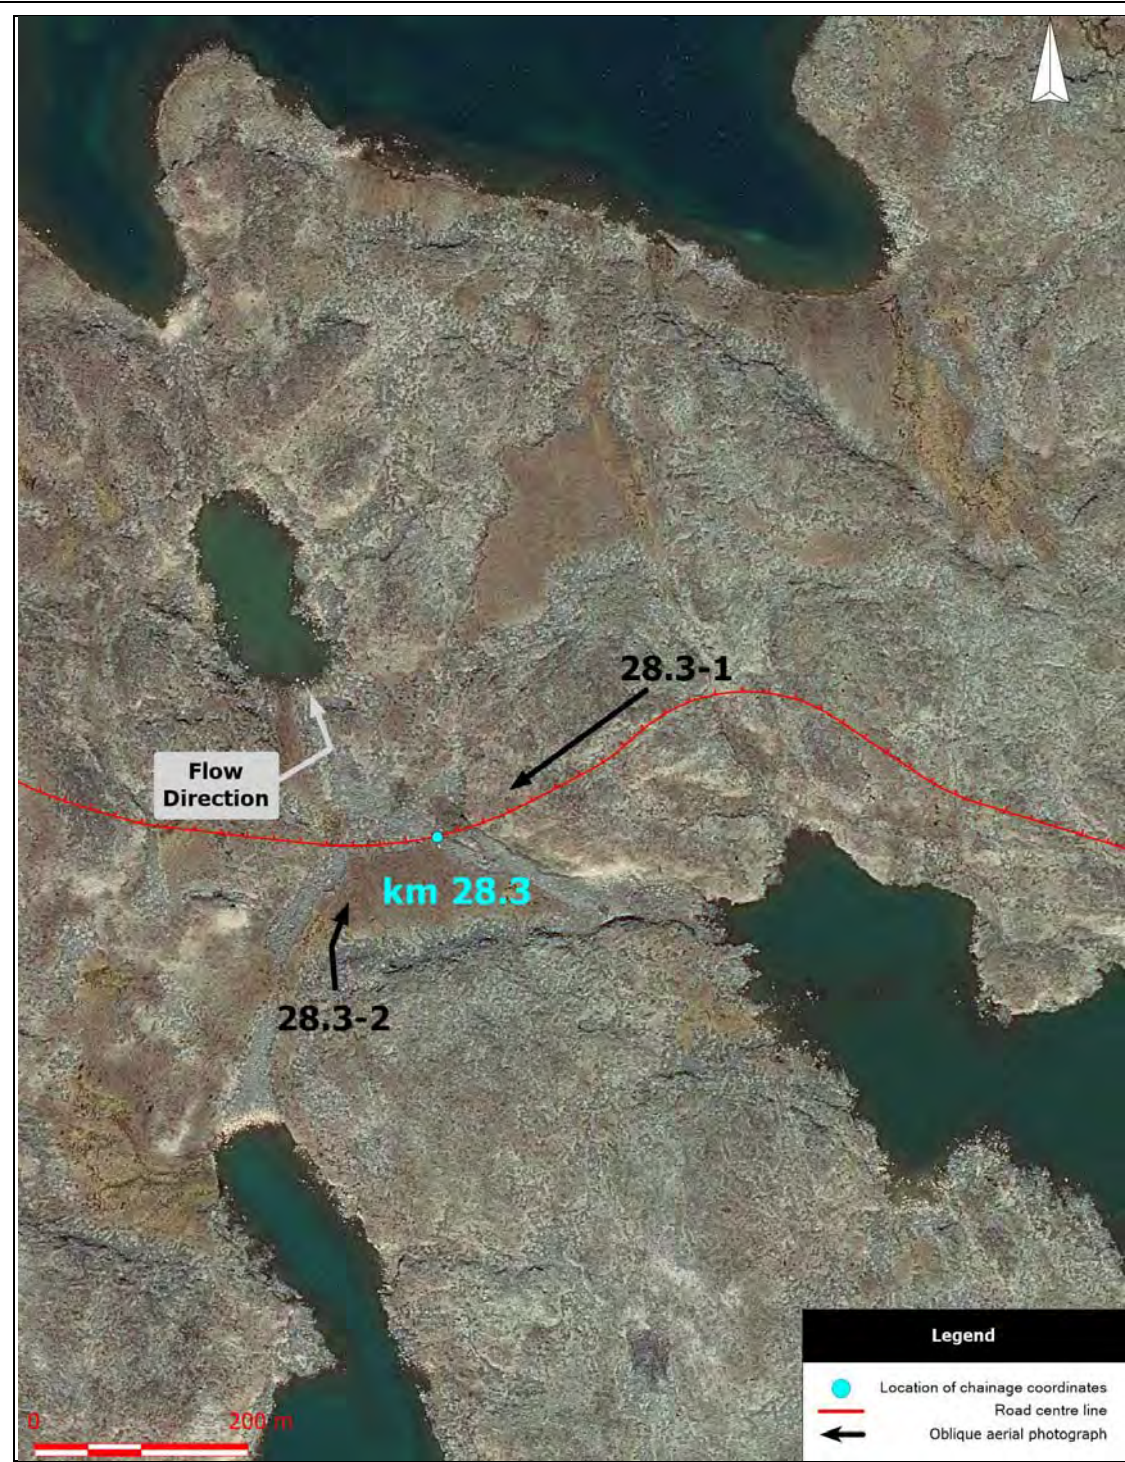
Kilometre 28.3. Aerial photograph showing the road centre line, the location of chainage coordinates provided in Table 3-2, the flow direction, and the location of oblique aerial photographs.

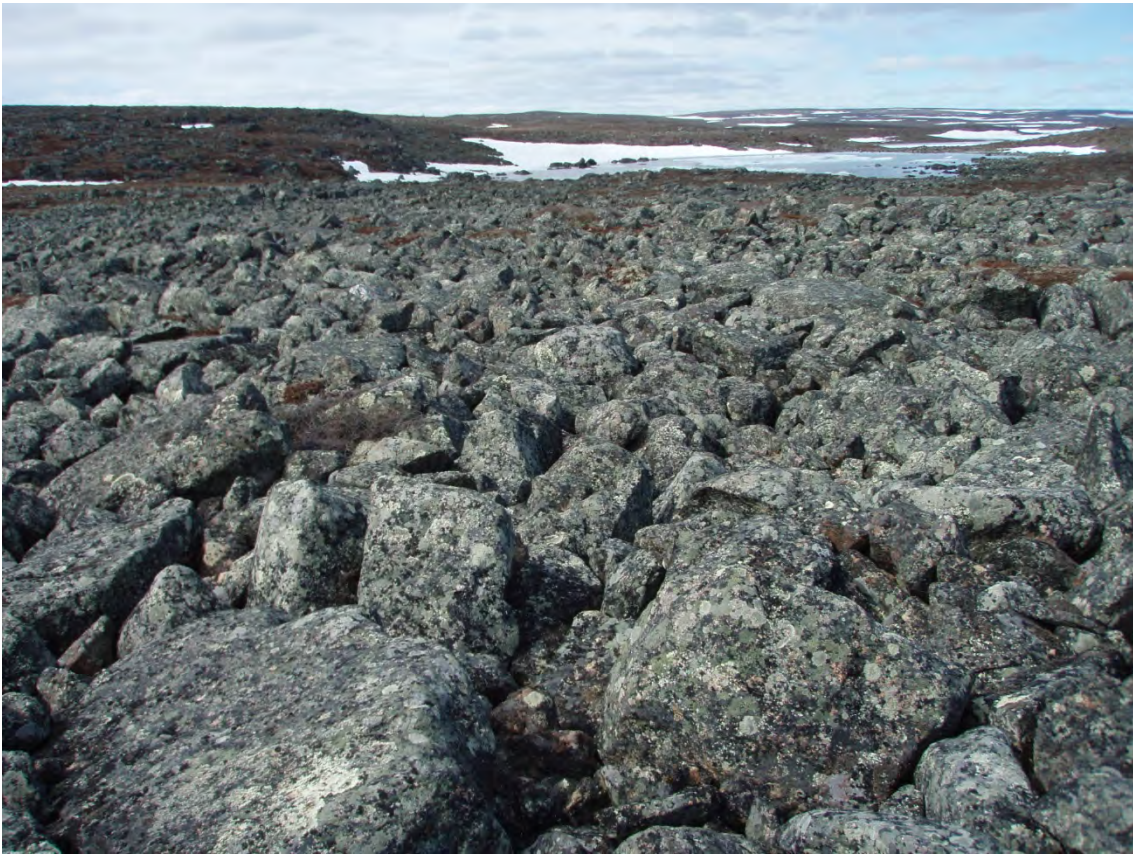
Kilometre 28.3. Photograph from the ground. Road crossing location. June 23, 2015.

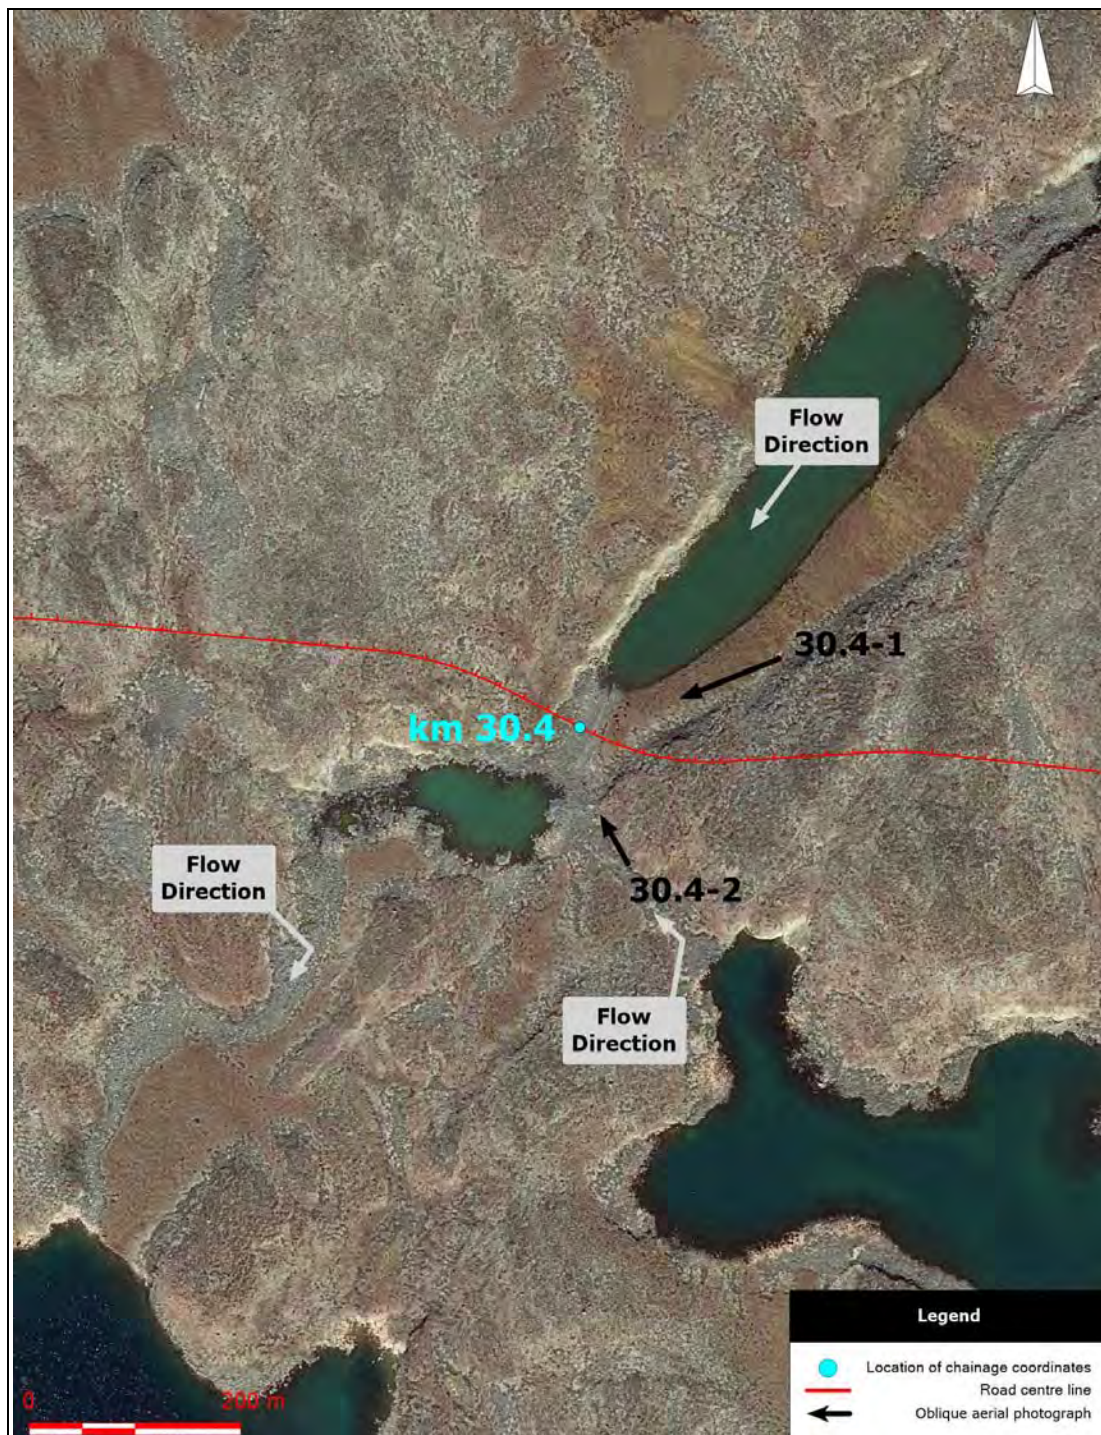
Kilometre 30.4. Aerial photograph showing the road centre line, the location of chainage coordinates provided in Table 3-2, the flow direction, and the location of oblique aerial photographs.

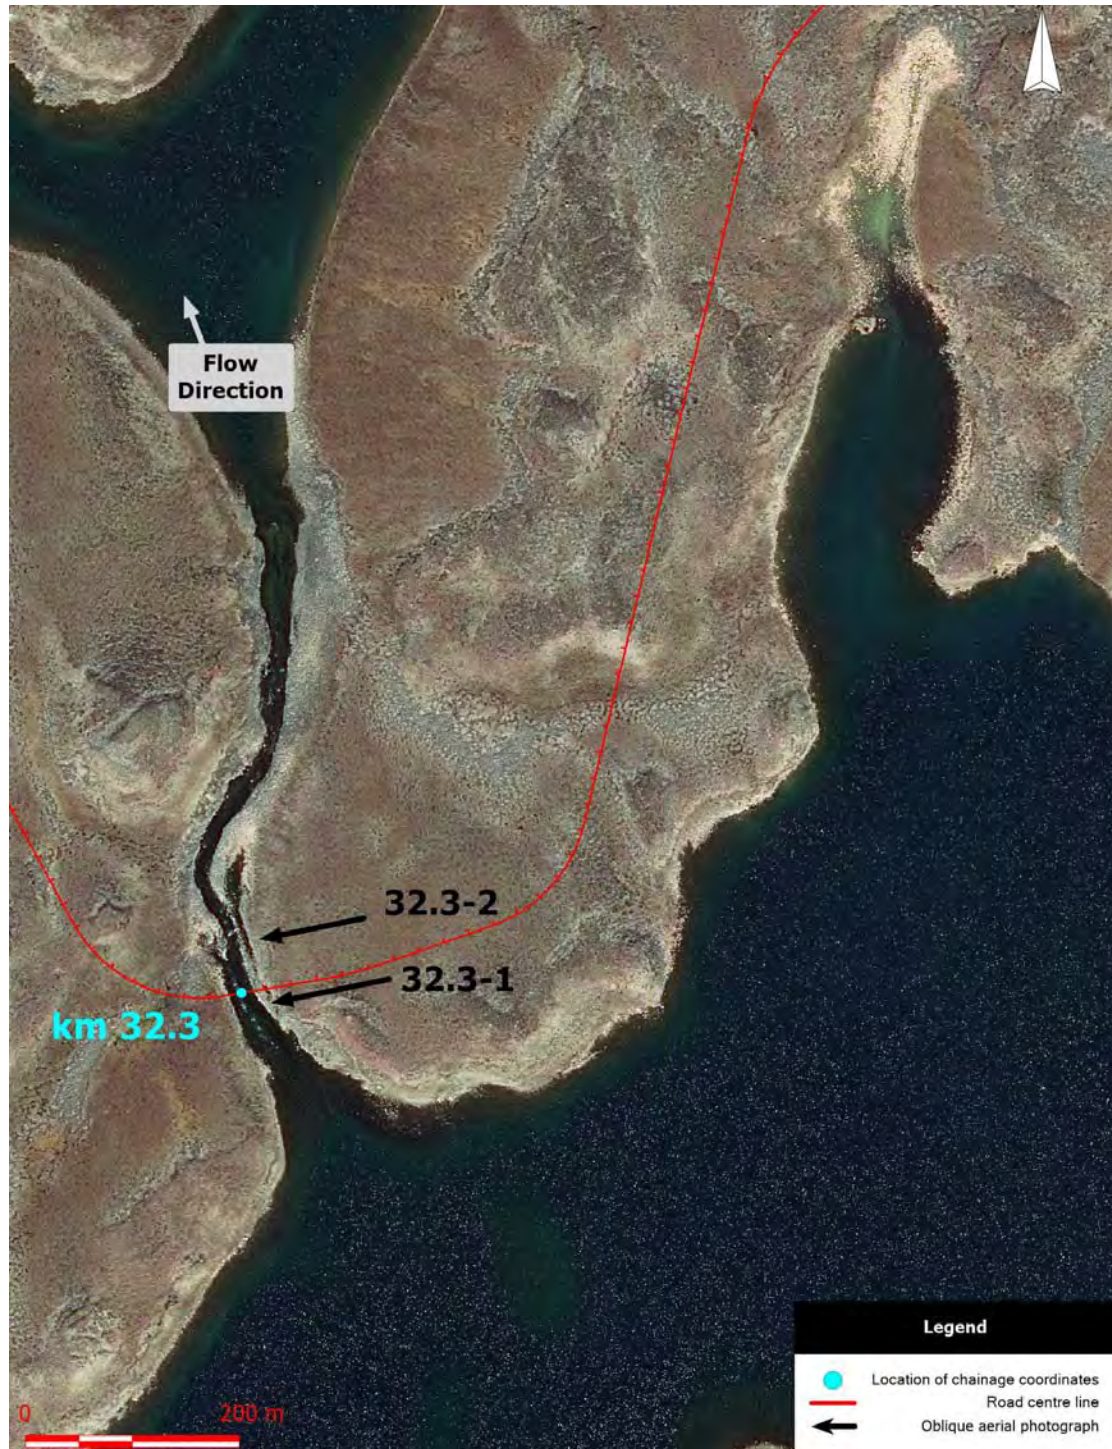
Kilometre 32.3. Aerial photograph showing the road centre line, the location of chainage coordinates provided in Table 3-2, the flow direction, and the location of oblique aerial photographs.

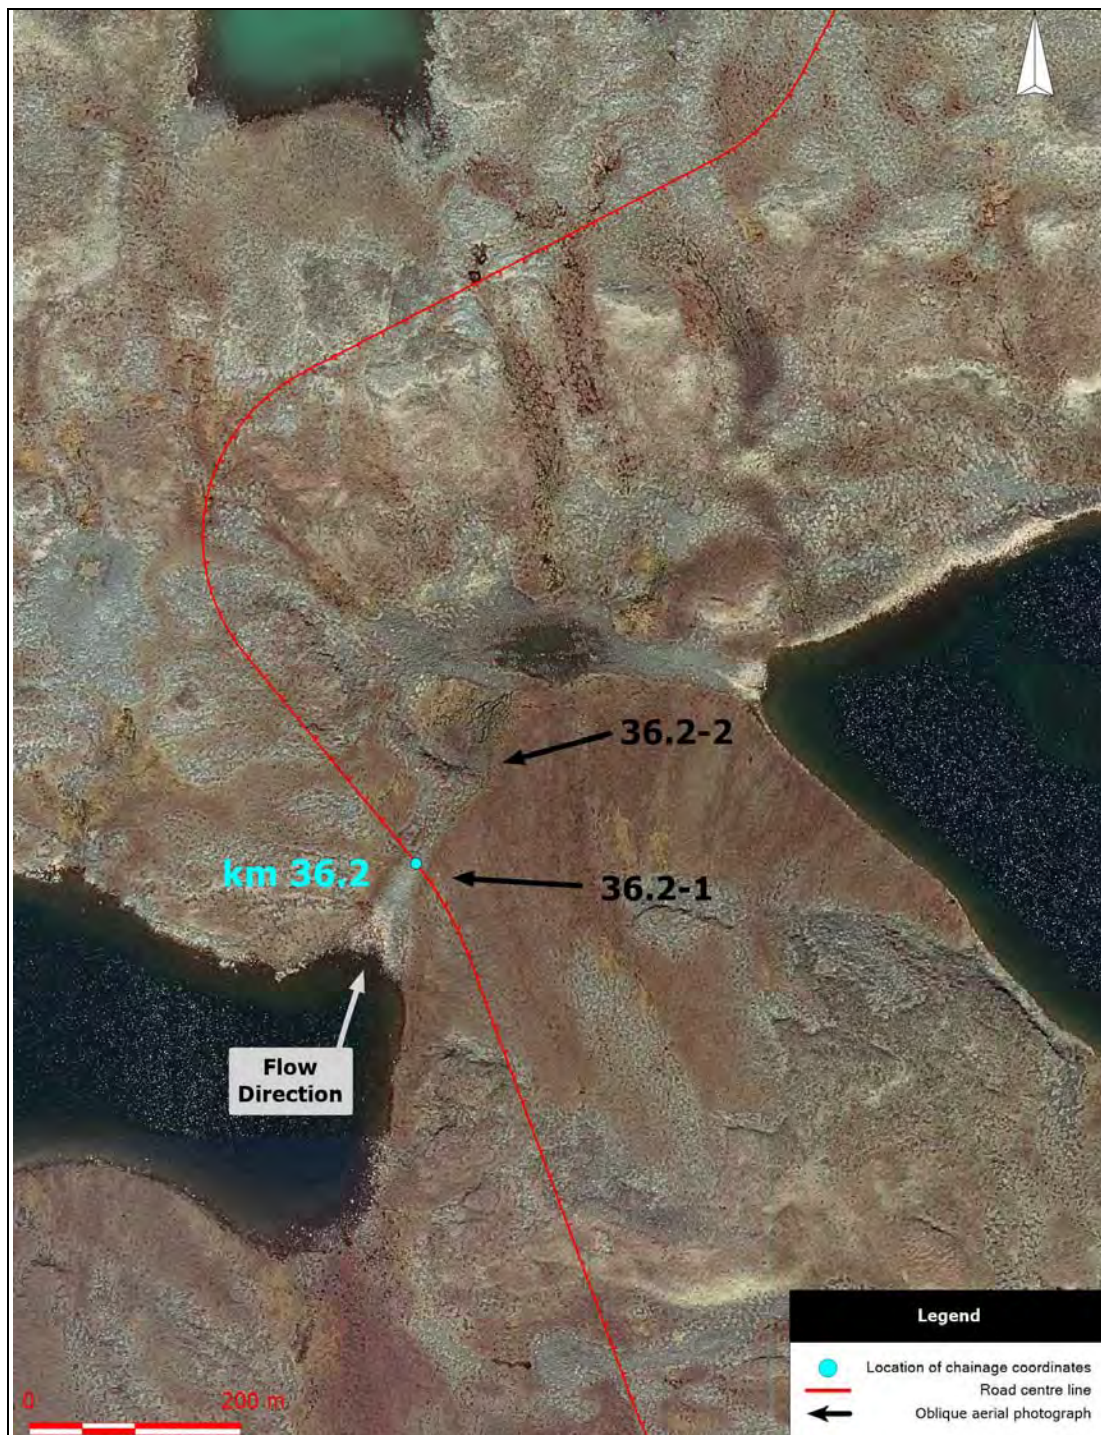
Kilometre 36.2. Aerial photograph showing the road centre line, the location of chainage coordinates provided in Table 3-2, the flow direction, and the location of oblique aerial photographs.

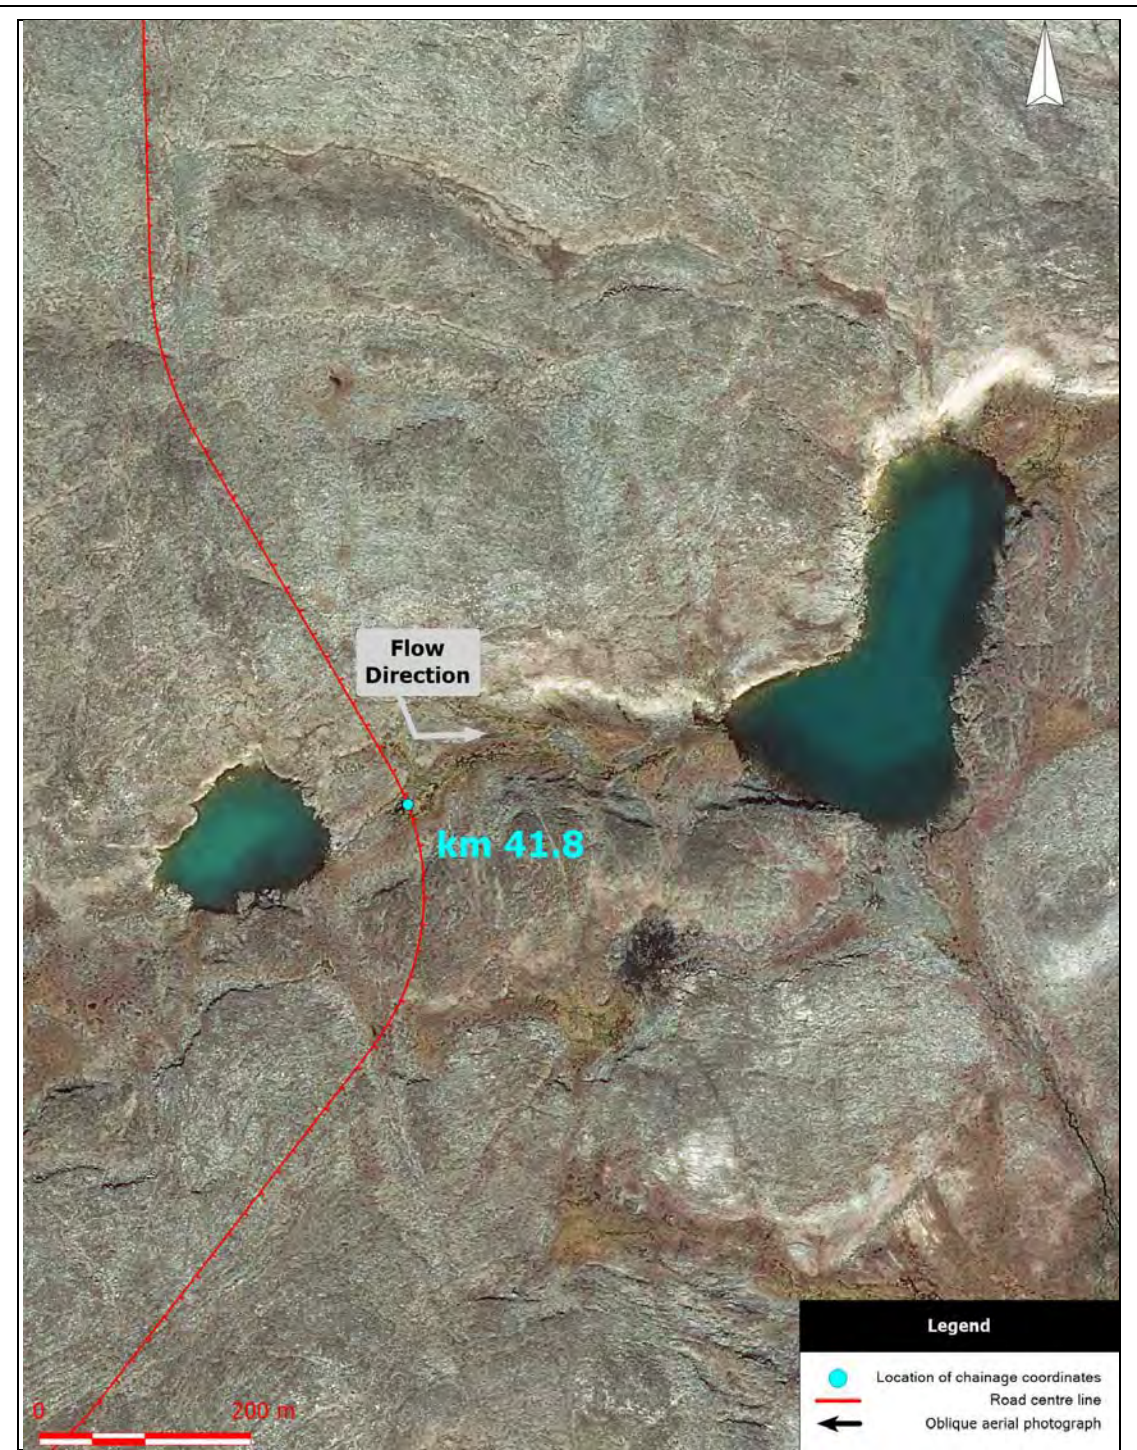
Kilometre 41.8. Aerial photograph showing the road centre line, the location of chainage coordinates provided in Table 3-2, and the flow direction.

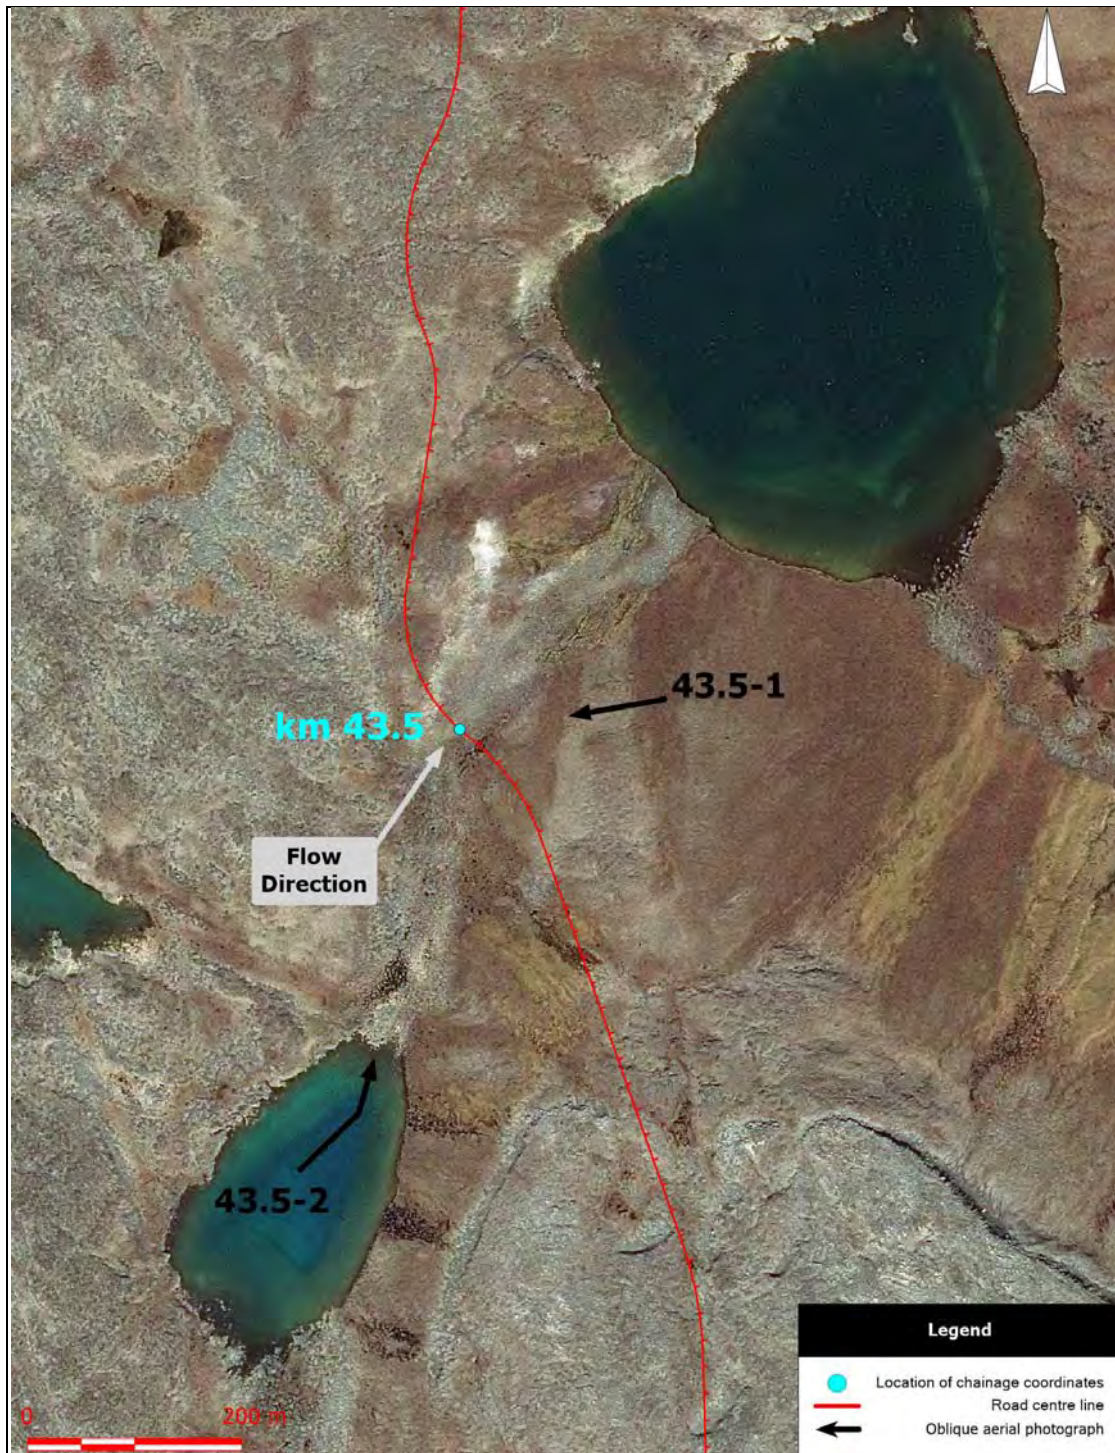
Kilometre 43.5. Aerial photograph showing the road centre line, the location of chainage coordinates provided in Table 3-2, the flow direction, and the location of oblique aerial photographs.
