## 6-D: Portt 2015 Road Baseline Report

# AMARUQ EXPLORATION ACCESS ROAD AQUATICS BASELINE REPORT 2015 AGNICO EAGLE MINES LTD. - MEADOWBANK DIVISION

November 25, 2015.

C. PORTT and ASSOCIATES  
63 Waterloo Avenue  
Guelph, Ontario, N1H 3H5  
[cportt@sentex.net](mailto:cportt@sentex.net)

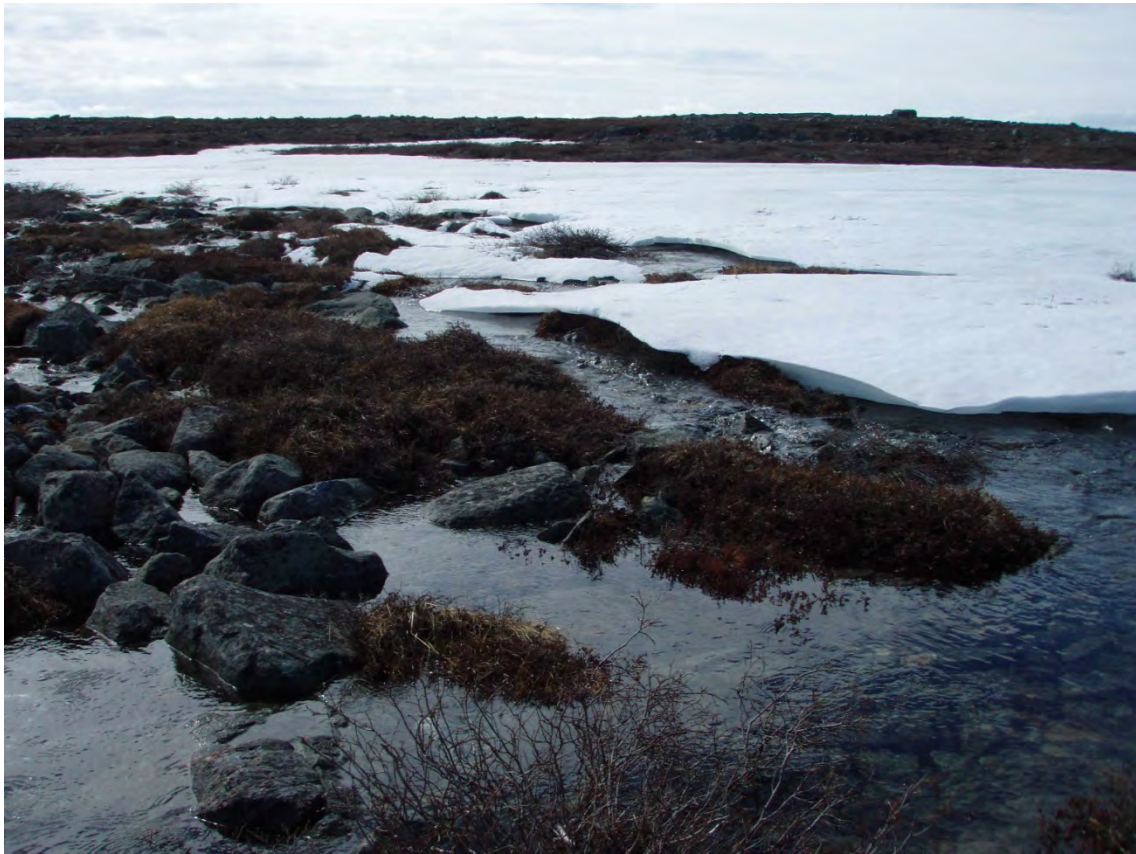
Kilometre 43.5. Photograph from the ground. Road crossing location. June 23, 2015.

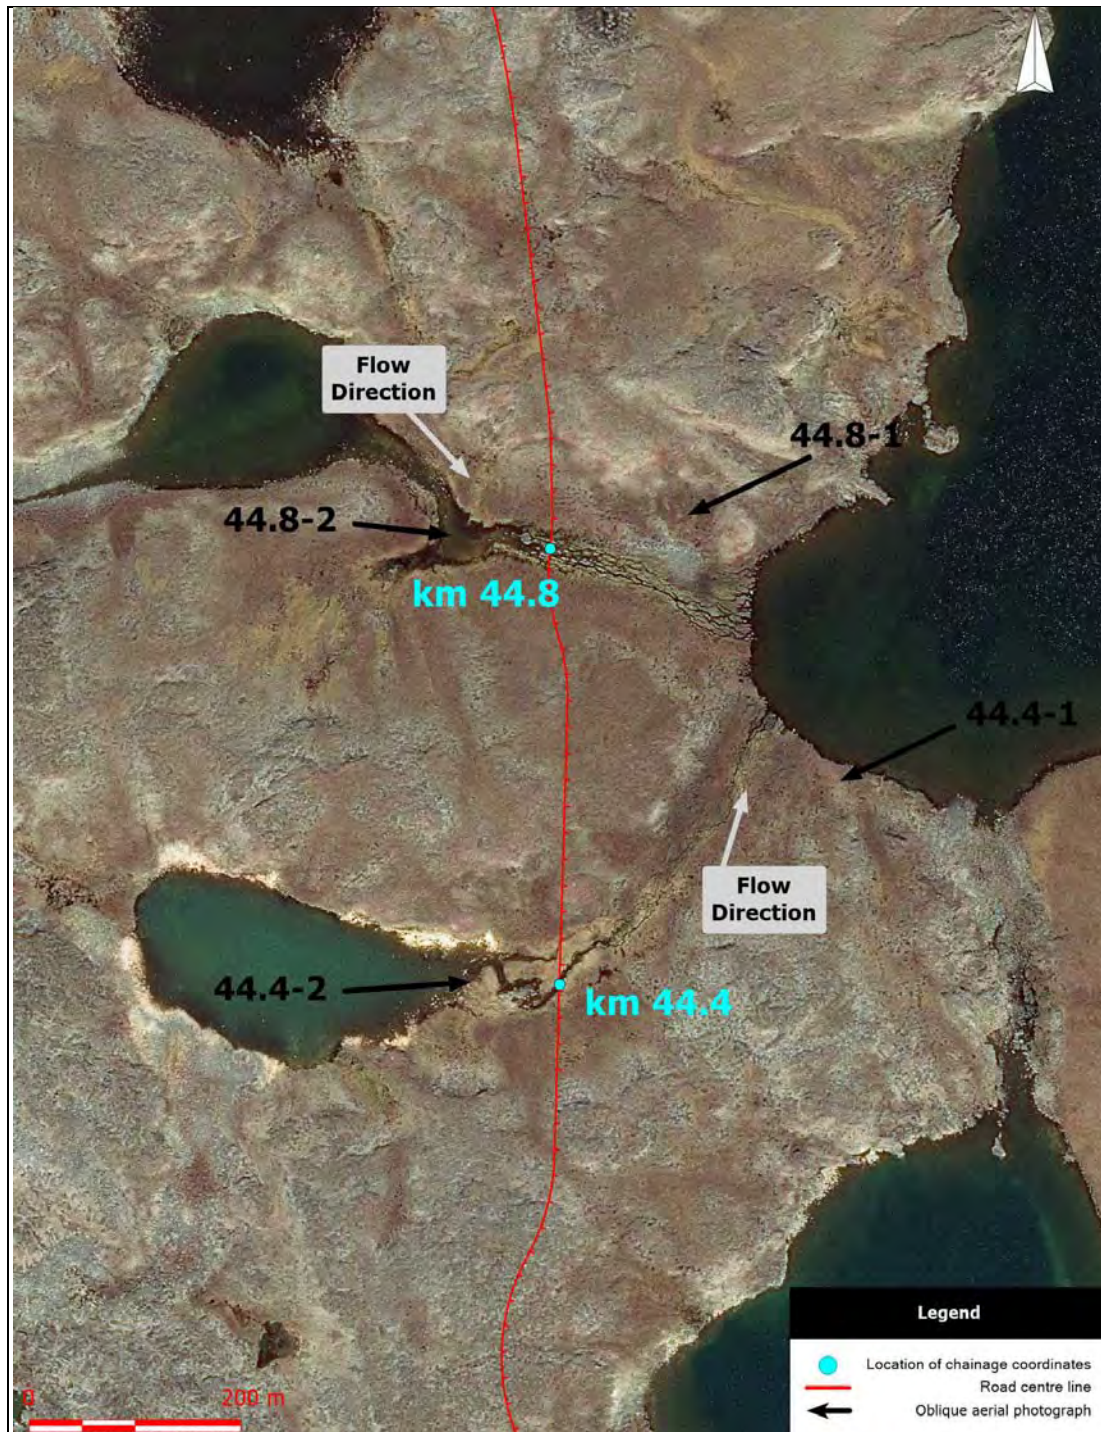
Kilometres 44.4 and 44.8. Aerial photograph showing the road centre line, the location of chainage coordinates provided in Table 3-2, the flow direction, and the location of oblique aerial photographs.

A juvenile Arctic Grayling was captured in the watercourse at km 44.8 in both 2014 and 2015 and there is gravel substrate suitable for Arctic Grayling spawning at numerous places within this watercourse, although no Arctic Grayling or disturbed gravel that might be indicative of Arctic Grayling spawning were observed here in the spring of 2015. This watercourse also provides a connection to a series of upstream lakes and therefore could be an important migration corridor. Due to the potential habitat significance, a clear-span bridge is also recommended at this location.

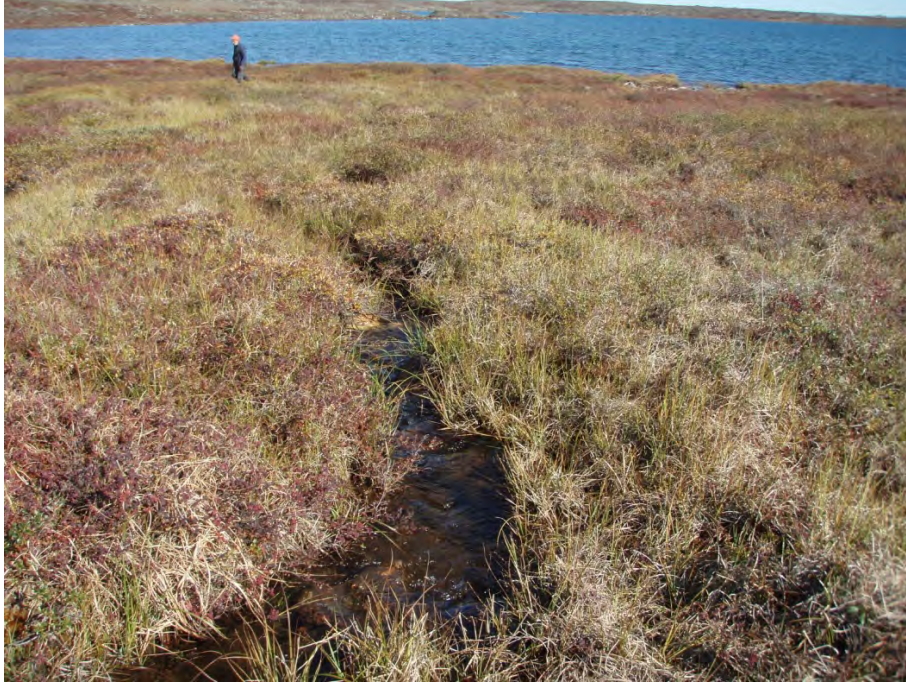
Kilometre 44.4. Photograph from the ground. Downstream view of one channel from 270 m downstream from the approximate crossing location. Rocky section of watercourse. September 1, 2014.

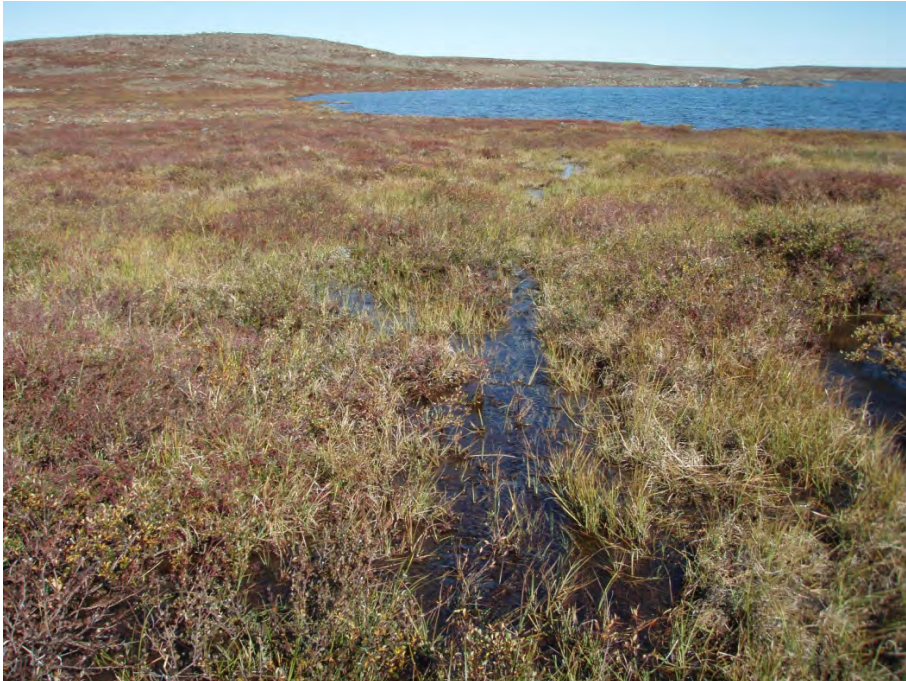
Kilometre 44.4. Photograph from the ground. Downstream view of one channel from 270 m downstream from the approximate crossing location. Diffuse flow through vegetation. September 1, 2014.

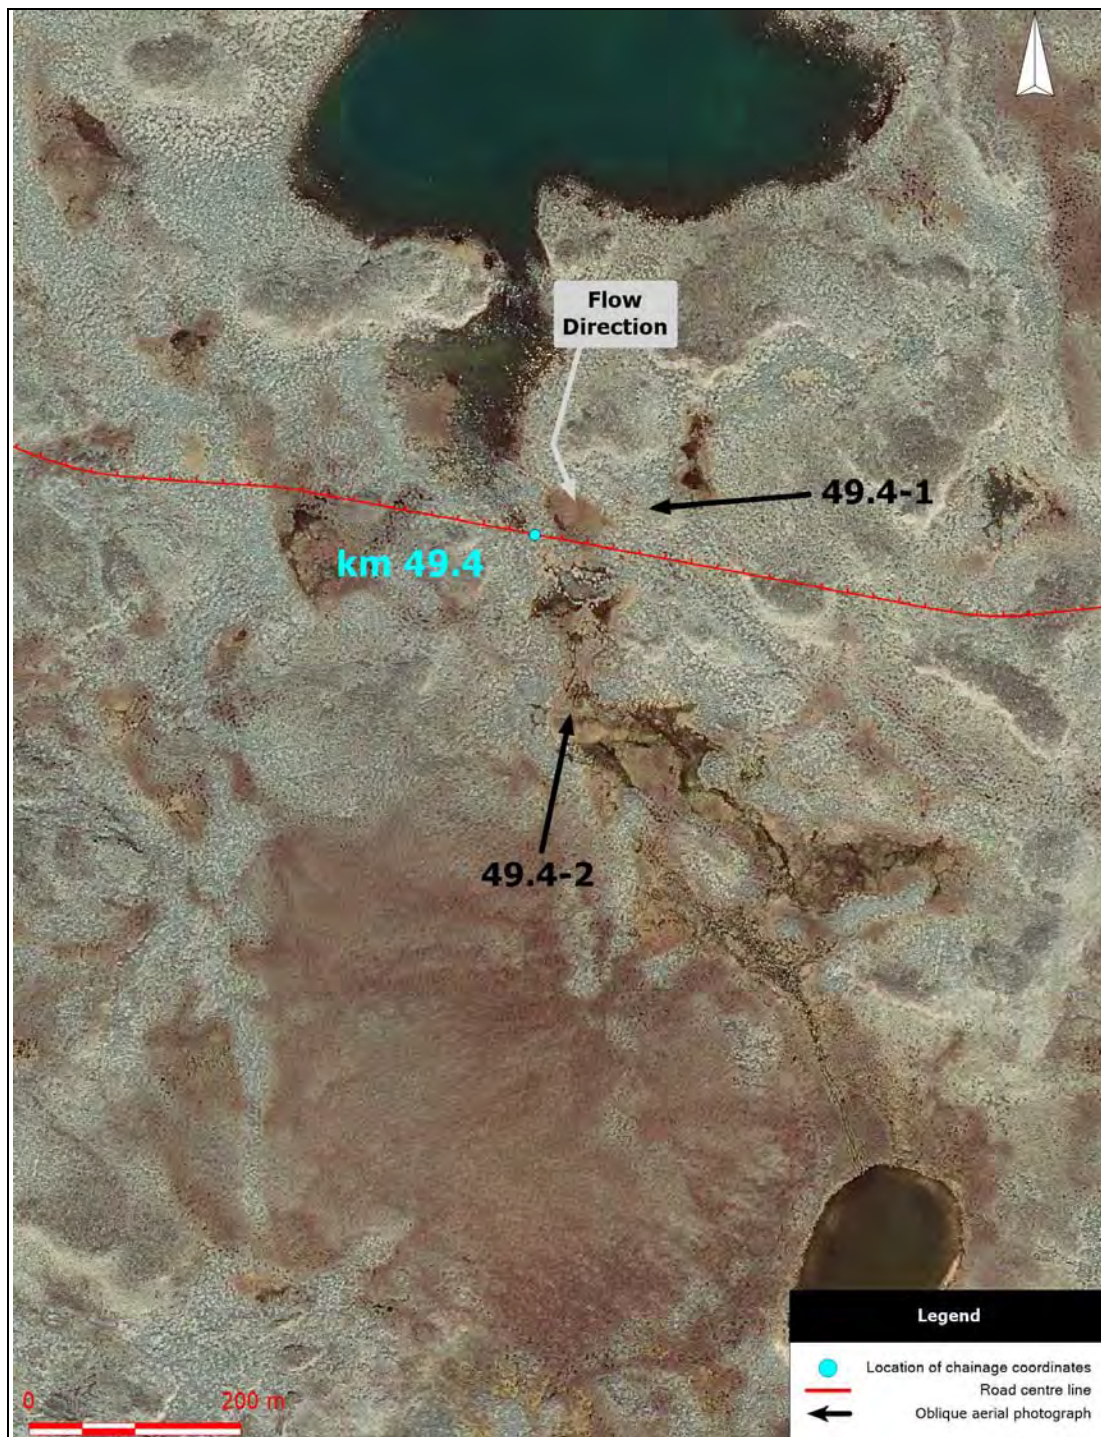
Kilometre 49.4. Aerial photograph showing the road centre line, the location of chainage coordinates provided in Table 3-2, the flow direction, and the location of oblique aerial photographs.
