## 6-J: Portt 2014 Baseline Road Report

# AMARUQ EXPLORATION ROAD AQUATICS BASELINE REPORT 2014 AGNICO EAGLE MINES LTD. - MEADOWBANK DIVISION

January 22, 2015.

C. PORTT and ASSOCIATES  
63 Waterloo Avenue  
Guelph, Ontario, N1H 3H5  
[cportt@sentex.net](mailto:cportt@sentex.net)

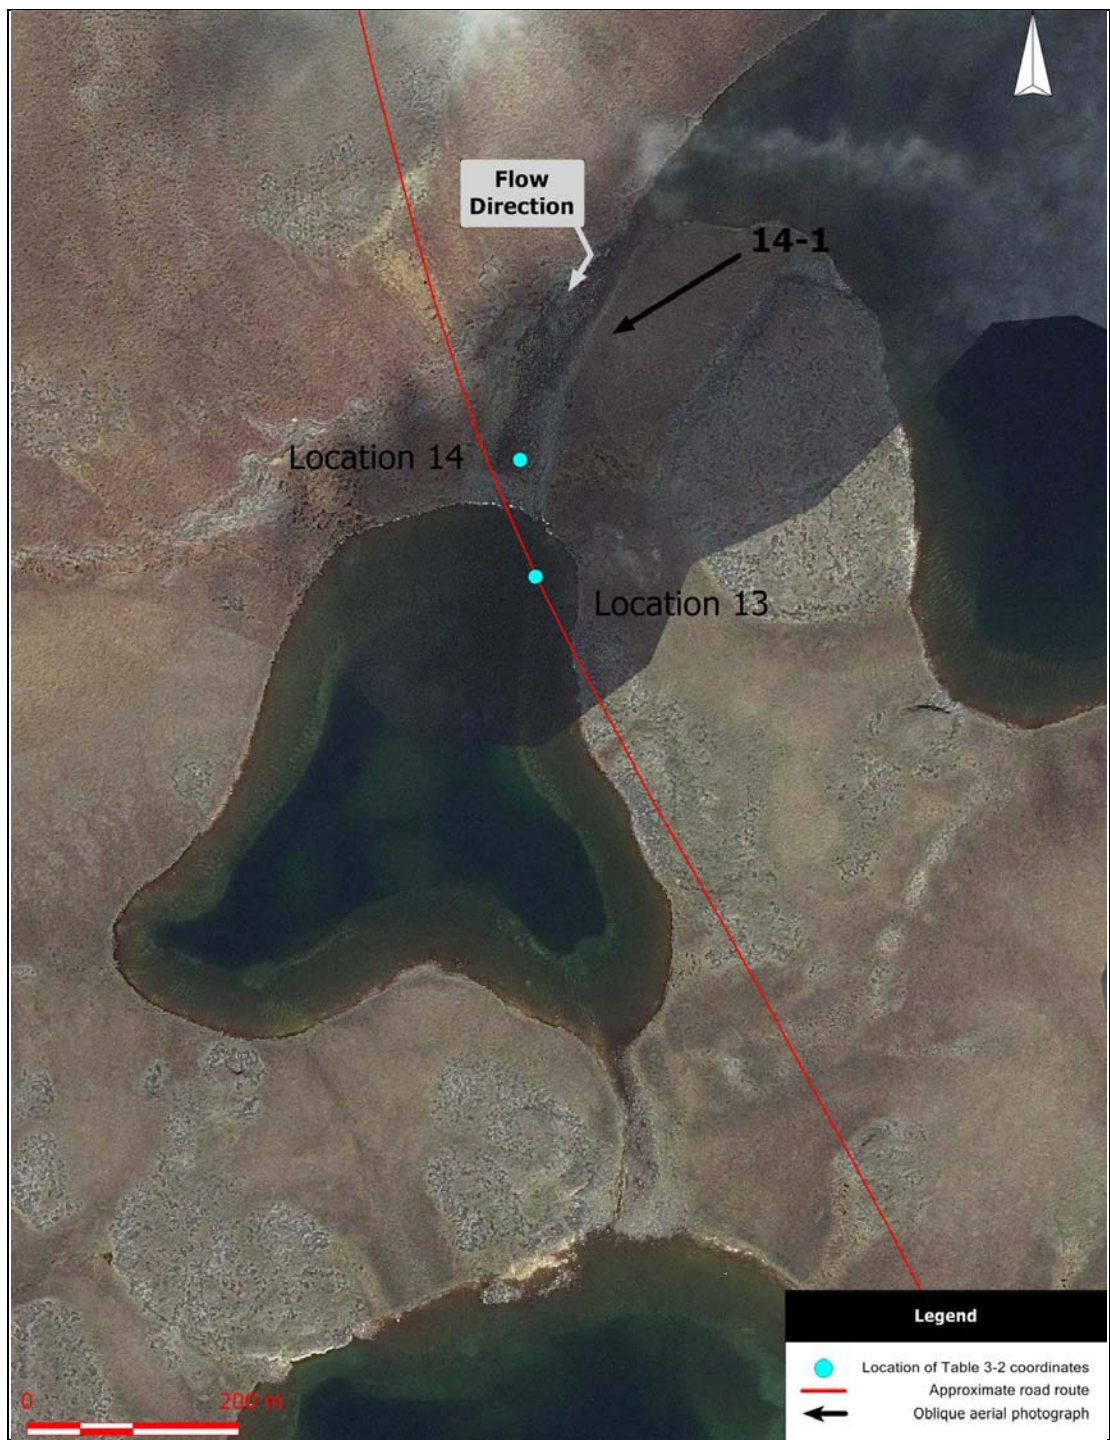
Locations 13 and 14. Aerial photograph (scale 1:5000) showing the approximate road route, the location of coordinates provided in Table 3-2, the flow direction, and the location of oblique aerial photographs. Lake at Location 13 will be avoided.

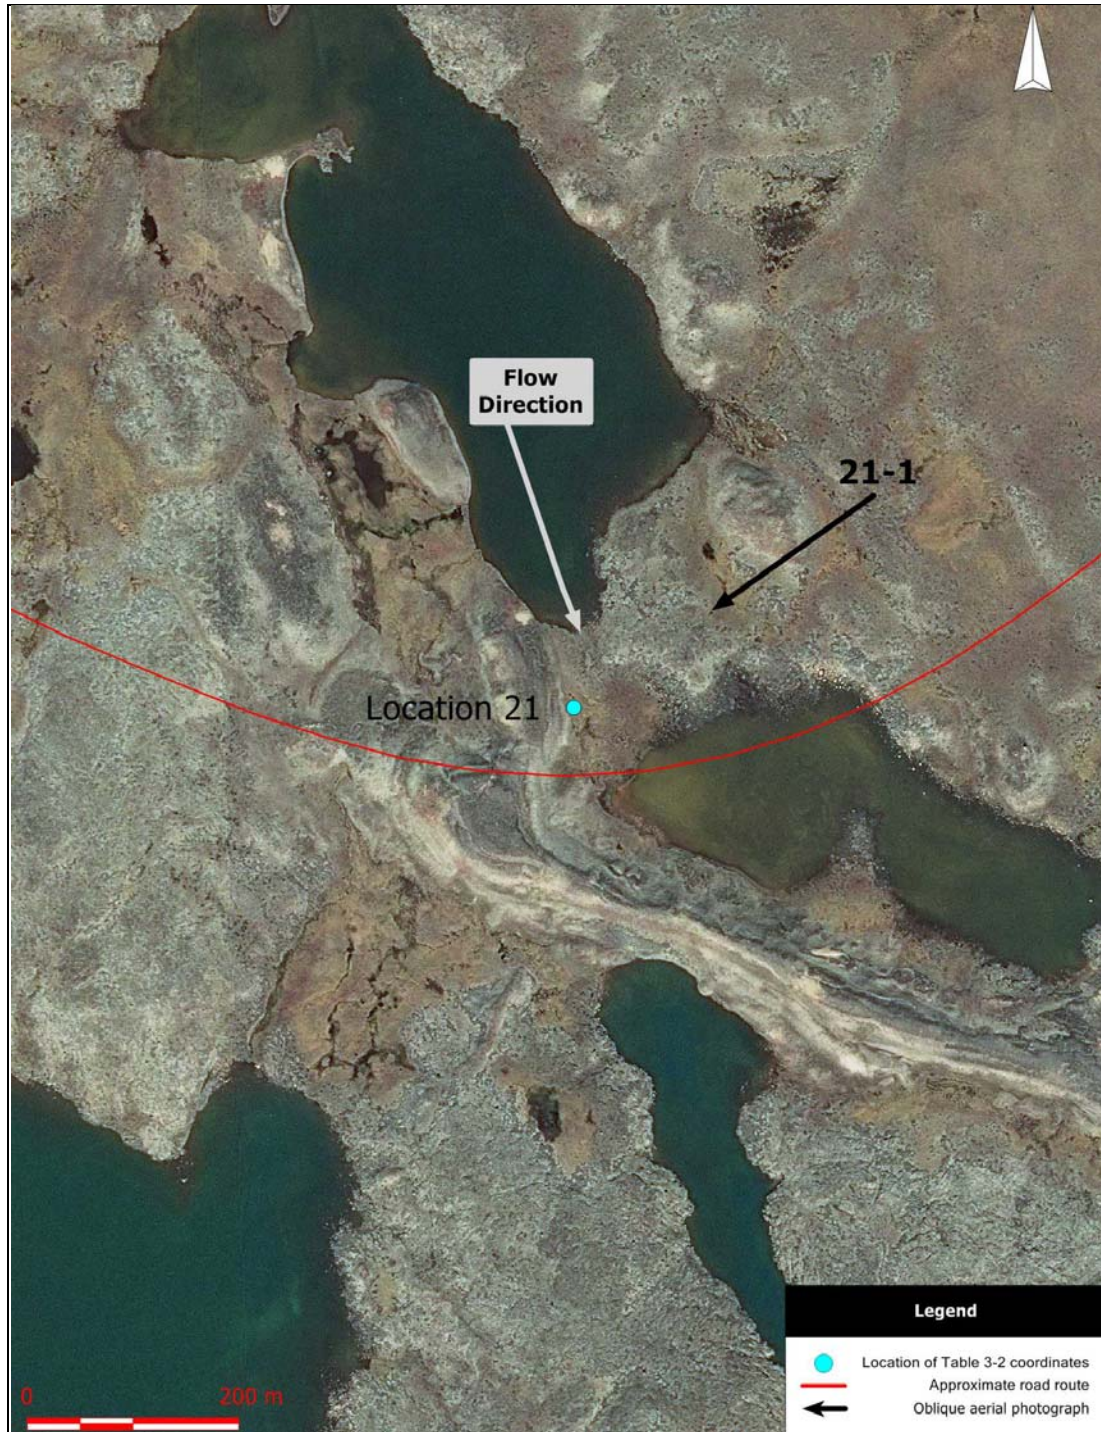
Location 21. Aerial photograph (scale 1:5000) showing the approximate road route, the location of coordinates provided in Table 3-2, the flow direction, and the location of oblique aerial photographs. Lake near Location 21 will be avoided.

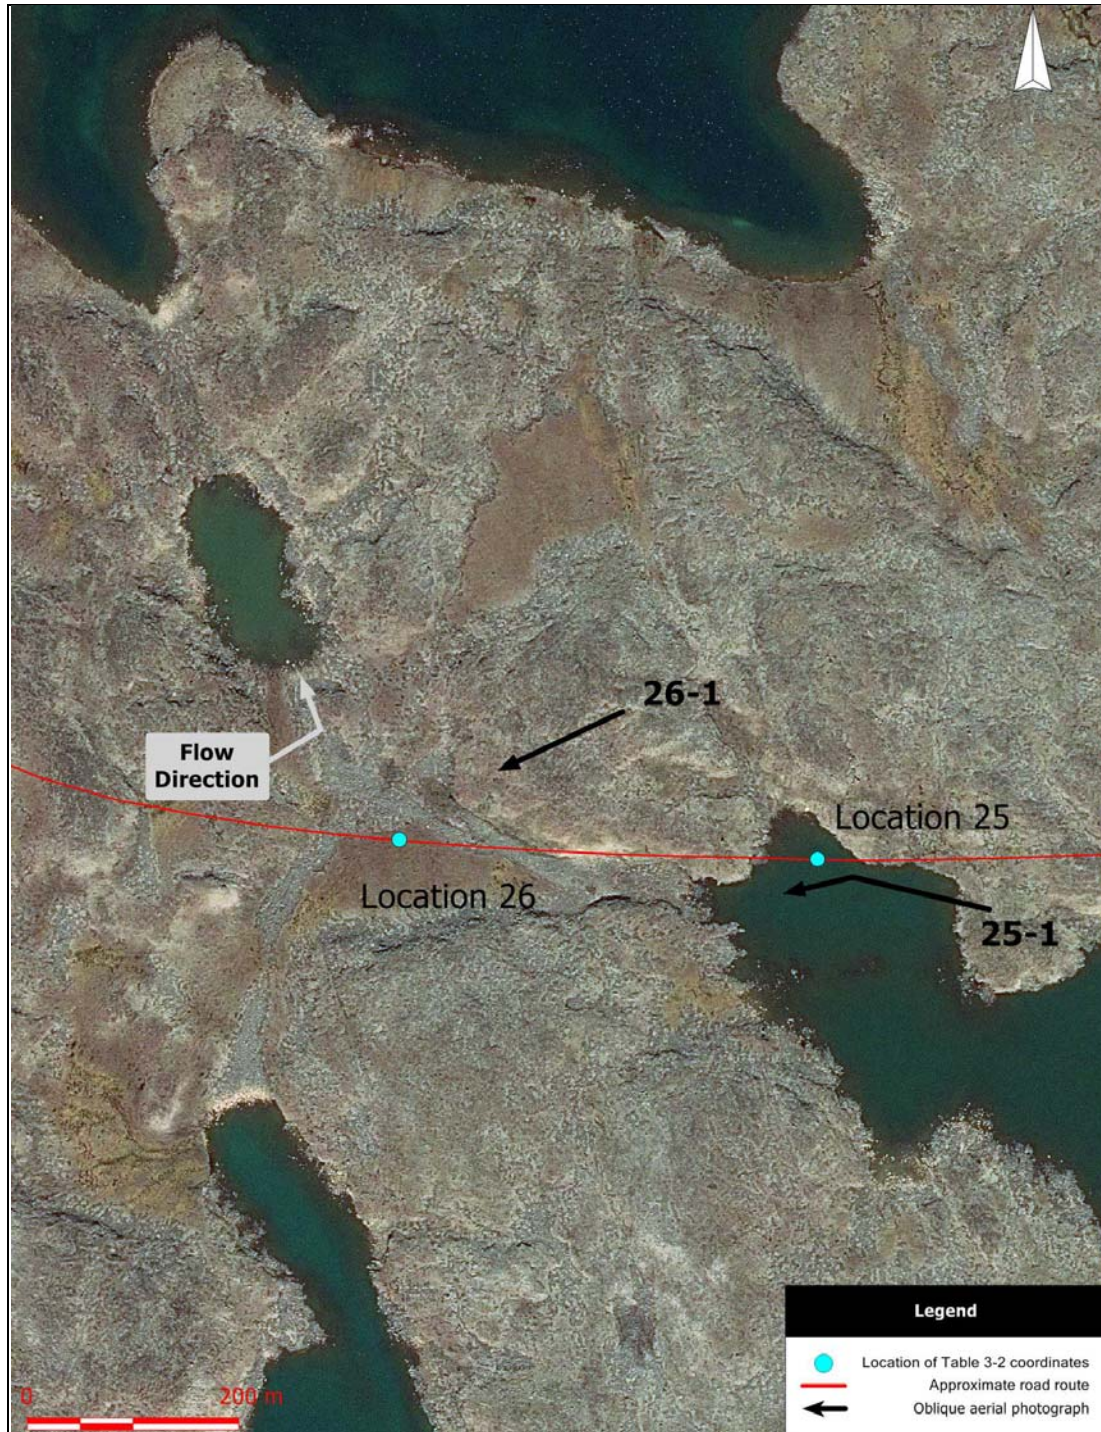
Locations 25 and 26. Aerial photograph (scale 1:5000) showing the approximate road route, the location of coordinates provided in Table 3-2, the flow direction, and the location of oblique aerial photographs. Lake at Location 25 will be avoided.
