6.1 Surveillance and Inspections by Mine and Environment Operations Staff

WRSF Stability Analysis

SUBJECT : Memorandum of the WRSF Stability analysis update

WRSF INSTRUMENTATION DESIGN

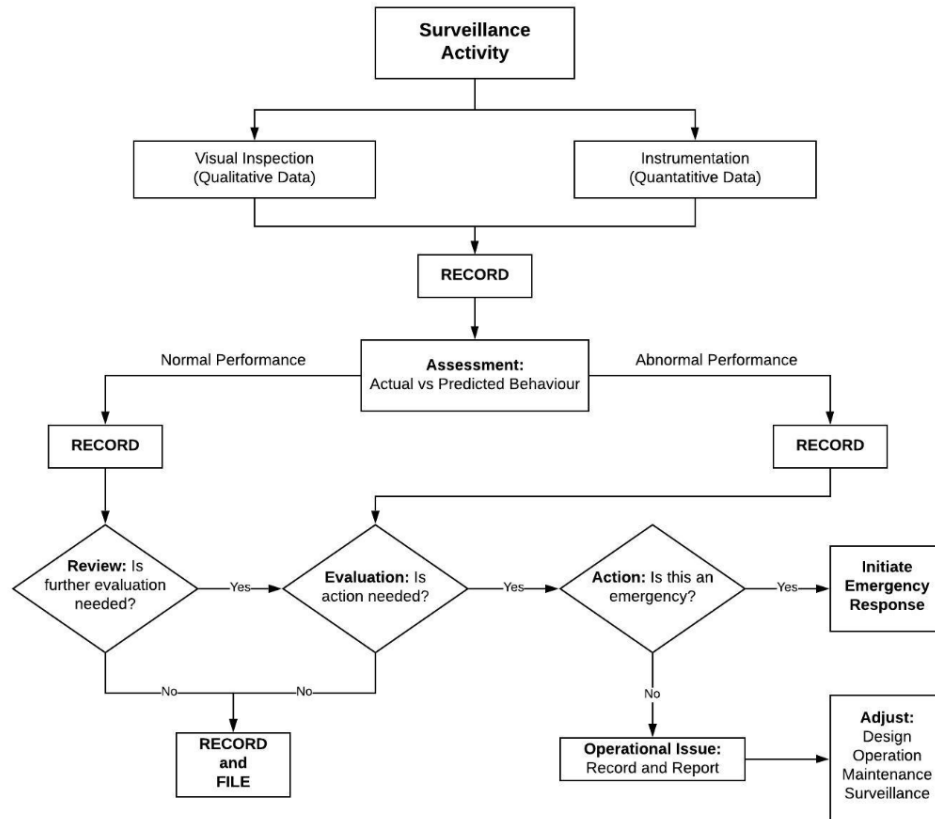
Figure 6.1: Example surveillance flow chart.

The surveillance program consists of regular visual and instrumentation observations, including:

- The conditions and performance of the WRSF, including cracking, slumping, depressions, seepage, and surface erosion;
- Water levels (in the Collection and Attenuation ponds);
- Thermal monitoring of the WRSF and surrounding ground;
- Function of hydraulic structures (diversions, ditches or spillways); and
- Total WRSF performance.
