Appendix 51

Meadowbank and Whale Tail Management Plans

MEADOWBANK GOLD PROJECT

Baker Lake Bulk Fuel Storage Facility: Environmental Performance Monitoring Plan, Version 4

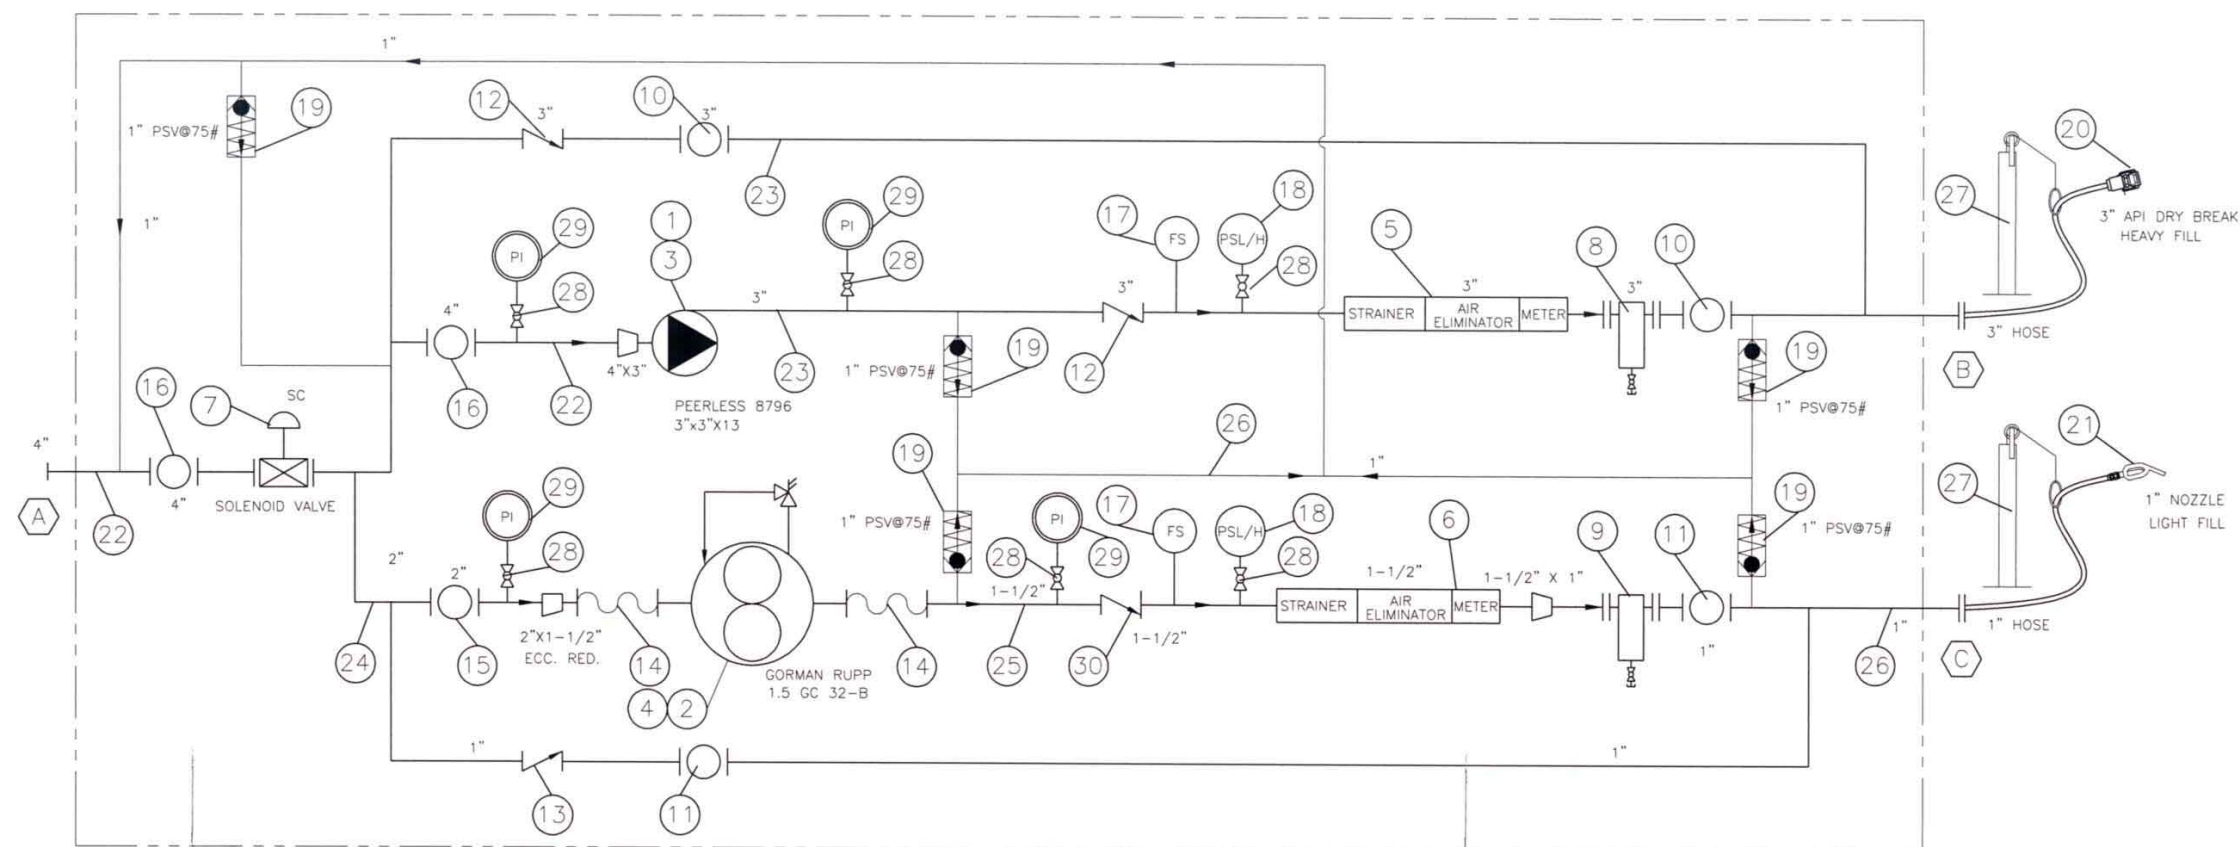
BAKER LAKE
DISPENSING MODULE

- LEGEND**
- ① PEERLESS - 3" X 3" - 1.3 MTP 8796 HEAVY FILL PUMP RATED AT 220 USGPM (1)
 - ② GORMAN RUPP GHS 1.5 GC 32-B PUMP RATED AT 10 USGPM - LIGHT FILL (1)

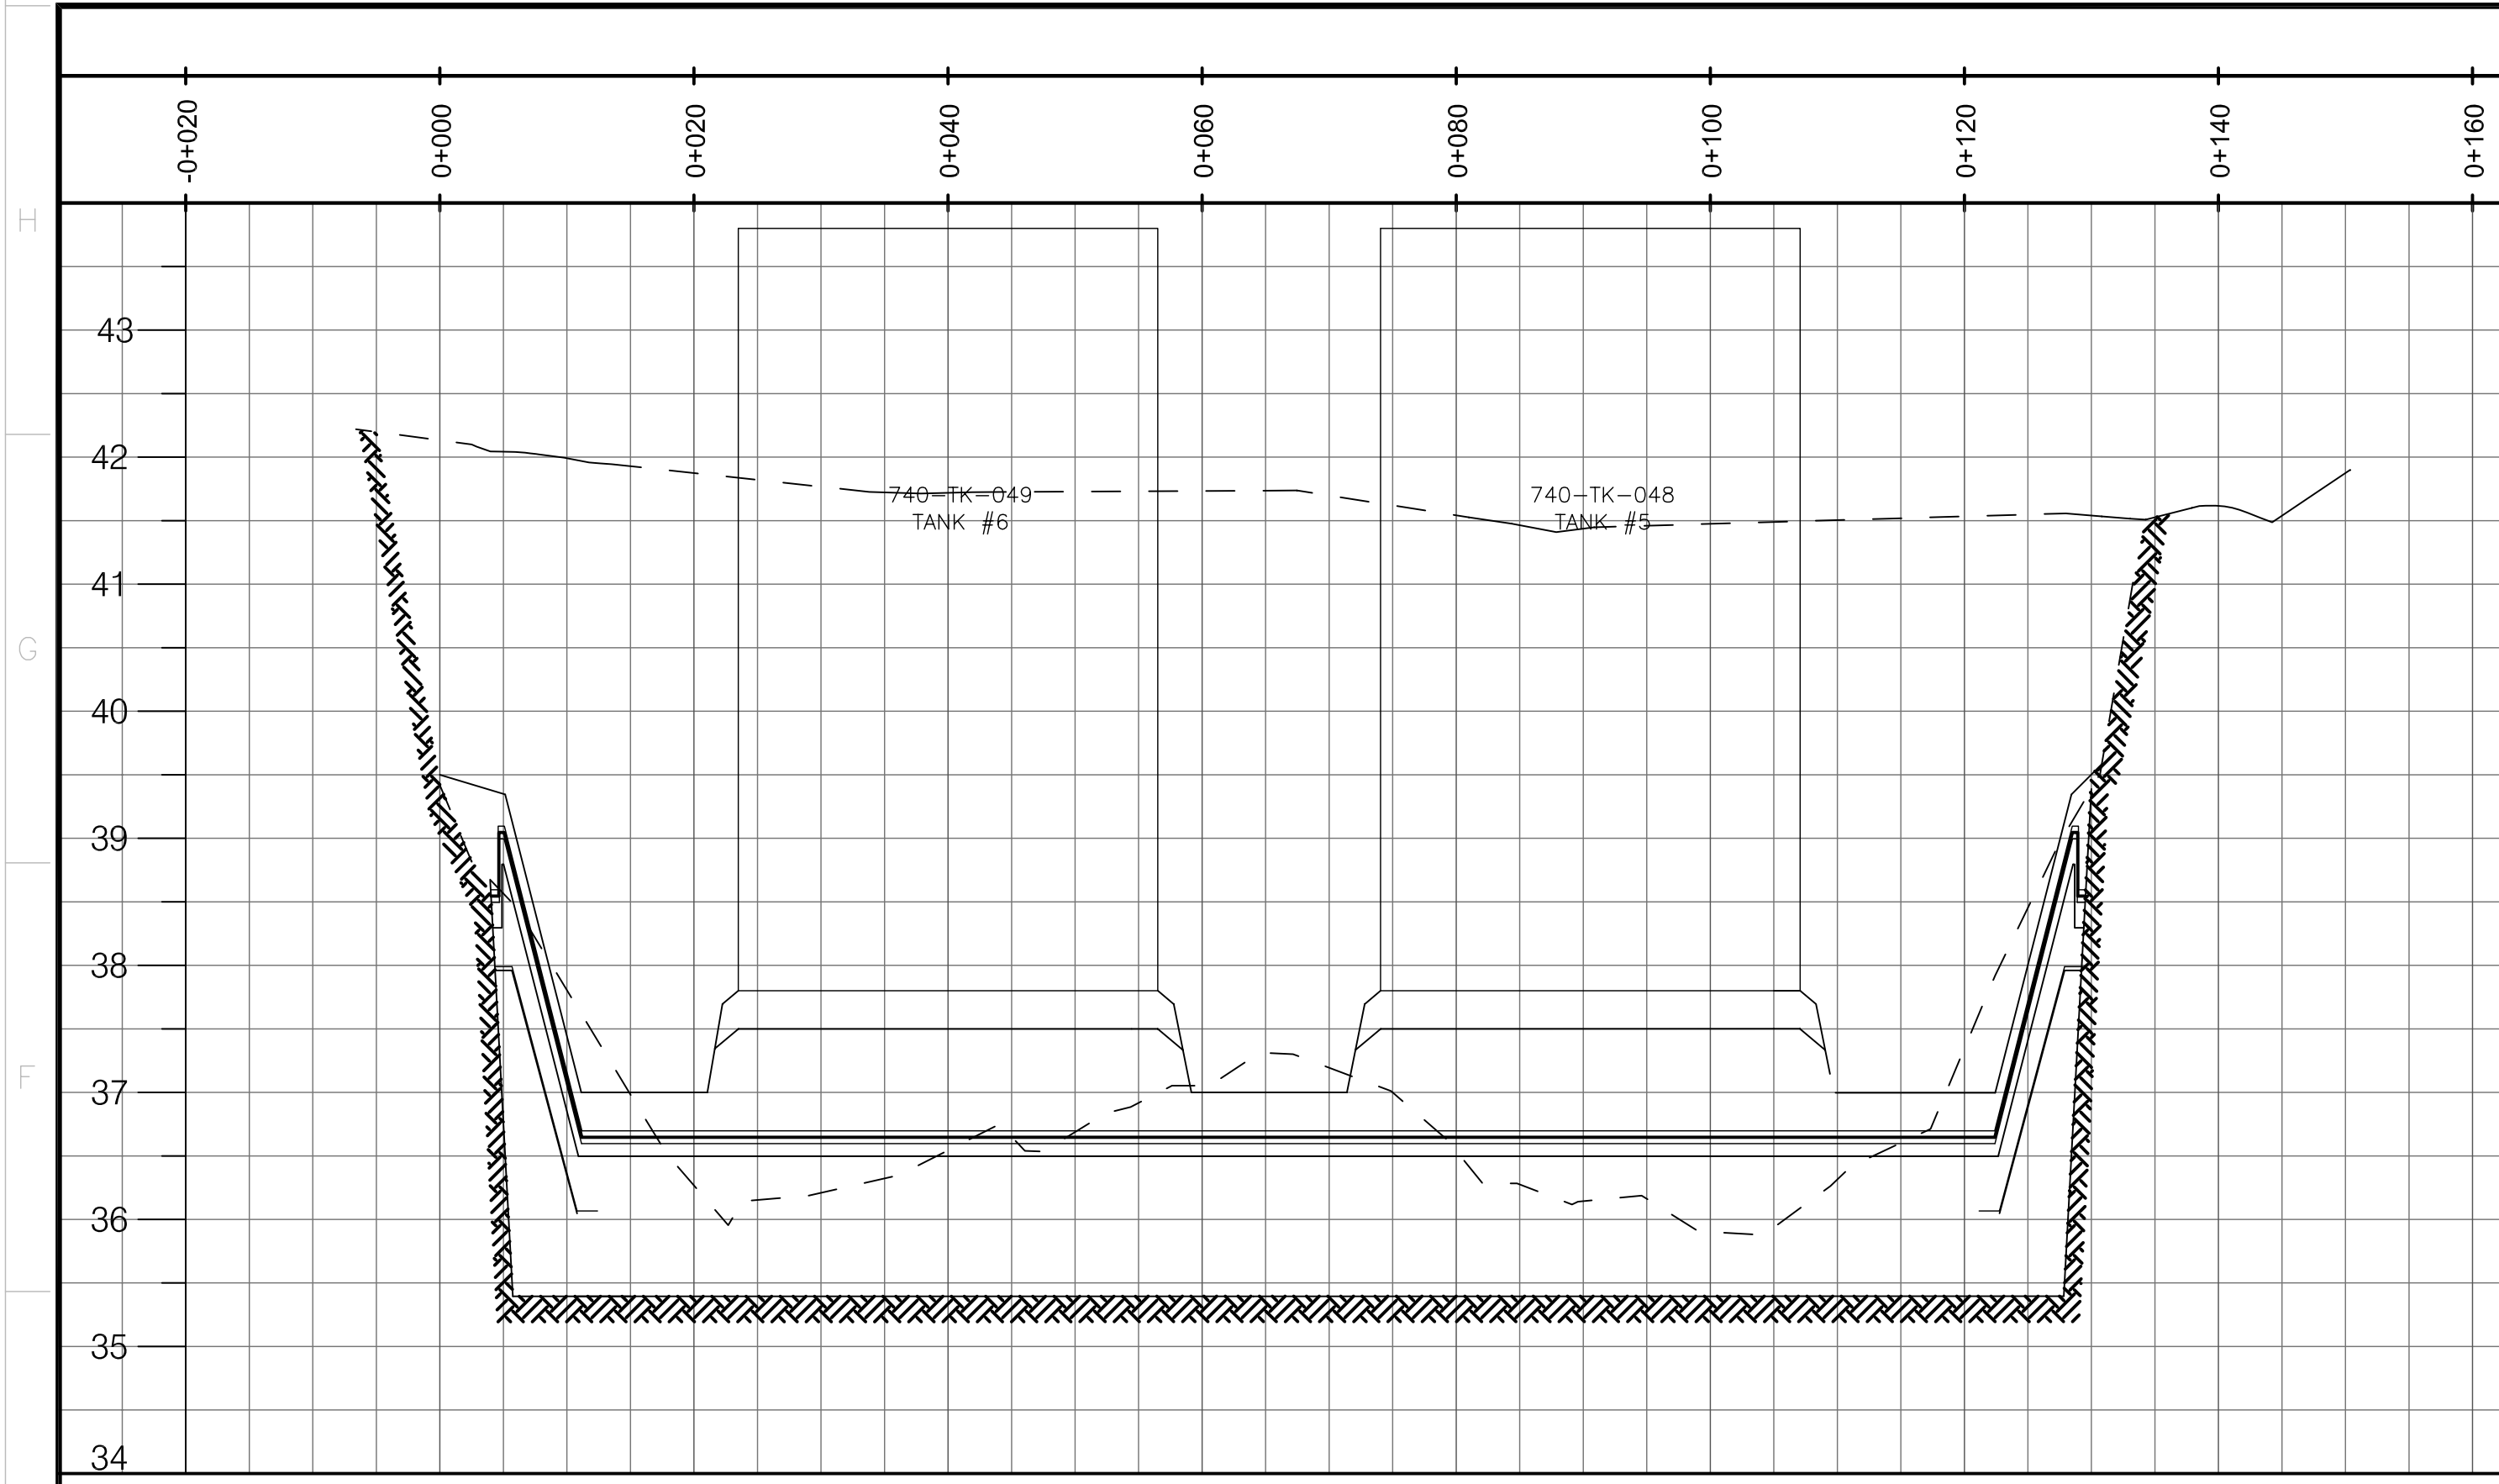
PROFIL TANK 5 & 6

CROSS SECTION C

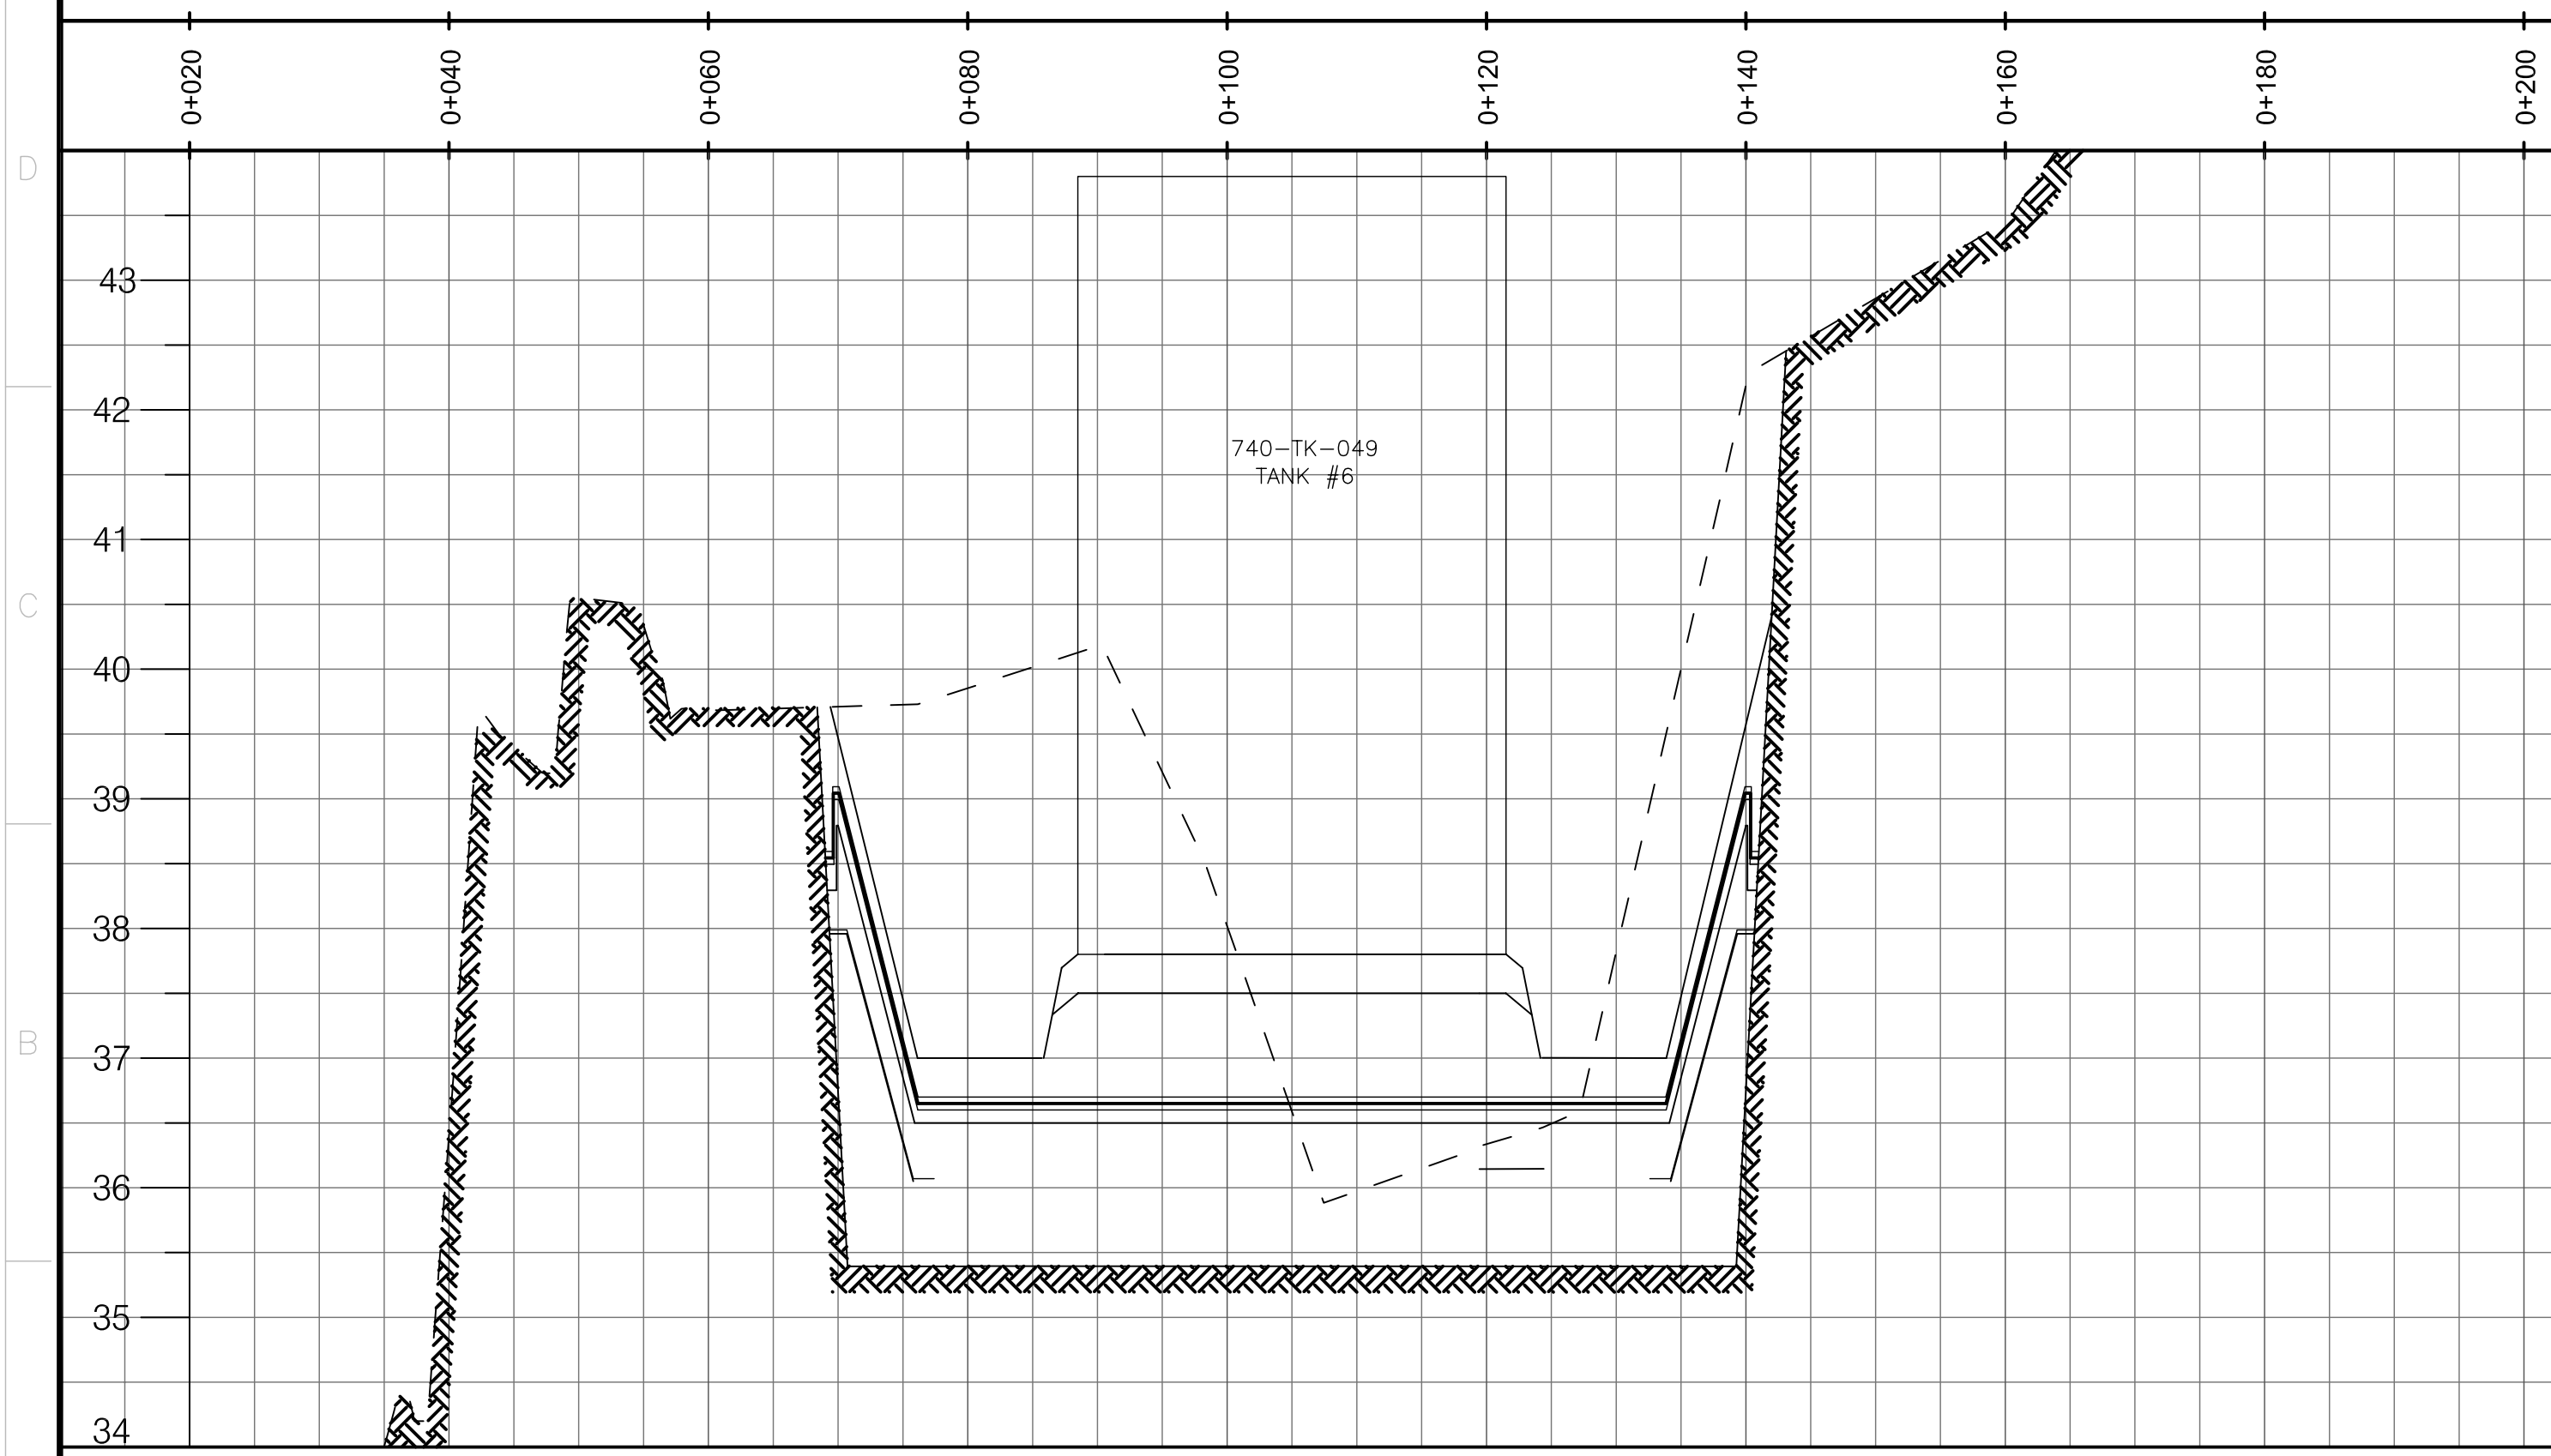
PROFIL TANK 6

CROSS SECTION A

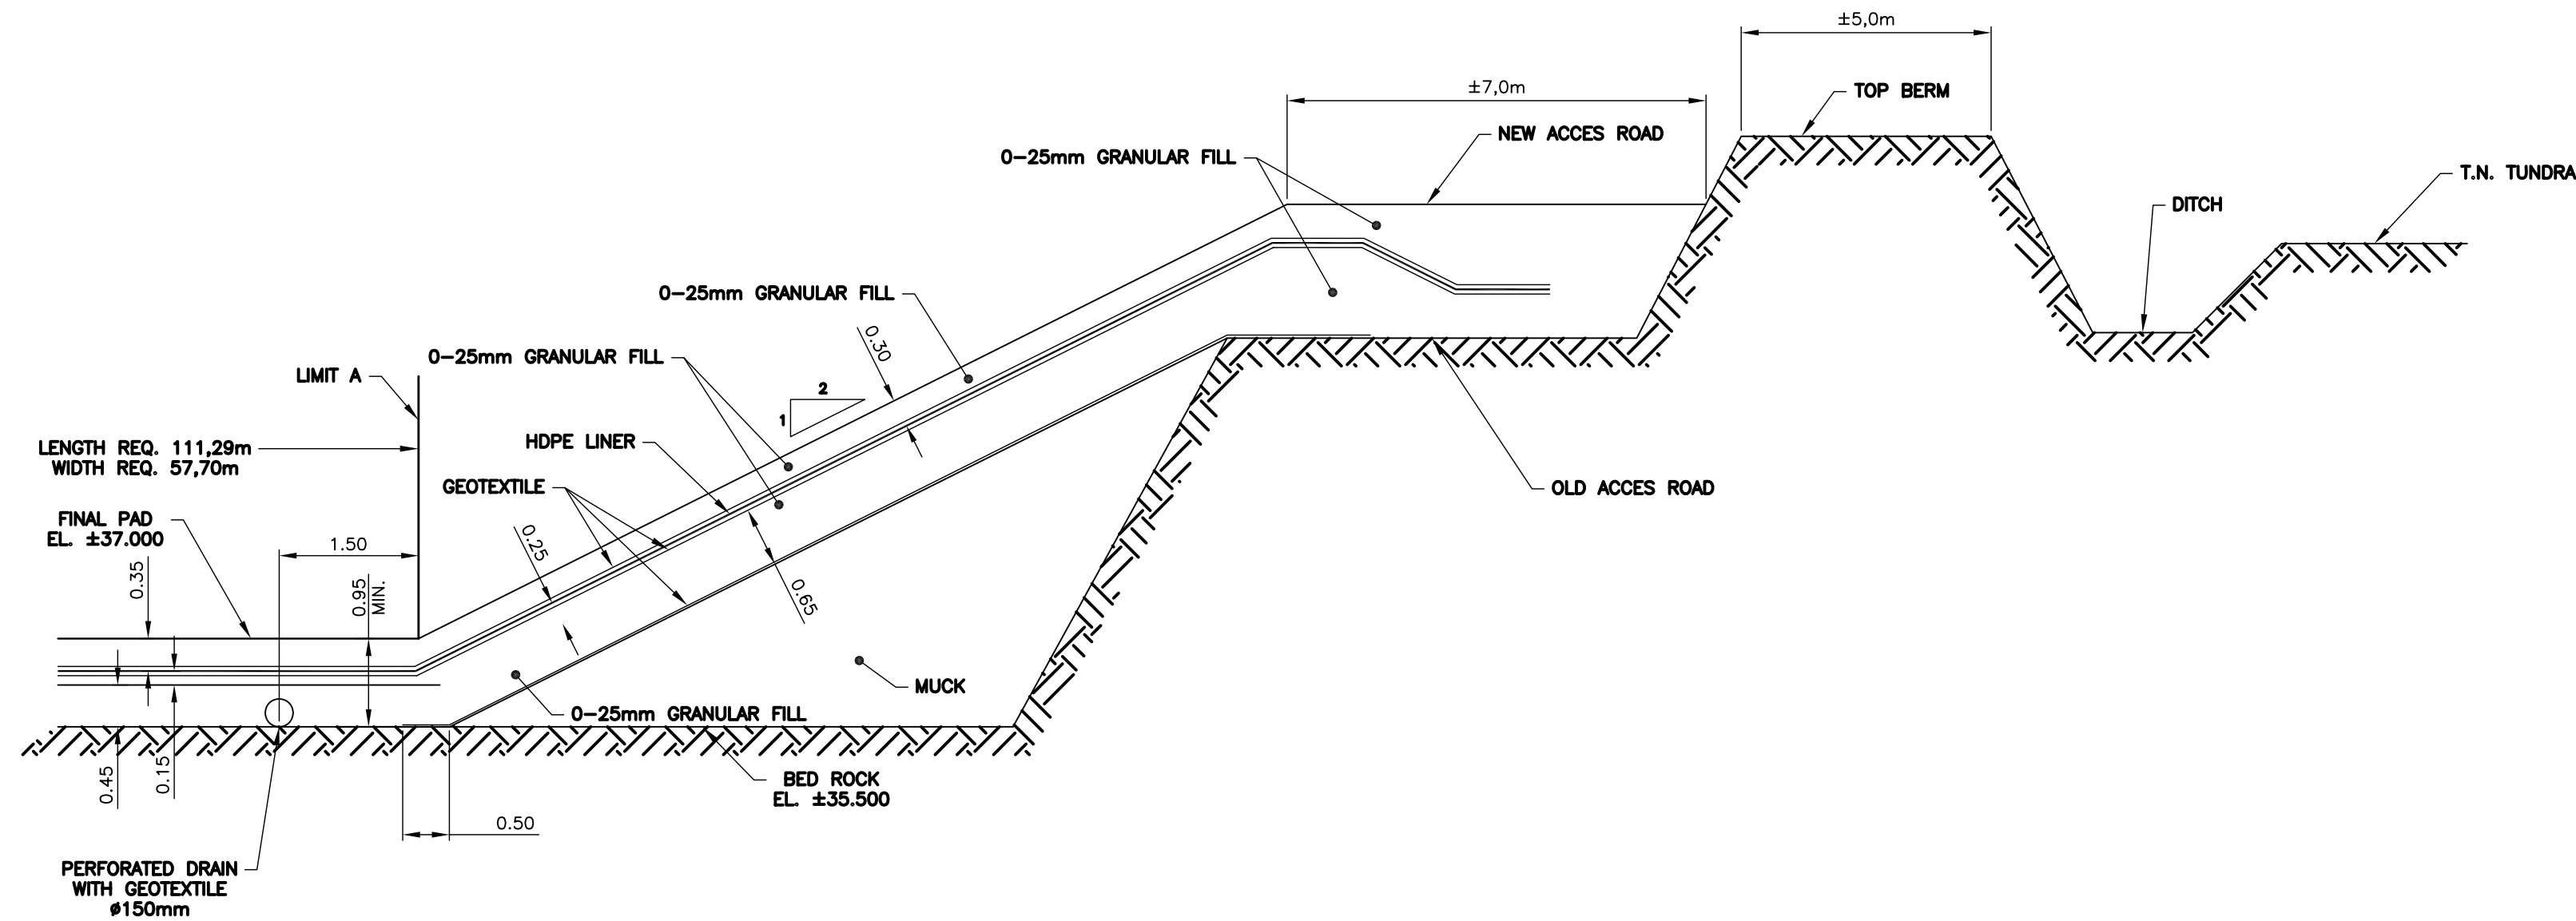
TYPICAL SECTION - DAM

SCALE : NONE
DETAIL 2

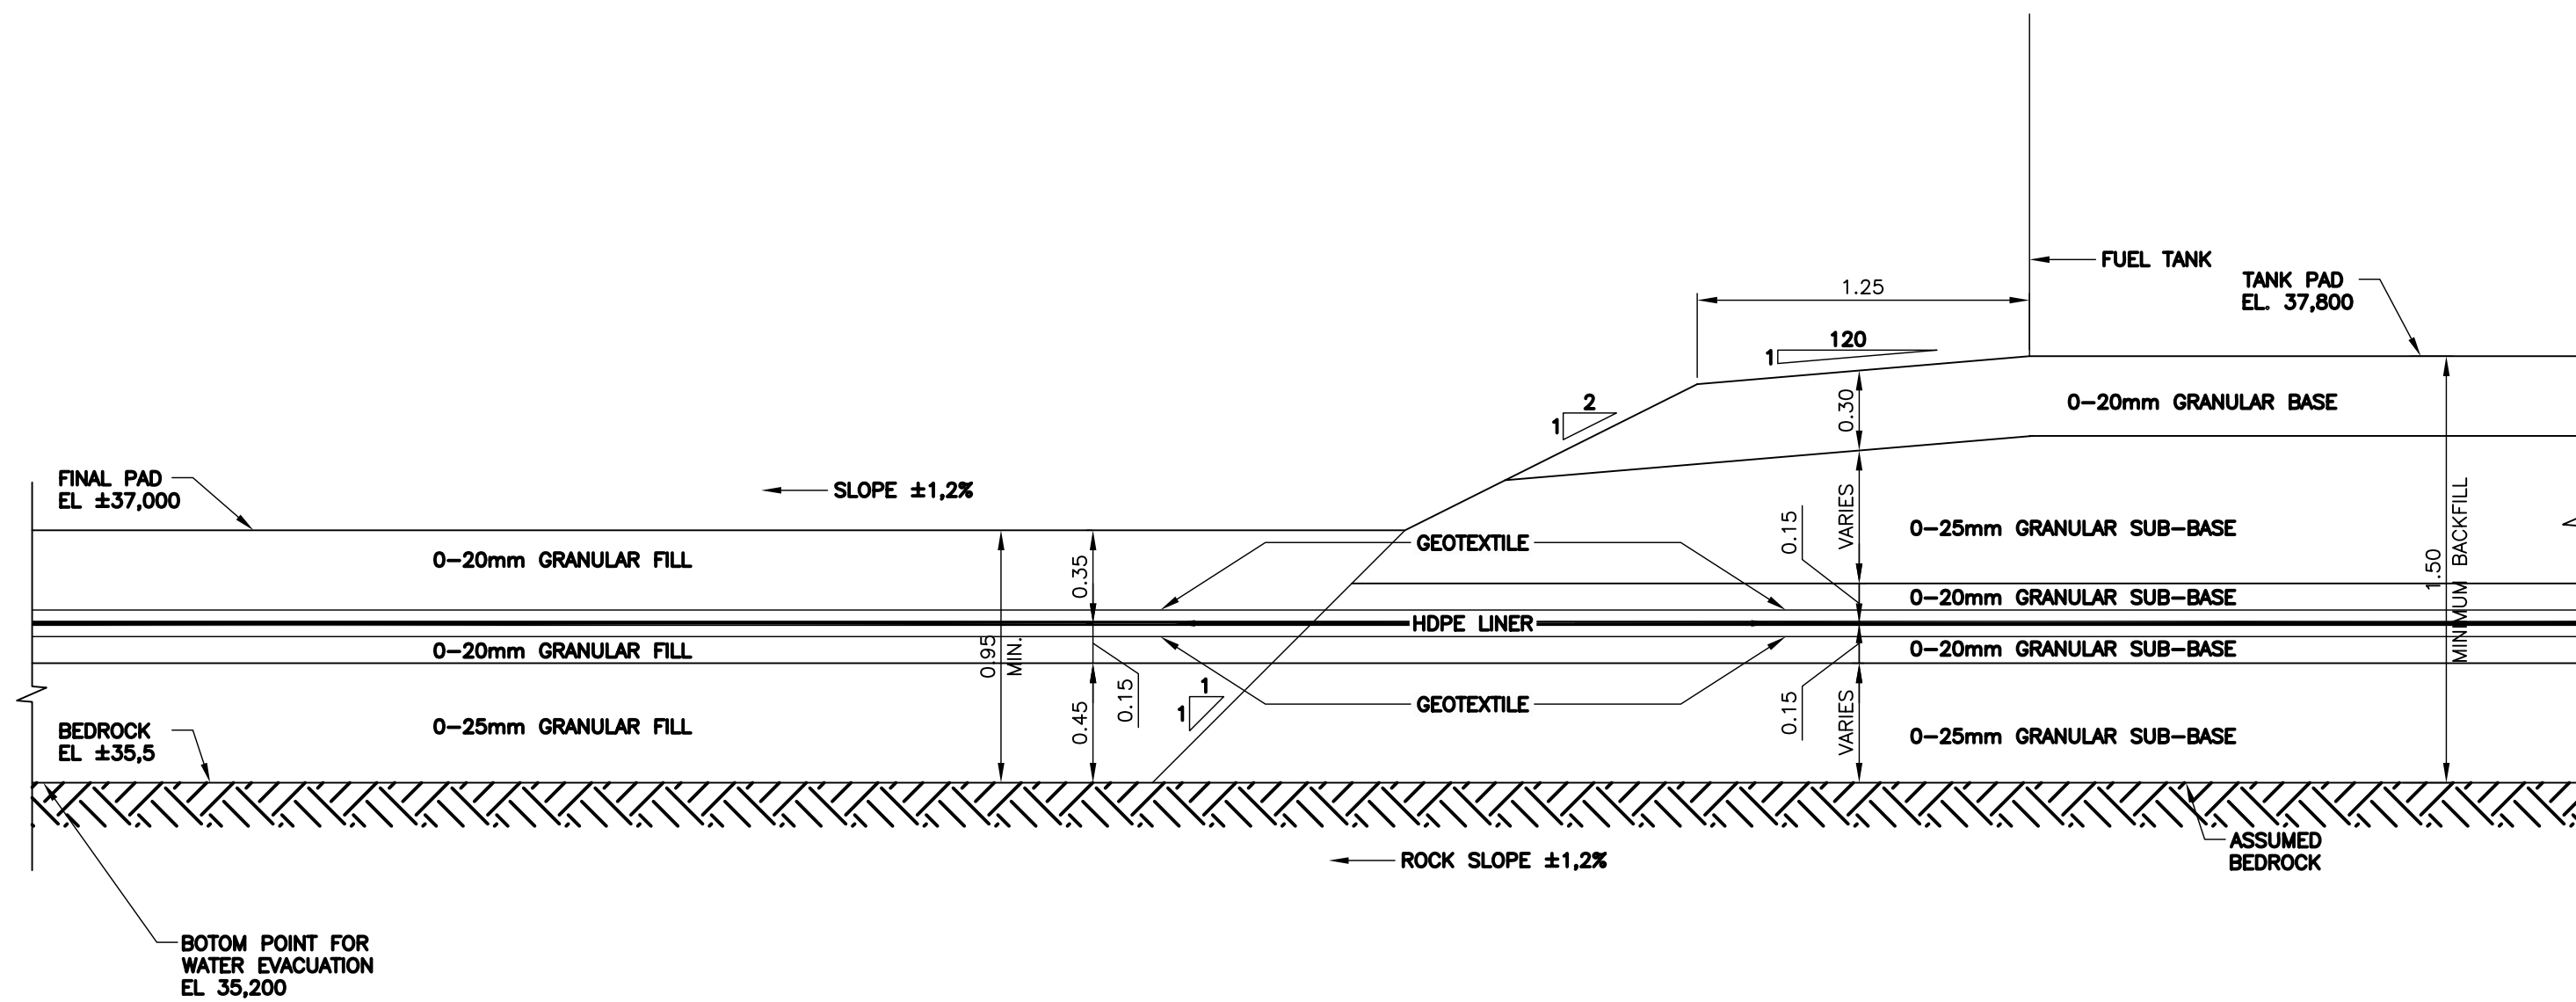
TYPICAL SECTION - PAD

SCALE : NONE
DETAIL 1

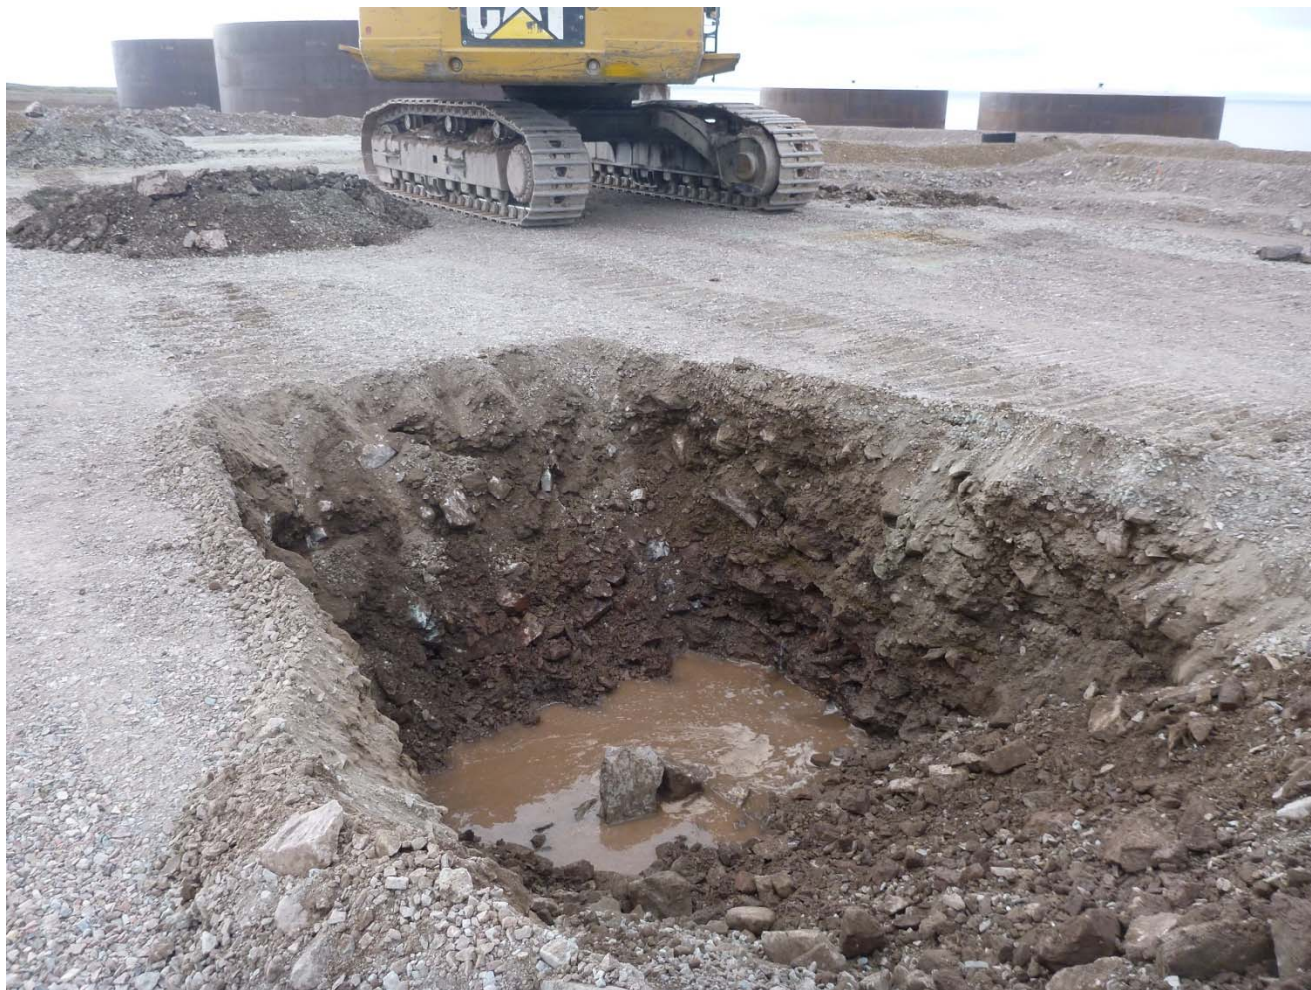
- Photo #1 – 3 test pits. Smell of Jet-A fuel and water arrival.

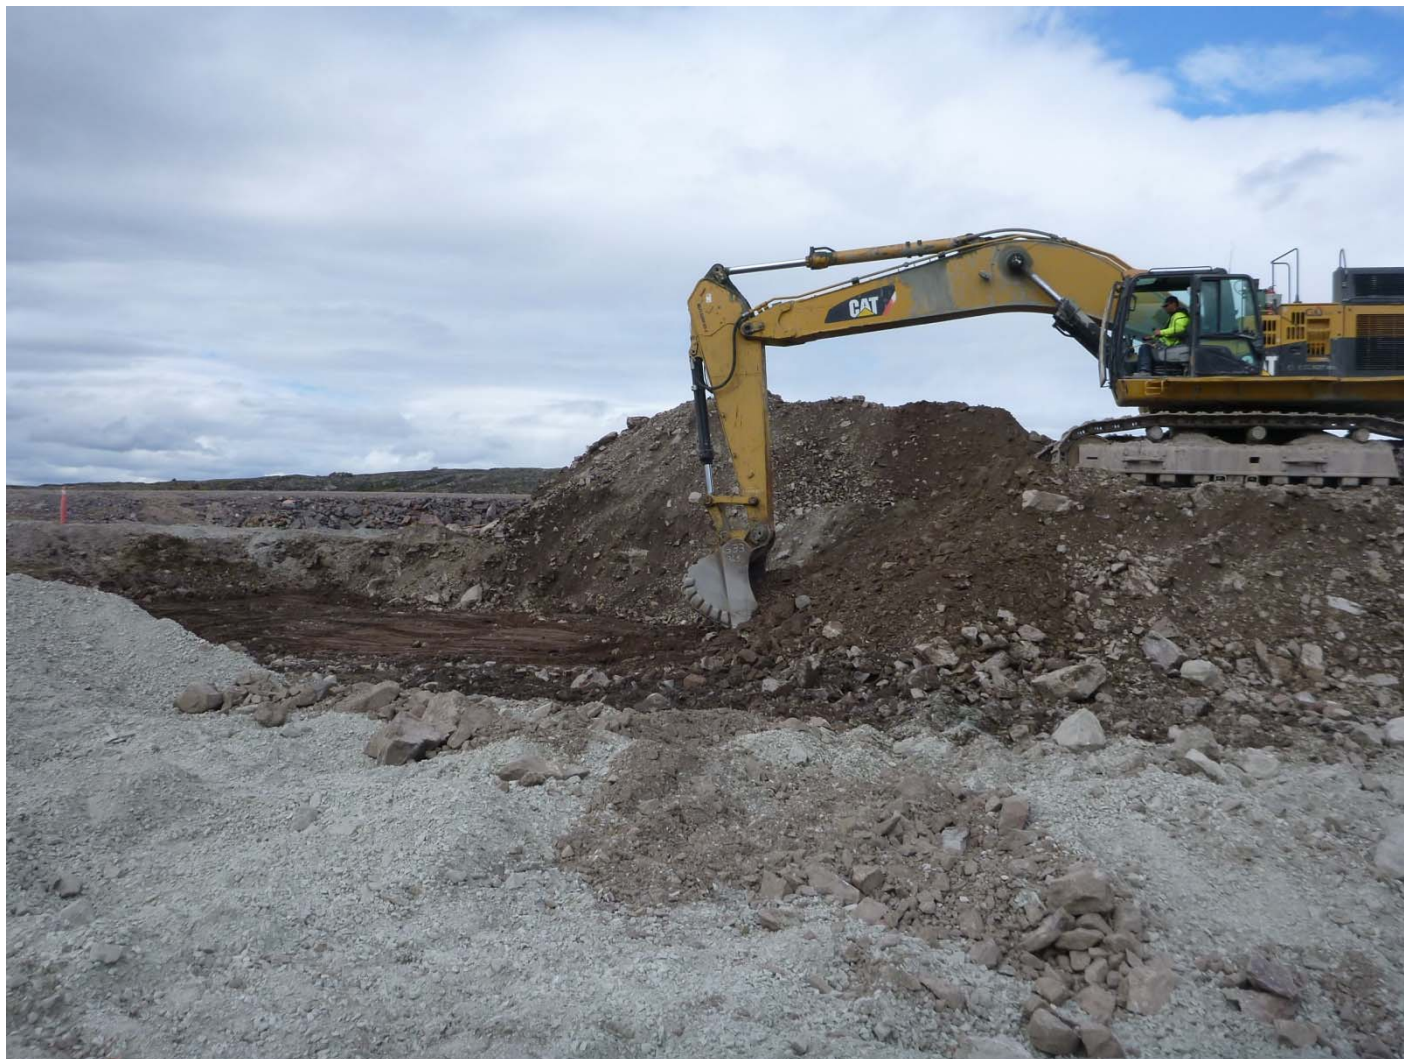
- Photo #2 – Excavation and stockpile of the contaminated material until the final level of the infra.

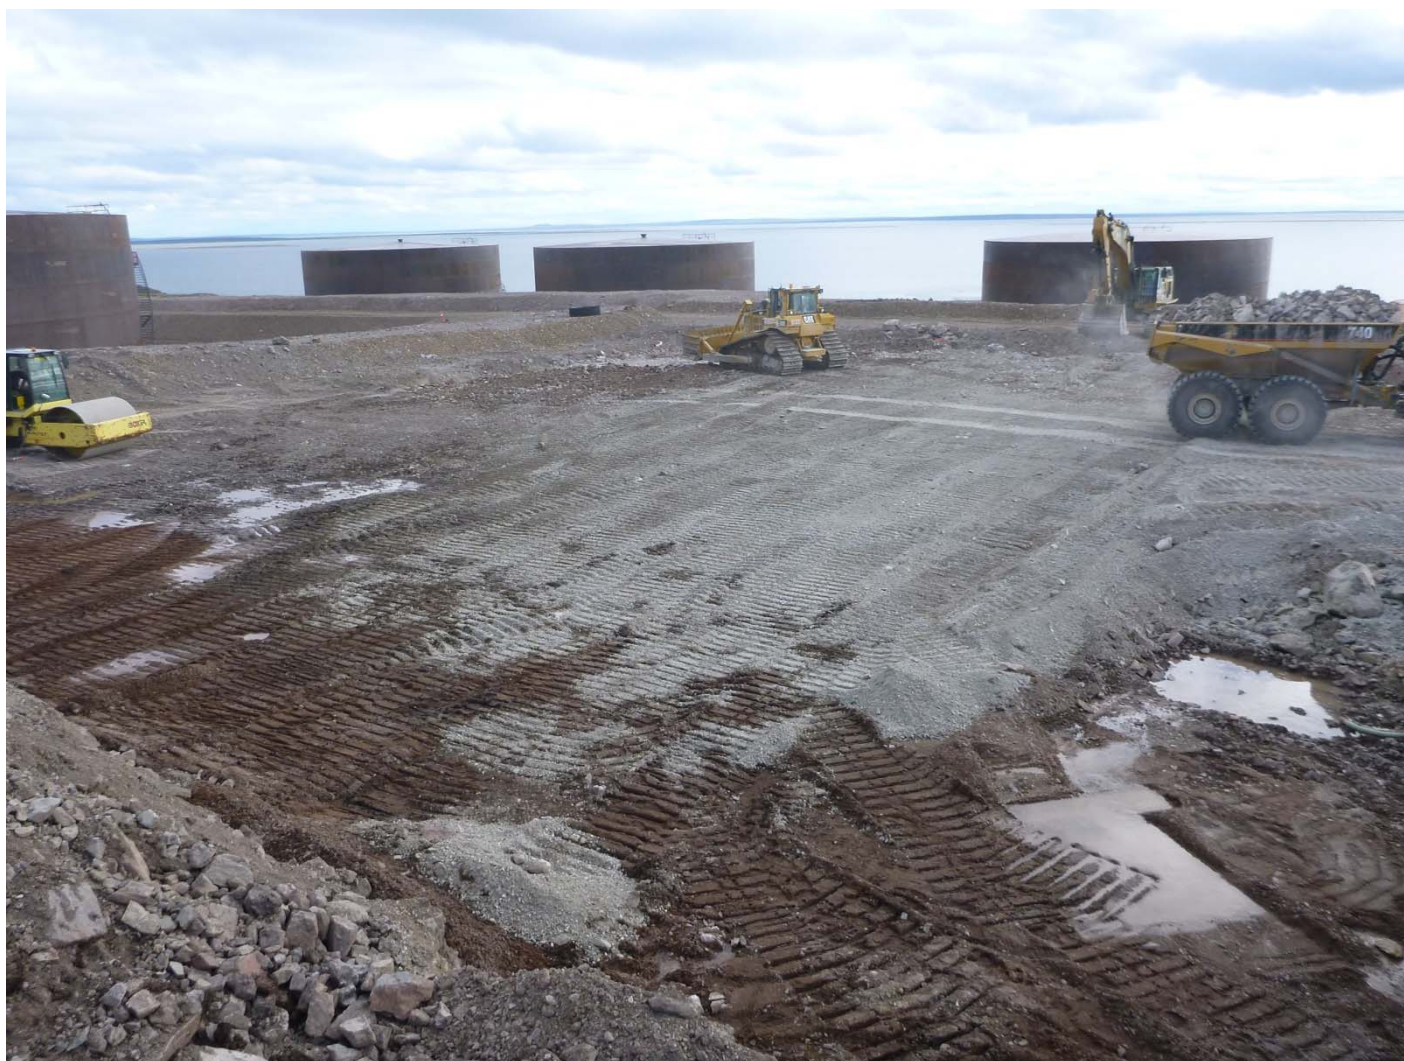
- Photo #1 – Overview of the infra. Some water accumulations caused by the thaw of the material in place. A small ditch will be made to try to drain this water during night.

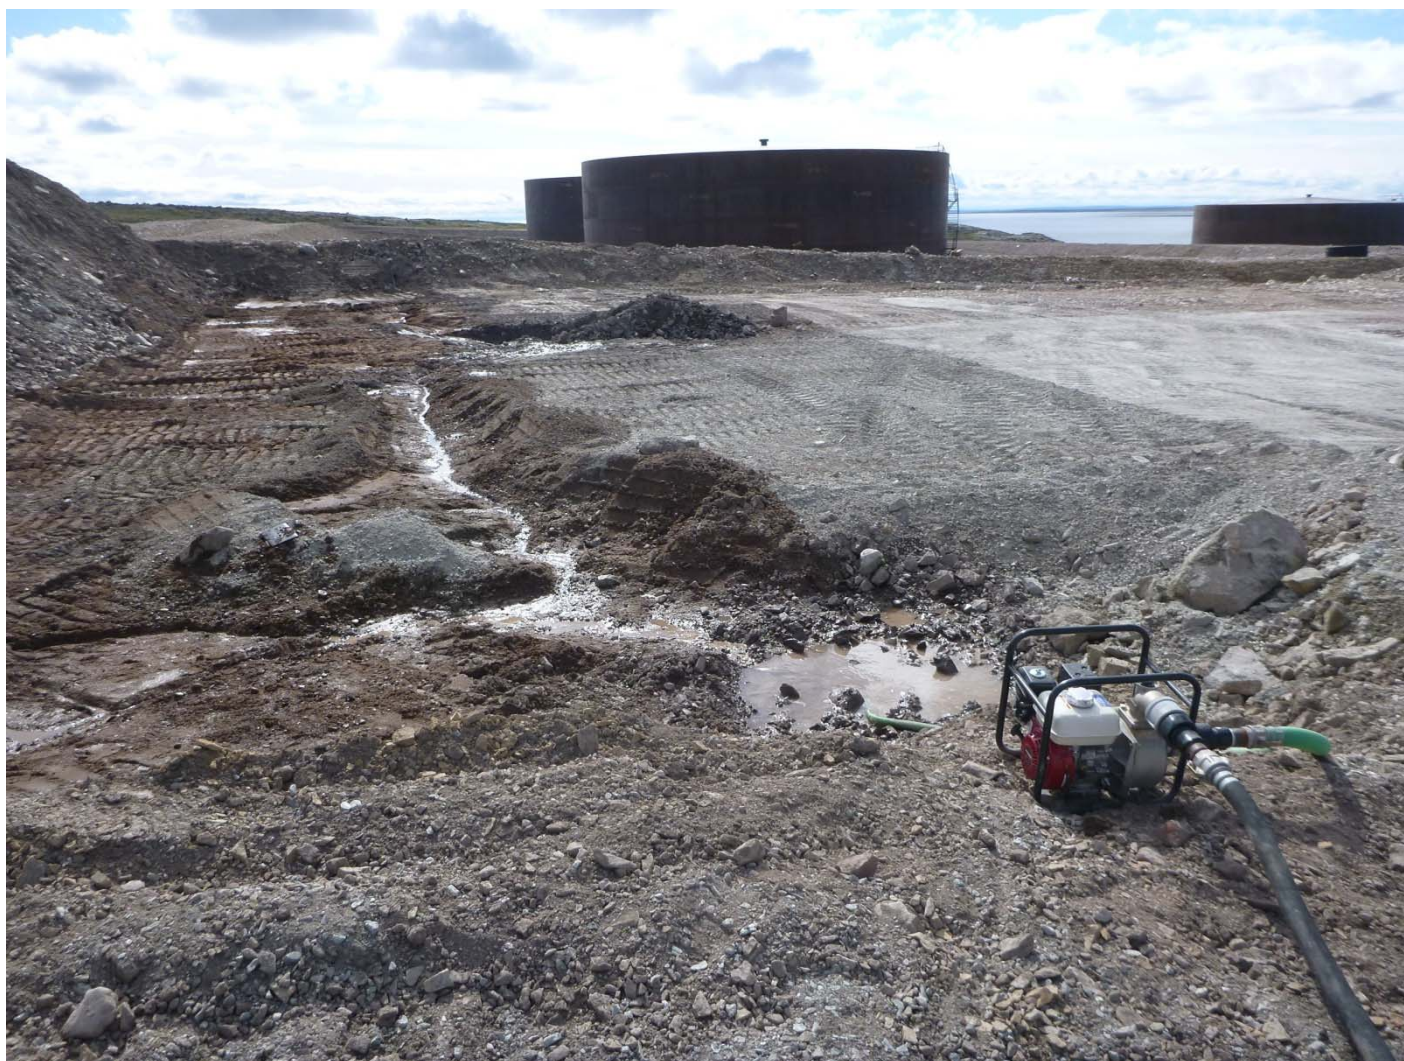
- Photo #2 – Drainage of the water on north side of the pad. The ground is more stable at the end of the day.

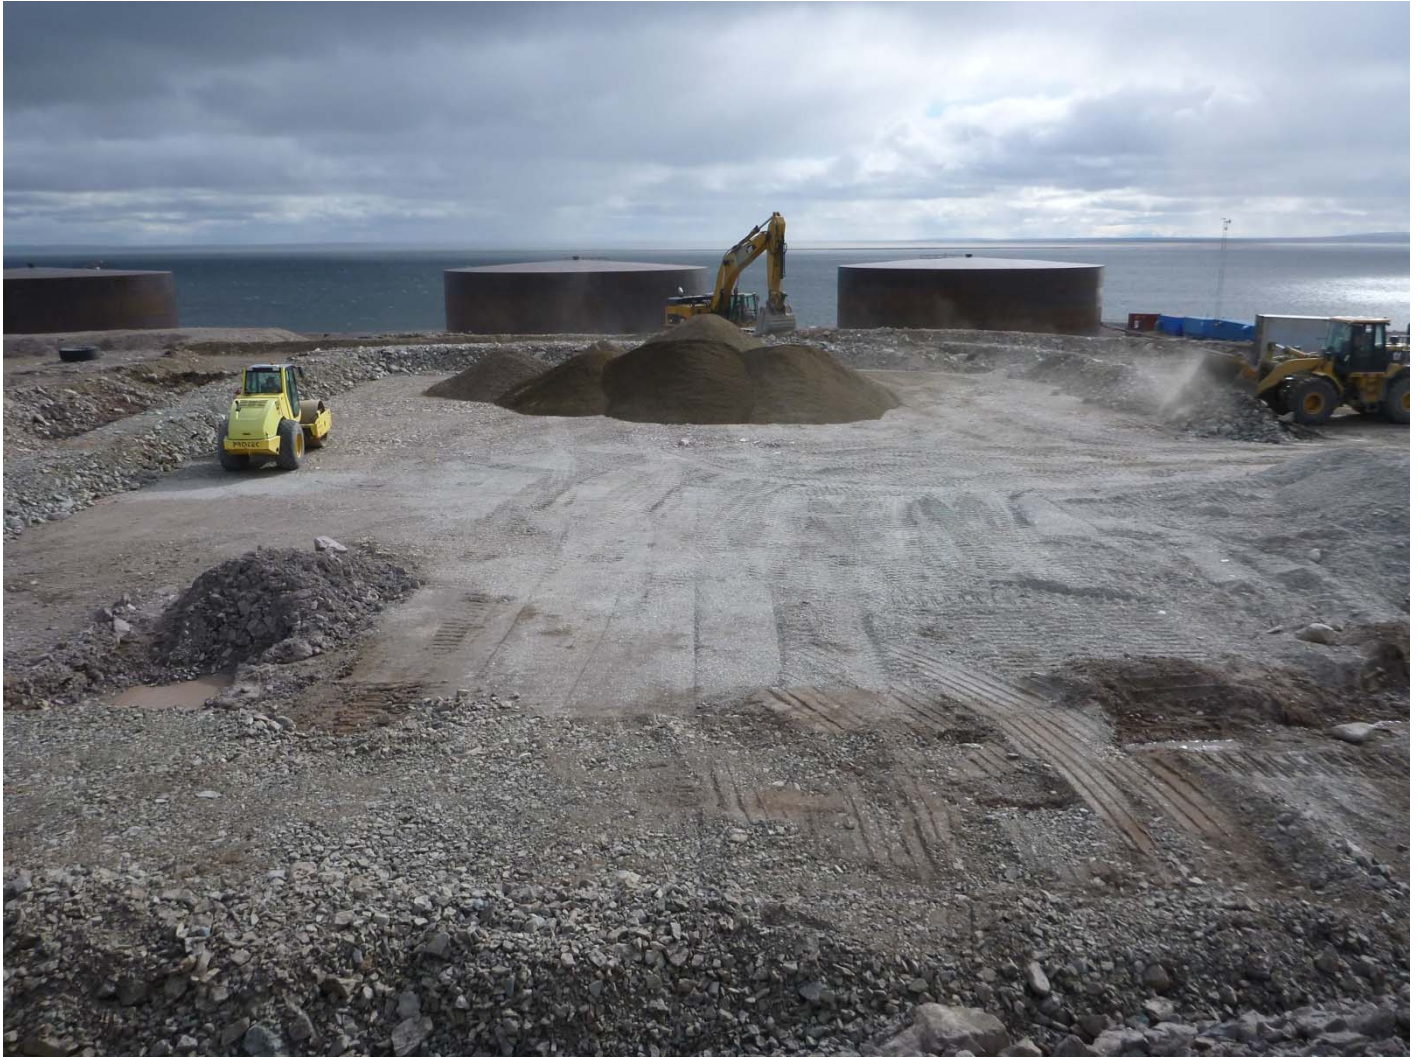
- Photo #1 – Construction of the mini dikes around the pad. Stockpile of the 0-20mm on the pad.

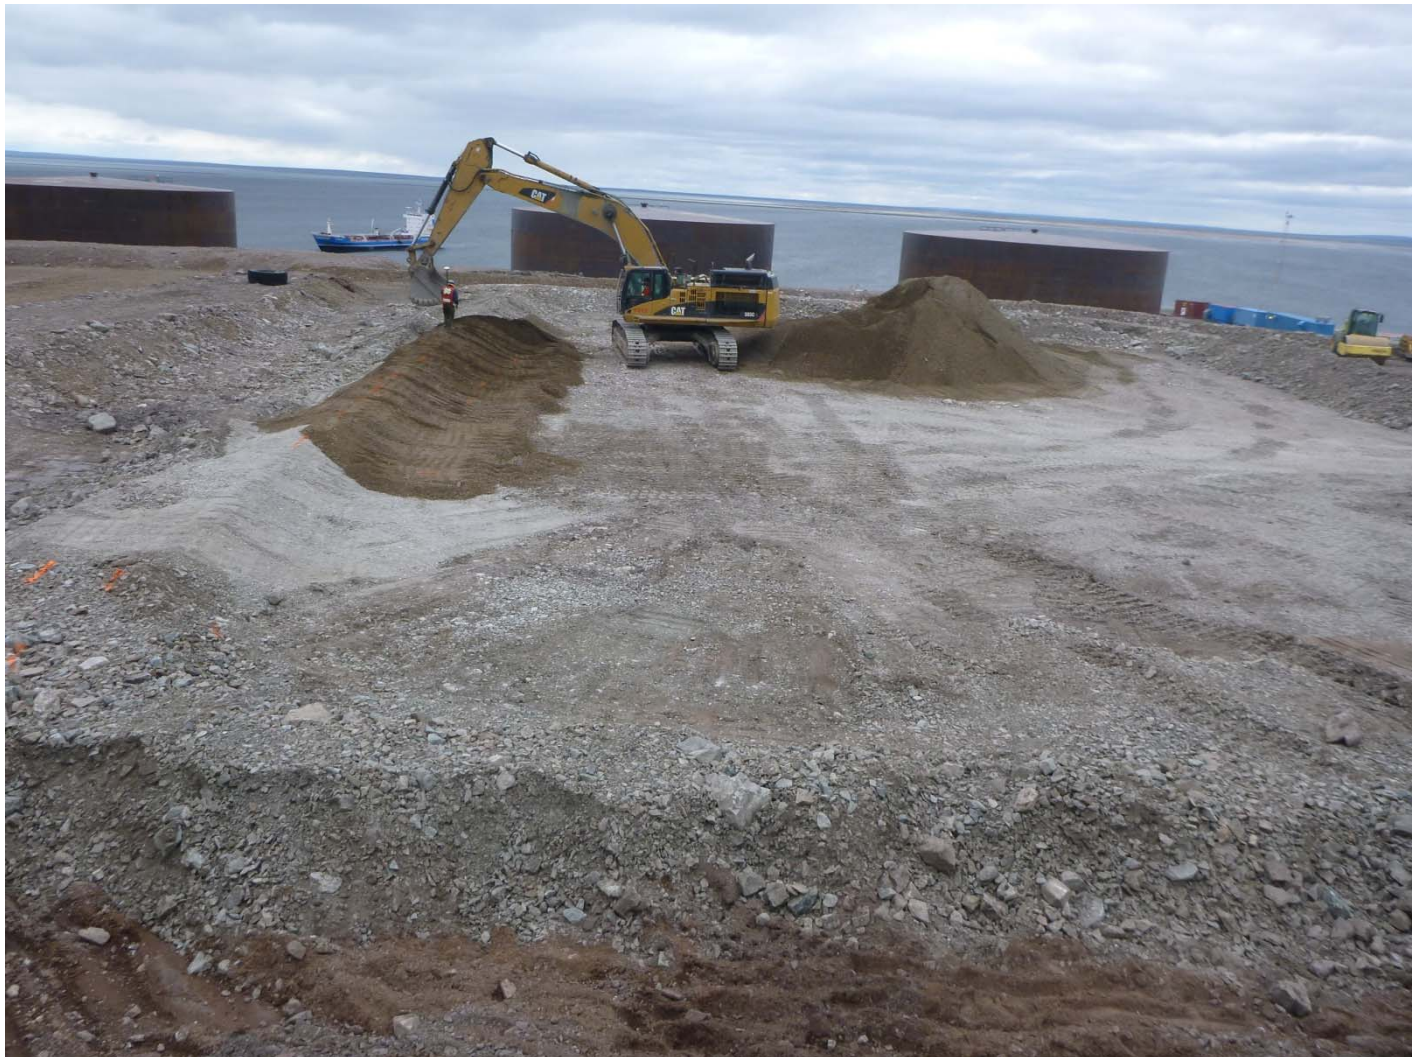
- Photo #1 – Placing the crushed stone 0-20mm on the mini dike.
