Appendix 51

Meadowbank and Whale Tail Management Plans

MEADOWBANK GOLD PROJECT

Baker Lake Bulk Fuel Storage Facility: Environmental Performance Monitoring Plan, Version 4

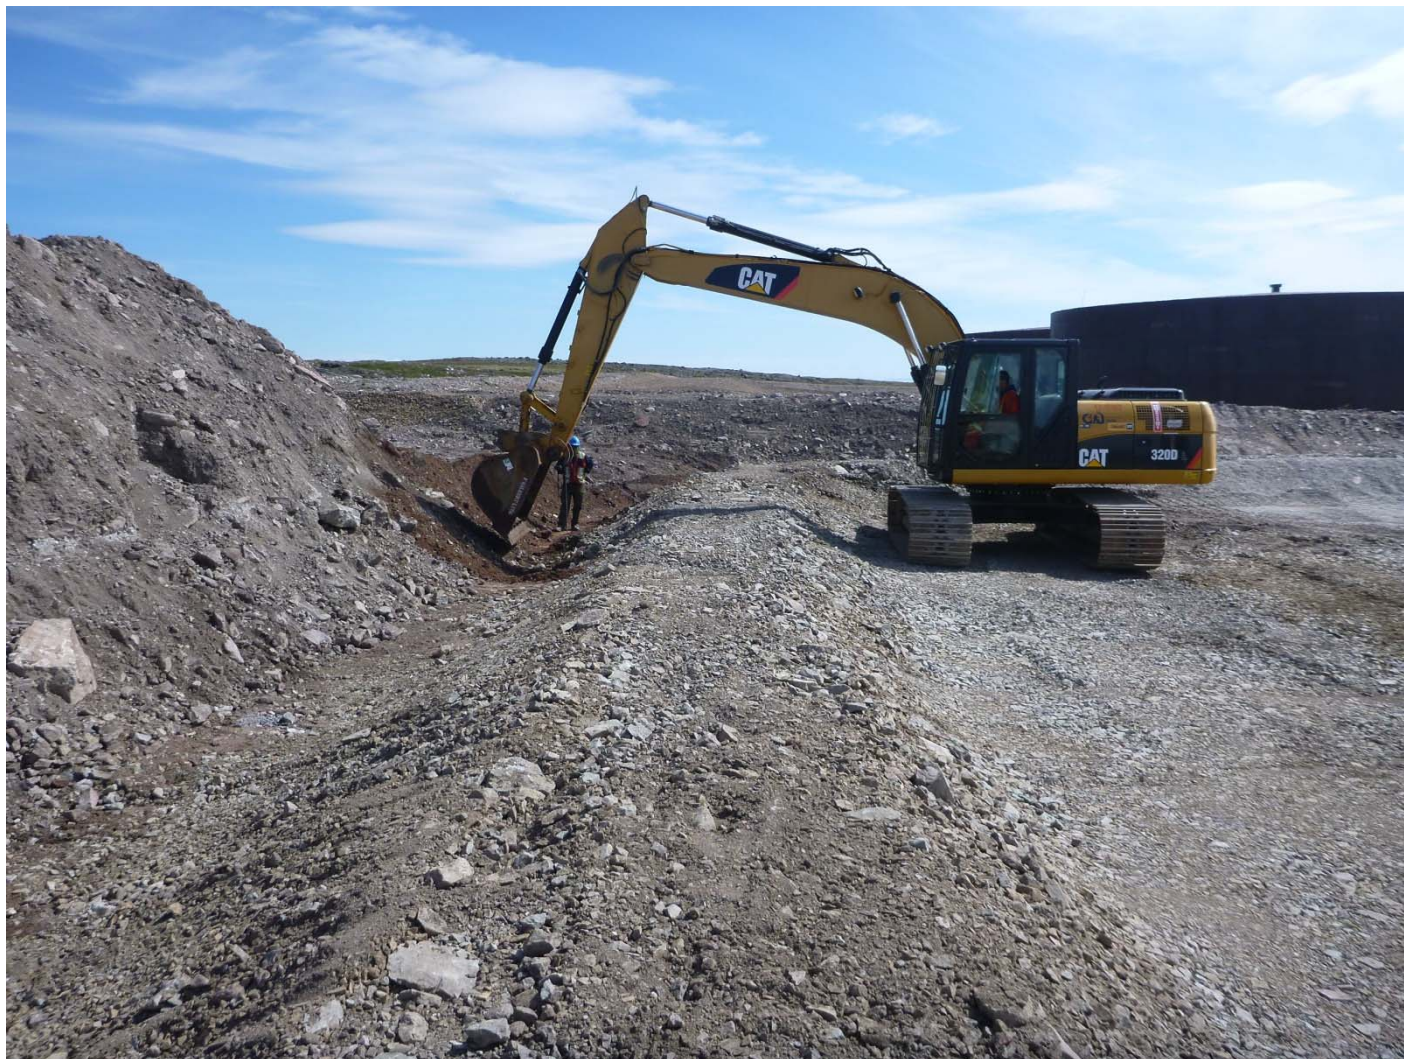
- Photo #1 – There is frost in the north ditch that prevent the excavation to the desired elevation.

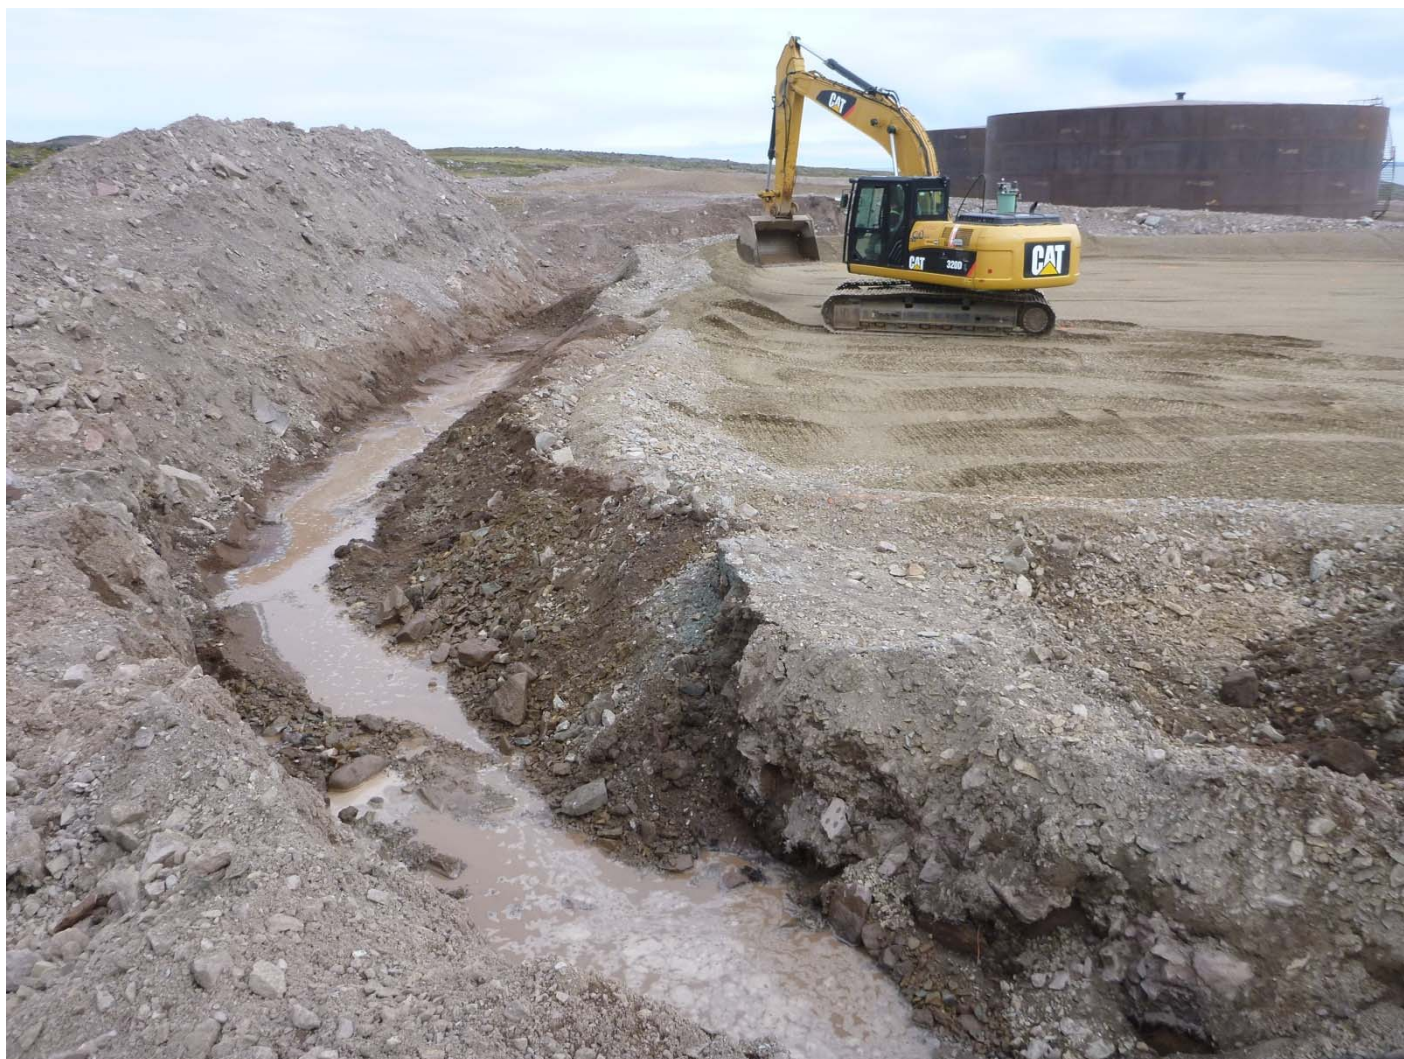
- Photo #1 – Excavation of the north ditch to the frost. There is a groundwater artery.

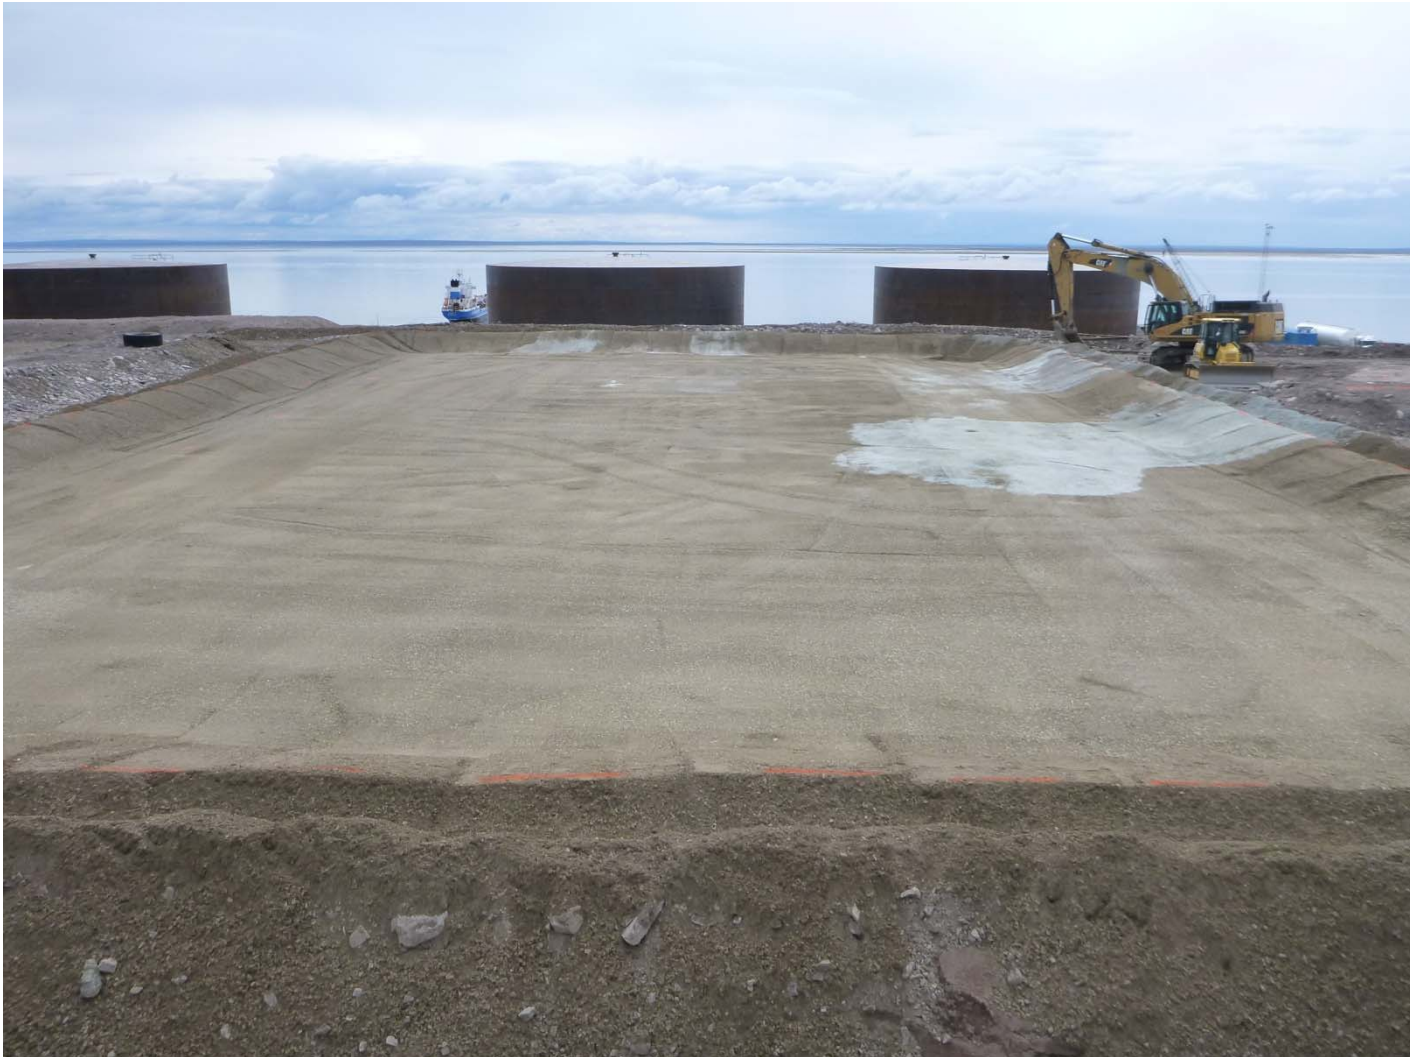
- Photo #1 – Overview of the pond ready for the geotextile and the bituminous geomembrane.

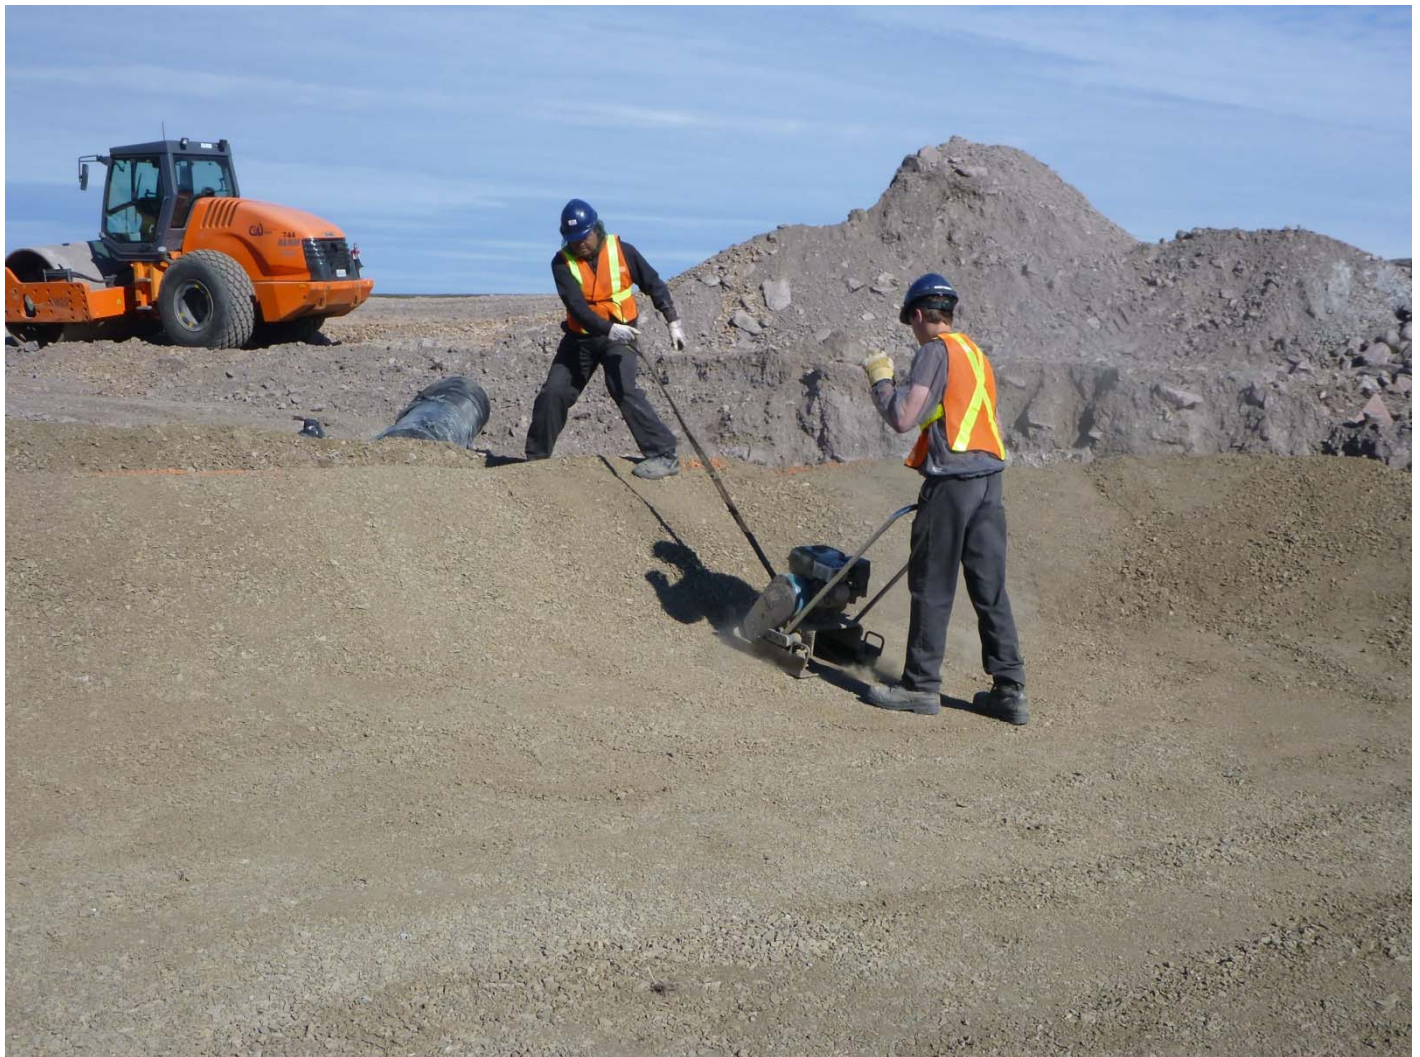
- Photo #1 – Compaction of the slopes with the vibratory plate to avoid rock punching in the membrane.

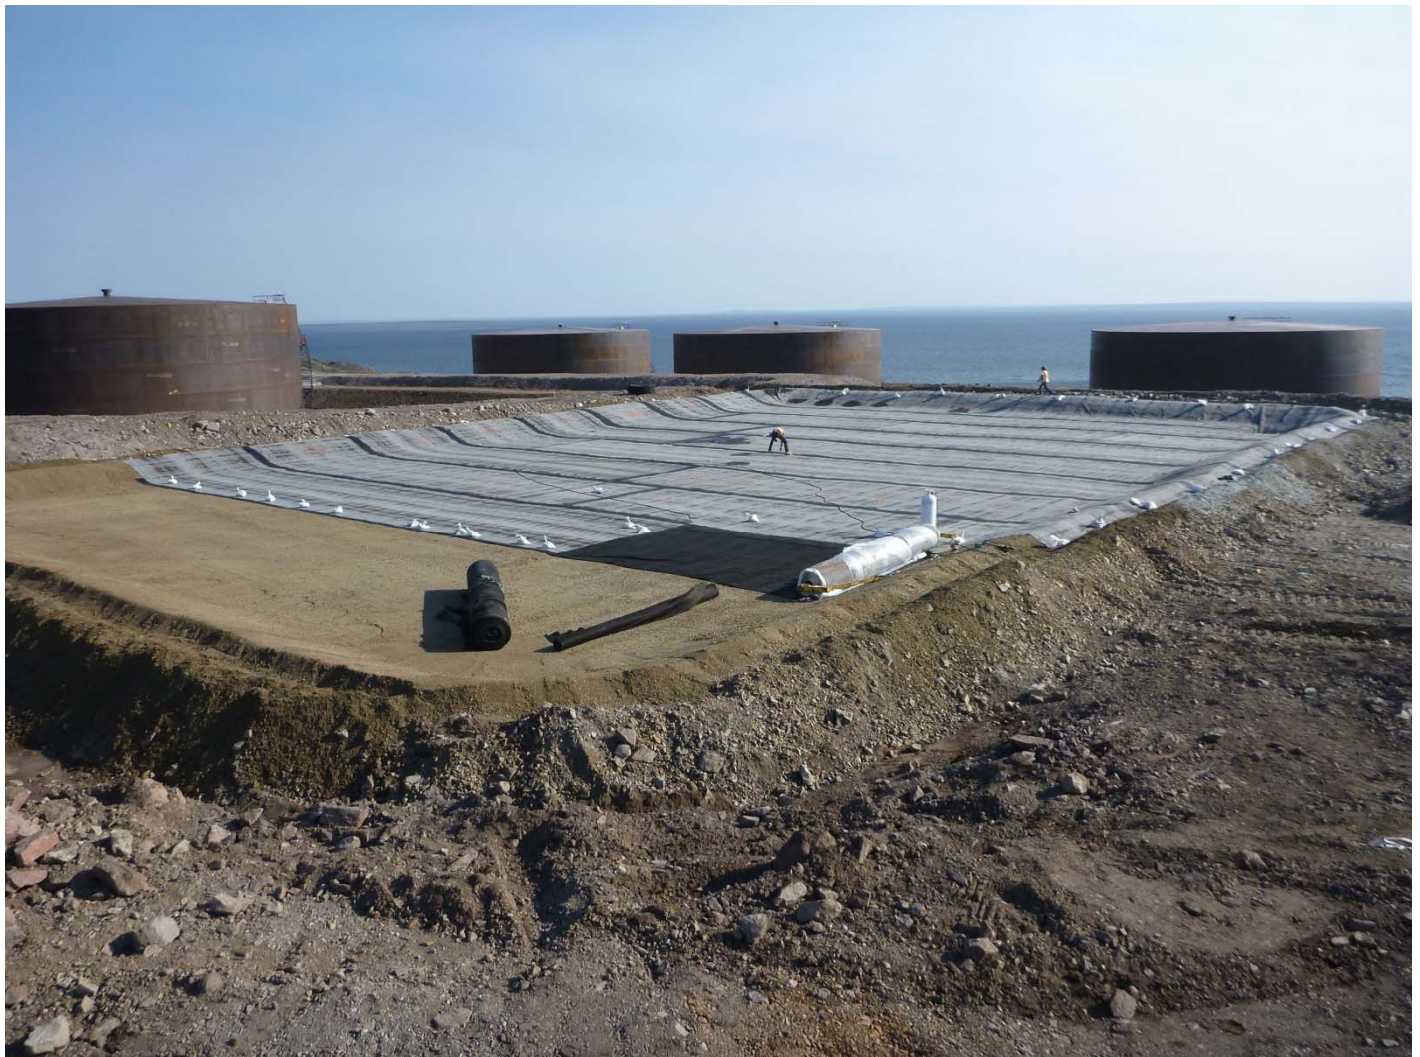
- Photo #1 – Placing the bituminous geomembrane with a geotextile under.

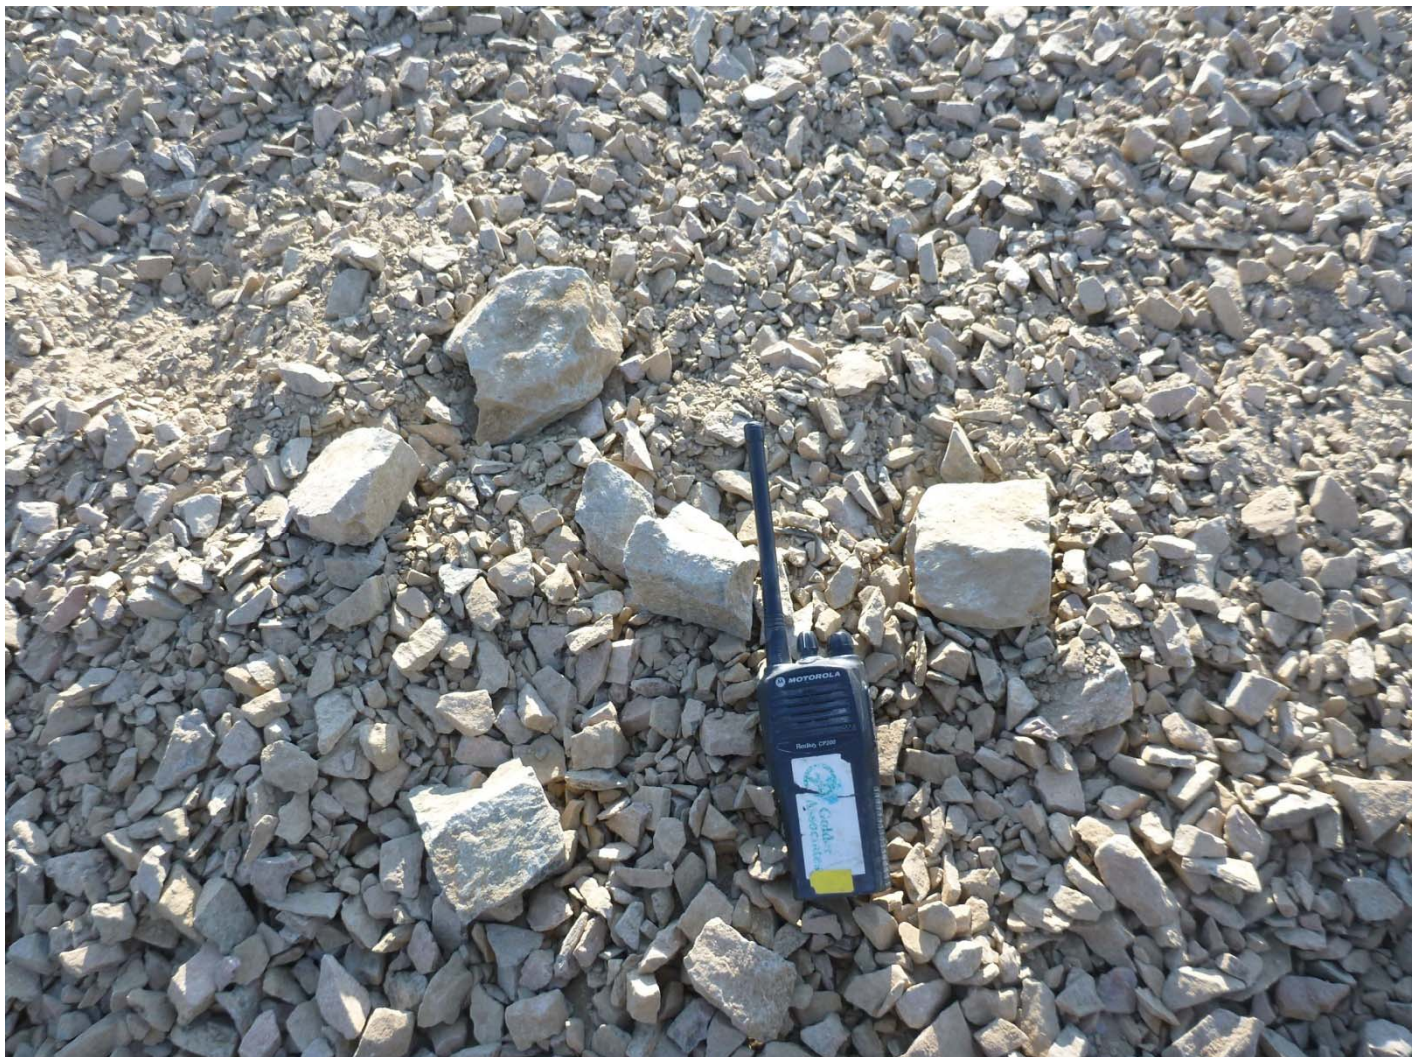
- Photo #1 – Lot of particules bigger than 20mm in the 0-20mm brought by BLCS. We advise BLCS to check the screener. Indeed, there was a gap on the side of the screen because of a missing inner bar. After the reparation of the screener, there is still presence of particules up to 100mm in the material from an unknow source. We remove them by hand on the field, but there is still a lot of rocks around 1 1/2" big.

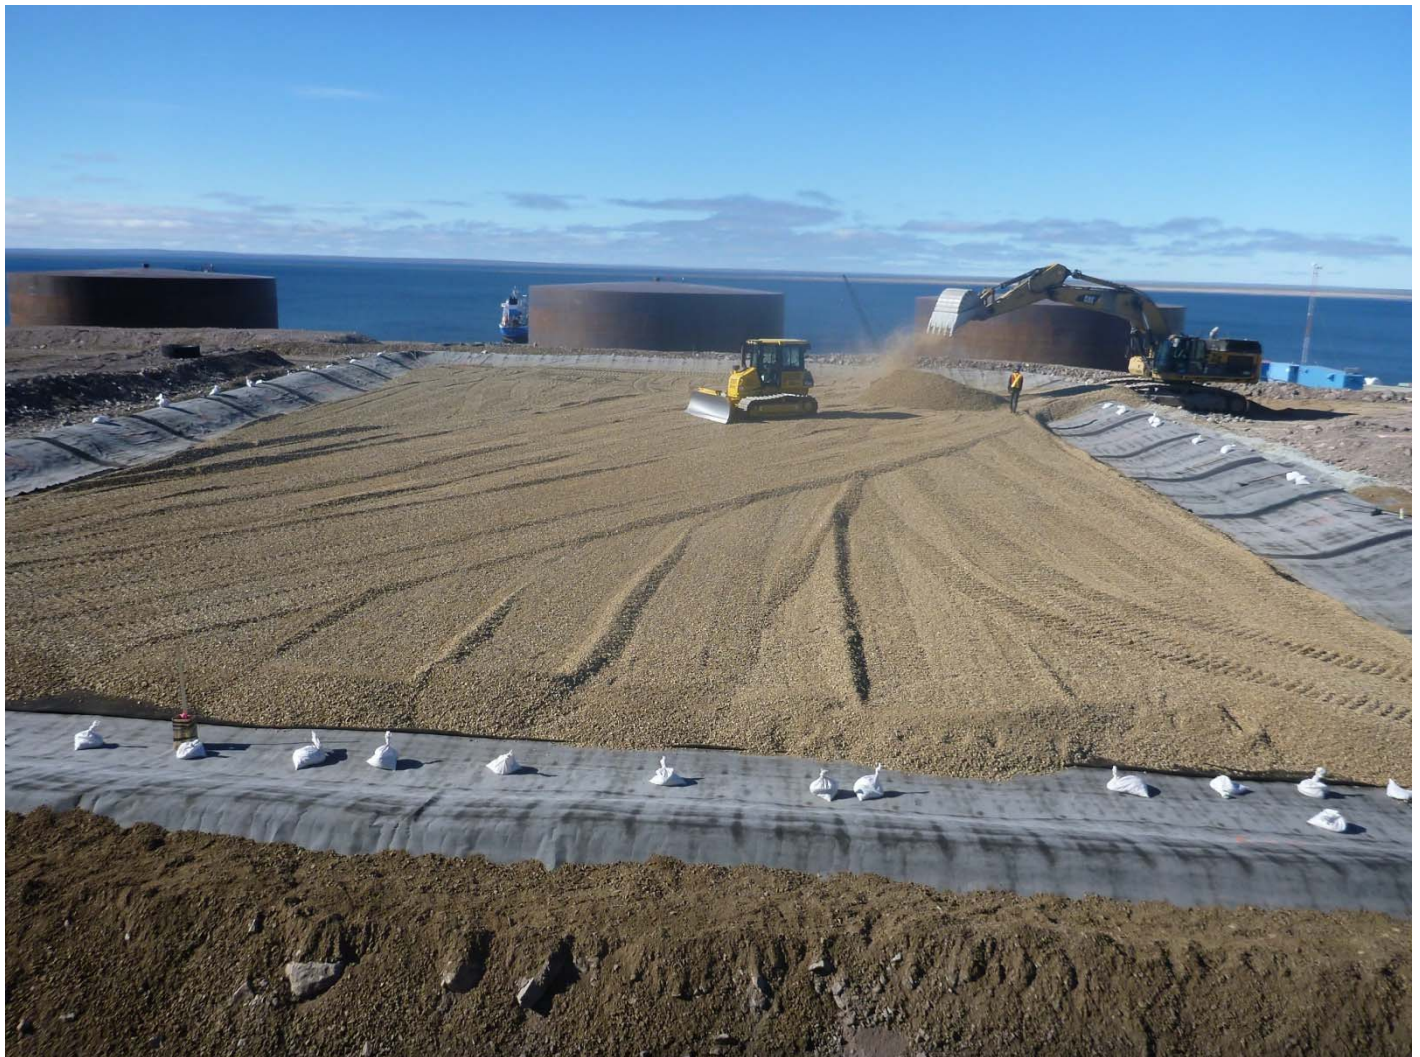
- Photo #2 – Placing the 0-20mm above the bituminous geomembrane. A geotextile is placed before.

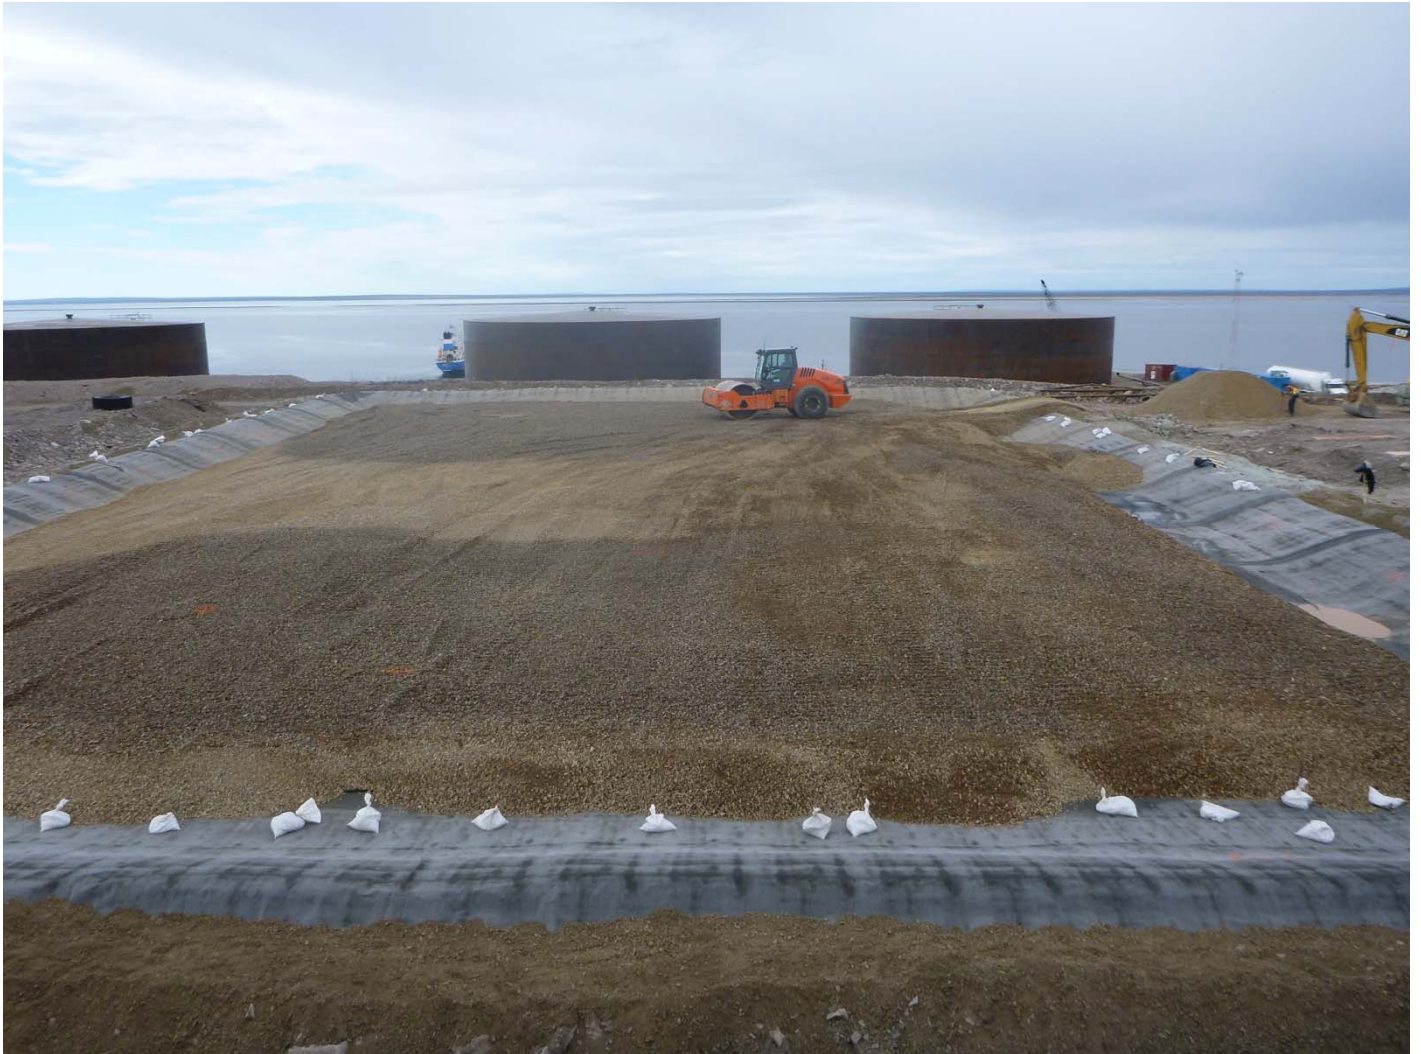
- Photo #1 – Moistening and compaction of the 0-20mm. Compaction: 2 static passes, 1 vibratory pass in each direction and 2 last static passes.

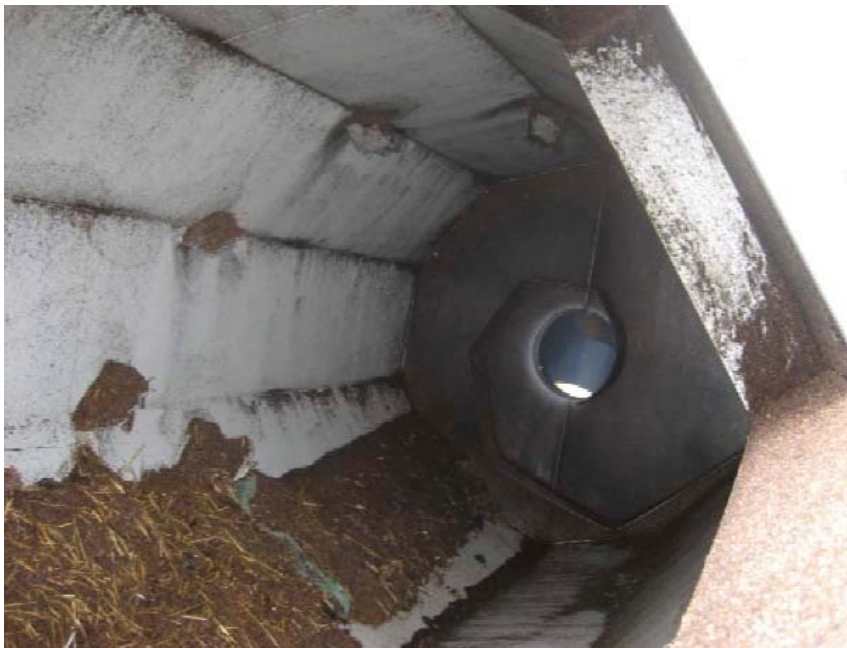
Figure 1 -- Interior view of the cylinder

This composter is designed to work year-round, indoors or outdoors, and can compost a wide variety of O.W. In certain extreme conditions, adaptation may be required during the installation process.

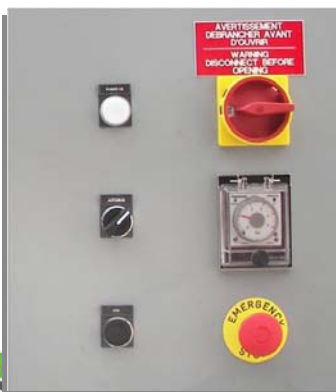
Figure 2 -- Brome Composter Control Panel

**Always make sure the emergency stop button is pulled
(composter is working) after each use.**

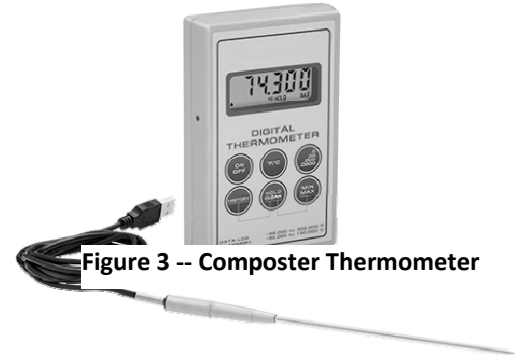
Figure 3 -- Composter Thermometer

Using a portable thermometer is recommended for taking temperature readings at various locations through the door opening, especially during the initial start-up phase.
