Design Report

Whale Tail Dike West Abutment Thermal Berm

12/16/2022

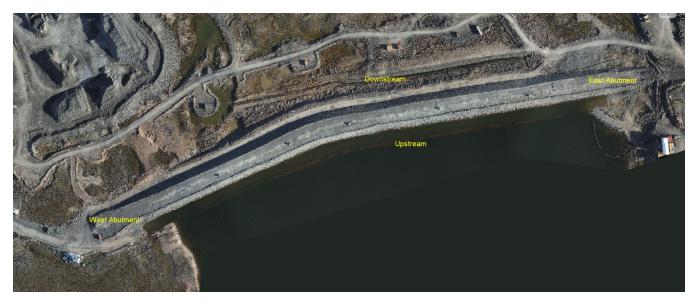
Figure 1: Aerial View of Whale Tail Dike

Whale Tail Dike is an infrastructure that isolate Whale Tail Pit from Whale Tail Lake South (Figure 1). The structure was constructed in the fall of 2018 and commissioned following completion of dewatering in 2020.

Specifically, the thermal berm lies on the south side of the Whale Tail Dike west abutment (*Figure 1*). It overprints part of the existing dike causeway and causeway access ramp, which were built on land in 2018-2019. The portion of the thermal berm footprint that will be constructed in-water is in a zone of temporary flooding that became inundated once the dike was fully advanced across the lake in 2019. This zone of temporary flooding which extends around Whale Tail South between approximately 153 masl (baseline) and 155 – 156 masl (current) is required for operational purposes and is scheduled to be drawn down to approximately 154 masl, in 2026 at closure.

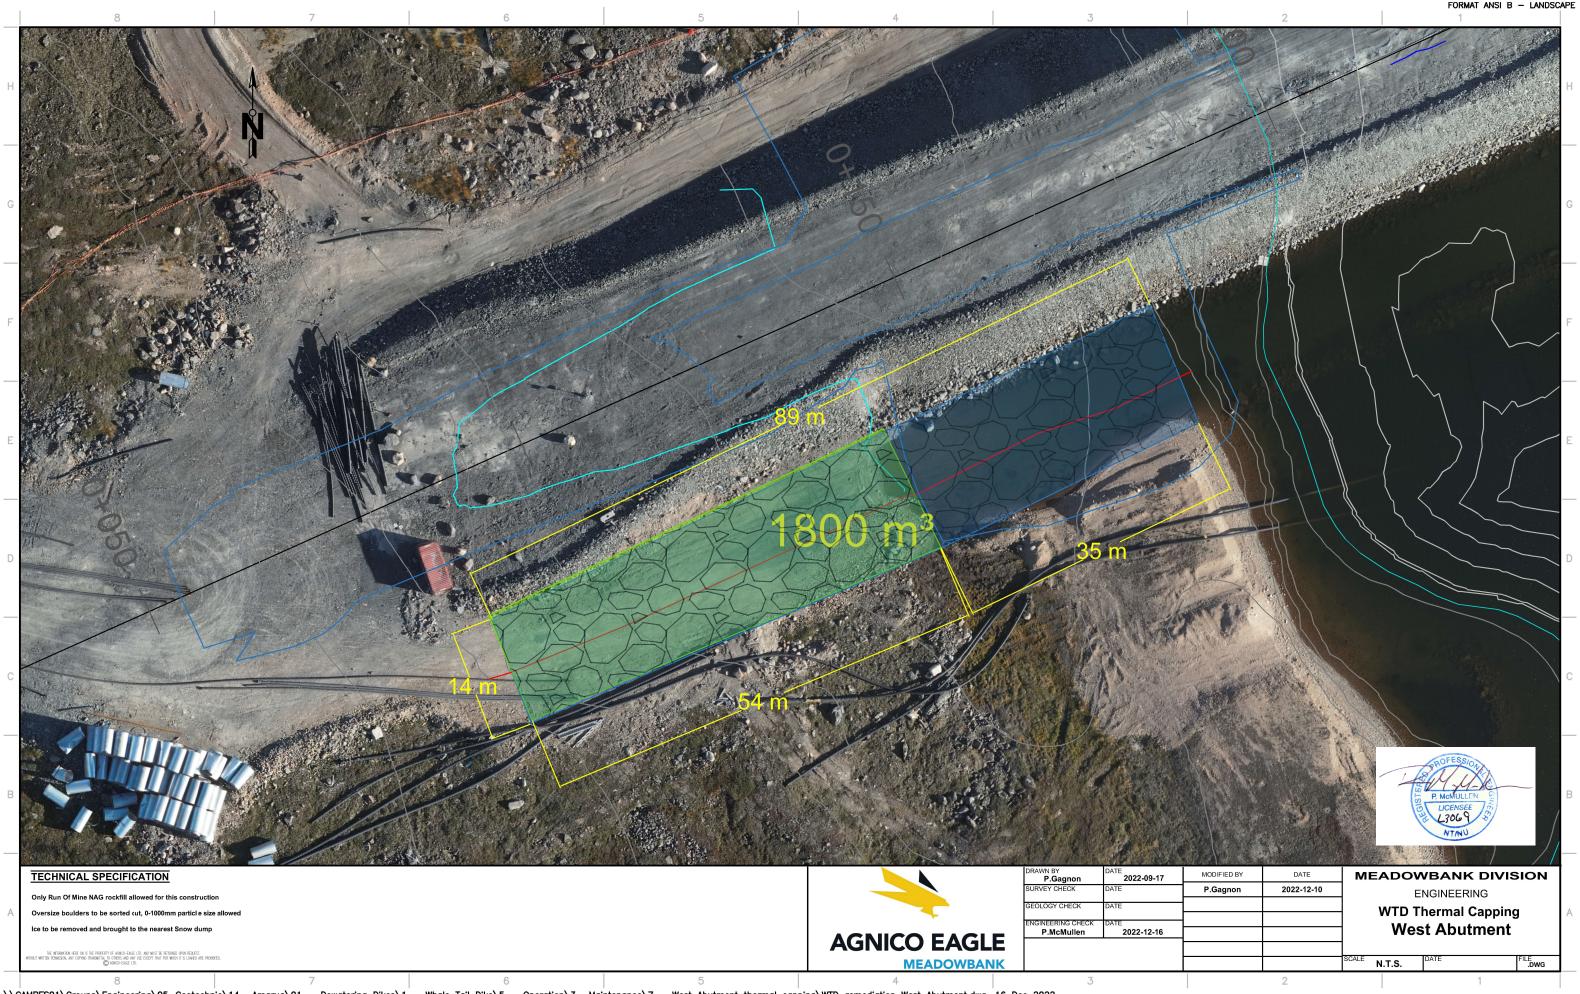
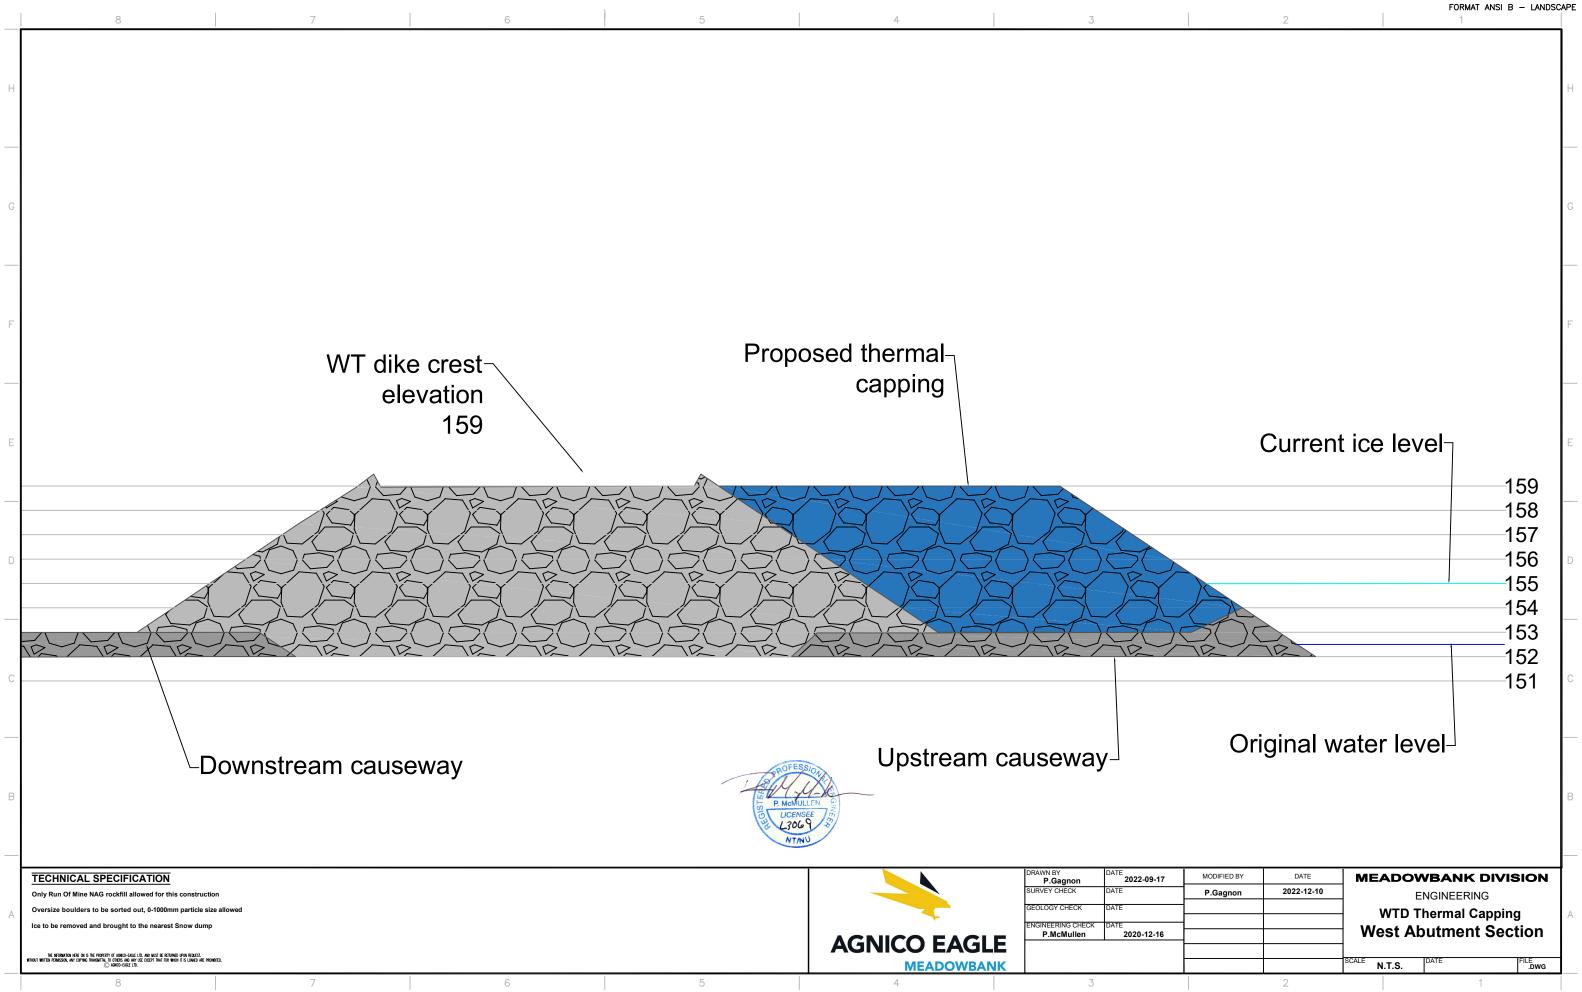
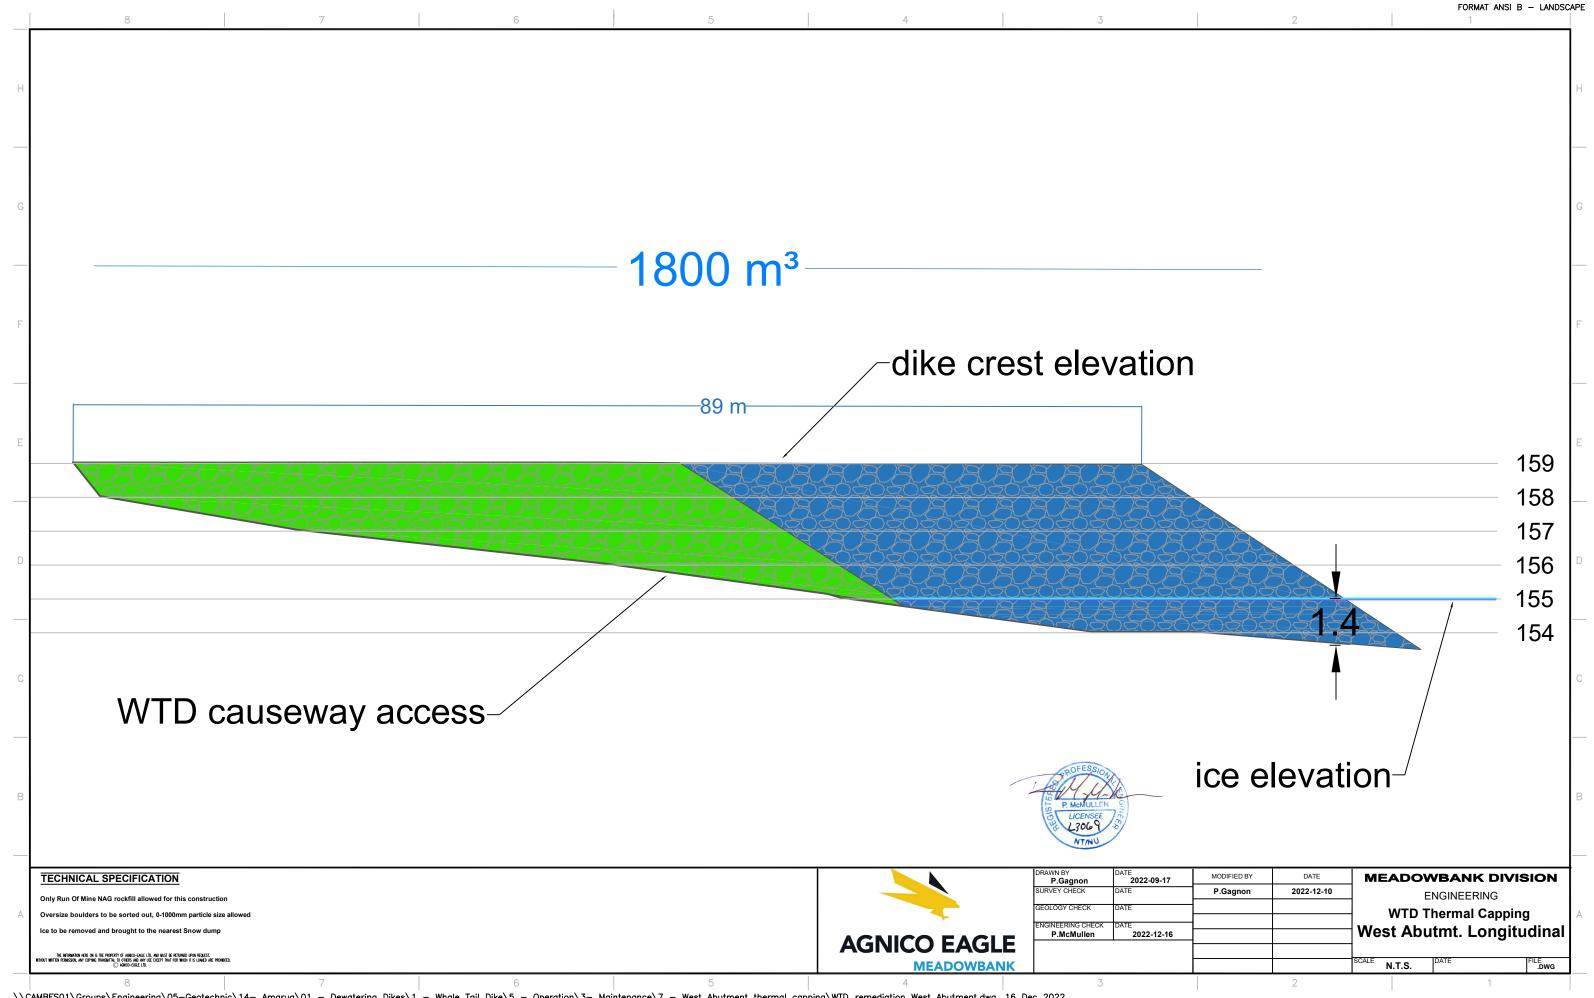
APPENDIX A: DRAWINGS

Appendix A show the construction drawings for the West Abutment Thermal Berm. The thermal berm will extend from the upstream causeway of the West abutment of Whale Tail Dike. The thermal berm will be 89 m long and 14 m wide. A length of 54 m of the berm will be constructed on land and a length of 35 m of the berm will be constructed in water having a maximum depth of 1.1m. Ice thickness will be confirmed in the work area prior to the beginning of rockfill placement.
