## Design Report for IVR Diversion

Detailed Engineering Design of Water Management and Geotechnical Infrastructures Phase 2 - Whale Tail Project Expansion

Agnico Eagle Mines Limited - Meadowbank Division

File no.: 6127-695-132-REP-004 (668284-7000-4GER-0001), Rev 00

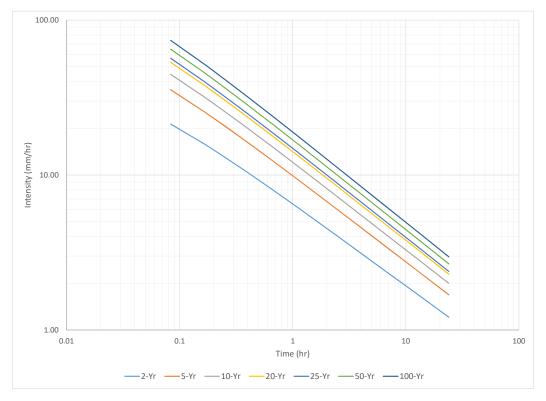
Figure 4-1: Bake Lake Station IDF (1987-2016)

The closest climatological station to the Amaruq mine site is the Baker Lake Station A, approximately 130 km south of the site. This station, ID No. 2300500, is operated by Environment Canada (EC) and has intensity-Duration-Frequency (I-D-F) relationships available with 22 years of data from 1987 to 2009. These data were updated in the last version of the IDF- CC Tool, version 4 (from Western University) with additional data up to the year 2016. This data was adopted for the design of the IVR Diversion, and it is presented in Figure 4-1.

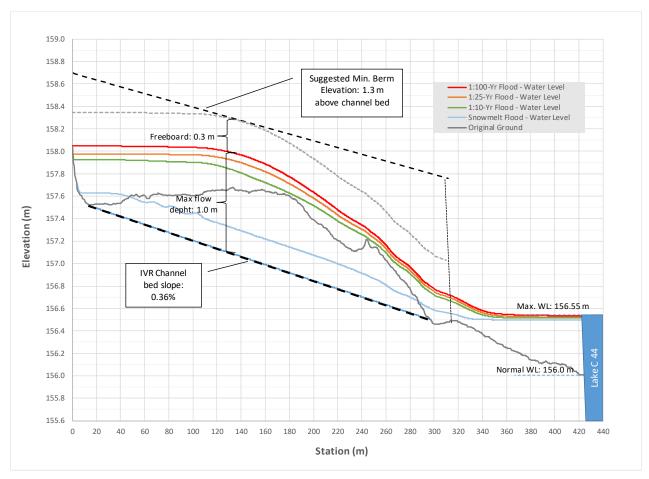
Figure 4-6: HEC-RAS Results

During a design flood event, non-contact water shall start flowing toward IVR Diversion. Once it reaches the diversion, it will be conveyed toward Lake C44 and eventually toward Nemo Lake. When the peak flood arrives into the channel, the water level in the channel shall gradually increase to a point where water shall start ponding temporarily onto the natural ground on the east side of the diversion. After a while, the water level in the diversion shall decrease and the ponded water shall drain out into the diversion. Figure 4-6 present snap-shot of the temporary ponding of water along the east side of the channel, during a design flood event (Figure 4-6 D). The figure also shows the flow depth results during the initial conditions (A), snowmelt rate of 0.3 m<sup>3</sup>/s (B), as well as during 1:25-Yr Flood (C).

The boundary conditions for the model included:

- Inflow hydrographs upstream of the IVR Diversion, at the 68.2 ha-watershed, described in Section
- Downstream boundary condition located at Nemo Lake. For this condition, an elevation of 156.5 m was adopted. This assumption is conservative, but reasonable since water level record for this lake were not available. The elevation of El. 156.5 m was established as the maximum water level in the

Representative Manning's n-values were used to simulate the resistance to flow along the channel bed and banks. Manning's n-values of 0.03 were adopted for the channel, while values of 0.07 were used for the overbank areas. These were assigned based on the conditions observed during the site visit and on the available aerial imageries.

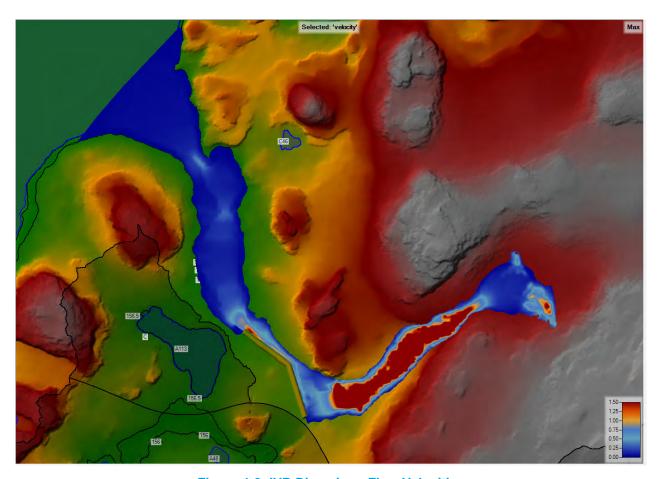
Figure 4-8: IVR Diversion - Flow Velocities

For the areas located a bit further to the east of the IVR Diversion, the HEC-RAS model shows velocities ranging approximately between 0.01 m/s to 0.75 m/s. For this range of velocities, substantial erosion or scouring of the natural ground is not expected. However, if erosion or scouring of the exposed soil is experienced during the operation of the IVR diversion, leading to higher total suspended solids (TSS) at the discharge of the IVR Diversion, additional erosion protection can be provided such as spreading non-erodible granular material (i.e. gravel of crashed rock material) in the affected area (Artic, 1981).

All of the water flowing into the IVR Diversion enters perpendicularly from its east side. For erosion protection on the east side of the diversion, the HEC-RAS model results showed that the flow velocities just east of the diversion ranges between 0.5 m/s to 1.0 m/s approximately. Hence, it is recommended to extend the rip-rap on the east at least 1.0 m to minimize erosion at this location, as shown in Figure 4-5.

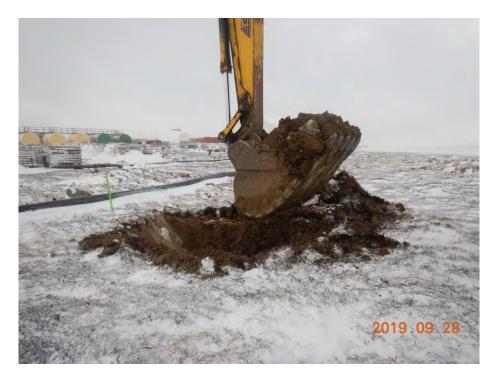
Figure 1: Test pit excavation (IVR-TP2, 2019-09-28).

The works started on September 28, 2019, with the excavation of test pits with a Komatsu 450 excavator (*Figure 1*).

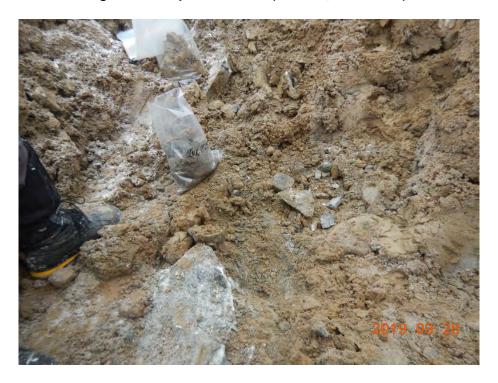
Figure 2: Soil sampling in a test pit (IVR-TP2, 2019-09-28).

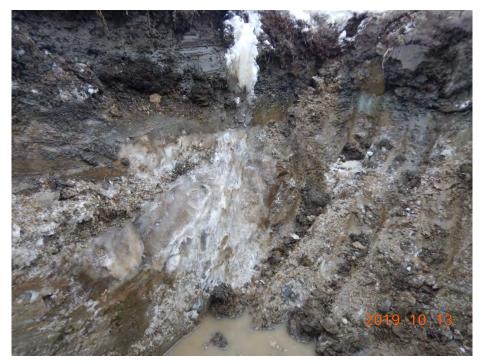
Figure 3: Presence of ice lenses indicating ice-rich soil (IVRDC-TP1, 2019-10-13).

- Large ice lenses (up to 500 mm wide) were observed in IVRDC-TP1 (see Figure 3), indicating ice-rich soils are present at least in the Diversion Channel area.
- o An ice layer was also identified in borehole #3 at 4.6 m depth.

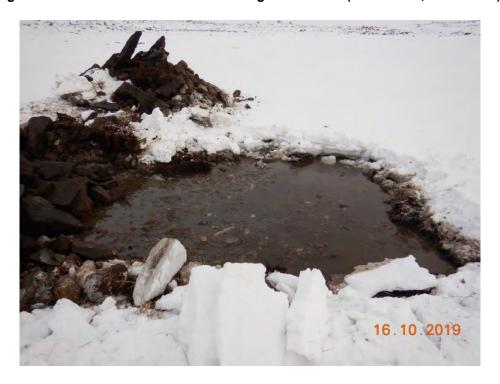
Figure 4: Flooded test pit (IVRWRSF-TP11, 2019-10-16).

- immediately flooded with water up to the surface (see *Figure 4*). Visual observation of the stratigraphy and soil sampling were impossible. As a result, the test pit was only advanced to 0.40 m below the surface.
- Lots of water came out of hole #8 during drilling. The drill slightly sank into a water puddle while tracking between holes #14 and 8 (thin ice cover, see *Figure 6*). This corresponds to the channel near lake A53 which was still unfrozen at the time of the campaign. No other wet area was encountered during drilling.

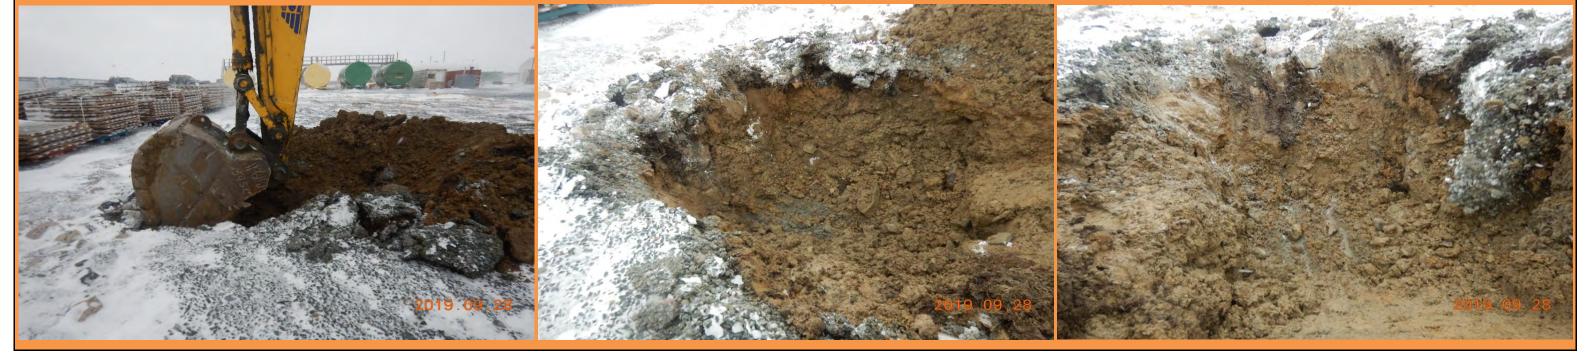
IVR-TP1	_			
De	pth (m)		Surveyed Co	ordinates (X,Y,Z): 607840.238,7255567.544,164.79
0.00	to	0.14	Organic materials	<u>Comments</u> :
0.14	to	1.50	Fine beige Sand, Gravel, Cobbles and Boulders	Mix of fine sand w/ pebbles and cobbles. Some boulders. Water content and unstable soil
1.50	to	1.55	Fine gray Sand, Gravel, Frozen	Frozen at the Gray Sand transition
				2 samples: A (0.5 m), B (1.5 m)
Depth of Test Pit:		1.55	5 Refusal (frozen soil)	
Water :		1.50	O Slight water inflow

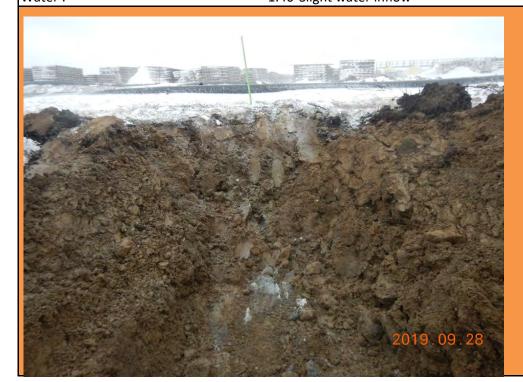
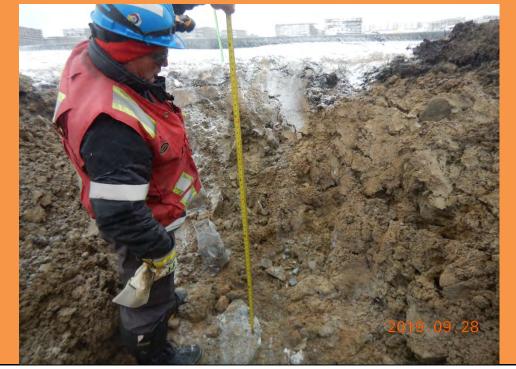
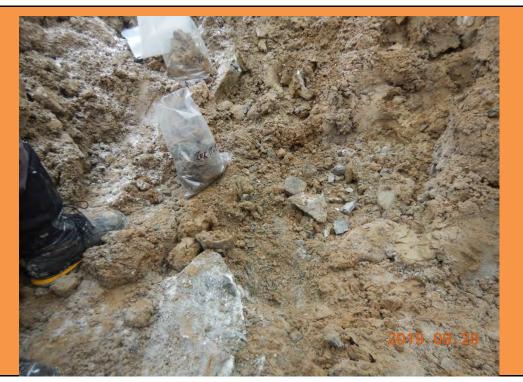
IVR-TP2				
Dep	oth (m)		Surveyed C	oordinates (X,Y,Z): 607867.61,7255546.262,163.242
0.00	to	0.12	Organic materials	<u>Comments</u> :
0.12	to	1.40	Fine beige Sand, Gravel, Cobbles and Boulders	Mix of fine sand w/ pebbles and cobbles. Some boulders. Water content and unstable soil
				2 samples: A (0.5 m), B (1.4 m)
Depth of Test Pit:		1.40	Refusal (bedrock or frozen soil)	Refusal seems to be a mix of Bedrock and Frozen soil.
Water :		1.40	0 Slight water inflow

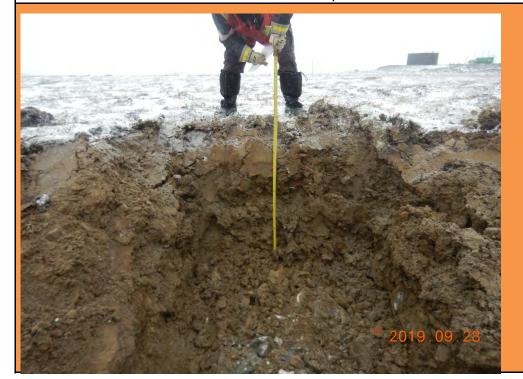
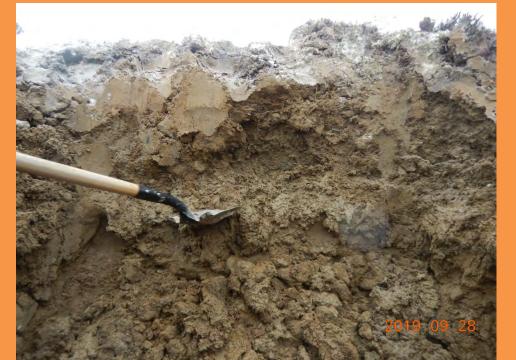
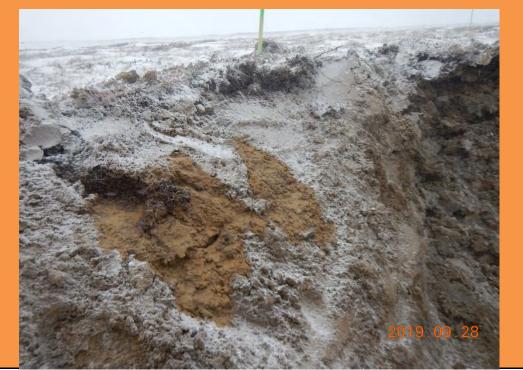
IVR-TP3				
Dep	th (m)		Surveyed C	oordinates (X,Y,Z): 608077.475,7255431.169,164.193
0.00	to	0.14	Organic materials	Comments: The test pit is on a flat area (wetland, low point).
0.14	to	1.40	Fine beige Sand, Gravel, Cobbles and Boulders	Mix of fine sand w/ pebbles and cobbles. Some boulders. Water content and unstable soil
				Water flow was coming out mostly under the organic layer and 0.50m depth with higher water content.
Depth of Test Pit:		1.40	<b>0</b> Refusal (frozen soil)	3 samples: A and C (0.5 m, taken on opposite walls), B (1.4 m)
Water :		0.14	4 Mostly from surface

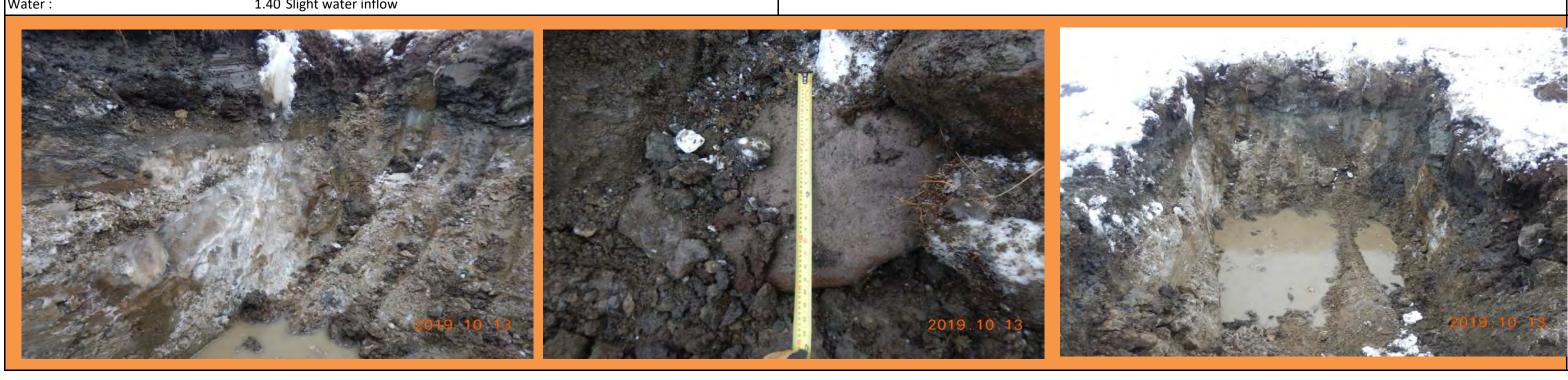
IVRDC-TP	IVRDC-TP1		by B. Lessard	
Dep	Depth (m)		Surveyed Coordinates (X,Y,Z): 607555.504,7256781.122,159.473	
0.00	to	0.25	Organic materials	<u>Comments</u> :
0.25	to	1.40	Sand and cobbles, grey to brown, frozen, presence of blocks and ice lenses.	Large ice lenses (up to 500 mm) in the soils
1.40	to			2 samples: A (0.7 m), B (1.4 m)
Depth of Test Pit:	Depth of Test Pit: 1.40 Refusal frozen soil)		Refusal frozen soil)	
Water :		1.40	O Slight water inflow

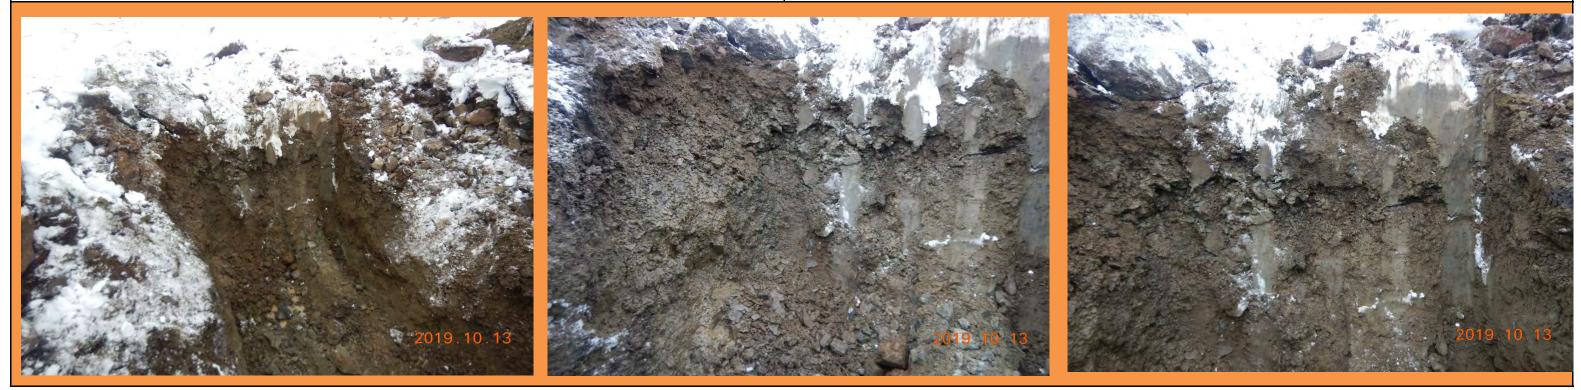
IVRDC-TP2	IVRDC-TP2		by B. Lessard		
Dep:	Depth (m)		Surveyed Coordinates (X,Y,Z): 607596.698,7256824.051,159.131		
0.00	to	0.15	Organic materials	<u>Comments</u> :	
0.15	to	1.70	Sand and gravel with presence of coarer gravel pockets, grey, wet	Wet walls and water coming into the excavation	
				2 samples: A (0.5 m), B (1.7 m)	
Depth of Test Pit:	1.70 Refusal (frozen soil)				
Water :		1.6	0 Slight water inflow

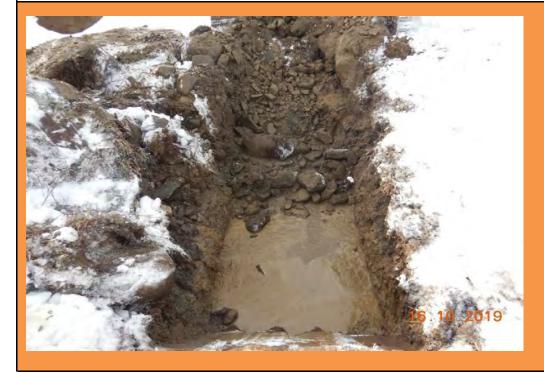
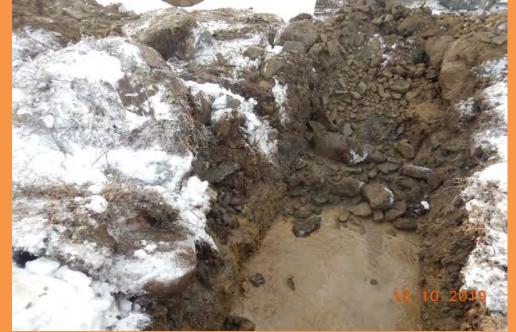
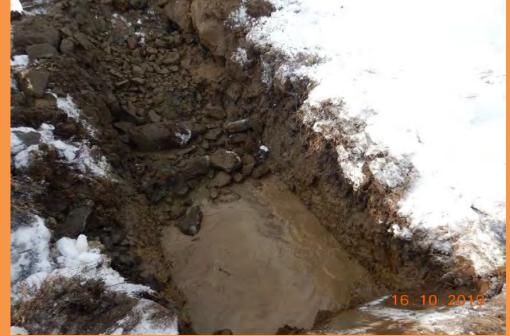
IVRDC-TP3		•	by T. Dahm		
Depth (m)			Surveyed Coordinates (X,Y,Z): 607617.592,7256924.919,159.15		
0.00	to	0.20	Organic materials, very dark in colour	<u>Comments</u> :	
0.20	to	0.80	Brown sand and gravel with cobbles, wet	Water was coming in just under the organics, large amounts. Hard to continue this hole and get good samples	
0.80	to	1.40	Brown sand and gravel with cobbles, wet	You can see by the pics it was very rocky material with minimal fines	
				1 sample: 1.0 m	
Depth of Test Pit :		1.40	Refusal (bedrock or frozen soil)		
Water: 0.20 large inflo			Olarge inflow

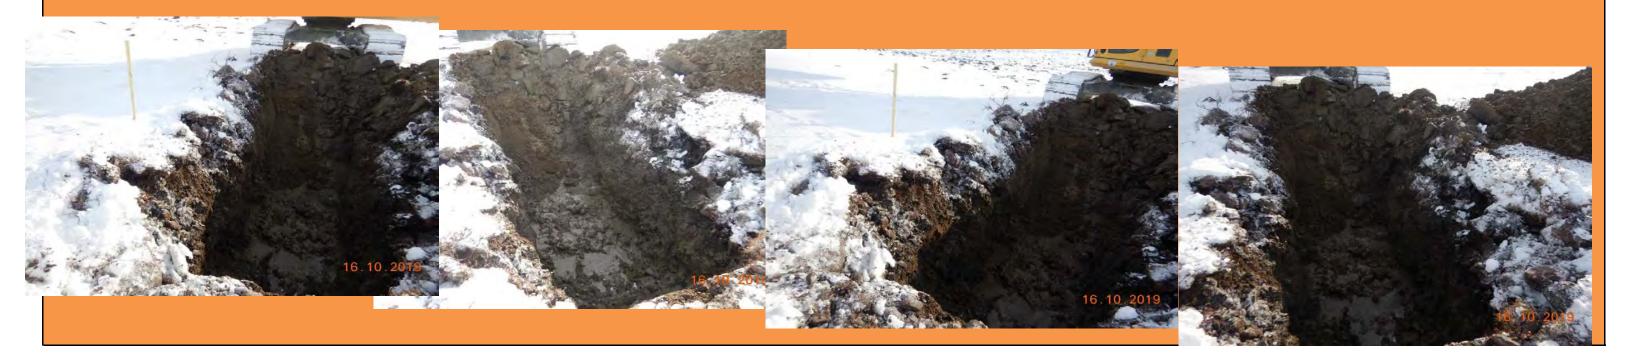
IVRDC-TP4			by T. Dahm	
De	Depth (m)		Surveyed Coordinates (X,Y,Z): 607521.168,7256962.9,157.861	
0.00	to	0.60	Organic materials, thick and black on top	<u>Comments</u> :
0.60	to	2.10	Brown, Wet sand and gravel with cobbles, tr. Silt	Lots of water inflow when opening up the hole. Water was coming from the top area
2.10	to			
Depth of Test Pit:	Depth of Test Pit: 2.10		Refusal (bedrock or frozen soil)	
Water:	·		O slight water inflow from the surface

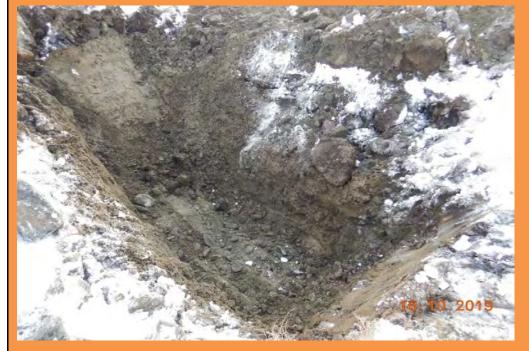
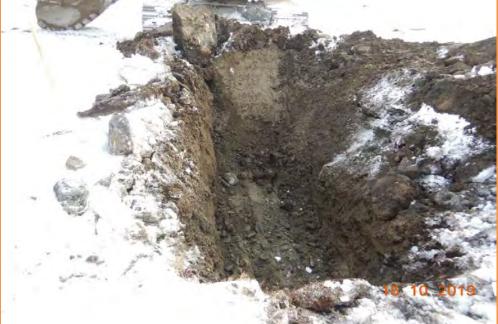
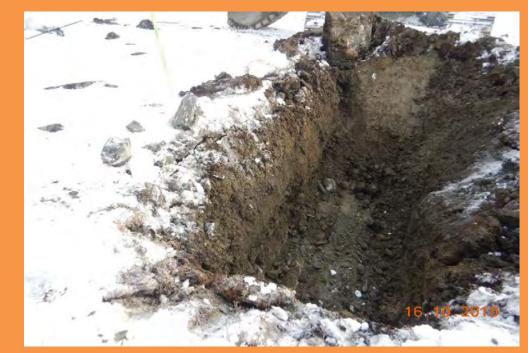
IVRDC-TP5	IVRDC-TP5		by T. Dahm		
Dep	Depth (m)		Surveyed Coordinates (X,Y,Z): 607467.134,7256988.561,157.981		
0.00	to	0.40	Organic materials, very thick and wet and dark	<u>Comments</u> :	
0.40	to	1.30	Brown sand and gravel with silt, moist	there is a finer layer of material then it has more stones and cobbles in it and less fines	
1.30	to	2.00	Brown sand and gravel with cobbles, trace silt, moist	3 samples: 0.5 m, 1.0 m, 2.0 m	
Depth of Test Pit:	Depth of Test Pit: 2.		<u>O</u> Refusal (bedrock or frozen soil)		
Water :	Water: N/A

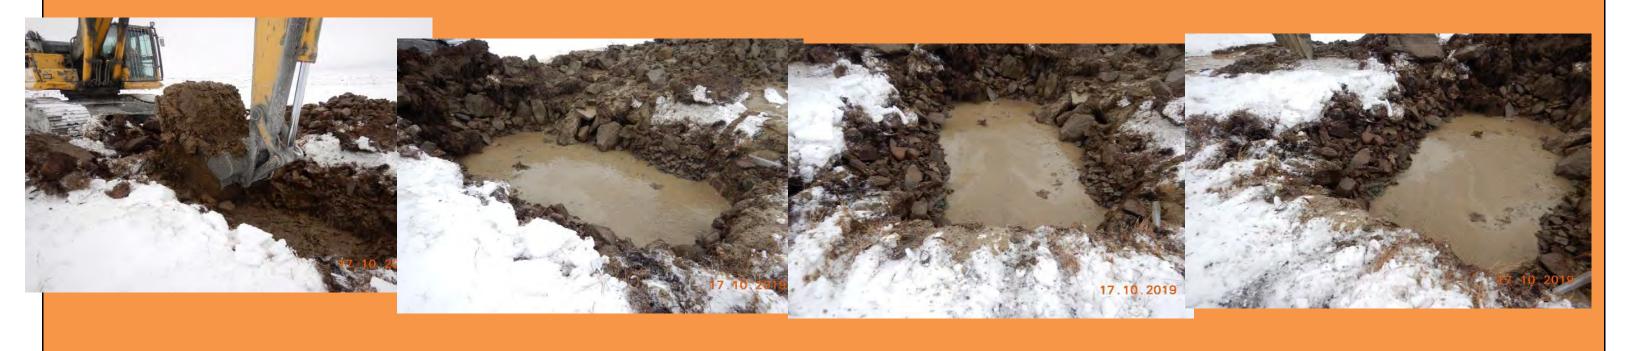
IVRDC-TP6	IVRDC-TP6		by T. Dahm		
Dep	th (m)		Surveyed Coordinates (X,Y,Z): 607654.014, 7256636.001, 165.01		
0.00	to	0.50	Organic materials with boulders	<u>Comments</u> :	
0.50	to	1.30	brown silty sand and gravel, wet	You can see the large influx of water when excavating. Large amount of organics and boulders during the	
1.30	to			beginning of the excavation.	
Depth of Test Pit:		1.30	<u>D</u> Refusal (bedrock or frozen soil)		
Water :		0.50	large water inflow

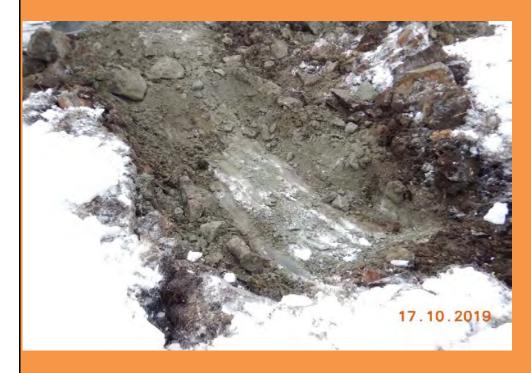
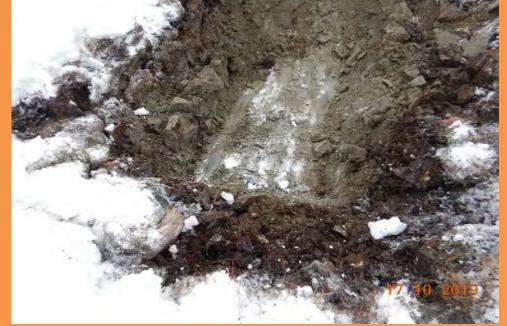
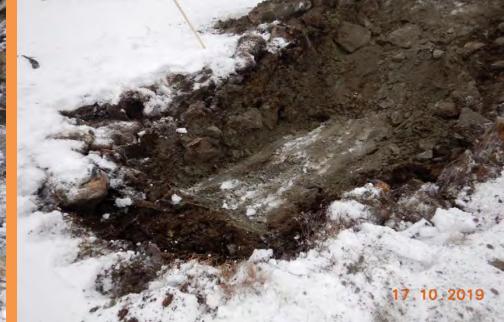
IVRDC-TP	IVRDC-TP8		by T. Dahm	
Dep	Depth (m)		Surveyed Coordinates (X,Y,Z): 607542.99, 7256907.002, 157.859	
0.00	to	0.60	Organic materials with cobbles	<u>Comments</u> :
0.60	to	1.00	grey sand and gravel with silt, moist	3 samples: 0.5 m, 1.0 m, 1.5 m
1.00	to	1.30	grey sand and gravel with cobbles some silt, moist	
Depth of Test Pit:	Depth of Test Pit: 1.30		<b>o</b> Refusal (bedrock or frozen soil)	
Water :		N/A

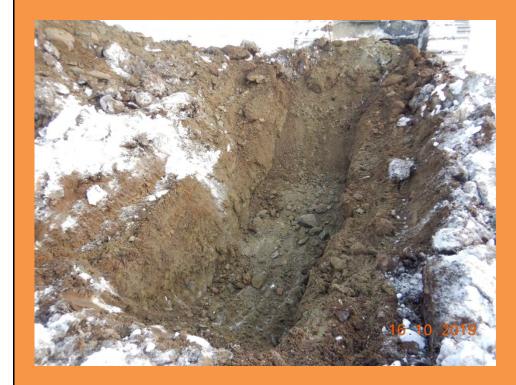
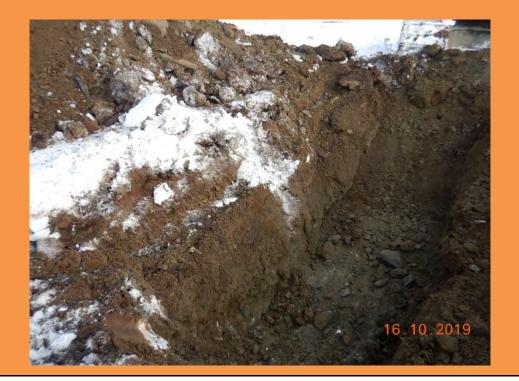
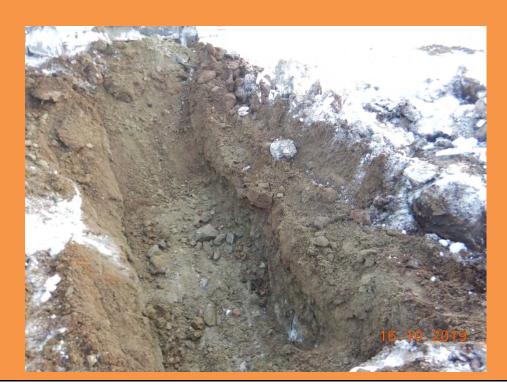
IVRNR-TP2	IVRNR-TP2		by T. Dahm		
Dept	Depth (m)		Surveyed Coordinates (X,Y,Z): 607168.937,7256917.451,156.73		607168.937,7256917.451,156.73
0.00	to	0.20	Organic materials		<u>Comments</u> :
0.20	to	1.10	brown silty sand and gravel, moist		3 samples: 0.8 m, 1.2 m, 1.8 m
1.10	to	1.90	brown silty sand, trace gravel, moist		
Depth of Test Pit:	Depth of Test Pit: 1.90		<b>0</b> Refusal (bedrock or frozen soil)		
Water :	N/A		_

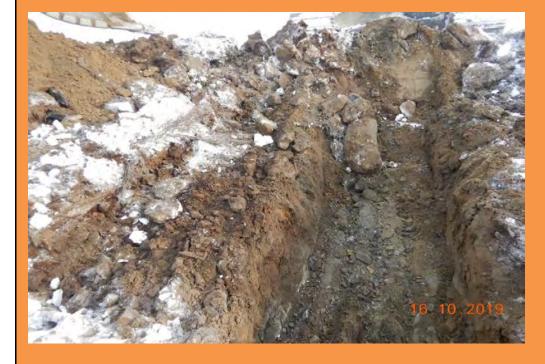
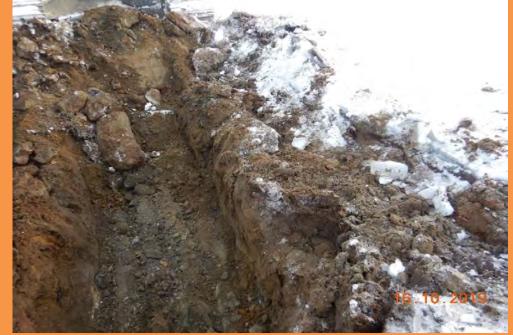
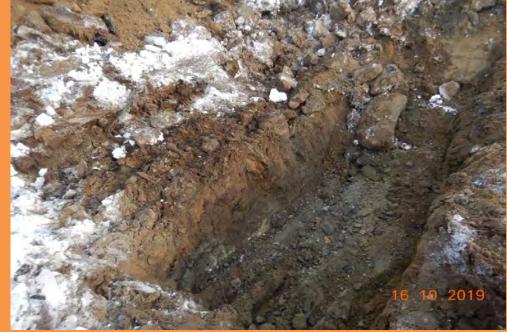
IVRNR-TP	3		by T. Dahm	
Dep	Depth (m)		Surveyed Coordinates (X,Y,Z): 607244.437,7256904.18,156.853	
0.00	to	0.20	Organic materials	<u>Comments</u> :
0.20	to	0.80	Brown sand and gravel with silt, moist	Water started to come in at the end of the hole. Not too much came in
0.80	to	1.90	brown sand and gravle with cobbles, some silt, moist	3 samples: 0.5 m, 1.0 m, 1.7 m
Depth of Test Pit:	<b>Depth of Test Pit:</b> 1.90 Refusal (bedrock or frozen soil)			
Water :		1.90	slight water inflow

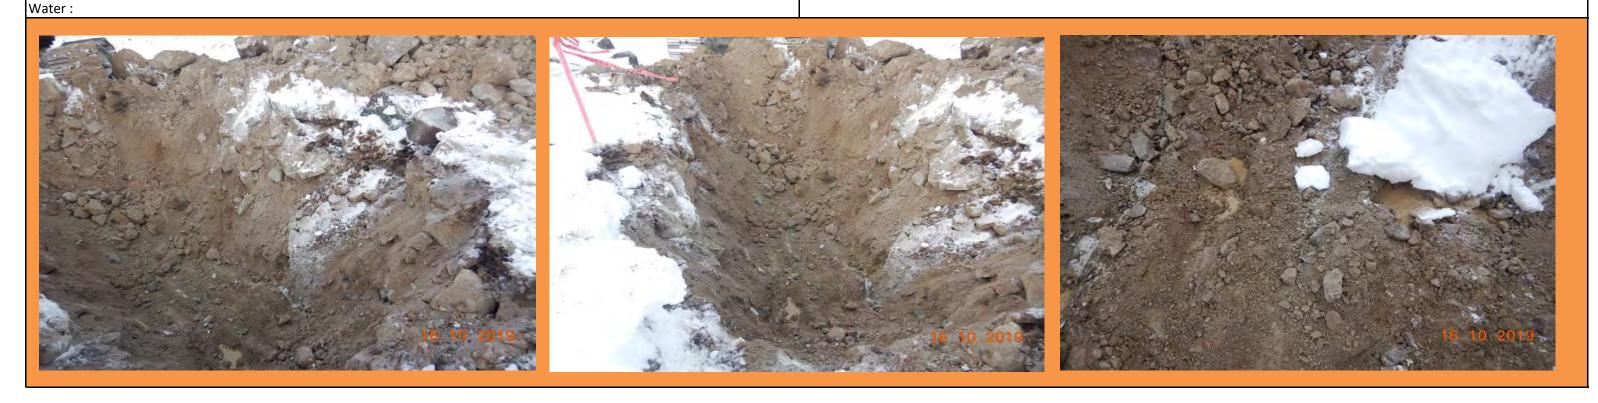
IVRWRSF-TP2		by T. Dahm				
th (m)		Surveyed Coordinates (X,Y,Z): 608652.366,7256847.644,174.931				
to	0.20	Organic materials	<u>Comments</u> :			
to	1.10	Brown sand and gravel, some silt, moist	Some inflow of water was present at the end of the hole. Coming in from the side.			
to	1.90	Brown sand and gravel with cobbles, some silt, moist	1 sample: 0.5 m			
Depth of Test Pit: 1.90		<b>0</b> Refusal (frozen soil)				
	th (m) to to	th (m)  to 0.20  to 1.10  to 1.90	th (m)  to 0.20 Organic materials to 1.10 Brown sand and gravel, some silt, moist

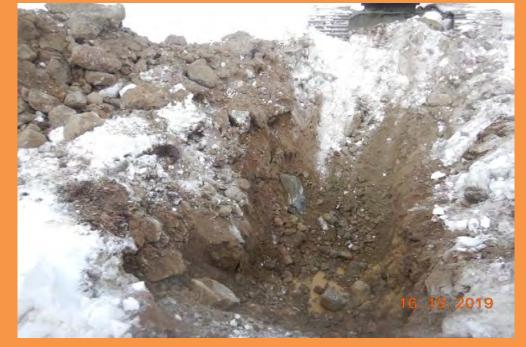
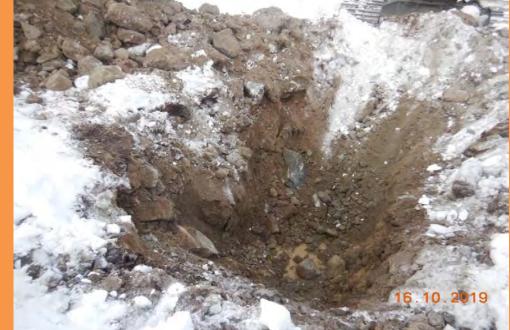
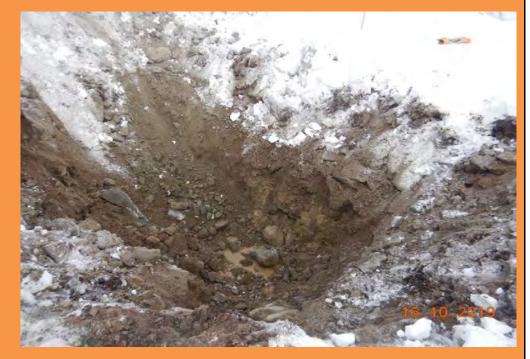
IVRWRSF-TP3			by T. Dahm		
Dep	Depth (m)		Surveyed Coordinates (X,Y,Z): 608546.868,7256851.902,174.021		
0.00	to	0.30	organic materials	<u>Comments</u> :	
0.30	to	1.30	brown sand and gravel, moist	Sand and gravel throughout the hole and water inflow at 2m	
1.30	to	2.60	brown sand and gravel with cobbles, moist	3 samples: 0.8 m, 1.2 m, 1.7 m	
Depth of Test Pit:		2.60	<b>0</b> Refusal (frozen soil)		
Water :	2.00 water coming into excavation

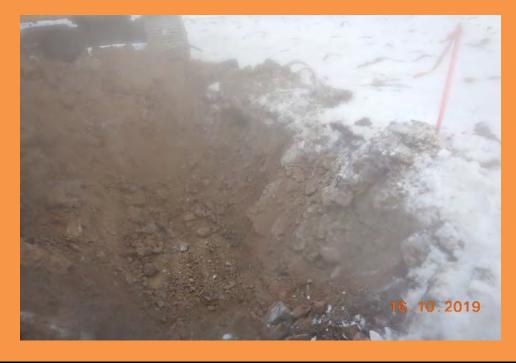
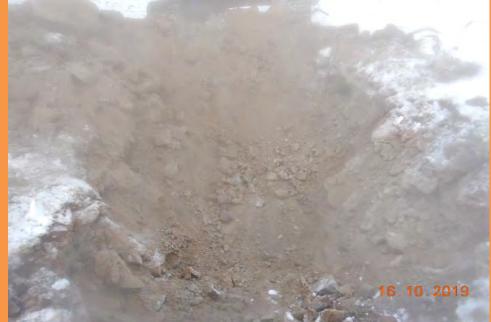
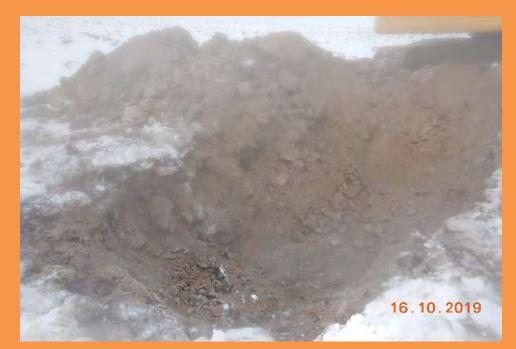
IVRWRSF-TP4			by T. Dahm	
Dep	oth (m)		Surveyed Coordina	ates (X,Y,Z): 608445.138,7256829.352,179.412
0.00	to	0.20	Organic materials	<u>Comments</u> :
0.20	to	1.60	Light brown sand and gravel with silt, moist	End of hole was filled with big rocks a
1.60	to	2.20	Brown sand and gravel with cobbles, some silt, moist	
Depth of Test Pit:		2.2	Refusal (frozen soil)	
Water:		N/A

End of hole was filled with big rocks and cobbles but overall was sand and gravel mix

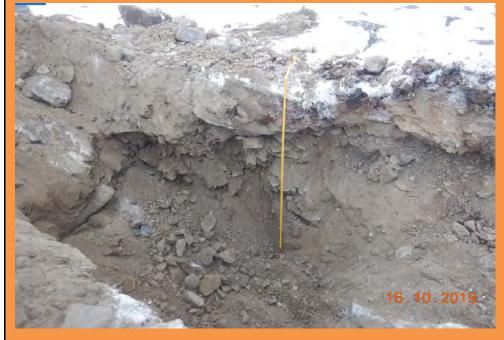
IVRWRSF-TP5			by T. Dahm				
Depth (m)			Surveyed Coordinates (X,Y,Z): 608371.557,7256809.12,180.319				
0.00	to	0.30	Organic materials	<u>Comments</u> :			
0.30	to	1.60	Grey sand and gravel, moist	Appeared to be some moisture in the hole but no visible water present.			
1.60	to	2.10	brown sand and gravel, trace silt with cobbles, moist	1 sample: 1.0 m			
Depth of Test Pit: 2.10 Refusal (frozen soil)		Pefusal (frozen soil)					
Water :		N/A

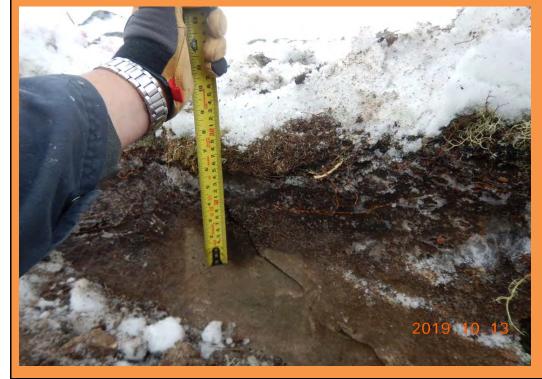
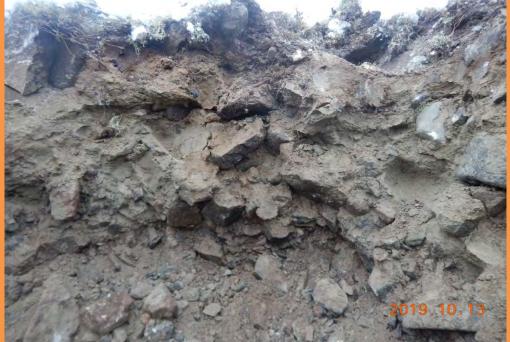
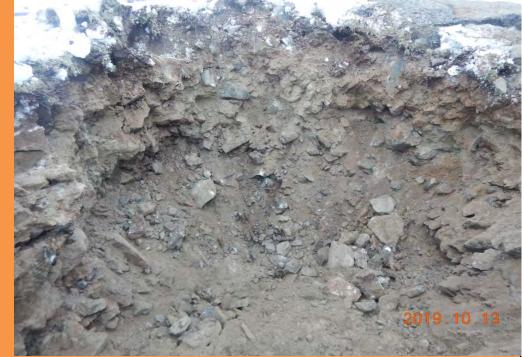
IVRWRSF-TP6 by B. Lessard Depth (m) Surveyed Coordinates (X,Y,Z): 608180.704,7256750.575,180.386 Organic topsoil Comments: 0.00 0.20 to Coarse gravel with pockets of fine sand, grey to brown, moist. Bedrock outcropping at 1.2 m on one side of the excavation. 0.20 to 1.70 3 samples: A (0.5 m), B (1.0 m), C (1.7 m) 1.70 to bedrock 1.70 Refusal (bedrock) Depth of Test Pit: Water: N/A

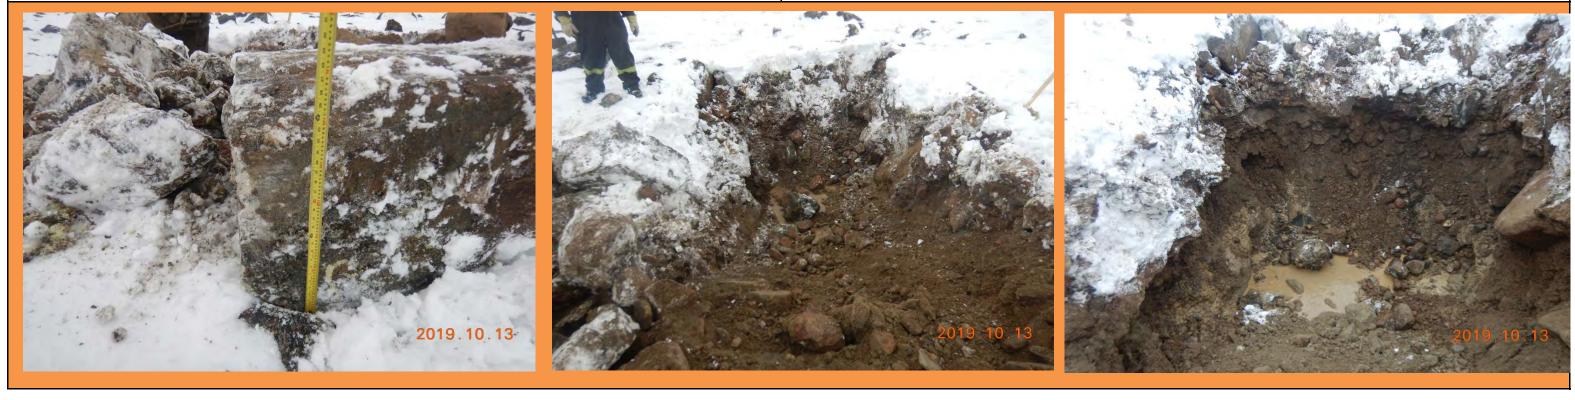
IVRWRSF-TI	IVRWRSF-TP7		by B. Lessard	
Dep	Depth (m)		Surveyo	d Coordinates (X,Y,Z): 608009.959,7256652.482,174.49
0.00	to	0.50	Boulders and cobbles, grey to brown, moist.	<u>Comments</u> :
0.50	to	1.50	Coarse gravel, brown, moist.	Many boulders at the surface.
1.50	to	2.20	Fine sand and gravel, brown, moist to wet.	3 samples: A (1.0 m), B (1.5 m), C (2.0 m)
Depth of Test Pit:	Depth of Test Pit: 2.20 Refusal (frozen soil)		<b>0</b> Refusal (frozen soil)	
Water :	·	1.60	water coming into excavation

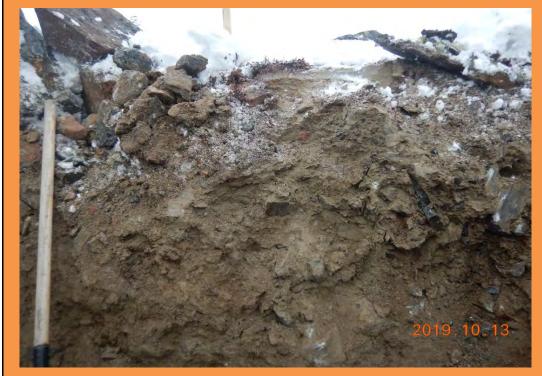
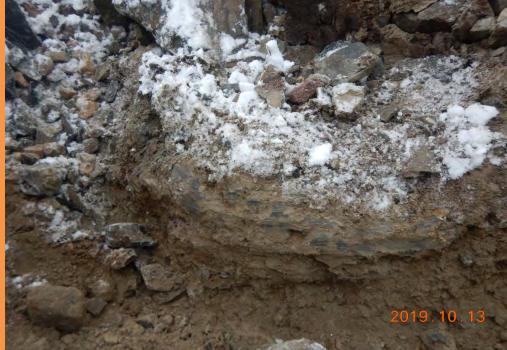
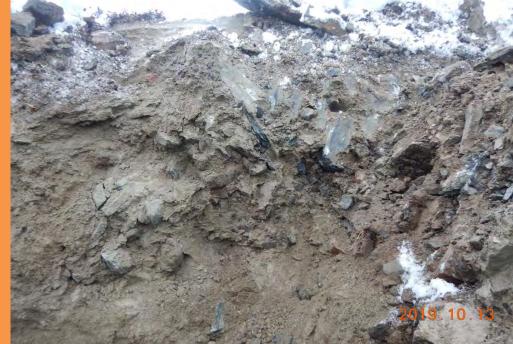
IVRWRSF-TP	8		by B. Lessard	
Dept	Depth (m)		Surveyed Coordinates (X,Y,Z)	: 607849.577,7256566.446,174.682
0.00	to	0.20	Organic topsoil, frozen. Presence of boulders on surface.	<u>Comments</u> :
			Fine sand and gravel, brown, presence of cobbles, mostly frozen. Presence of	
0.20	to	1.40	gravel pockets.	2 samples: A (0.8 m), B (1.4 m)
1.40	to			No water, frozen surface 0.35m
Depth of Test Pit:		1.40	Pefusal (bedrock)	
Water :		N/A

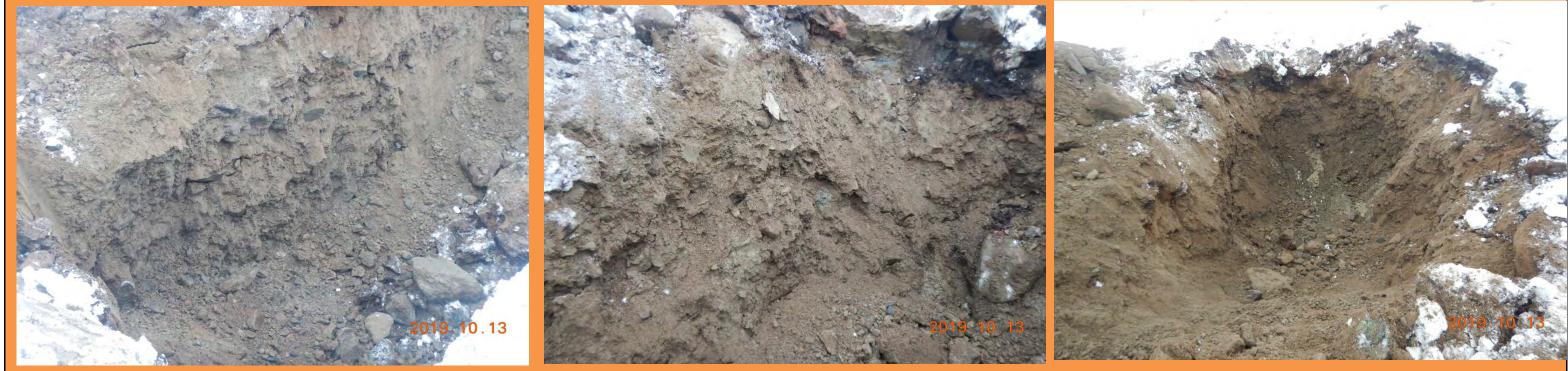
IVRWRSF-T	P10		by T. Dahm	
Dep	Depth (m)		Surveyed Coordinates (X,Y,Z): 607664.088,7256272.543,161.814	
0.00	to	0.10	Ice	<u>Comments</u> :
0.10	to	0.30	Organic materials with boulders	From the organic and boulder layer there was a major flow of water into the hole.
0.30	to	1.80	brown sand and gravel, wet	Descriptions were from taking material under the water
Depth of Test Pit:	Depth of Test Pit: 1.80		<b>0</b> Refusal (frozen soil)	
Water :		0.30	Large inflow

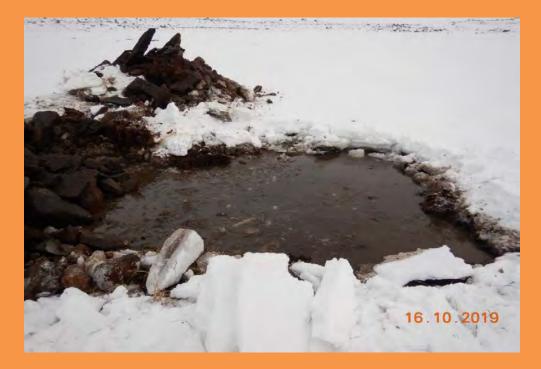
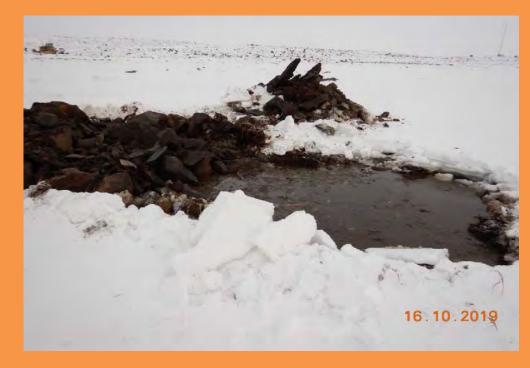
IVRWRSF-1	IVRWRSF-TP11		by T. Dahm		
De	Depth (m)		Surveyed Coordinates (X,Y,Z): 607691.124,7256111.005,162.3		
0.00	to	0.40	Organic materials and boulders	9	Comments :
0.40	to			-	There was large amounts of standing water. It seemed to have just stones and very difficult to collect a
0.00	to				proper sample for analysis. Hole was abaondoned. You can see a .4m layer of organics and large rocks.
Depth of Test Pit: 0.4		0.4	<b>0</b> Abandoned (too much water)		
Water: 0.0		0.00	excavation flooded almost to the surface

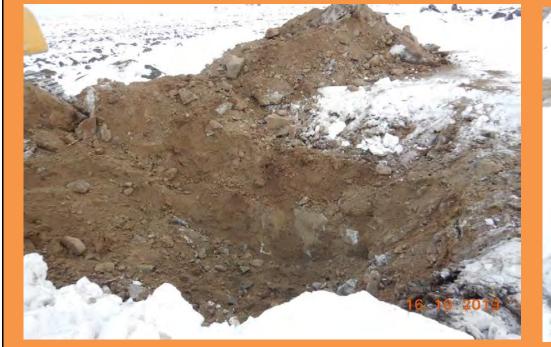
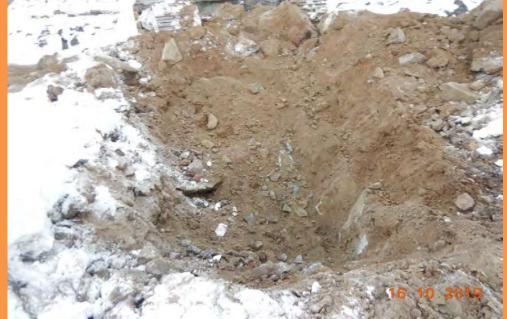
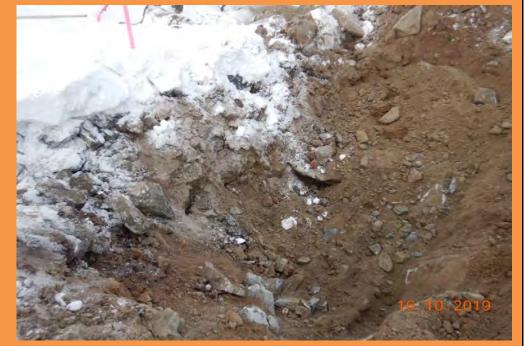
IVRWRSF-TP	12		by T. Dahm		
Dept	Depth (m)		Surveyed Coordinates (X,Y,Z): 607870.392,7255949.188,165.391		
0.00	to	0.20	Organic materials	Comments :	
0.20	to	1.30	Light brown silty sand and gravel, moist	Finer material at the top section of the hole with more stones and cobbles at the bottom	
1.30	to	1.90	Light brown silty sand and gravel with cobbles, moist	1 sample: 1.2 m	
Depth of Test Pit:		1.90	Refusal (frozen soil)		
Water :	•	N/A			
Depth of Test Pit :		1.90

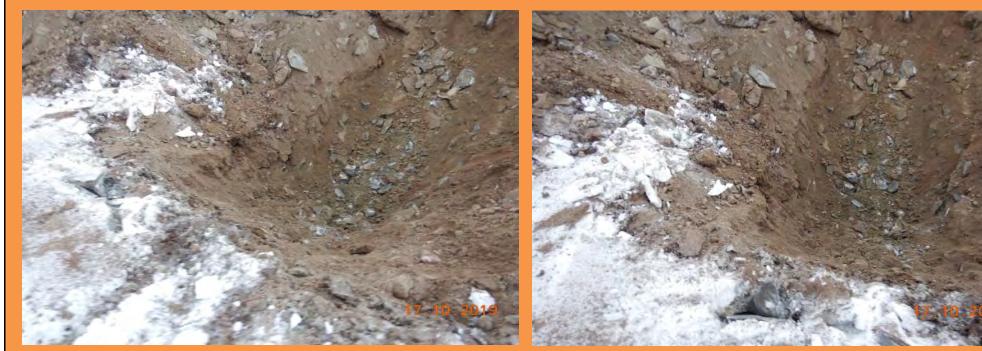
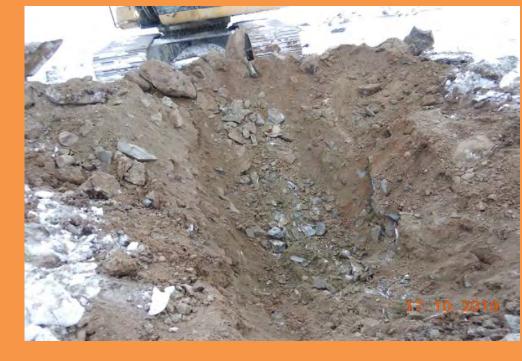
WTWRSF-T	P1		by T. Dahm		
Dep	Depth (m)		Surveyed Coordinates (X,Y,Z): 606041.502,7256291.834,169.148		
0.00	to	0.20	Organic materials	<u>Comments</u> :	
0.20	to	0.60	Sand and gravel, brown, moist.	The end of the hole also had broken rock material that occurred while digging. This hole was on a mound	
1.50	to	1.60	Sand and gravel with some cobbles, brown, moist.	that appeared to be a large rock pile. The rest of the area around is flat terrain.	
				1 sample: 1.2 m	
Depth of Test Pit:		1.60	Refusal (frozen soil)		
Water :		N/A			
Water :		N/A

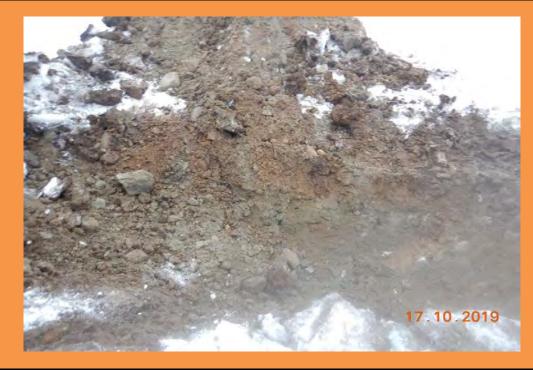
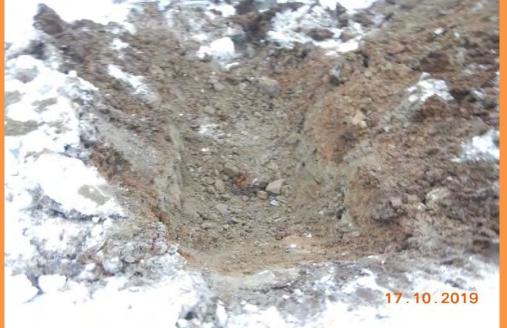
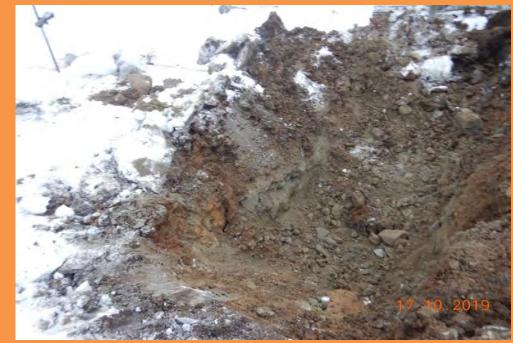
WTWRSF-1	гР3	•	by T. Dahm	
Depth (m)			Surveyed Coordinates (X,Y,Z)	: 606163.192,7256327.14,165.358
0.00	to	0.20	Organic materials	<u>Comments</u> :
0.20	to	1.20	brown silty sand trace gravel, moist	the lower layer was a greyish brown
1.20	to	2.10	brownish grey sitly sand with gravel and cobbles, moist	3 samples: 0.9 m, 1.3 m, 1.9 m

the lower layer was a greyish brown colour, appeared to be more frozen type material 3 samples: 0.9 m, 1.3 m, 1.9 m

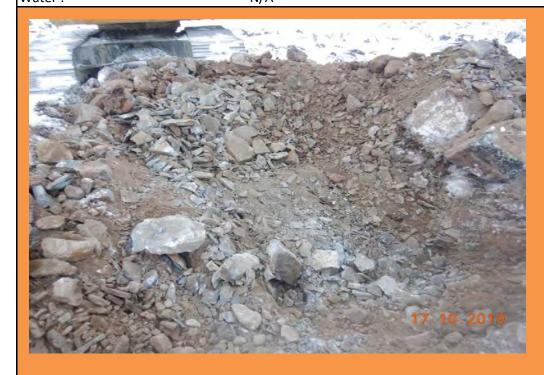
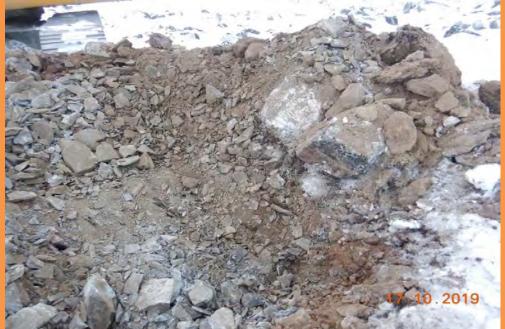
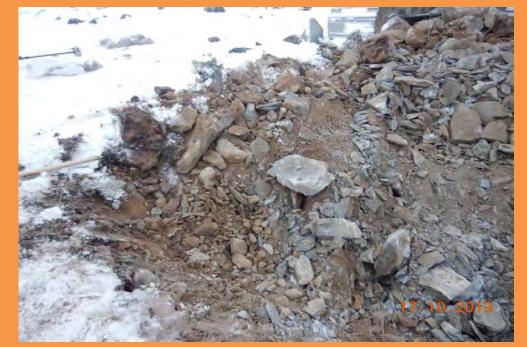
WTWRSF-TP5			by T. Dahm		
Depth (m)			Surveyed Coordinates (X,Y,Z): 606301.659,7256378.535,164.728		
0.00	to	0.20	Organic materials	<u>Comments</u> :	
0.20	to	1.20	brown sand and gravel, some silt, moist	hole appeared to have lots of loose bedrock material, was in a hilly boulder field. Lots of blocky material in	
				hole. The rest of the area around is flat terrain.	
				2 samples: 0.6 m, 0.9 m	
Depth of Test Pit:		1.2	Refusal (frozen soil)		
Water :		N/A	<del>-</del>

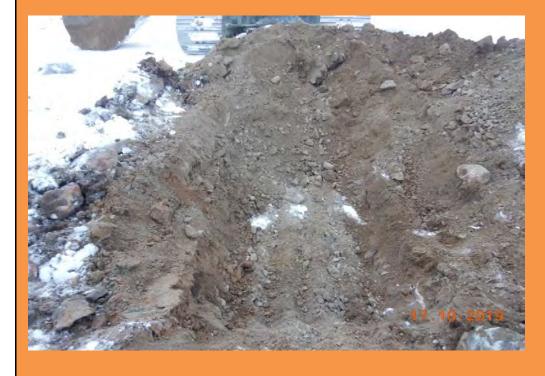
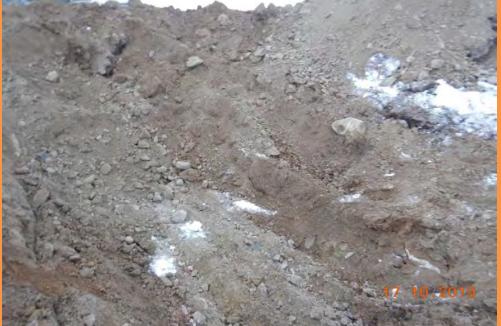
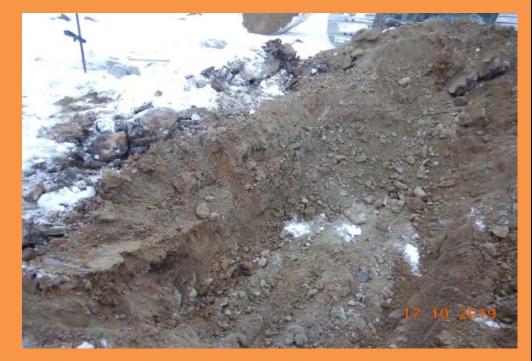
WTWRSF-TI	P7		by T. Dahm		
Dep	Depth (m)		Surveyed Coordinates (X,Y,Z): 606		606447.282,7256376.625,164.295
0.00	to	0.20	Organic materials		<u>Comments</u> :
0.20	to	0.80	Brown sandy silt some gravel, moist		1 sample: 1.3 m
0.80	to	1.30	sand and gravel with cobbles, some silt, moist		
Depth of Test Pit:	Depth of Test Pit: 1.30		.30 Refusal (frozen soil)		
Water:	•	N/A

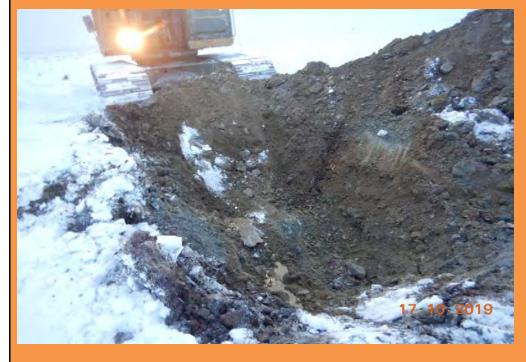
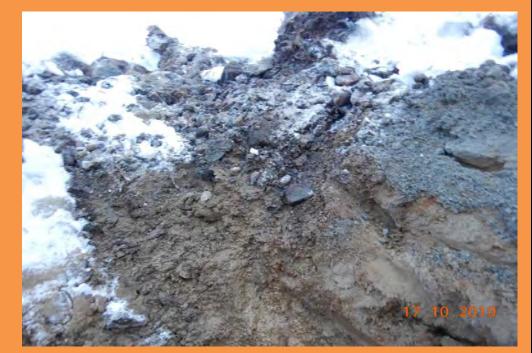
WTWRSF-TP9			by T. Dahm	
Dep	Depth (m)		Surveyed Coo	ordinates (X,Y,Z): 606435.376,7256142.658,163.802
0.00	to	0.20	Organic materials	<u>Comments</u> :
0.20	to	0.60	Greyish Brown silty sand and gravel, moist	There was water inflow at 0.8m. It was a slow seepage.
0.60	to	1.60	Brown silty sand and gravel with cobbles, moist	3 samples: 0.9 m, 1.1 m, 1.5 m
Depth of Test Pit:		1.60	Pefusal (frozen soil)	
Water:		0.80	slight water inflow

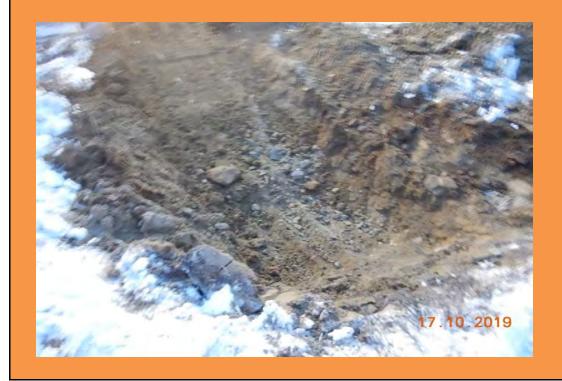
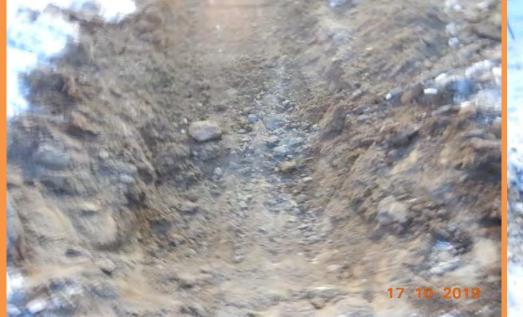
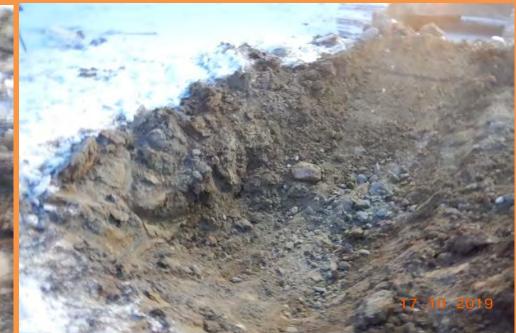
WTWRSF-TF	P10		by T. Dahm	
Dep	Depth (m)		Surveyed Coordinates (X,Y,Z): 606418.313,7255943.839,164.177	
0.00	to	0.20	Organic materials	Comments :
0.20	to	0.50	Brown silty sand and gravel, moist	Hole was stable and good . As the hole gets deeper the larger the rocks
0.50	to	1.20	Brown silty sand and gravel with cobbles, moist	2 samples: 1.0 m, 2.0 m
Depth of Test Pit:	epth of Test Pit: 1.20 Refusal (frozen soil)			
Water :		N/A

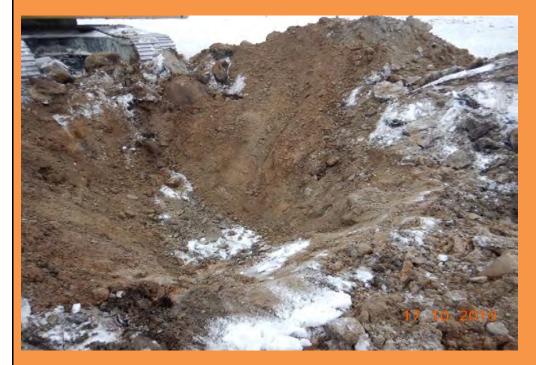
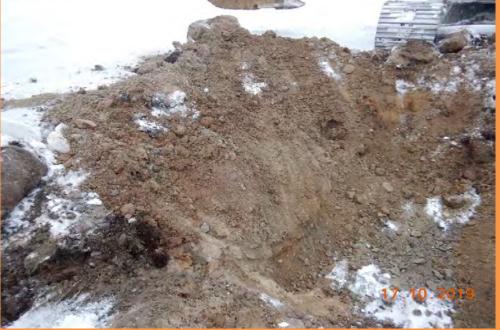
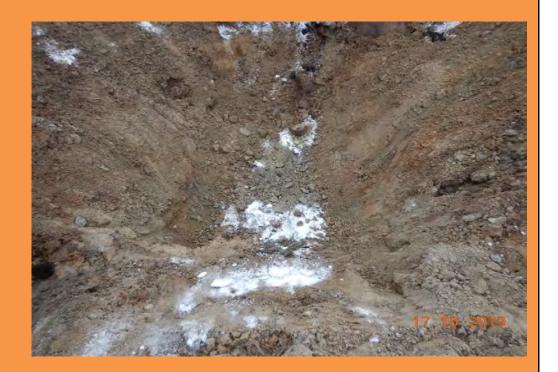
WTWRSF-T	WTWRSF-TP11		by T. Dahm	
De	Depth (m)		Survey	ed Coordinates (X,Y,Z): 606343.732,7255780.851,163.073
0.00	to	0.20	Organic materials	Comments:
0.20	to	0.80	Brown sand and gravel, some silt, moist	Hole was moved as original co ordinates were in the side of Road #7
0.80	to	1.60	Brown sandy silt with cobbles, moist	2 samples: 0.6 m, 1.6 m
Depth of Test Pit:	Depth of Test Pit: 1.60		<b>0</b> Refusal (frozen soil)	
Water:		N/A	_
