## Design Report for IVR Diversion

Detailed Engineering Design of Water Management and Geotechnical Infrastructures Phase 2 - Whale Tail Project Expansion

Agnico Eagle Mines Limited - Meadowbank Division

File no.: 6127-695-132-REP-004 (668284-7000-4GER-0001), Rev 00

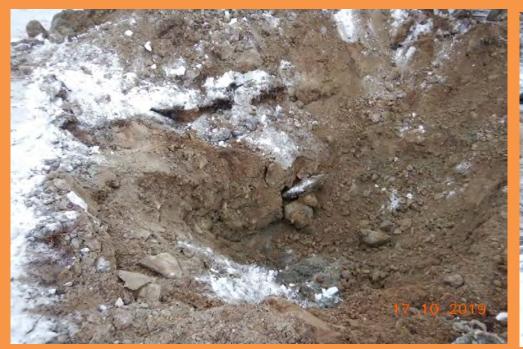
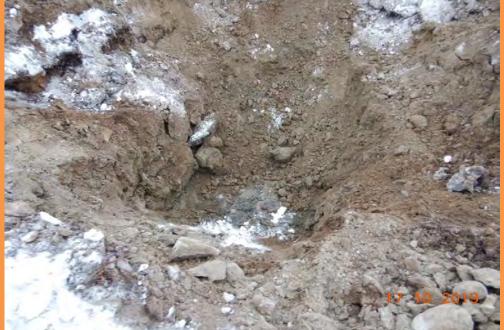
WTWRSF-T	P12		by T. Dahm	
Dej	oth (m)			Surveyed Coordinates (X,Y,Z): 606178.06,7255654.898,159.996
0.00	to	0.20	Organic materials	<u>Comments</u> :
0.20	to	1.20	brown silty sand, trace gravel, moist	Hole was moved as original co ordinates were in the side of Road #7
1.20	to	1.60	brown silty sand, some gravel, moist	1 sample: 0.1 m
1.60	to	2.00	grey silty sand and gravel, moist	
Depth of Test Pit:		2.00	Refusal (frozen soil)	
Water:		N/A	_

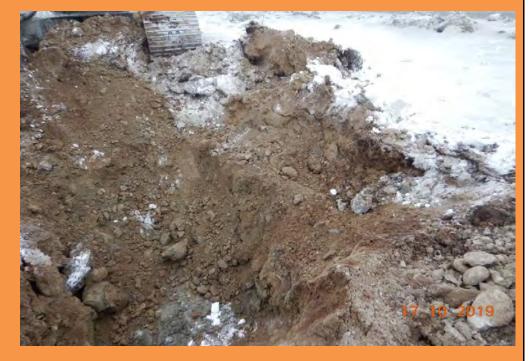
WTWRSF-TF	P13		by T. Dahm						
Dep	oth (m)		Surveyed Coordinates (X	Z): 606072.68,7255481.035,159.281					
0.00	to	0.30	Organic materials	<u>Comments</u> :					
0.30	to	1.10	brown silty sand and gravel, moist	Hole was moved as original co ordinates were in the side of Road #7					
1.10	to	1.60	grey brown sand and gravel with cobbles, some silt, moist	3 samples: 0.5 m, 1.2 m, 1.6 m					
Depth of Test Pit:		1.60	Pefusal (frozen soil)						
Water :		N/A

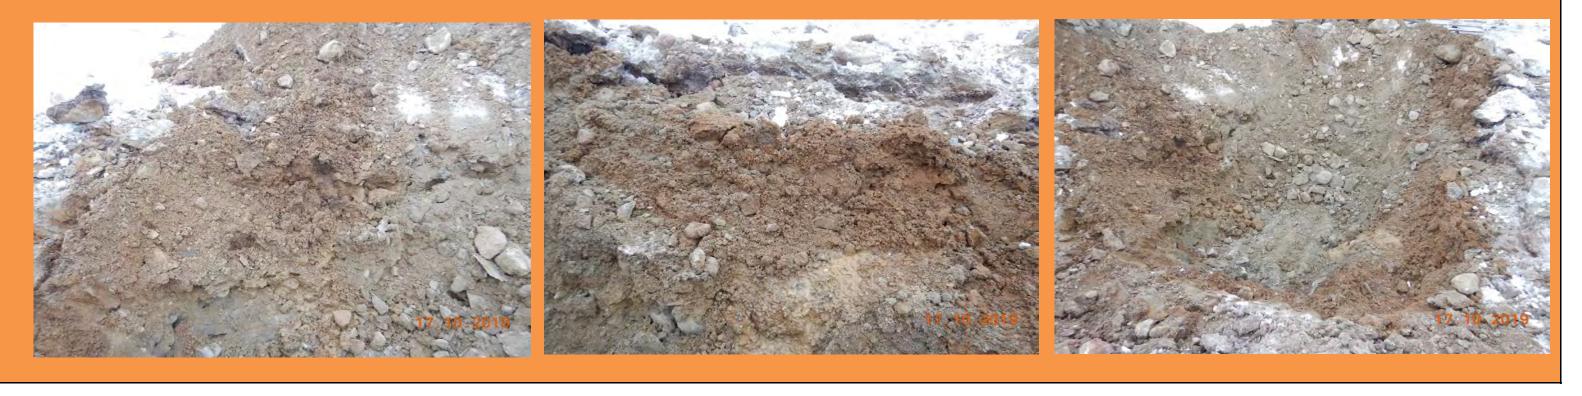
WTWRSF-TF	P14		by T. Dahm						
Dep	oth (m)		Surveyed Coordinates (X,Y,Z)	(): 605960.558,7255467.581,161.061					
0.00	to	0.40	Organic materials	<u>Comments</u> :					
0.40	to	1.10	Grayish brown silt sand and gravel, moist	Hole was moved as original coordinates were in the side of Road #7					
1.10	to	1.70	brown sand and gravel with cobbles, some silt, moist	2 samples: 0.5 m, 1.1 m					
Depth of Test Pit:		1.70	Refusal (frozen soil)						
Water :	•	N/A

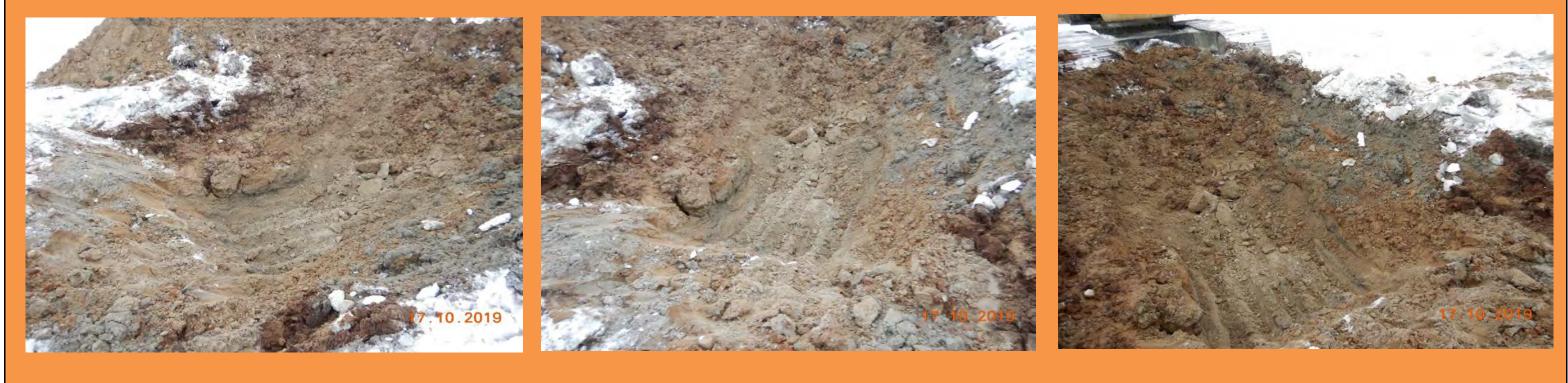
WTWRSF-T	P15		by T. Dahm	
Dep	oth (m)		Surveyed Coordinates (X,Y,Z)	: 605859.992,7255626.948,164.515
0.00	to	0.30	Organic materials	<u>Comments</u> :
0.30	to	1.10	Brown silty sand and gravel, moist	4 samples: 0.5 m, 1.2 m, 1.6 m, 1.8 m
1.10	to	1.80	sand and gravel with cobbles, some silt	
Depth of Test Pit:		1.80	Refusal (frozen soil)	
Water :		1.80	Bottom of the hole was showing some slight water
