MAMMOTH LAKE TREATED WATER DIFFUSERS WHALE TAIL PROJECT

Construction Summary Report

Treated Water Diffuser in Mammoth Lake - Construction Summary Report

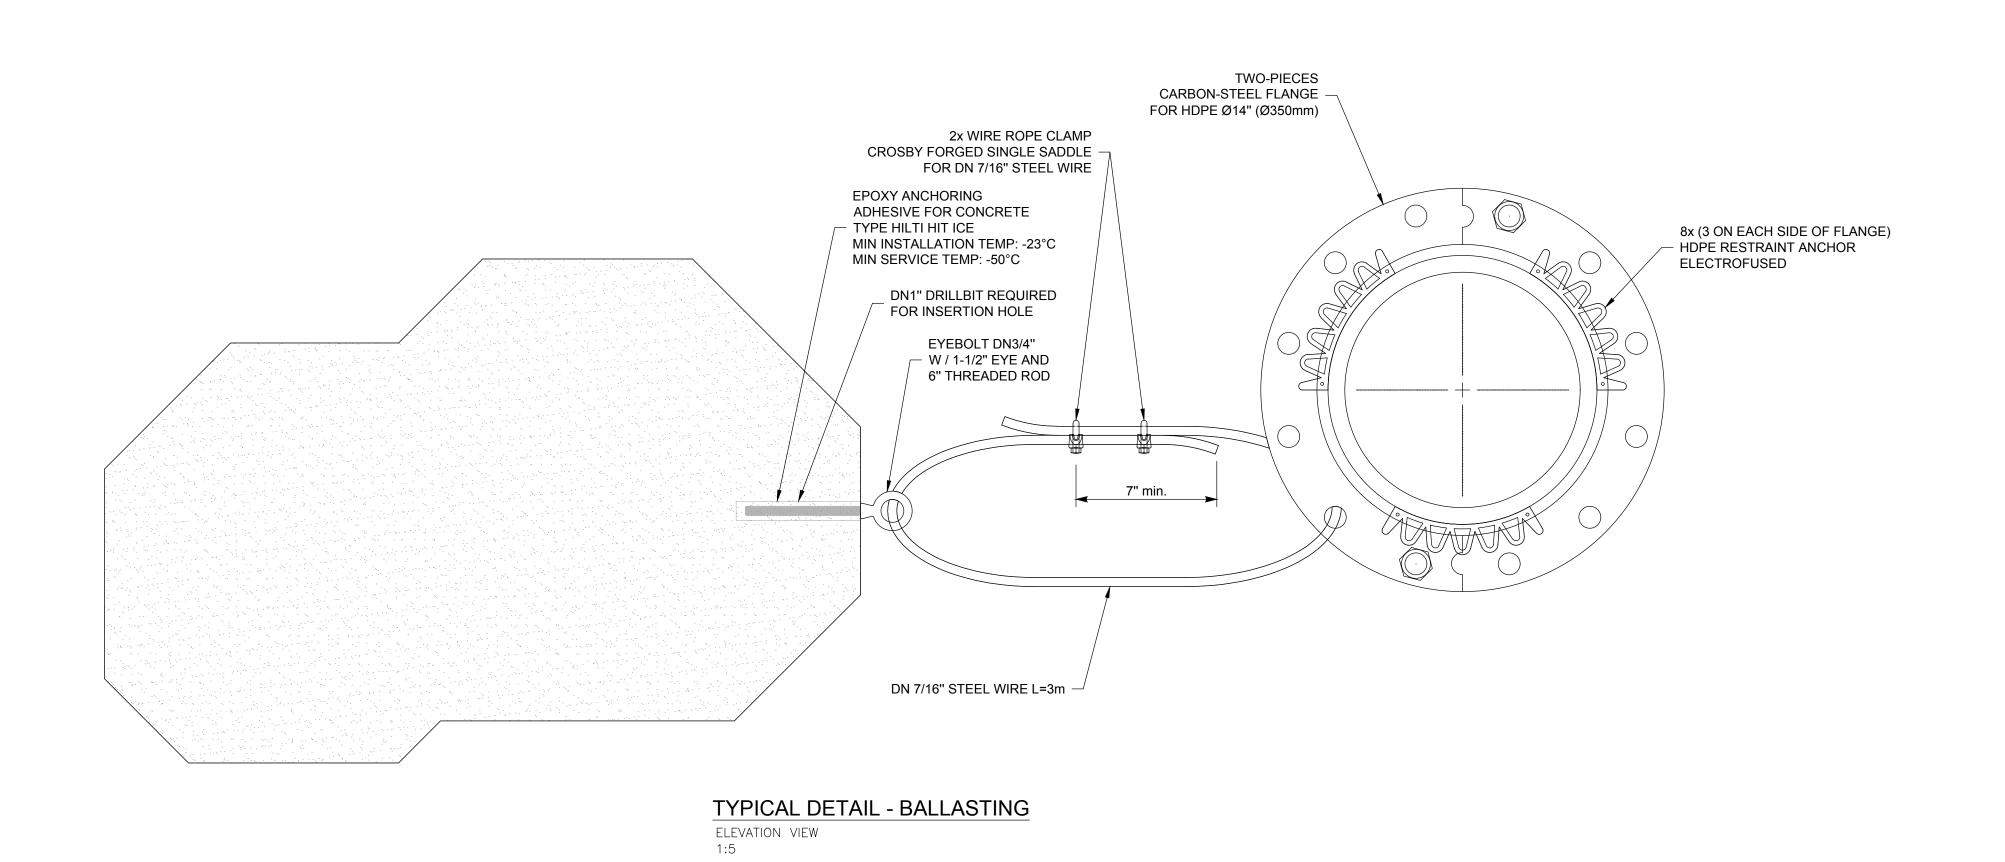
TYPICAL DETAIL
DIFFUSER OUTLETS AND BALLASTING
ELEVATION VIEW

Boulders are used as ballast. They are installed every 20m approximately along the pipeline, from the diffuser end to the shoreline.

The proposed method for ballasting the diffuser and submerged pipeline length is not according to standard practice nor does it comply with the pipe manufacturer's recommendations. It is based upon AEM's experience and site constraints.

constraints. 2) The spacing between ballasts here specified is greater than the maximum recommended spacing and may cause the pipeline to arc upwards between ballasts. This may cause air to be entrapped along the line and reduce pumping capacity. The air should be pushed out of the line once pumping starts. However, if this is not the case, air pockets may be evacuated subsequently by drilling a small hole at the apex of the submerged arc. This will require a diver. Pre-Drilling is not recommended and will affect the pipe's structural integrity. 3) The proposed spacing dictates the boulder sizing. The greater the spacing, the greater the boulder size. The proposed boulders are important weights acting on a small pipe surface and may cause the pipeline to kink, especially given the cold temperatures that could render the pipe more brittle. 4) Given AEM's chosen installation method, the final pipeline location cannot be guaranteed. The pipeline may sink elsewhere than at the intended coordinates, determined by Golder Associates Inc. Indeed, the rate at wich it will sink, as well as where it sink are dependent upon the climate and weather as well as the rate at wich the ice melts. To mitigate the risk: a) Allow for a longer pipeline length on the south shore of

A blind flange was installed at the end of each the HDPE pipe. Each discharge port consisted of an Ø80 mm diameter pipe (725 mm long) mounted on a saddle. The end of the pipe is equipped with an orifice plate with an opening of 61 mm. The diffuser and submerged portion of the pipelines are weighted using boulders as ballasts. Eye bolts were installed on each boulder and they were attached by a steel wire to clamp rings installed on the pipe. The distance between each ballast was set at 20 m and the minimum weight of each boulder was set at 1500 kg. That anchoring configuration was chosen to accommodate the installation method selected which was on ice installation.

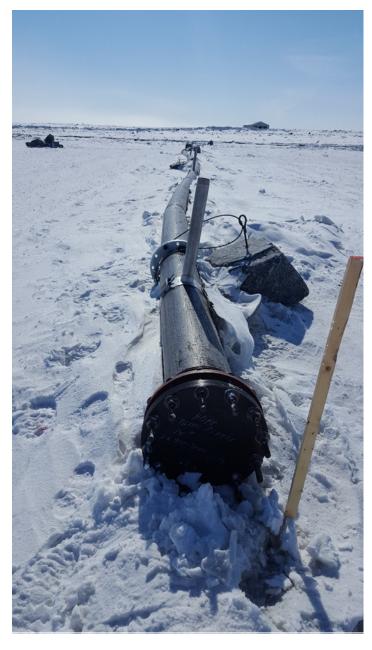
Photograph 1 – View of the West summer diffuser installed on the icesheet (looking SE). The blind flange, discharge port and ballasting can be observed

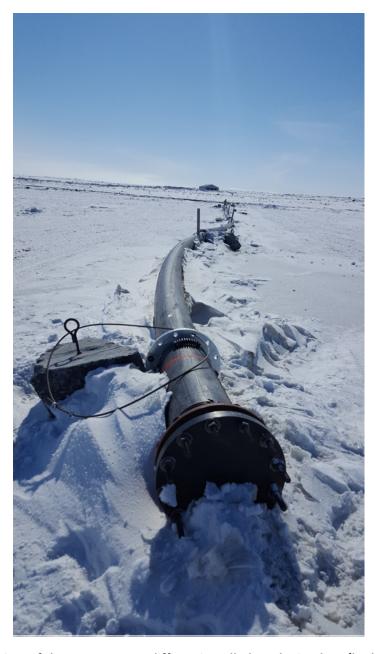
Photograph 2 – View of the East summer diffuser installed on the icesheet(looking SE). The blind flange, discharge port and ballasting can be observed

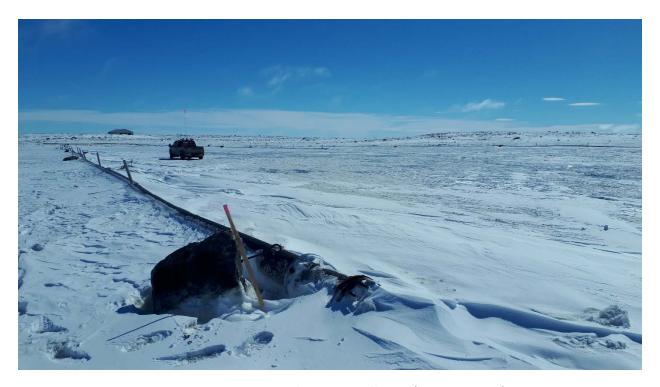
Photograph 3 – View of all three diffusers (looking South)

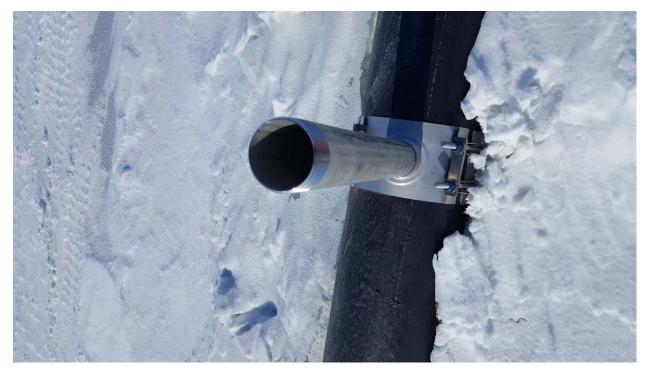
Photograph 4 – View of one of the discharge port

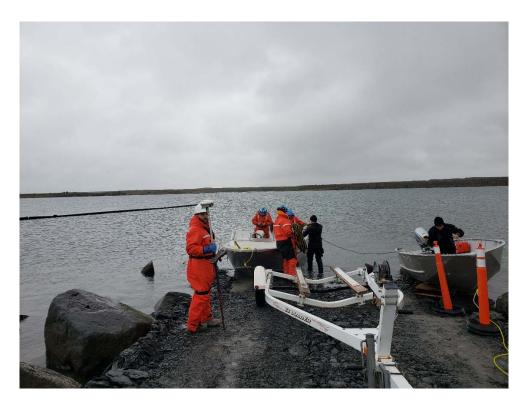
Photograph 5 – View of the boats used to re-install the diffusers into place (looking NW)

Due to air trapped in the HDPE pipe, the ballasting weight was not enough to sink the Eastern and Western diffusers. Following the ice sheet thaw of Mammoth Lake, they remained afloat and drifted out of place. With the help of boats, AEM towed the diffusers back into place. Professional divers then partially opened the blind flange letting water enter the diffuser and removed the discharge port caps letting air escape. Once the diffusers and pipelines were full of water, they sank into place on the lake bed. The divers then closed the blind flange and reinstalled the discharge port caps.

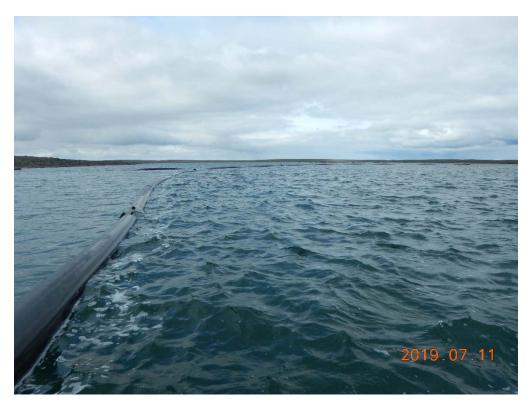
Once the spring melt began, the winter diffuser sank as planned, but the Eastern and Western diffusers kept afloat and drifted due to the wind and the water currents. With the help of boats and professional

Photograph 6 – View of the summer diffusers afloat (looking SW)

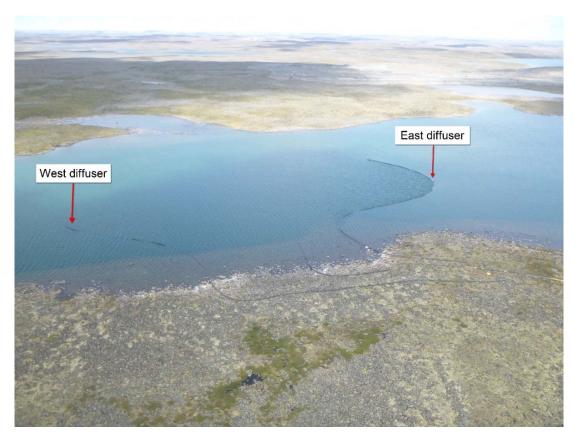
Photograph 7 – Arial view of the summer diffusers afloat and the sunk winter diffuser (looking NW)

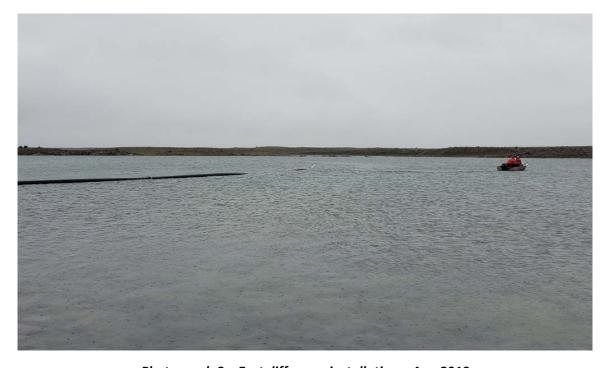
Photograph 8 – East diffuser reinstallation – Aug 2019

divers, the summer diffusers were reinstalled back into their original alignment and successfully sunk. The Eastern diffuser was sunk on August 4, 2019 while the Western diffuser was sunk on August 14, 2019.

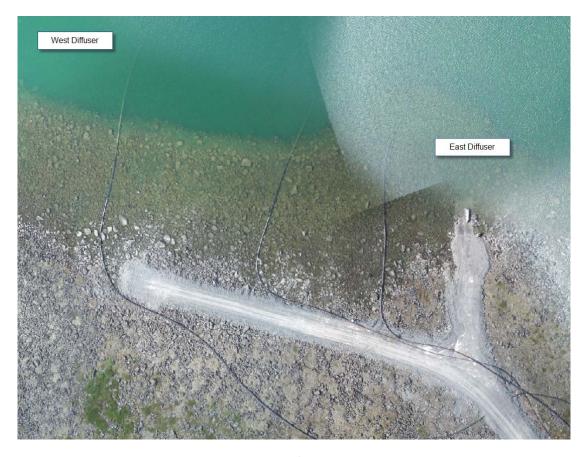
Photograph 9 – Aerial plan view after reinstallation – Summer 2020

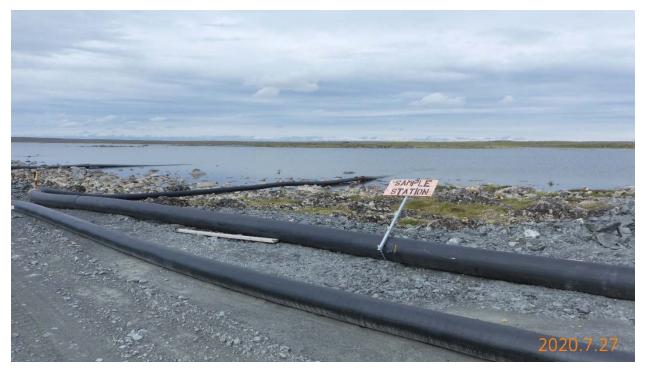
Photograph 10 – View of Diffuser entering into Mammoth Lake – Summer 2020
