## Construction Summary Report Whale Tail Lake South Basin Treated Water Winter/Summer Diffuser

Agnico Eagle Mines Ltd

6127-695-132-REP-013\_R1

January 22, 2021

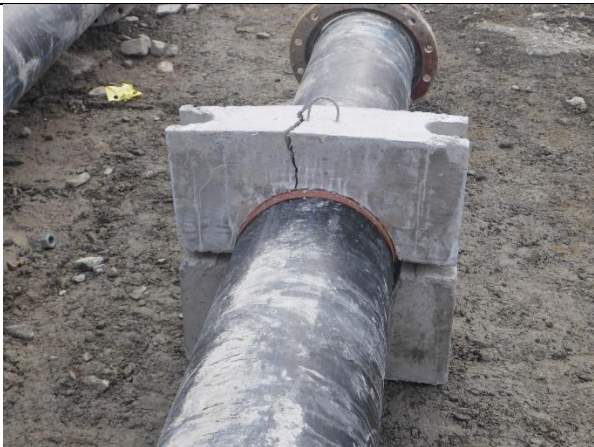
1.1 Tension fracture on a concrete ballast that needs to be changed.

| QA Activities | Approximate location | Visual observation during field visit |
|---|---|---|
| Inspection of the WTS diffuser installation | Whale Tail South dike downstream | <ul style="list-style-type: none"> <li>• The faults surveyed on the concrete ballasts have been corrected prior to the installation of the pipe in the lake.</li> <li>• The placement of the ballasts compared to the outlets have been corrected prior to installation.</li> <li>• Some ballasts are still fractured in the middle and/or misplaced on the winter diffuser.</li> <li>• The summer diffusor was sunk</li> <li>• There was no final survey of the summer diffusor</li> <li>• The as-built location of each chimney will be determined with the buoy location and the distance</li> </ul> |

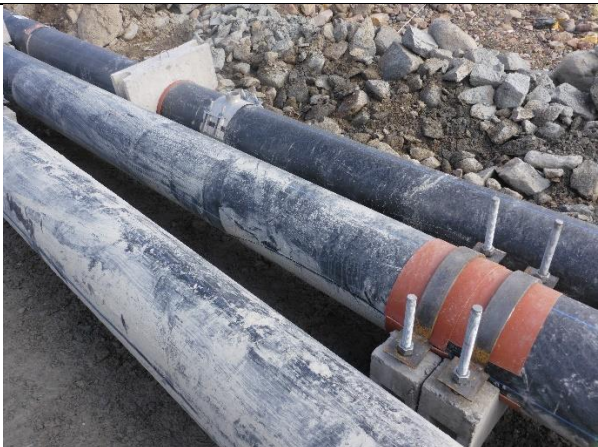
1.2 Changed ballast configuration to ensure adequate floatability.

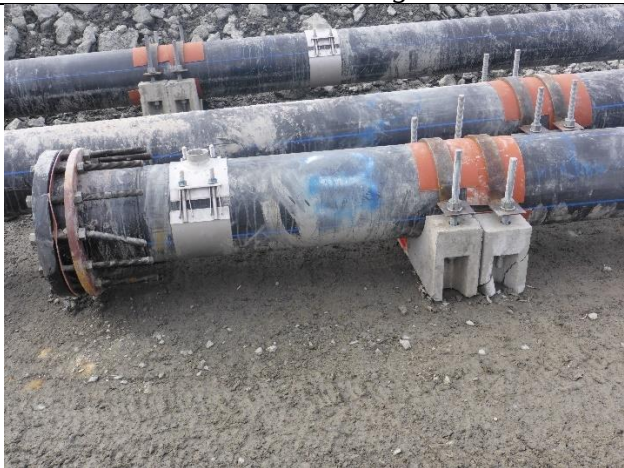
1.3 Bent bolt and slightly broken ballast.

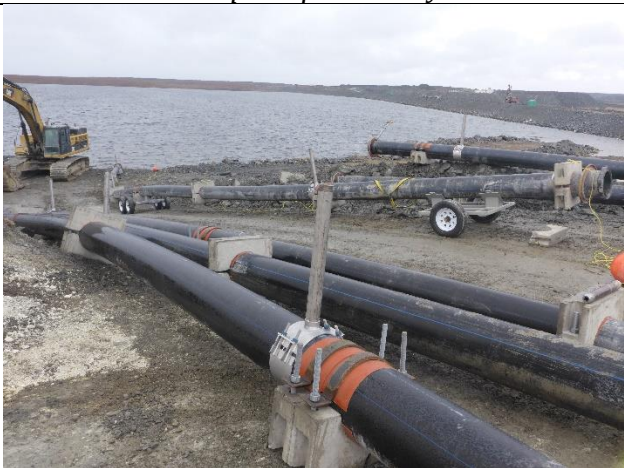
1.4 Pipe placed on trailers and diffuser outlets installed.

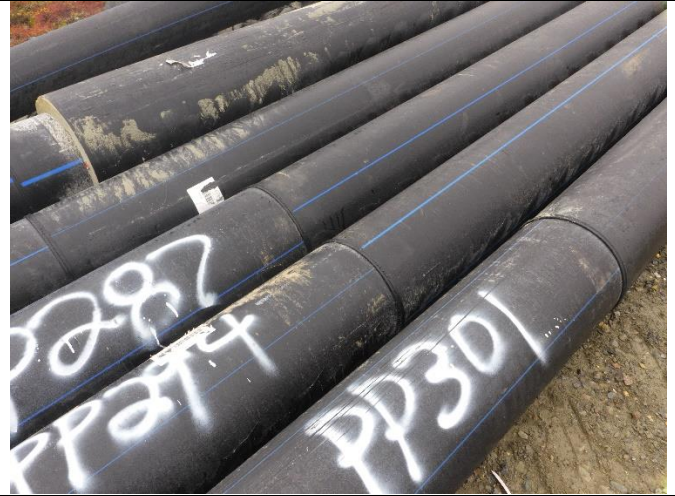
2.1 Adequate fusion observed during a spot check in the pipe stockpile.

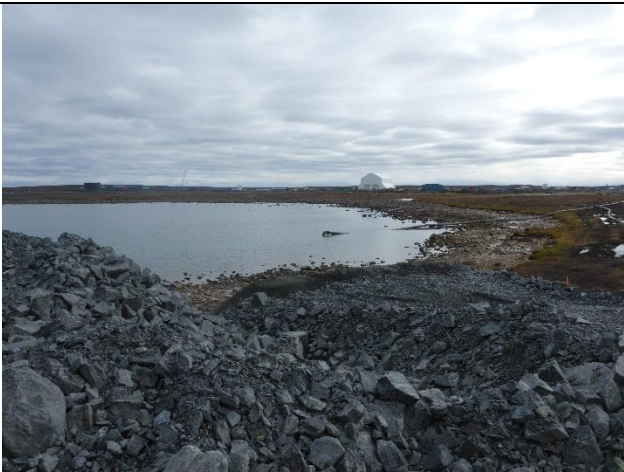
3.1 Pad of lake the A-53 that needs to be extended

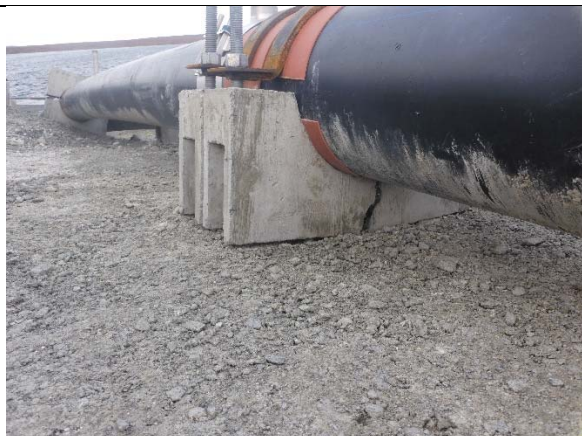
1.1 *Fractured ballast that needs to be changed on the winter diffuser*

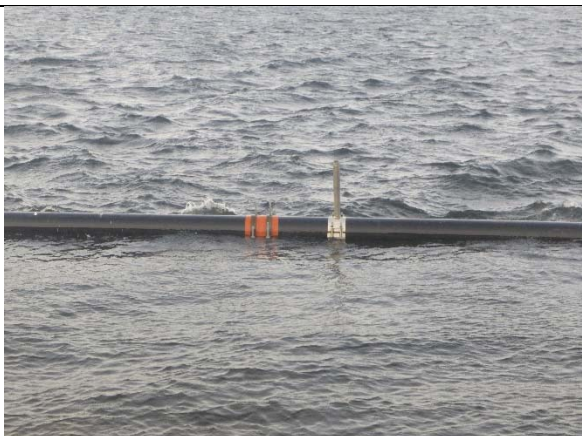
1.2 *Ballast placement that was corrected compared to the outlet*

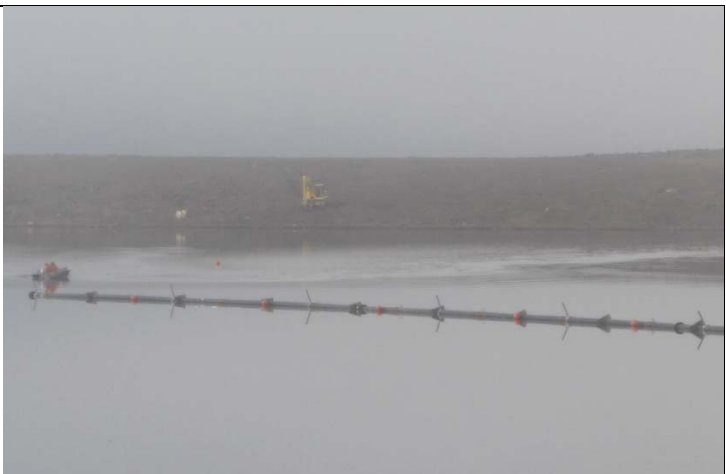
1.2 Excavator on the West shore of WTS and a boat to place the diffuser

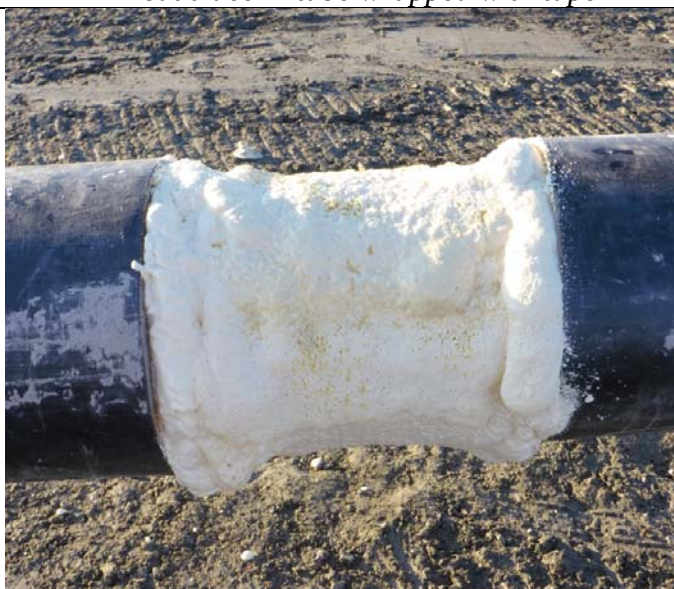
2.3 Urethane over the tape to insulate the pipe

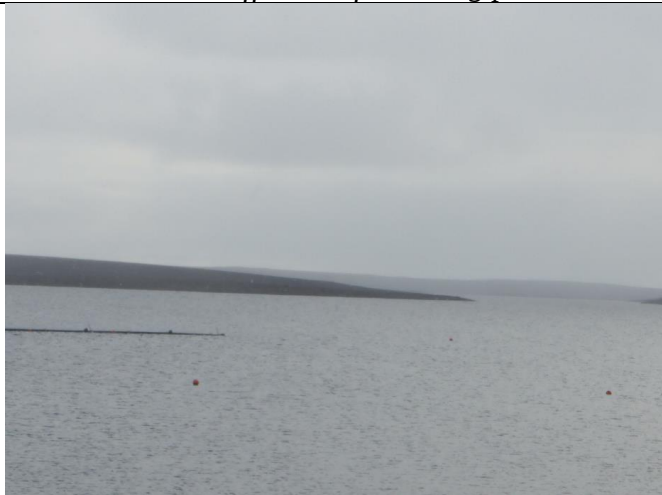
1.3 The end of the winter diffusor is not reaching the buoy.

| ID | DATE | SUBJECT | ITEM | LOCATION | DRAWING OR SPEC REF. | DESIGN | CHANGE | STATUS | APPROVED BY | NOTES |
|---|---|---|---|---|---|---|---|---|---|---|
| 4 | 2020-10-01 | Diffuser | WTS diffusers:<br>695-350-WFR-PC17-0136 | Whale Tail south lake | 61-695-270-224 | The end of the winter diffuser is reaching the middle of the lake at chaining 0+411 and elevation 143.0. | Winter diffuser is too short of 30 feet, so reaching the original ending location is impossible. | Approved | SNC | After discussions with the designer, it has been concluded that the 30 foot shortening of the diffuser does not cause any problem. As long as the diffuser's end is below the elevation of 145.0, wich is the case in this situation, the change can be applied |

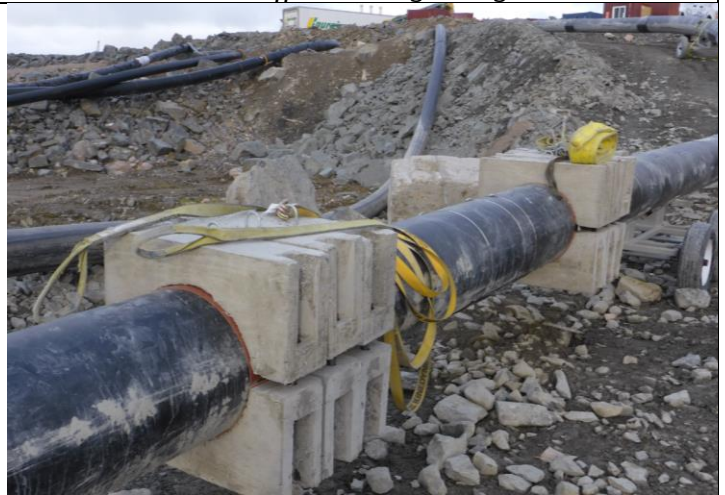
1.4 Installation of ballasts on the insulated part of the winter diffuser.

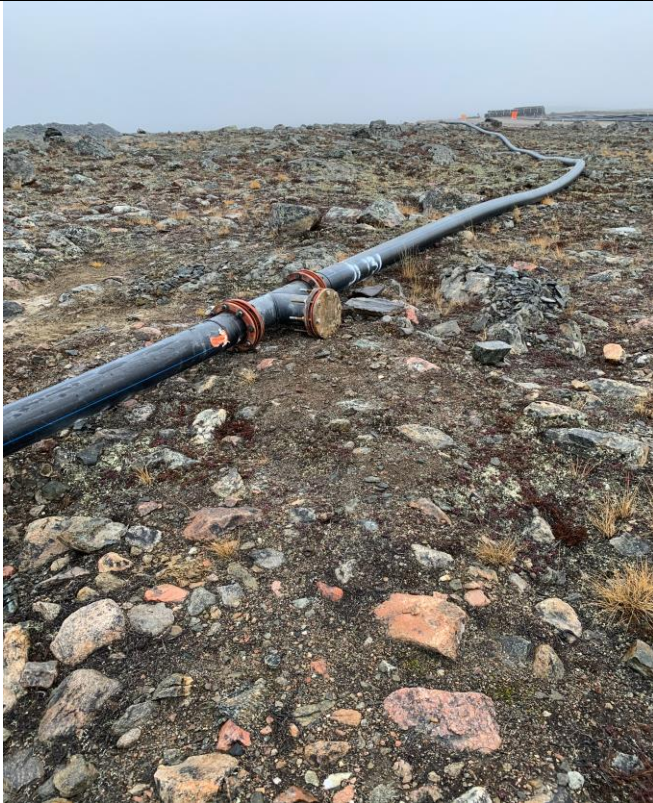
2.1 Missing butterfly valves at the T joint near Nemo Road..

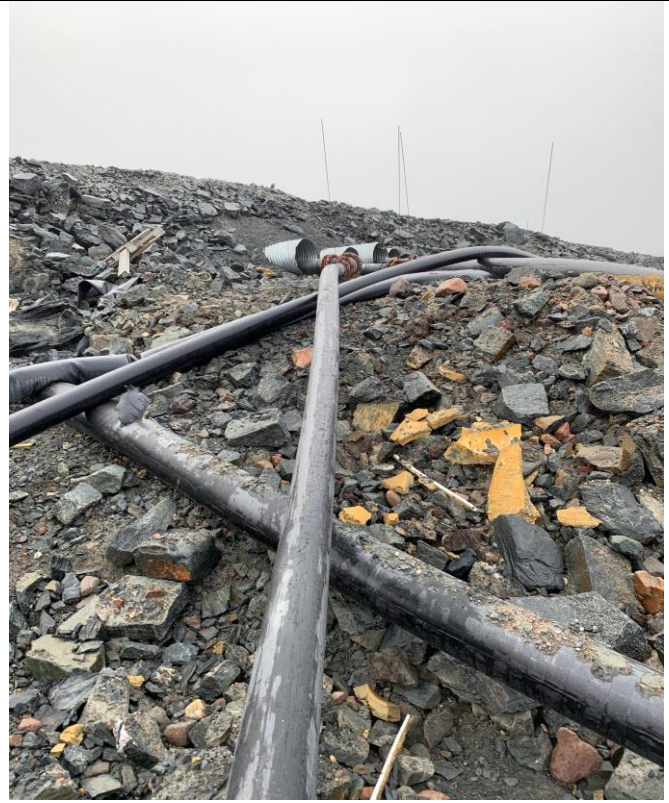
2.2 8" pipe merging into 14" pipe at the culvert between Quarry 1 and WTN

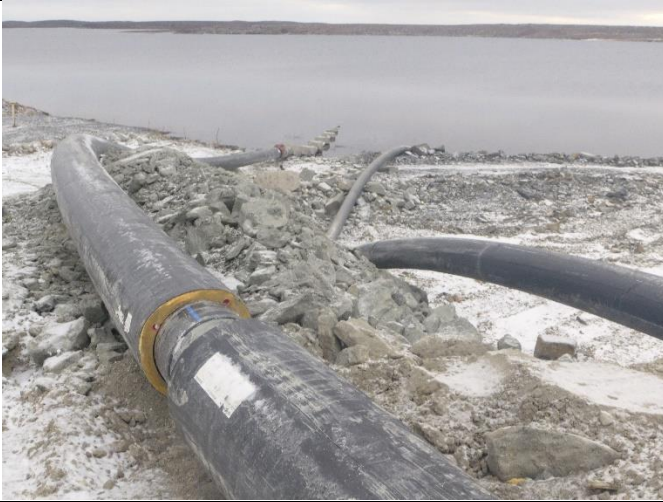
1.1 Whale Tail South diffusers, extended on the shore. Note the heat traced pipe for the winter diffuser.

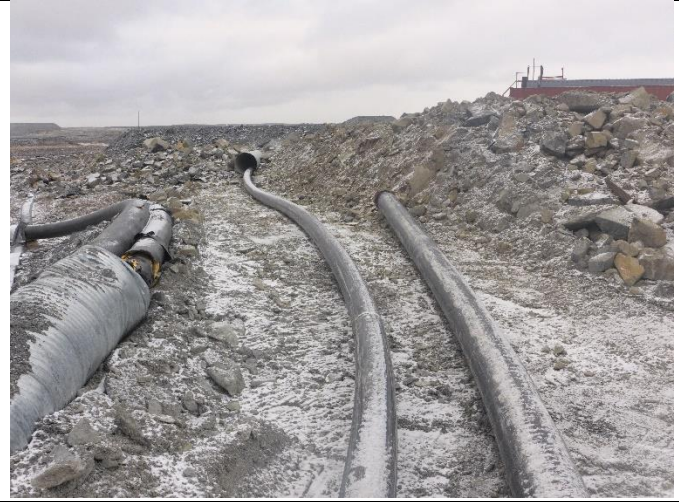
1.1 Whale Tail South diffusers extensions towards the WTP.

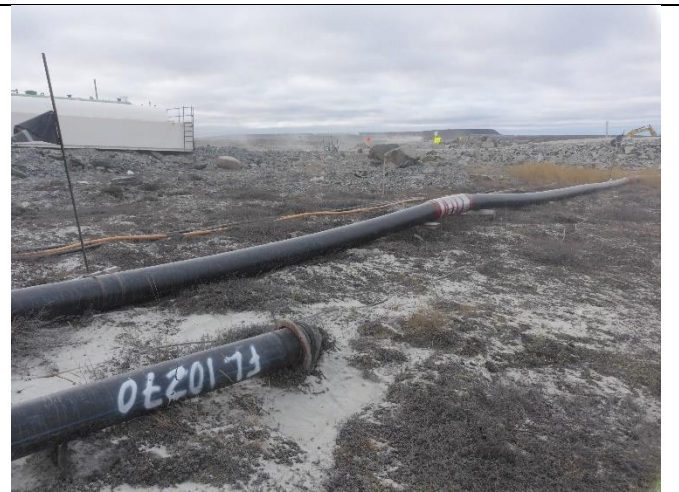
2.2 West end of the section of line 113 & 115 leading to IVR attenuation pond. Regarding West, with the Road 7-Nemo Road intersection in the background

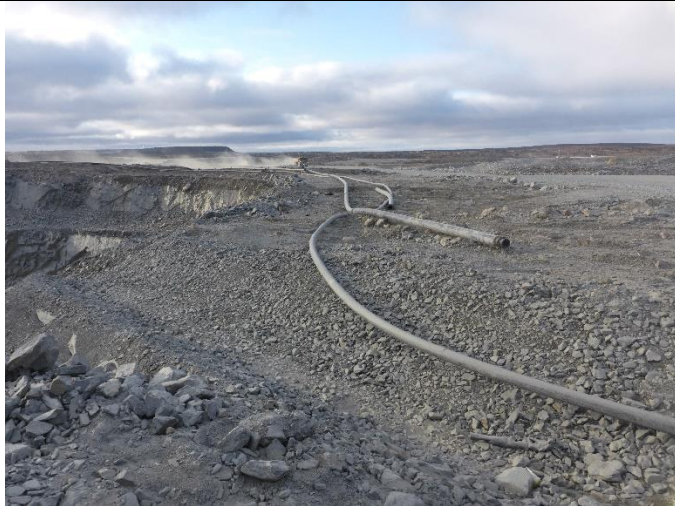
2.3 Line 115 located south of road 7, with the unidentified line on the left

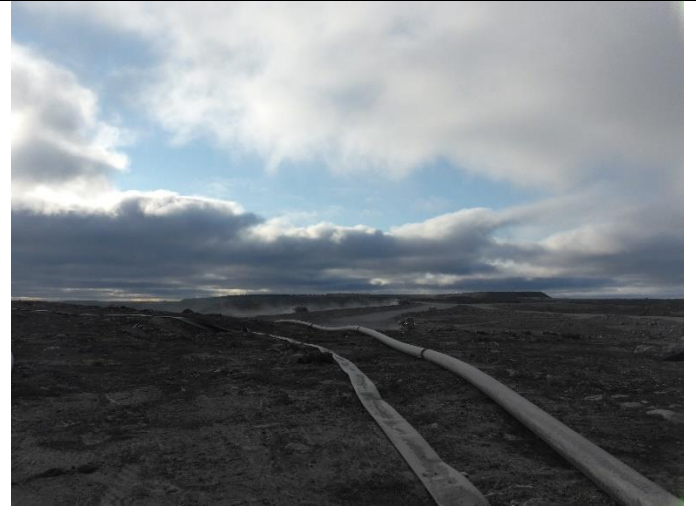
2.4 Line 115 on the right hand side, leading to the IVR south ring road.

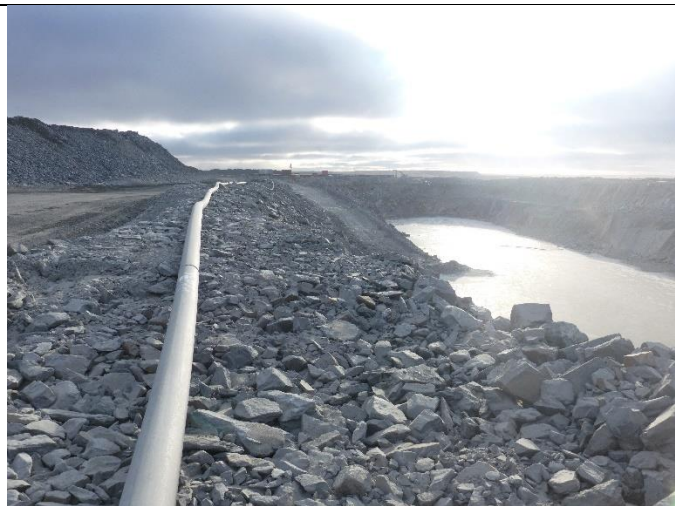
3.1 Line 114 on the berm between AP5 and the road

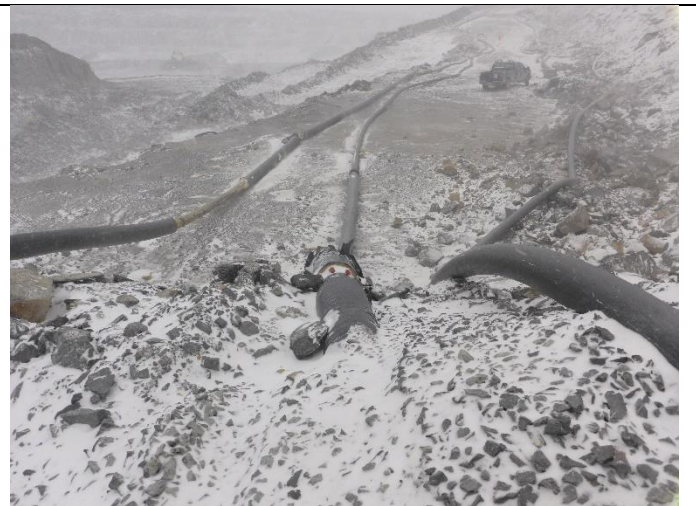
3.2 Old insulated section of line 114 crossing Road 7 straight in the rock, near Quarry 1.

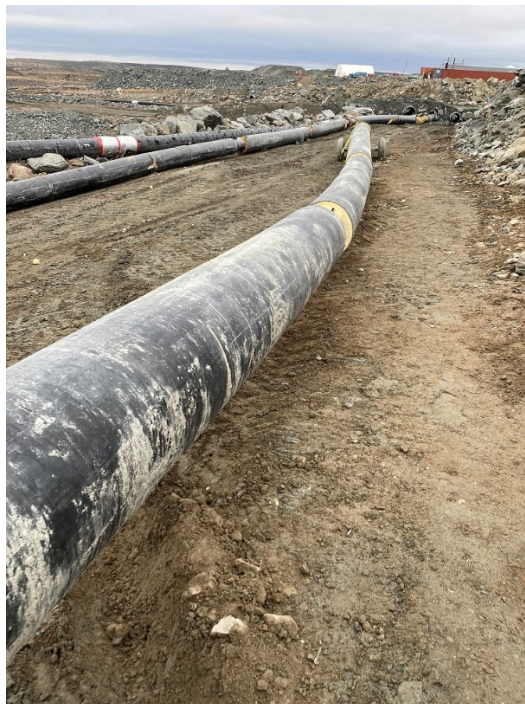
2. View of the installed pipeline

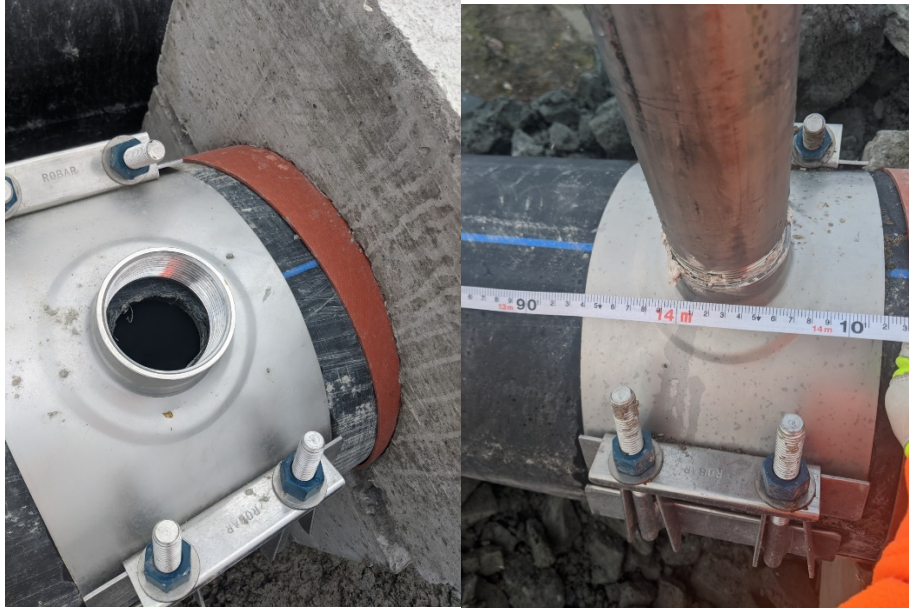
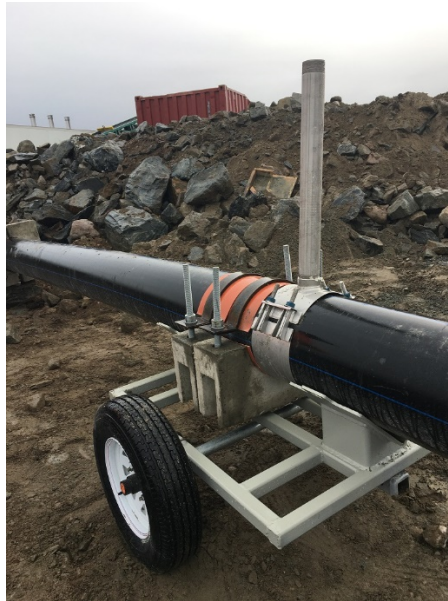
3. Details on a discharge port assembly (branch saddle, 2.5 in Stainless Steel Pipe and final assembly)

- > 7 discharge ports spaced out at 14 m intervals starting at the end of the line on a 14-in DR17 HDPE pipeline;
- > Each port consists of a Ø63.5 mm (2.5-in) diameter schedule 40 stainless steel pipes mounted on a branch saddle with a total length of 720 mm. The internal diameter of the pipe is 62.7 mm;

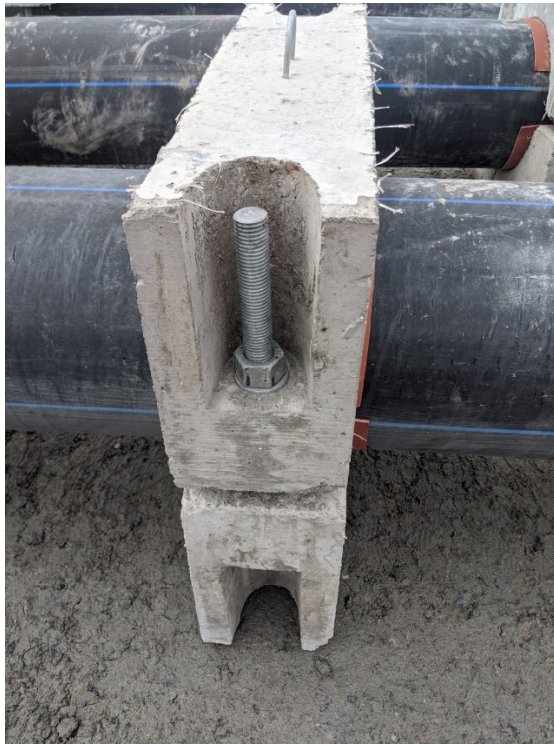
4. Illustration of a 90kg concrete ballast installed along the diffuser

- > The diffuser and offshore pipelines are weighted using concrete ballasts, each weighing approximately 90 kg. The ballasts are uniformly distributed along the diffuser and offshore pipeline. Each concrete ballast is sized to fit around a 14-in HDPE non-insulated pipe.

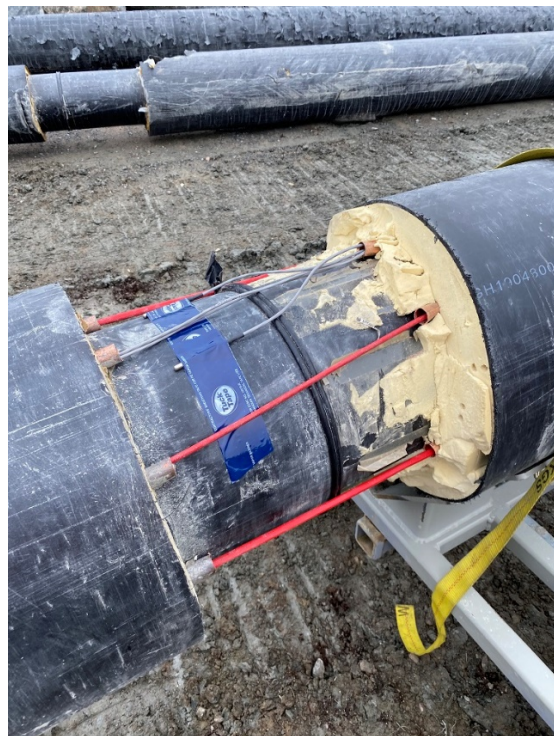
5. Illustration of the insulated portion of the offshore pipeline

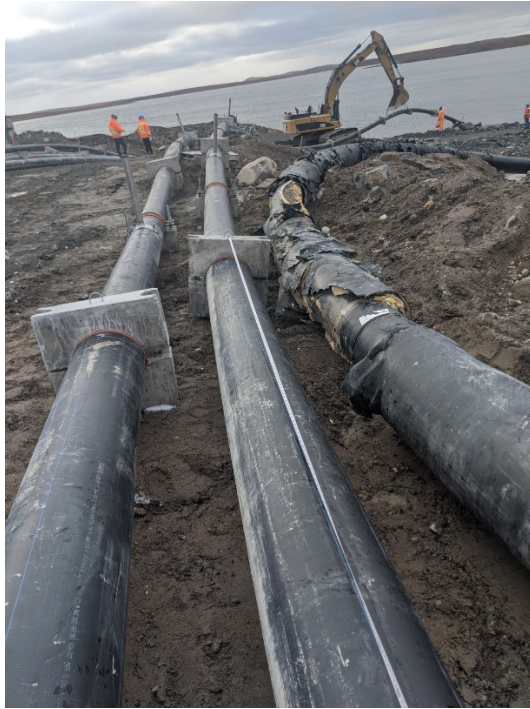
6. Illustration of the assembly work of the diffuser

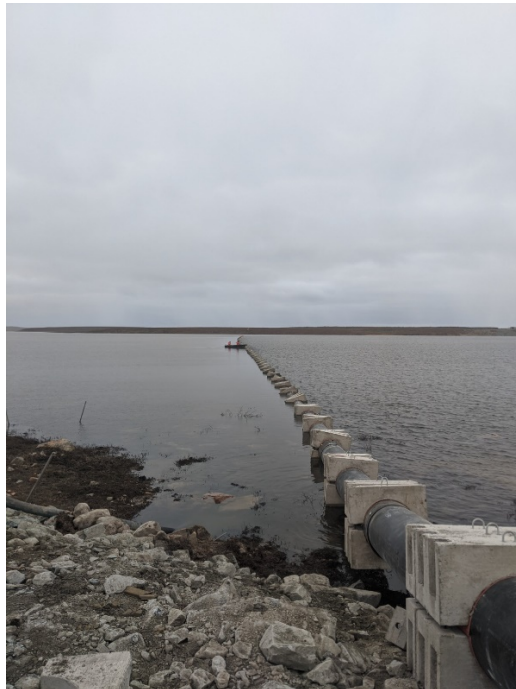
7. Final alignment of the diffuser in the WTS basin

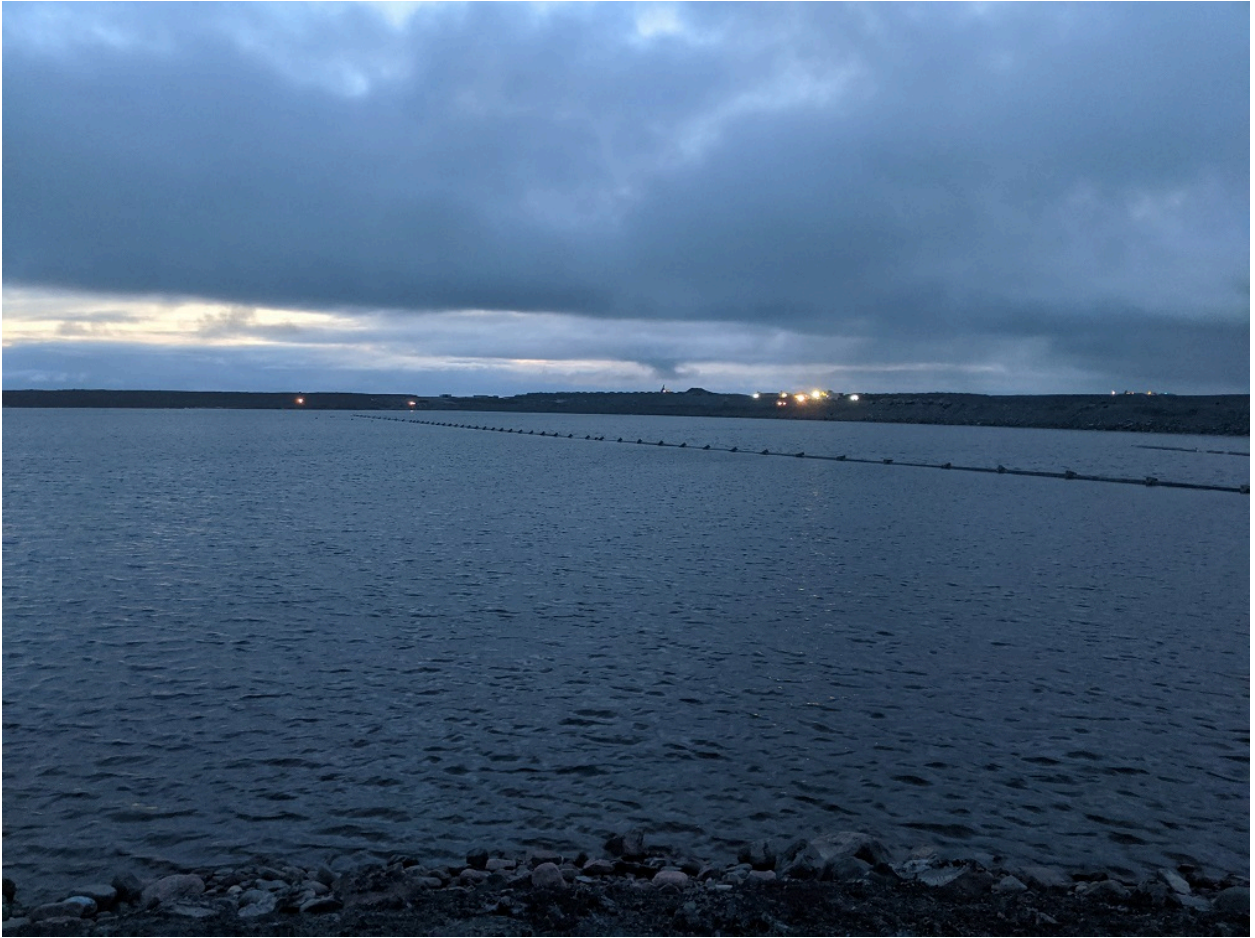
8. Final result before sinking
