### WHALE TAIL MINE MAIN CAMP PAD EXTENSION

#### CONSTRUCTION SUMMARY REPORT MEADOWBANK COMPLEX

December 20, 2022

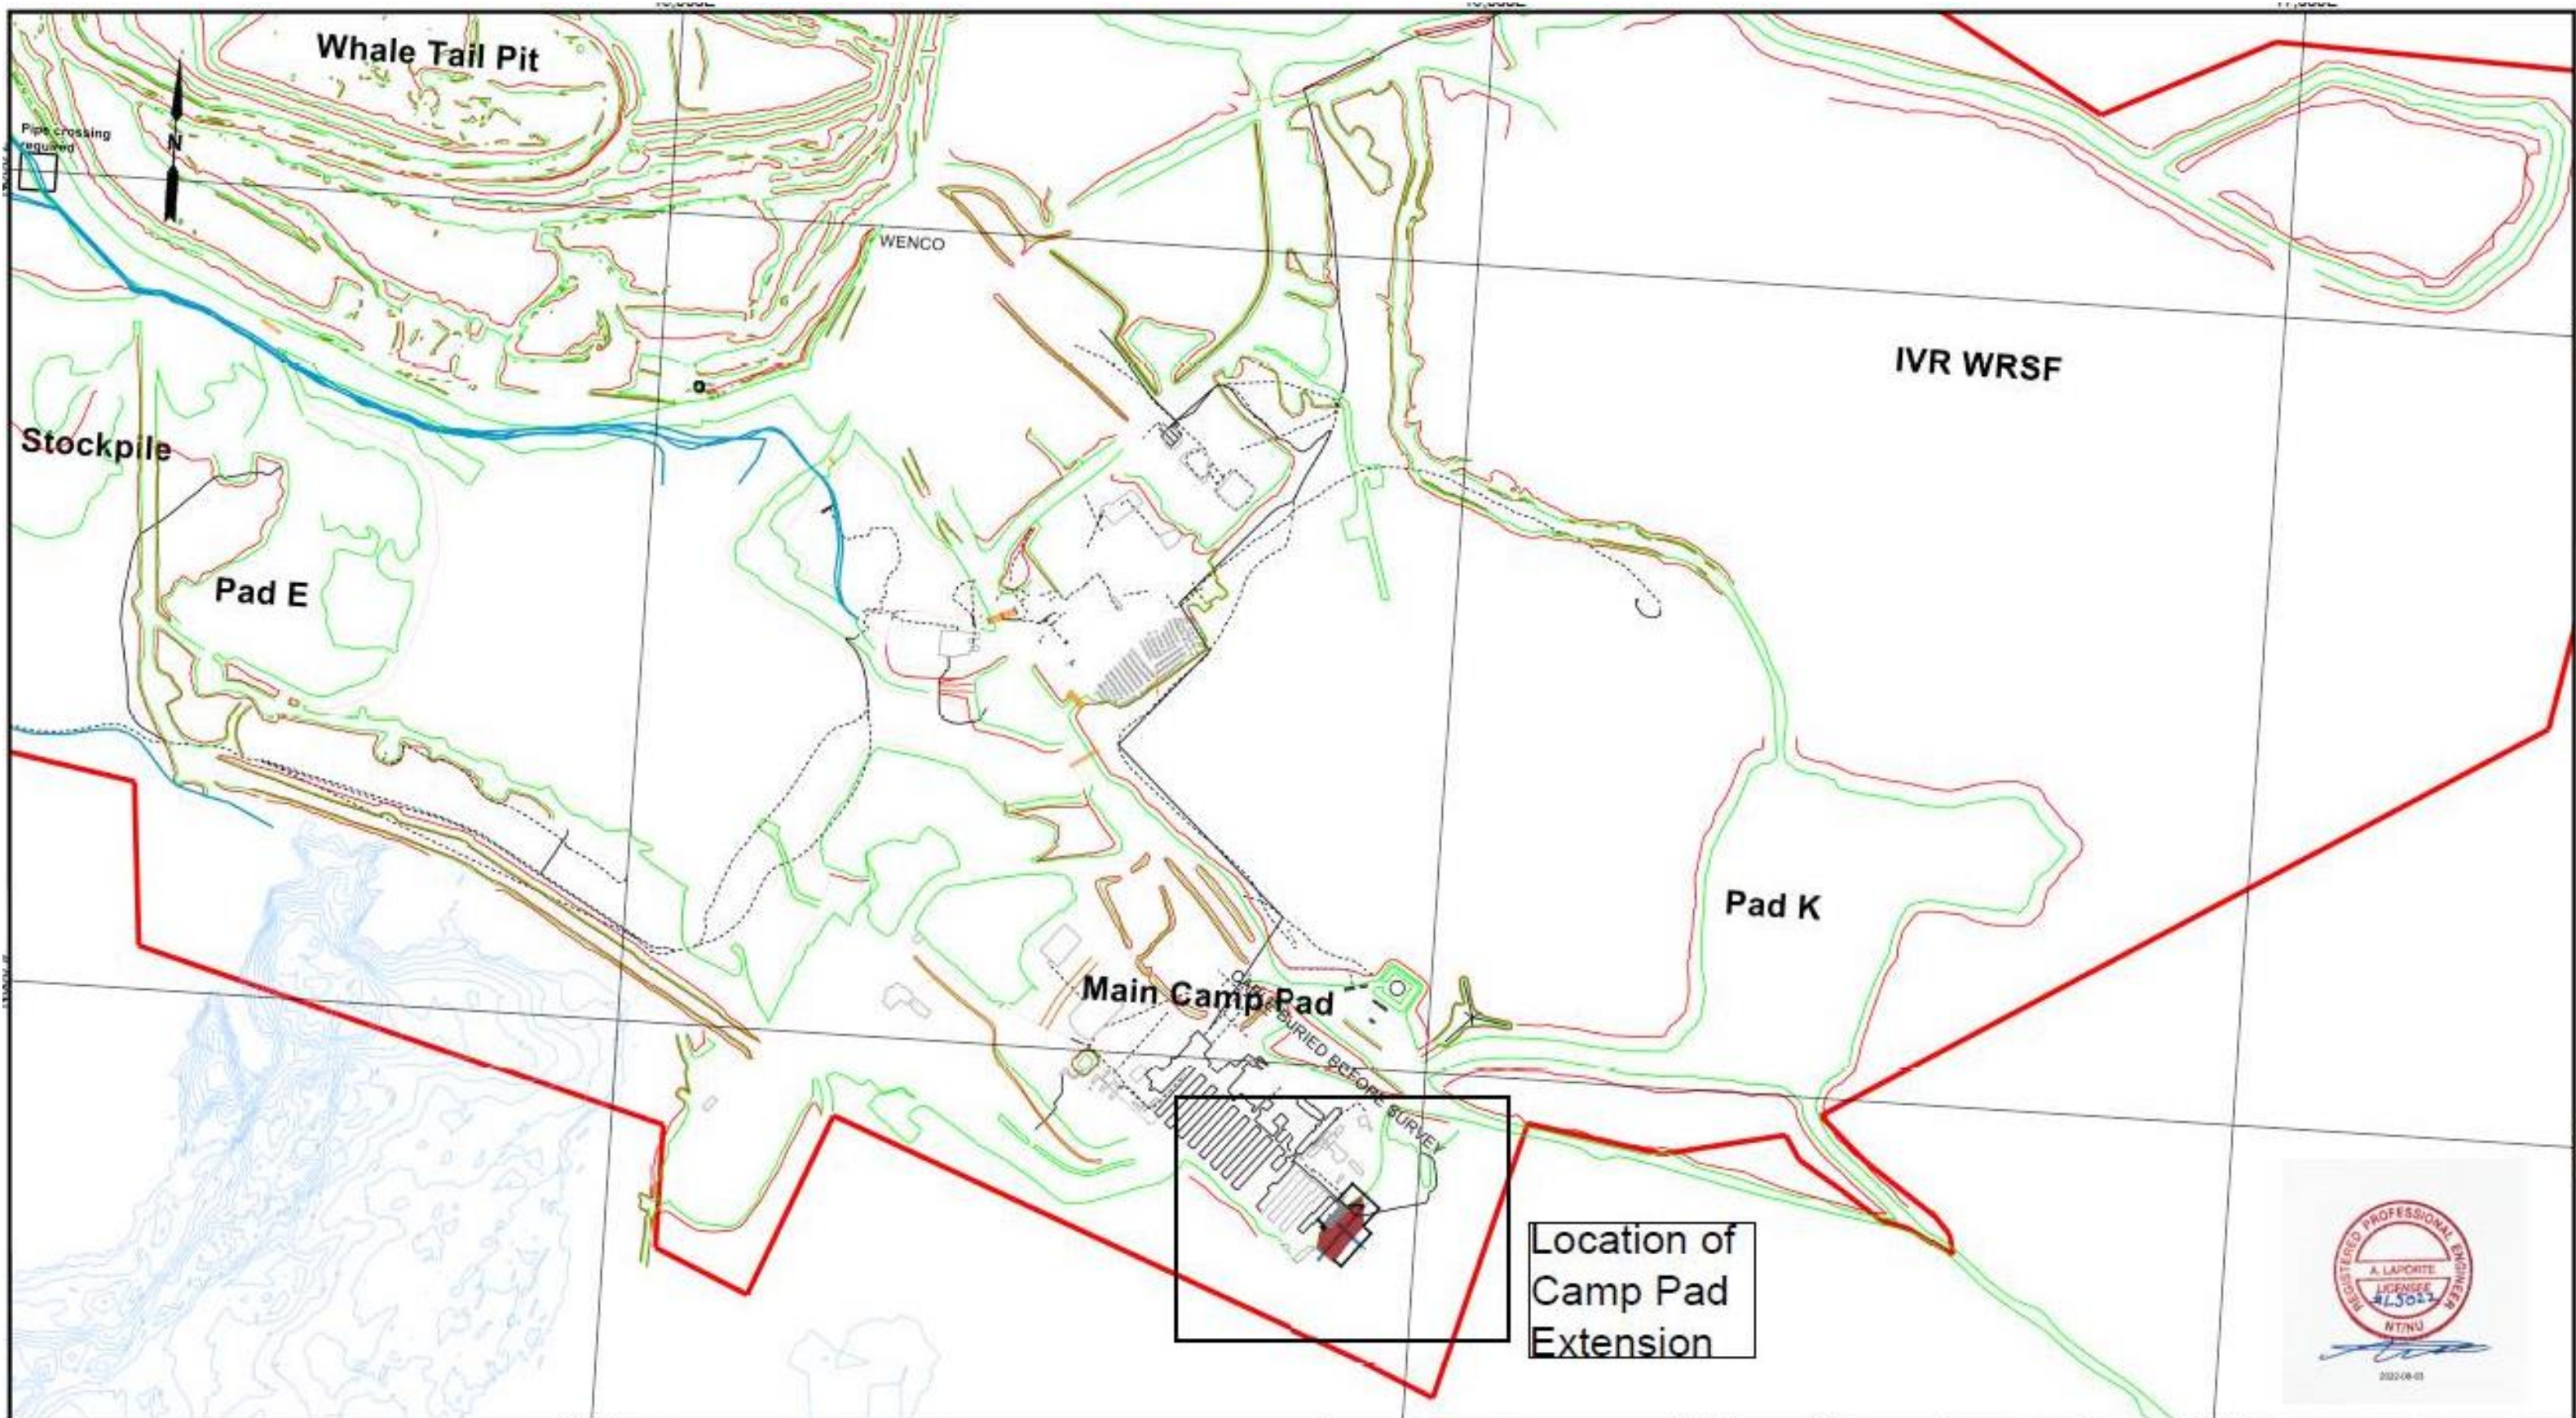
MEADOWBANK DIVISION  
 ENGINEERING  
 Amarug Project  
**Camp Pad Extension**  
 Overview - As Built Revision  
 SCALE: N.T.S. DATE: 8/03/2022 FILE: DWG

— Proposed camp extension  
 — LEASE LIMIT  
 — Electrical wire - will require relocation prior to construction of pad

15,000E  
 Pad will require 2200m<sup>3</sup> or 5000t of NAG pit run  
 The pad is constructed within the lease limit

Pad Dimensions  
 - 45m from end of current wing  
 - 55m long with road access from north and south  
 - 16m from corner of planned extension to edge of pad

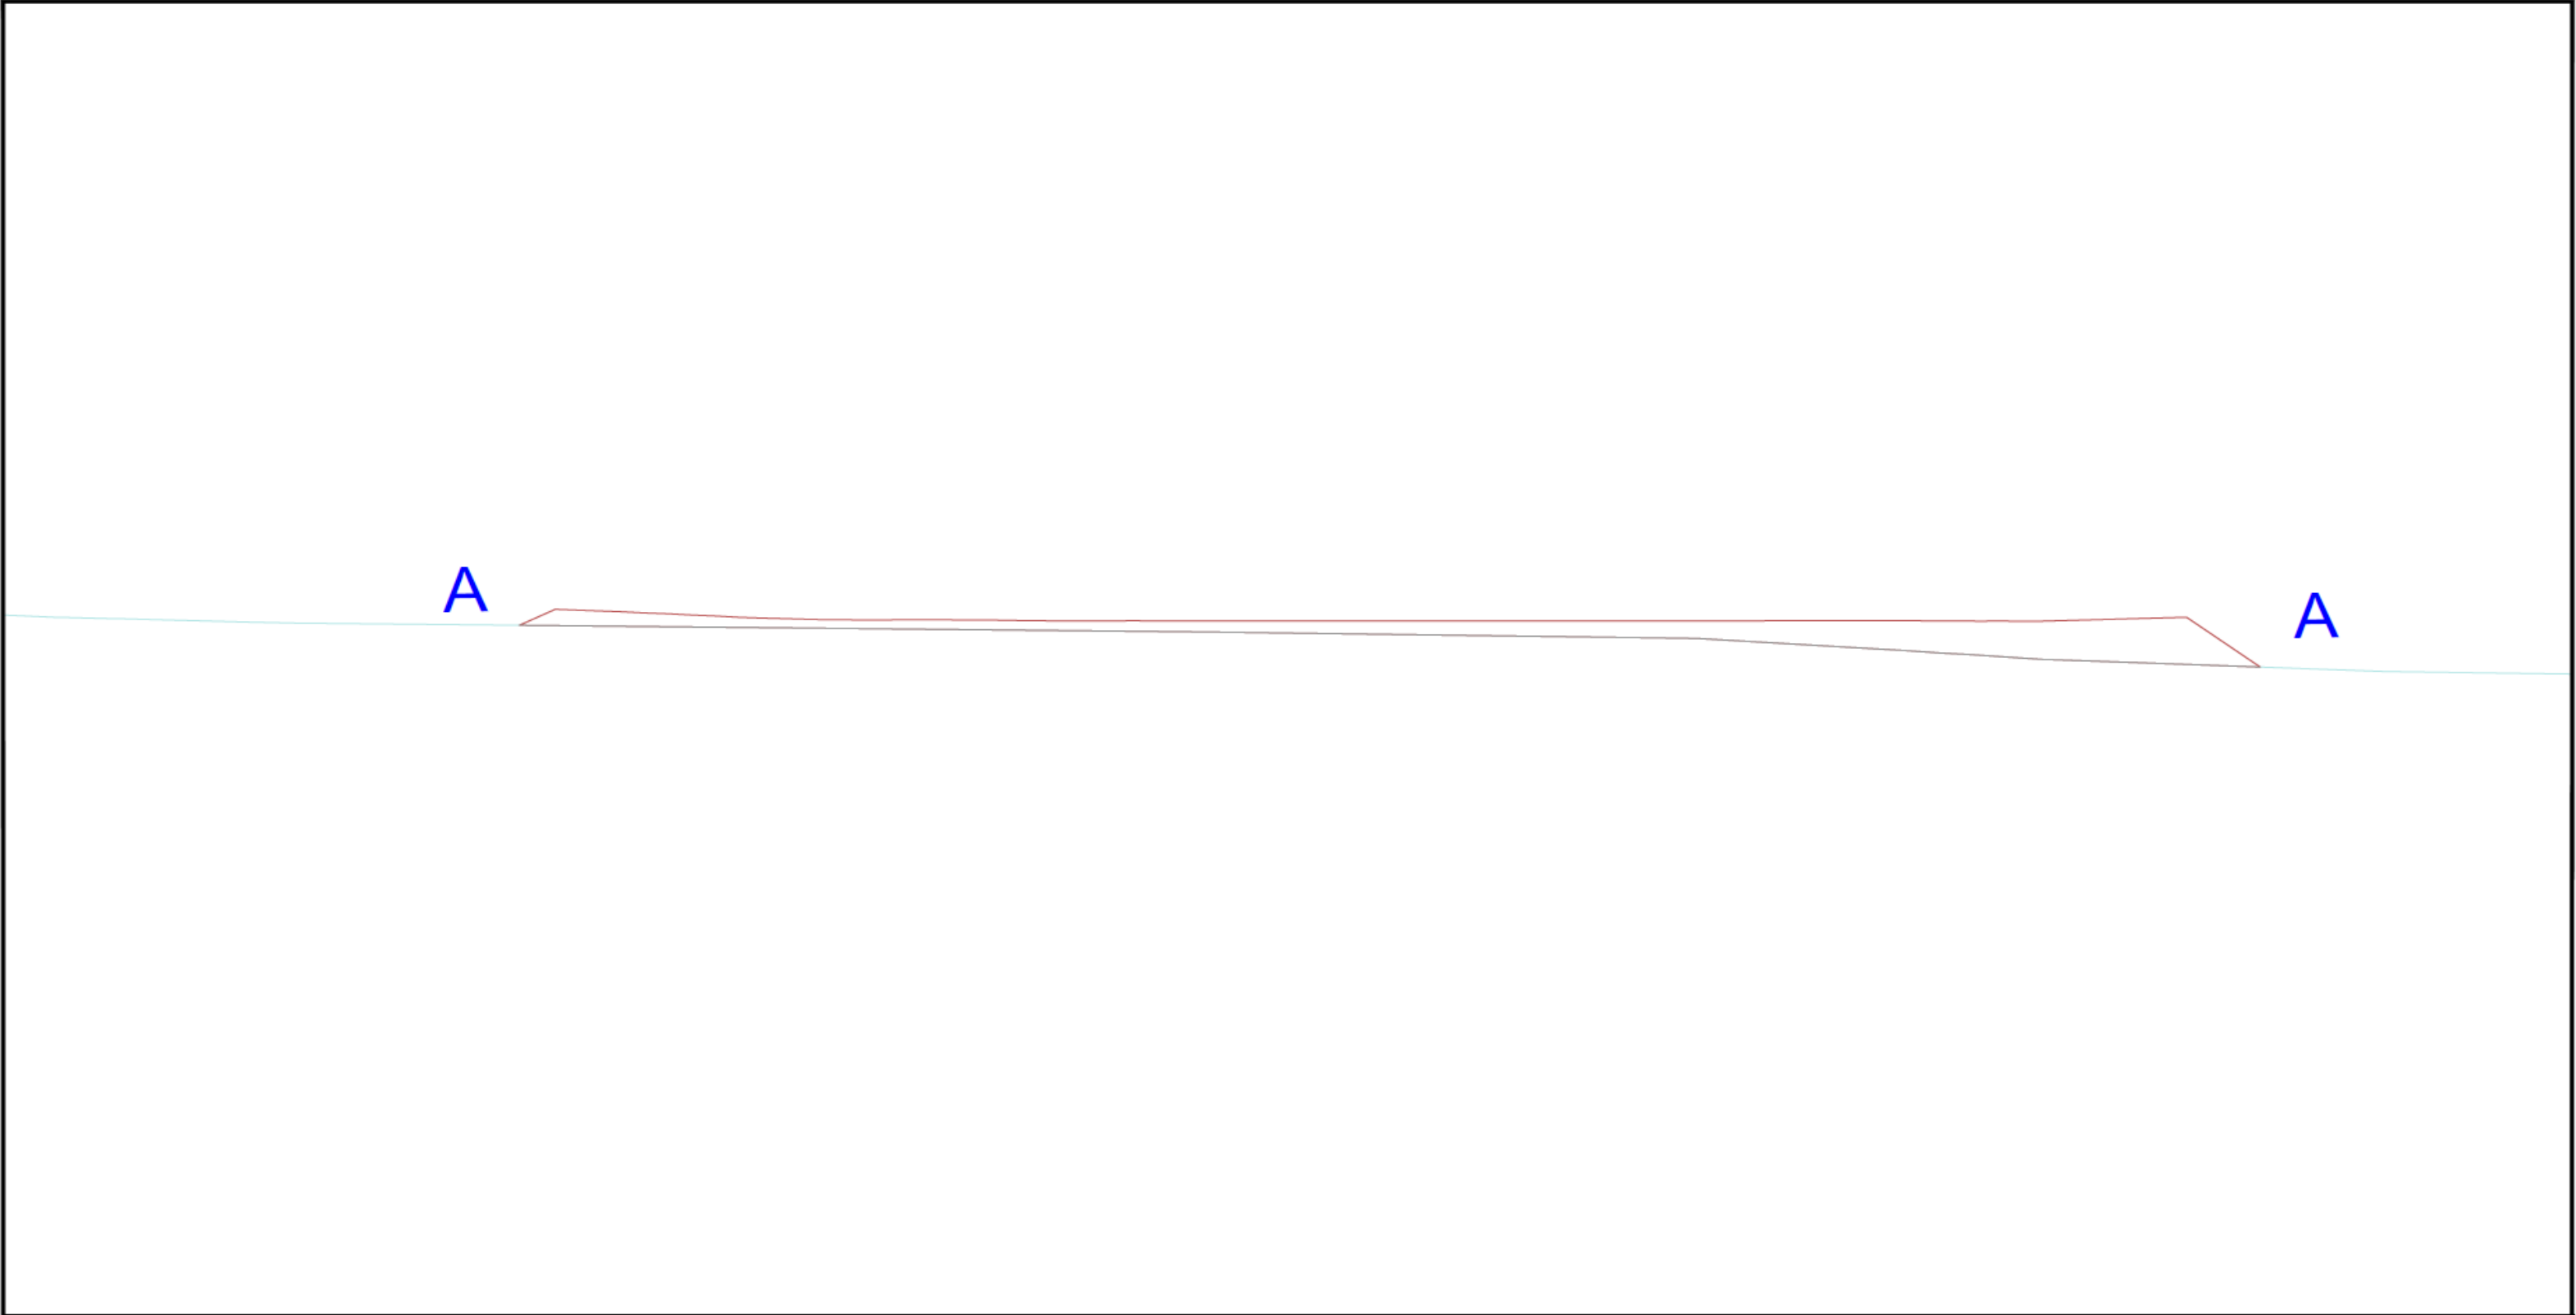
MEADOWBANK DIVISION		
ENGINEERING		
Amaruq Project		
Camp Pad Extension		
A-A'		
SCALE	N.T.S.	DATE
		FILE
		.DWG

# Section A-A'

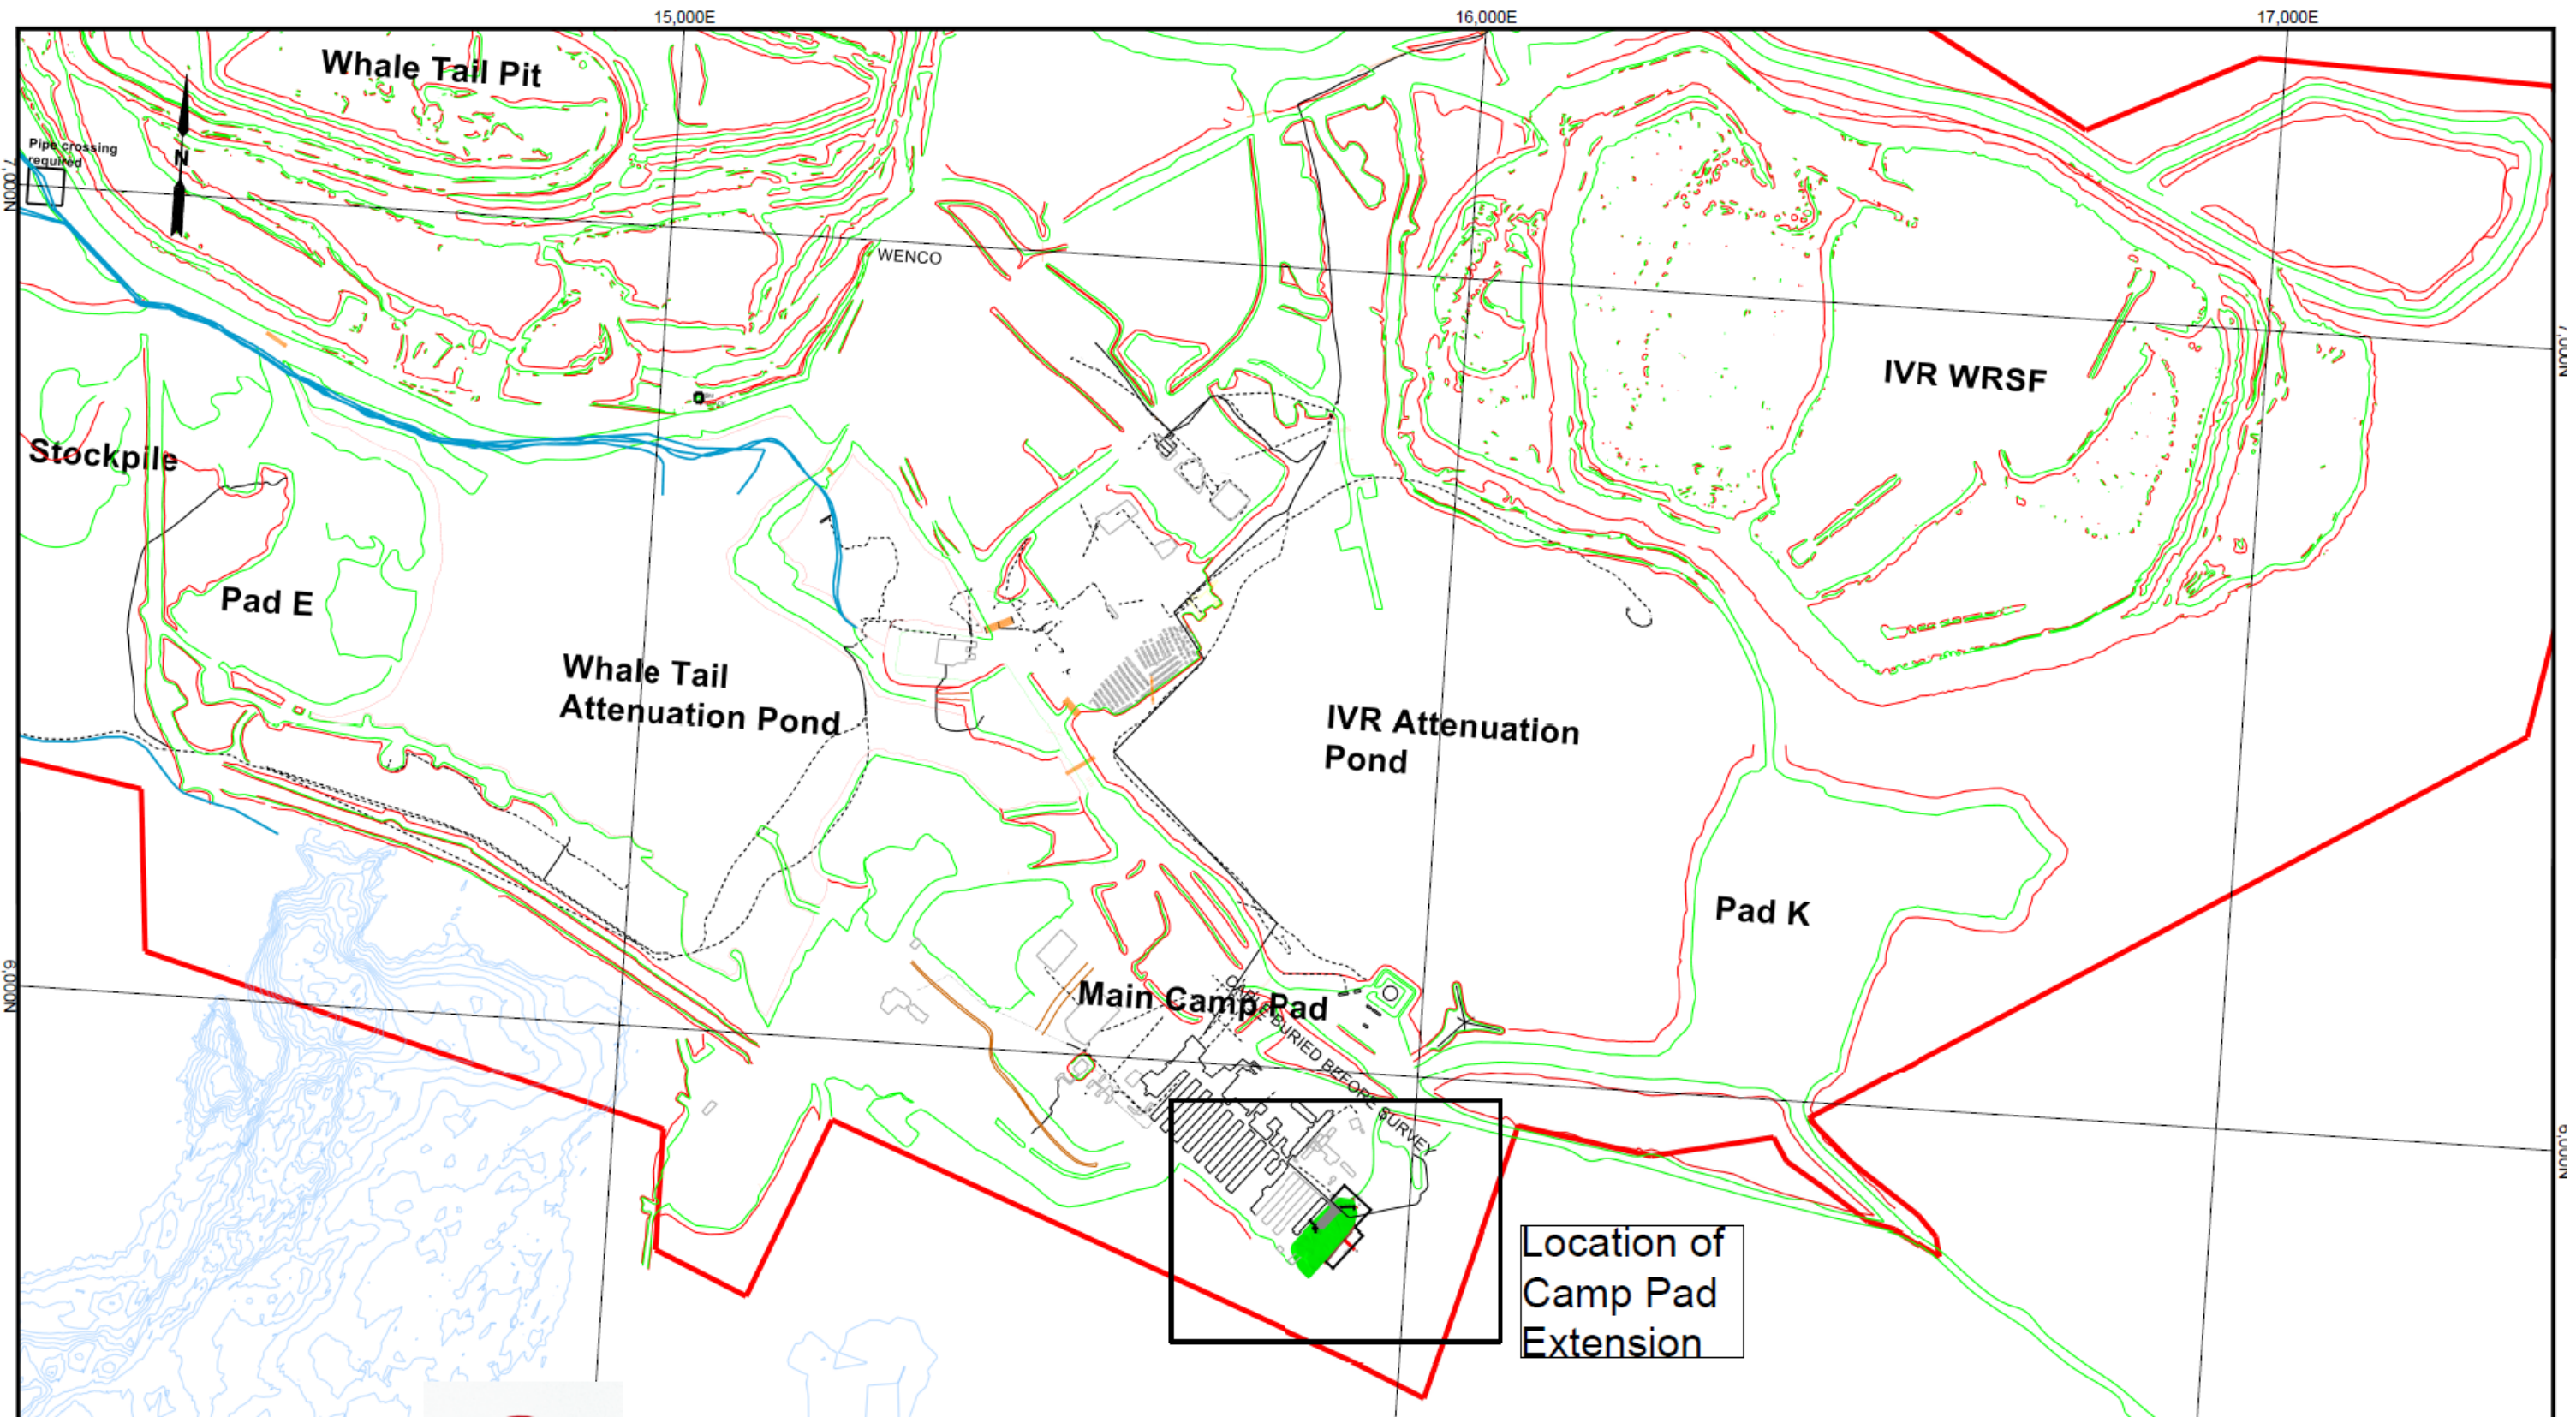
MEADOWBANK DIVISION			
ENGINEERING			
Amaruq Project			
Main Camp Pad Extension			
Overview - As Built			
SCALE	N.T.S.	DATE	8/03/2022
		FILE	.DWG

AS BUILT IN LIGHT GREEN  
DESIGN IN ORANGE

Proposed camp extension  
LEASE LIMIT

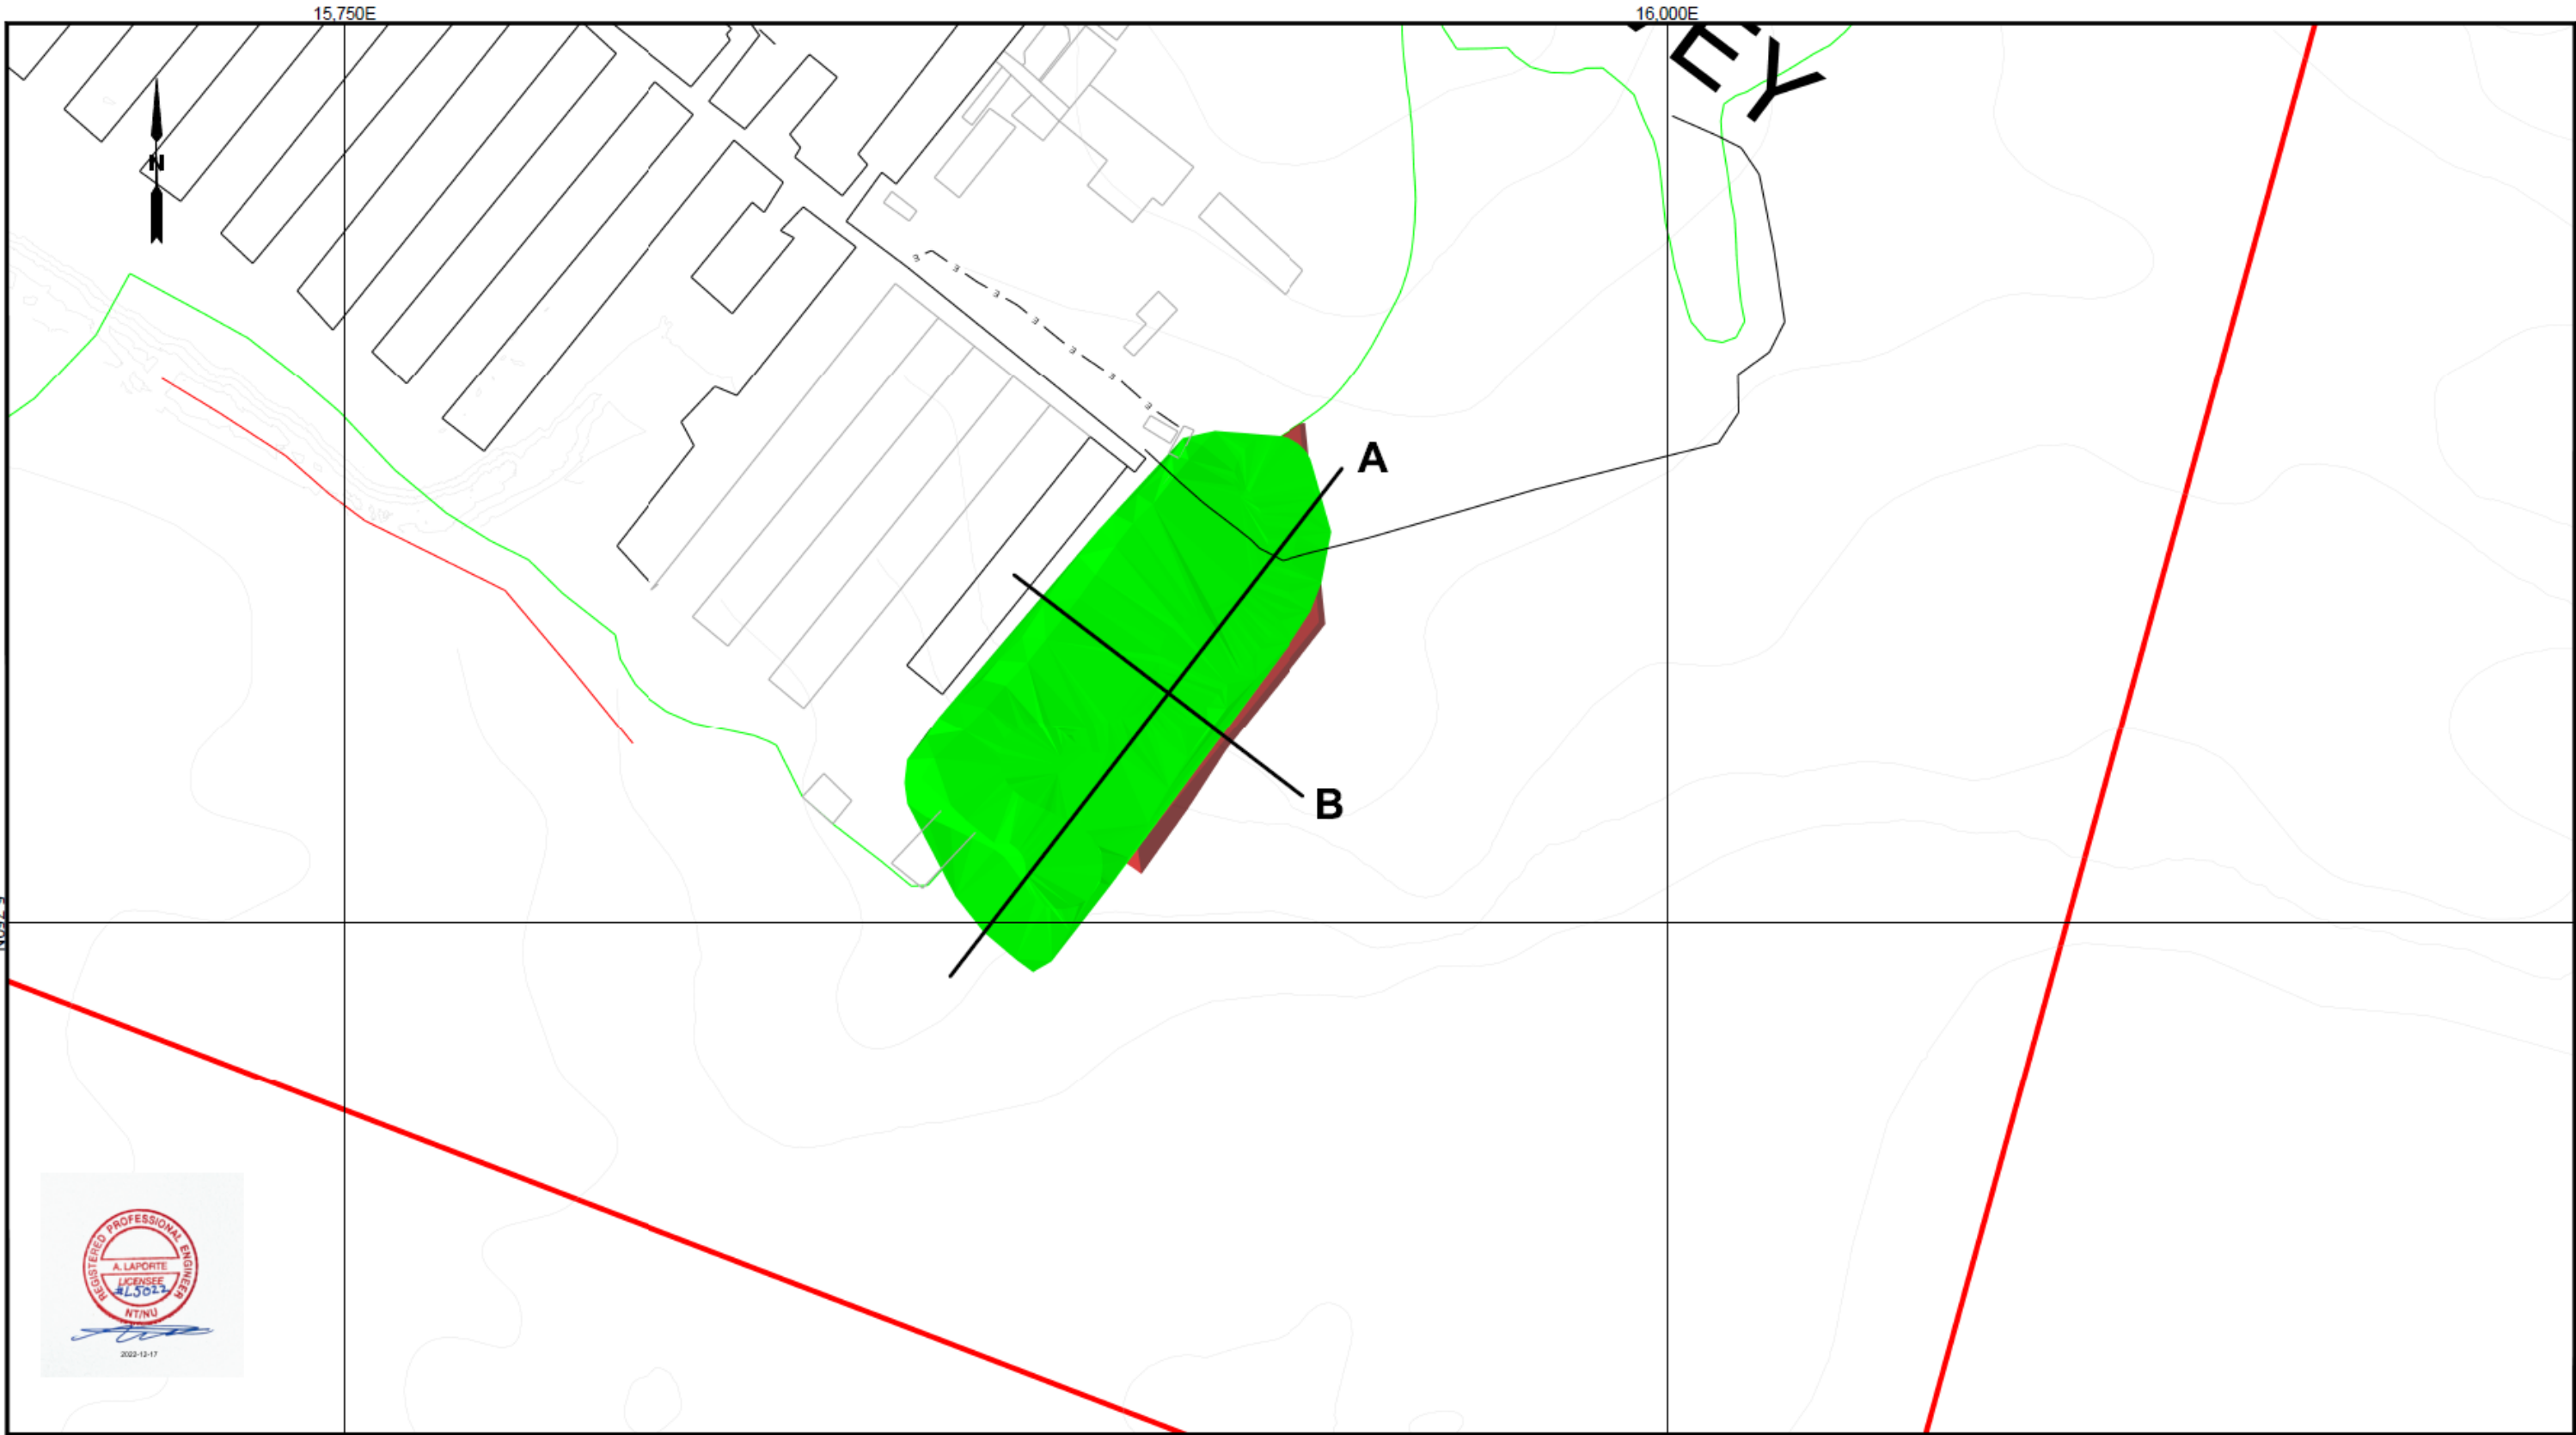
**MEADOWBANK DIVISION**  
ENGINEERING  
Amaruq Project  
**Main Camp Pad Extension**  
Close-up View - As Built

- LEASE LIMIT
- DEWATERING PIPES
- Electrical wire

Total tonnes = 15 800t  
Totam Volume = 7180m3

AS BUILT IN LIGHT GREEN  
DESIGN IN ORANGE

The Pad and New Road 22 was built with 15,800m<sup>3</sup> of NAG Material.

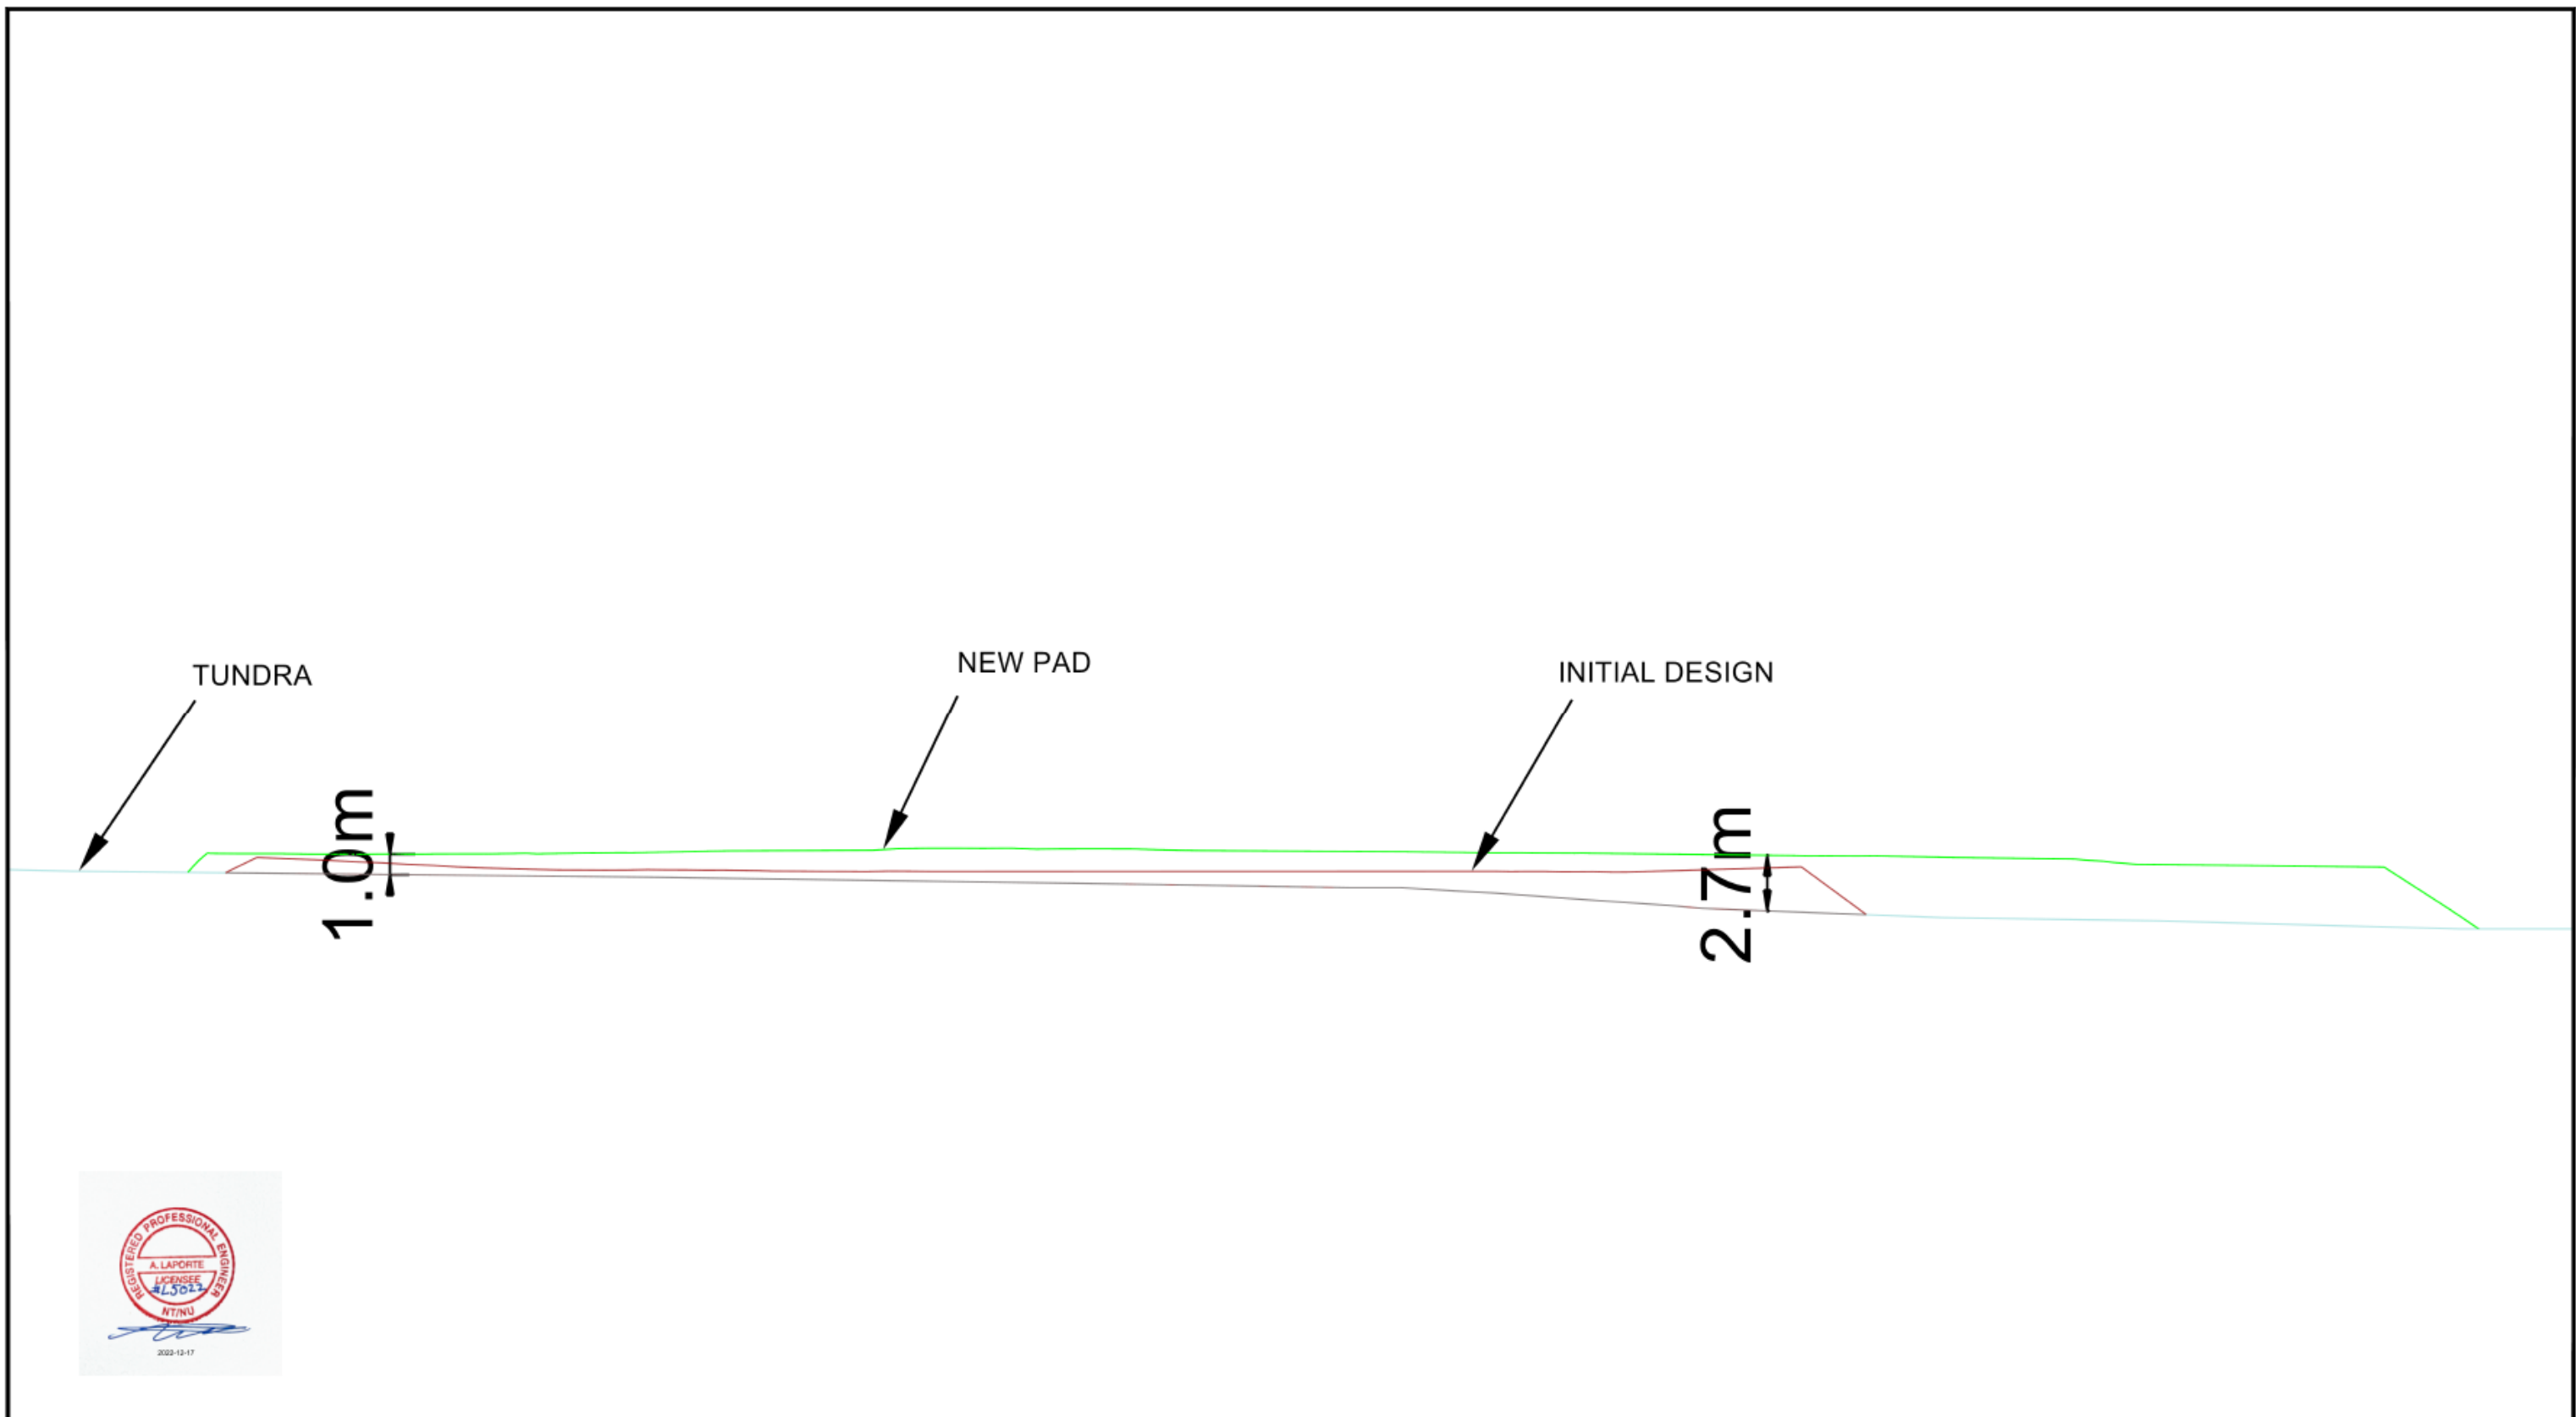
MEADOWBANK DIVISION		
ENGINEERING		
Amaruq Project		
Camp Pad Extension		
A-A'		
SCALE	N.T.S.	DATE
		FILE .DWG

- Pad built above design to ensure electrical cable was protected properly
- Pad was extended to the south to allow vehicle traffic around the new camp wing

The initial design submitted for the 60 days' notice was modified to ensure the 5kV line was protected once the Pad was constructed on top. The Pad was raised 1.2m in elevation from the original design. It was also extended to the south as room for vehicles to drive around the new wing was required.

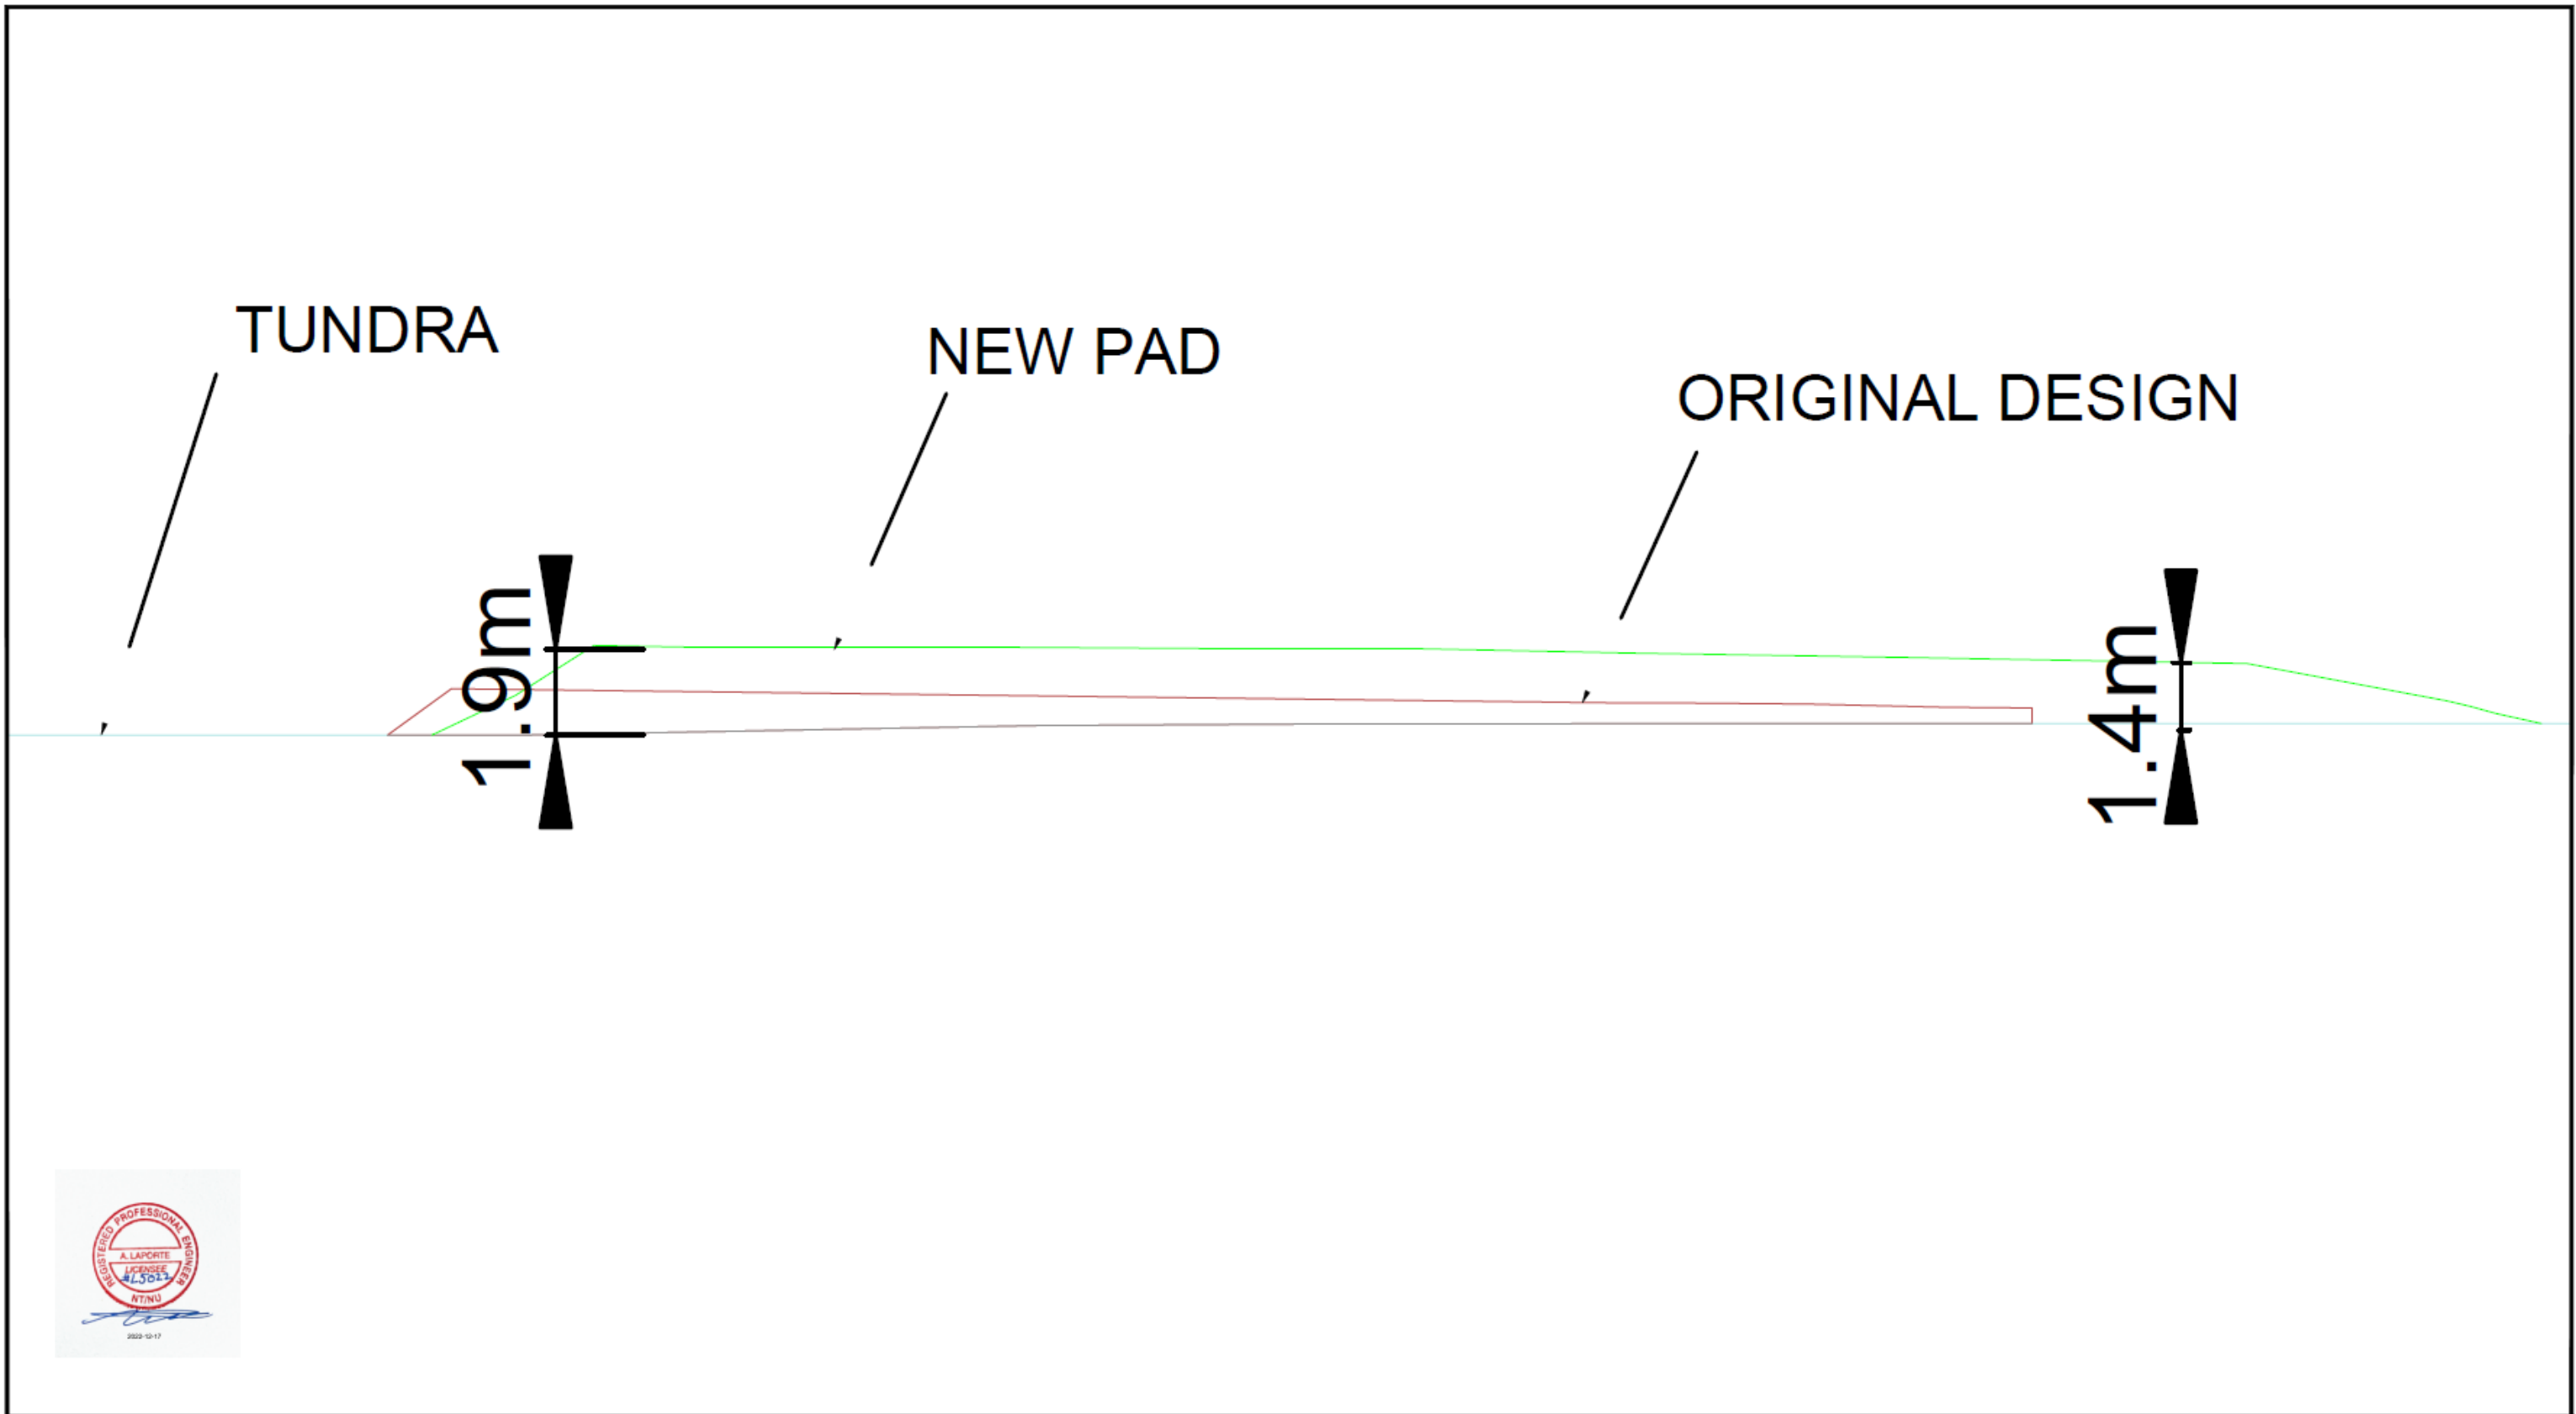
- Pad built above design to ensure electrical cable was protected properly
- To ensure pad was not overbuilt the toe was pushed short of the final design

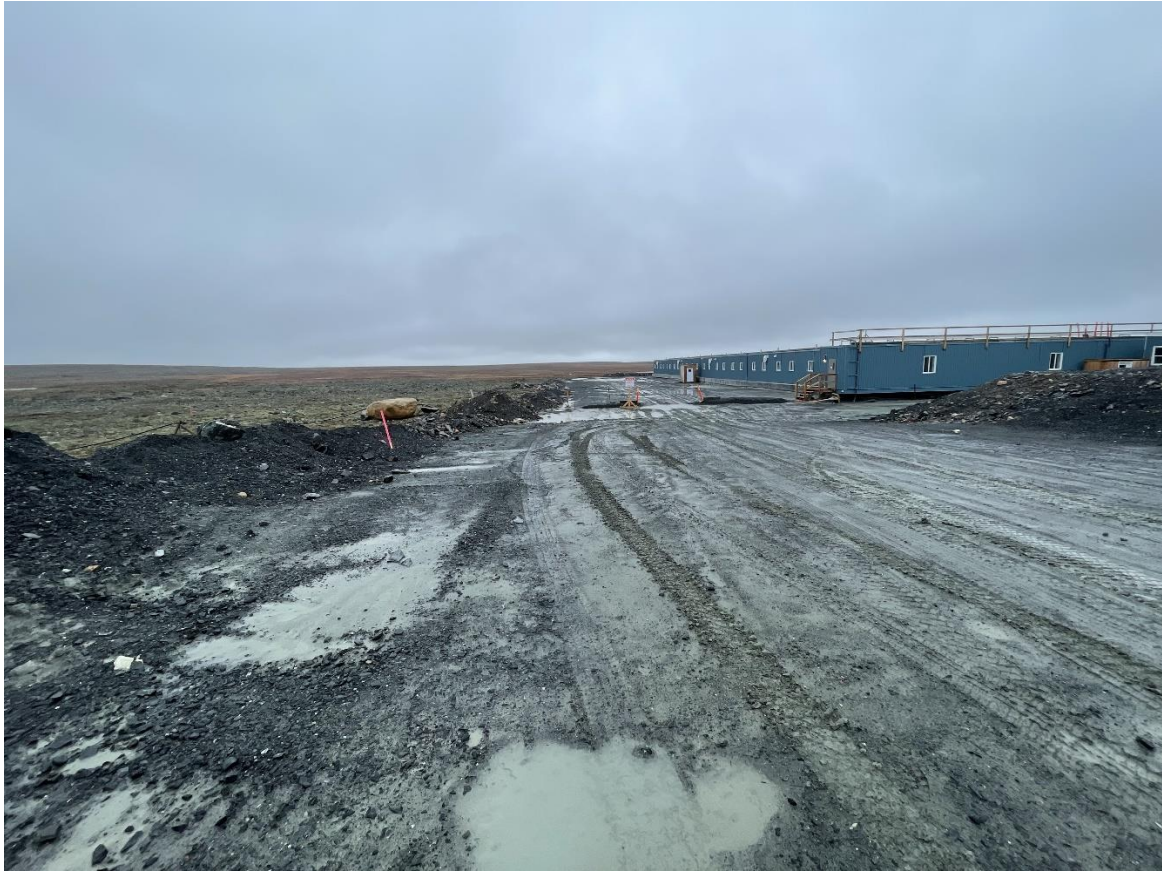
Photo 1. Construction area prior to NAG rock placement
