### WHALE TAIL MINE MAIN CAMP PAD EXTENSION

#### CONSTRUCTION SUMMARY REPORT MEADOWBANK COMPLEX

December 20, 2022

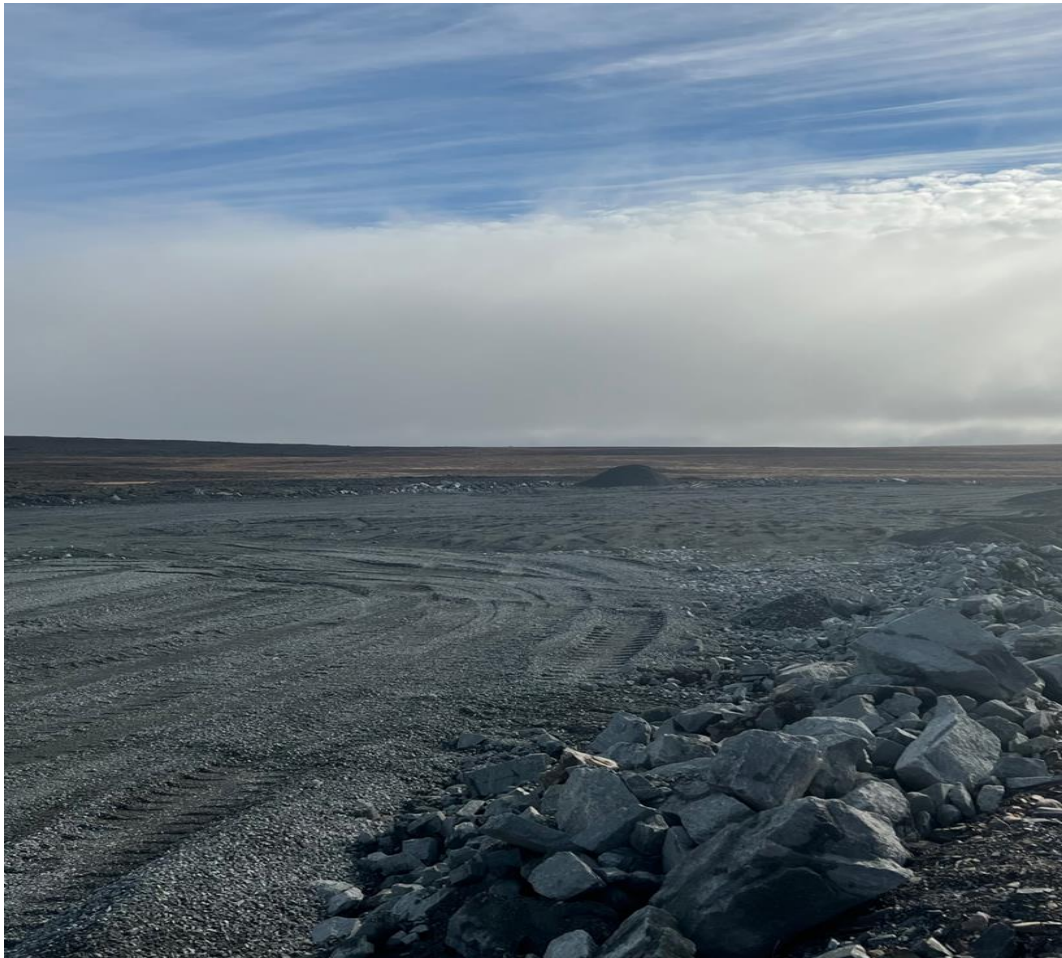
Photo 2: Final Pad construction
