**WHALE TAIL MINE WATER MANAGEMENT AND
GEOTECHNICAL INFRASTRUCTURES**

WHALE TAIL DIKE ABUTMENT THERMAL CAPPING

CONSTRUCTION SUMMARY REPORT

July 2023

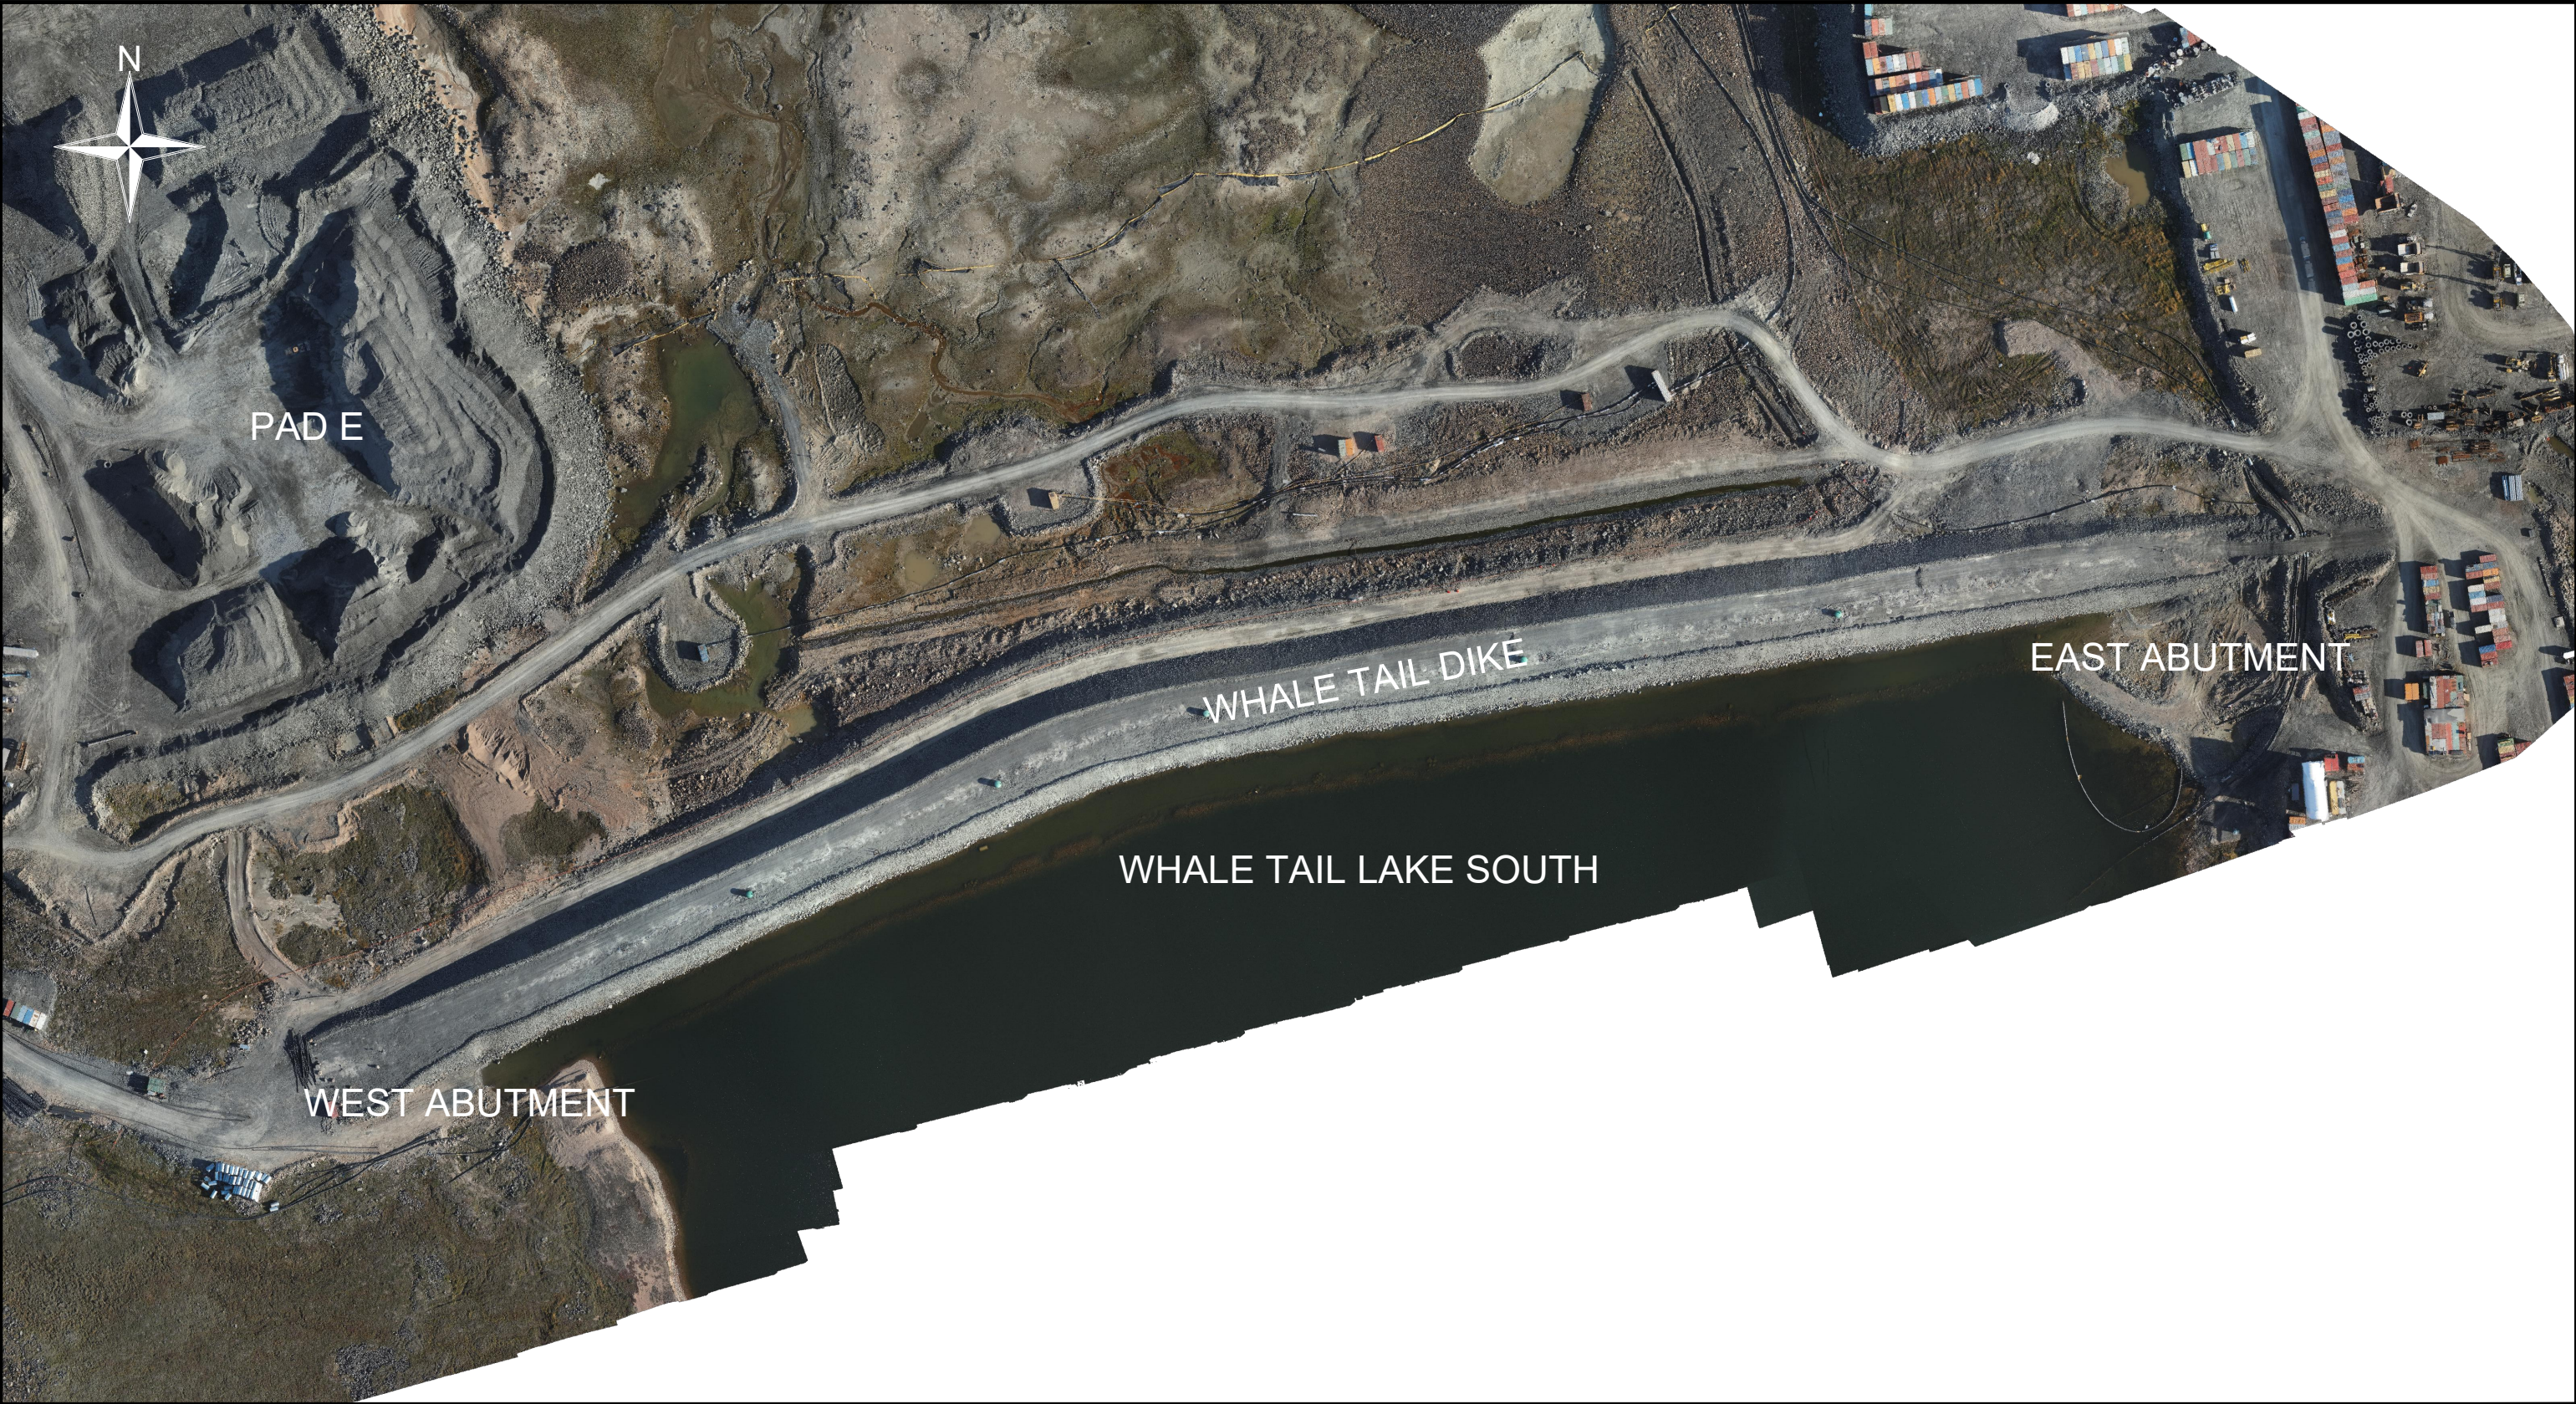
MEADOWBANK DIVISION
ENGINEERING
**WTD Thermal Capping
Plan View**

NOTES:
1. IMAGERY CAPTURED VIA DRONE ON AUGUST 25, 2022.

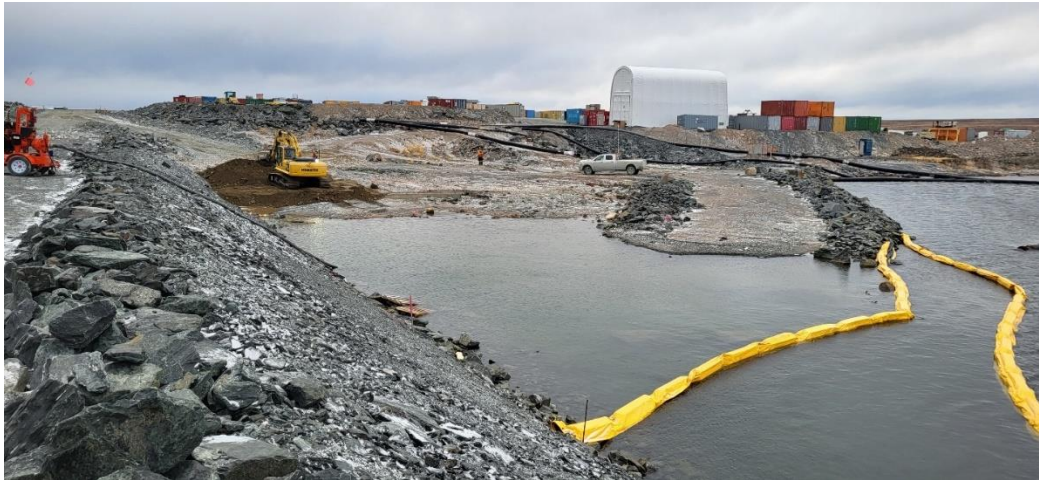
Photo E.1	 
	Before construction, turbidity barrier installation.
Photo E.2

Beginning of material placement, Zone 1 (September 25, 2022).

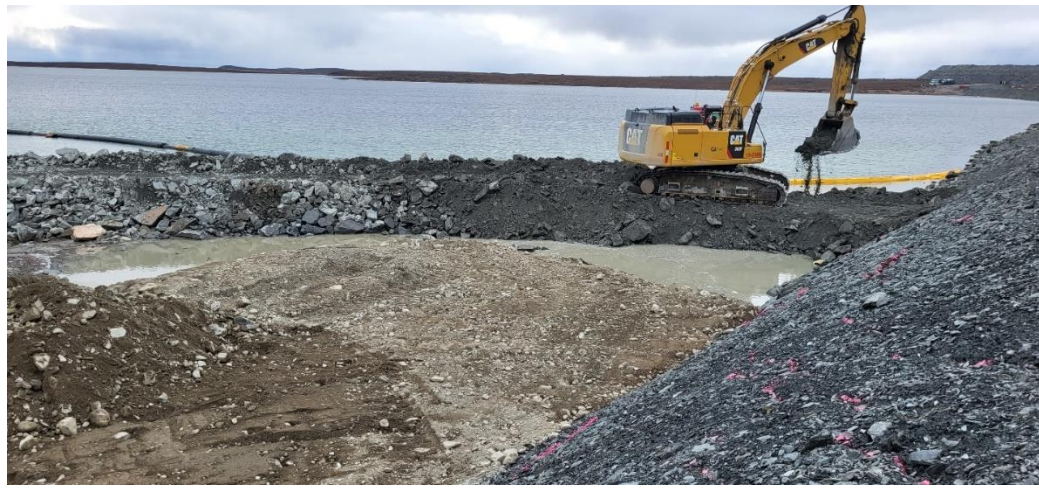
Photo E.3

Roadway material placement. First layer on of Zone 1 almost completed (September 26, 2023).

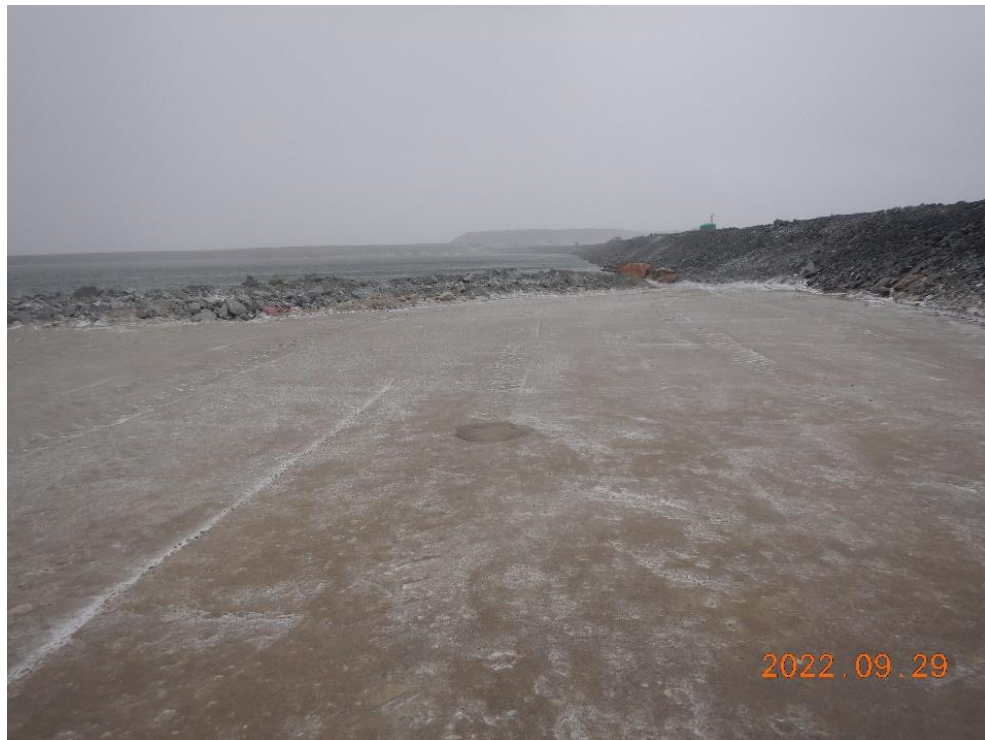
Photo E.4

Final lifts of esker completed and compacted, looking towards the downstream roadway and lake – observation of wet material and water resurgence in the middle of the photo.

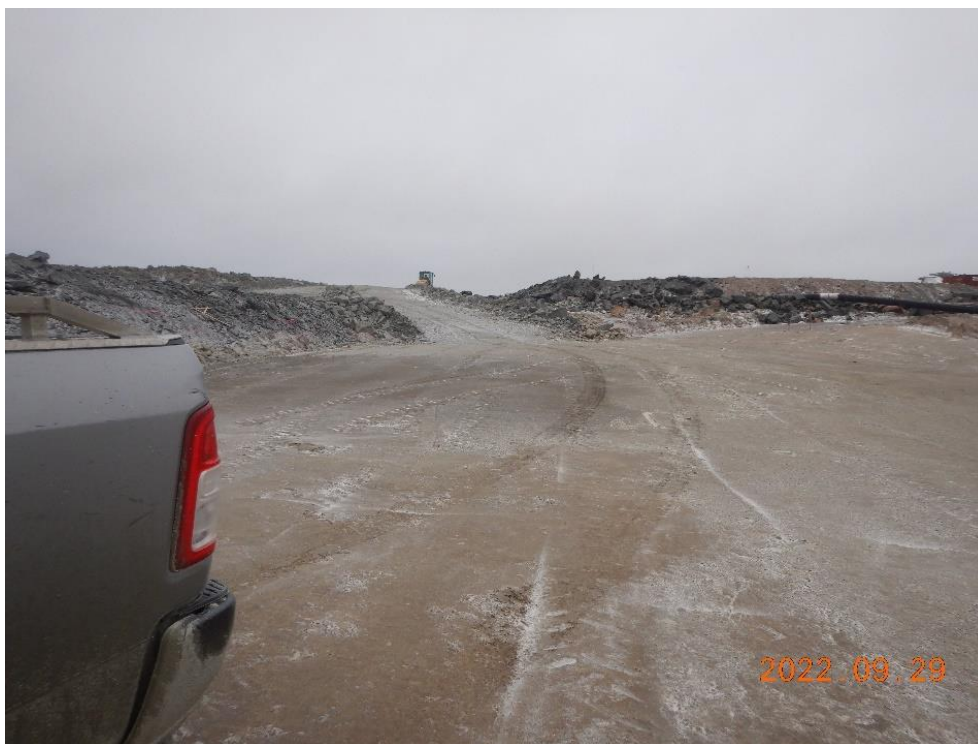
Photo E.5

Completed Phase 1 earthworks, looking towards the east abutment and dike upstream toe.

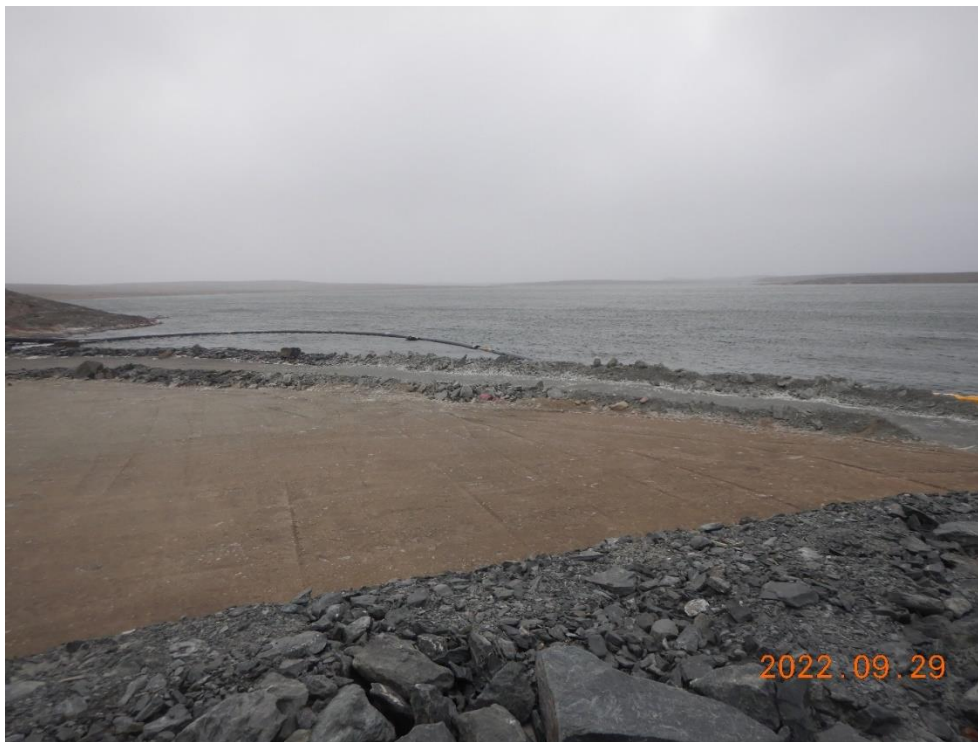
Photo E.6

Phase 1 remediation completed.

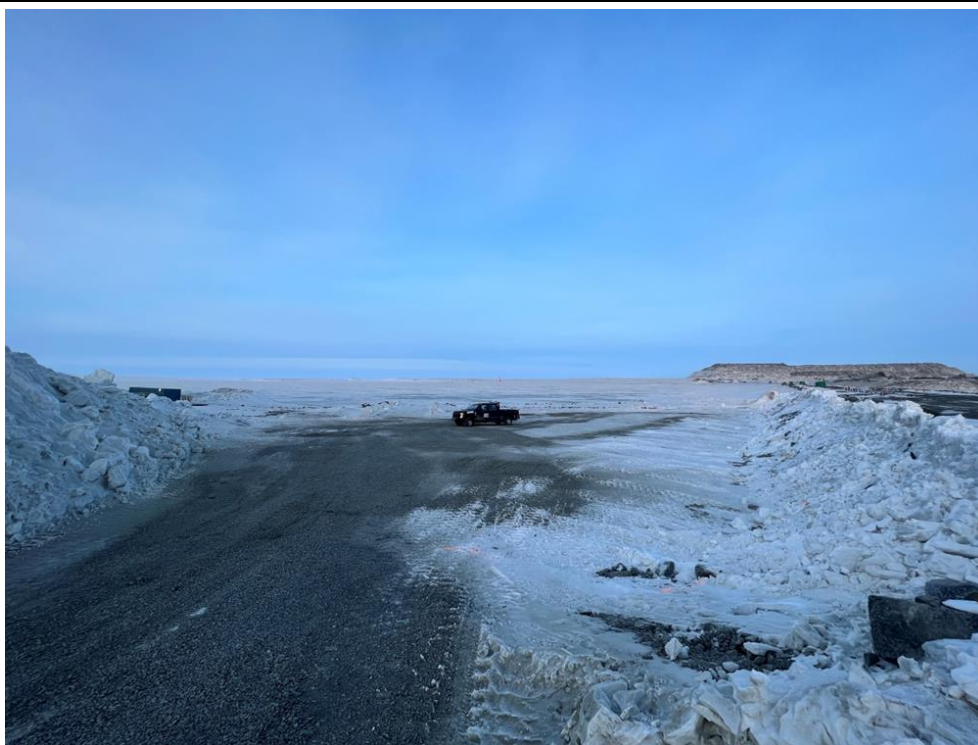
Photo E.7

Cleared snow at East abutment on April 12, 2023. Crushed gravel placed for traction.

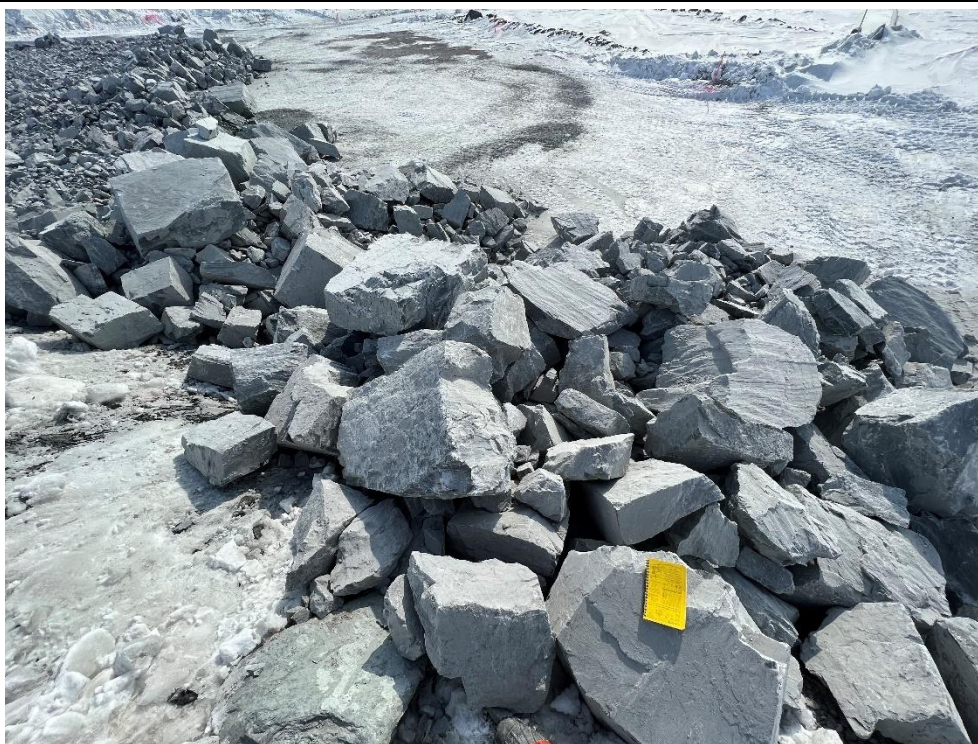
Photo E.8

Close-up of material placed.

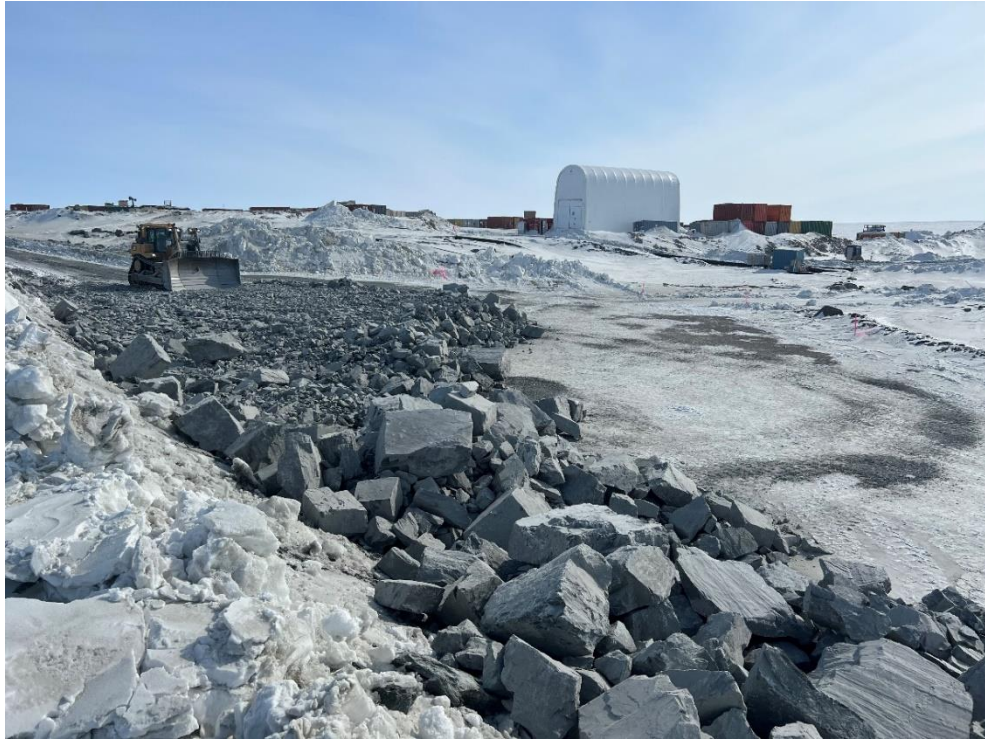
Photo E.9

Beginning of East abutment Lift #1

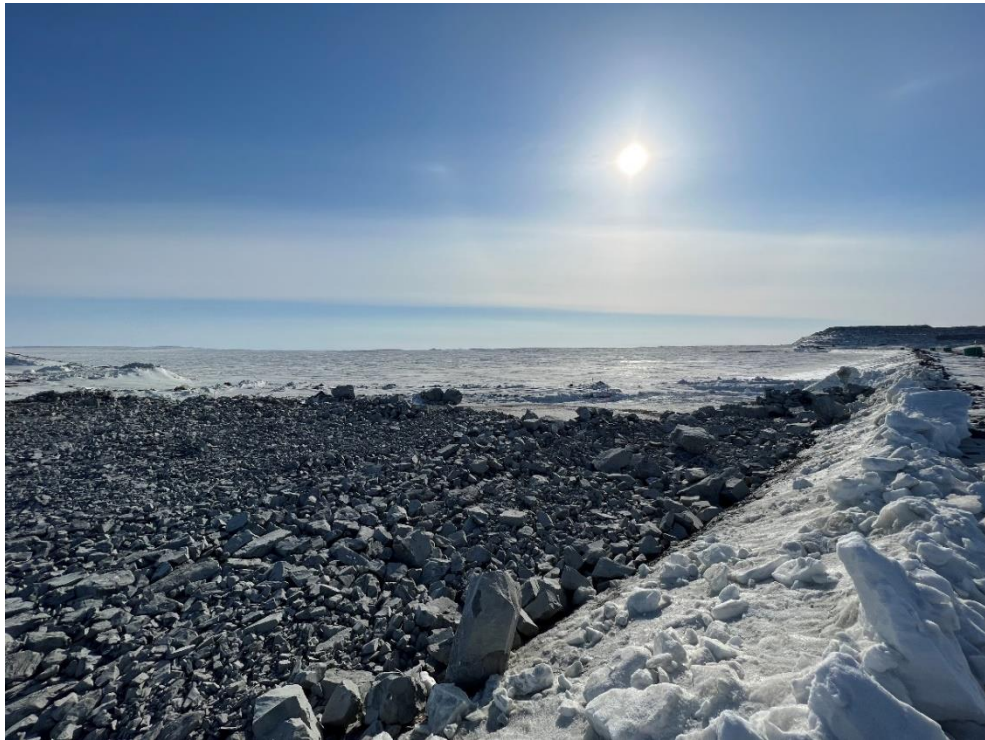
Photo E.10

Placement of Lift #1 progress at East abutment at end of day of April 12, 2023

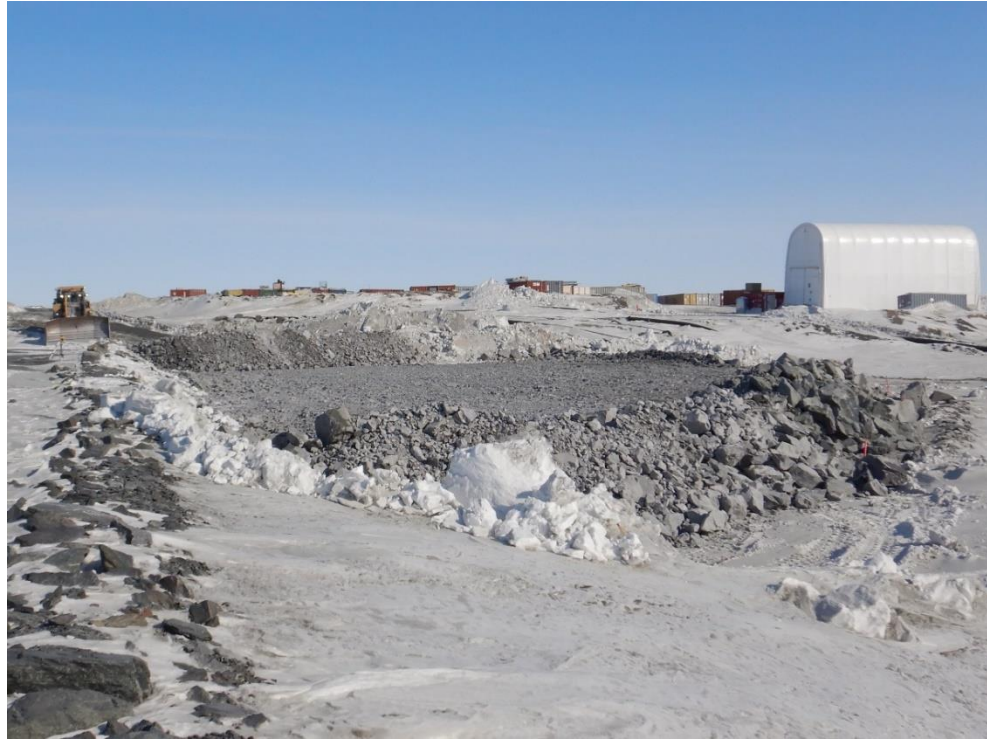
Photo E.11

Completion of Lift #1 at East abutment on April 13, 2023 and beginning of Lift #2

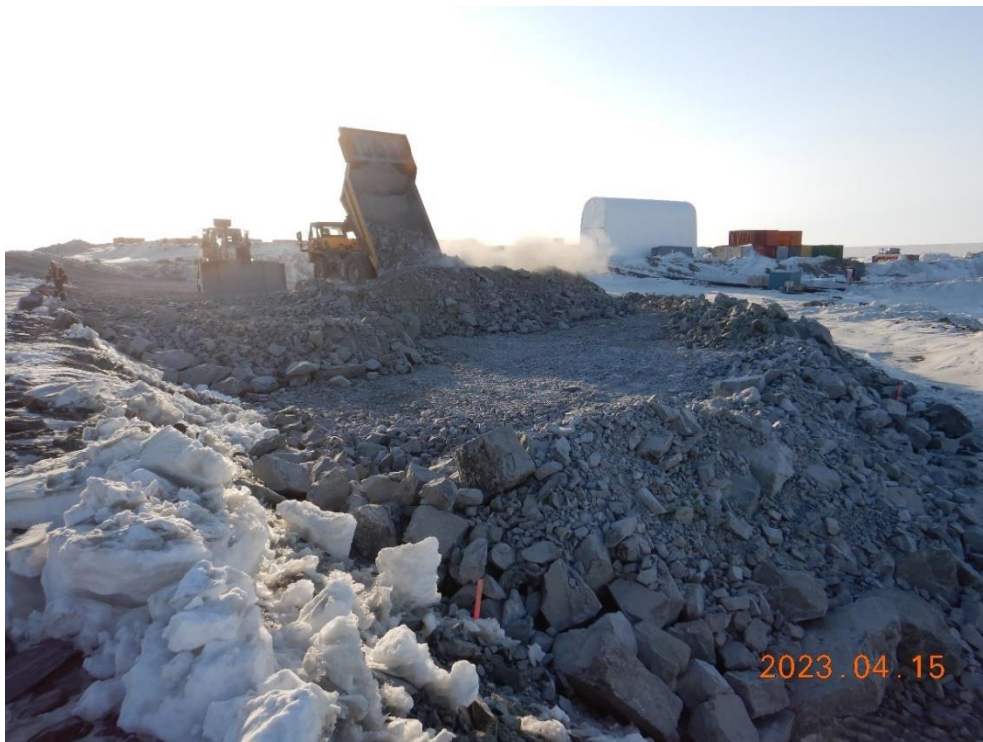
Photo E.12

Progress of East abutment Lift #2 on morning of April 15, 2023

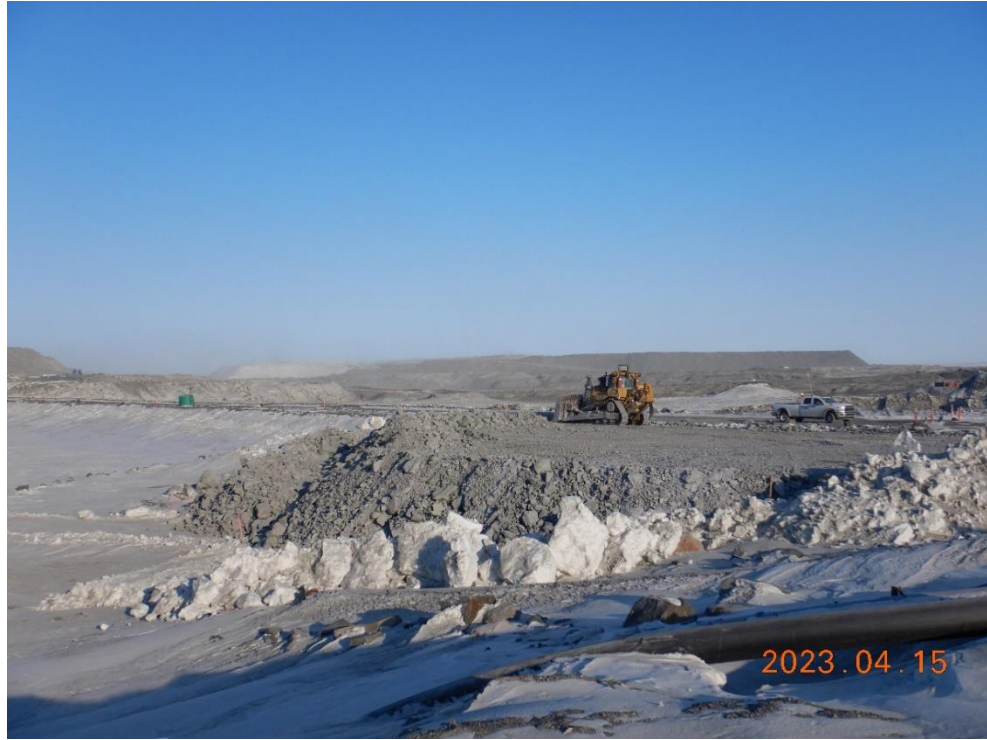
Photo E.13

Progress of East abutment Lift #2

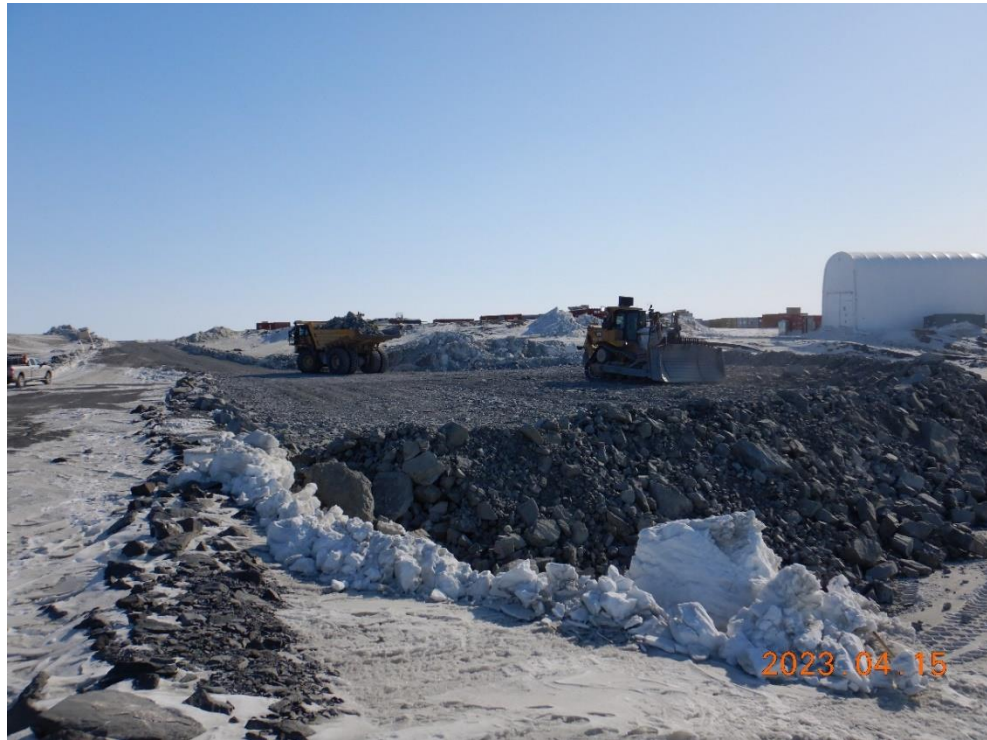
Photo E.14

Looking east at completion of East abutment Lift #2 to El. 159 m

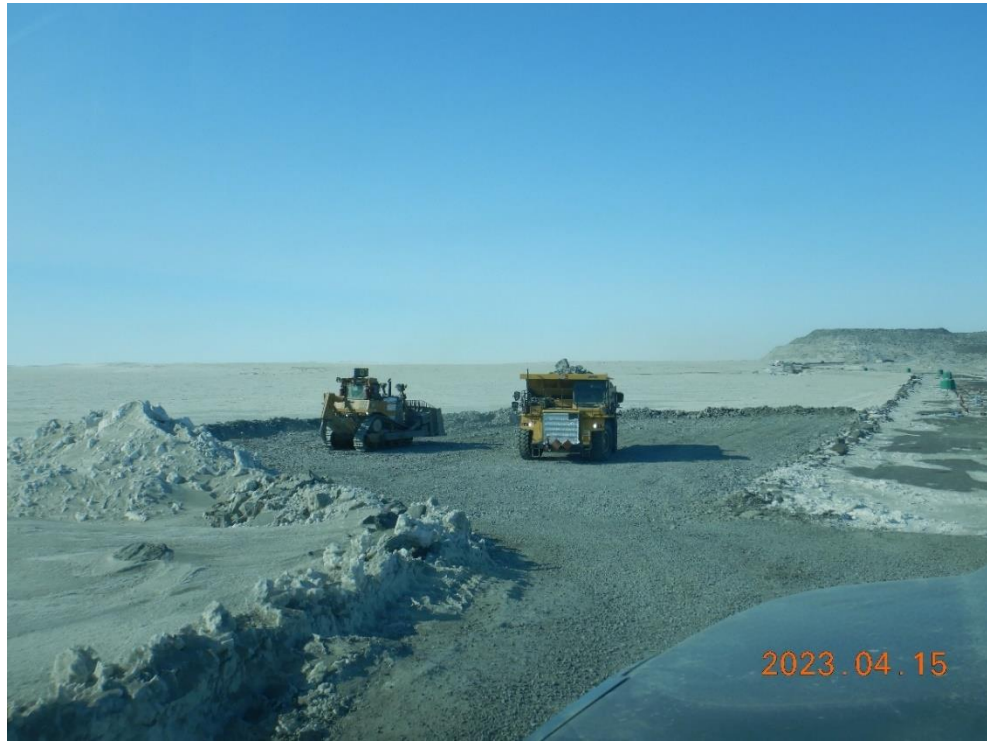
Photo E.15

Looking west at final compaction of completed East abutment Lift #2

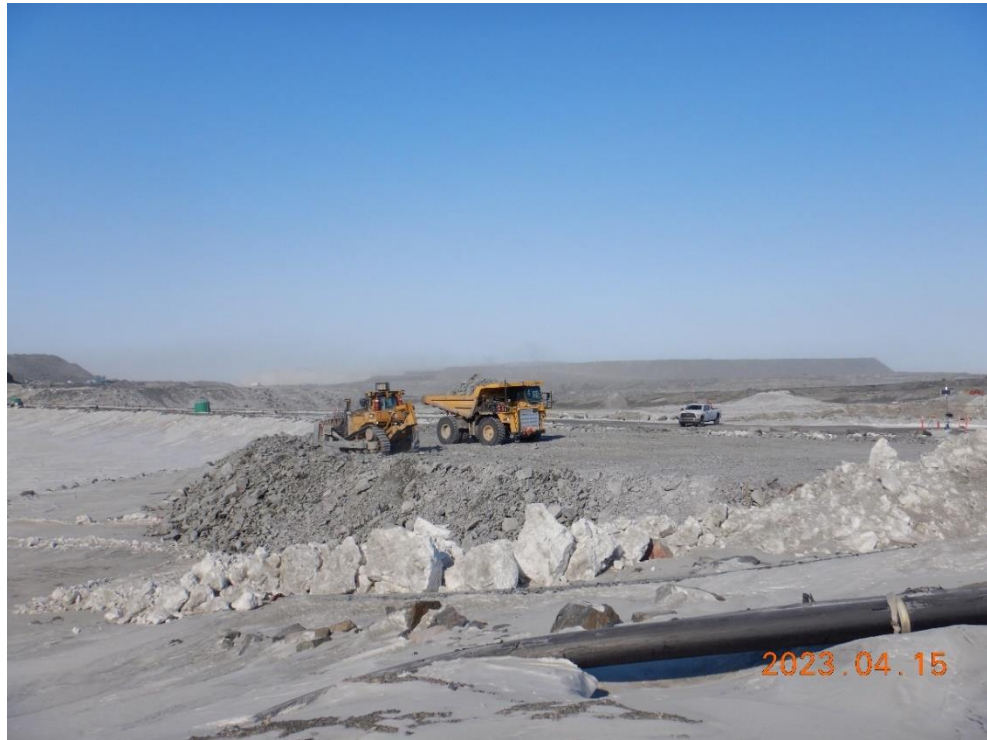
Photo E.16

Looking north at final compaction of completed East abutment Lift #2

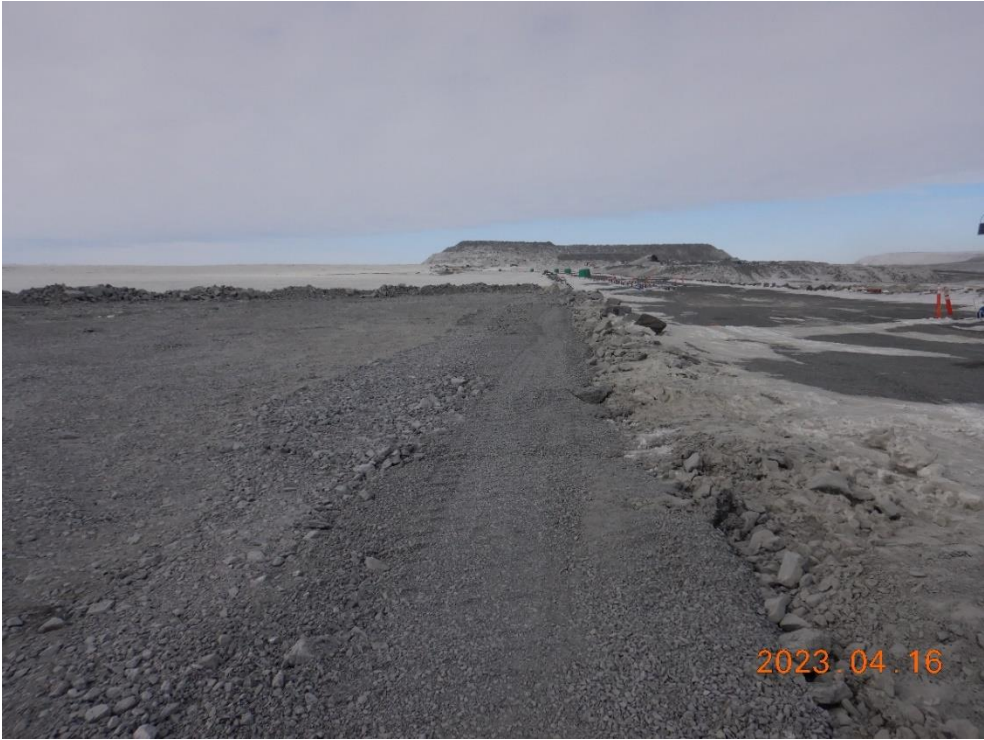
Photo E.17

Minor resurfacing and profiling of Phase 2 remediation at East abutment

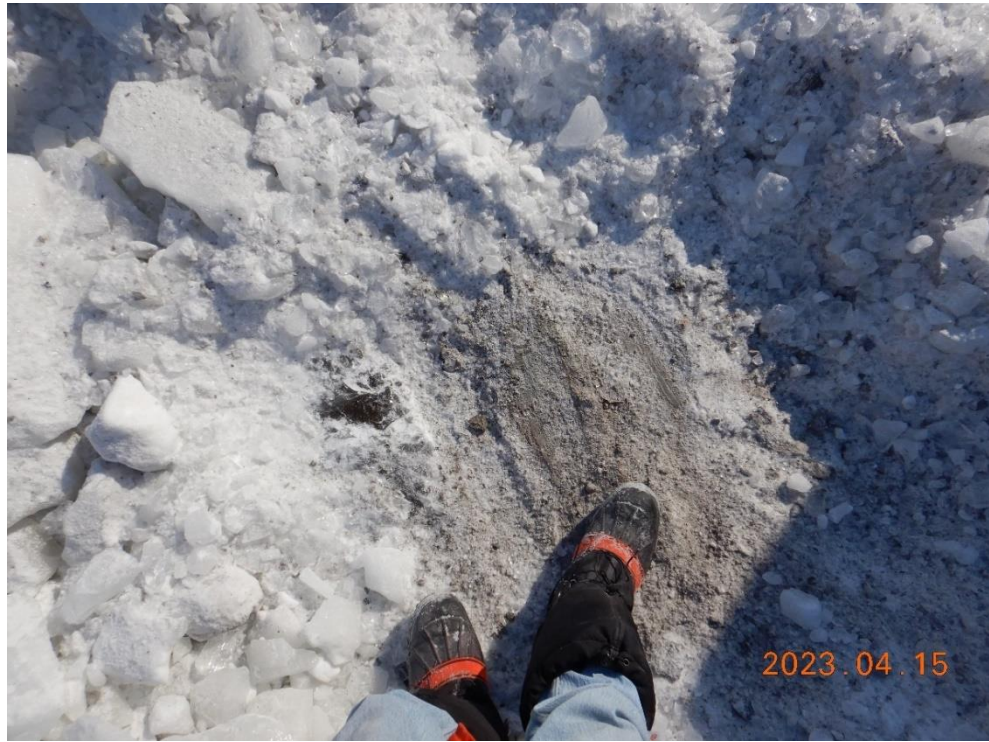
Photo W.3

Confirmation of competent foundation with no ice or unfrozen water

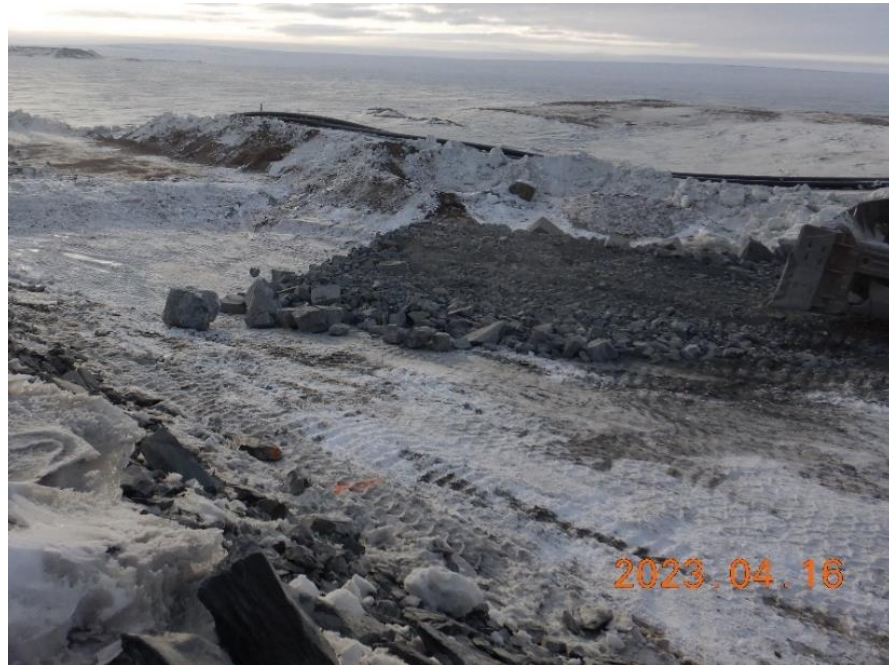
Photo W.4

Lift #1 at West abutment

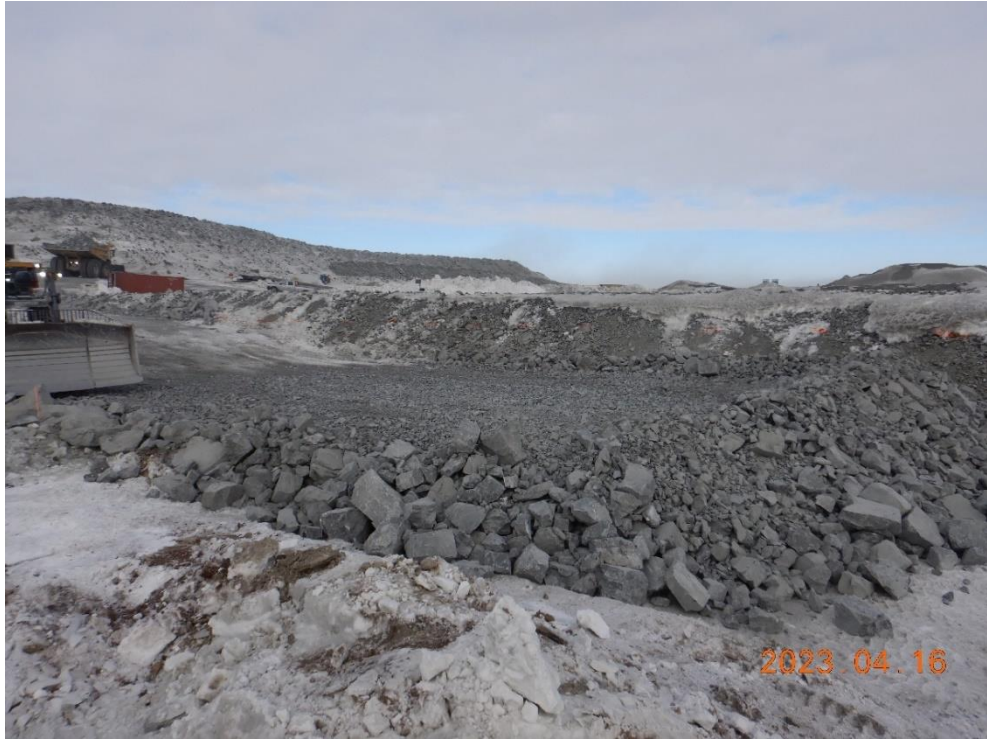
Photo W.5

Completion of Lift #1 at West abutment

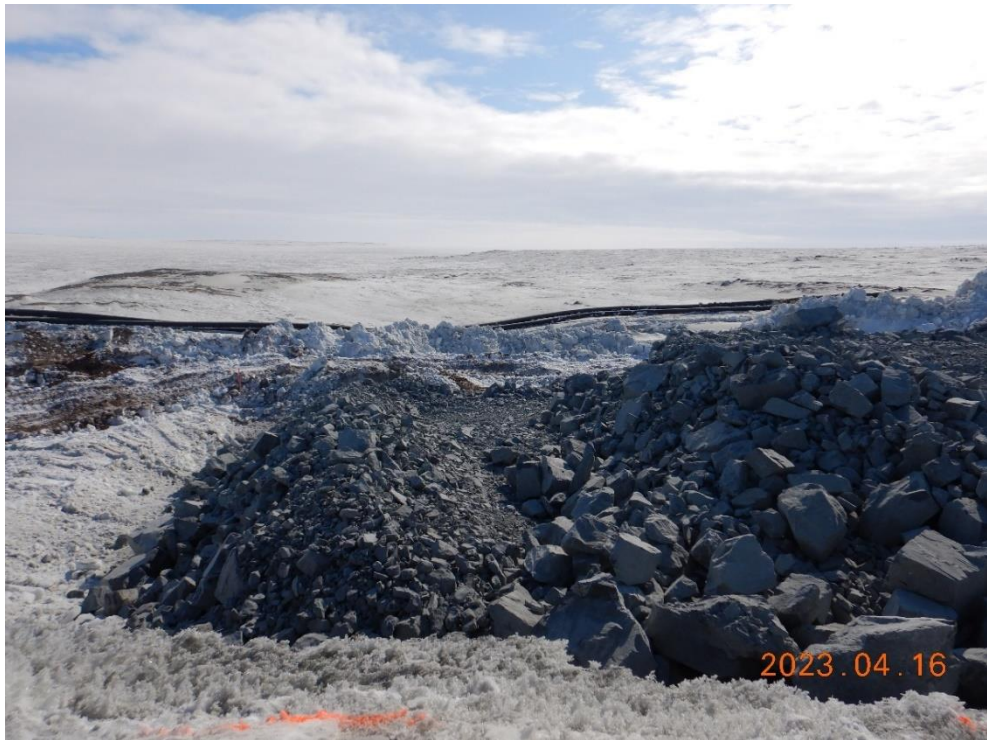
Photo W.6

Progress of Lift #2 at West abutment

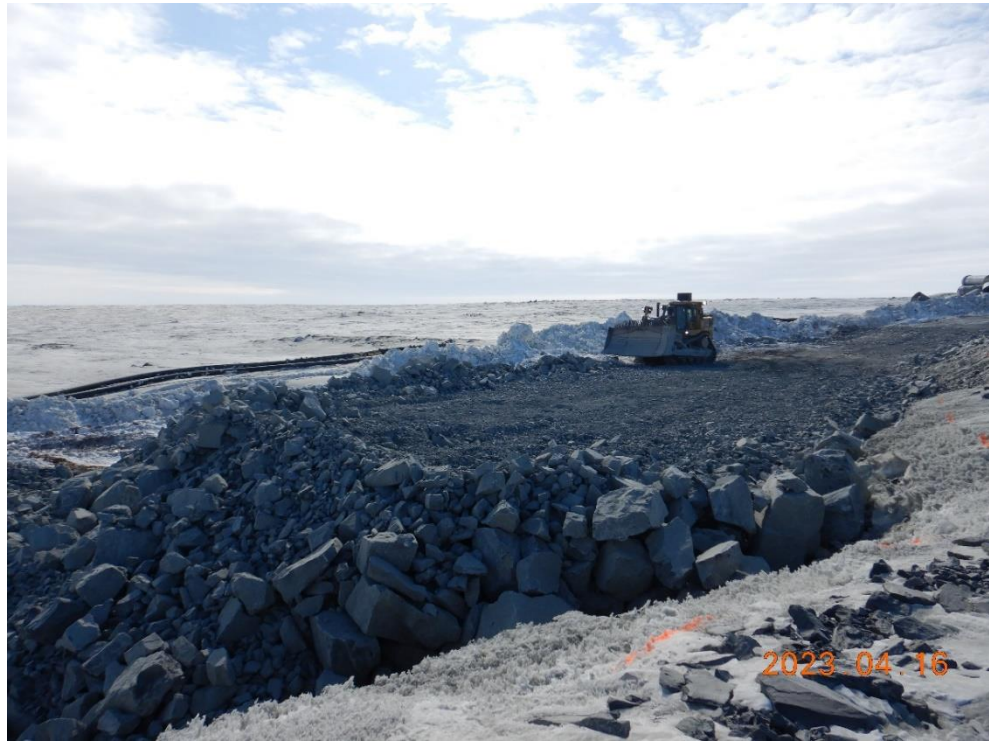
Photo W.7

Completion of material placement for Lift #2 at West abutment

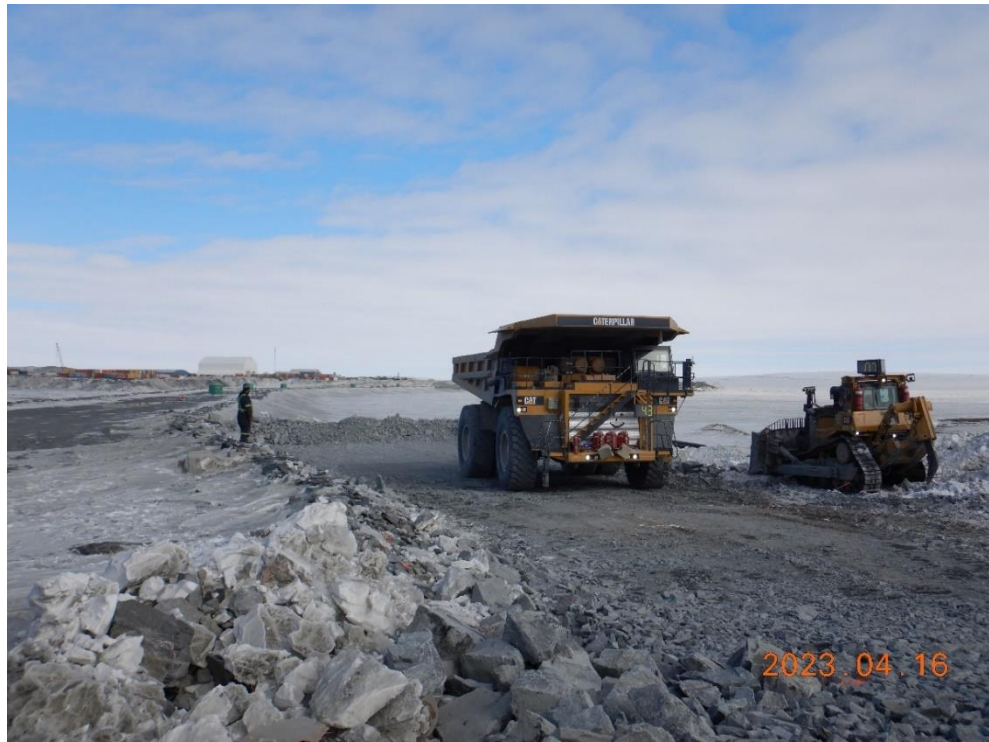
Photo W.8

Compaction of completed Lift #2 at West abutment

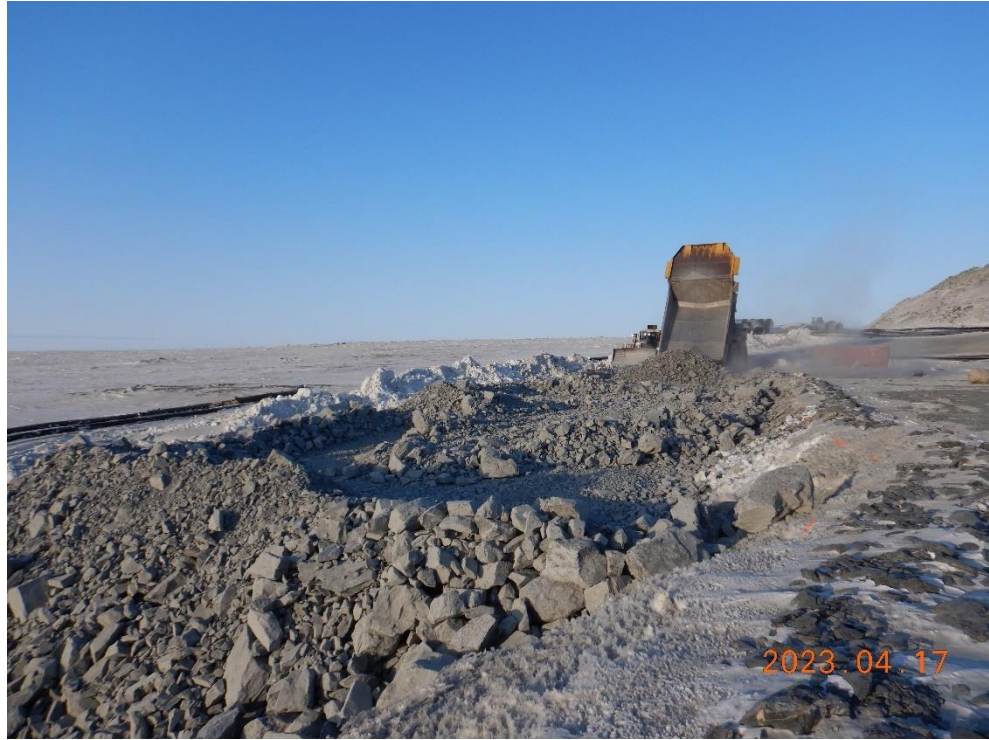
Photo W.9

Placement of Lift #3 at West abutment

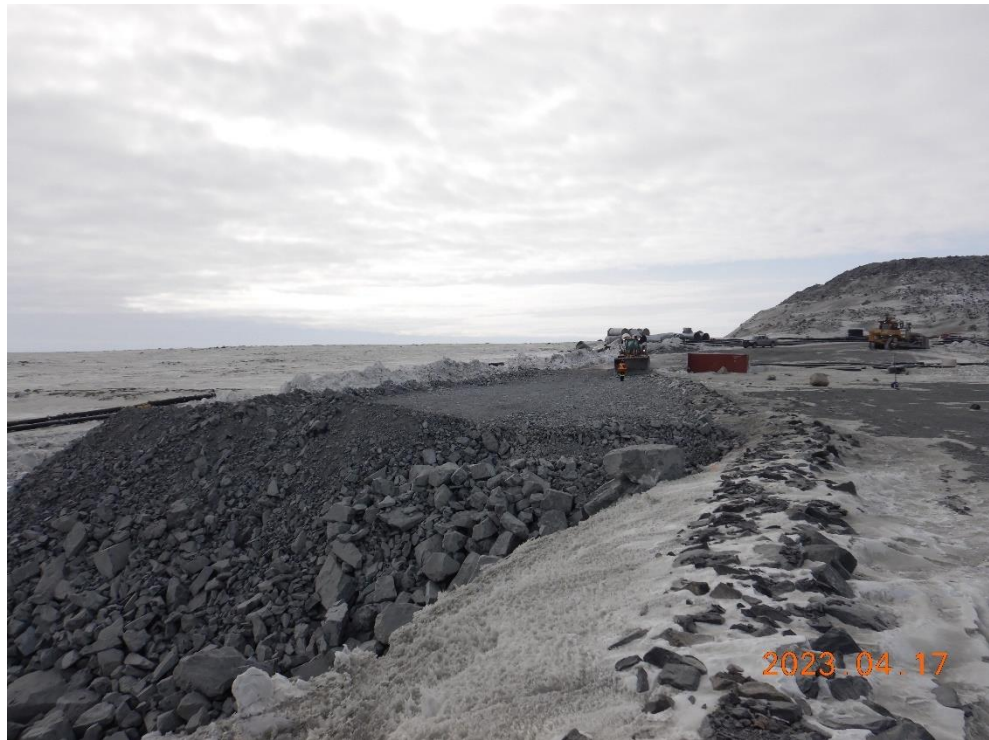
Photo W.10

Looking west at completion of Lift #3 at West abutment

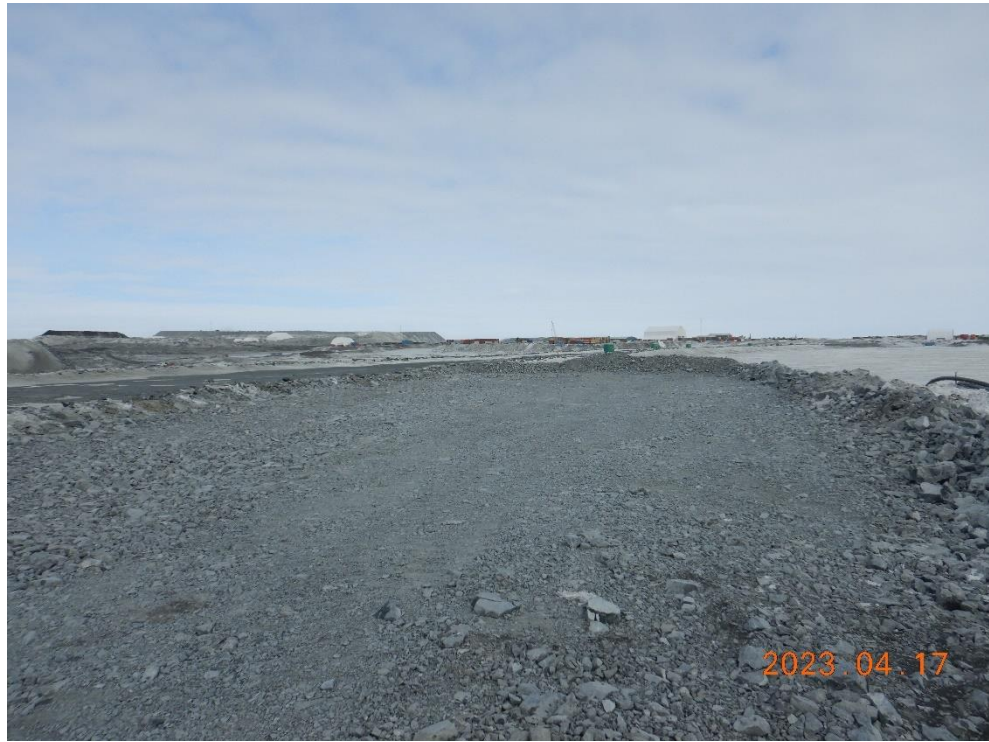
Photo W.11

Looking east at completion of Lift #3 at West abutment

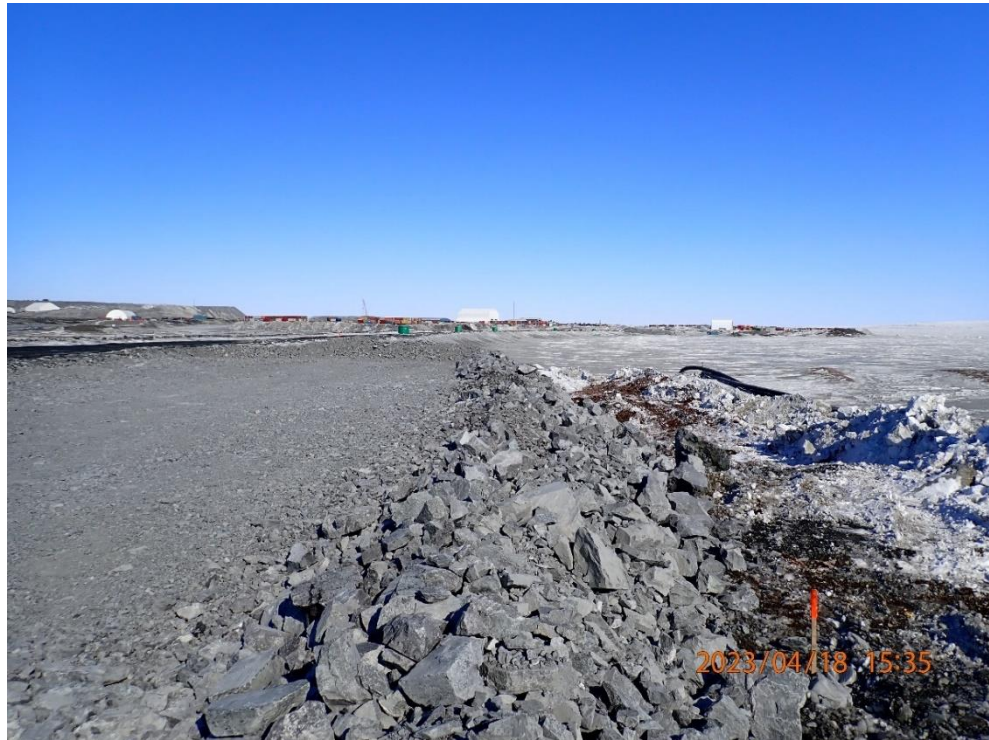
Photo W.12

Looking east at completion of Lift #3 at West abutment and upstream slope of thermal capping
