MEADOWBANK COMPLEX

WHALE TAIL MINE SANA CRUSHER PAD

CONSTRUCTION SUMMARY REPORT  
MEADOWBANK COMPLEX

November 21<sup>st</sup>, 2022

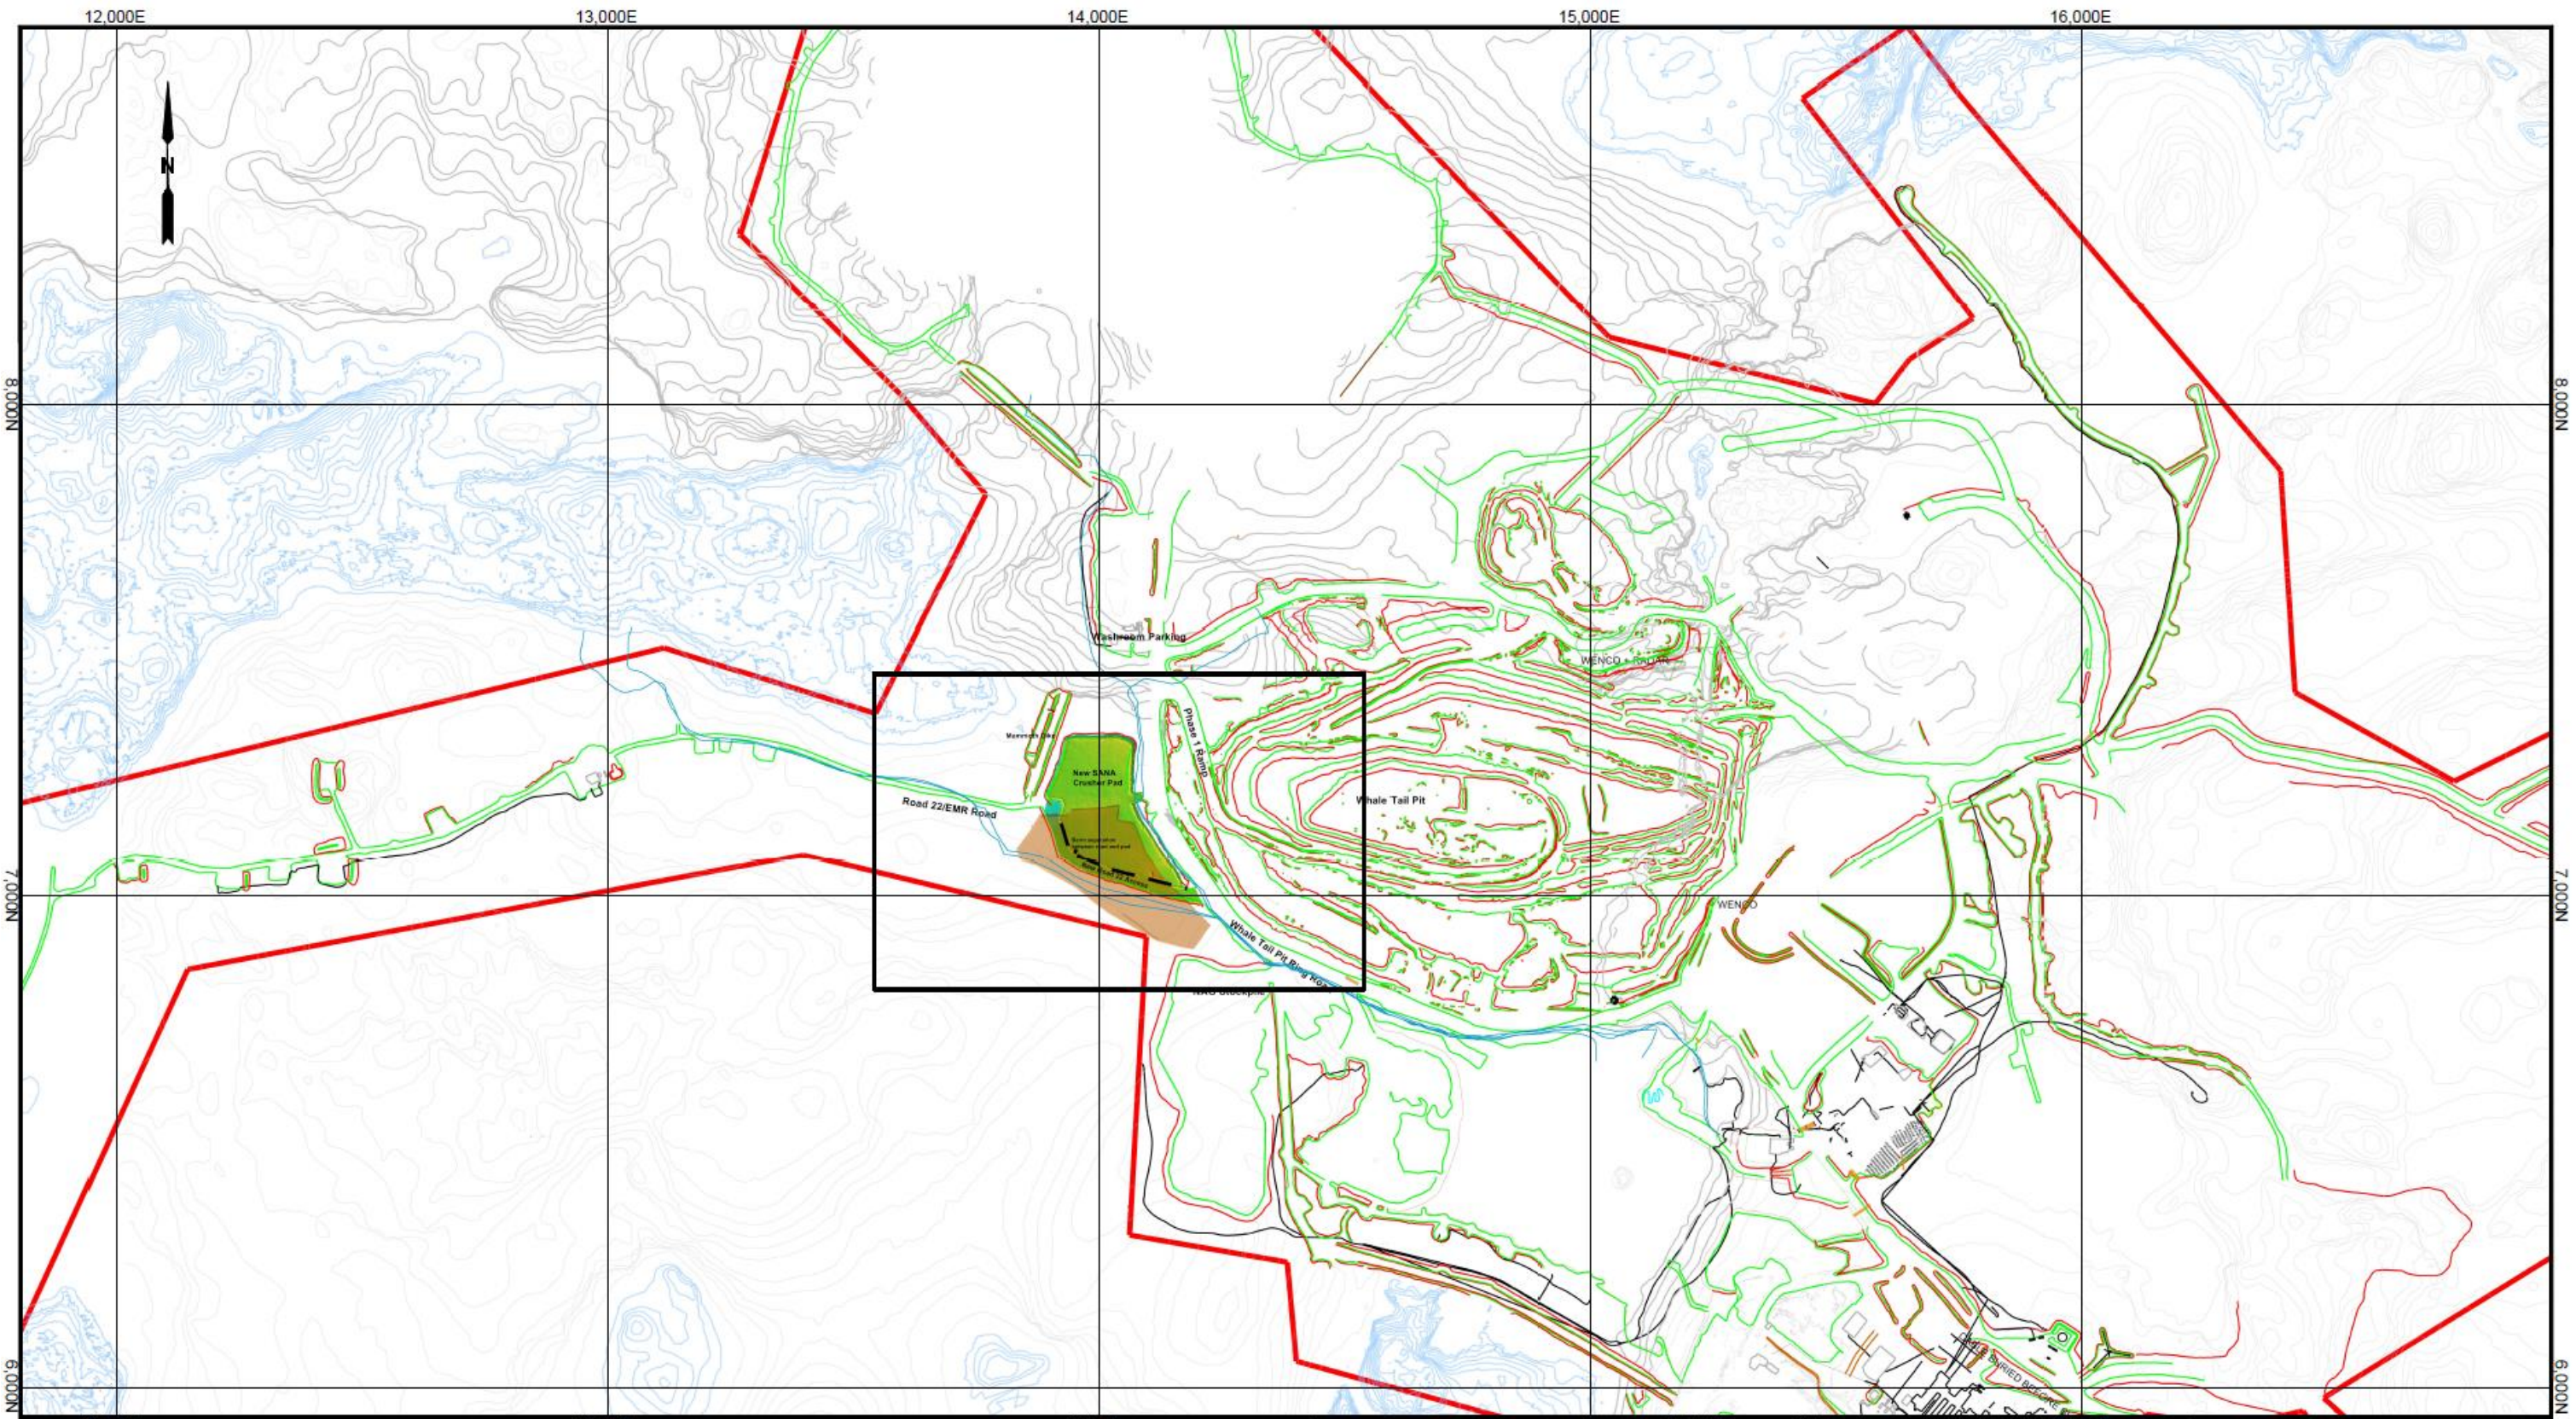
**MEADOWBANK DIVISION**  
ENGINEERING  
Amaruq Project  
**New SANA Crusher Pad**  
AS-BUILT - Overview

As-built Pad in Green  
Initial Design in translucent orange

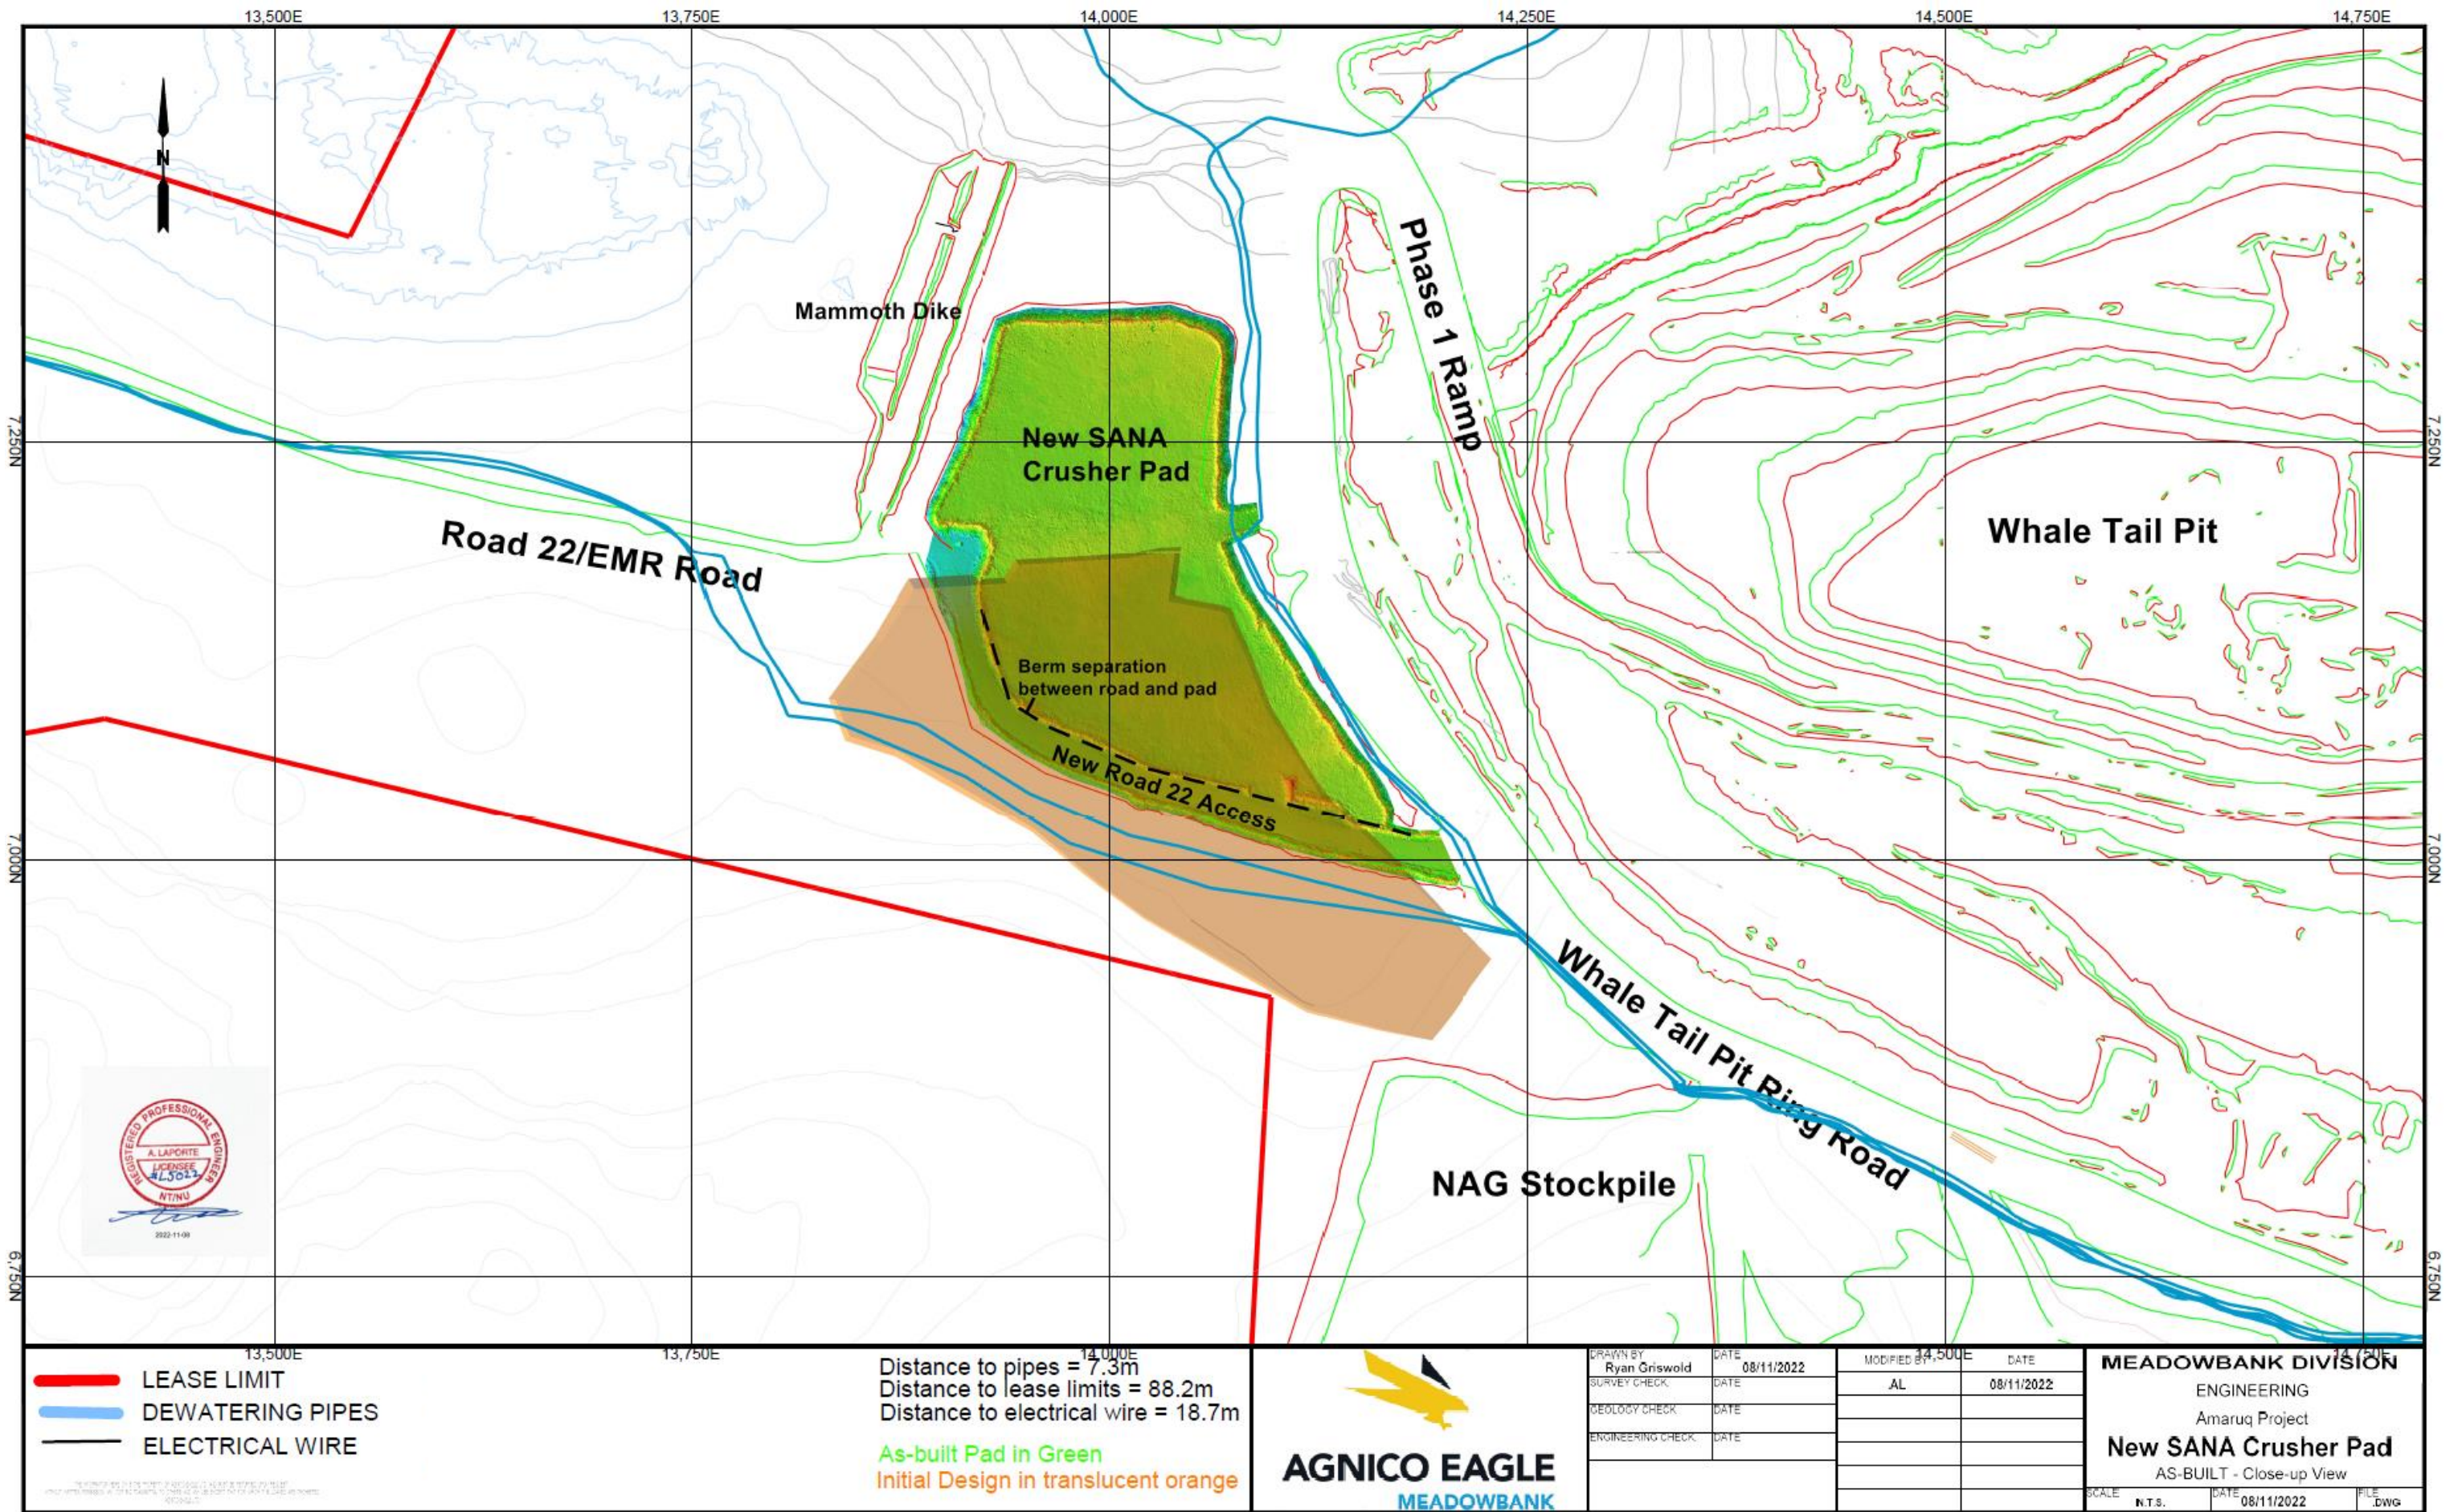
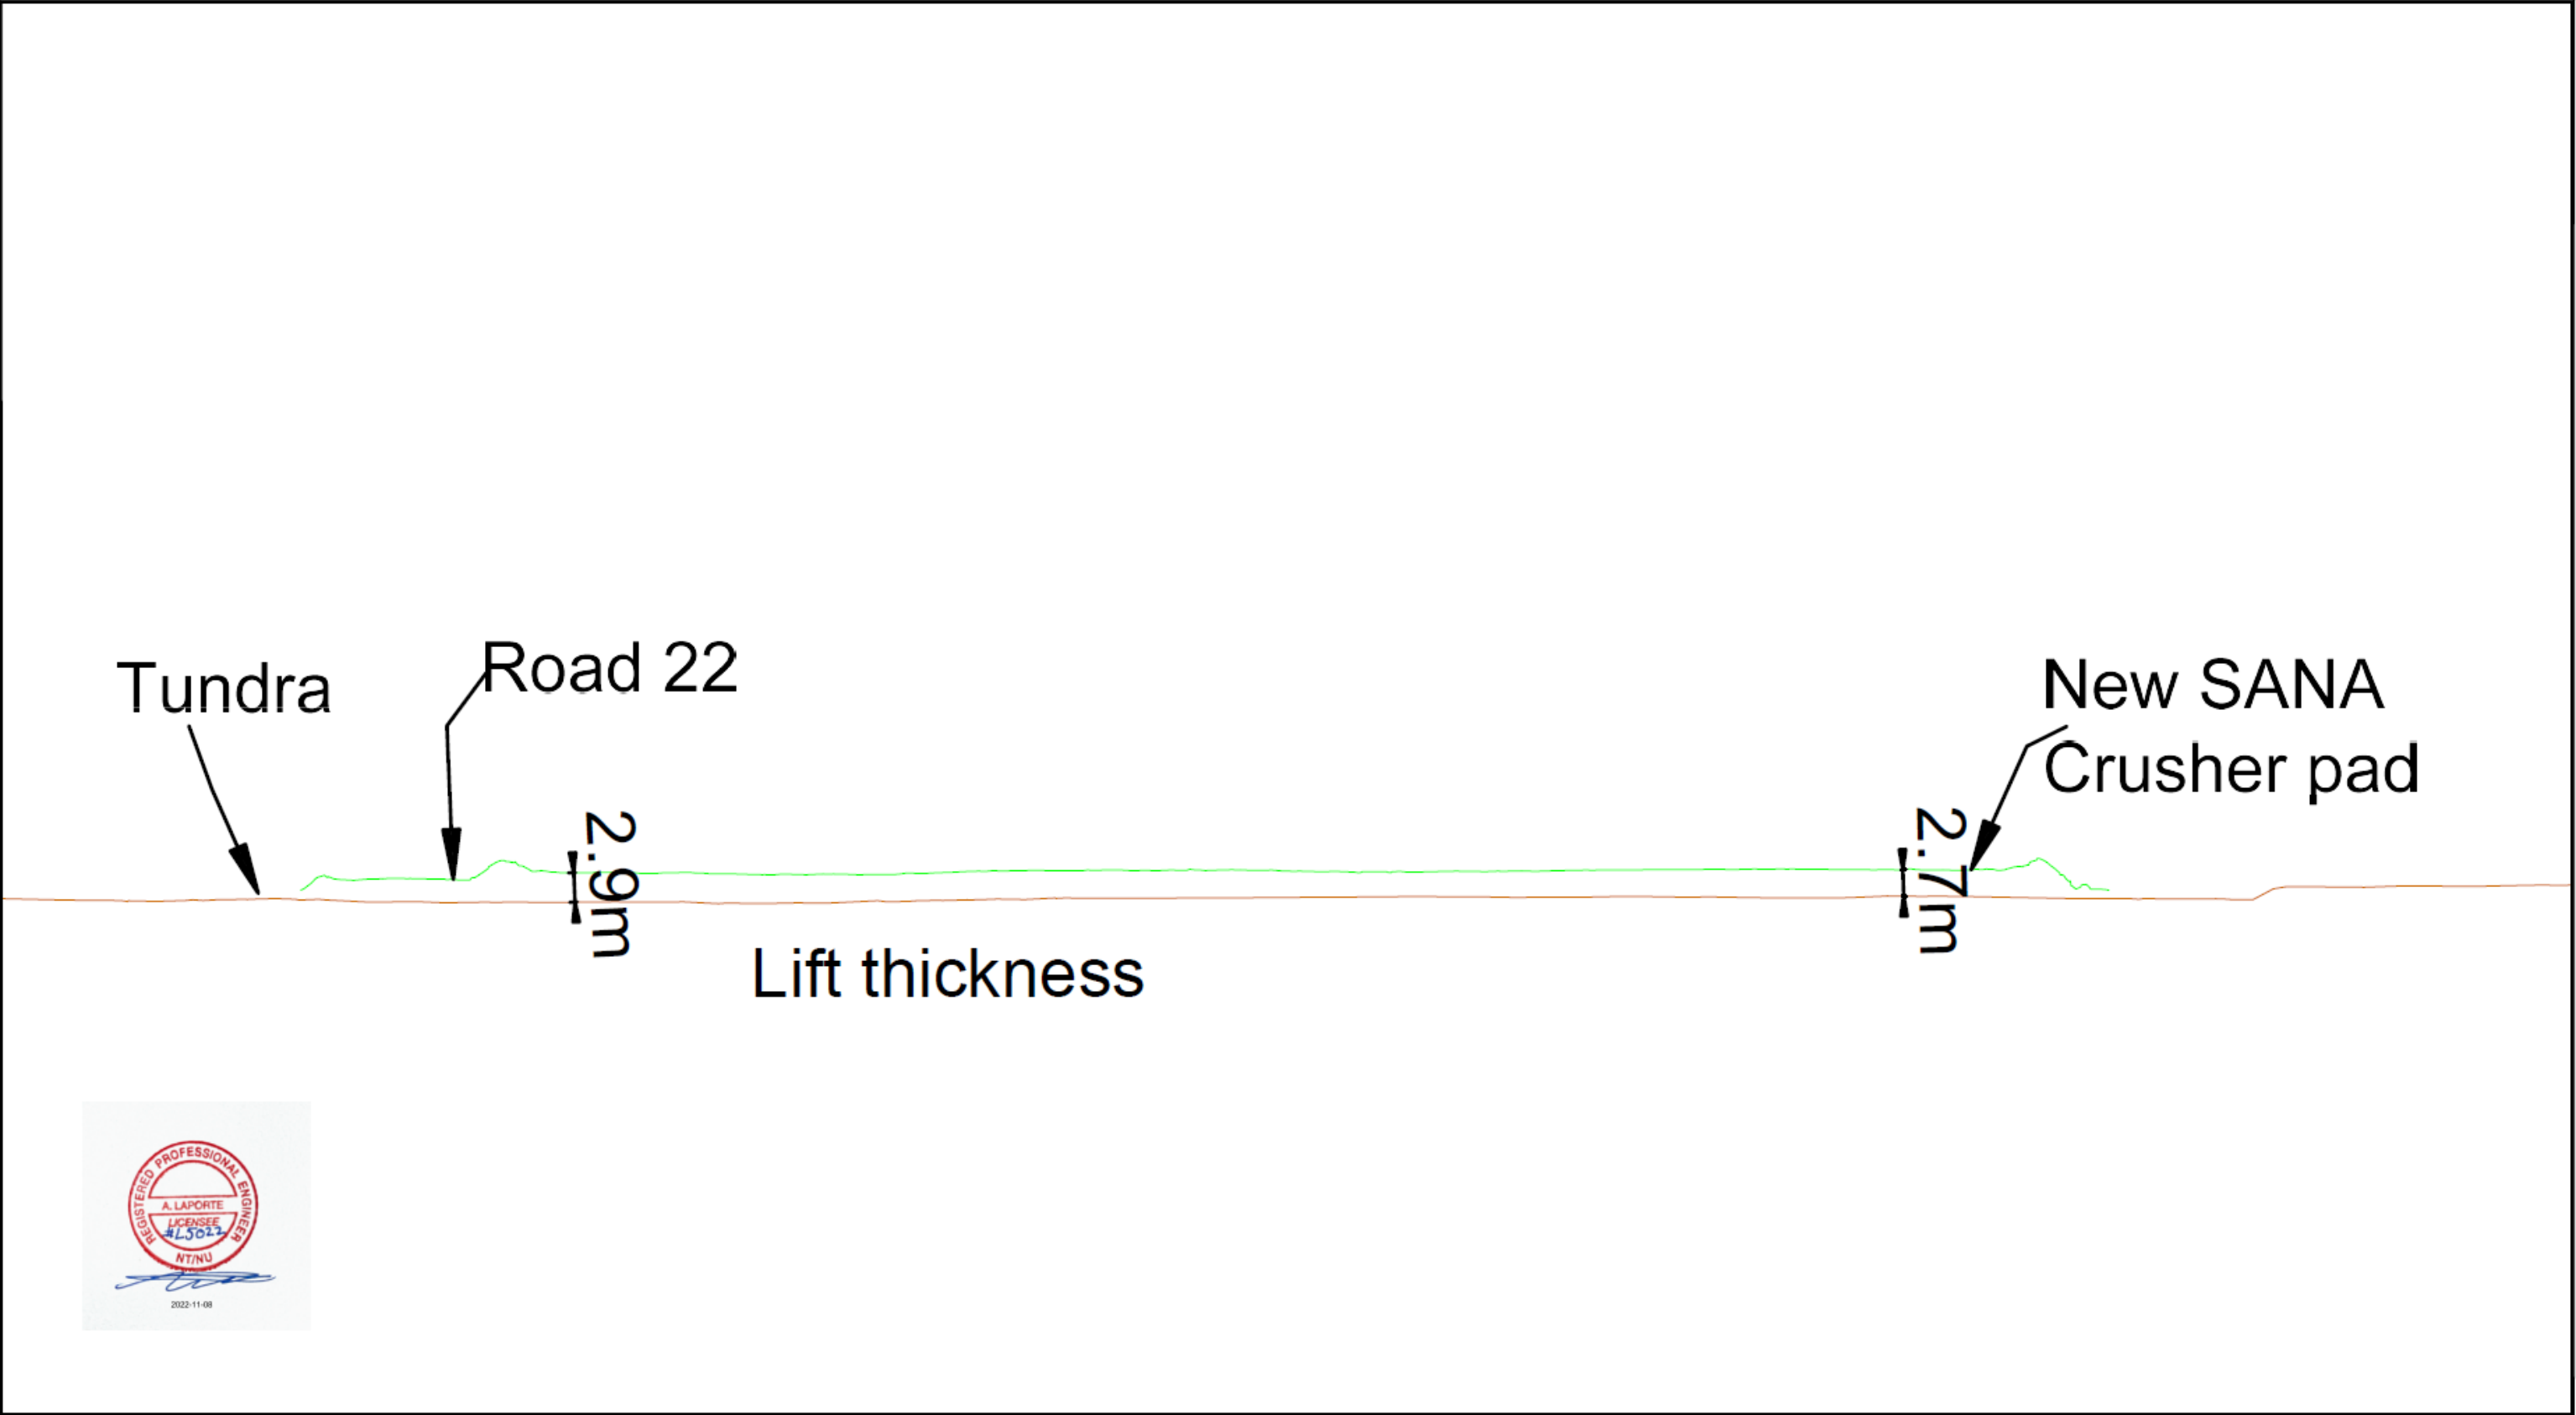
MEADOWBANK DIVISION		
ENGINEERING		
Amaruq Project		
New SANA Crusher Pad		
B-B' DESIGN & AS-BUILT		
SCALE	N.T.S.	DATE
		FILE .DWG

Section view B-B

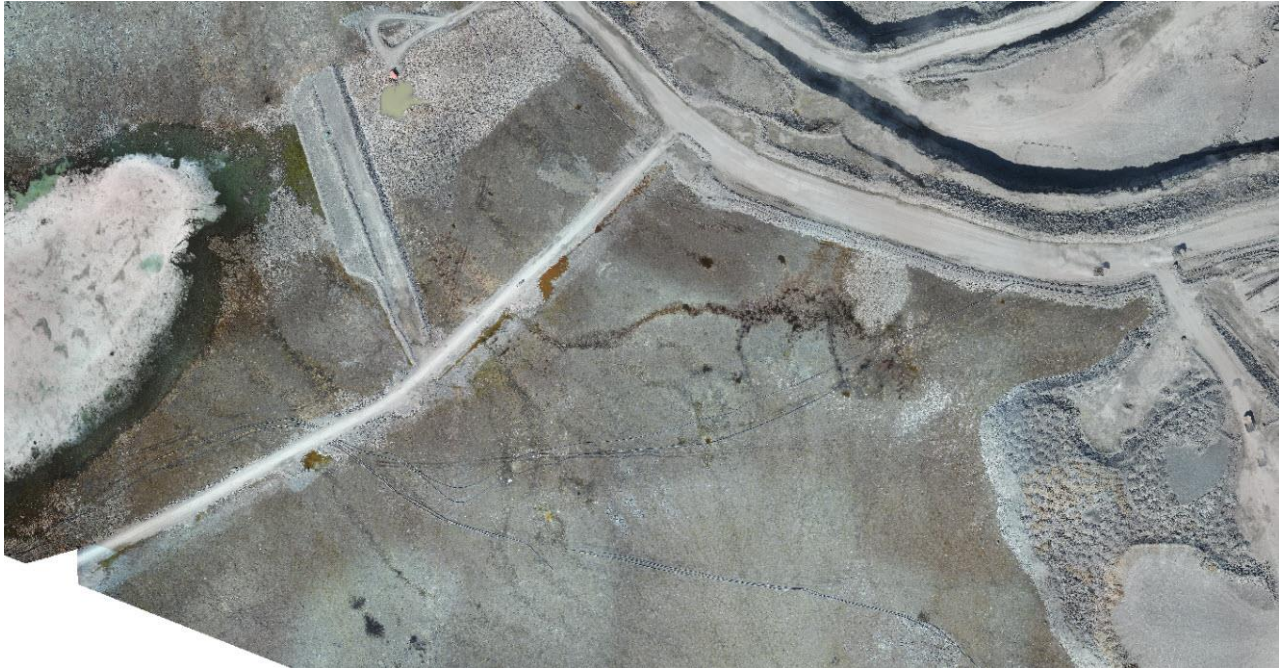
Photo 1. Initial site view

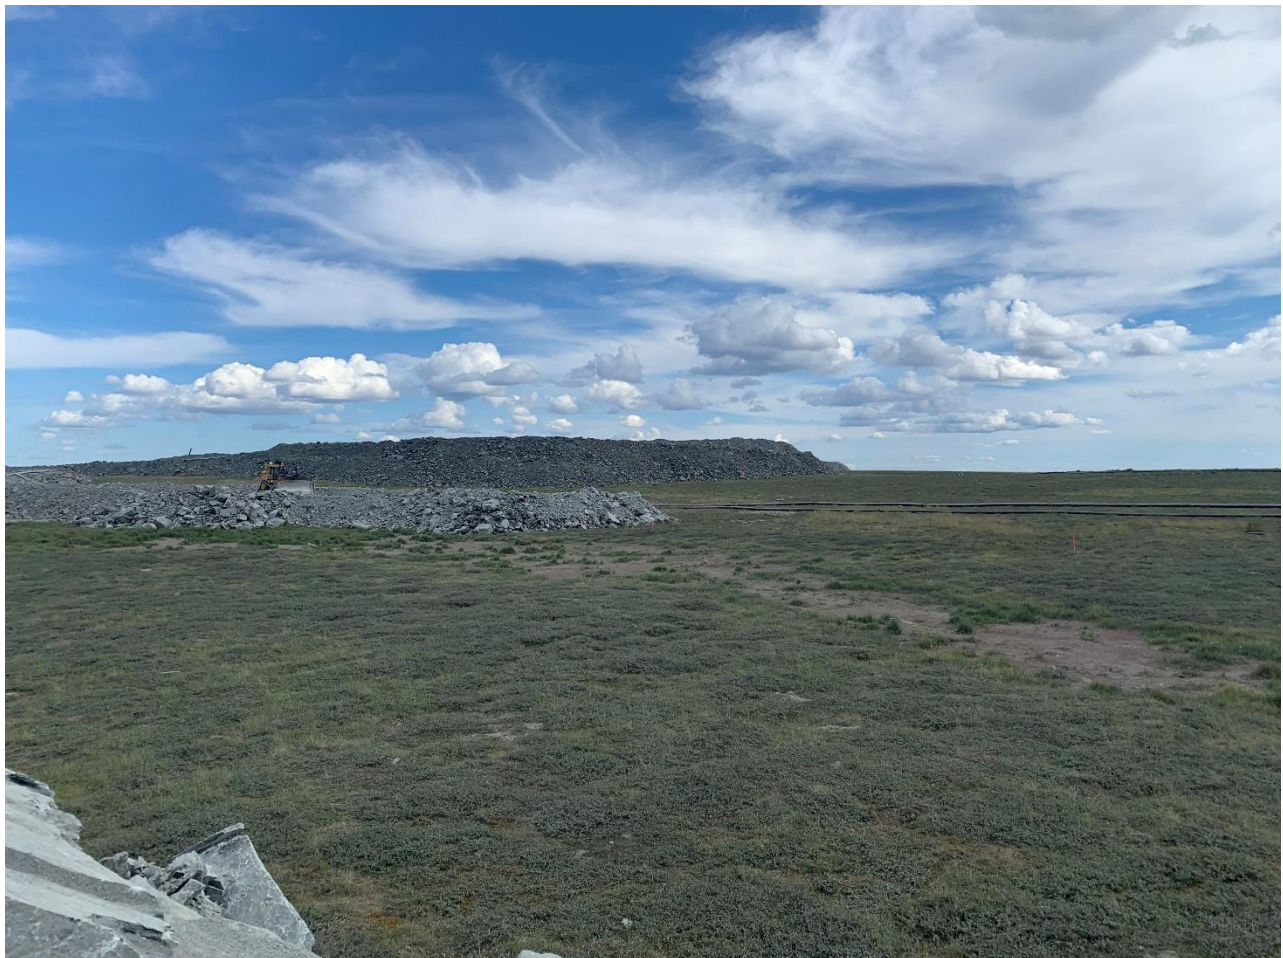
Photo 2: Construction of New Road 22.

The New Road 22 was designed to be at the same elevation as the Pad with NAG material. The road was started from the Whale Tail South Ring Road going towards the Old Road 22. The material was placed with a D10 Caterpillar dozer with NAG Pit run coming from Whale Tail Pit with 777s and 785s Caterpillar Haul Trucks. The level of the road was monitored by AEM Engineering surveyors to respect design parameters.

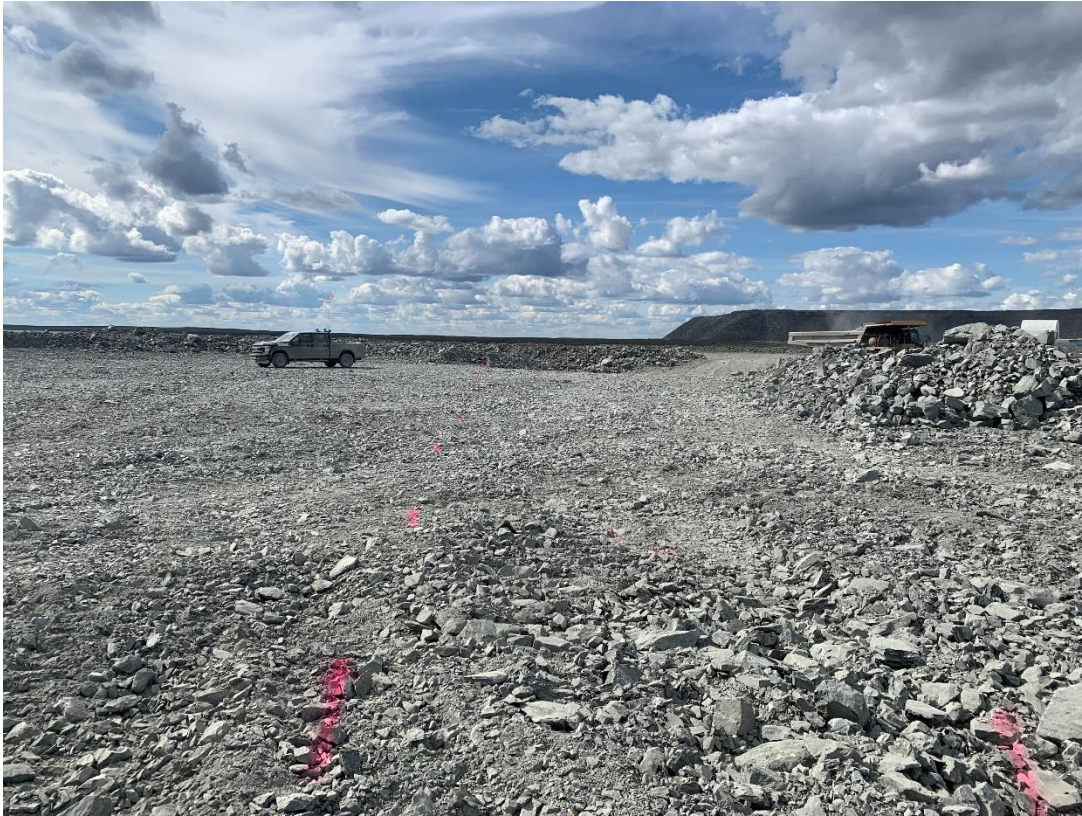
Photo 3. Delimitation of Road 22 and Pad for construction of berm

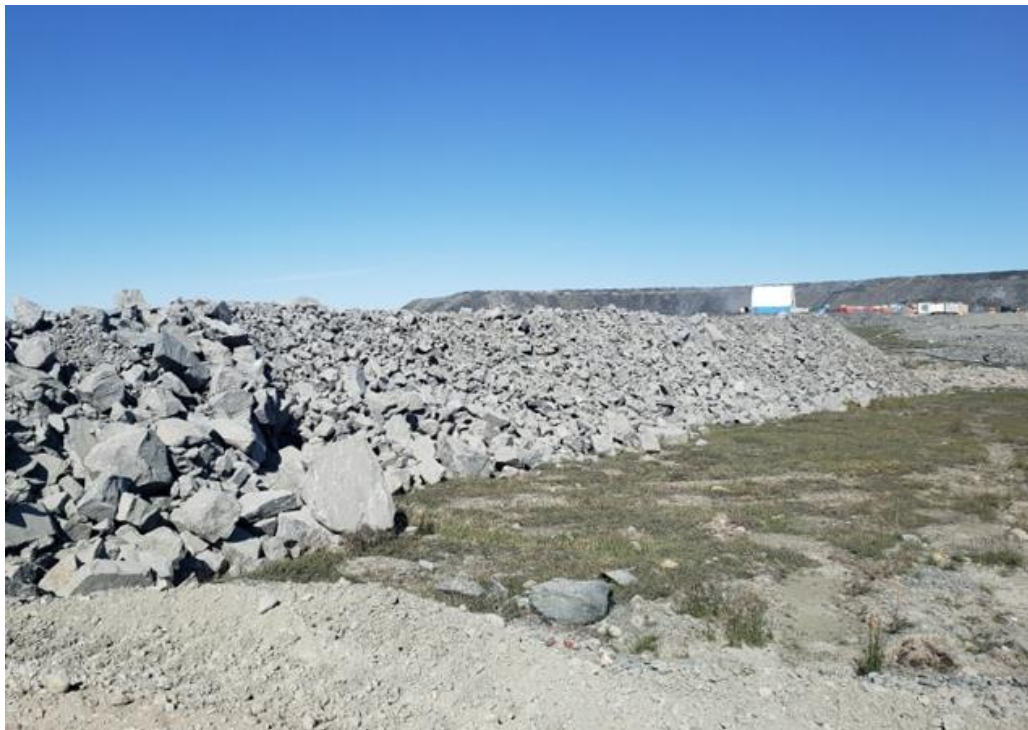
Photo 4. Final limit of Pad looking towards the WT WRSF
